**Storm Water Management and Erosion control**  
**Location Name: QB Energy KRK 7-1 (A7E) Pad**  
**Location #: 323941**

**Location Overview: Location is within High  
Priority/Density/Black Bear Habitat areas.**

**Section/Township/Range: 7 7S92W**

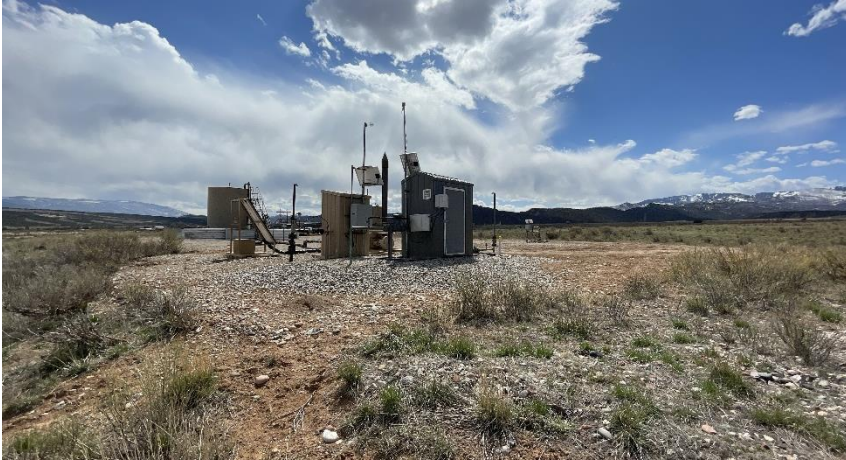
**North West corner of location.**

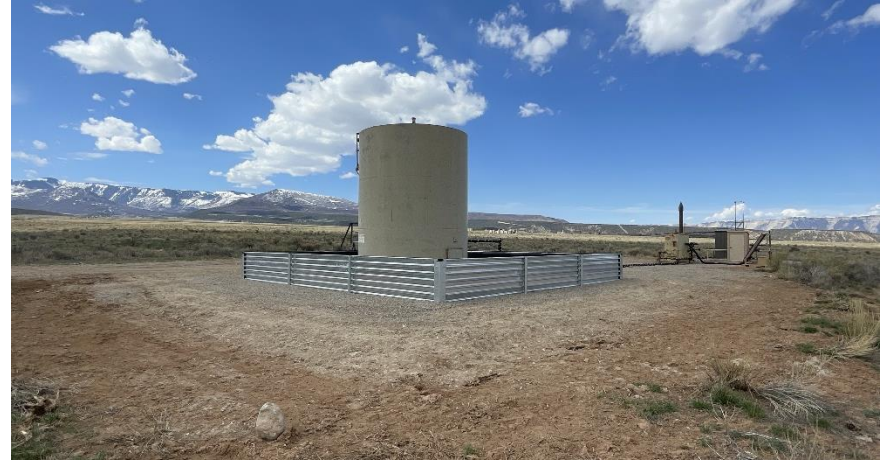
**North East corner of location.**

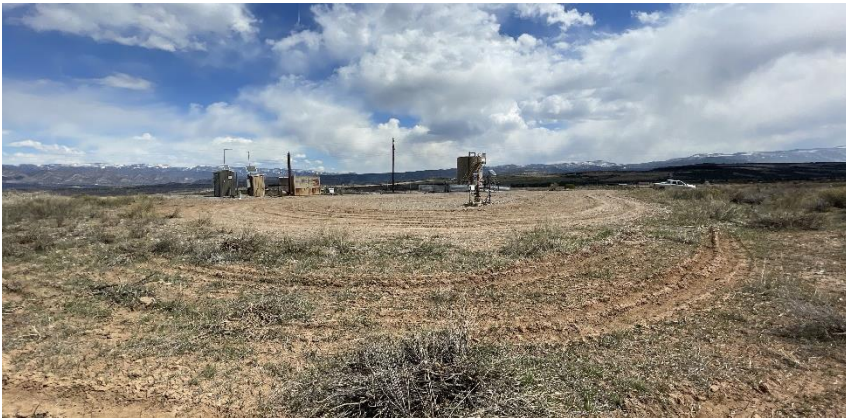
**South West corner of location.**

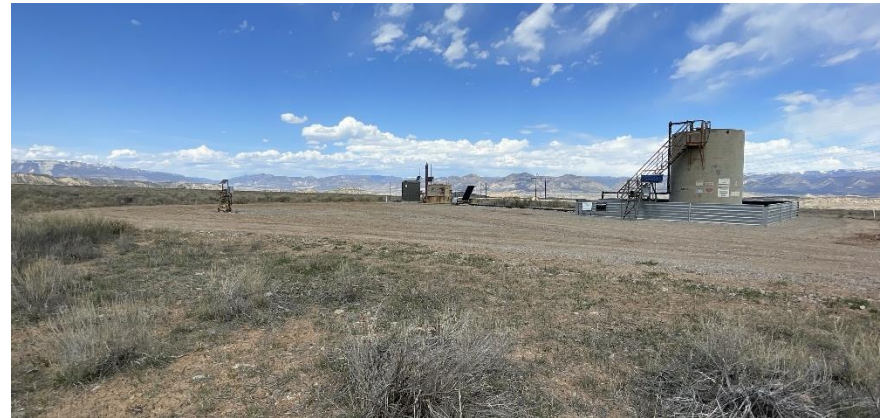
**South East corner of location.**

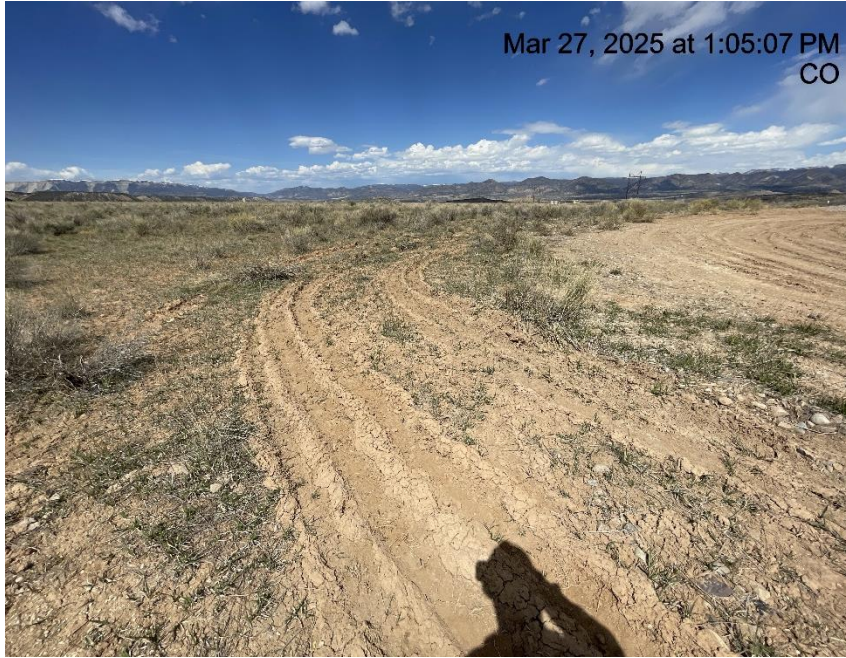
Photo # 8015 Failure to minimize surface disturbance

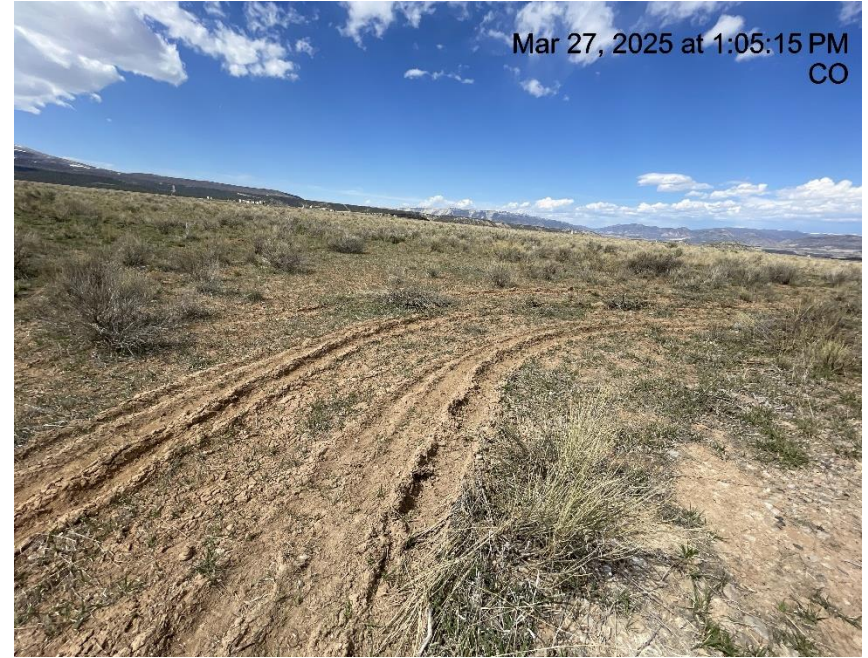
Photo # 8016 Failure to minimize surface disturbance

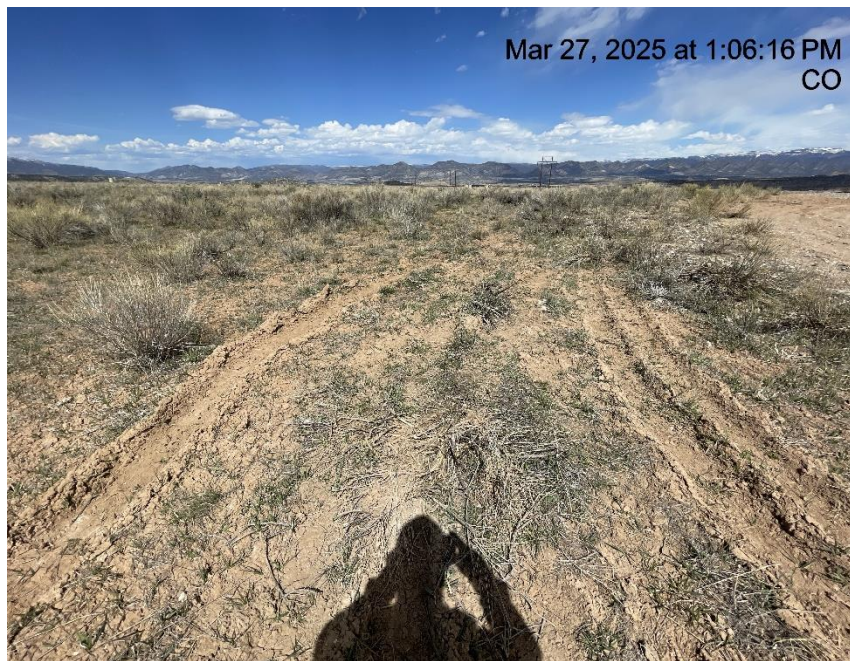
Photo # 8017 Failure to minimize surface disturbance

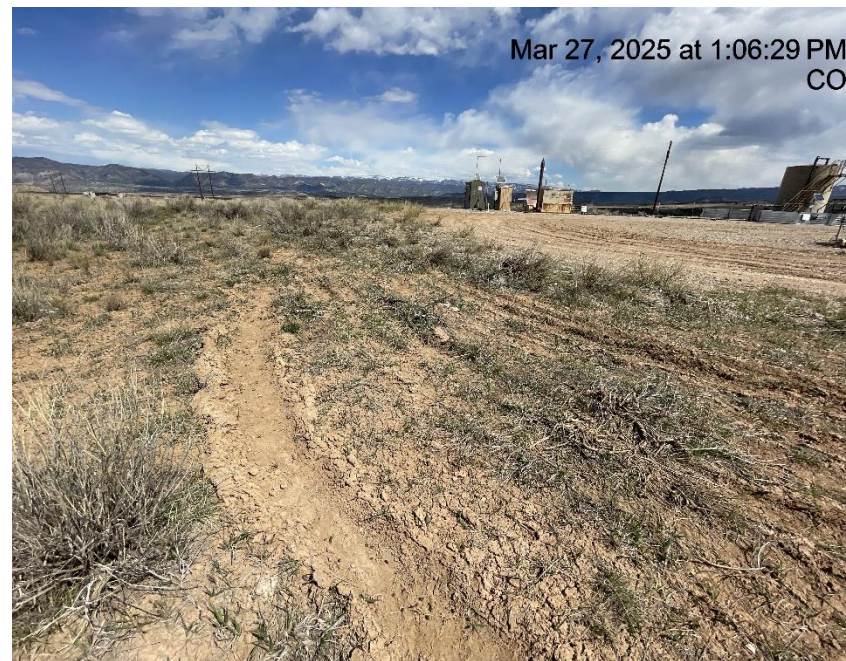
Photo # 8018 Failure to minimize surface disturbance

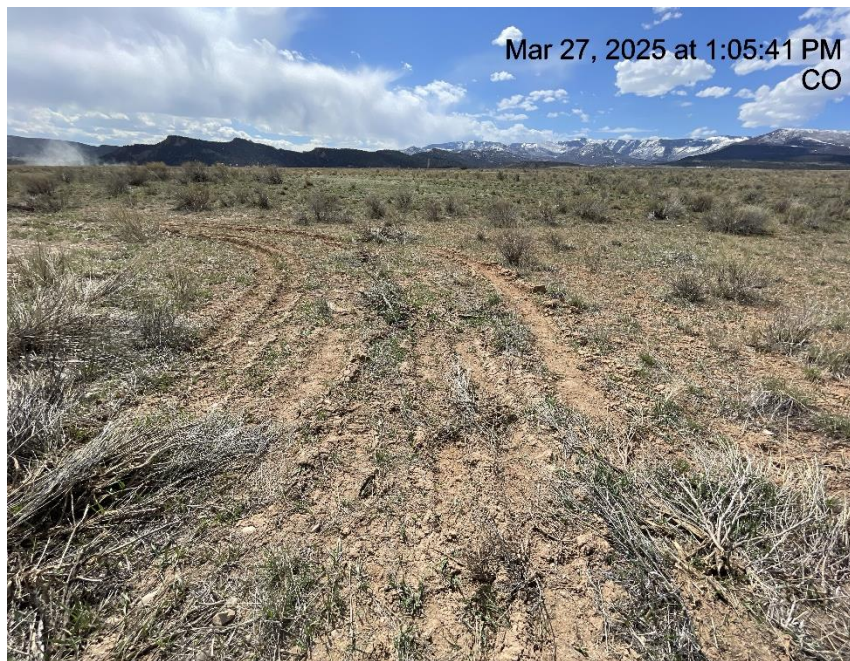
Photo # 8019 Failure to minimize surface disturbance

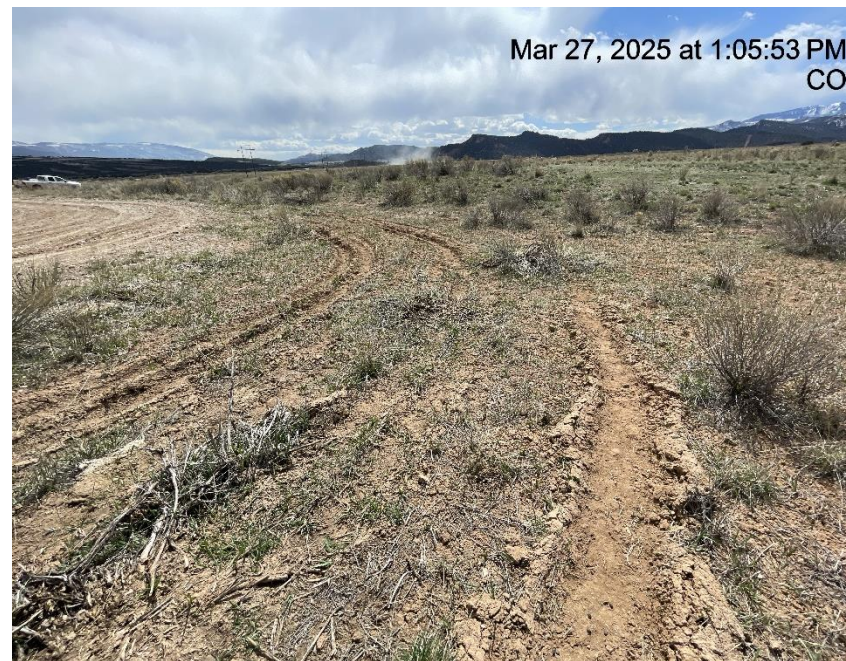
Photo # 8020 Failure to minimize surface disturbance

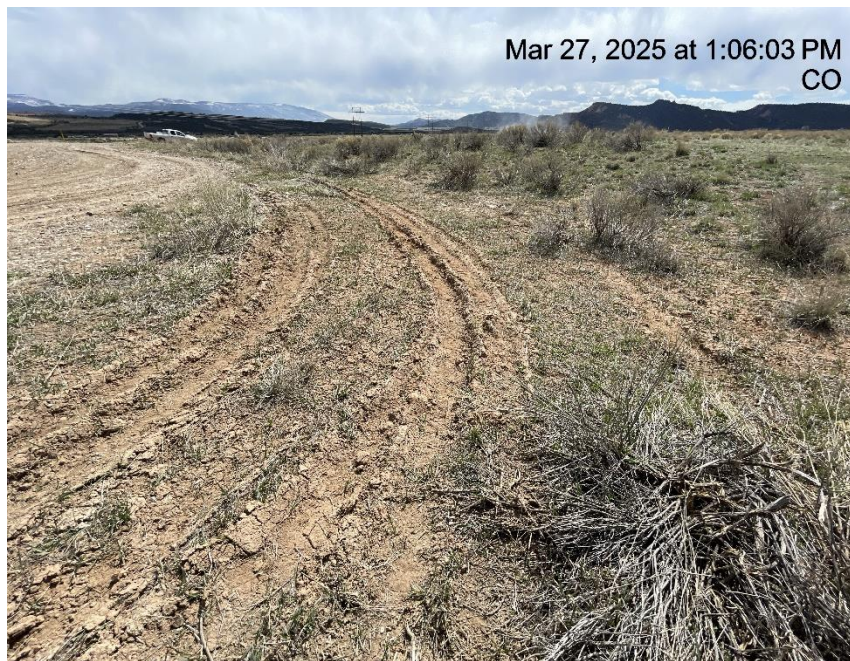
Photo # 8021 Failure to minimize surface disturbance

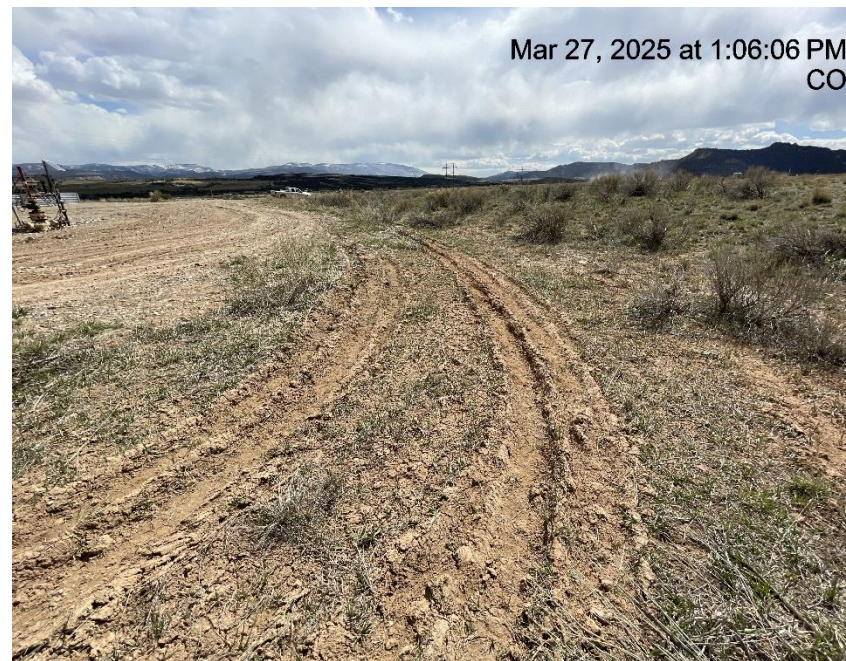
Photo # 8022 Failure to minimize surface disturbance

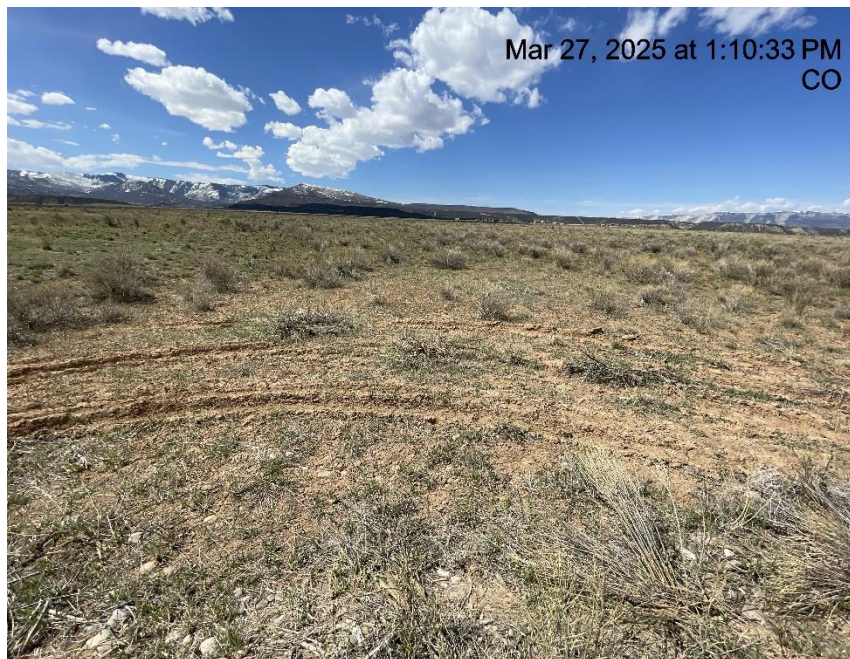
Photo # 8023 Failure to minimize surface disturbance

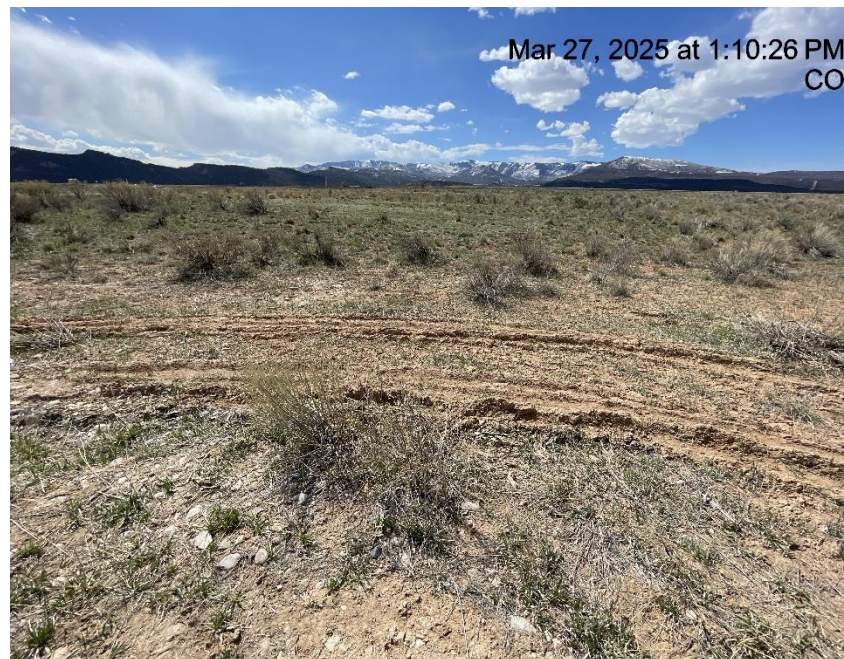
Photo # 8024 Failure to minimize surface disturbance

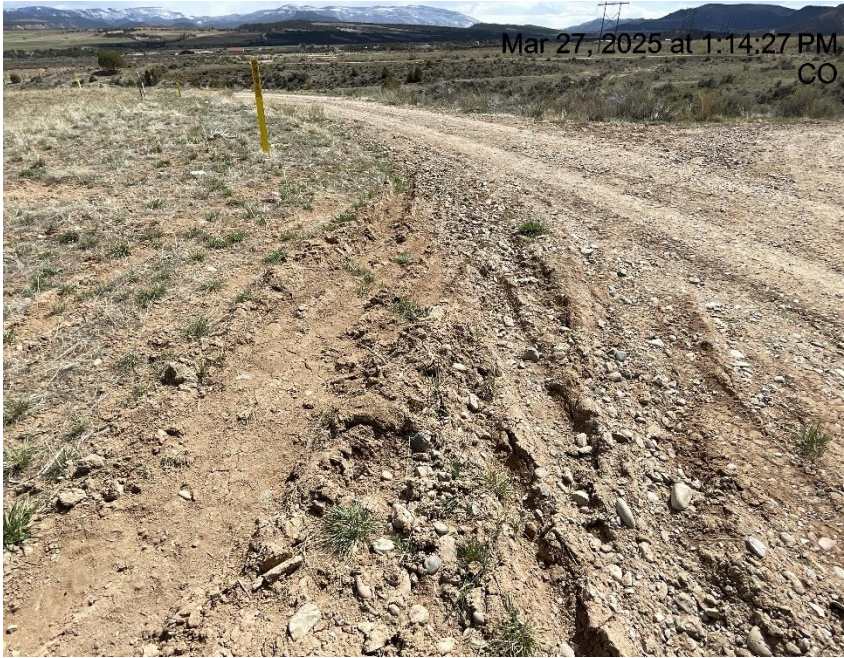
**Photo # 8025 Failure to minimize surface disturbance**

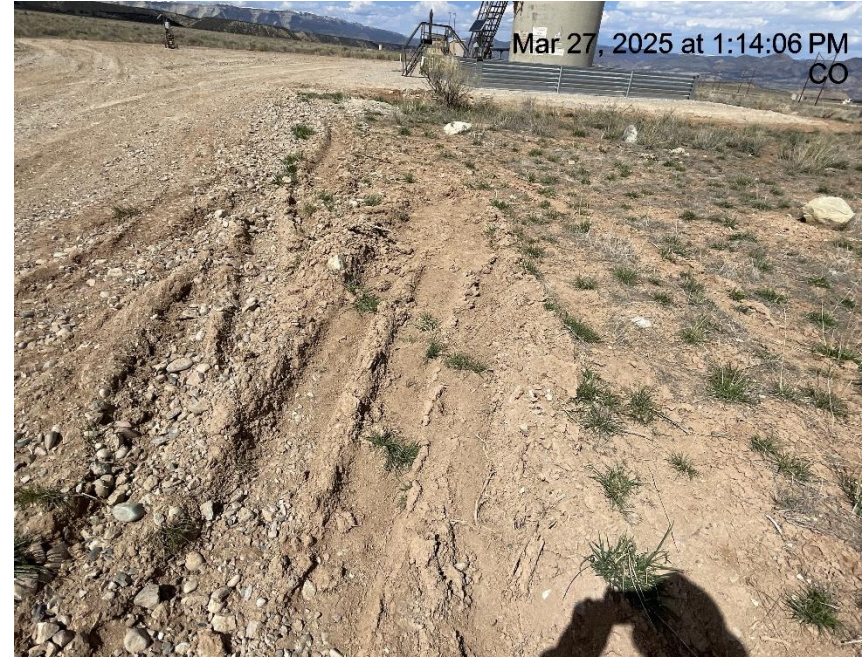
**Photo # 8026 Failure to minimize surface disturbance**

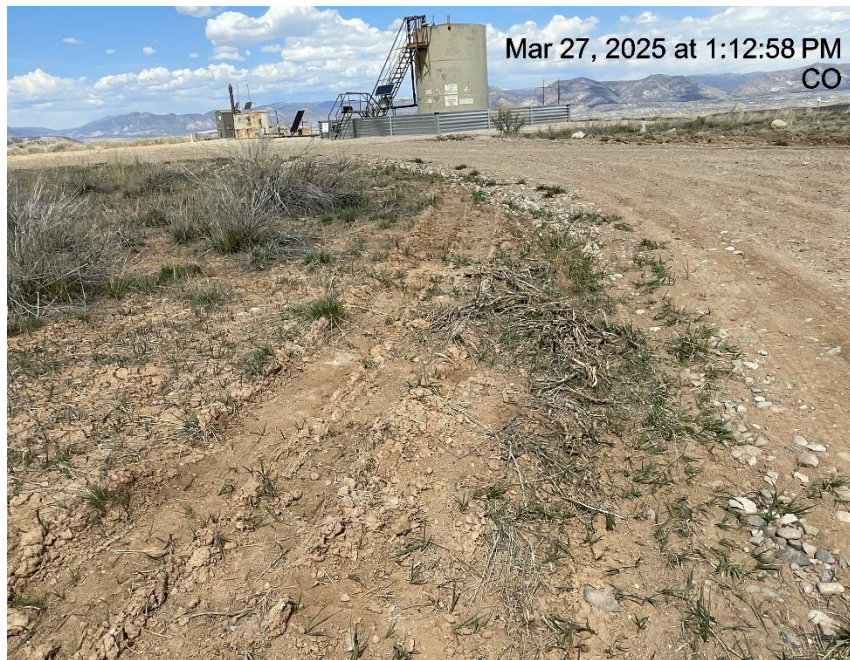
Photo # 8027 Failure to minimize surface disturbance

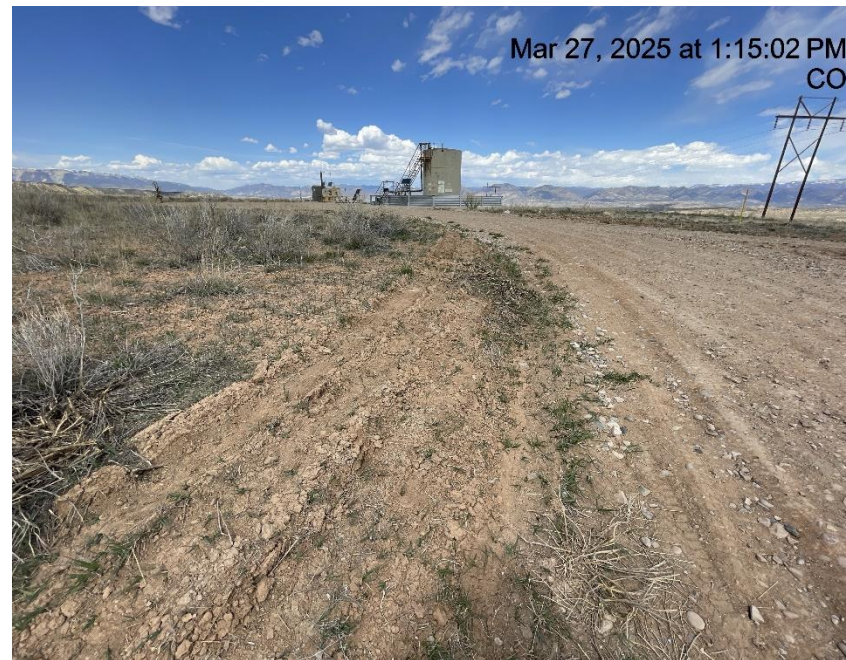
Photo # 8028 Failure to minimize surface disturbance
