Interim Reclamation and Stormwater Inspection

Operator: PADCO LLC - 24500

Location ID: 317233

Inspection Document #: 718700227

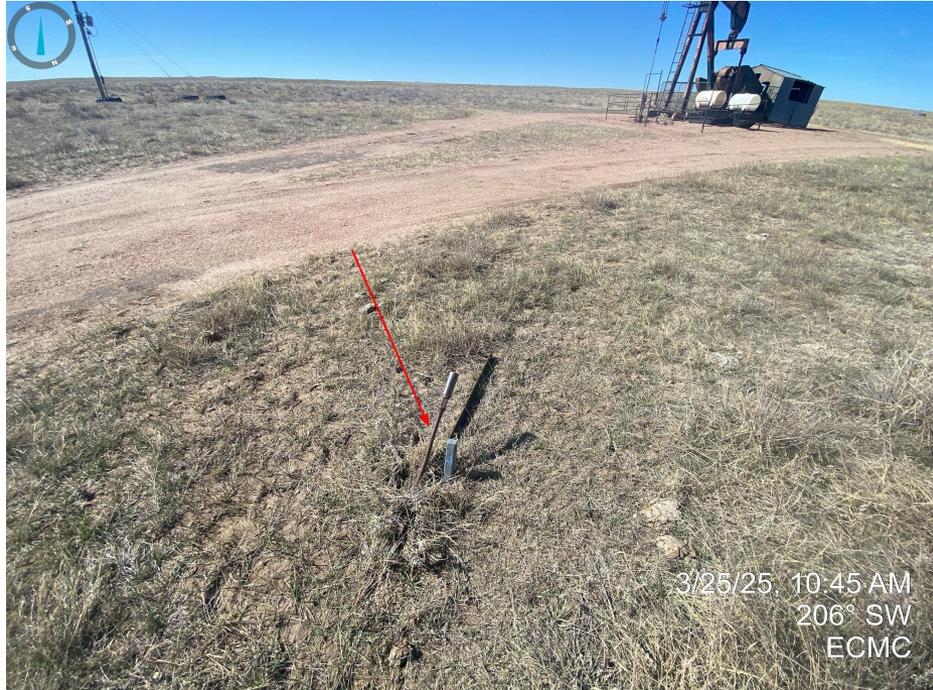
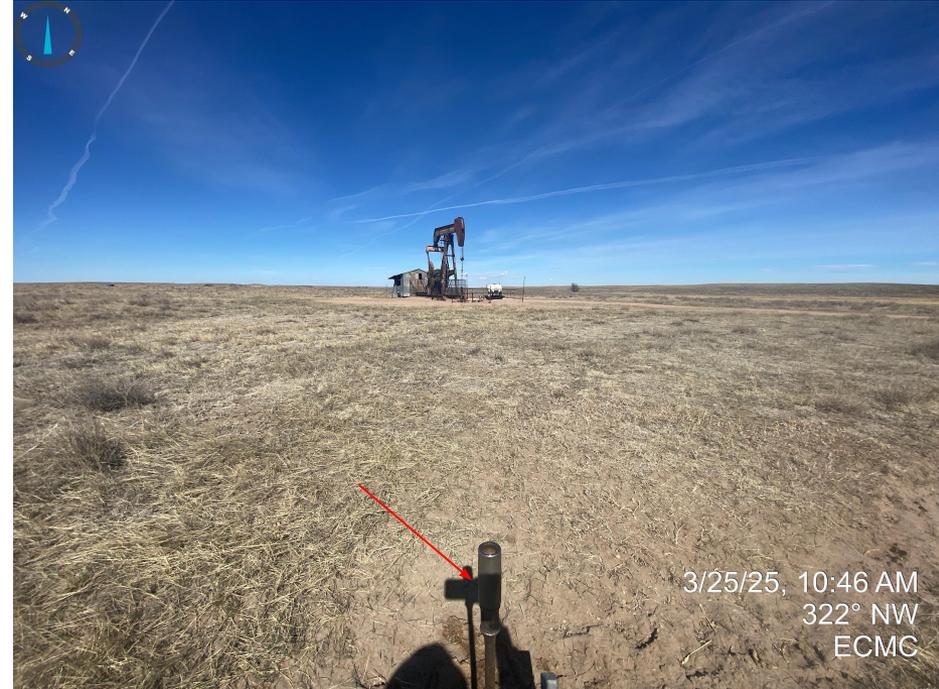
Photos 1 & 2. Taken from the northeast (Photo 1; left) and southeast (Photo 2; right) portions of the location. Guy lines anchors do not appear to be properly marked (e.g. bright colored marker not less than four (4) feet in height).

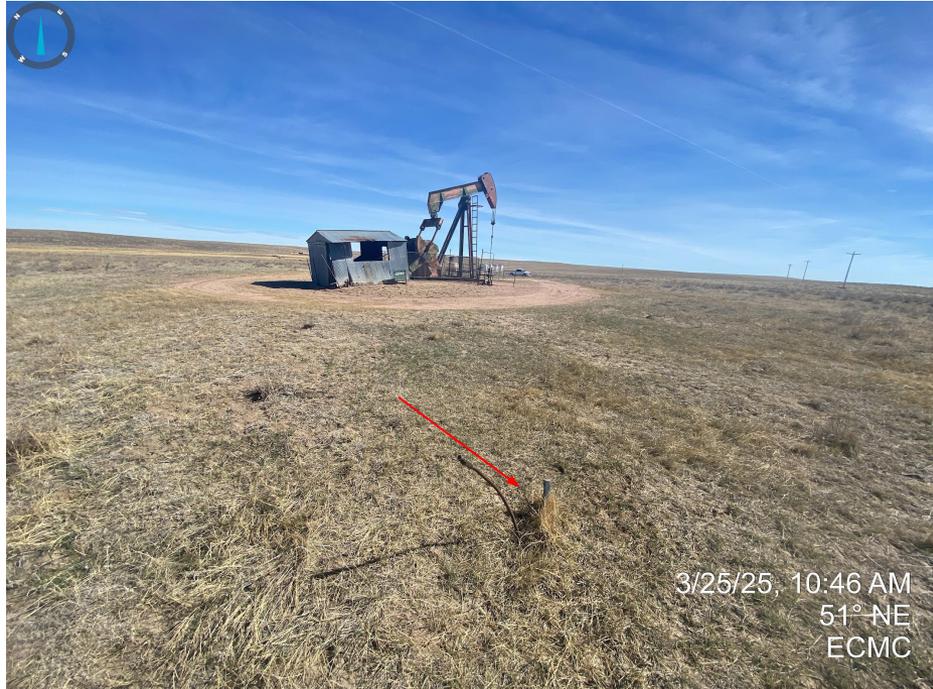
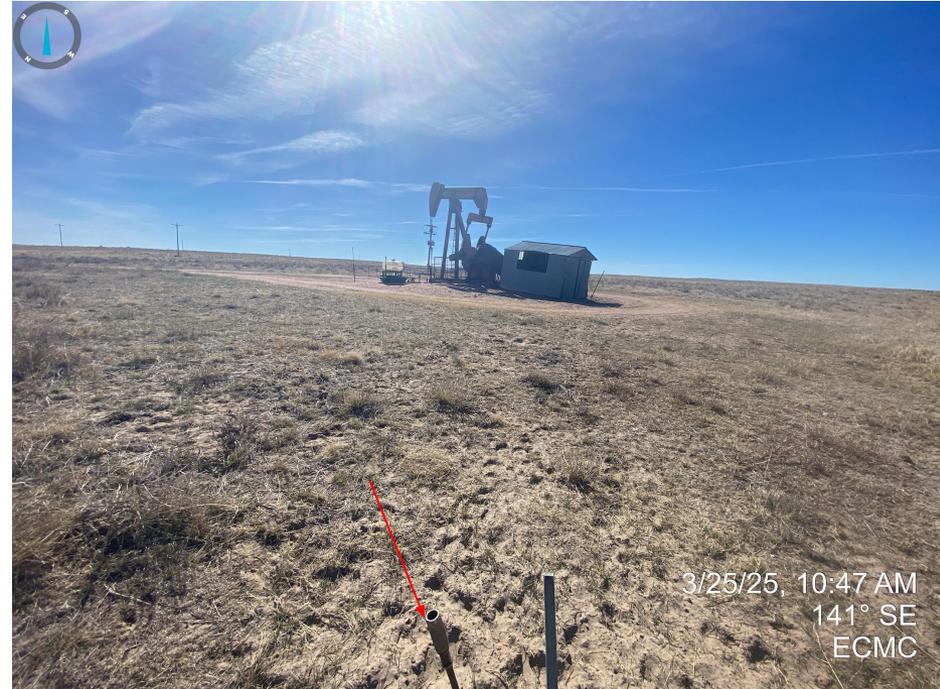
Photos 3 & 4. Taken from the southwest (Photo 3; left) and northwest (Photo 4; right) portions of the location. Guy lines anchors do not appear to be properly marked (e.g. bright colored marker not less than four (4) feet in height).

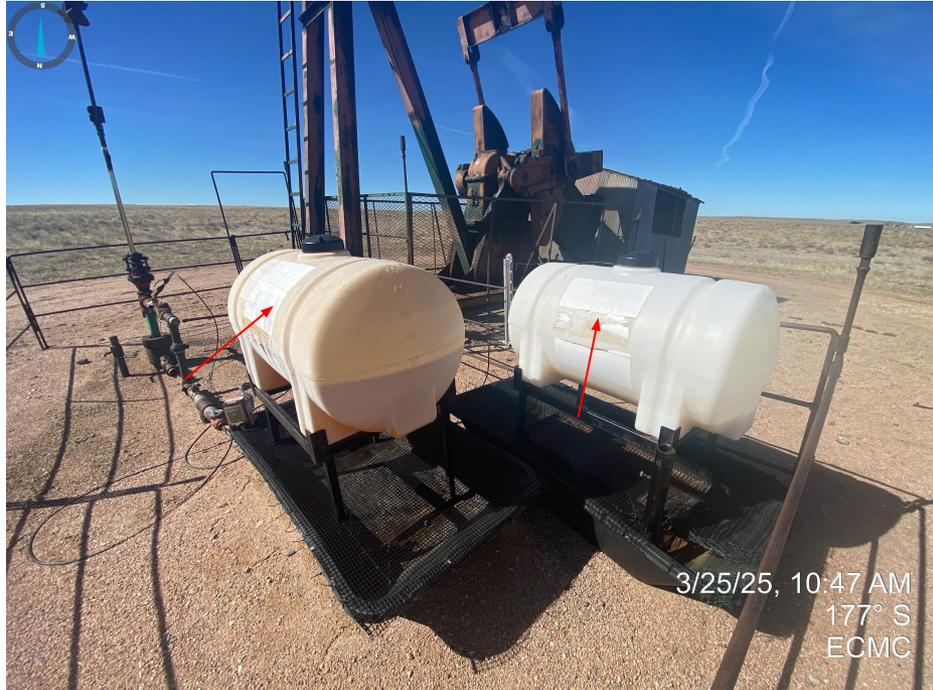
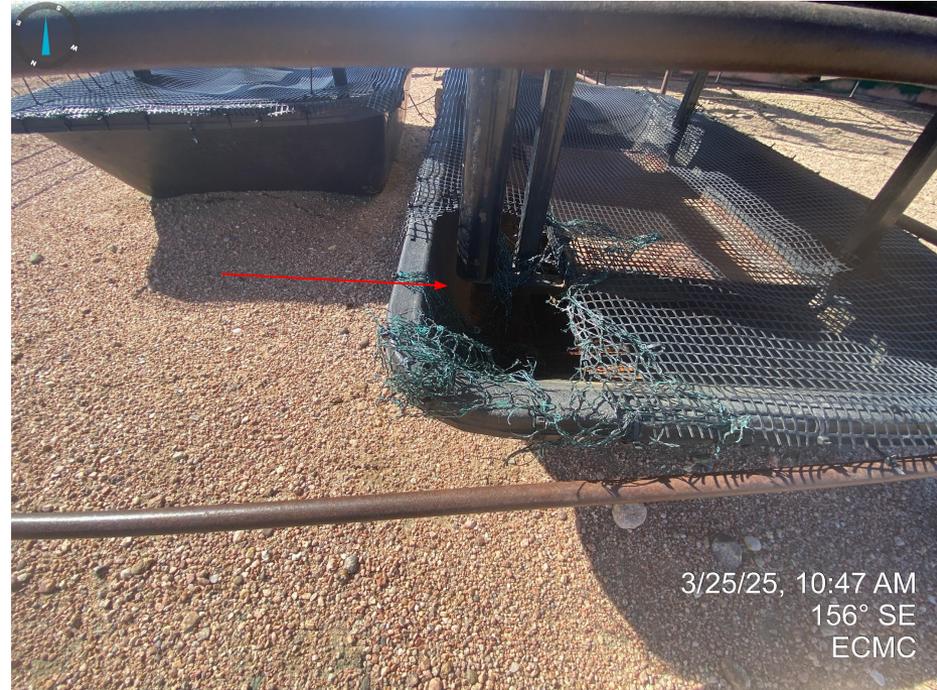
Photos 5 & 6. Tank labels/NFPA placards are not legible at day tanks (Photo 5; left) and wildlife exclusion device requires maintenance and/or replacement (Photo 6; right).

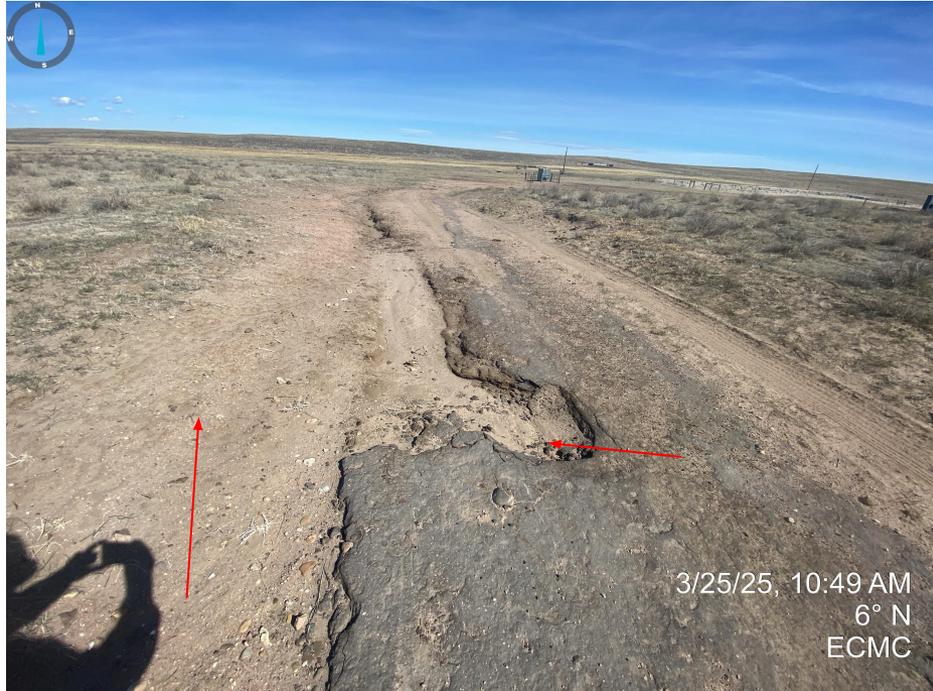
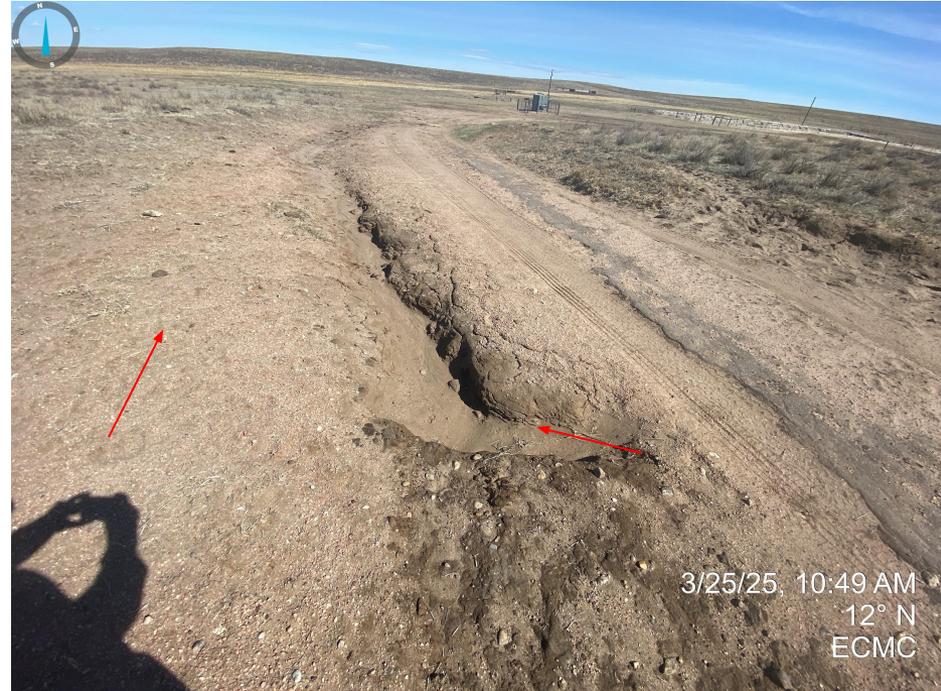
Photos 7 & 8. Erosion degradation and unstabilized soils observed along the access road to the well location.

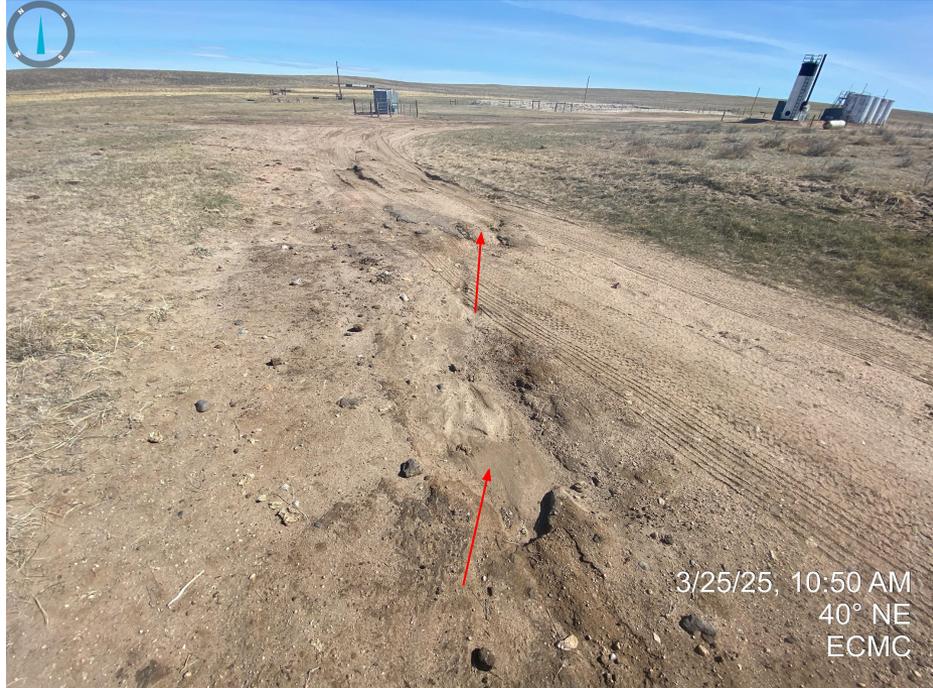
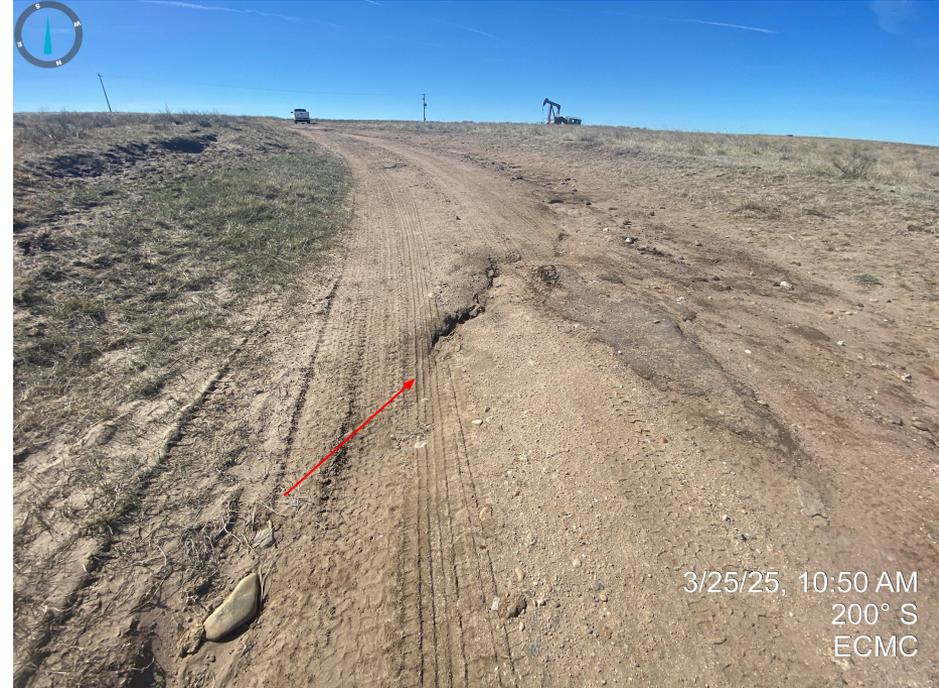
Photos 9 & 10. Erosion degradation and unstabilized soils observed along the access road to the well location.
