Final Reclamation and Stormwater Inspection

March 17, 2025

Well Name: DUMLER #2-A

Inspection Document #: 718600398

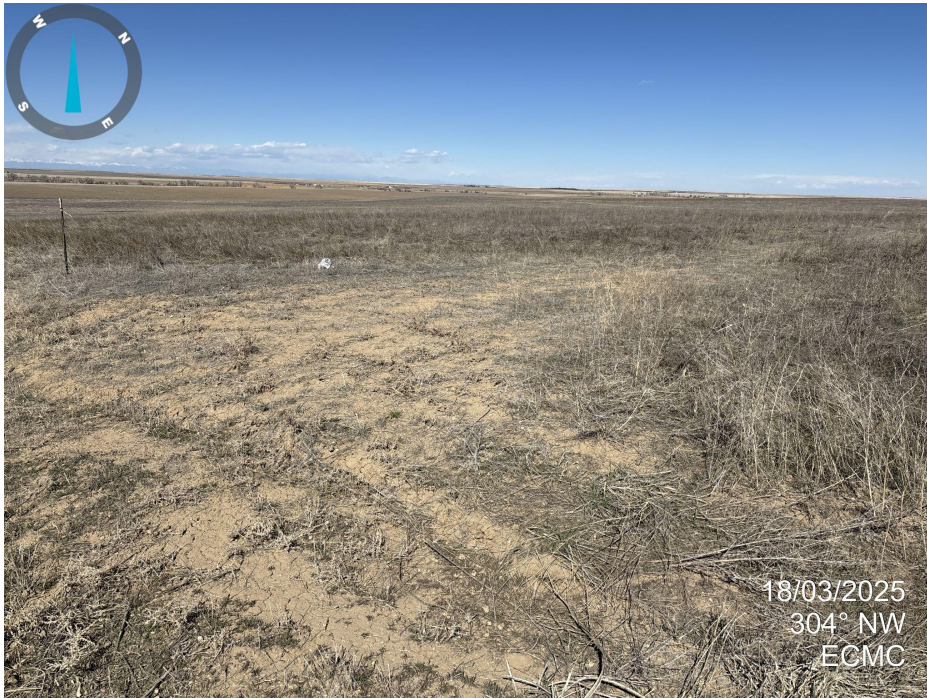
Photo 1. Looking northwest across entrance of access road. This spot has lower vegetation compared to surrounding area, with some bare soil.

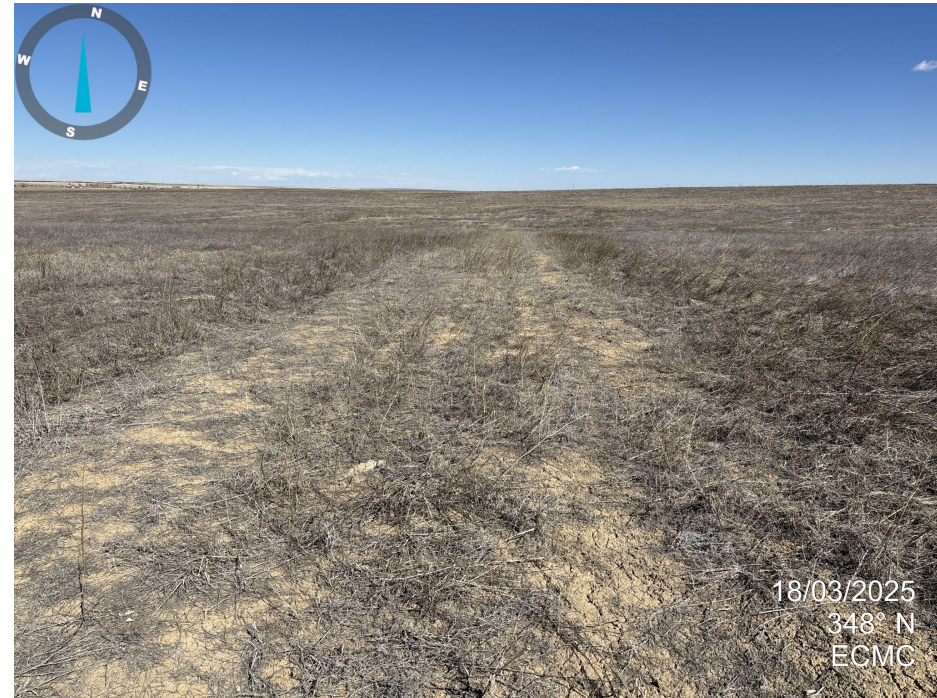
Photo 2. Looking north down former access road. vegetation establishment is low on the road with non-uniform coverage. There is very little desirable vegetation establishment.

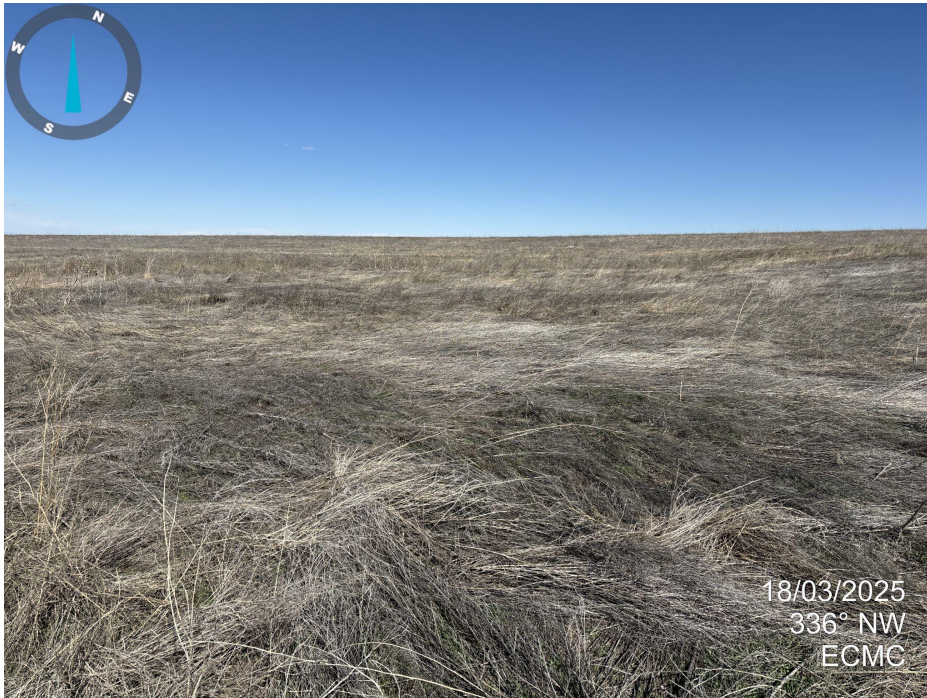
Photo 3. Looking north across the well location. Vegetation on well location appears to consist of weedy species such as Tansy and Blue Mustard, Kochia, Russian thistle, as well as List C noxious weed cheatgrass. Reference area vegetation is also poor but mustard family weeds are not as prevalent.

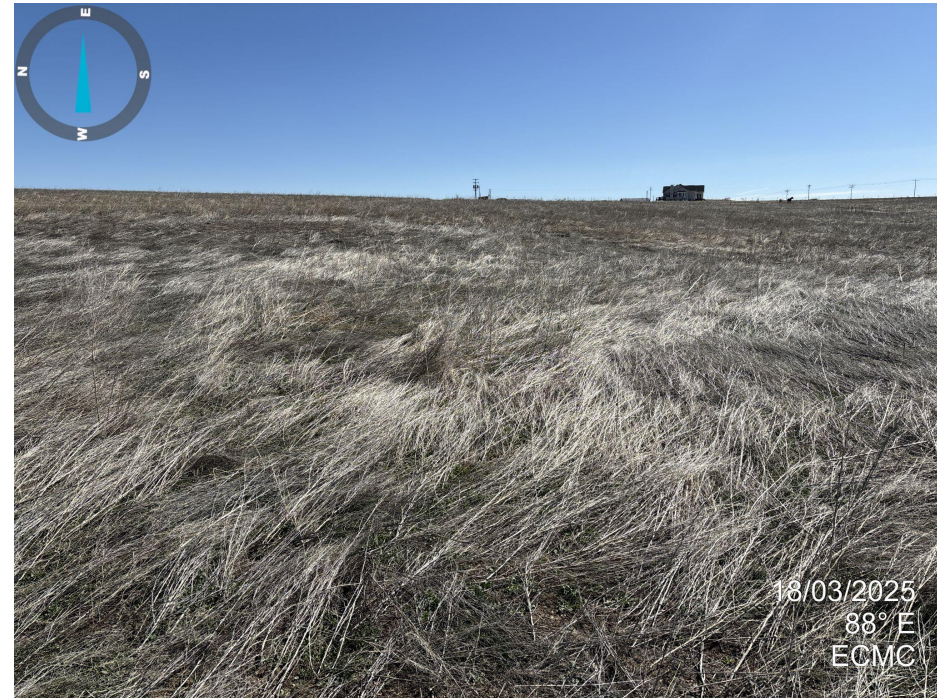
Photo 4. Looking east from wellbore. See photo 3 comments.

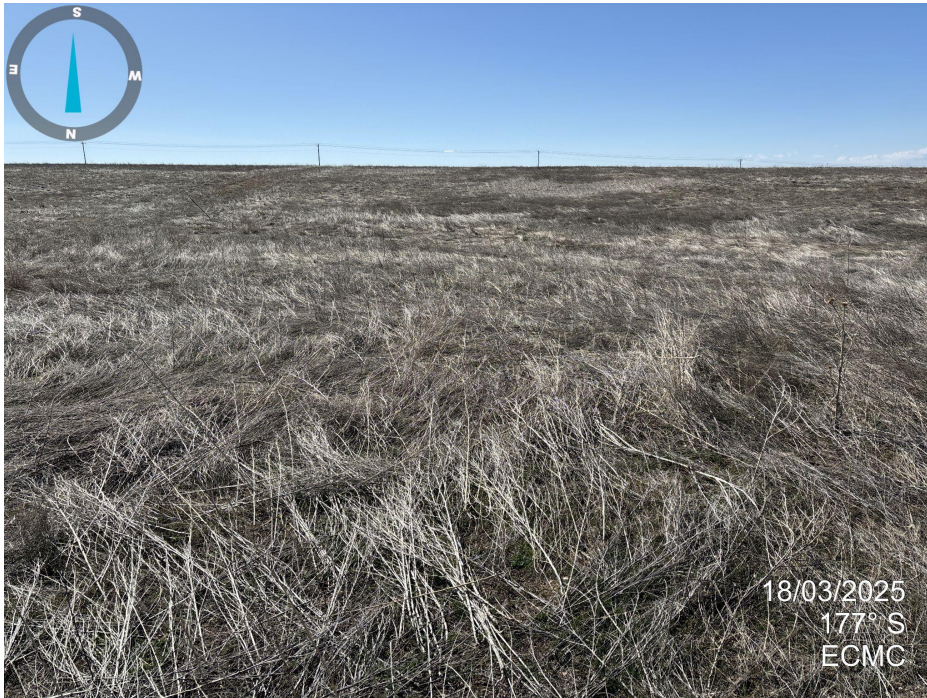
Photo 5. Looking south from wellbore. See photo 3 comments.

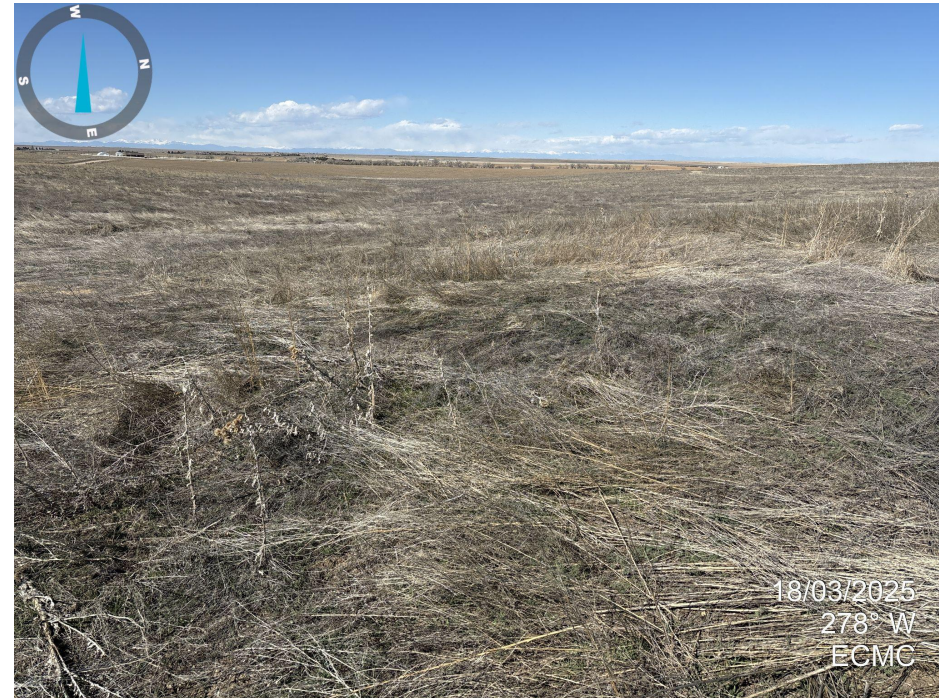
Photo 6. Looking west from wellbore. List B noxious weed scotch thistle is present on location.

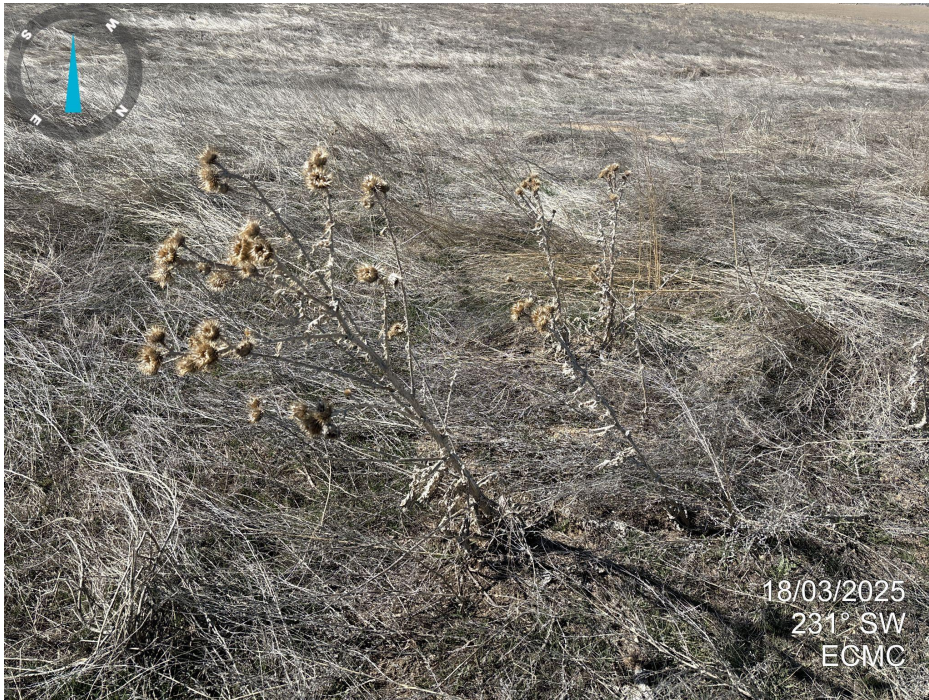
Photo 7. Picture taken on west side of location. Scotch thistle on location

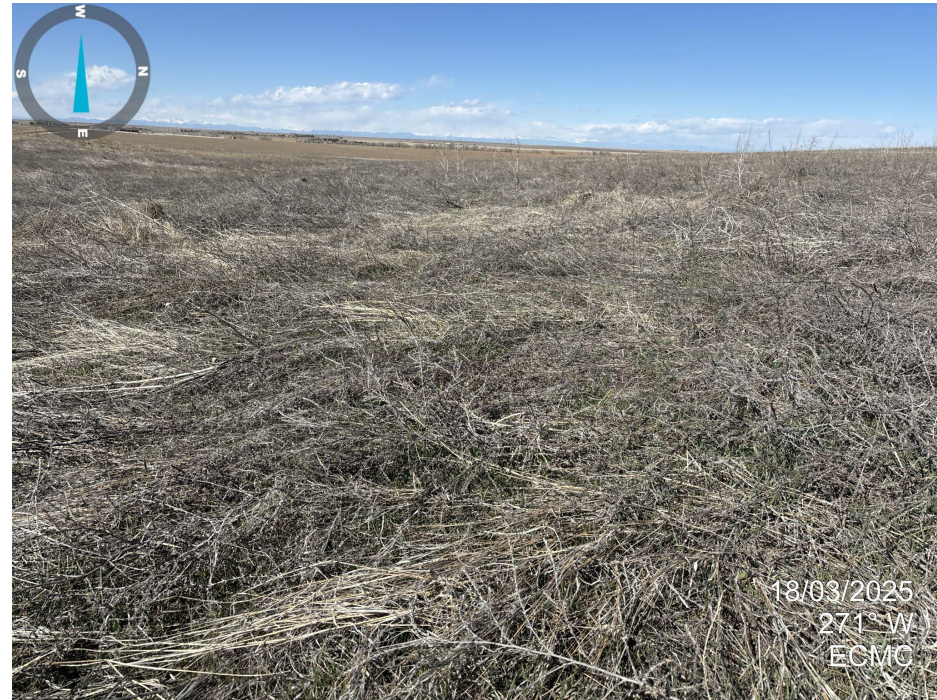
Photo 8. Reference vegetation to the west of location. Vegetation is relatively poor, primarily weedy plants and cheatgrass. Some native forbs.
