Final Reclamation and Stormwater Inspection

Operator: BAYSWATER EXPLORATION & PRODUCTION LLC - 10261

Location ID: 320109

Well Name: ANDERSON #4

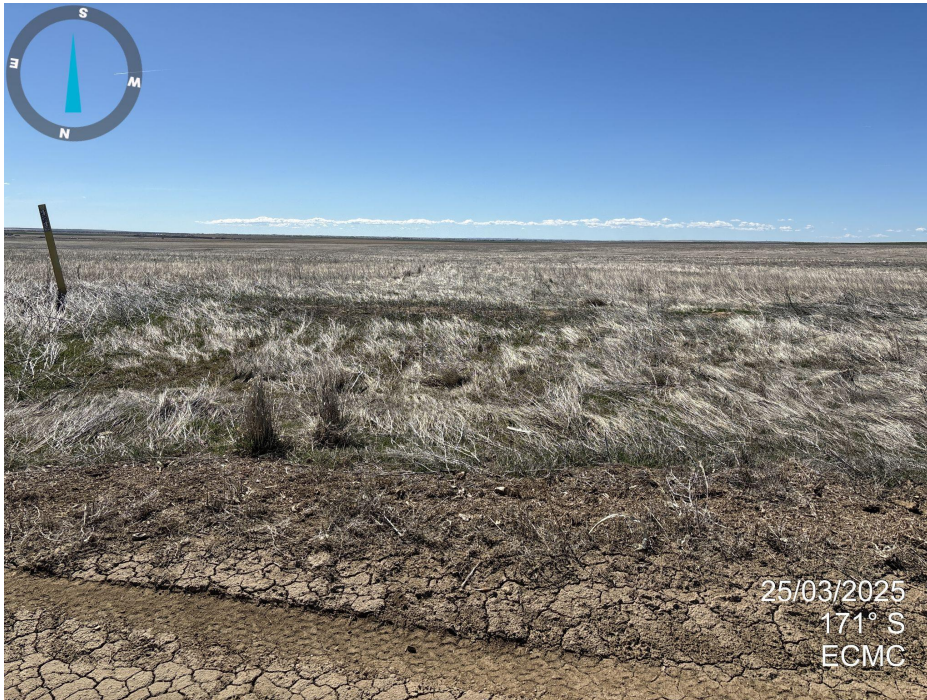
Photo 1. Looking south down former access road. A large amount of list C noxious weed Downy Brome is present on access road. Desirable perennial vegetation has established on the access road and appears to be progressing towards 80% of reference area coverage.

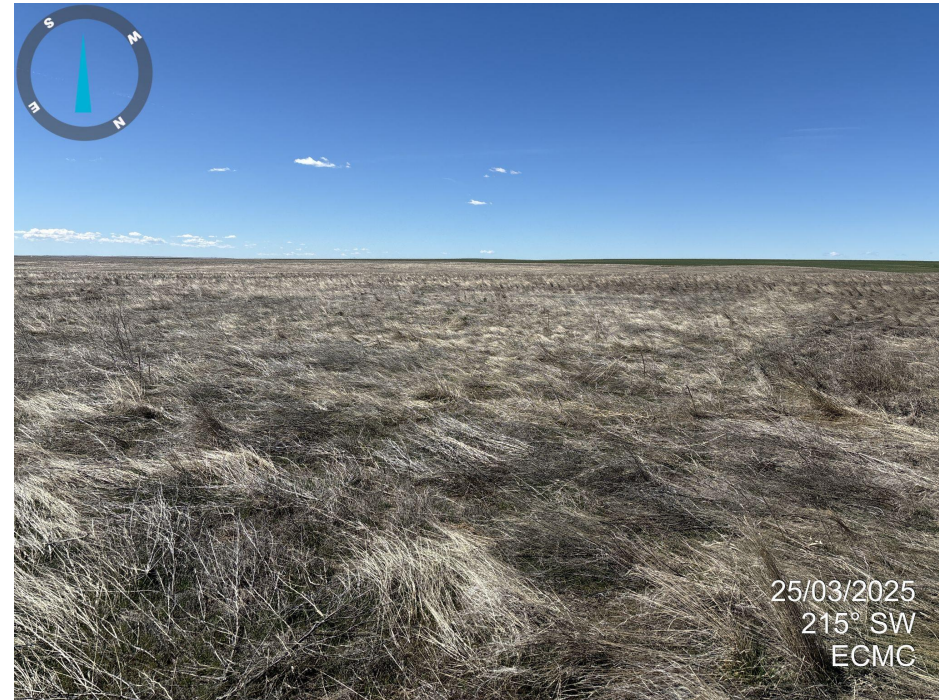
Photo 2. Looking southwest across the well location. All oil and gas equipment has been removed. Densely covered in Downy Brome. Desirable vegetation is present throughout the site and appears to be progressing towards 80% vegetation coverage.

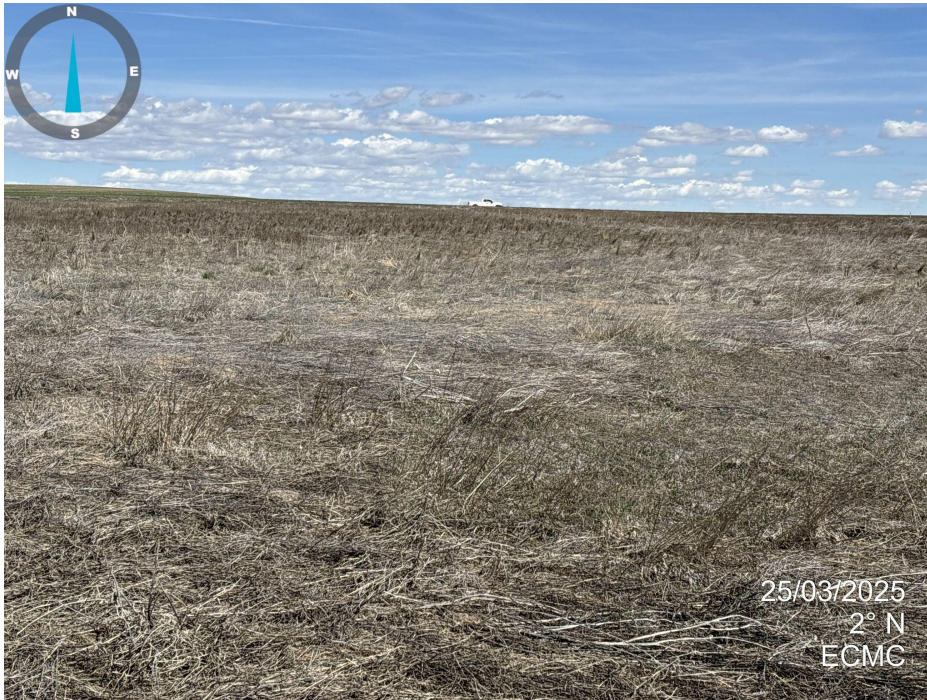
Photo 3. Looking looking north from wellbore across location.
See photo 2 comments.

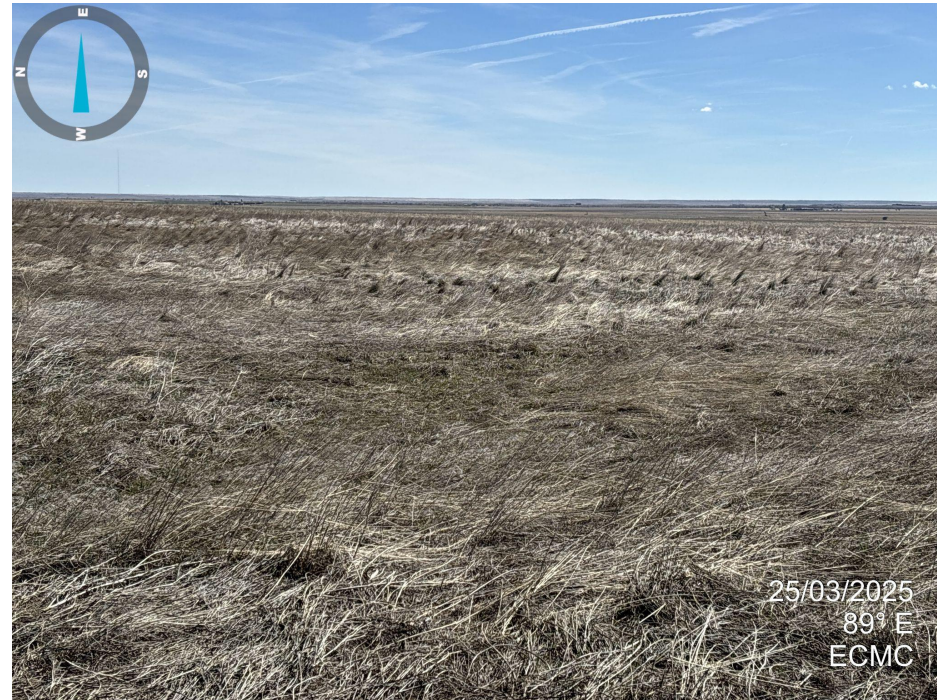
Photo 4. Looking east from wellbore. See photo 2 comments.

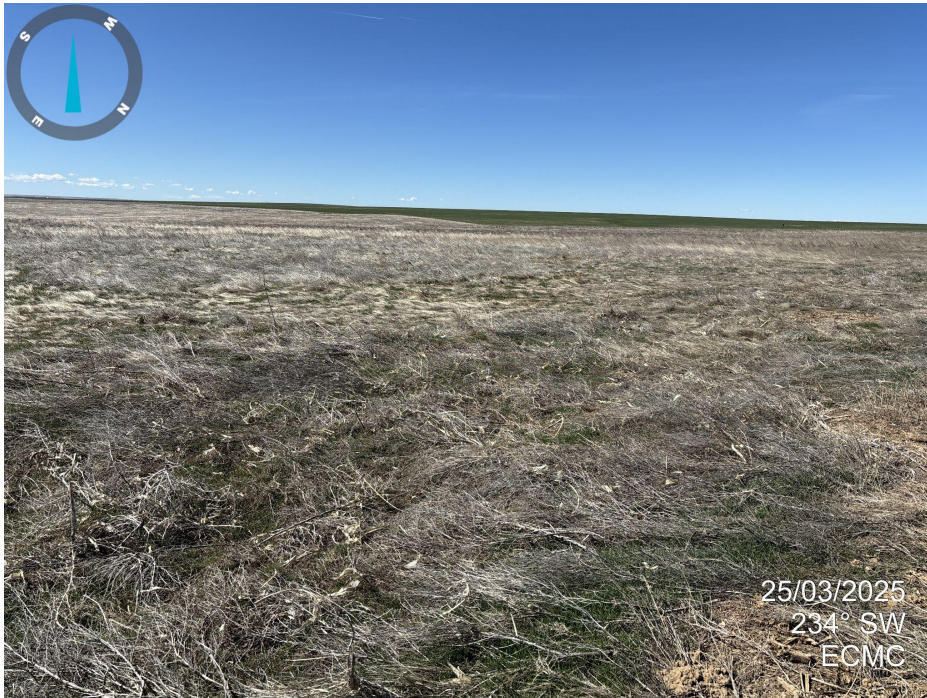
Photo 5. Looking southwest across the flowline junction/ Spill area associated with this wells flowline. Vegetation is primarily list C noxious weed Downy Brome. The reference vegetation near the road has a much higher level of Downy Brome.

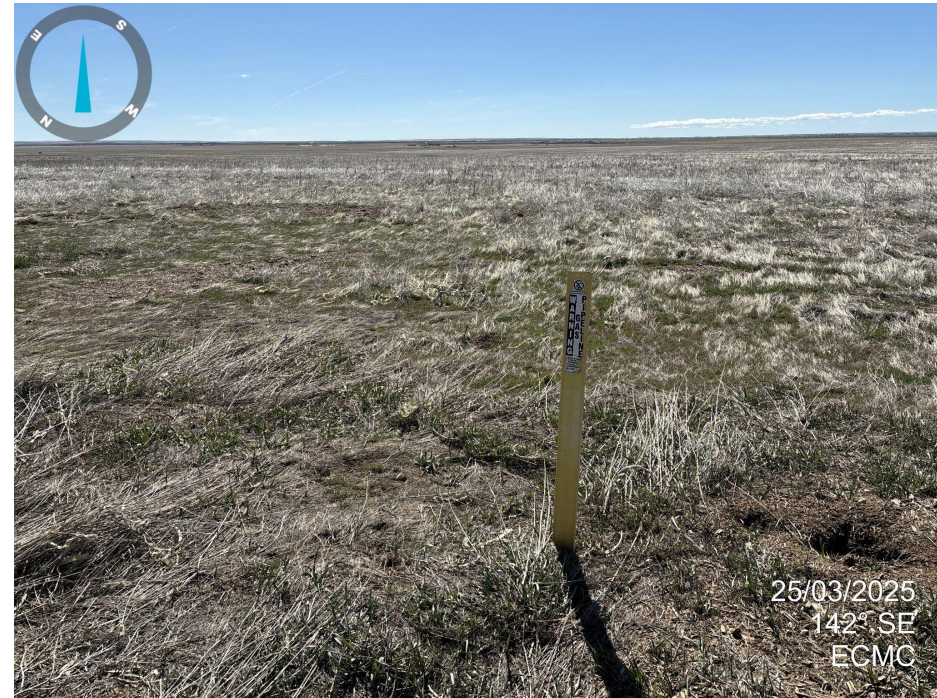
Photo 6. Looking southeast across flowline junction area. A sign marked gas pipeline. No other oil and gas equipment remains.

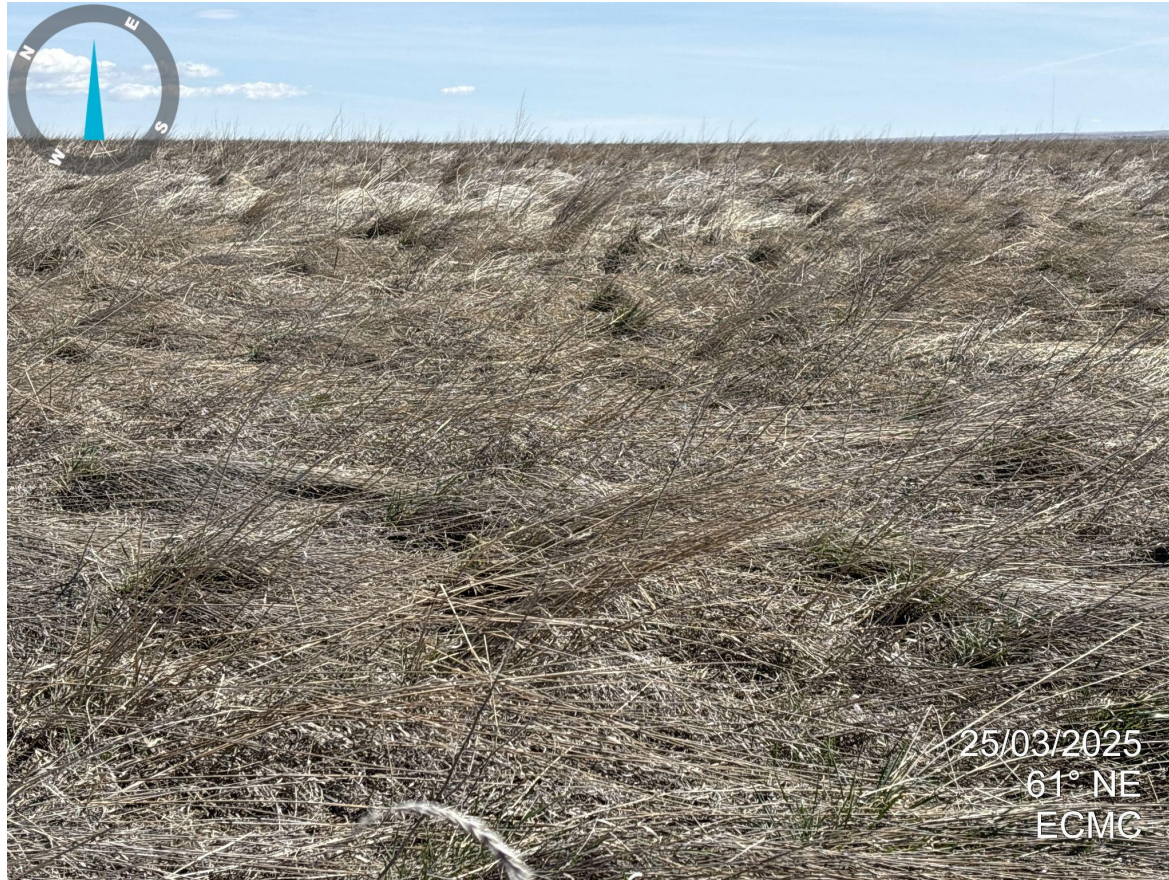
Photo 7. Reference vegetation to the east of well location.
