# Final Reclamation and Stormwater Inspection

Operator: DECLAR OIL & GAS INC - 23320

Location ID: 402523

Inspection Photos  
Location Name: Fassler #1  
Location ID: 402523

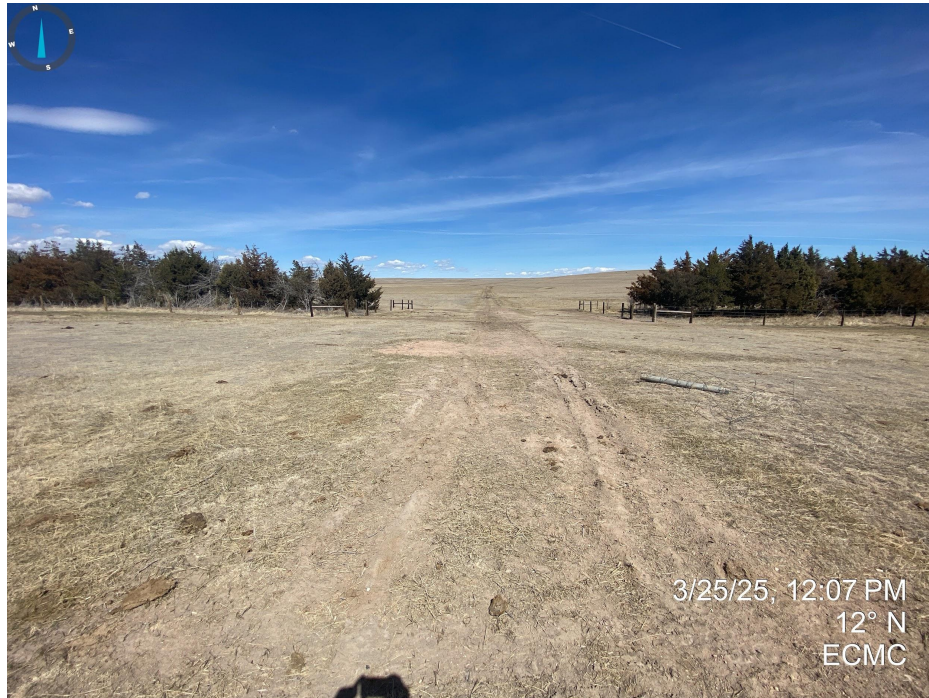
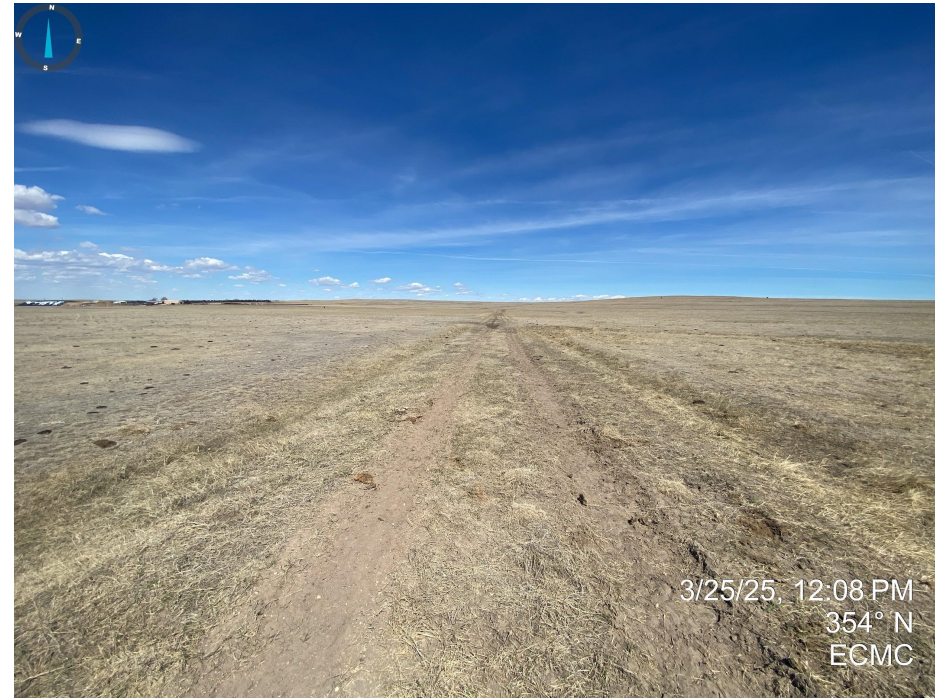
**Photos 1 & 2.** Taken from the start (e.g. southern portion) of the access road. It does not appear that the access road has been reclaimed with contour and grading issues evident.

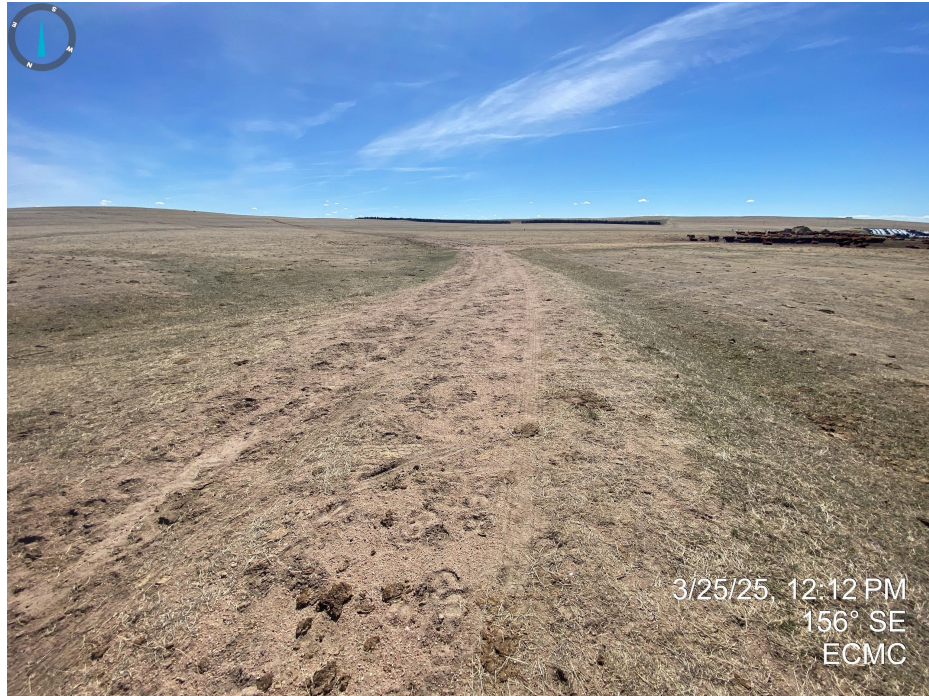
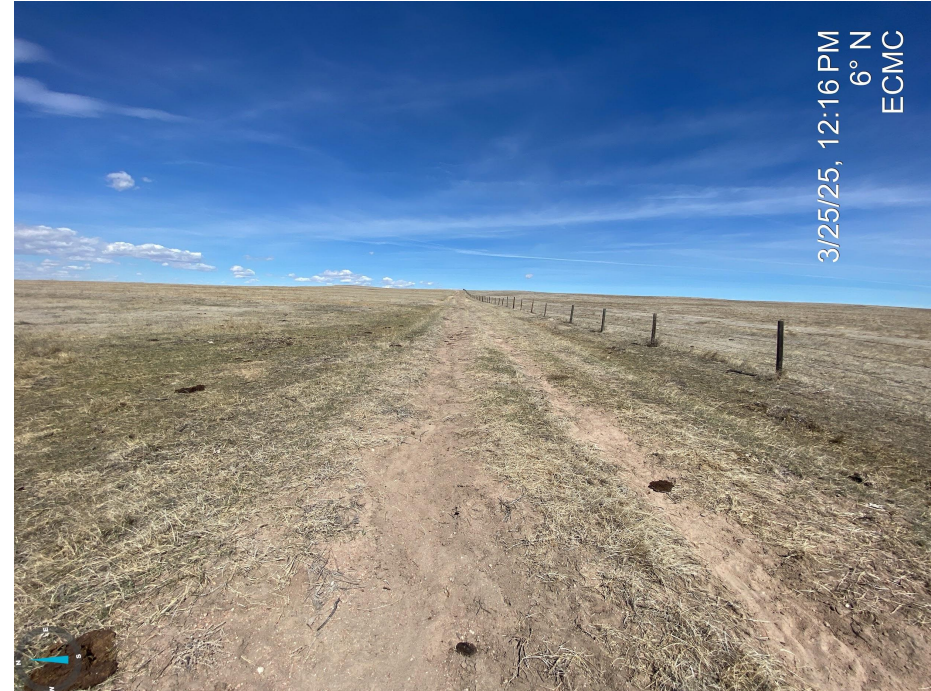
**Photos 3 & 4.** Taken from the middle portion of the access road. It does not appear that the access road has been reclaimed with contour and grading issues evident.

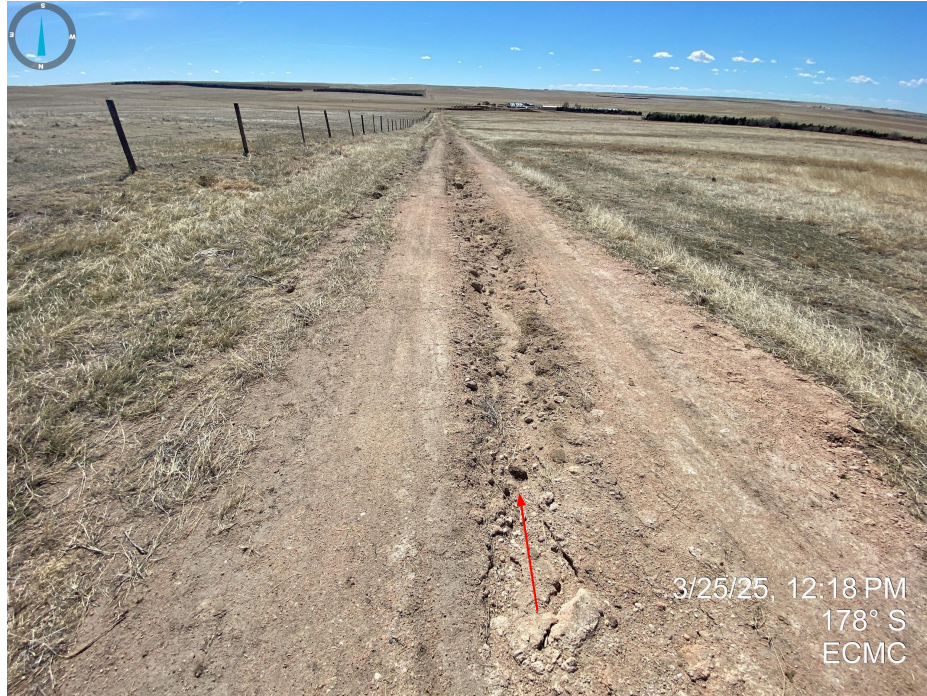
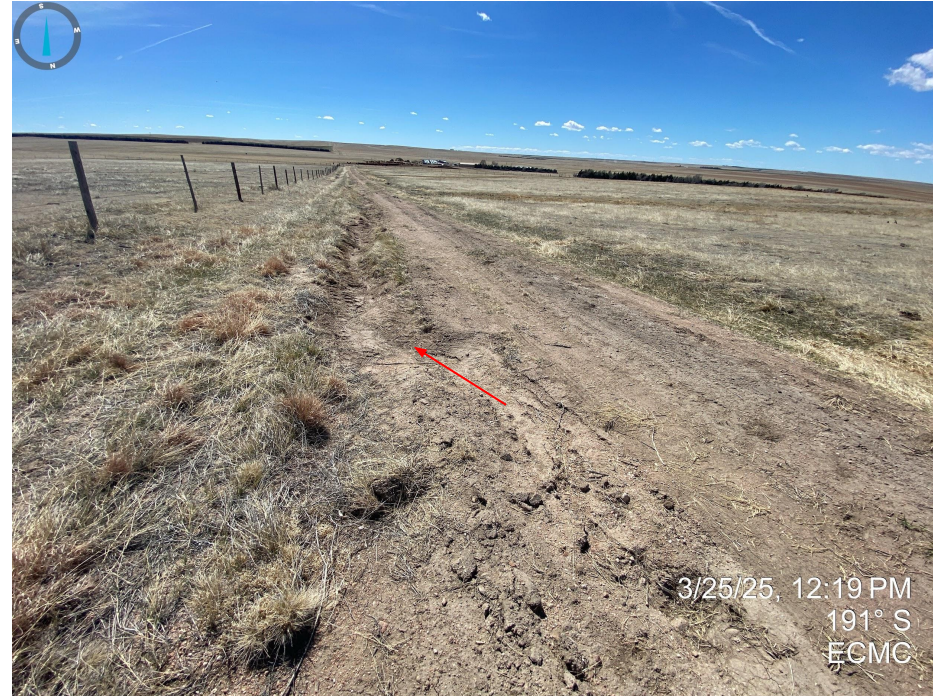
**Photos 5 & 6.** Taken from the middle portion of the access road. It does not appear that the access road has been reclaimed with contour/grading issues and erosion degradation evident.

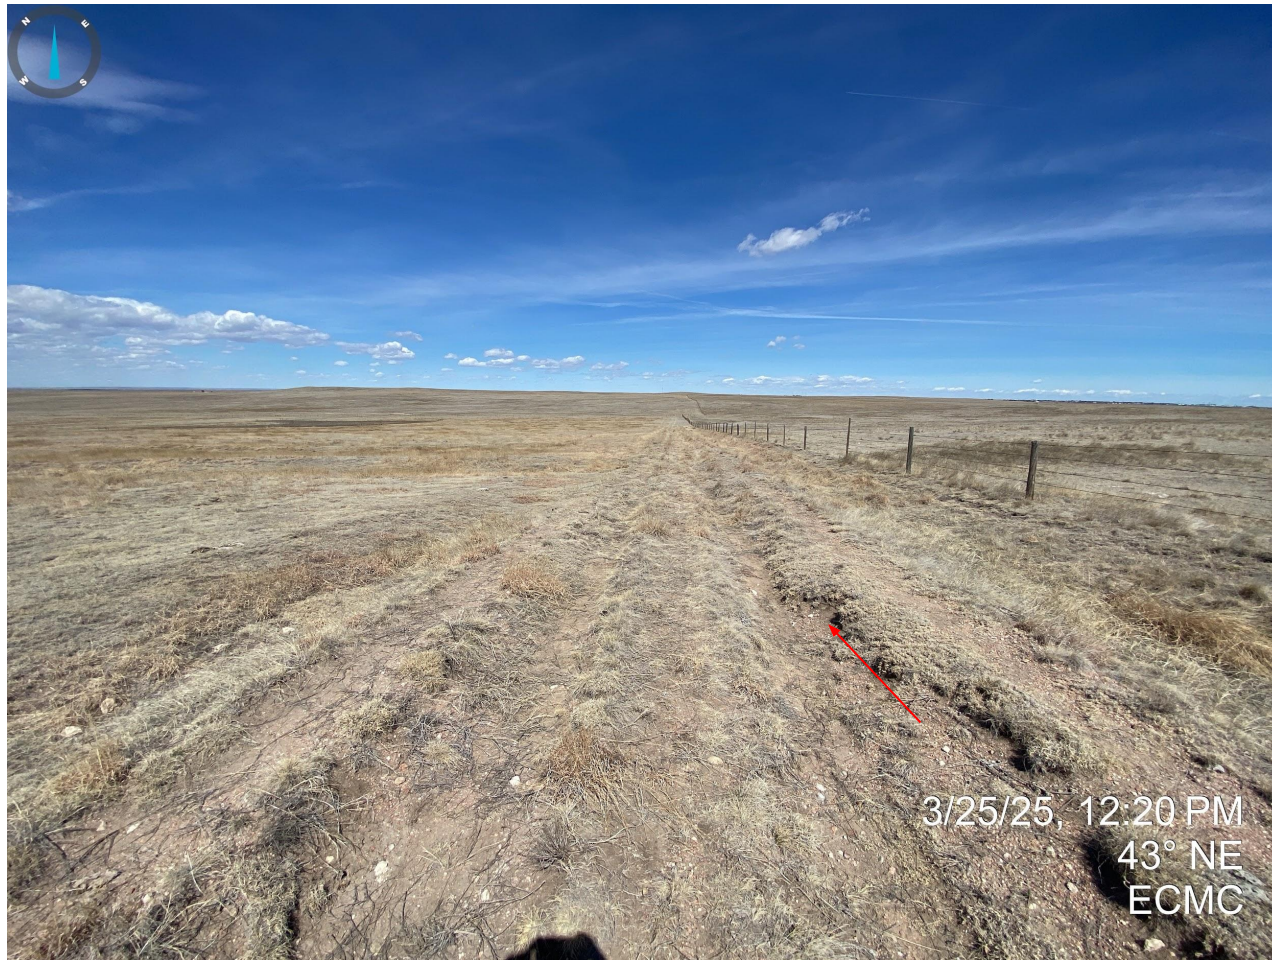
**Photo 7.** Taken from the northern portion of the access road. It does not appear that the access road has been reclaimed with contour/grading issues and erosion degradation evident.

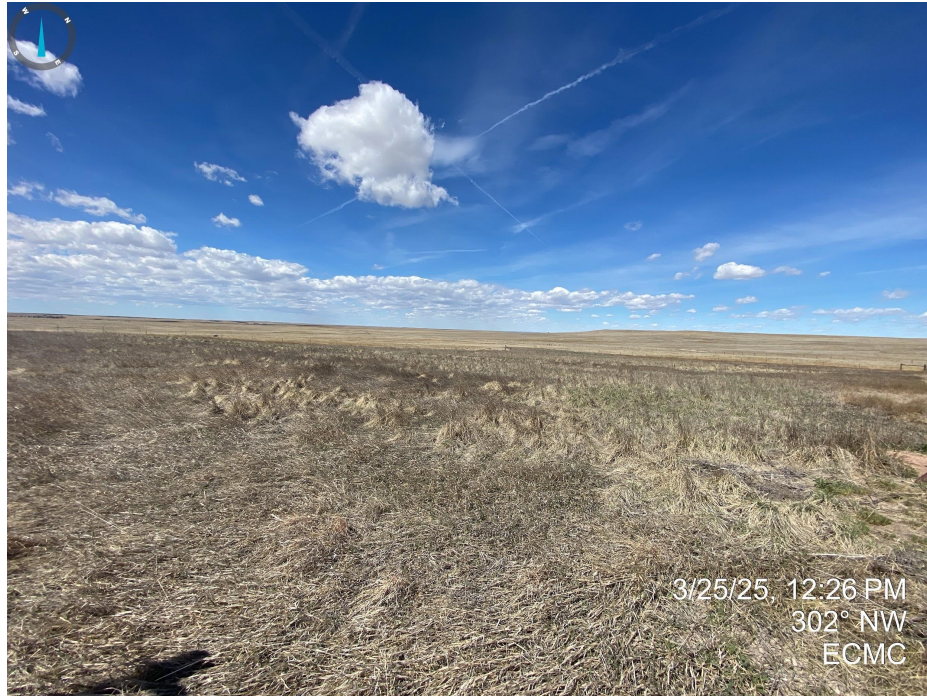
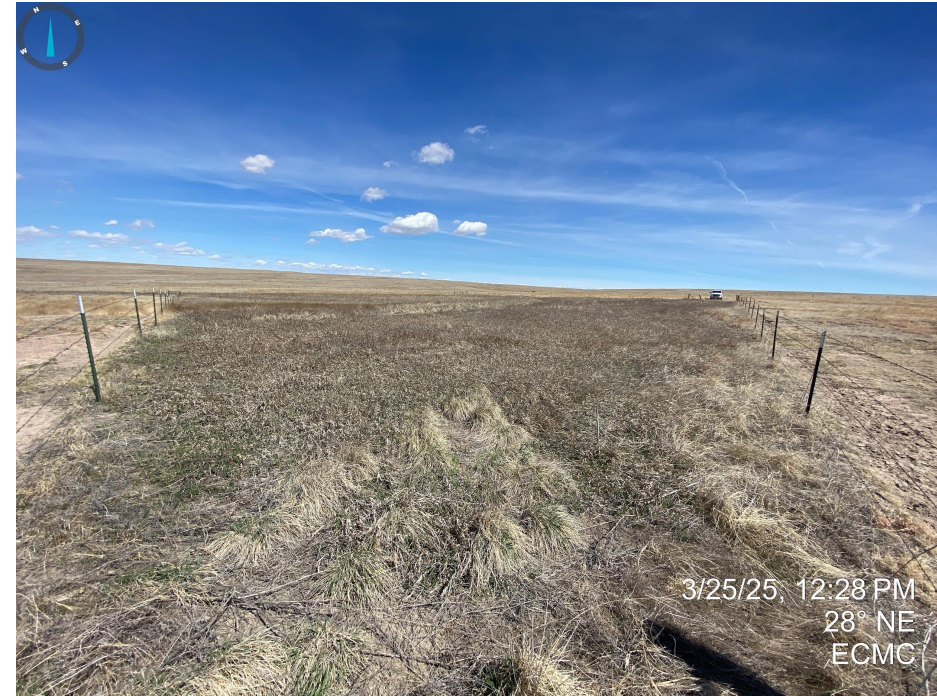
**Photos 8 & 9.** Taken from the southeastern (left; Photo 8) and southwestern (right; Photo 9) portions of the location. Photo illustrates that the reclaimed areas have significant smooth brome coverage, which is an introduced species and not reflective of the reference areas.

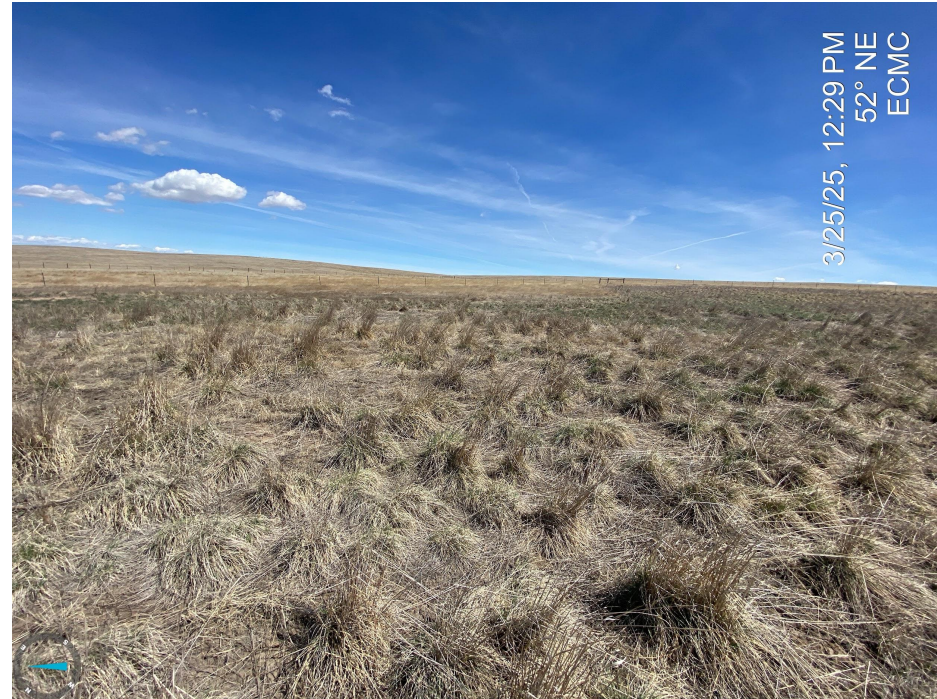
**Photos 10 & 11.** Taken from the middle portion of the location, near the former pit. Photo 10 (left) illustrates smooth brome observed near former pit and Photo 11 (right) illustrates intermediate wheatgrass coverage, both of which are not reflective of the adjacent reference areas.

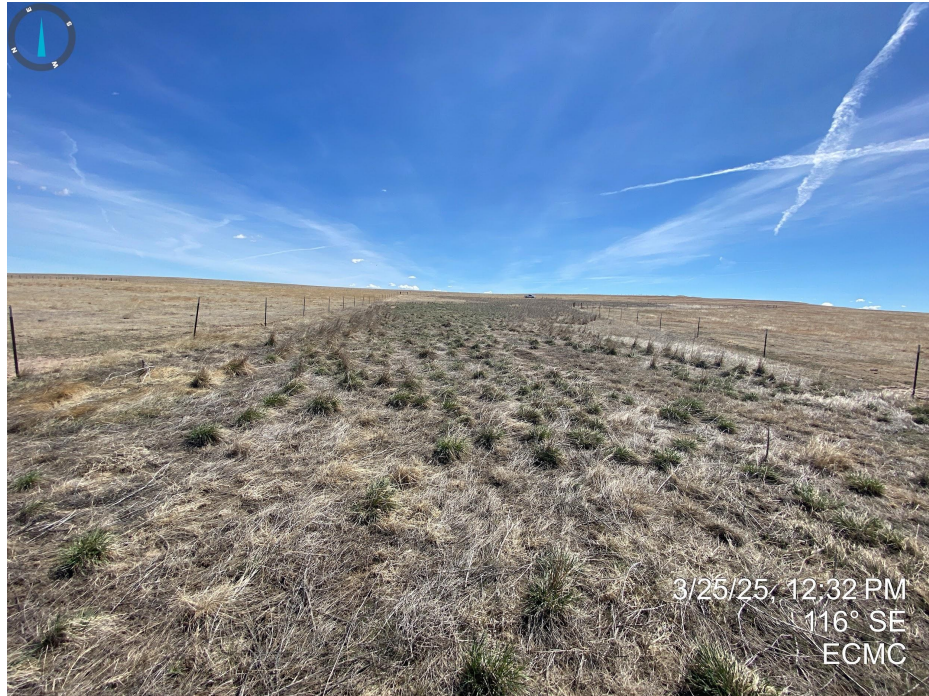
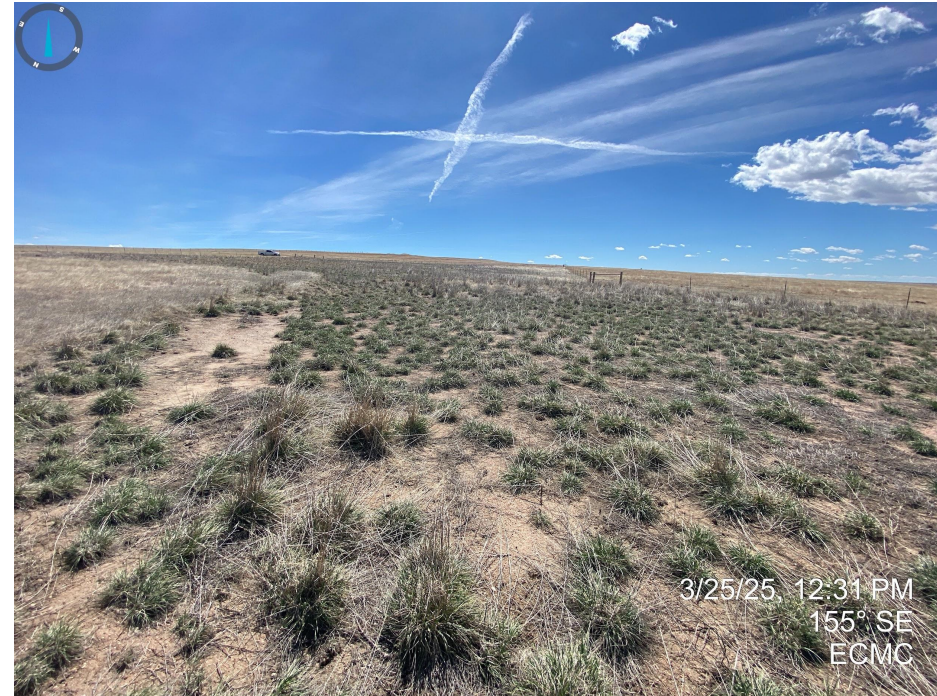
**Photos 12 & 13.** Taken from the northern portion of the of the location. Photos illustrates intermediate wheatgrass throughout the reclaimed portions.

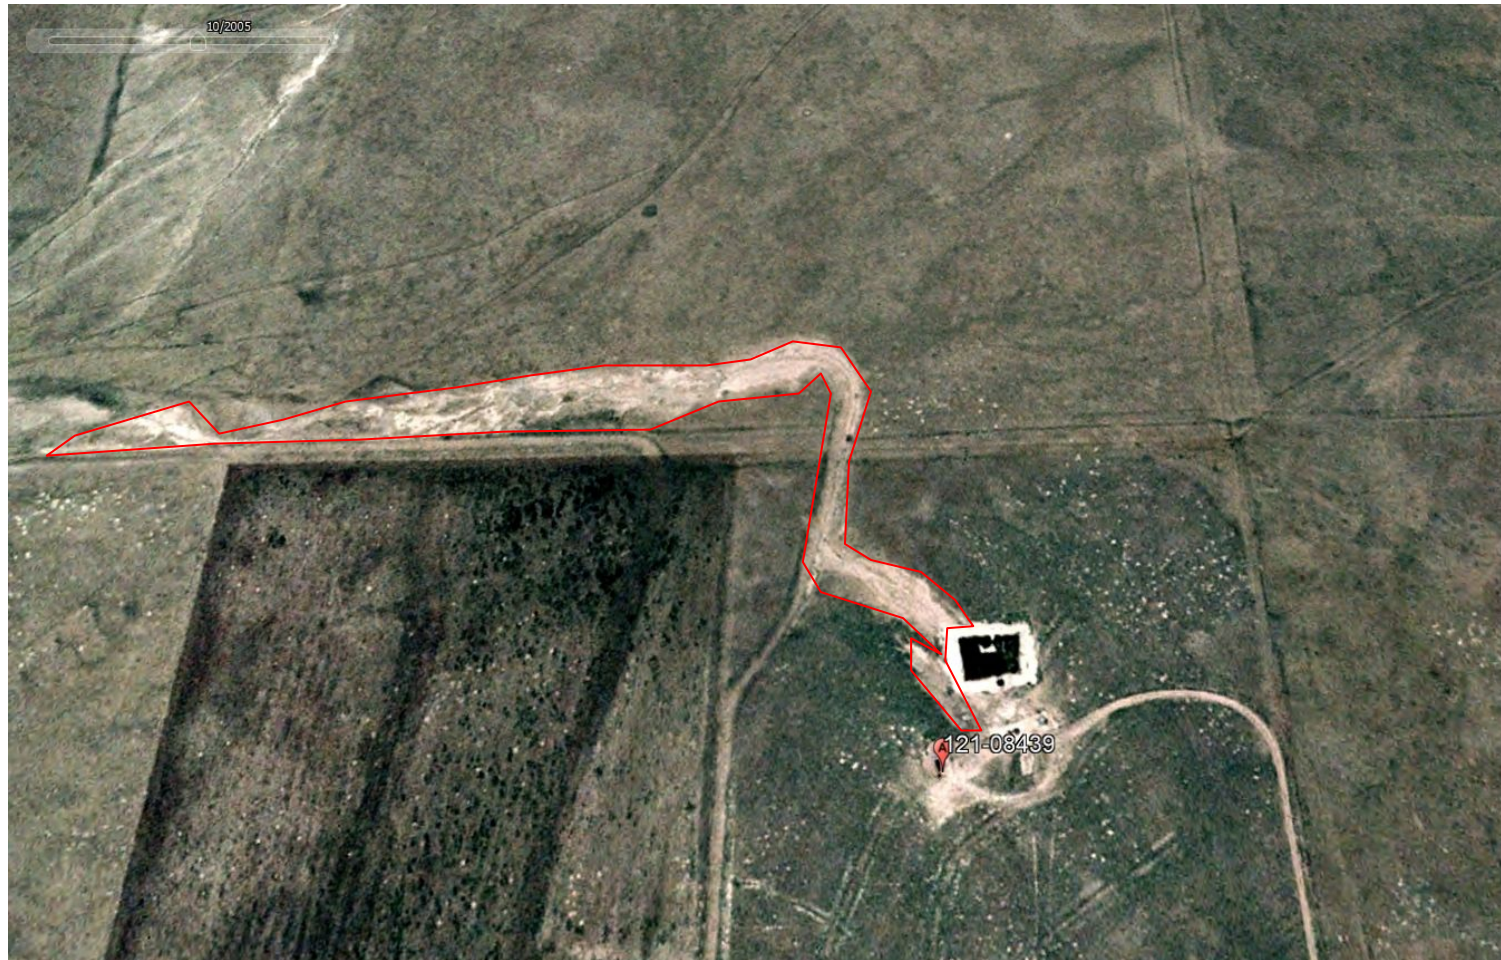
**Photo 14.** Google Earth aerial imagery (circa 10/2005) during active operations, illustrating salt kill impacts originating from the northwest corner of the former pit, with impacts observed throughout the adjacent drainage to the northwest/west, approximated by red outline.

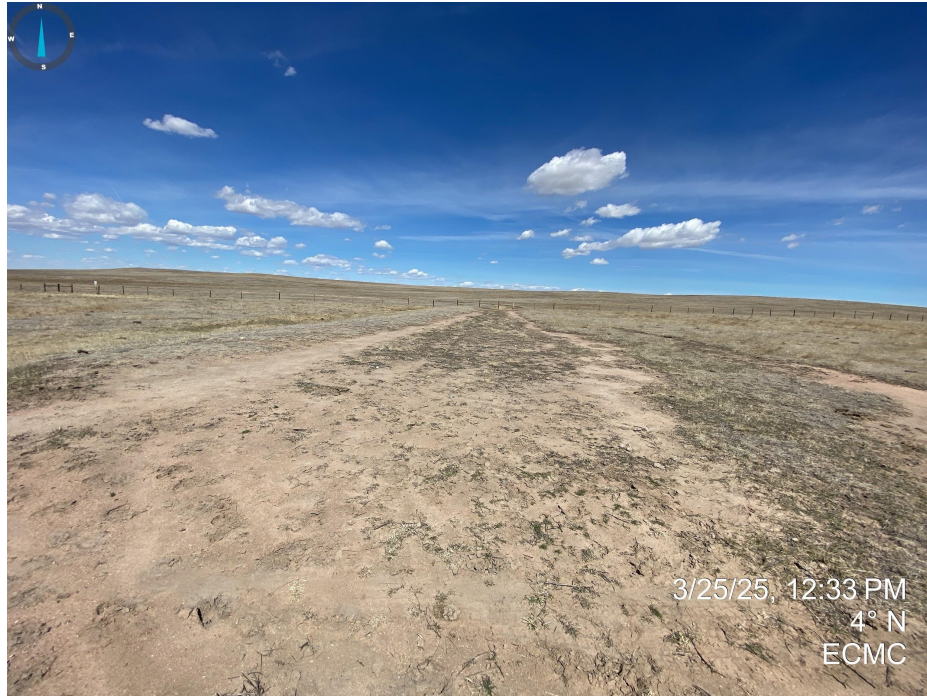
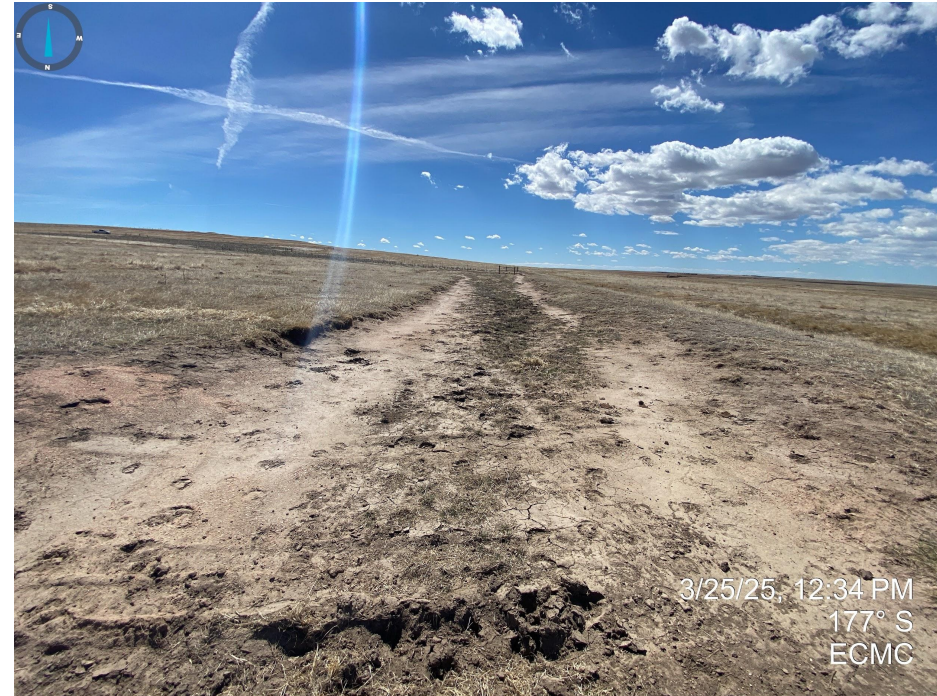
**Photos 15 & 16.** Photos taken from the northern part of the former location along the salt kill impacted area. Further remedial activities are required to delineate the salt kill impacts.

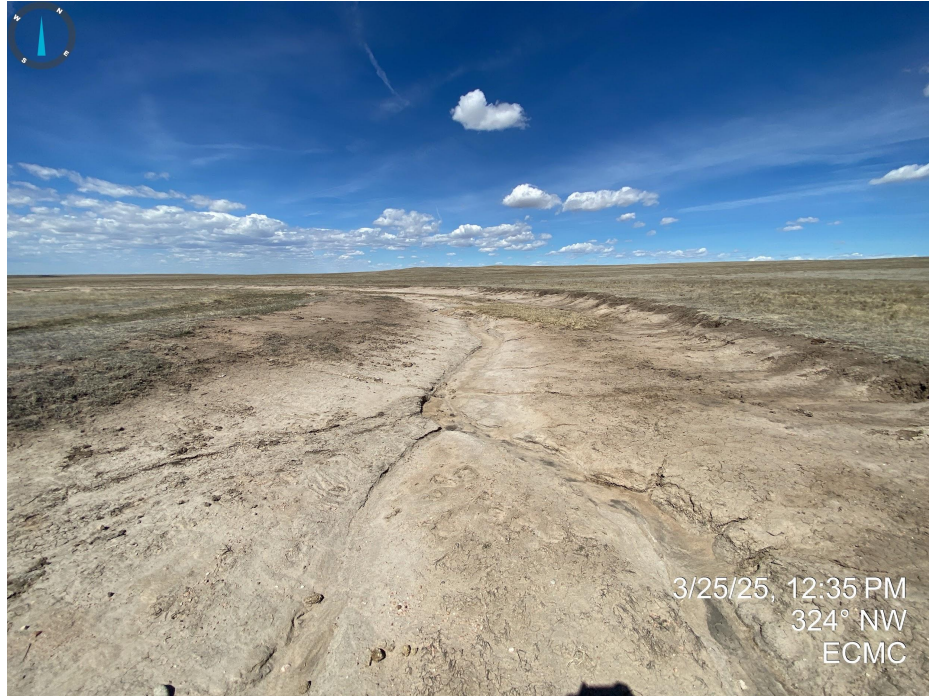
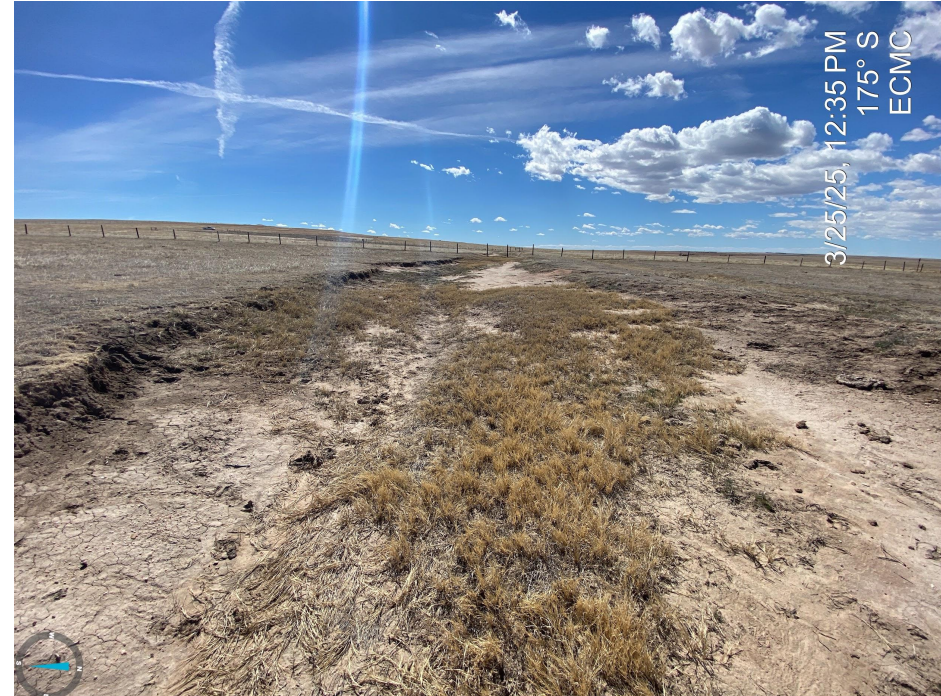
**Photos 17 & 18.** Photos taken from the southern part the salt kill impacted area. Further remedial activities are required to delineate the salt kill impacts.

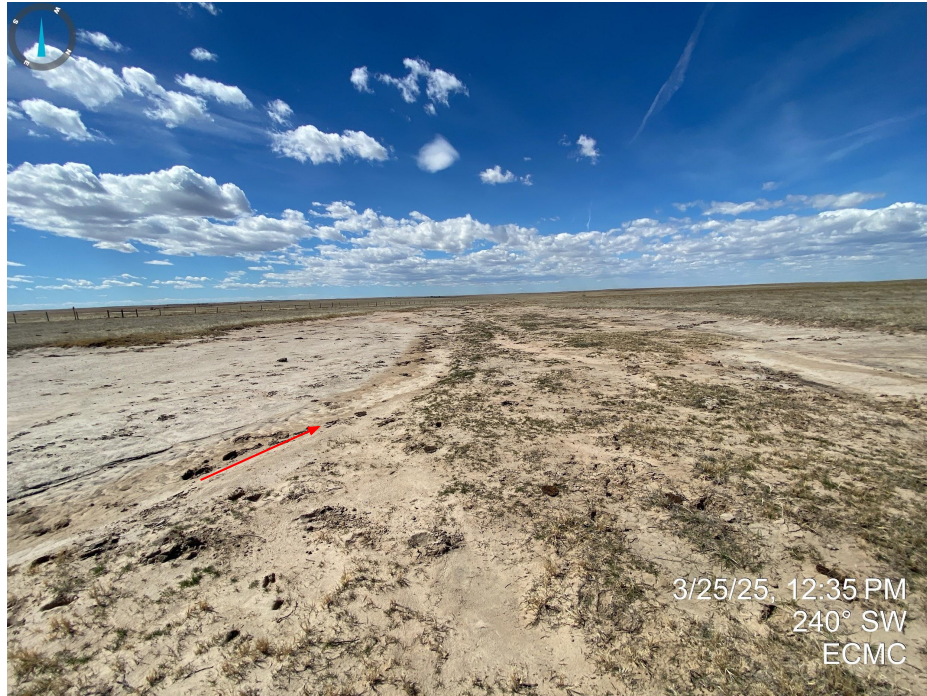
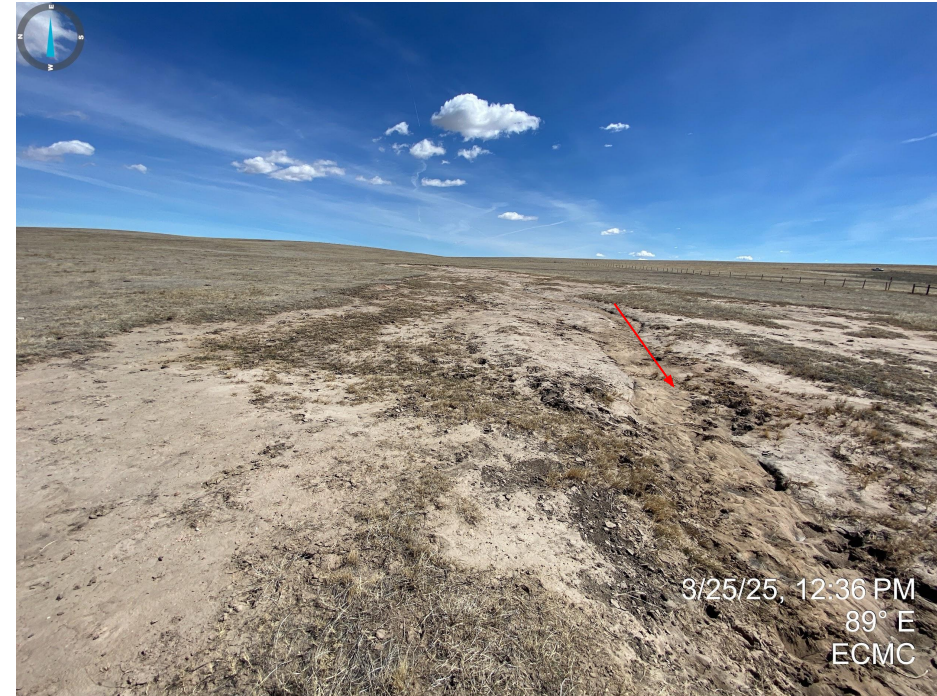
**Photos 19 & 20.** Photos taken from the northeast part the salt kill impacted area. Further remedial activities are required to delineate the salt kill impacts. Erosion degradation illustrated by red arrows.

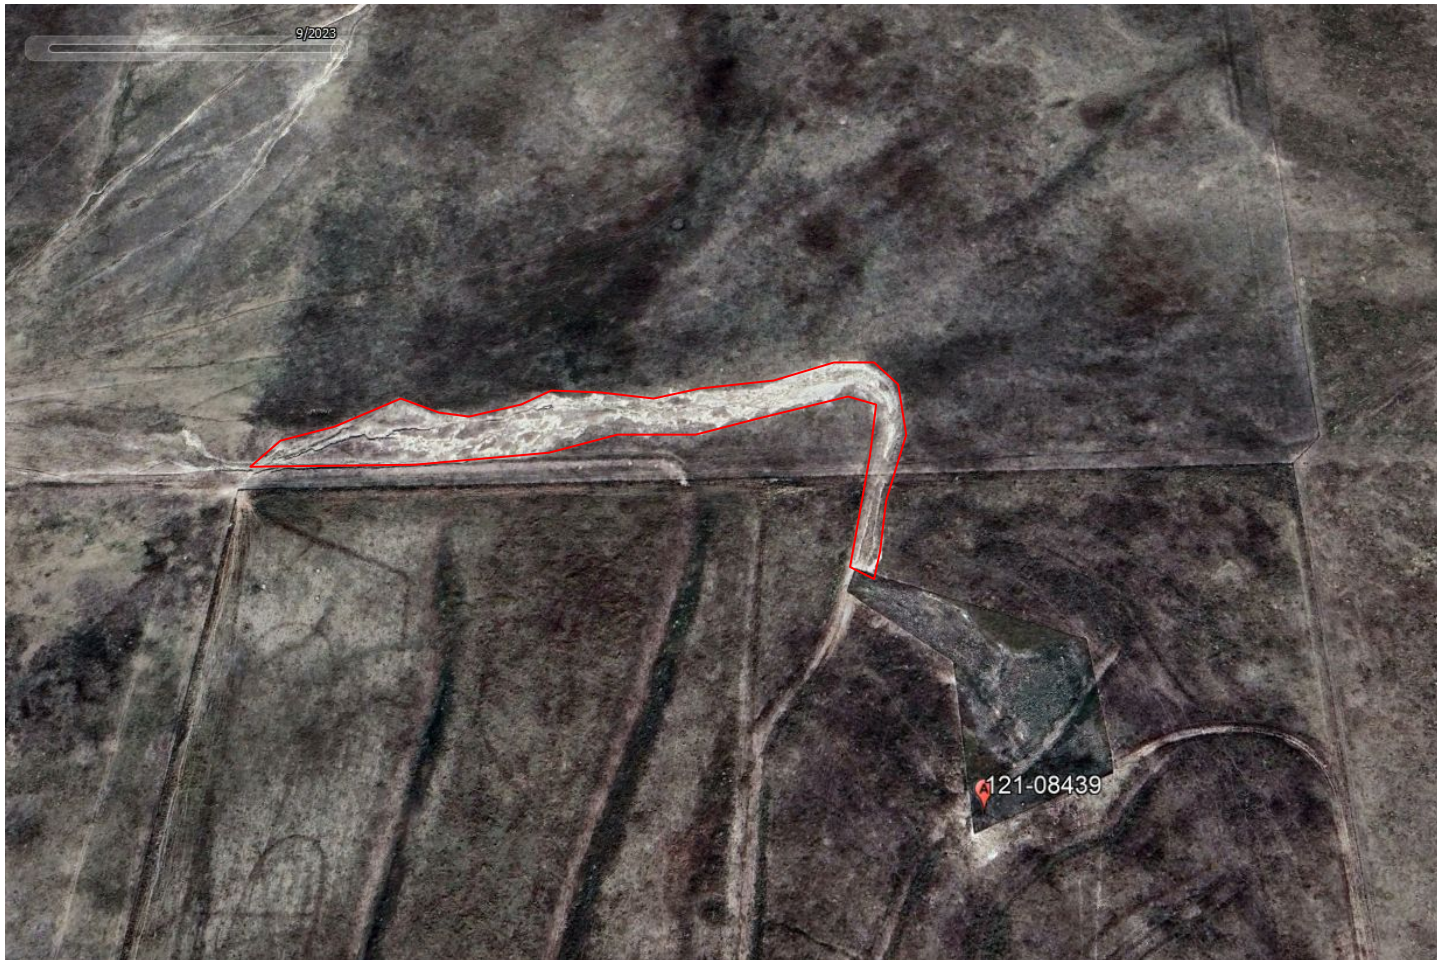
**Photo 25.** Google Earth aerial imagery (circa 09/2023) after facility decommissioning, illustrating salt kill impacts originating from the northwest corner of the former pit, with impacts observed throughout the adjacent drainage to the northwest/west, approximated by red outline.

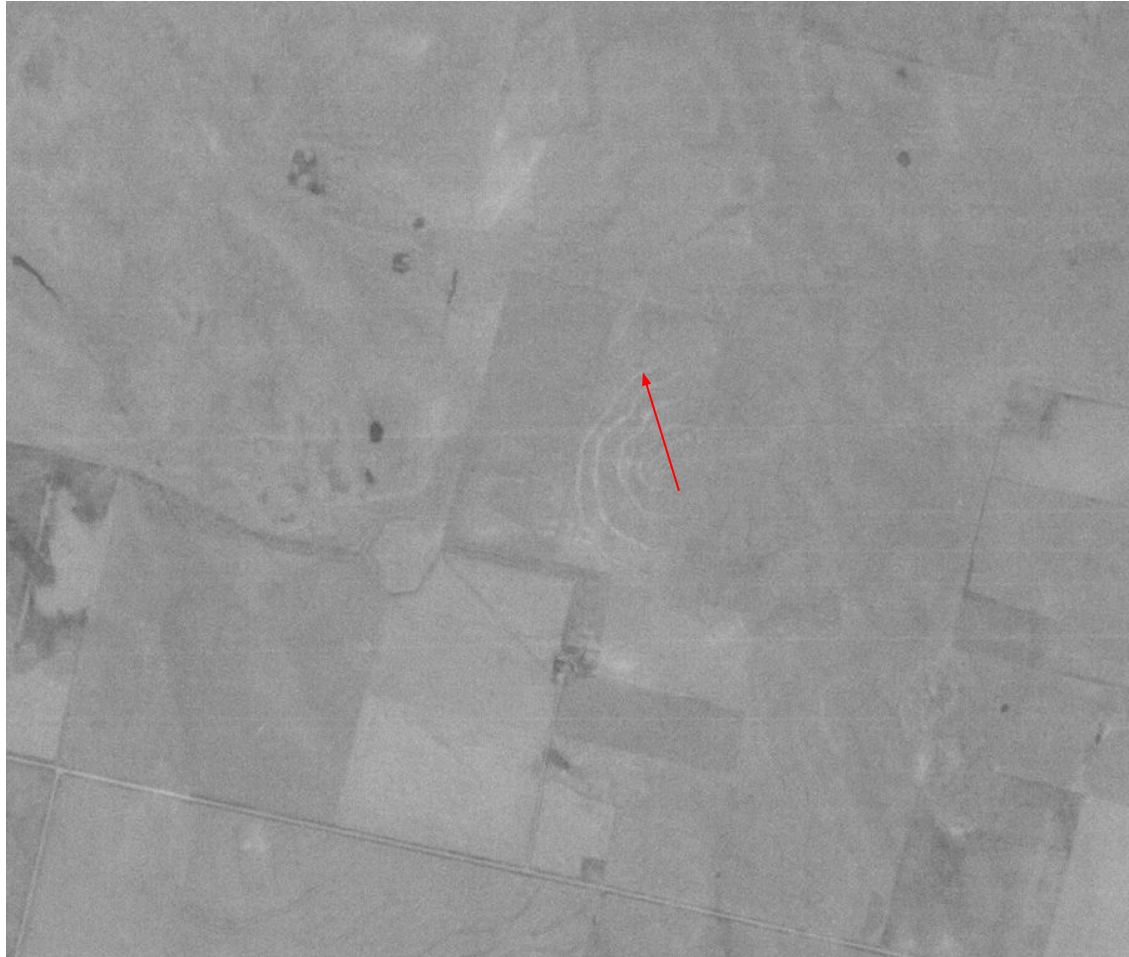
**Photo 26.** Historical Imagery (circa 06/1956) illustrating that salt kill impacts did not appear on the landscape prior to oil and gas development of the Fassler #1 (121-08439; spud date of 02/26/1970). Red arrow illustrates approximate location of Wel API 121-08439
