Construction and Stormwater Inspection

April 1, 2025

Well Name: ACACIA/13-17

Inspection Document #: 718600462

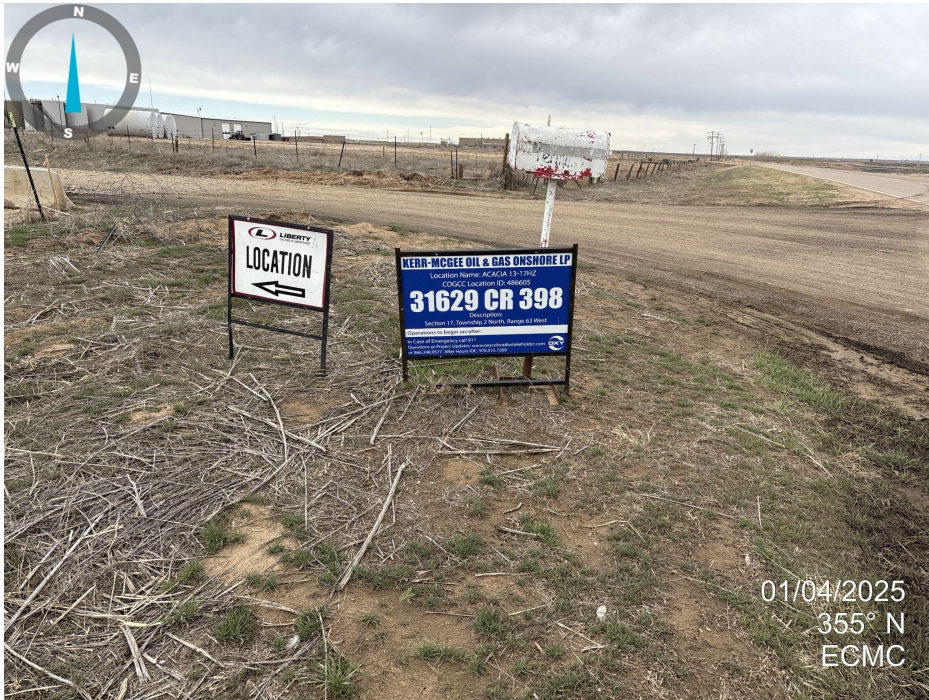
Photo 1. Sign and 2A posted near entrance of access road.

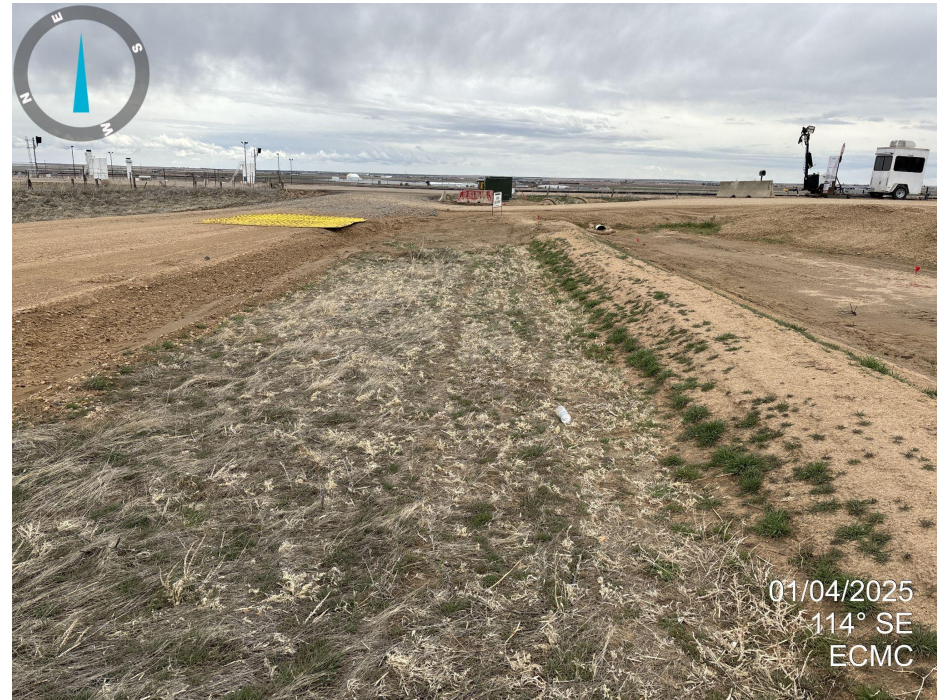
Photo 2. Looking east down access road. A track out mat is present on the outboard lane. Culvert under access road has inlet protection.

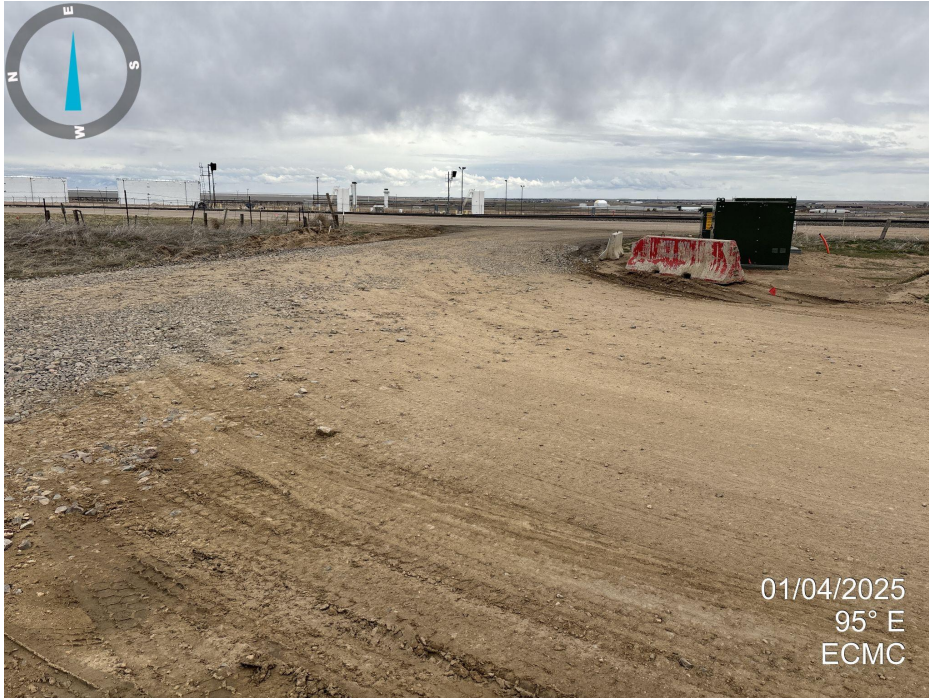
Photo 3. Riprap behind track out pad is full of sediment

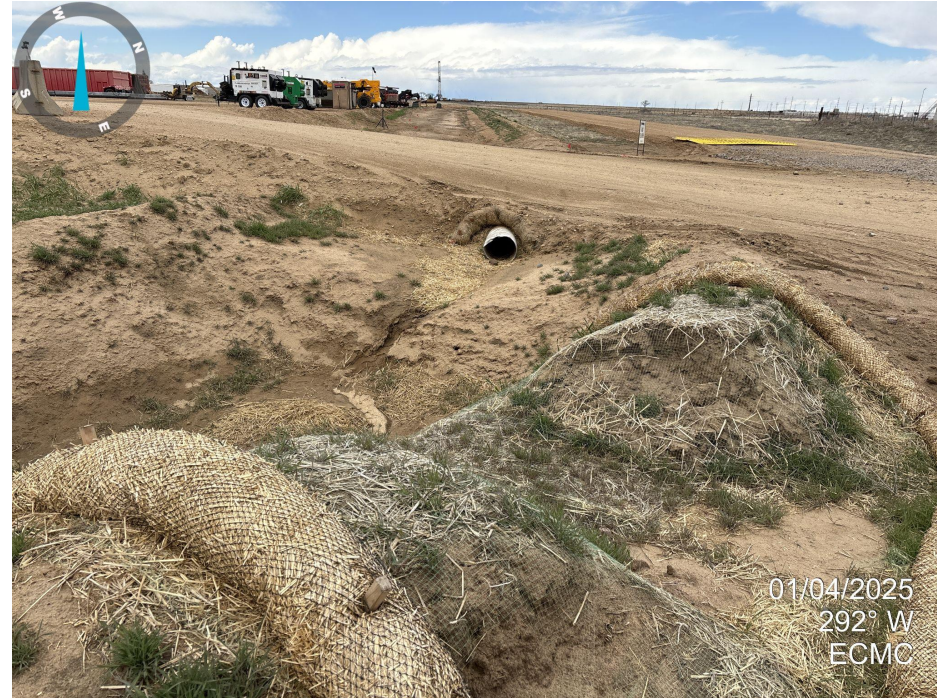
Photo 4. Picture taken at northeast corner sediment trap. Outflow BMP are in place. A small amount of erosion is beginning to form under the culvert.

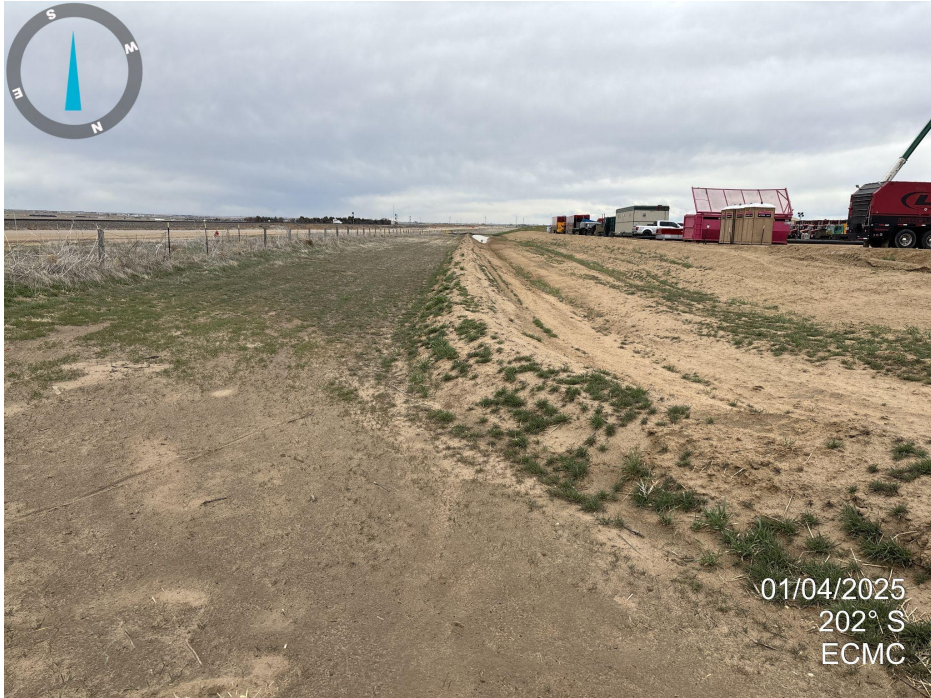
Photo 5. Looking south down the east side of location. Ditch appears stabilized.

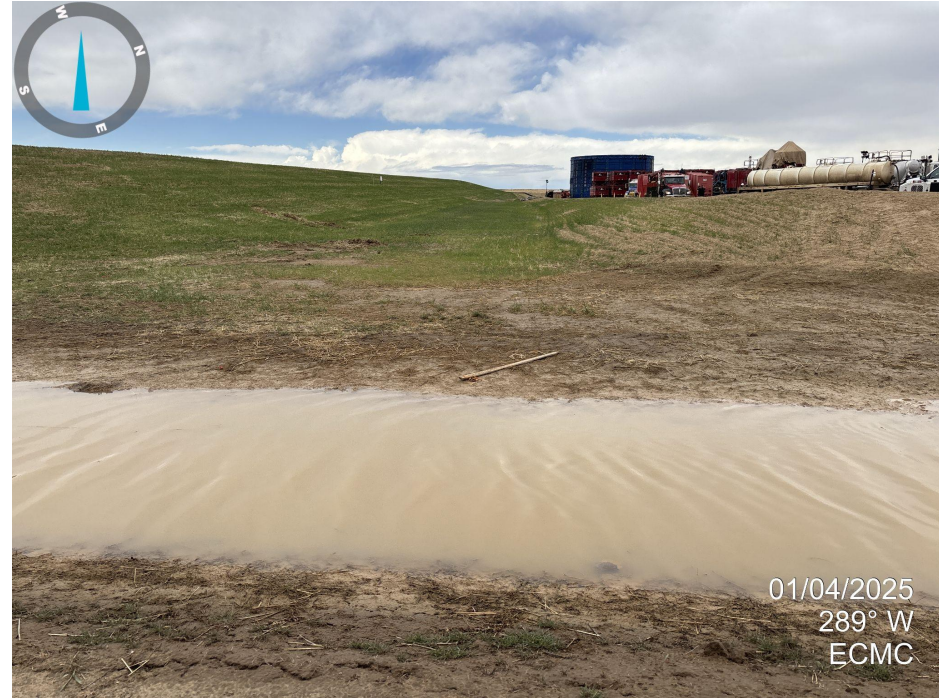
Photo 6. Looking west between the southern topsoil stockpile and pad. Area appears stabilized with vegetation germination.

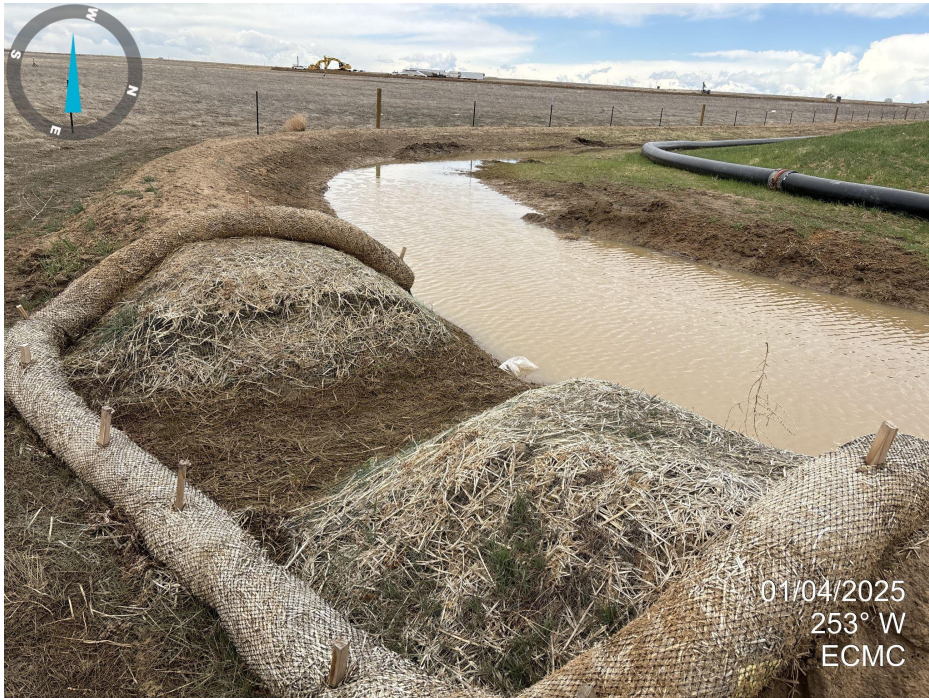
Photo 7. Picture taken at sediment trap at southwest corner of location. It does not appear that sediment is leaving the location.

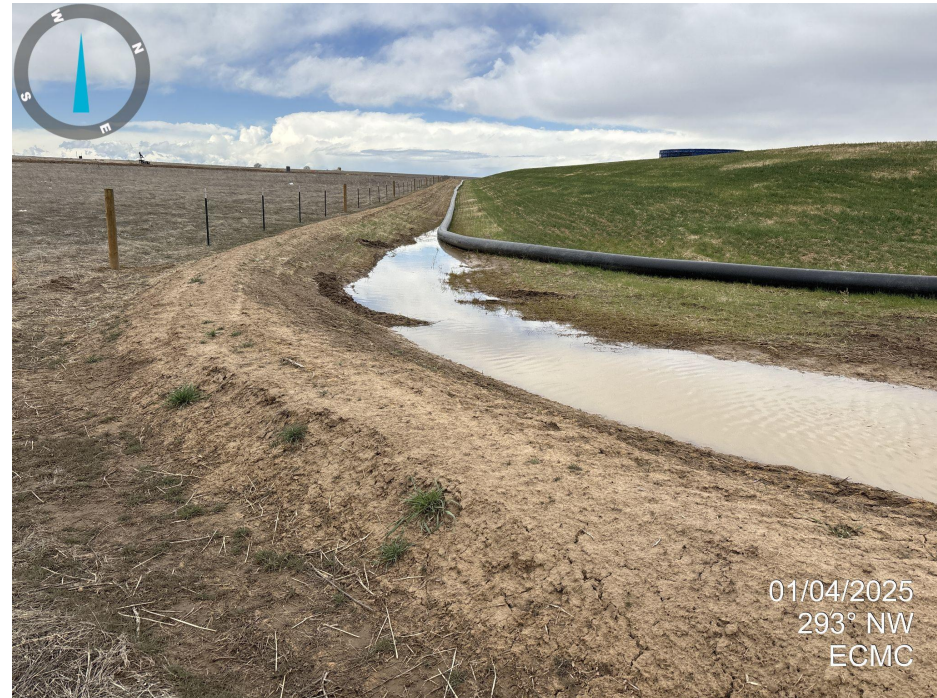
Photo 8. Looking west along the southern edge of location. Southern topsoil stockpile appears to be stabilized with germination of vegetation.

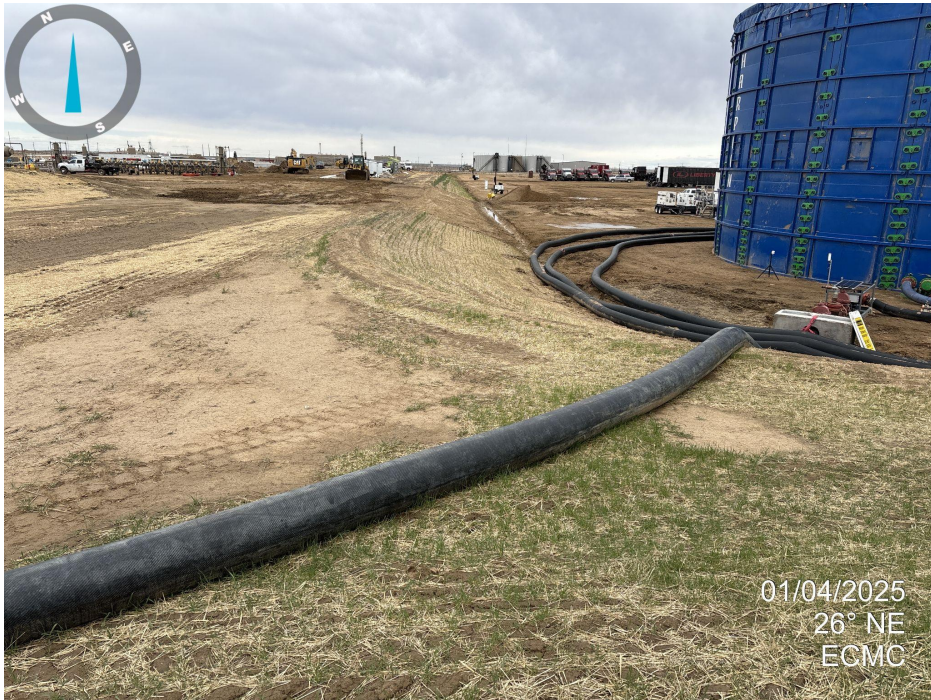
Photo 9. Looking north between the pad and production facilities. Slope appears to have been stabilized and seeded with evidence of germination.

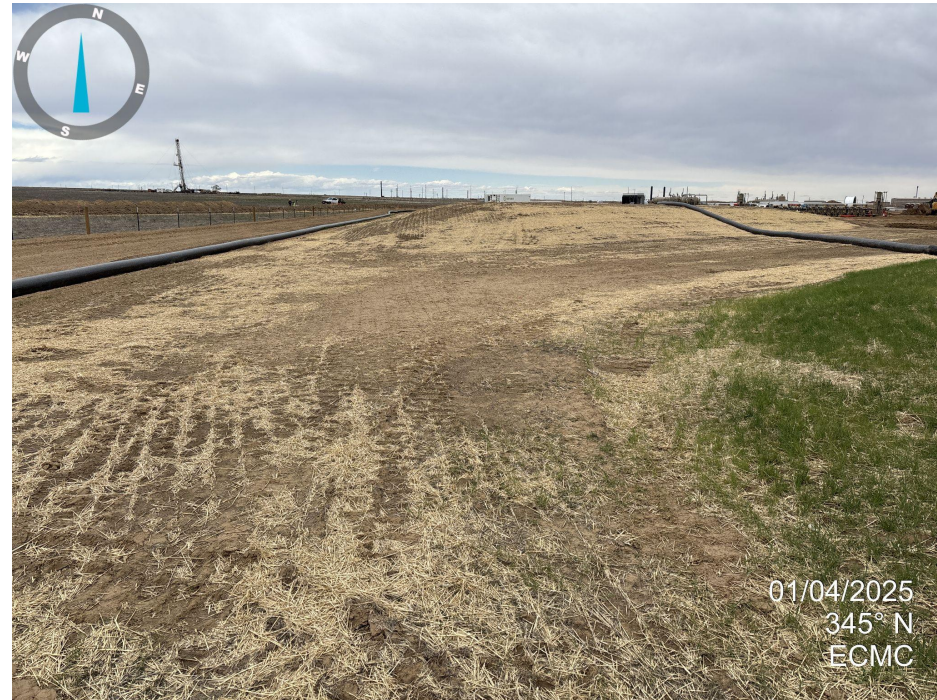
Photo 10. Triangular shaped topsoil stockpile on the west side of location. Stockpile appears to have been stabilized with crimped straw.

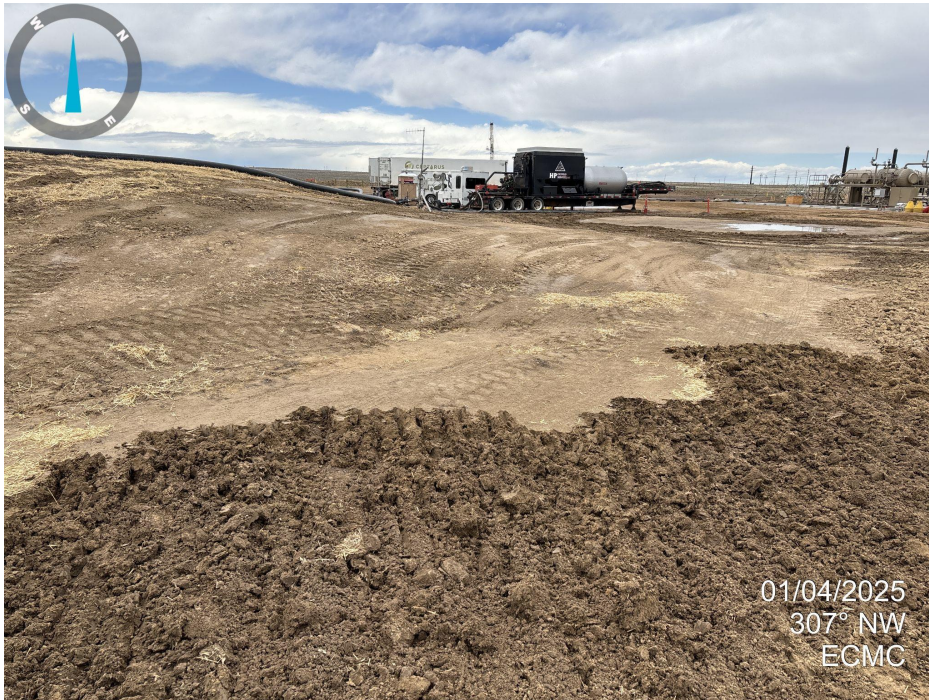
Photo 11. Looking at the northwest corner of the triangular topsoil stockpile towards the production facility. It appears that equipment has been driving over the corner of the topsoil stockpile.

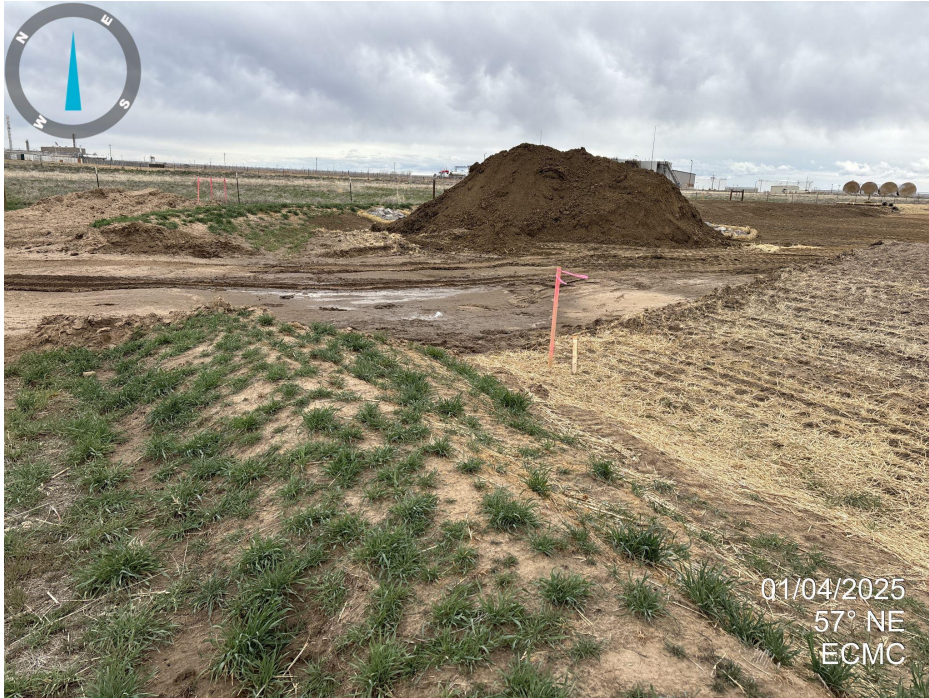
Photo 13. Looking northeast down the west side of the location. The ditch and berm have been removed for access out the west side of location. A culvert is not present and the road is muddy over the ditch. A soil pile without erosion BMPs is present.

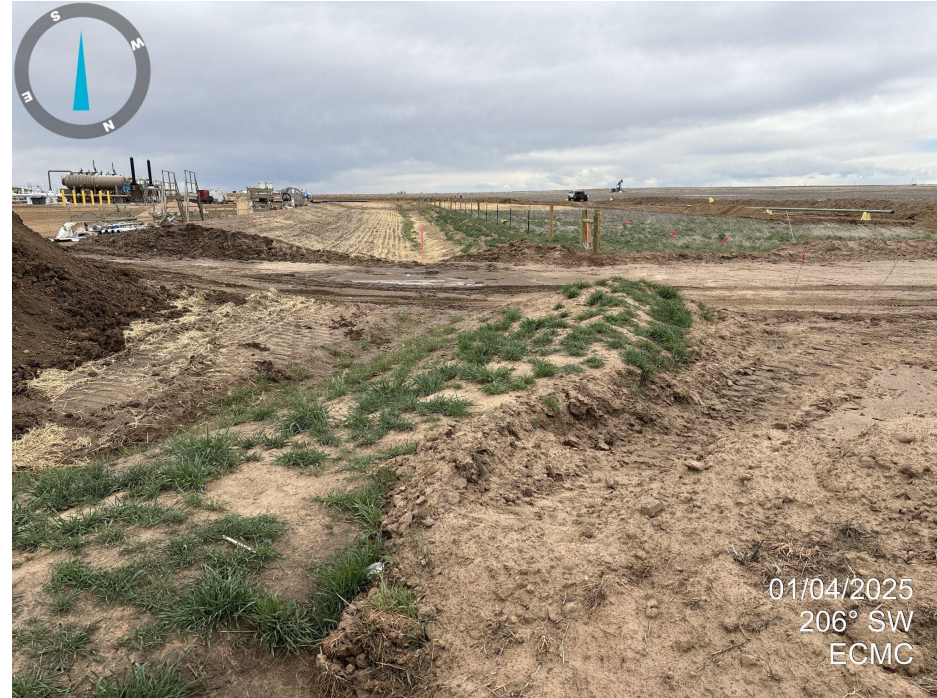
Photo 14. Looking south down the west side of the location. The ditch and berm have been removed. It does not appear that the ditch can convey water to the sediment trap.

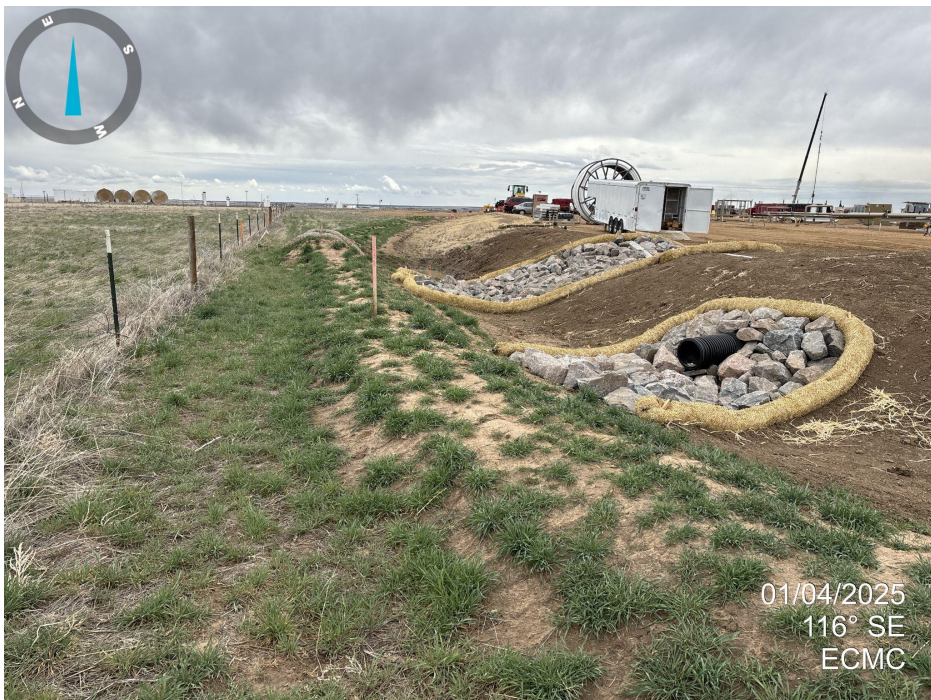
Photo 15. Looking east down the north side of location. Outlets are reinforced and a sediment trap is present.

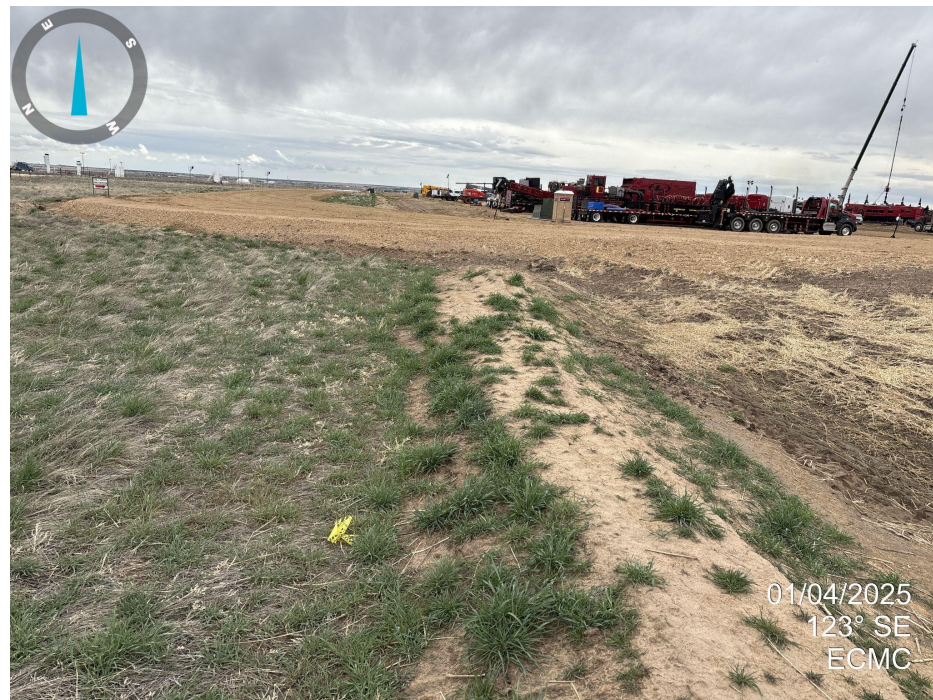
Photo 16. Looking east down north side of location. Ditch is present and appears to be stabilized.
