Final Reclamation and Stormwater Inspection

Date: 04/01/2025

Operator: BONANZA CREEK ENERGY OPERATING
COMPANY LLC - 8960

Location ID: 428278

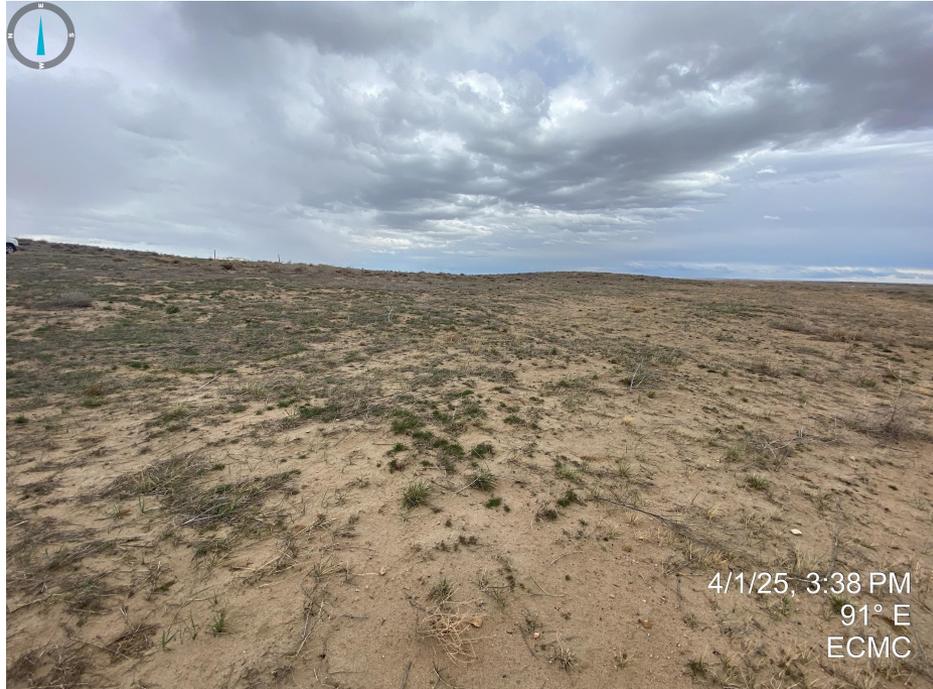
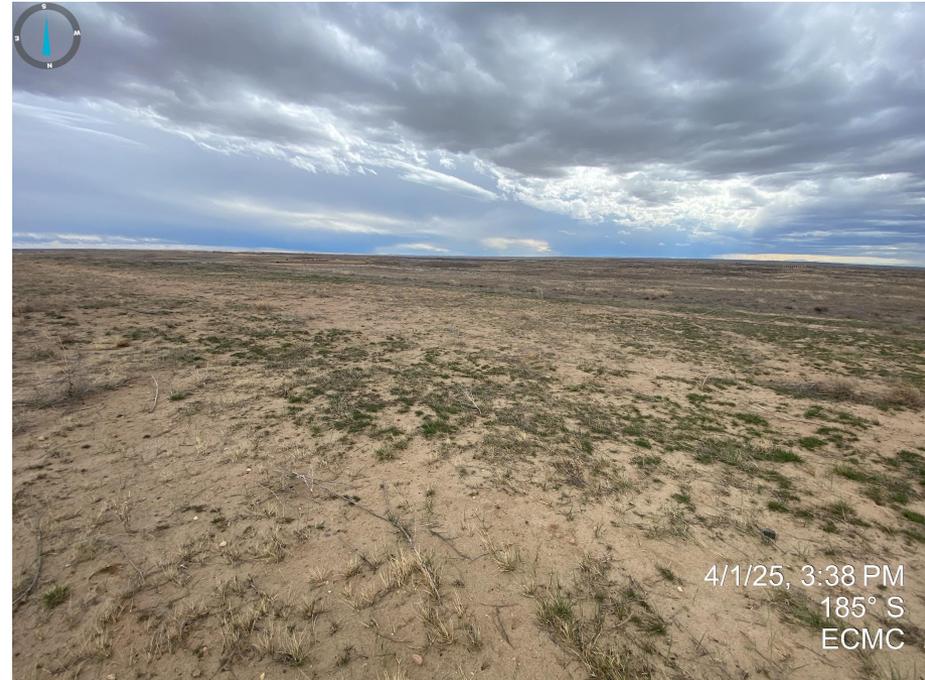
Photos 1 & 2. Taken from the northwestern portion of the location. Photos illustrate that the disturbance areas do not appear to be progressing towards reclamation standards and regulations with evidence of bare/unstabilized soils and undesirable vegetation.

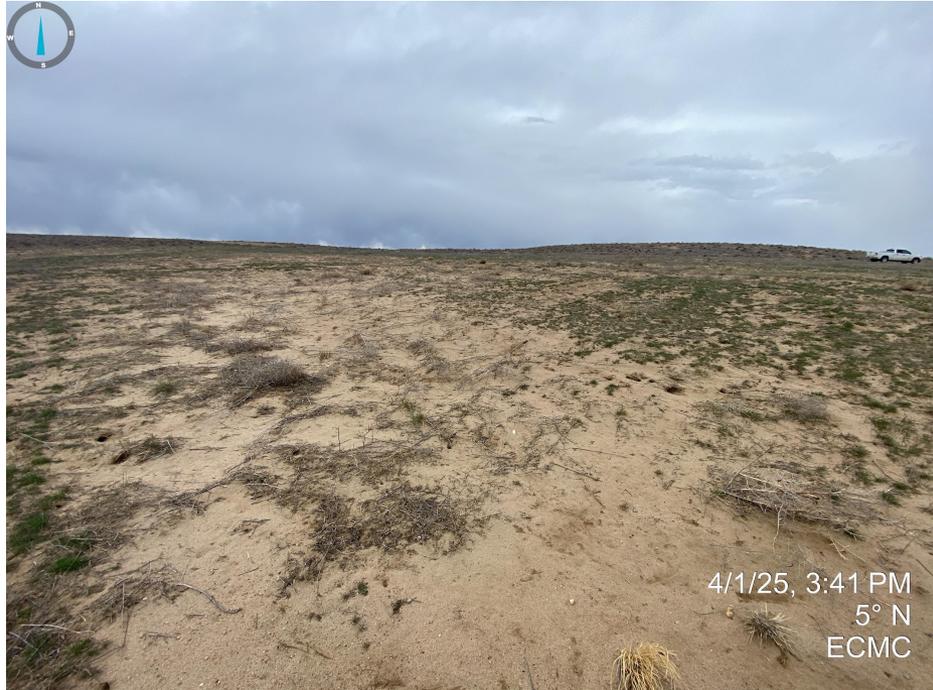
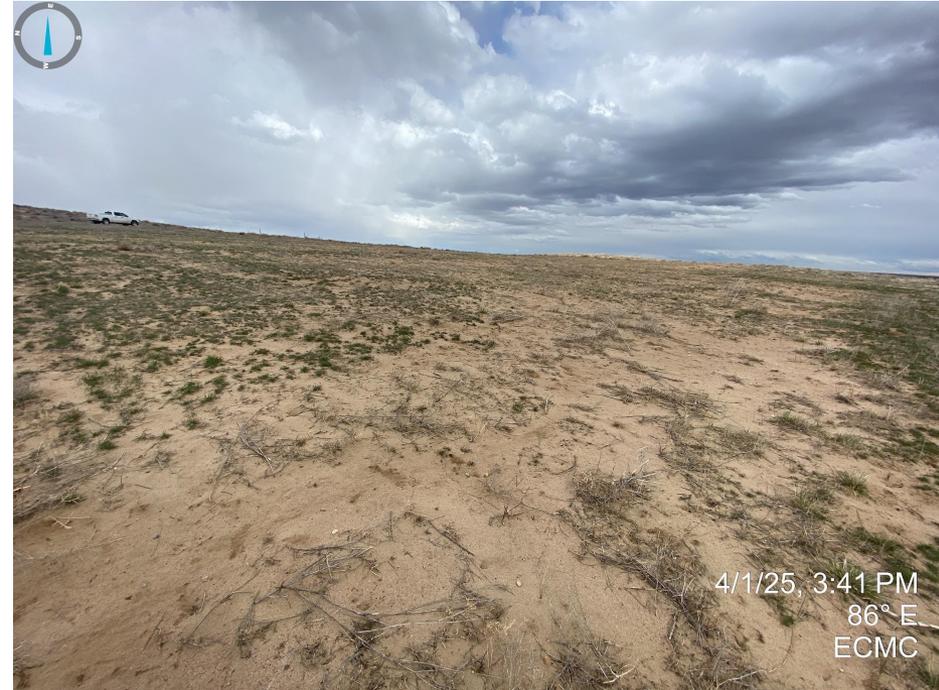
Photos 3 & 4. Taken from the northern/center of the location. Photos illustrate that the disturbance areas do not appear to be progressing towards reclamation standards and regulations with evidence of bare/unstabilized soils and undesirable vegetation.

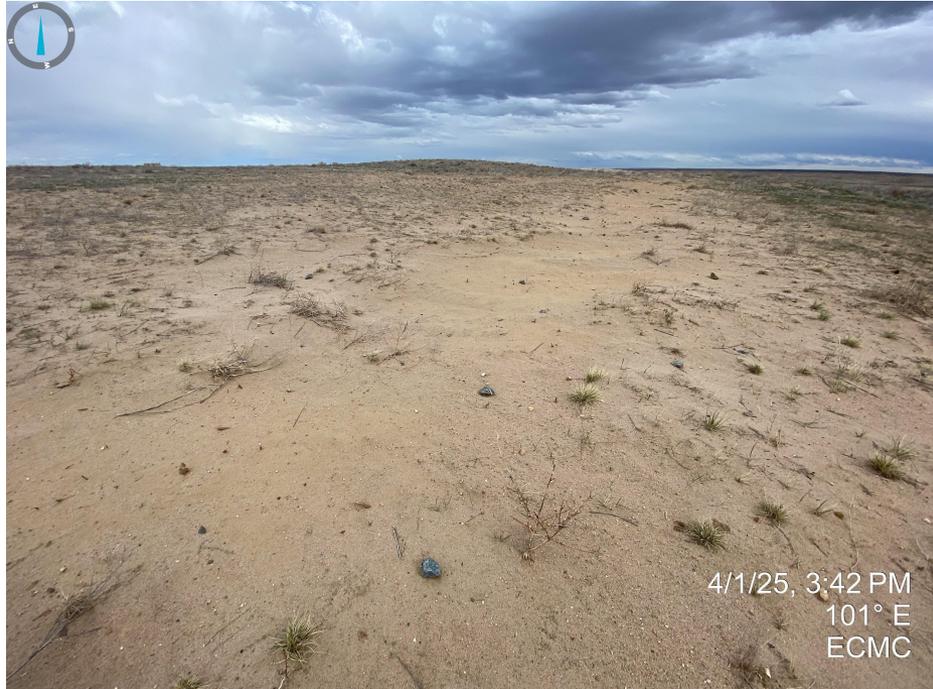
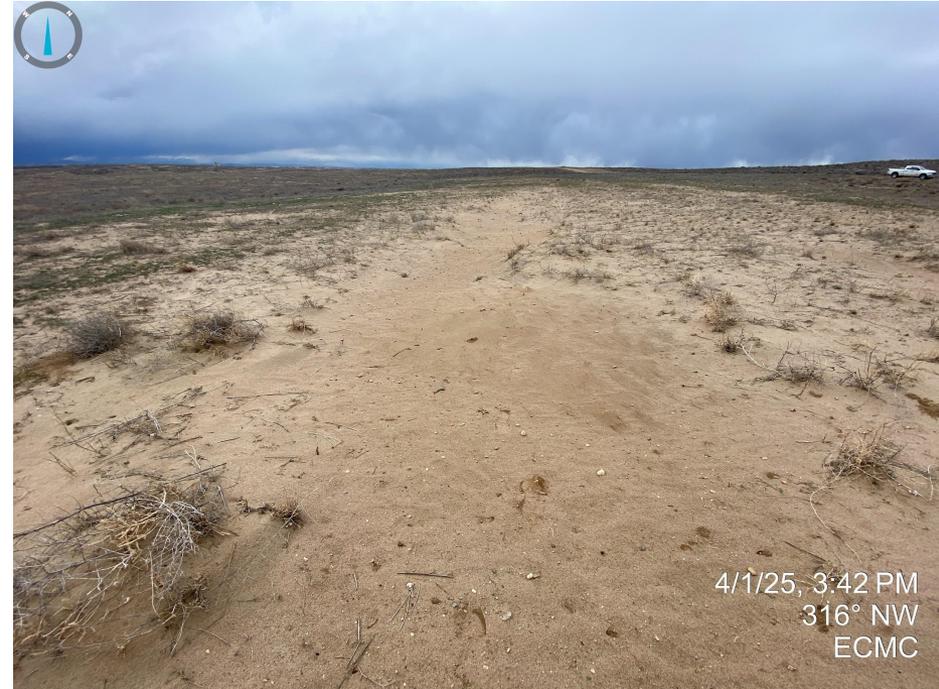
Photos 5 & 6. Taken near the southern/center portion of the location. Photo illustrates a portion of the disturbance area that appears to be experiencing wind erosion due to unstabilized soils.

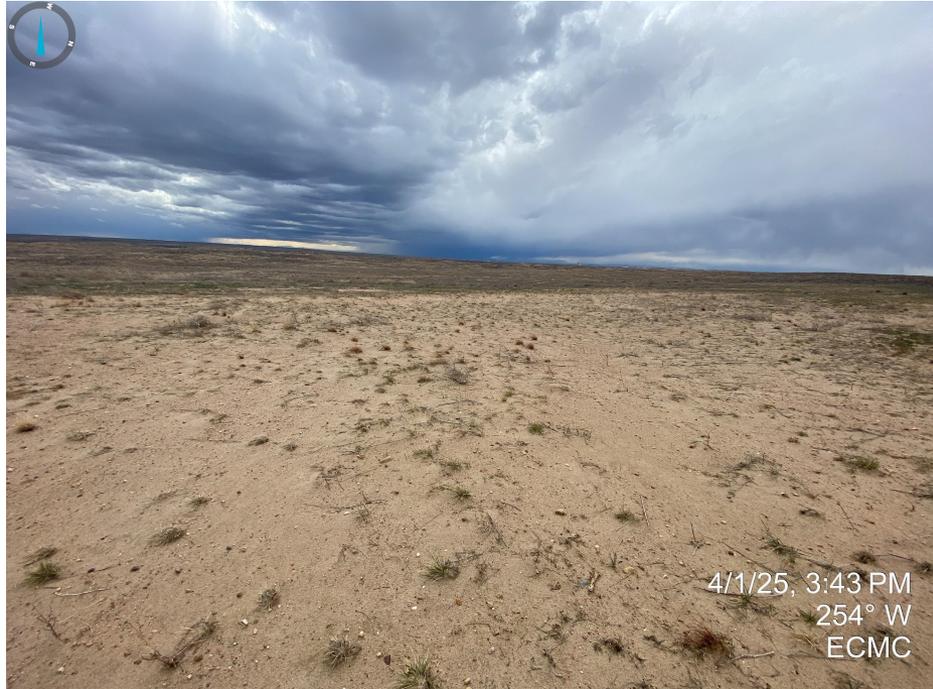
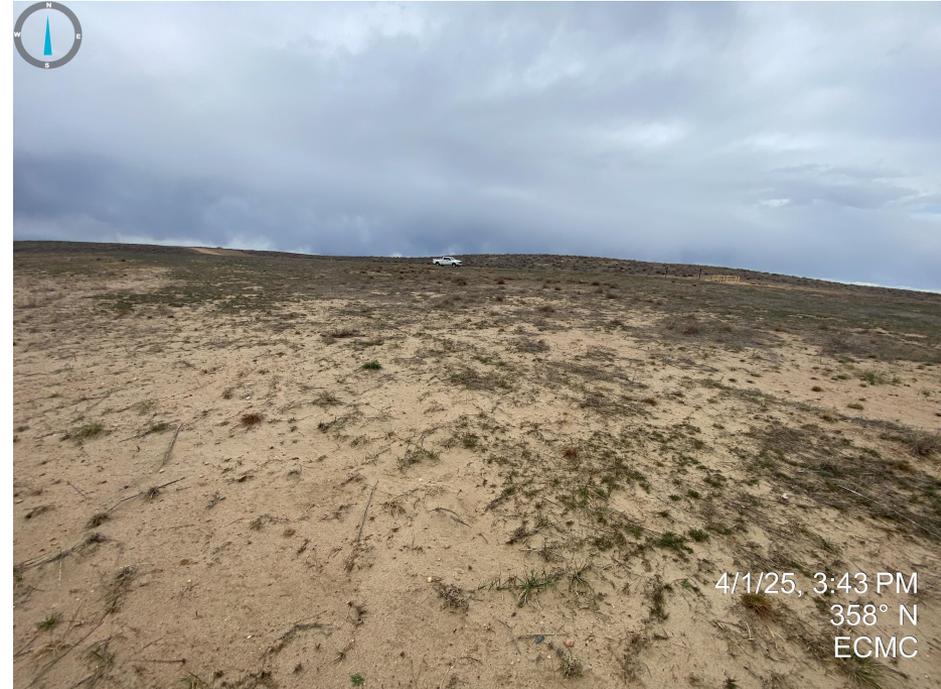
Photos 7 & 8. Taken from the southeastern portion of the location. Photos illustrate that the disturbance areas do not appear to be progressing towards reclamation standards and regulations with evidence of bare/unstabilized soils and undesirable vegetation.

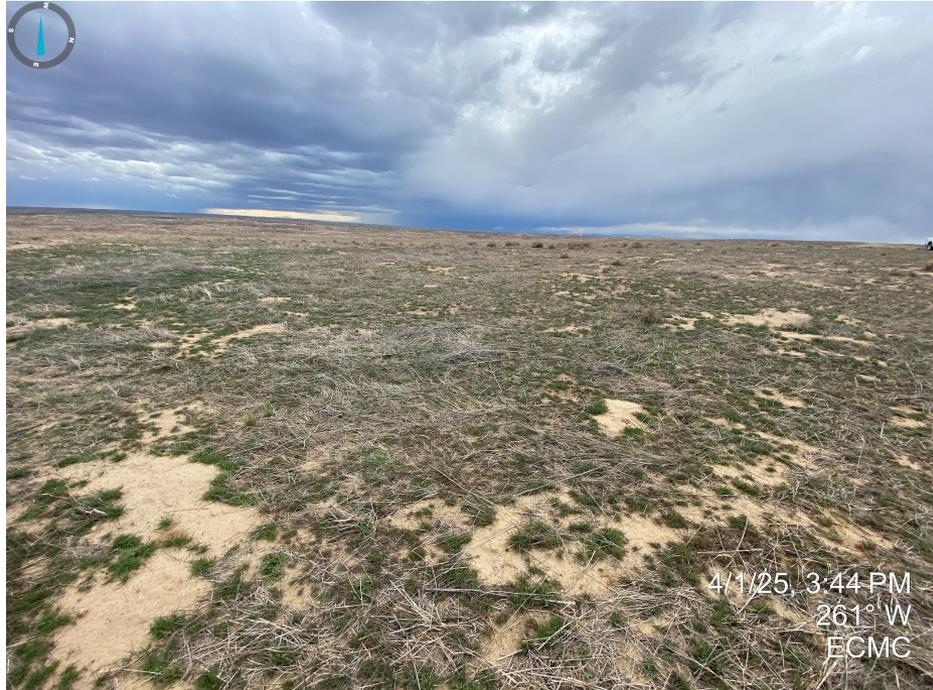
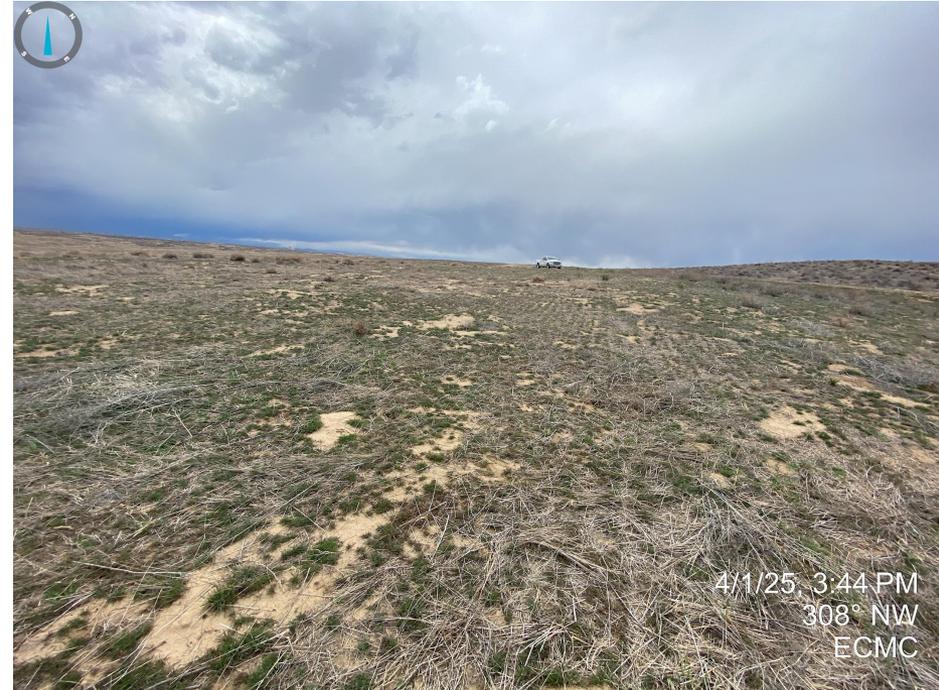
Photos 9 & 10. Taken near the former access point, or northeastern portion of the location. Photo illustrates the presence of undesirable vegetation (CO List C Noxious Weed-cheatgrass) throughout.

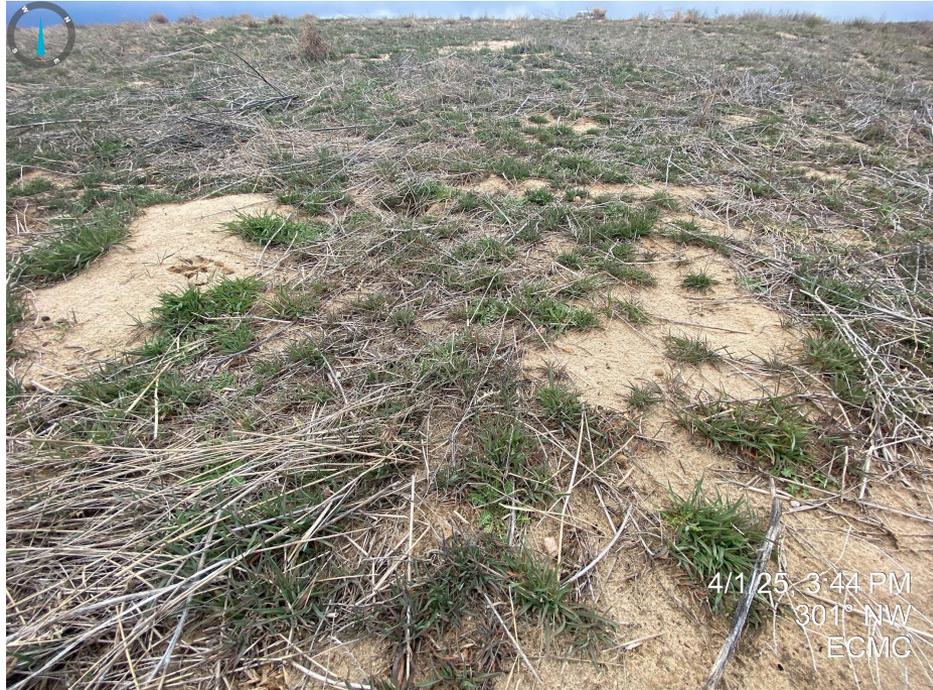
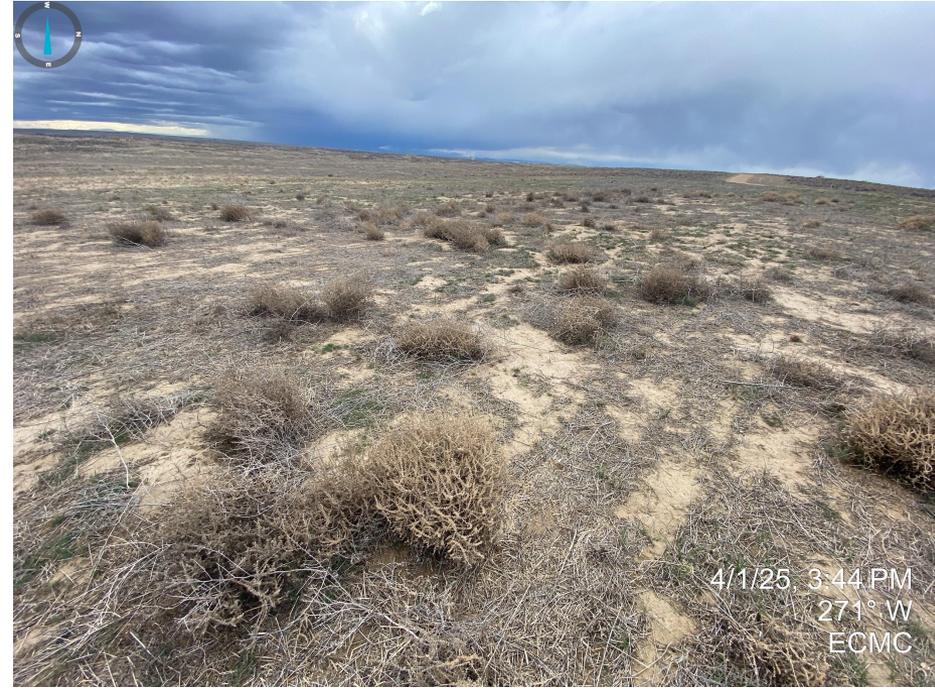
Photos 11 & 12. Examples of undesirable vegetation observed throughout the reclaimed disturbance areas; cheatgrass (left) and russian thistle (right).
