Caerus Piceance LLC – QB Energy Corporation LLC
Figure Four Unit-64S98W 1SWSW
Location ID: 335790

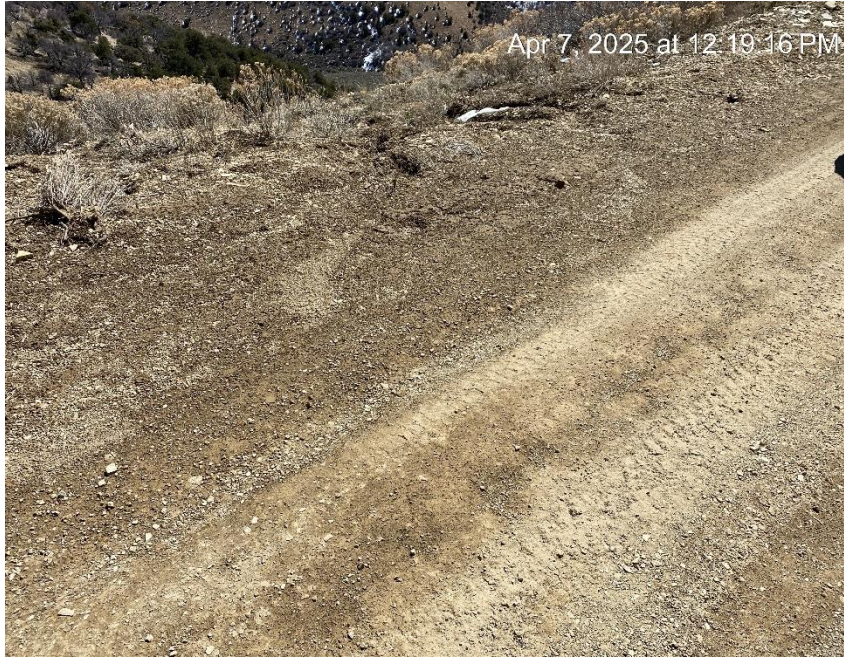
Erosion and sediment migration

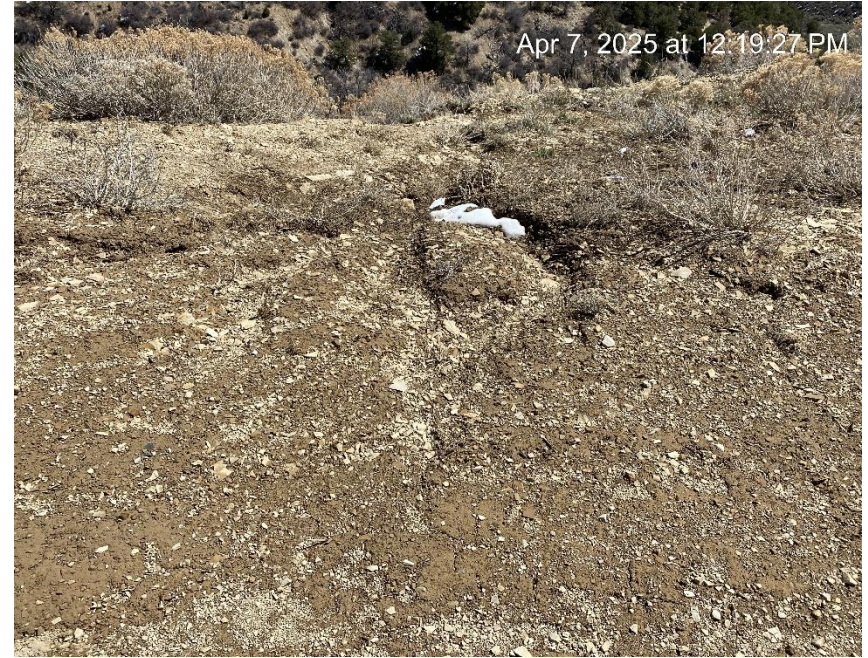
Stormwater BMP not maintained

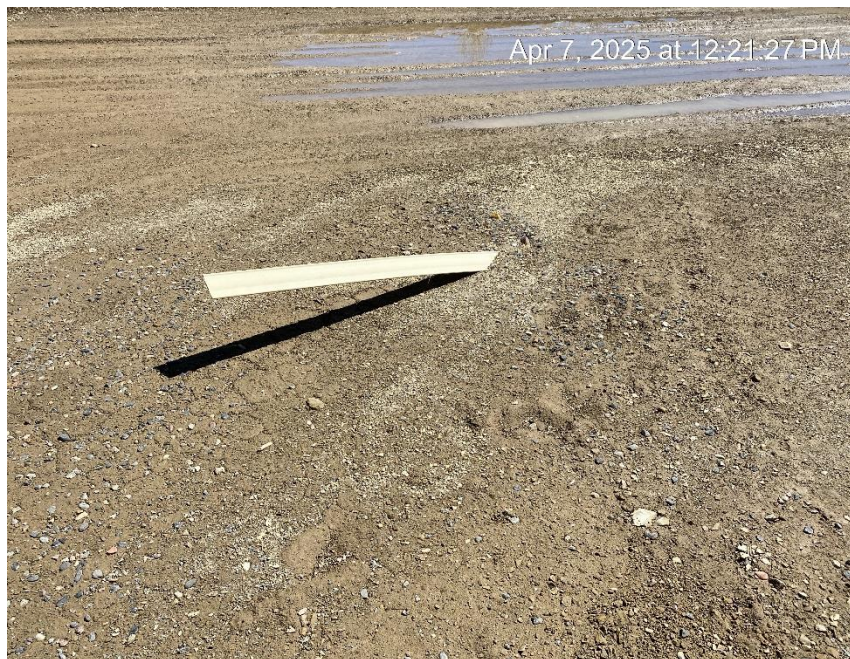
Unmarked anchor

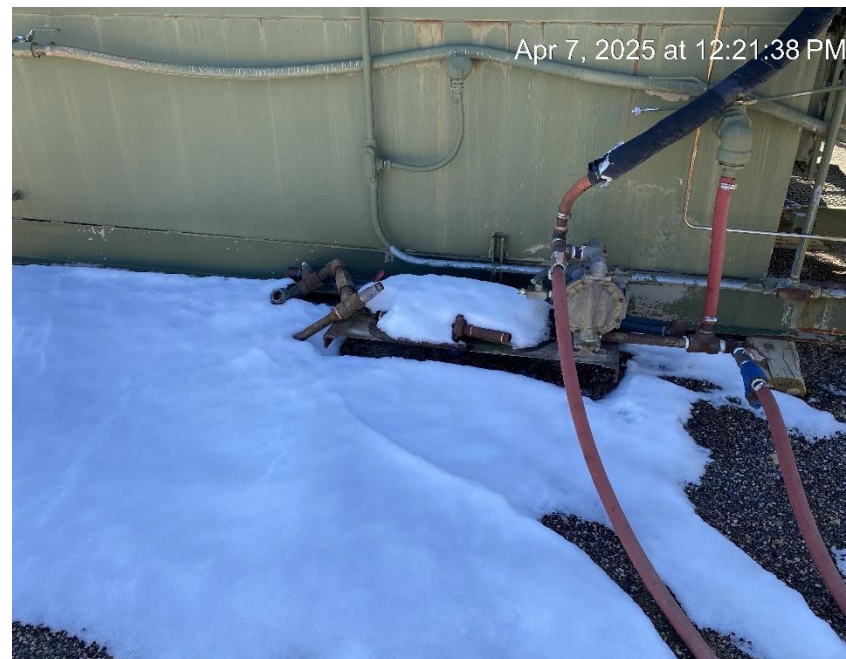
Debris

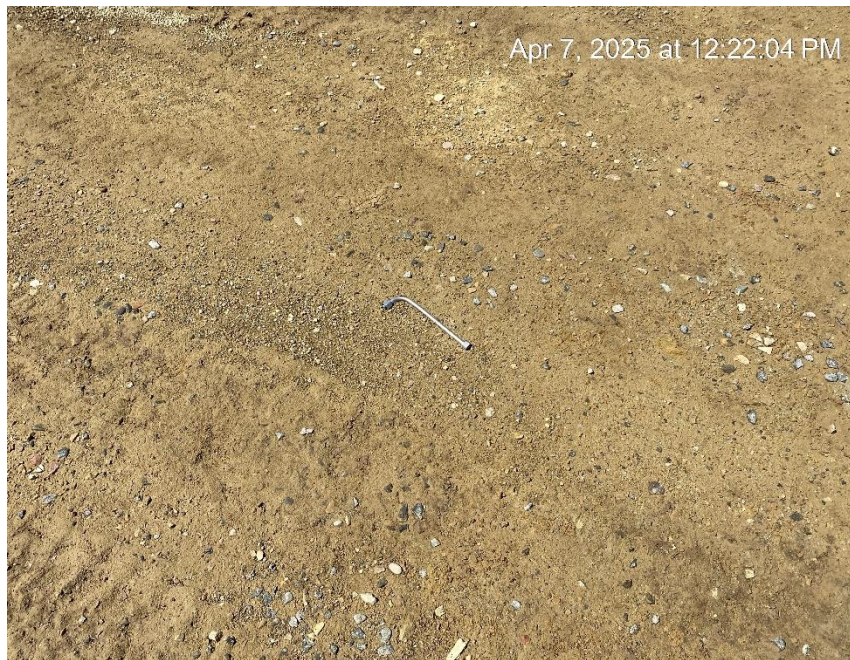
Debris

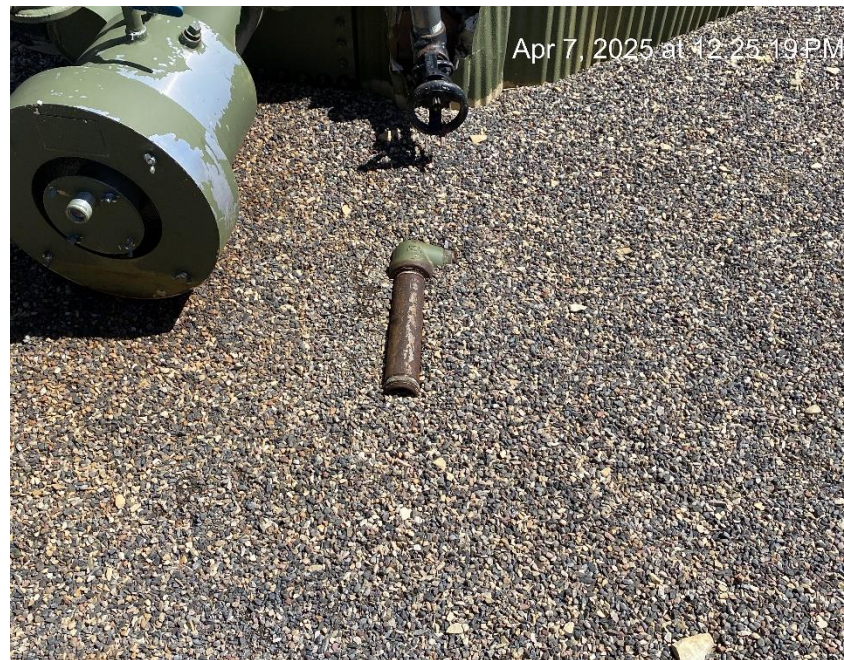
Debris

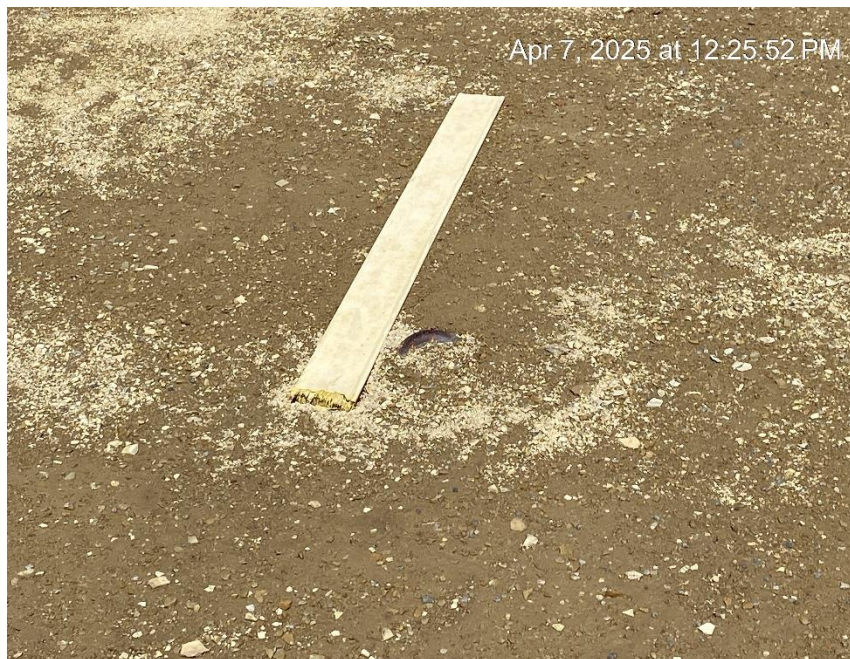
Unmarked anchor

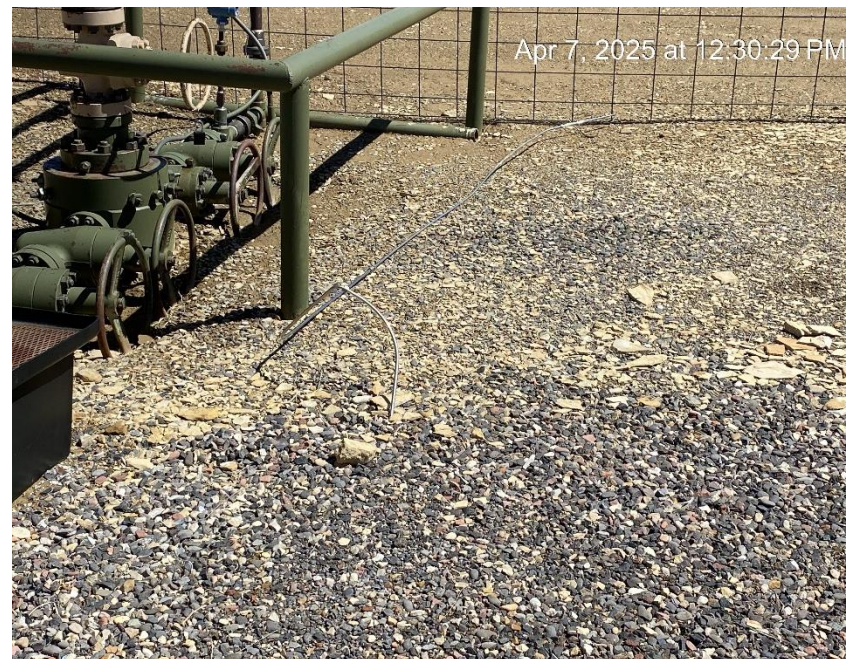
Debris

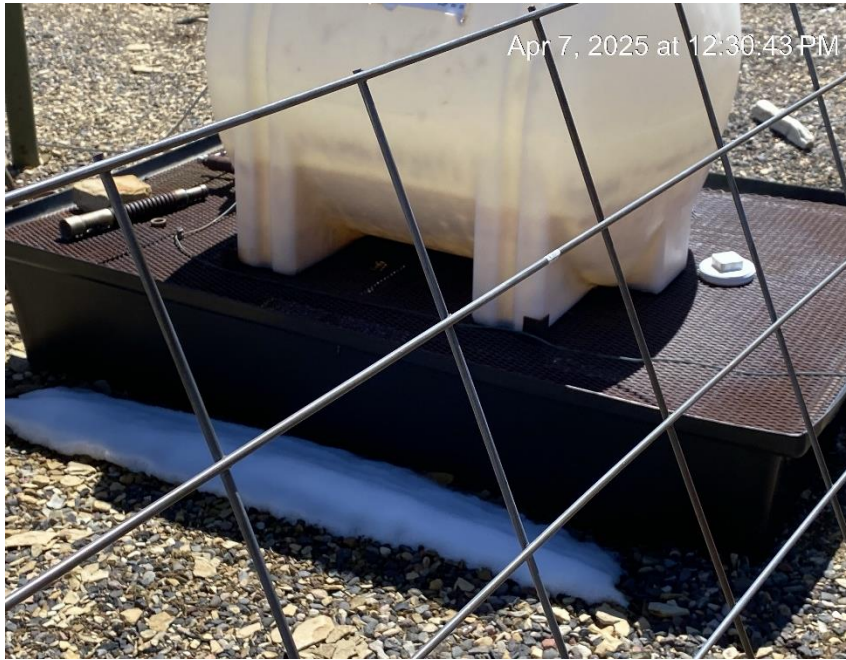
Debris

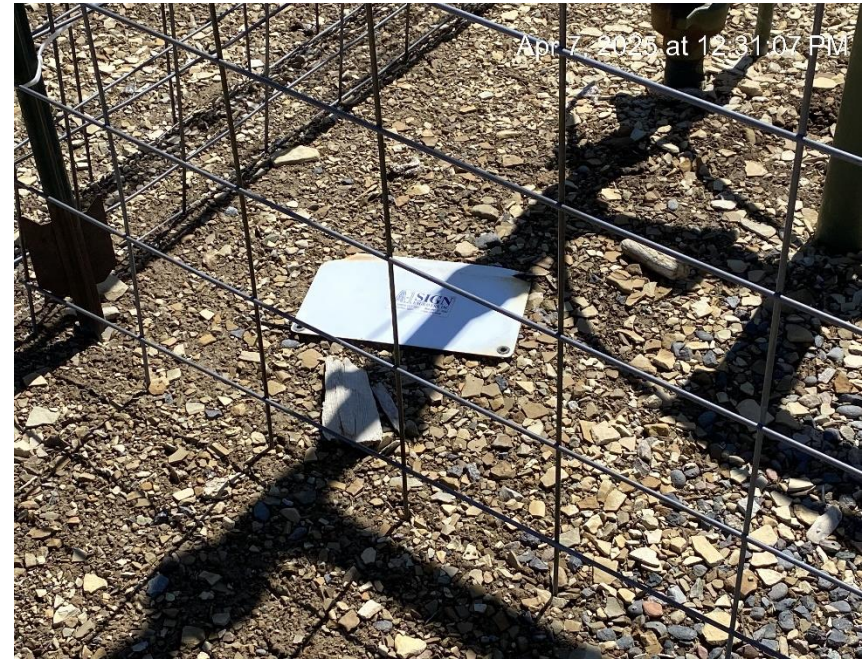
Well sign not displayed

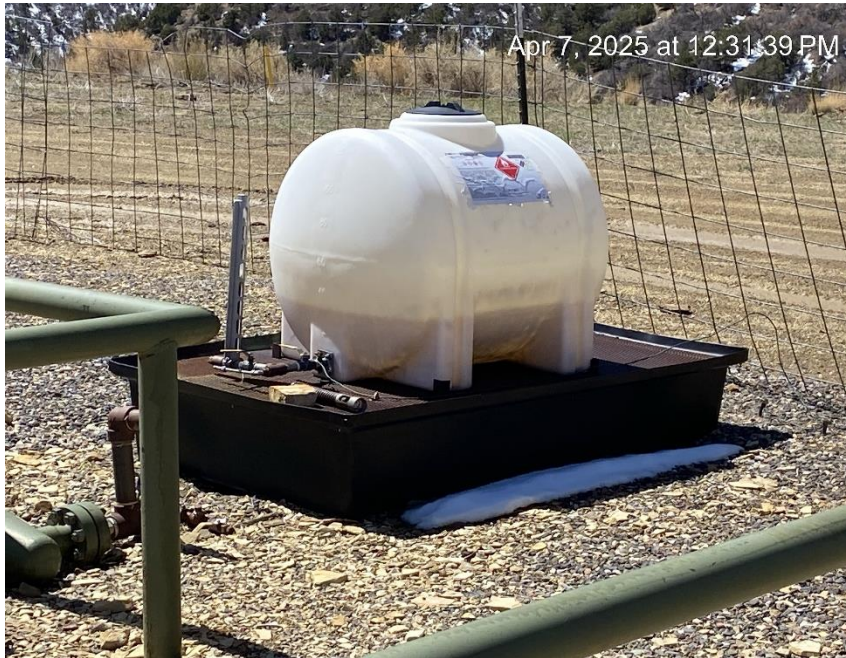
Unused equipment

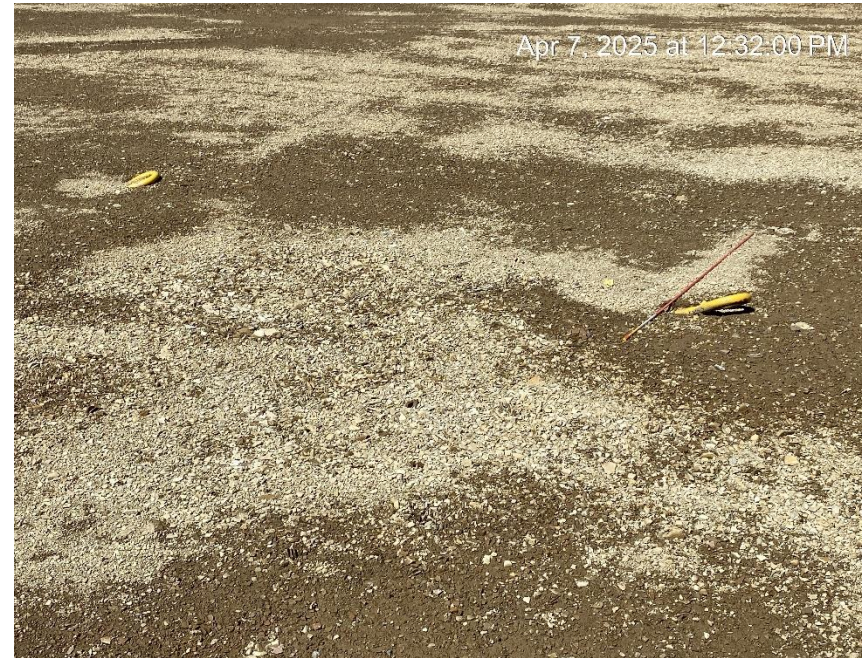
Unmarked anchors
