**Operator: BONANZA CREEK ENERGY OPERATING CO.**

**Location Name: Pronghorn 31-9 Pad**

**Loc ID: 306037**

**Inspection: 718700177**

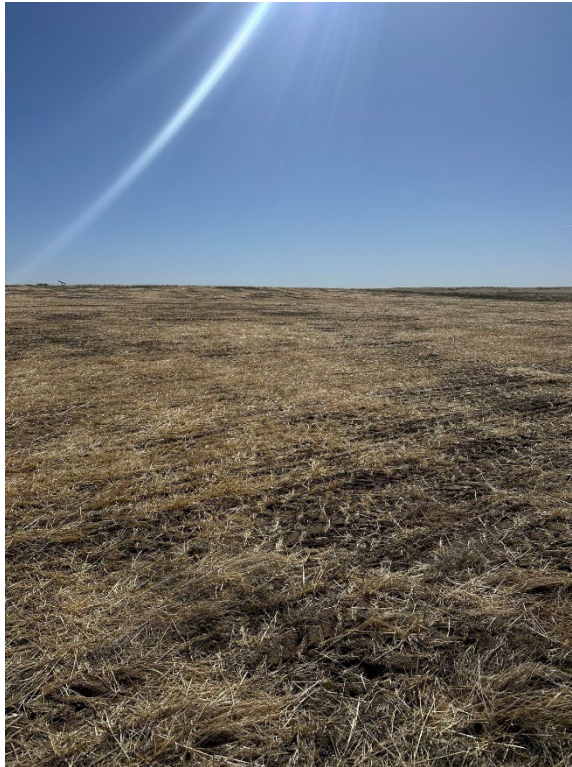
**Exhibit D**

**CA:** This location does not comply with Rule 1004. Previous FIR (doc #713900049) documented that the access road and well location did not appear to have been reclaimed (e.g. contoured or graded). Operator submitted FIRR (doc #403620207) stating that the corrective action was completed and the location was mowed, recontoured and reseeded. During this inspection, it was observed that the access road and location appeared to have been previously reseeded, however, the location does not appear to have been contoured or graded to reflect the adjacent topography or pre-disturbance conditions. Additional reclamation activities (e.g. contouring, grading, etc) is required. Refer to attached inspection photos. Comply with Rule 1004. Contour/grade the entire location and reseed disturbance areas using a seed mixture requested by the surface owner, or a mixture prescribed by the local county NRCS. Establish vegetation with total perennial, non-invasive uniform plant cover of at least eighty (80) percent of reference area levels. Ensure erosion controls are implemented to stabilize the seeded soil. Operator shall continue to monitor and manage this site until the location meets Rule 1004 standards, including stormwater and weed management.

**CA Resolution:** Operator has completed the recontouring of this location to match surrounding topography and seeding, in order to comply with Rule 1004.
