Interim Reclamation and Stormwater Inspection

Operator: DENOVA SEQUESTRATION LLC - 10790

Location ID: 483817

Inspection Document #: 718700274

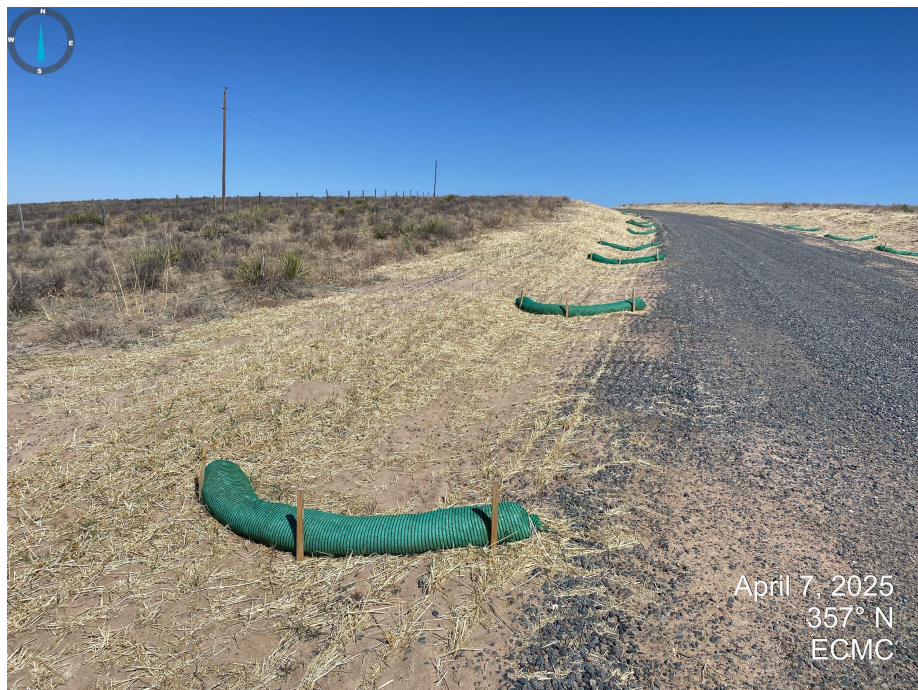
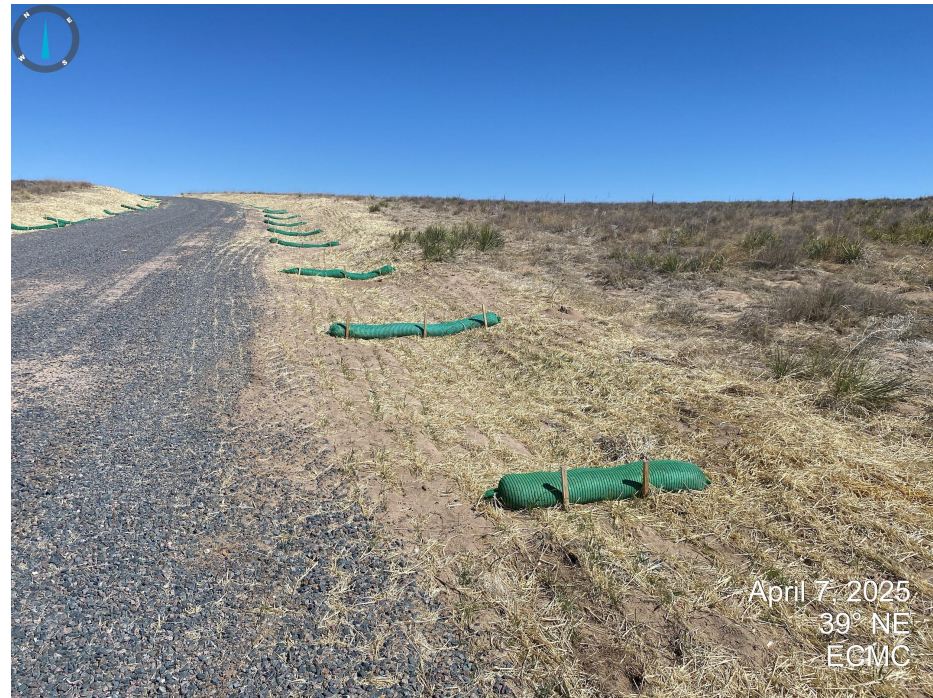
Photos 1 & 2. Taken along the access road. It appears that stormwater control measures have been maintained, erosion degradation has been repaired, and unstabilized soils were drill seeded and mulched.

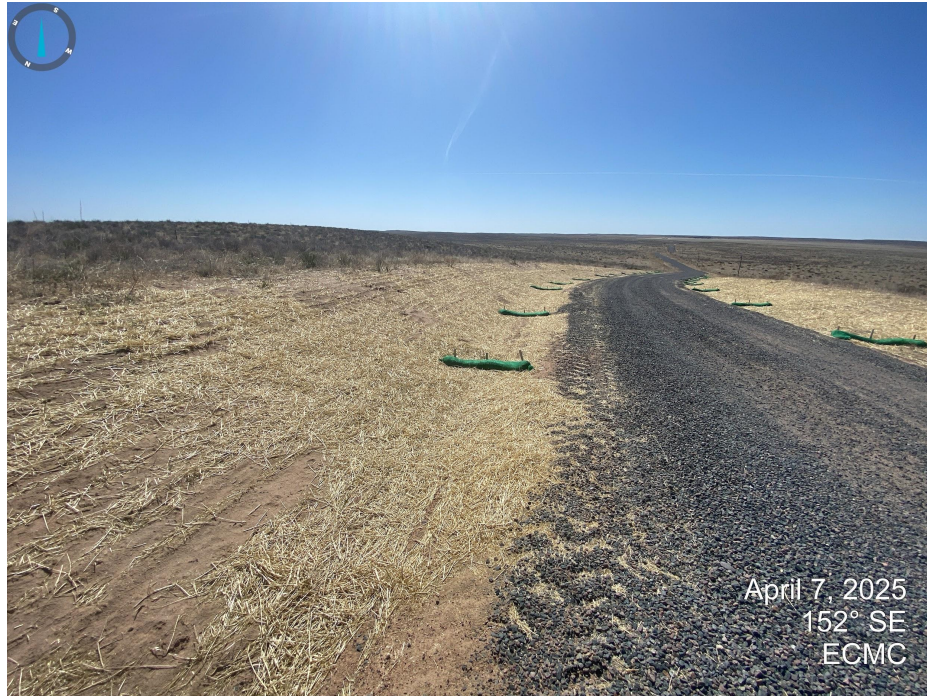
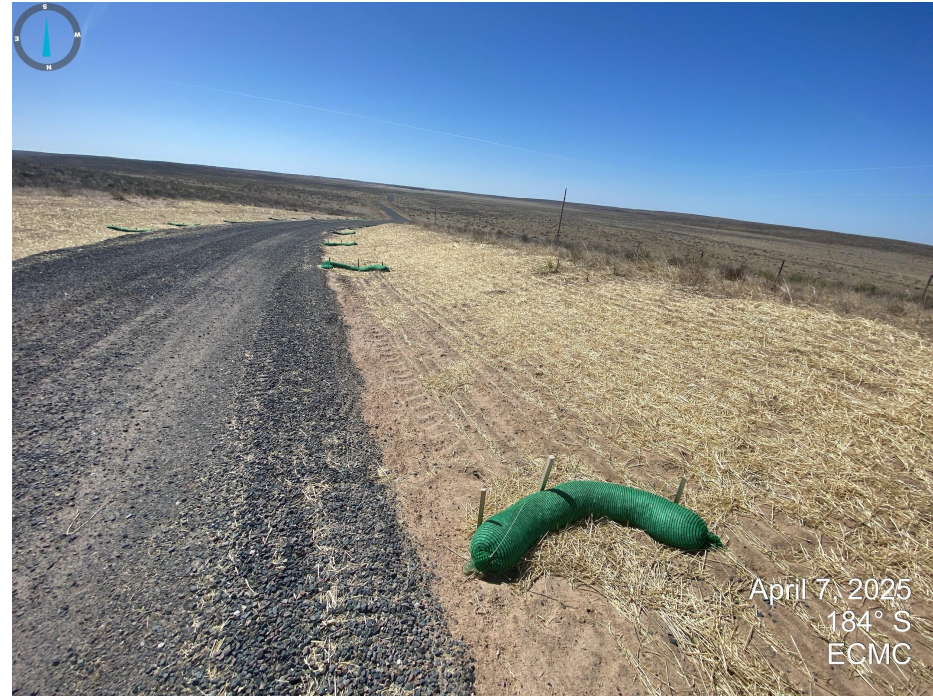
Photos 3 & 4. Taken along the access road. It appears that stormwater control measures have been maintained, erosion degradation has been repaired, and unstabilized soils were drill seeded and mulched.

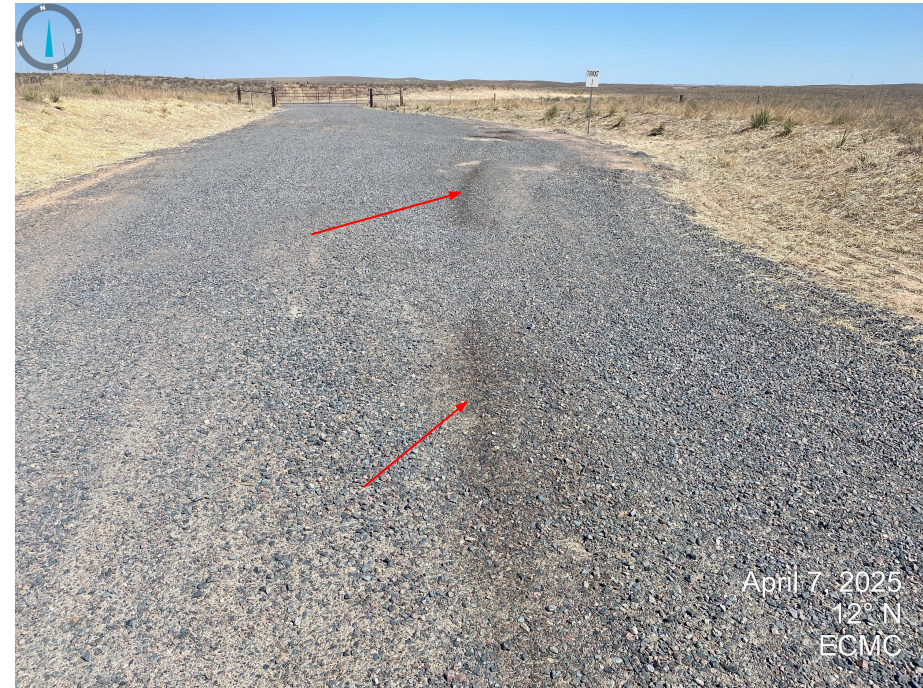
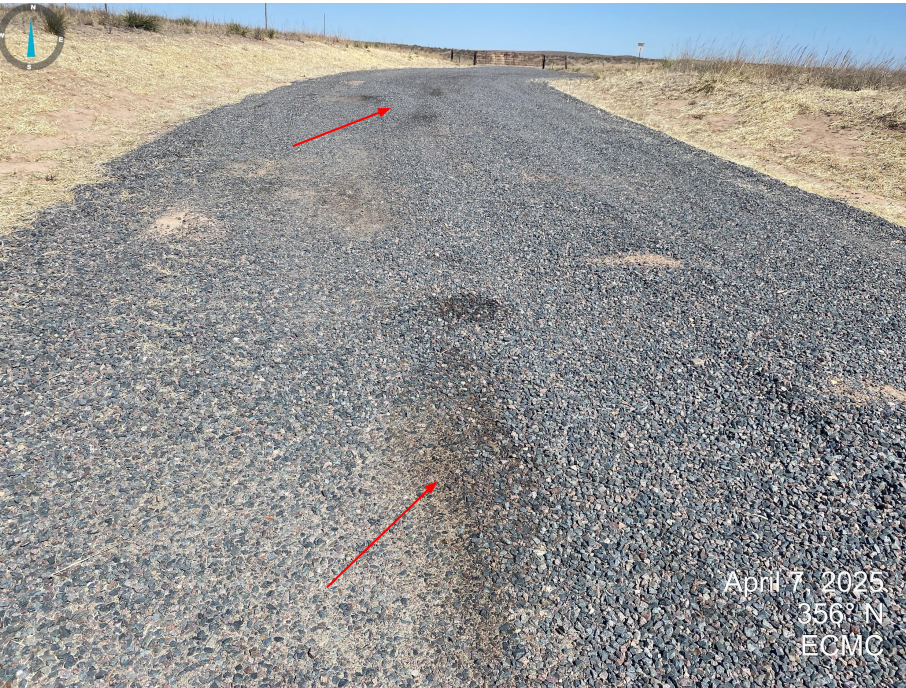
Photos 5 & 6. Stained soils observed along the access road.

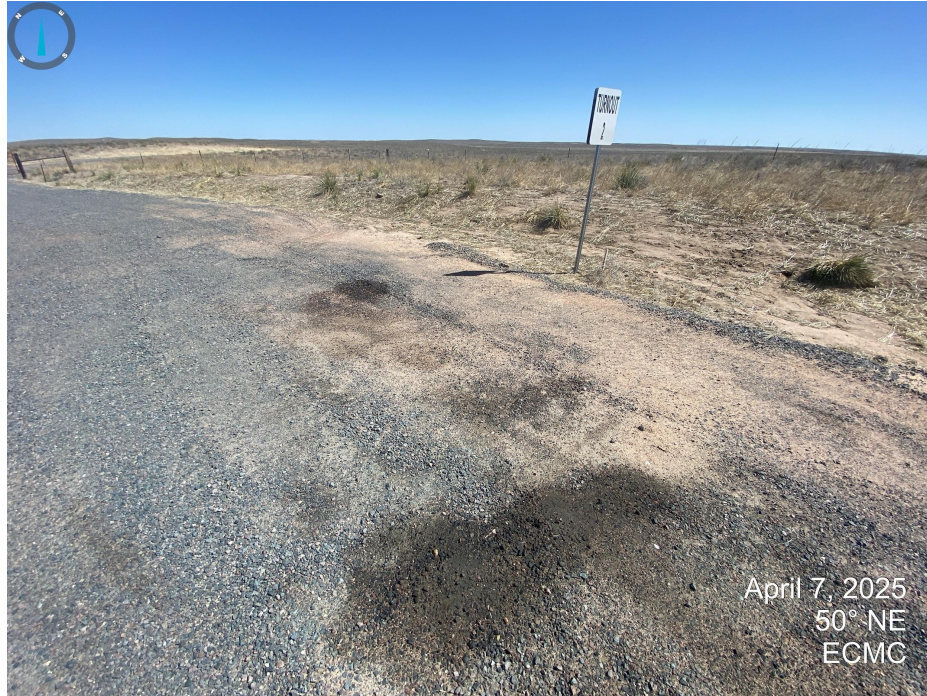
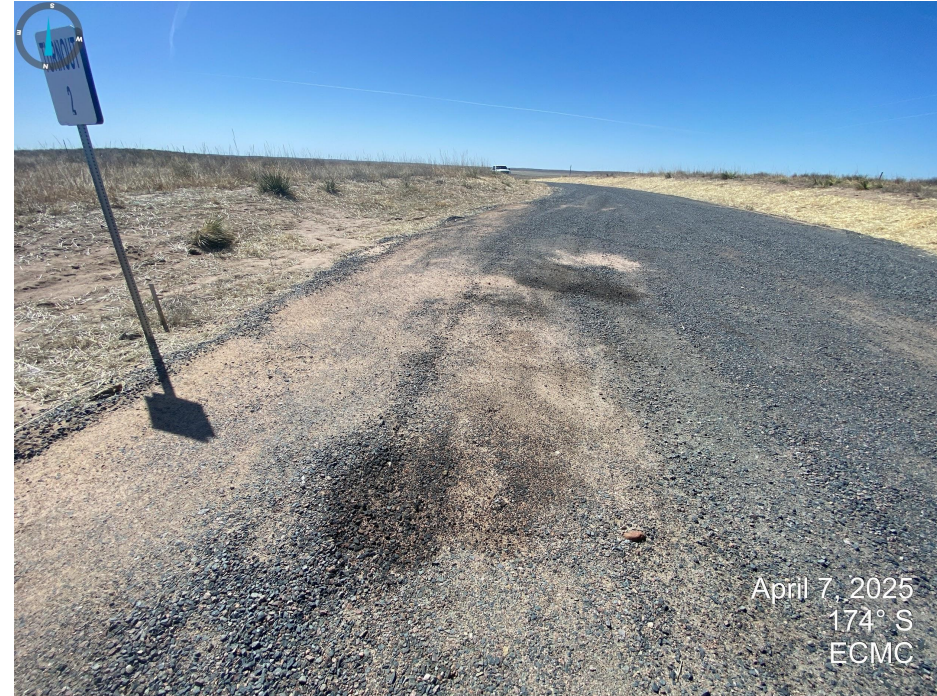
Photos 7 & 8. Stained soils observed along the access road.

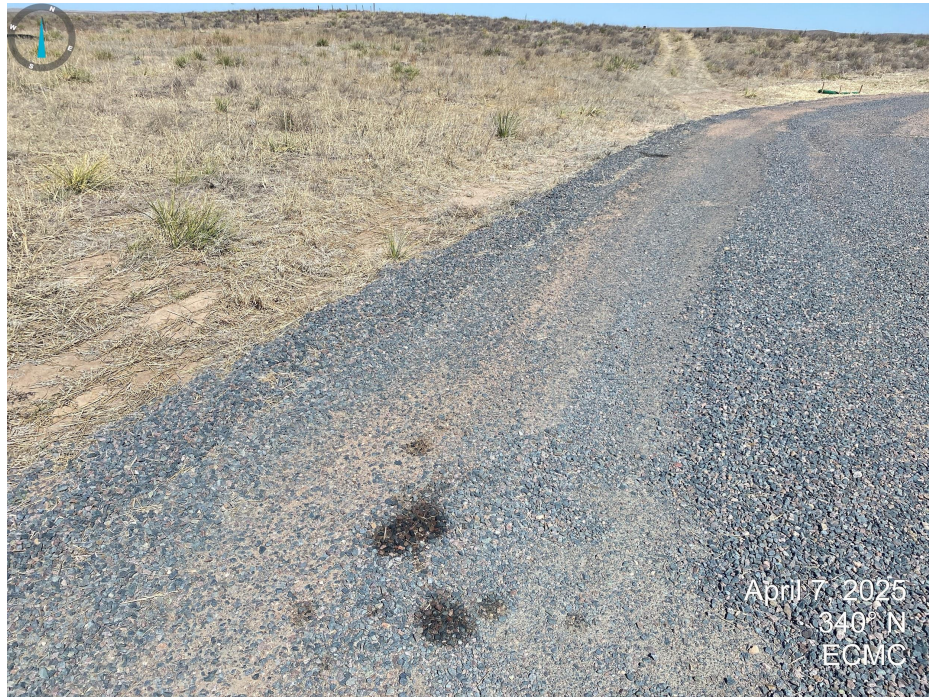
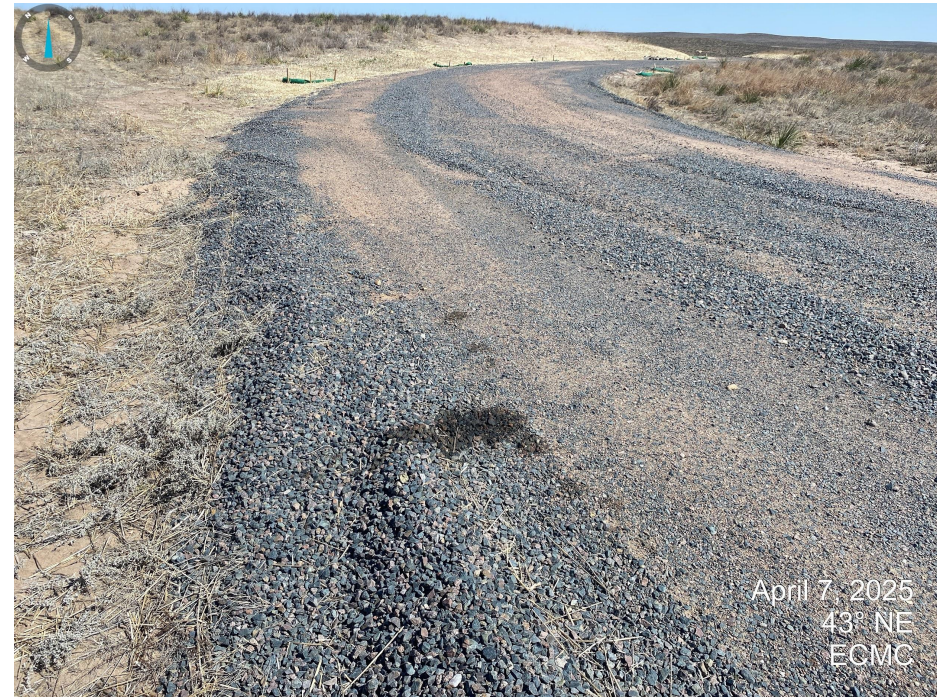
Photos 9 & 10. Stained soils observed along the access road.

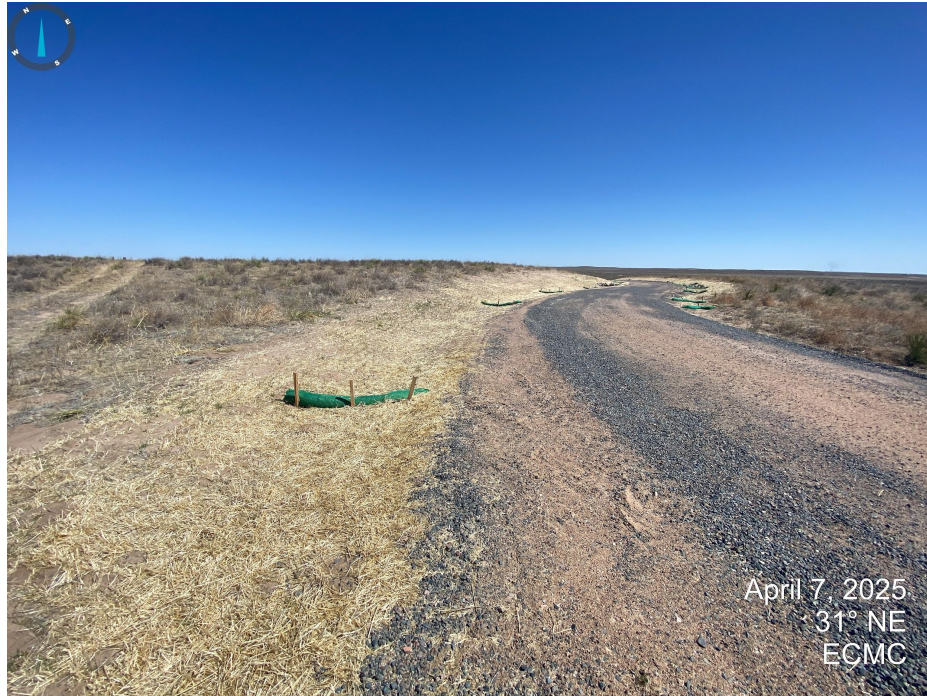
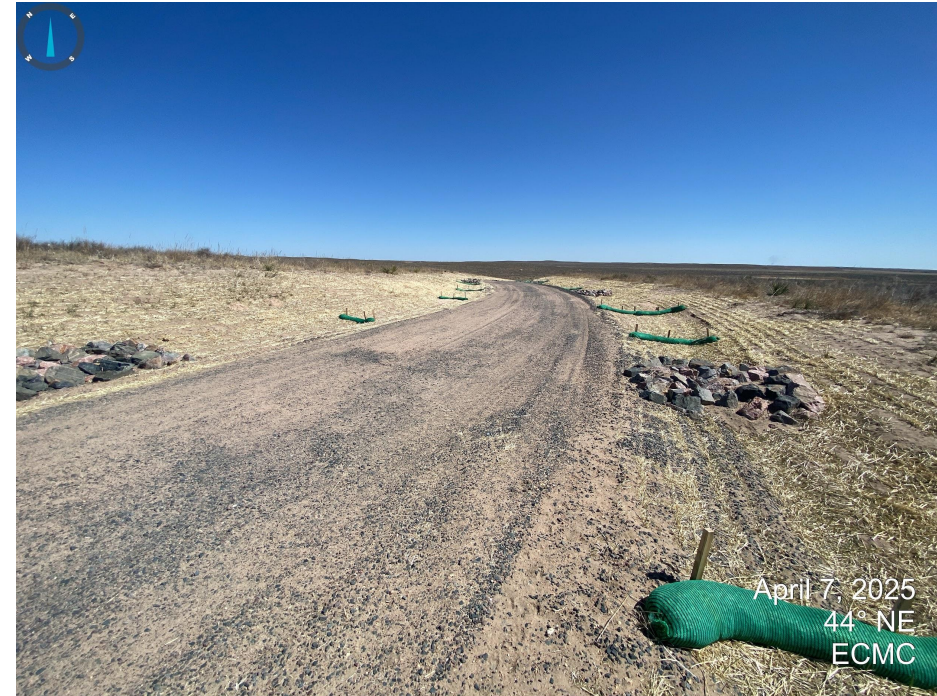
Photos 11 & 12. Taken along the access road. It appears that stormwater control measures have been maintained, erosion degradation has been repaired, and unstabilized soils were drill seeded and mulched.

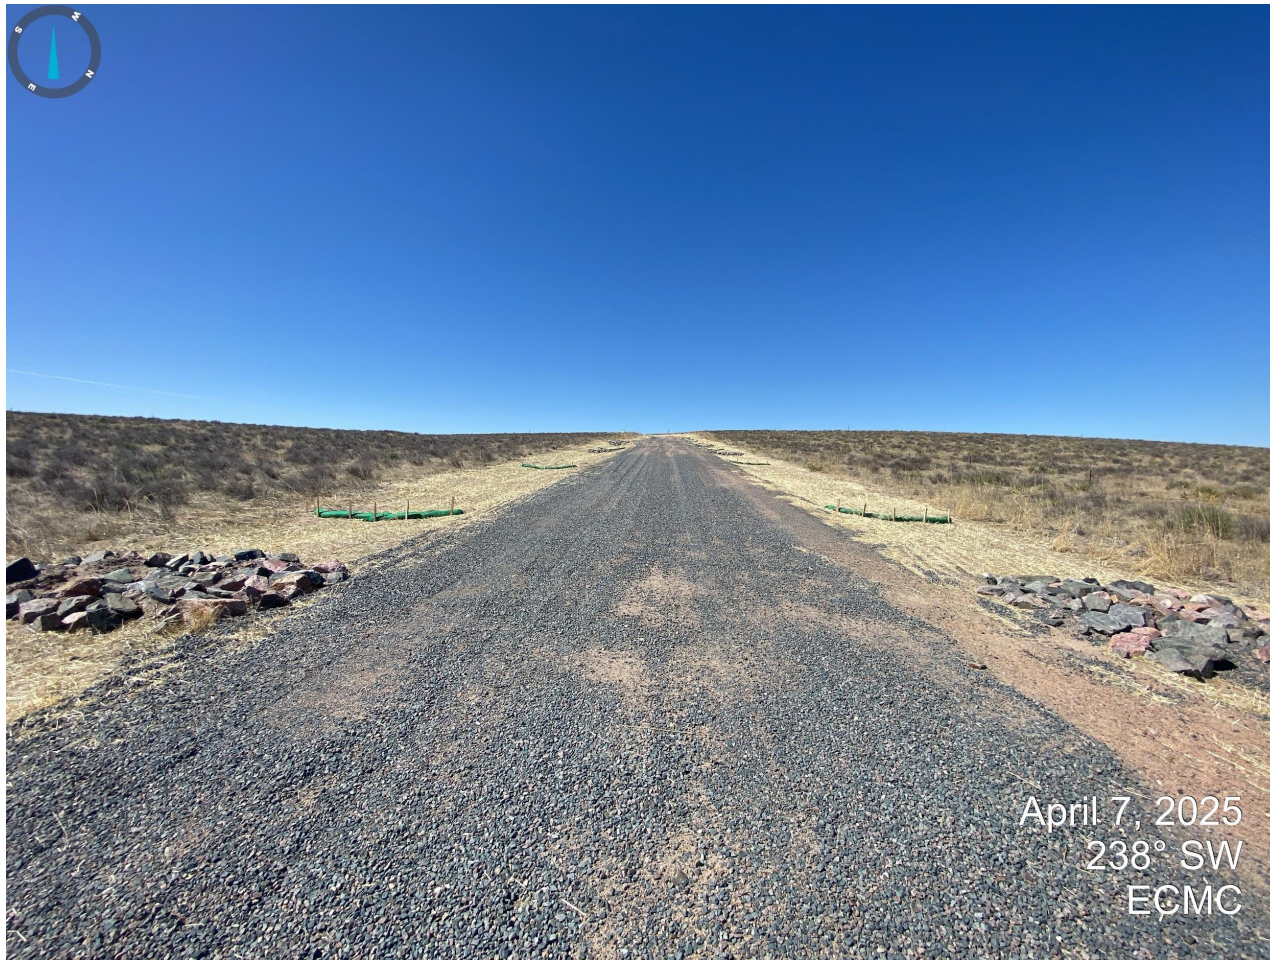
Photo 13. Taken along the access road. It appears that stormwater control measures have been maintained, erosion degradation has been repaired, and unstabilized soils were drill seeded and mulched.

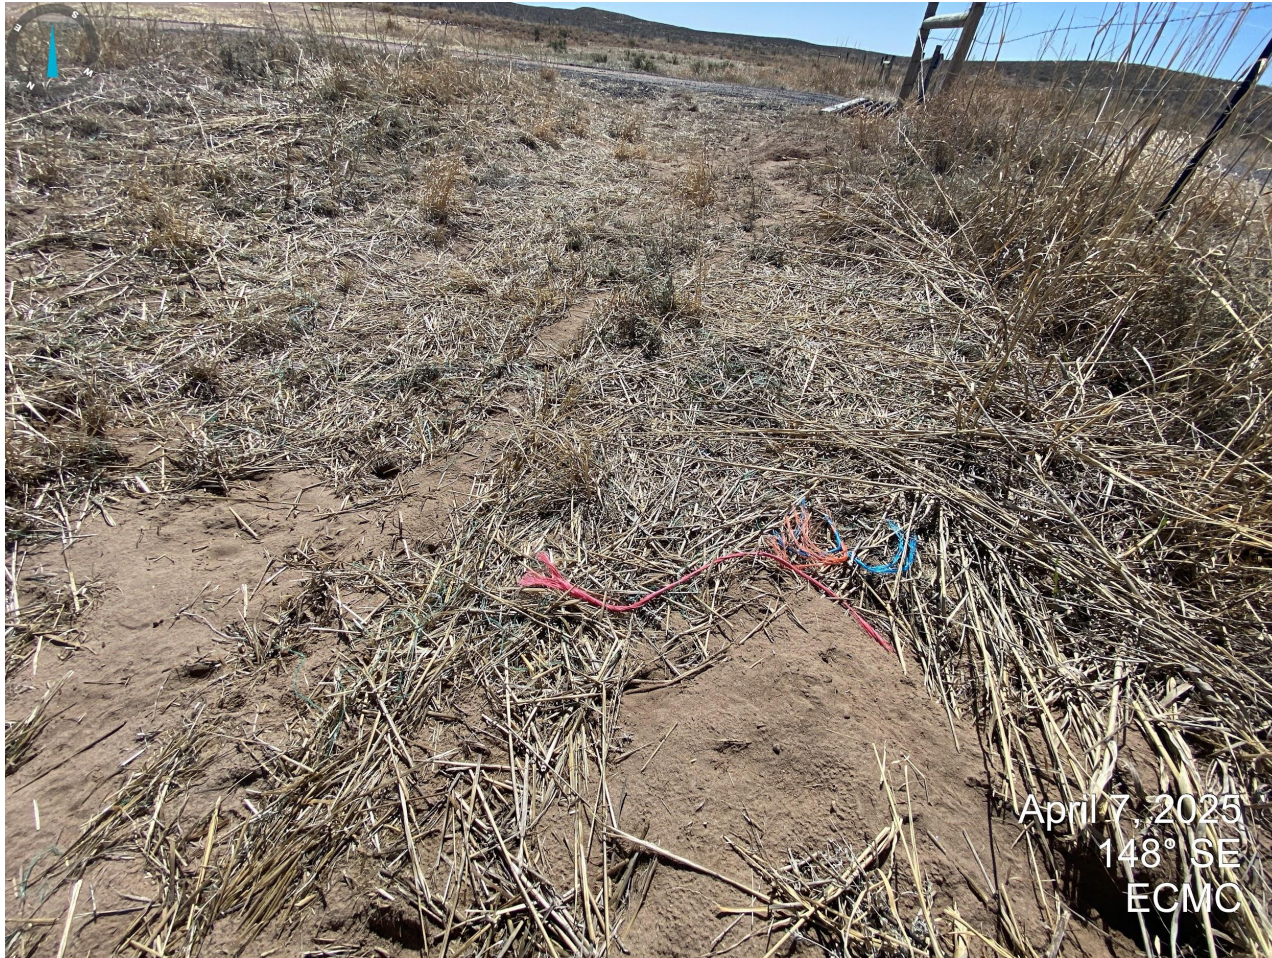
Photo 14. Examples of baler twine (trash) observed on location. Operator shall self inspect the entire location and remove all trash.

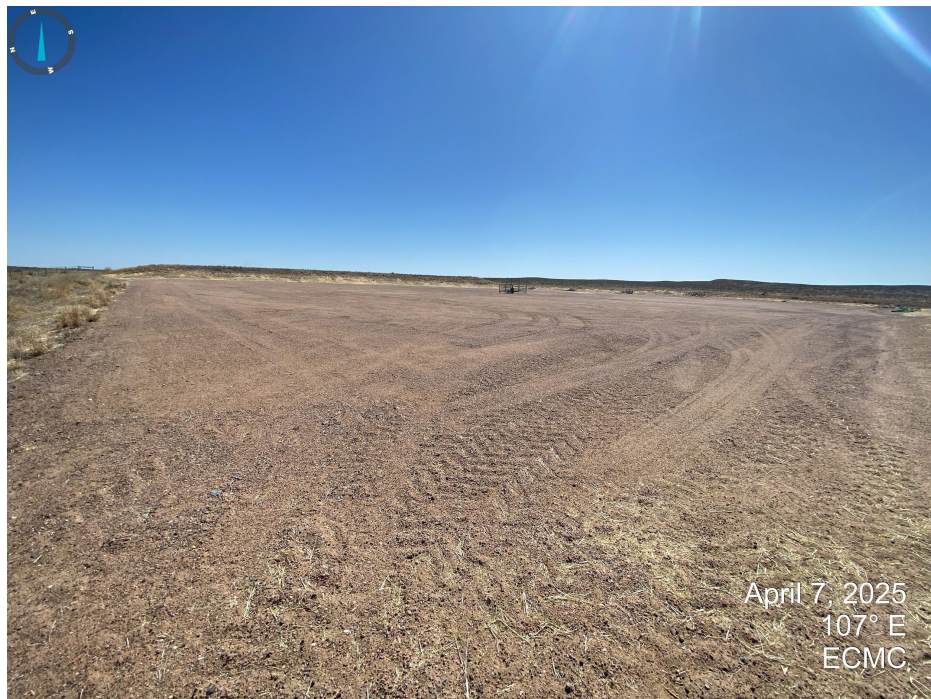
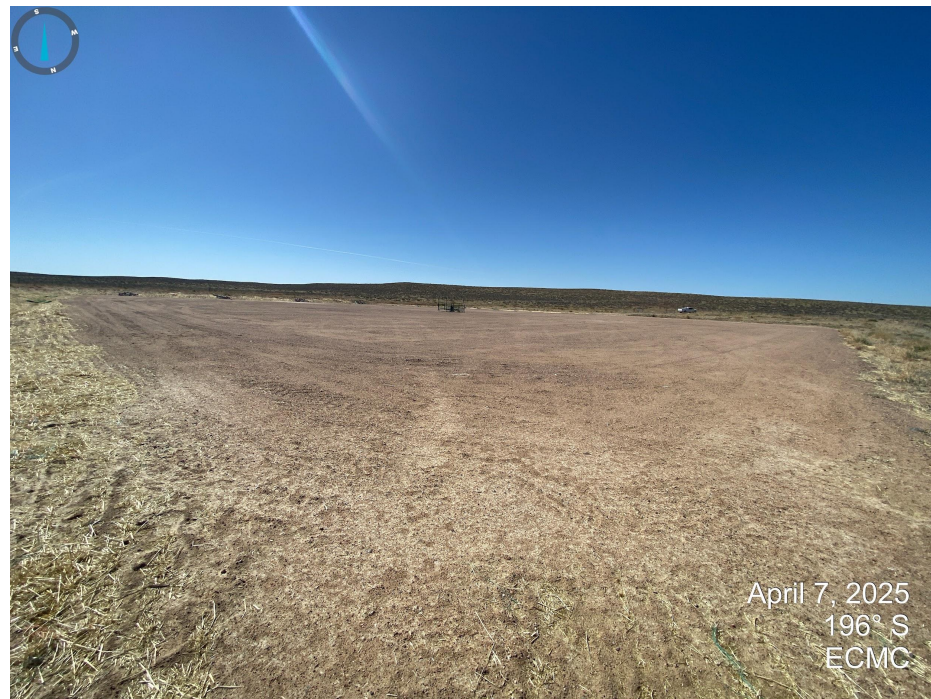
Photos 15 & 16. Taken from the northwest (Photo 15; left) and northeast (Photo 16; right) portions of the drilling pad. Photo illustrates that interim reclamation does not appear to have been performed as the drilling pad was not reduced in size only needed for production operations.

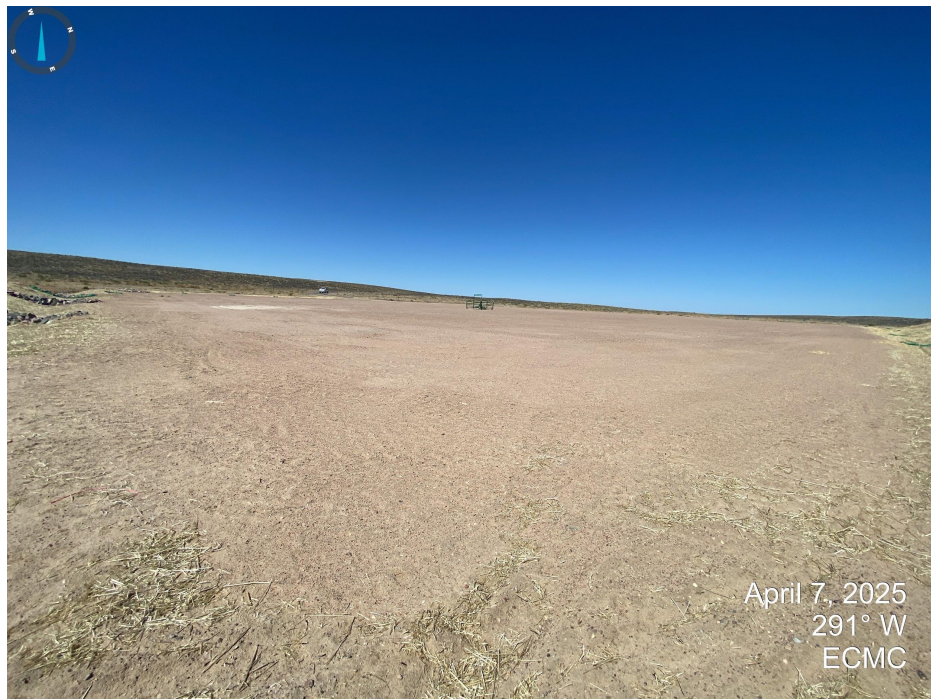
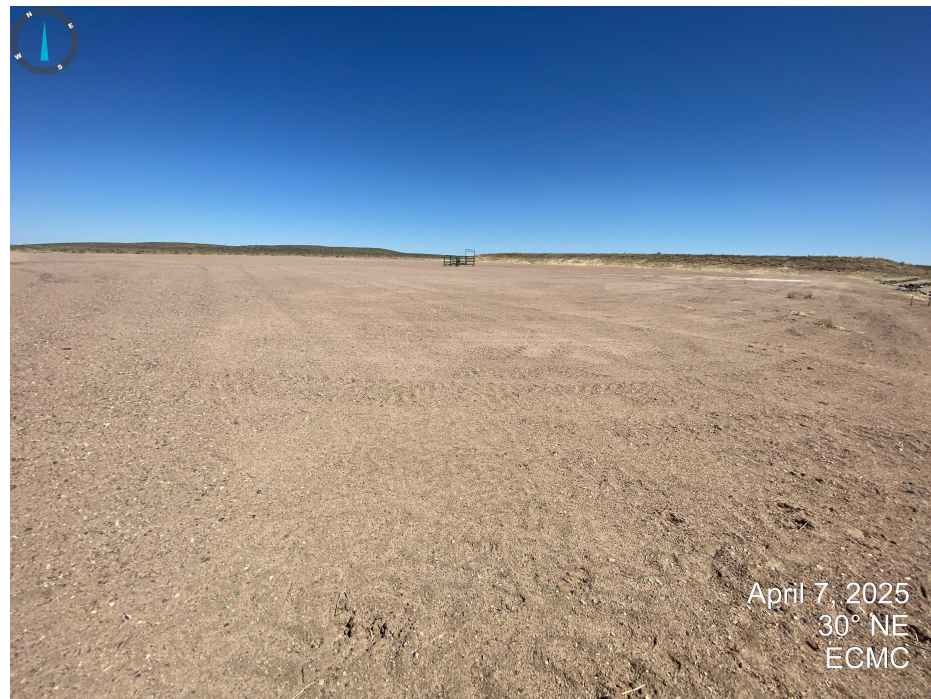
Photos 17 & 18. Taken from the southeast (Photo 17; left) and southwest (Photo 18; right) portions of the drilling pad. Photo illustrates that interim reclamation does not appear to have been performed as the drilling pad was not reduced in size only needed for production operations.

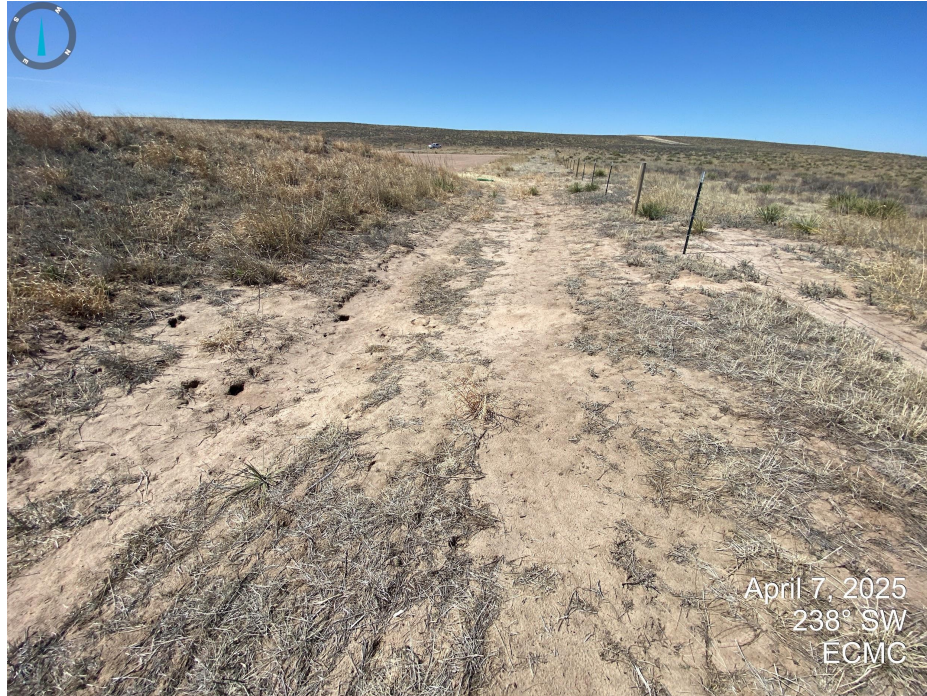
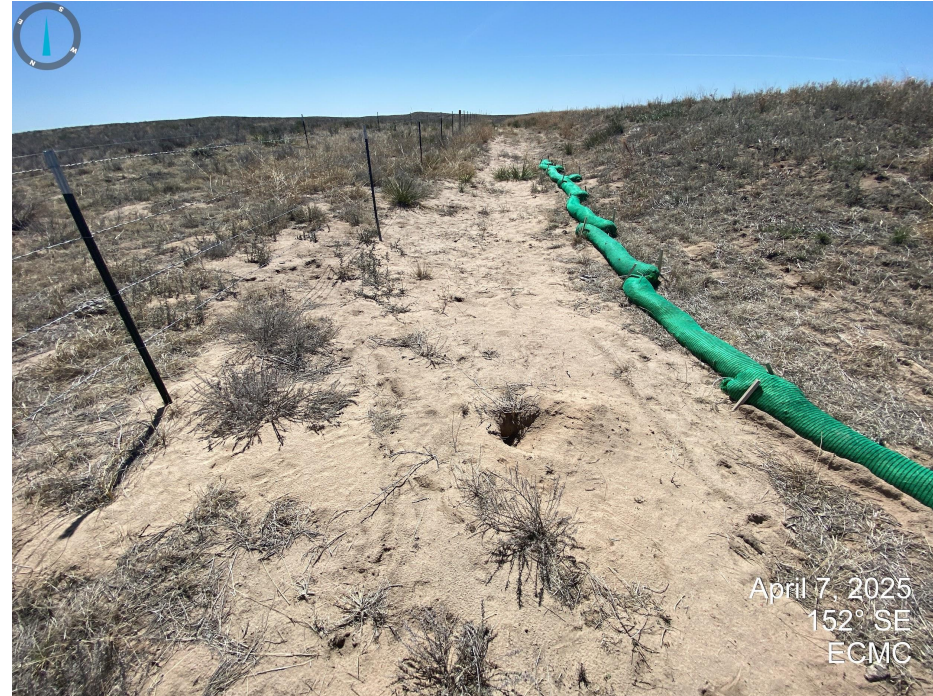
Photos 19 & 20. Taken near the northeast corner of the location. Photos illustrates bare/unstabilized soils near the topsoil stockpile.

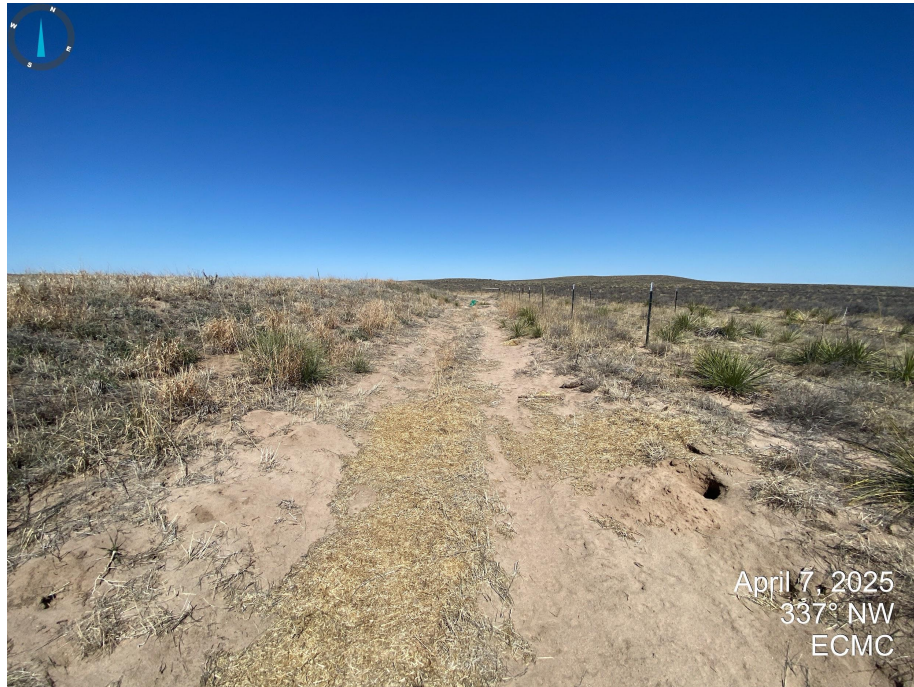
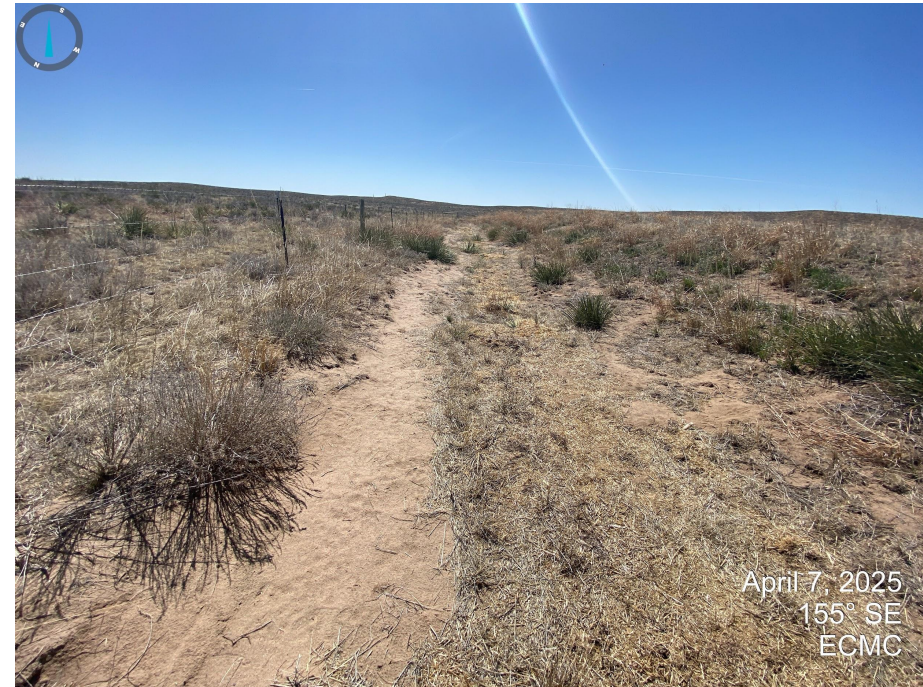
Photos 21 & 22. Taken near the eastern side of the location. Photos illustrates bare/unstabilized soils near the topsoil stockpile.

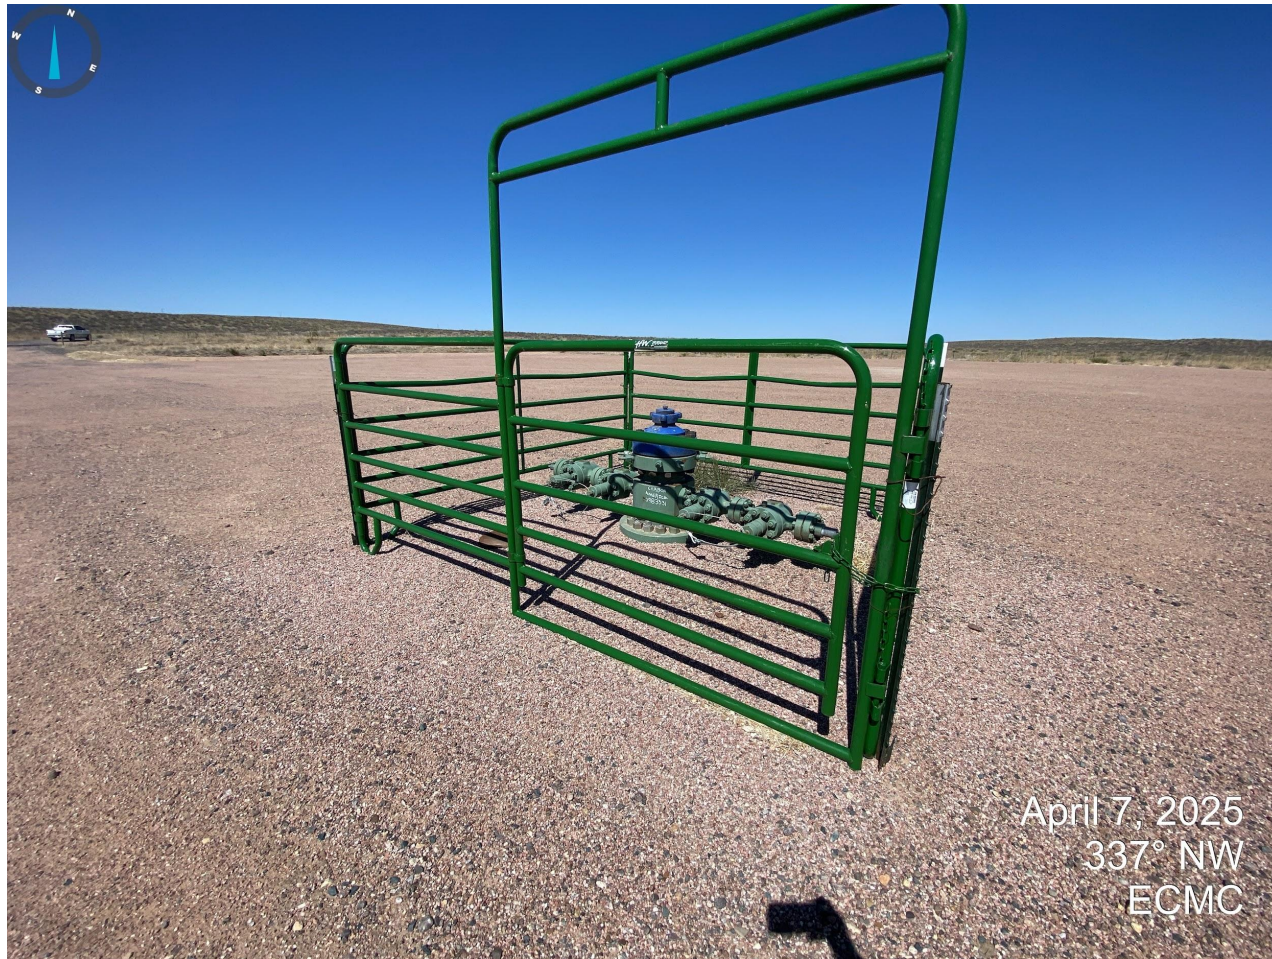
Photo 23. No sign observed at the well location.

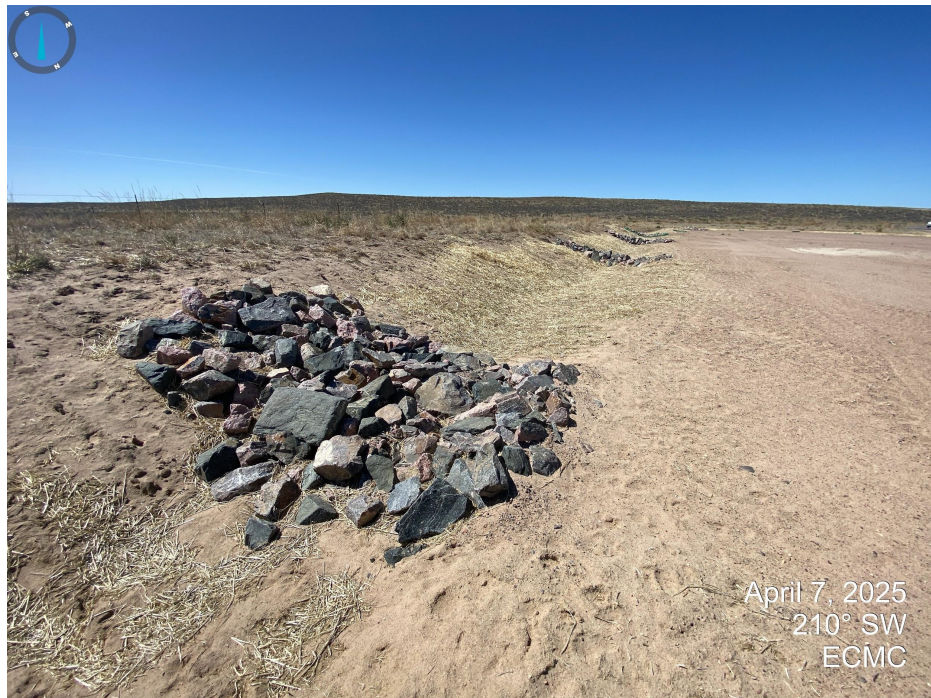
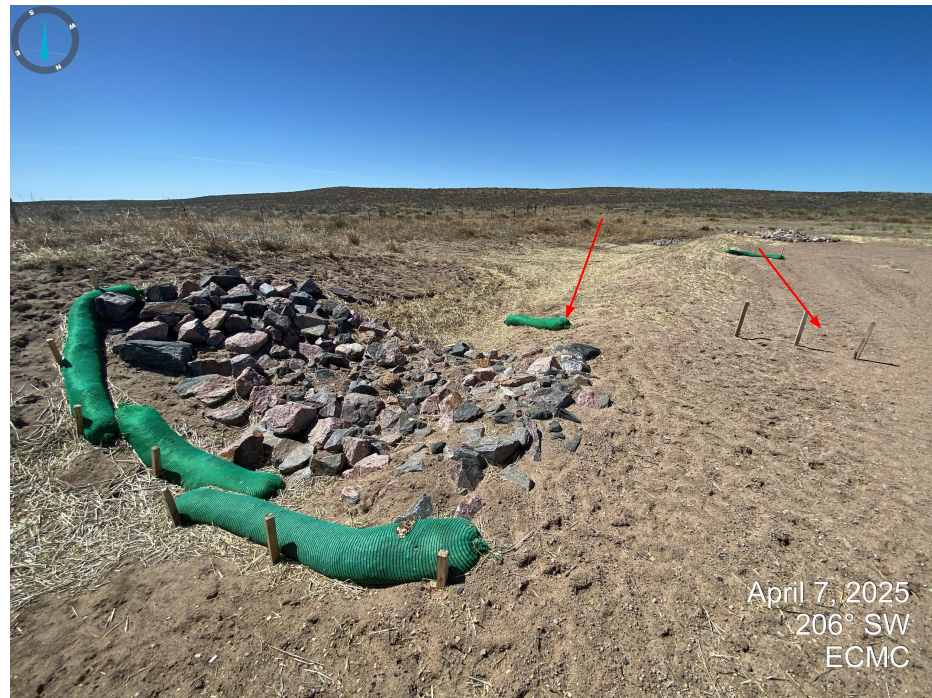
Photos 24 & 25. Taken from the south side of the drilling pad. It appears that additional stormwater control measures have been implemented, erosion degradation has been repaired, and unstabilized soils were drill seeded and mulched. Red arrow indicates filtertrench wattle that requires maintenance.

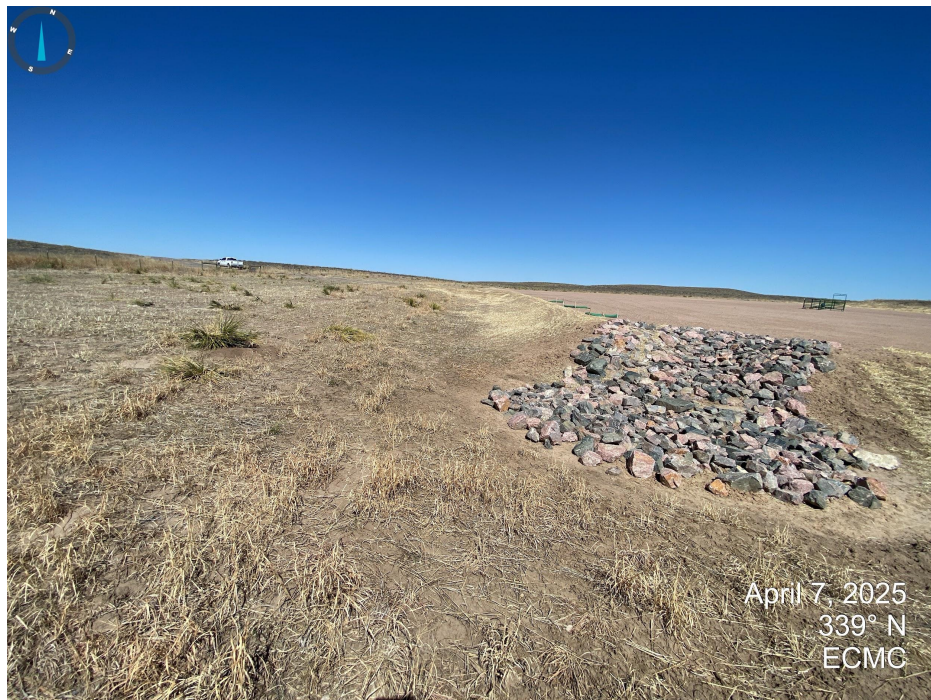
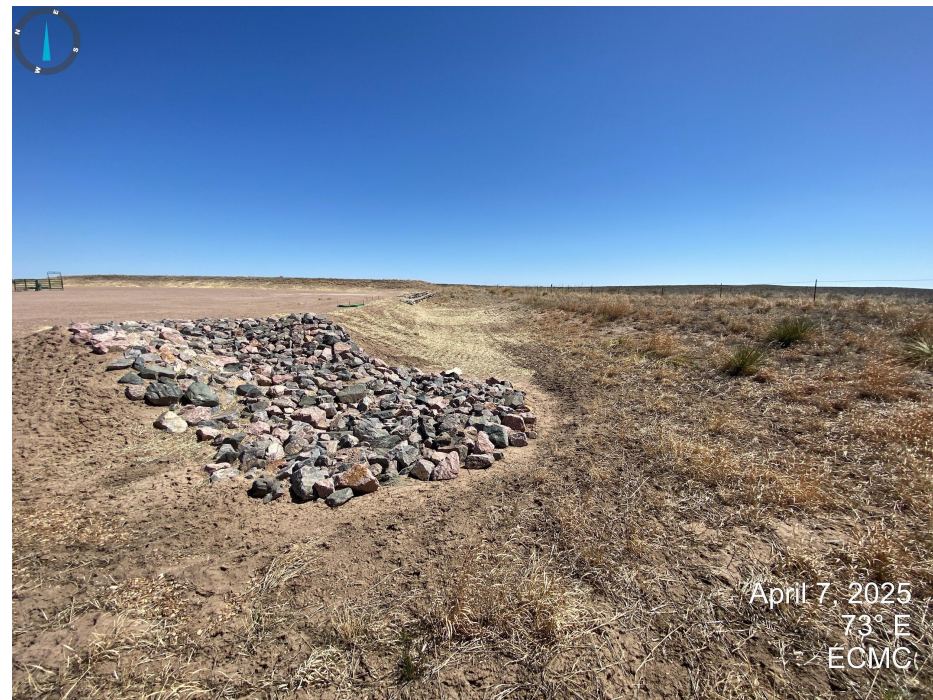
Photos 26 & 27. Taken near the sediment basin on the southwest corner of the drilling pad. It appears that additional stormwater control measures have been implemented, erosion degradation has been repaired, and unstabilized soils were drill seeded and mulched.

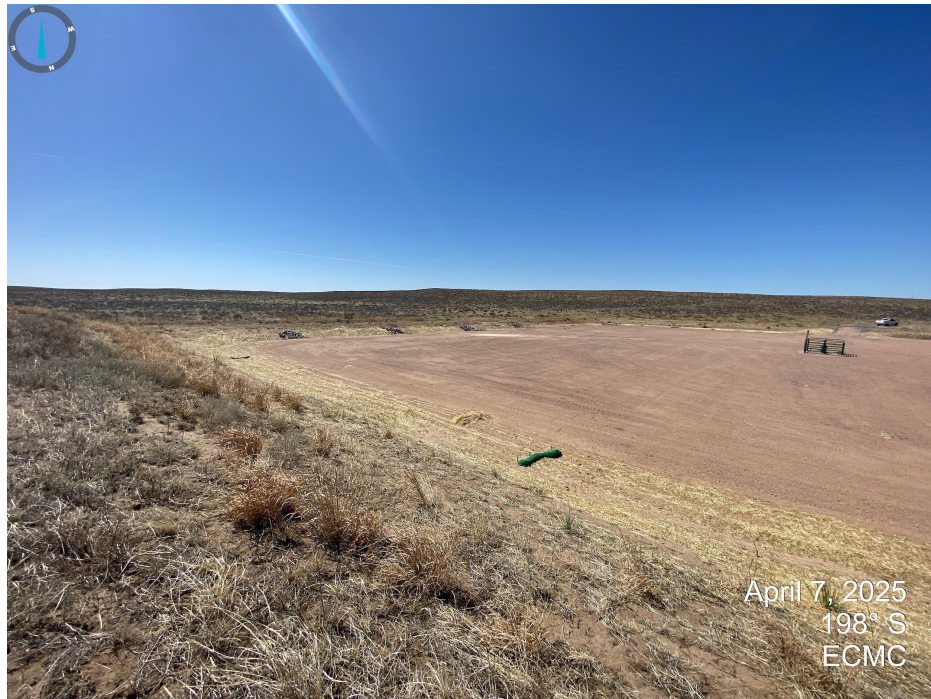
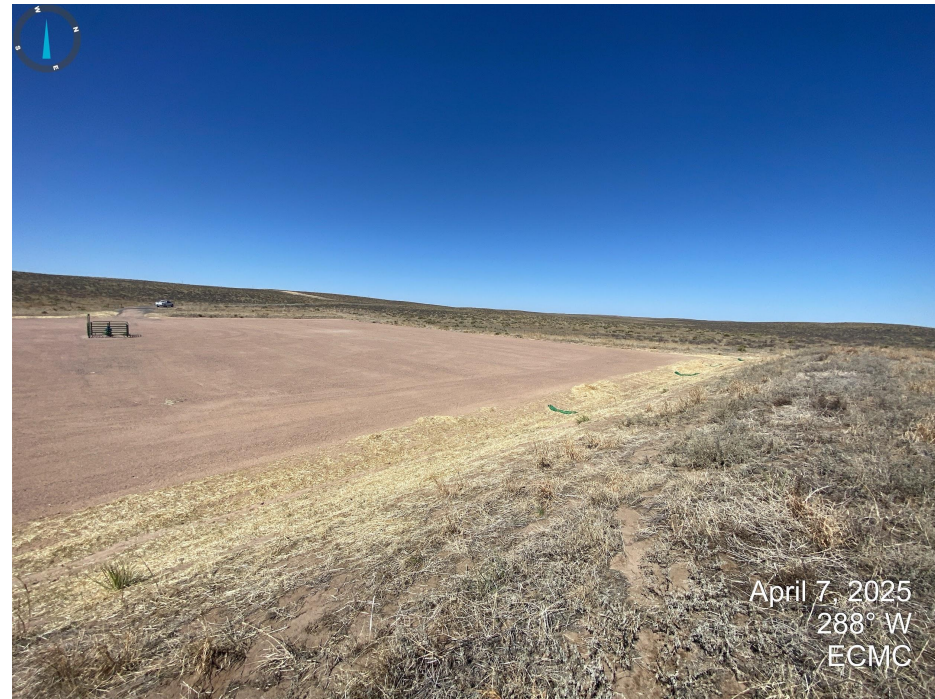
Photos 28 & 29. Overview of the drilling pad, taken from the topsoil stockpile. Photos illustrate that interim reclamation does not appear to have been performed as the drilling pad was not reduced in size only needed for production operations.
