Final Reclamation and Stormwater Inspection

Operator: KERR MCGEE OIL & GAS ONSHORE LP - #47120

Location ID: 462560

Inspection Document #: 697505887

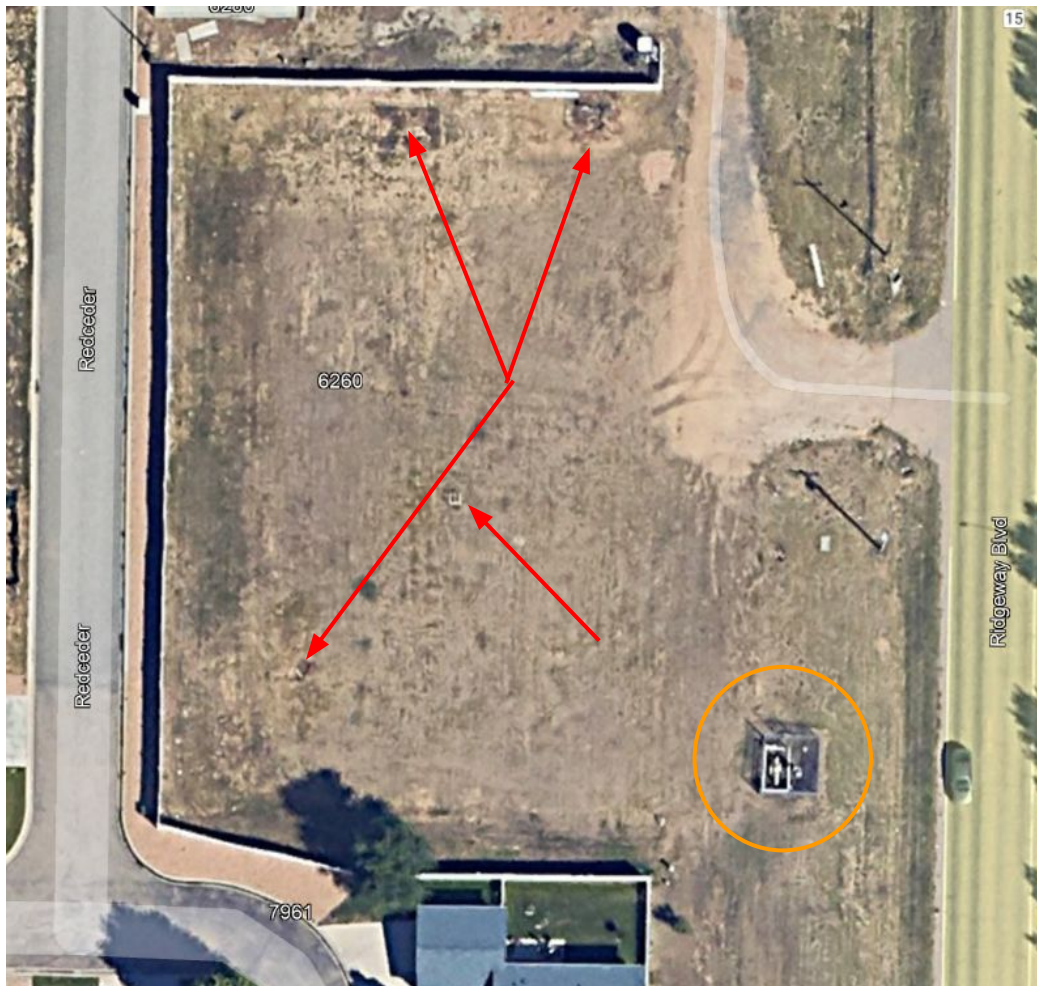
Photo 1. Google Earth aerial imagery illustrates risers/pipe that remain that all appear to be owned and operated by KPK (red arrows). Orange circle was DCP midstream equipment that has been taken over by KPK.

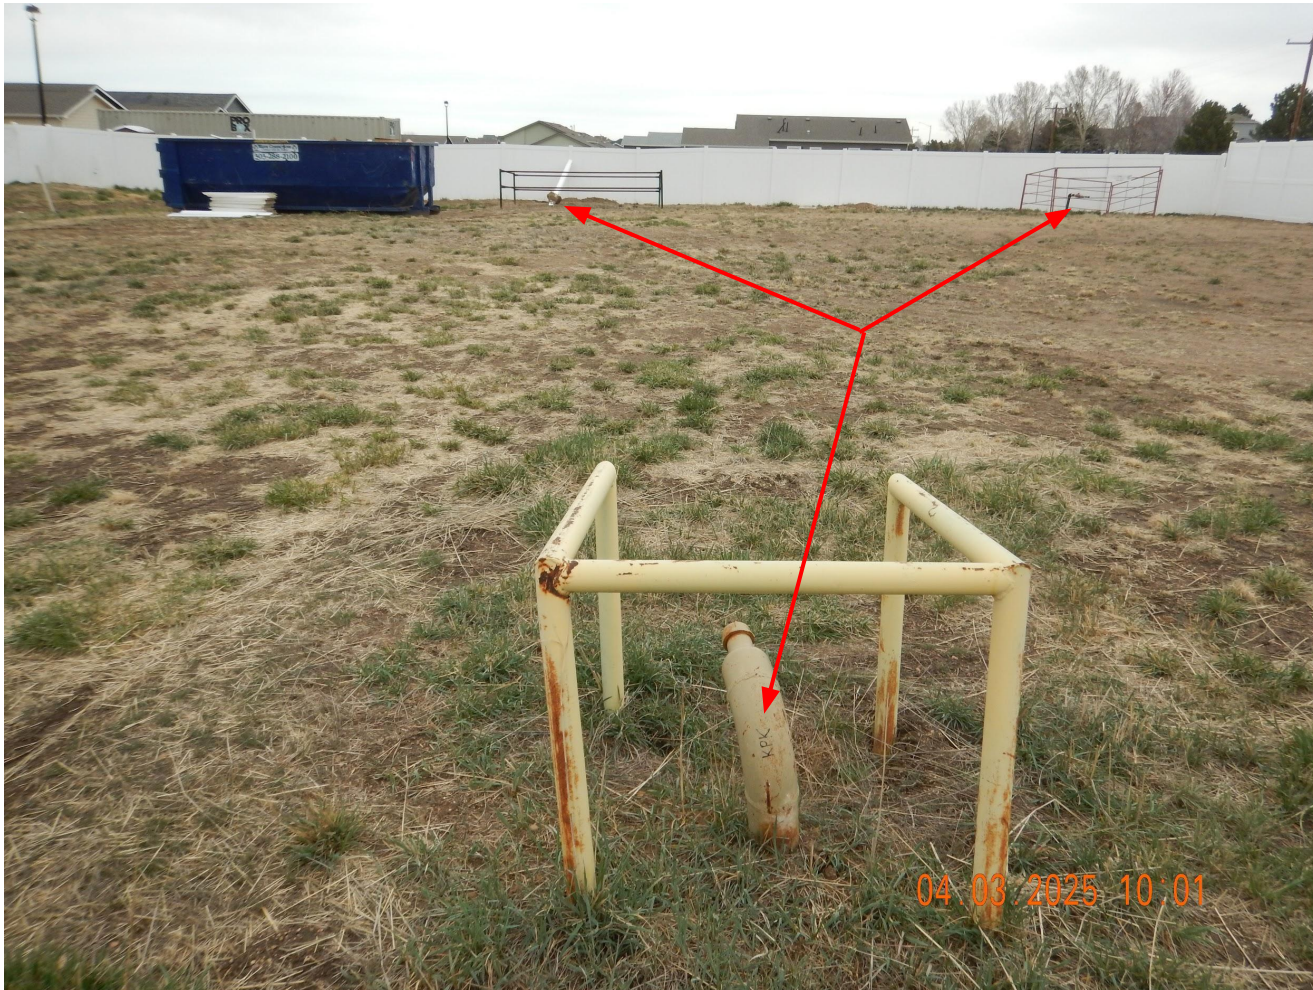
Photo 2. Photo taken from the location, facing North. Photo illustrates risers that remain all appear to be owned and operated by KPK. KPK signage was observed at the northeastern riser, northwestern risers have been confirmed by KPK and the yellow riser has KPK written on it.

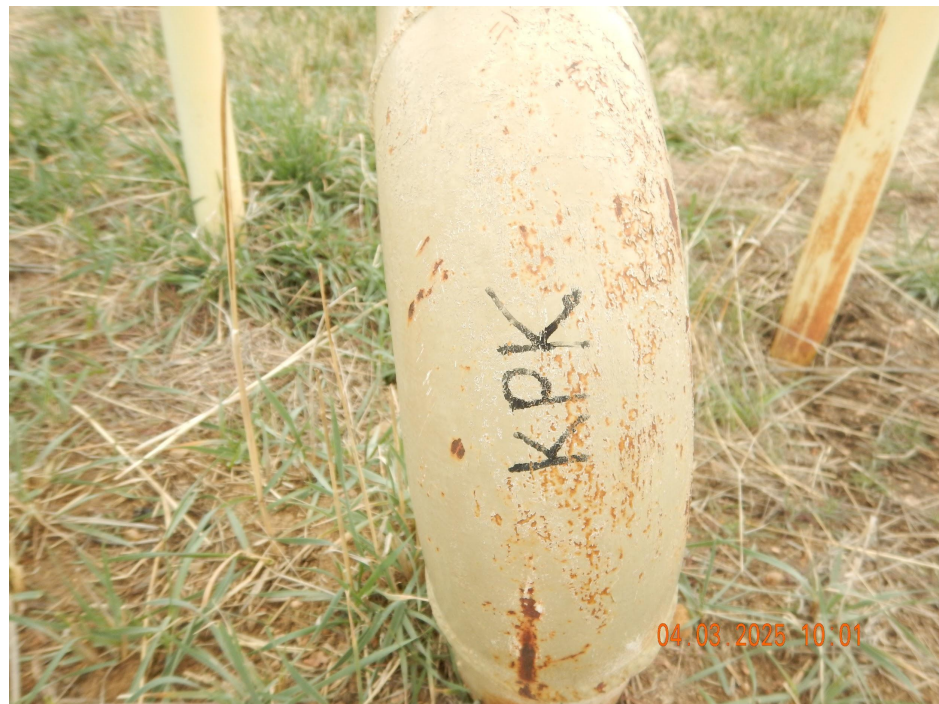
Photo 3. Photo taken of the yellow riser. See comments under Photo 2.

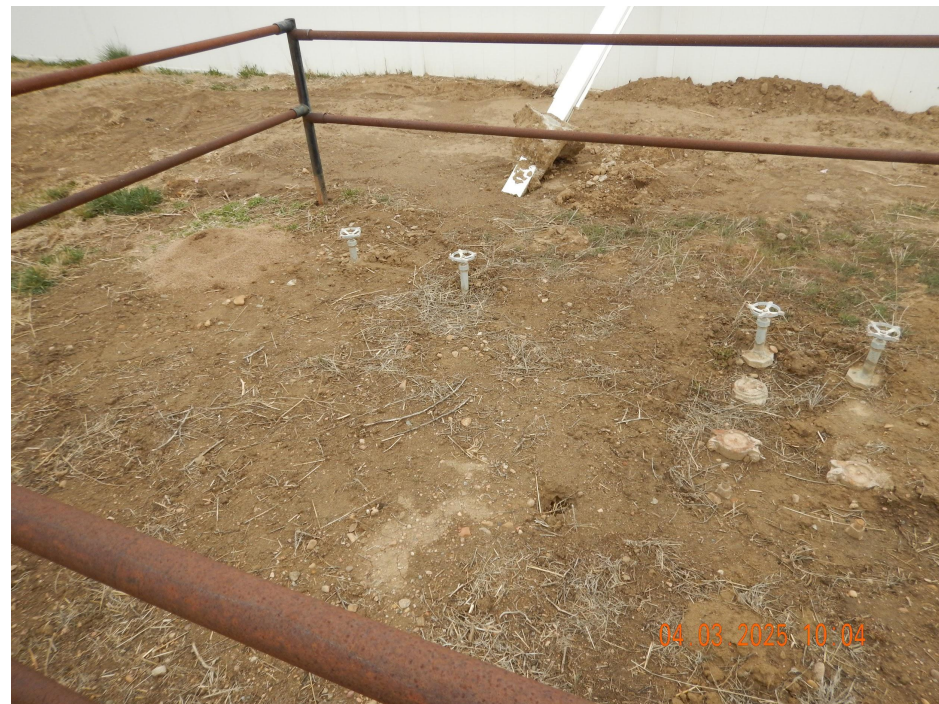
Photo 4. Photo taken from the northwestern risers. See comments under Photo 2.

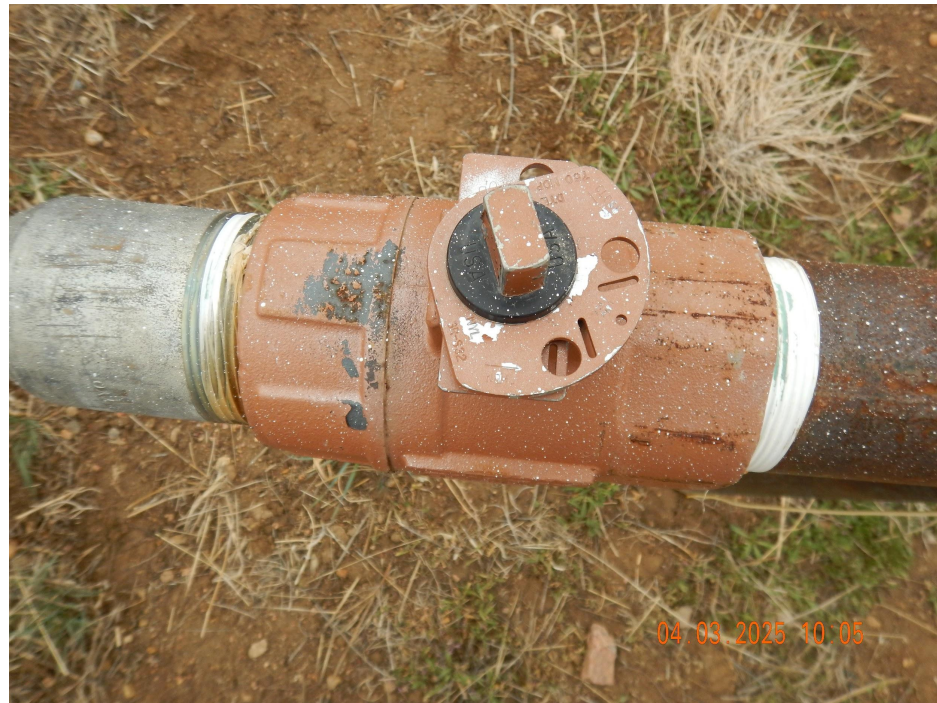
Photo 5. Photo taken from the northeastern riser. See comments under Photo 2.

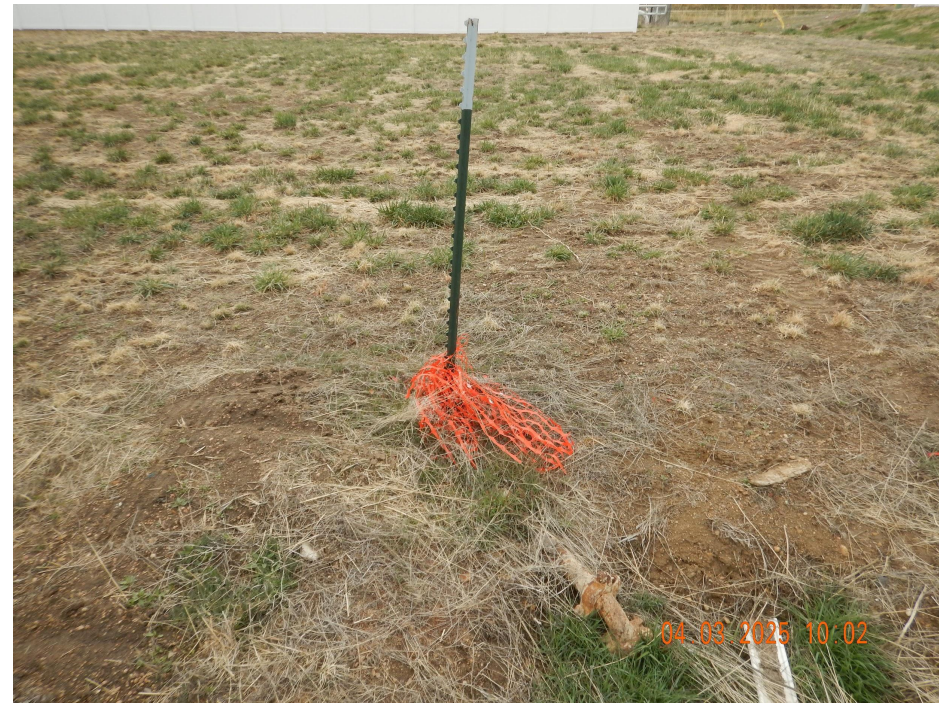
Photo 6. Photo taken from the southwestern pipe. See comments under Photo 2.

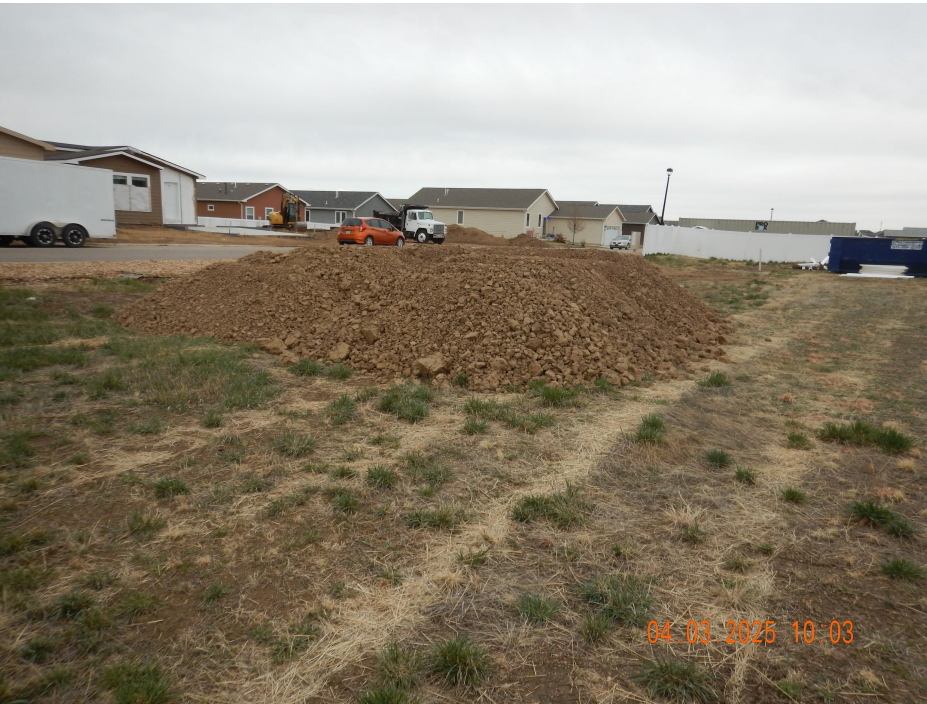
Photo 7. Photo taken from the western location, facing North. Photo illustrates housing development activity at the location.

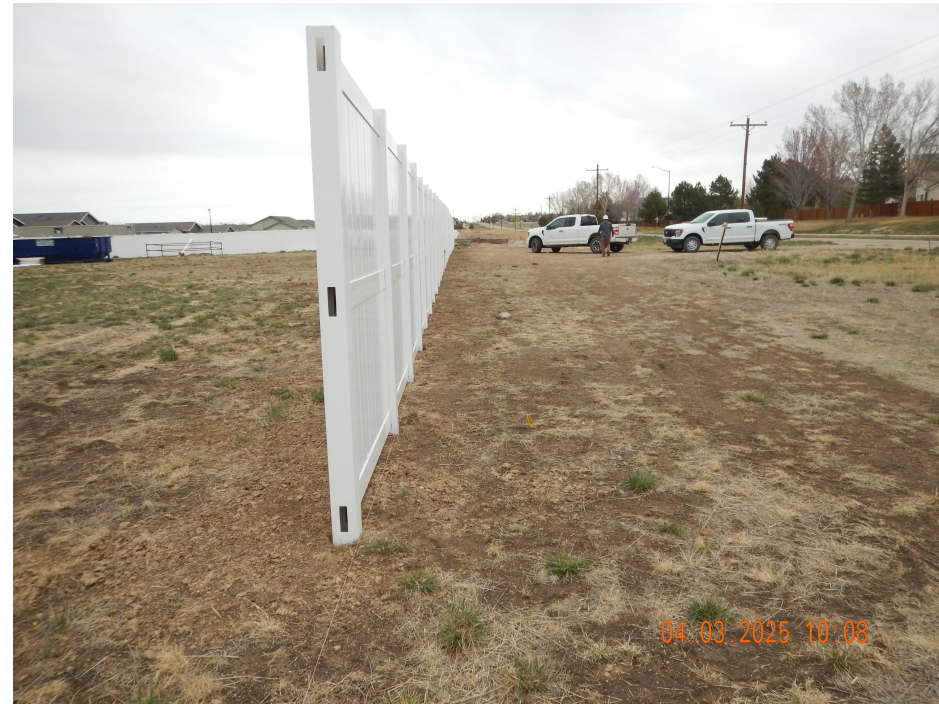
Photo 8. Photo taken from the eastern location, facing North. Photo illustrates a fence installed by housing development since the previous inspection.

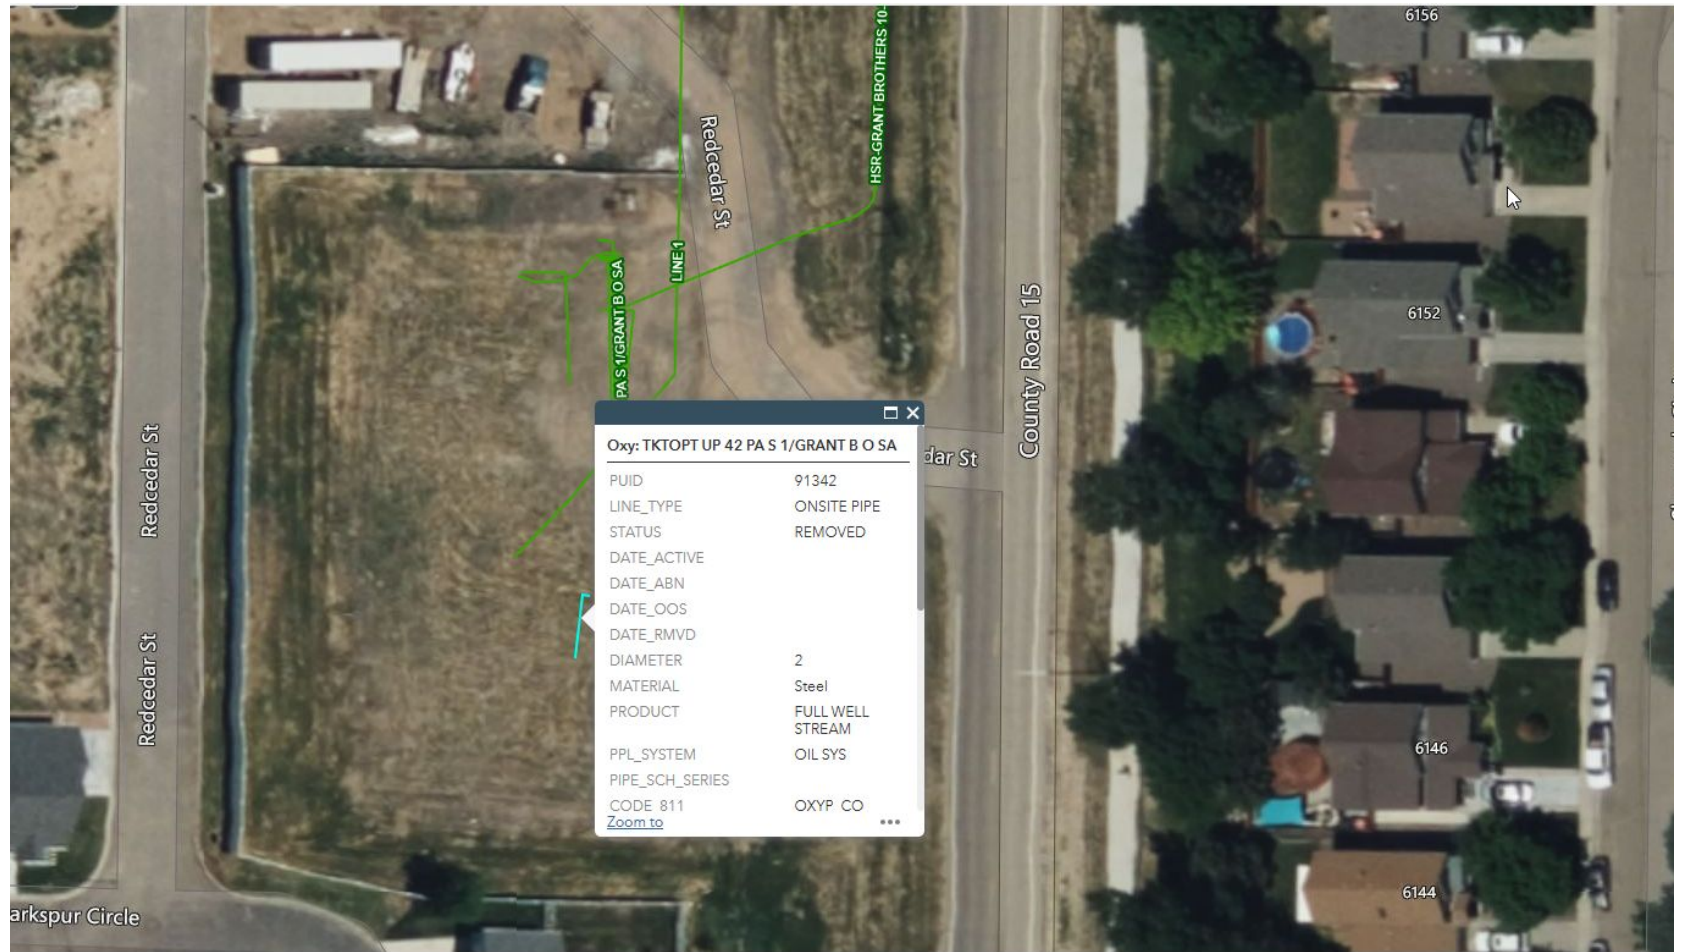
Photo 9. Imagery provided by Kerr McGee illustrates that all their lines have been removed. Imagery is an internal line mapping system.
