**ECMC
Environmental
Field Inspection**

Facility 4 @ Ditlev
© 19-Mar-25 10:57:38 AM
ECMC Environmental Inspection

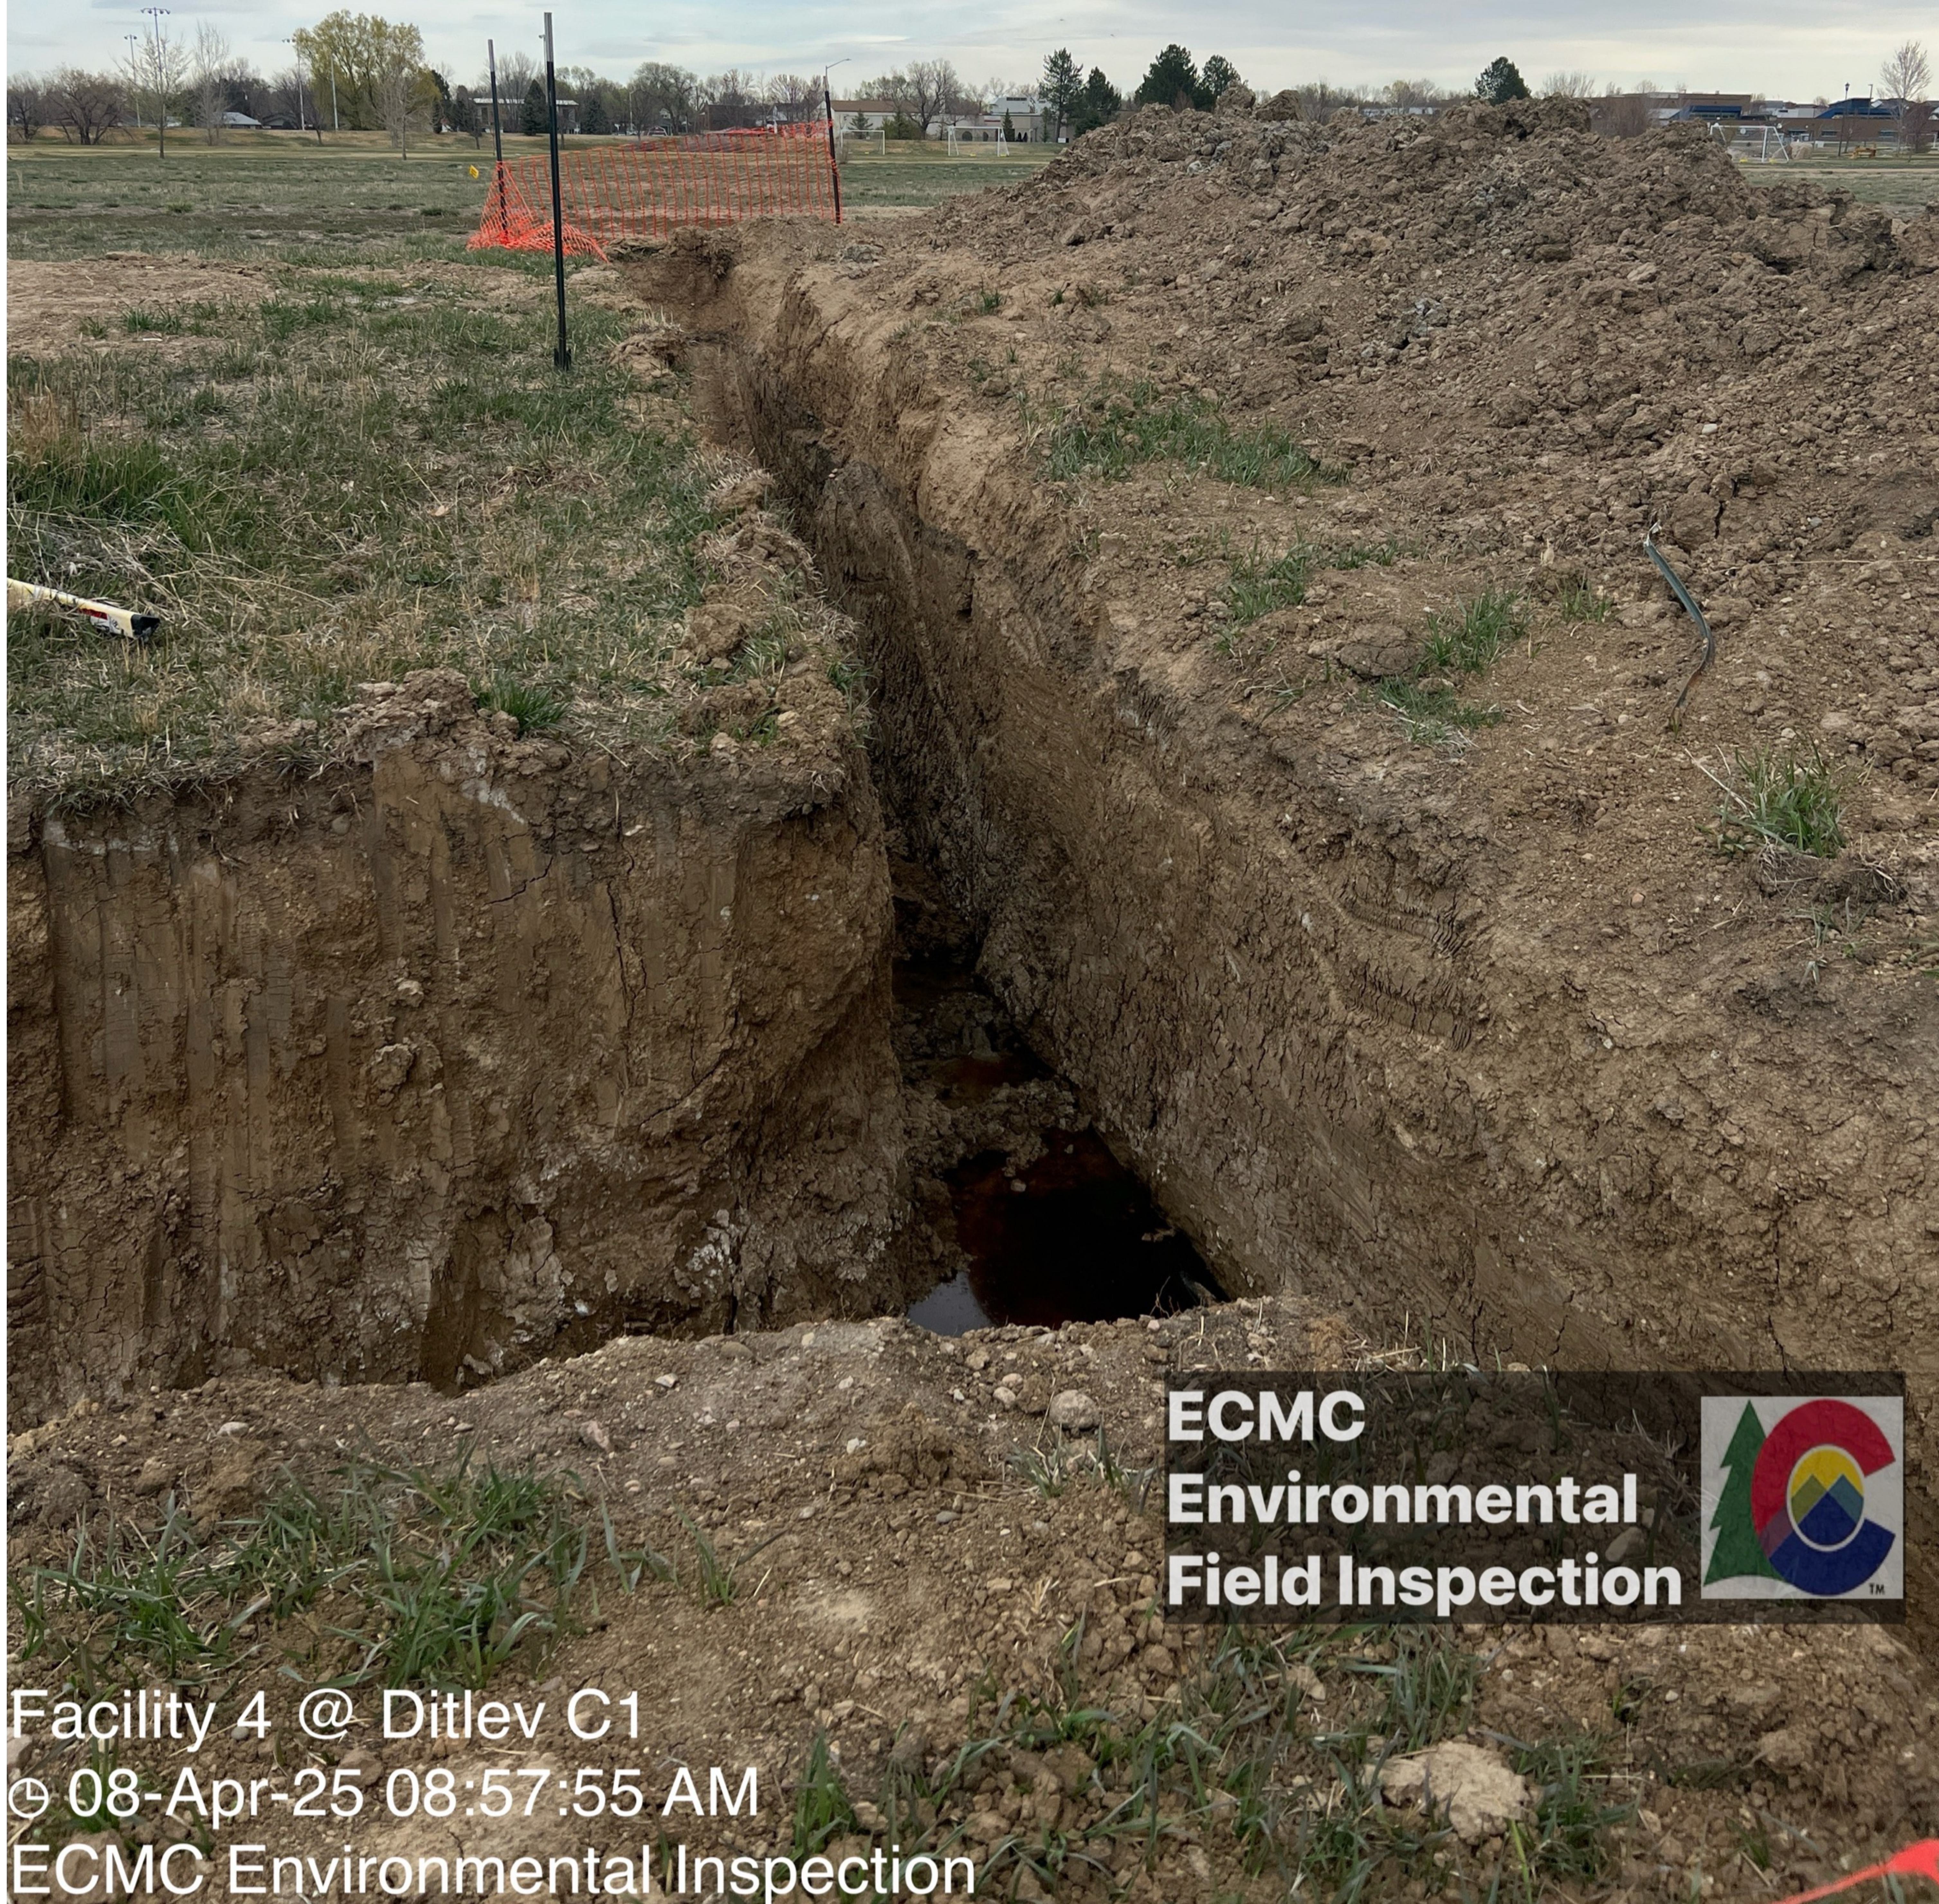
Sheen at northern elbow observed on 3/19/2025 and 4/8/2025

Free product on groundwater at southern elbow observed on 4/8/2025

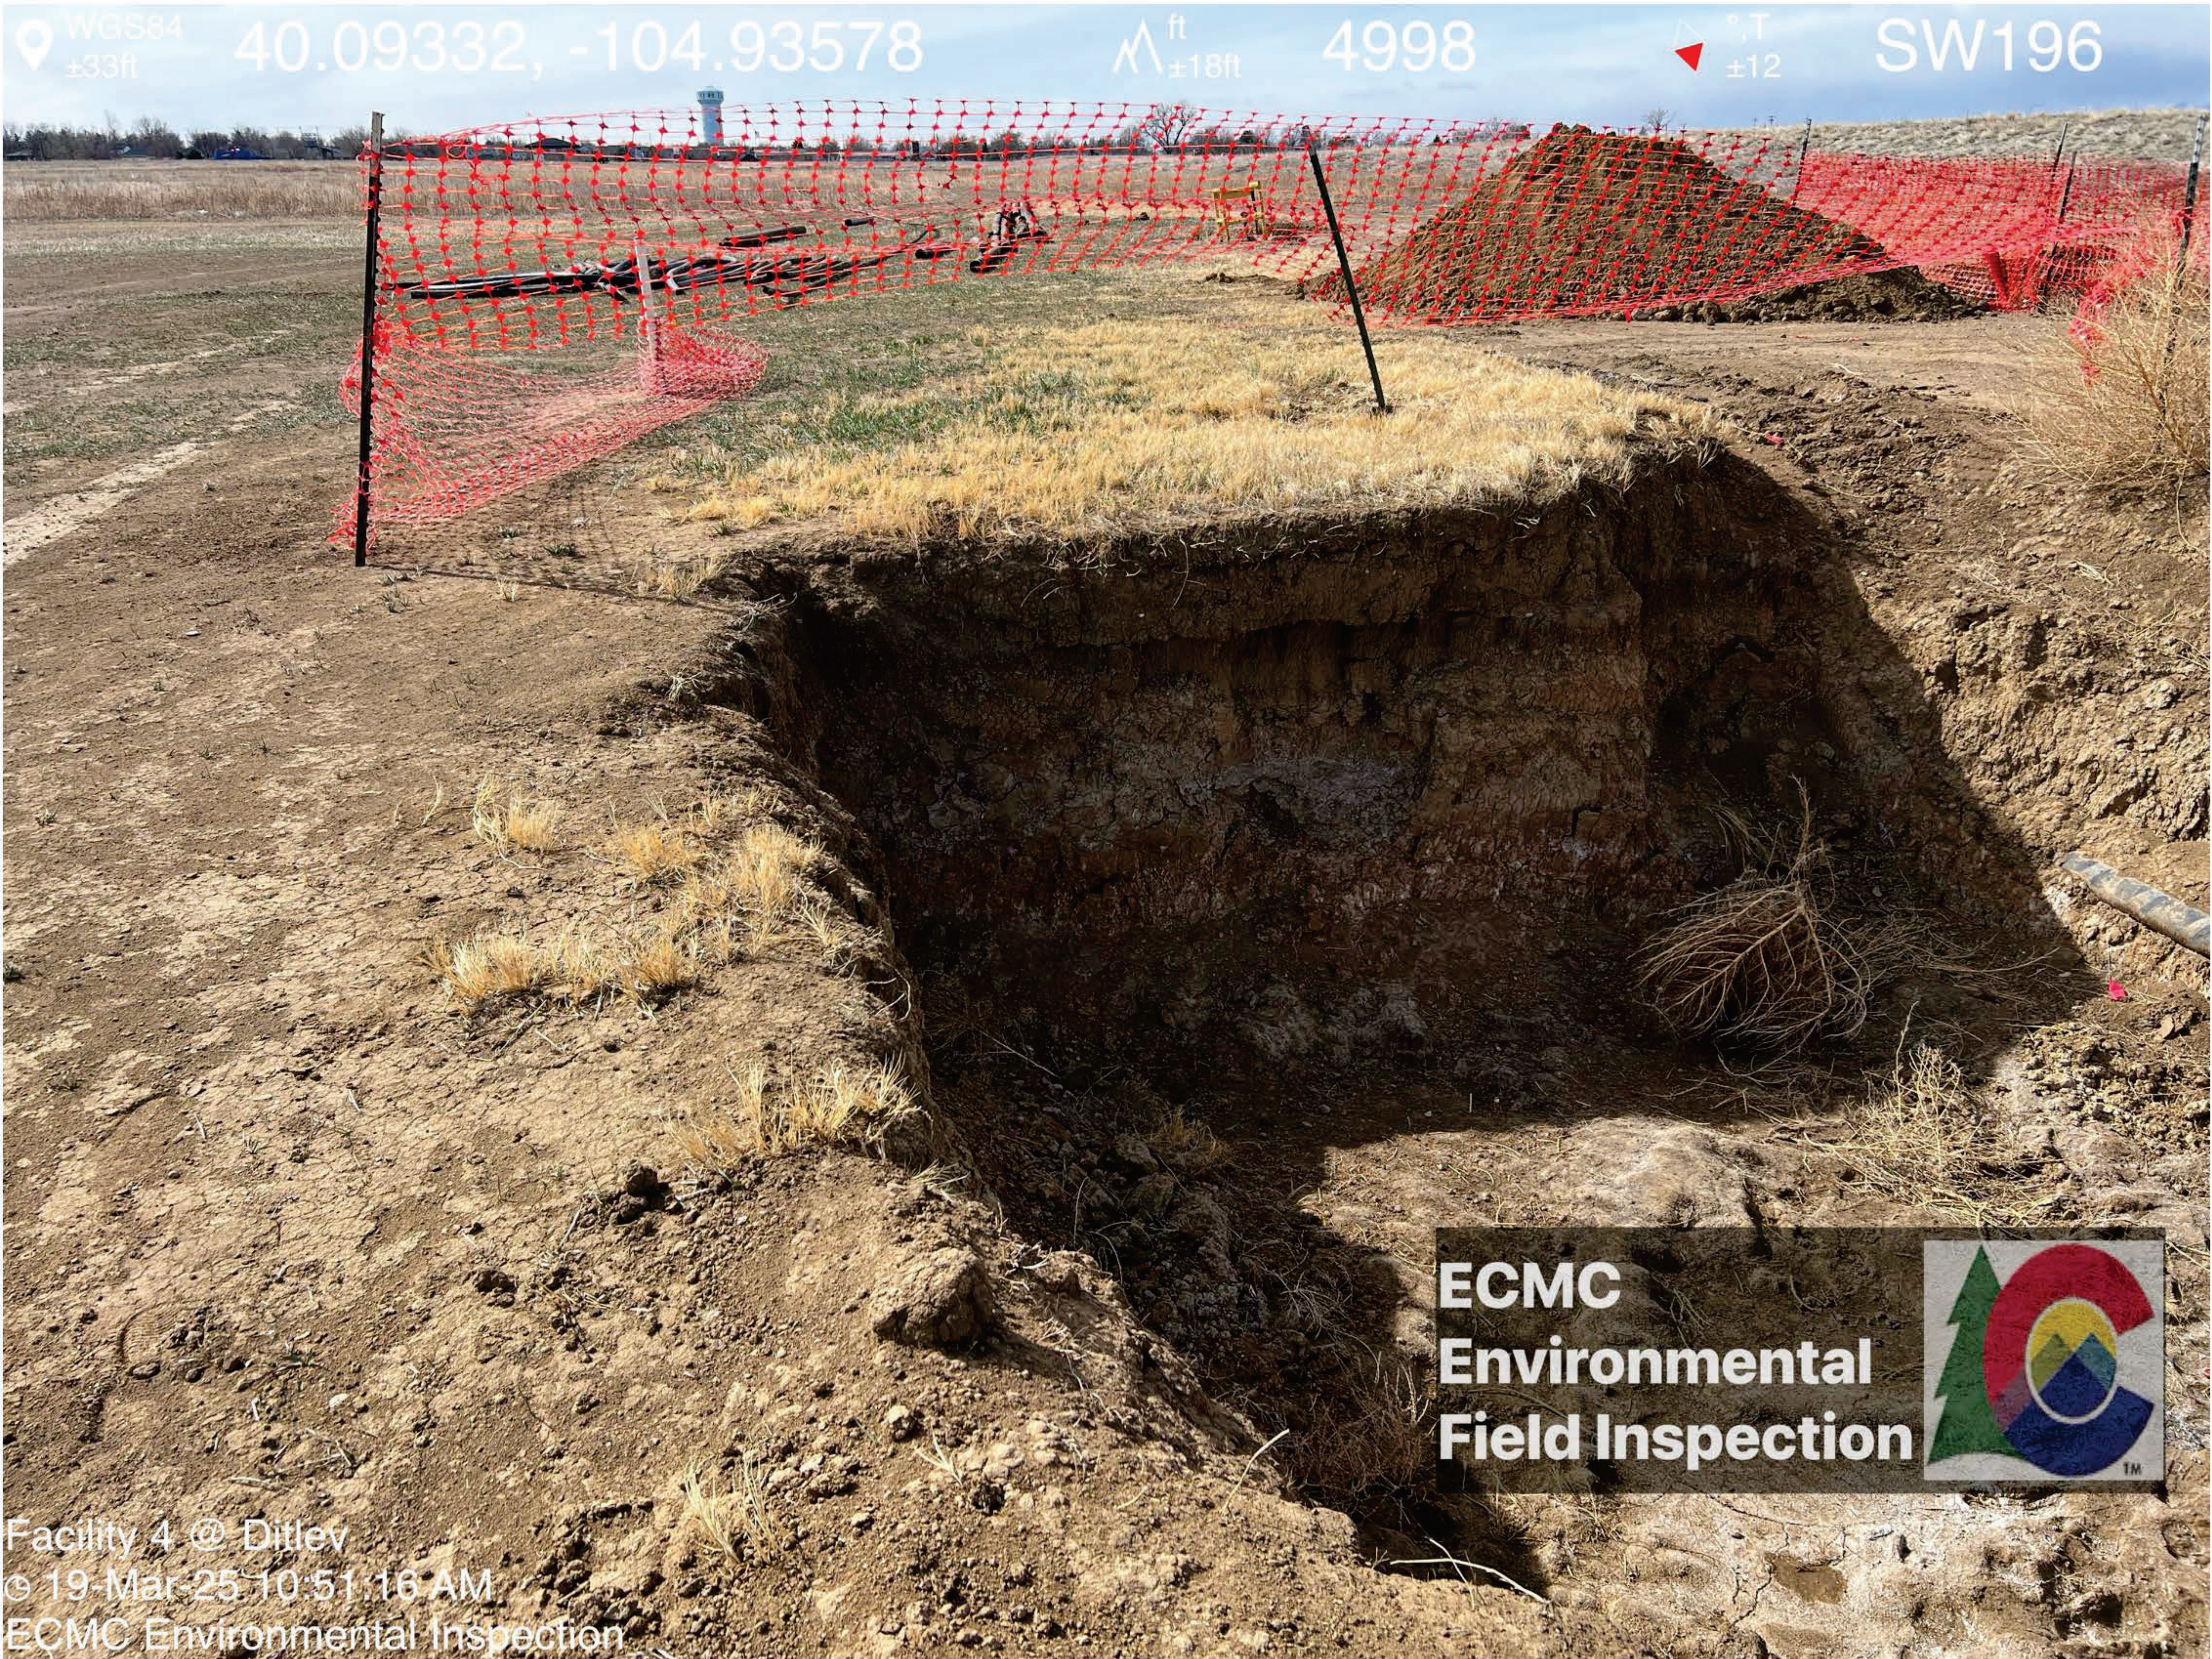
Flowline trenches/excavations with inadequate fencing. Groundwater and free product observed within base of the northernmost trench. Soil stockpiled adjacent to open trenches/excavations without signage/BMPs. Located in close proximity to soccer field within Town of Frederick.

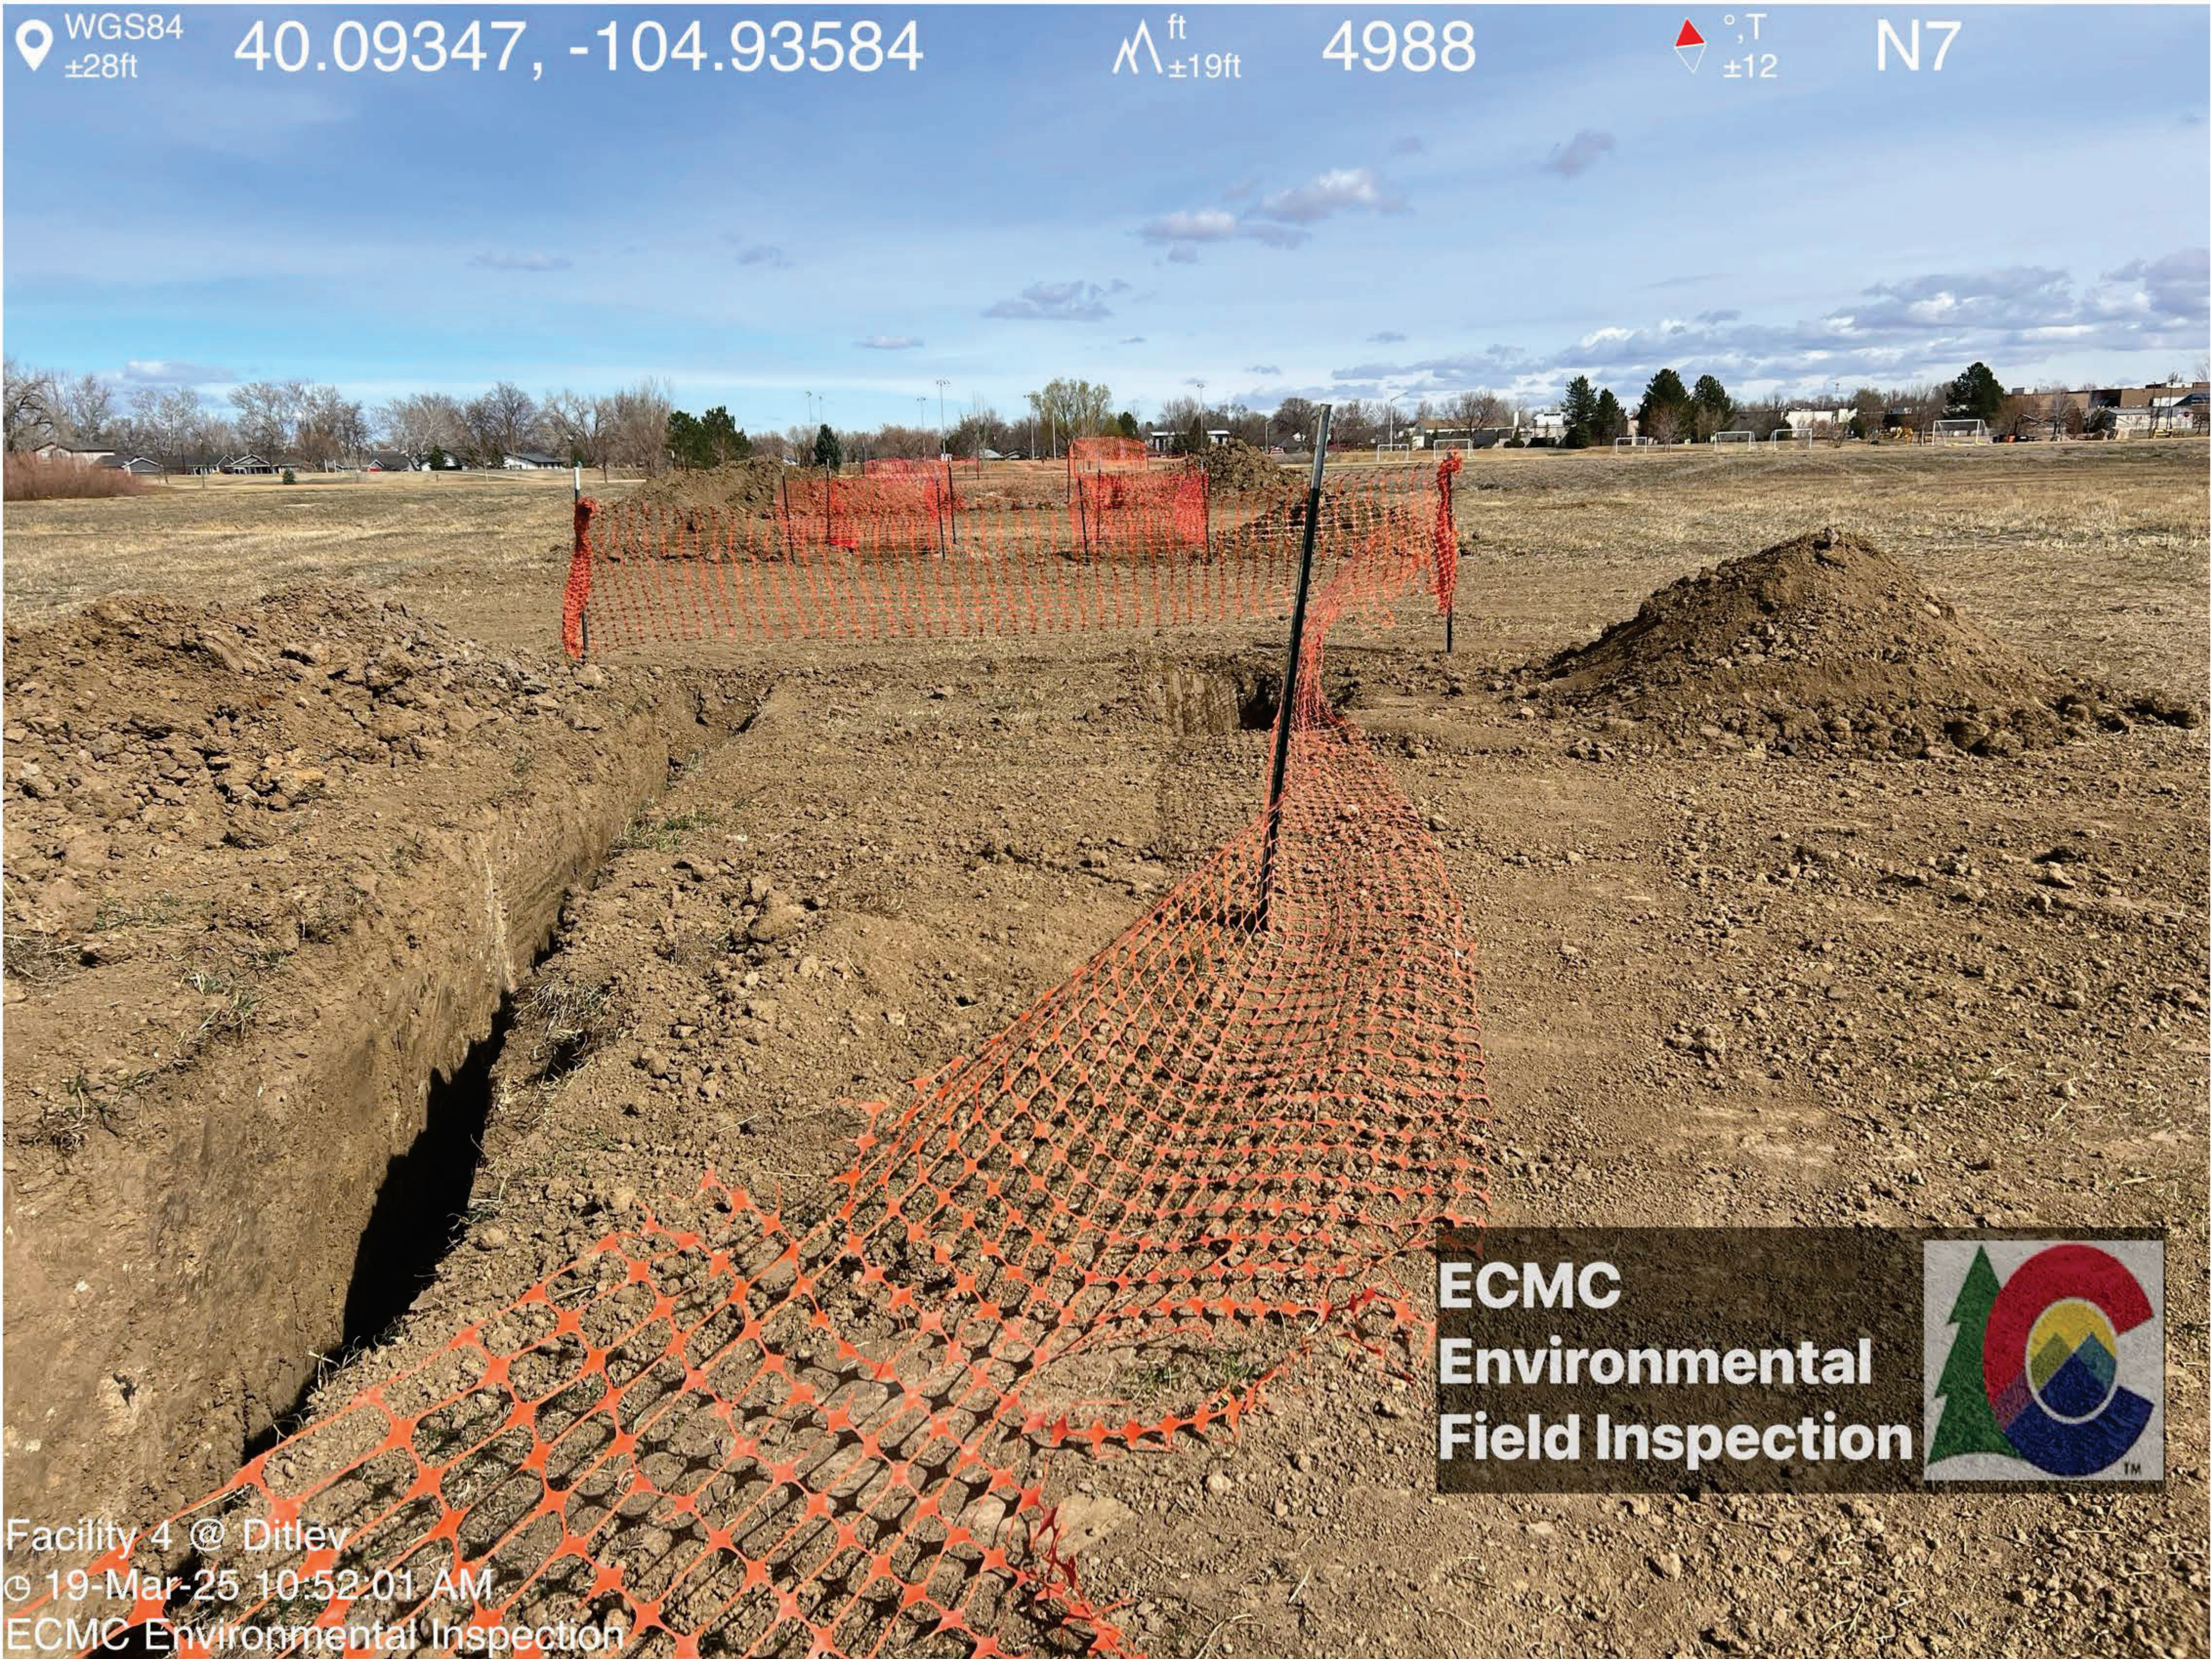
Inadequate fencing around to Facility 4 @ Ditlev Spill excavation. Weeds observed within the open excavation. Soil stockpiled on location without signage/BMPs. Unused equipment was observed on location.

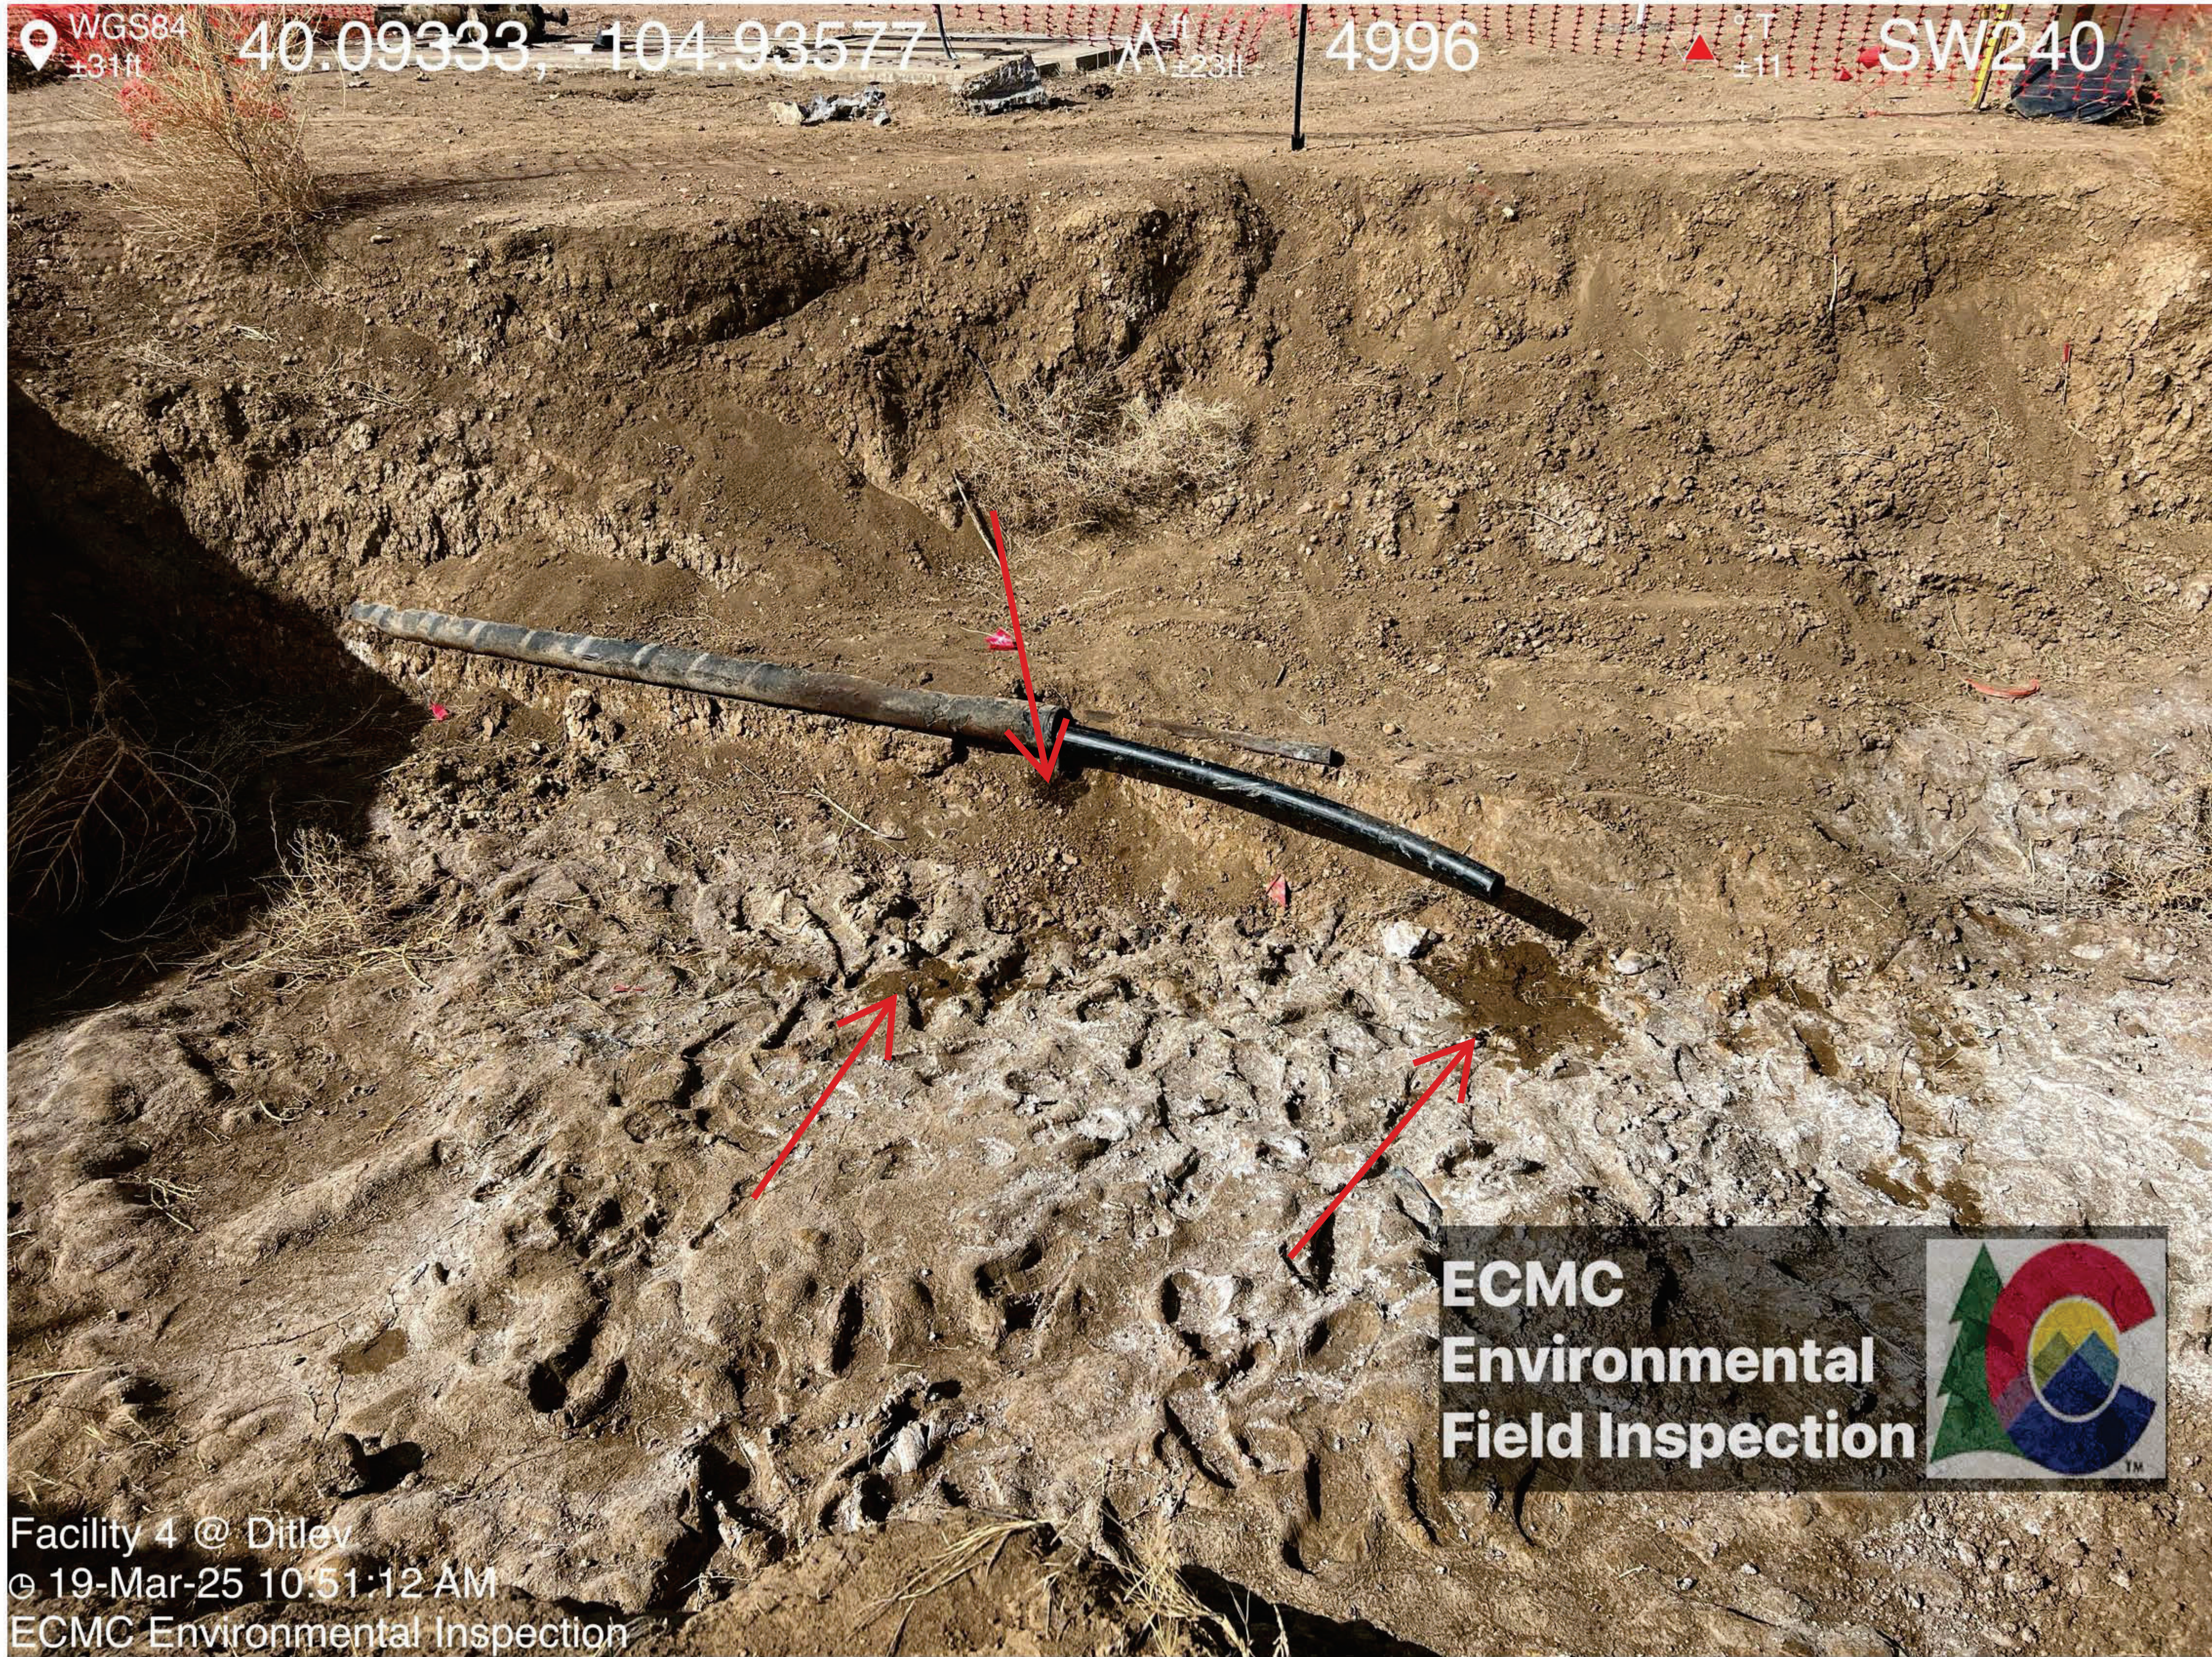
Facility 4 @ Ditlev Spill - Oil stained soil observed at base of the excavation. Flowlines have been cut and remain uncapped/not properly sealed and visible within the open excavation.

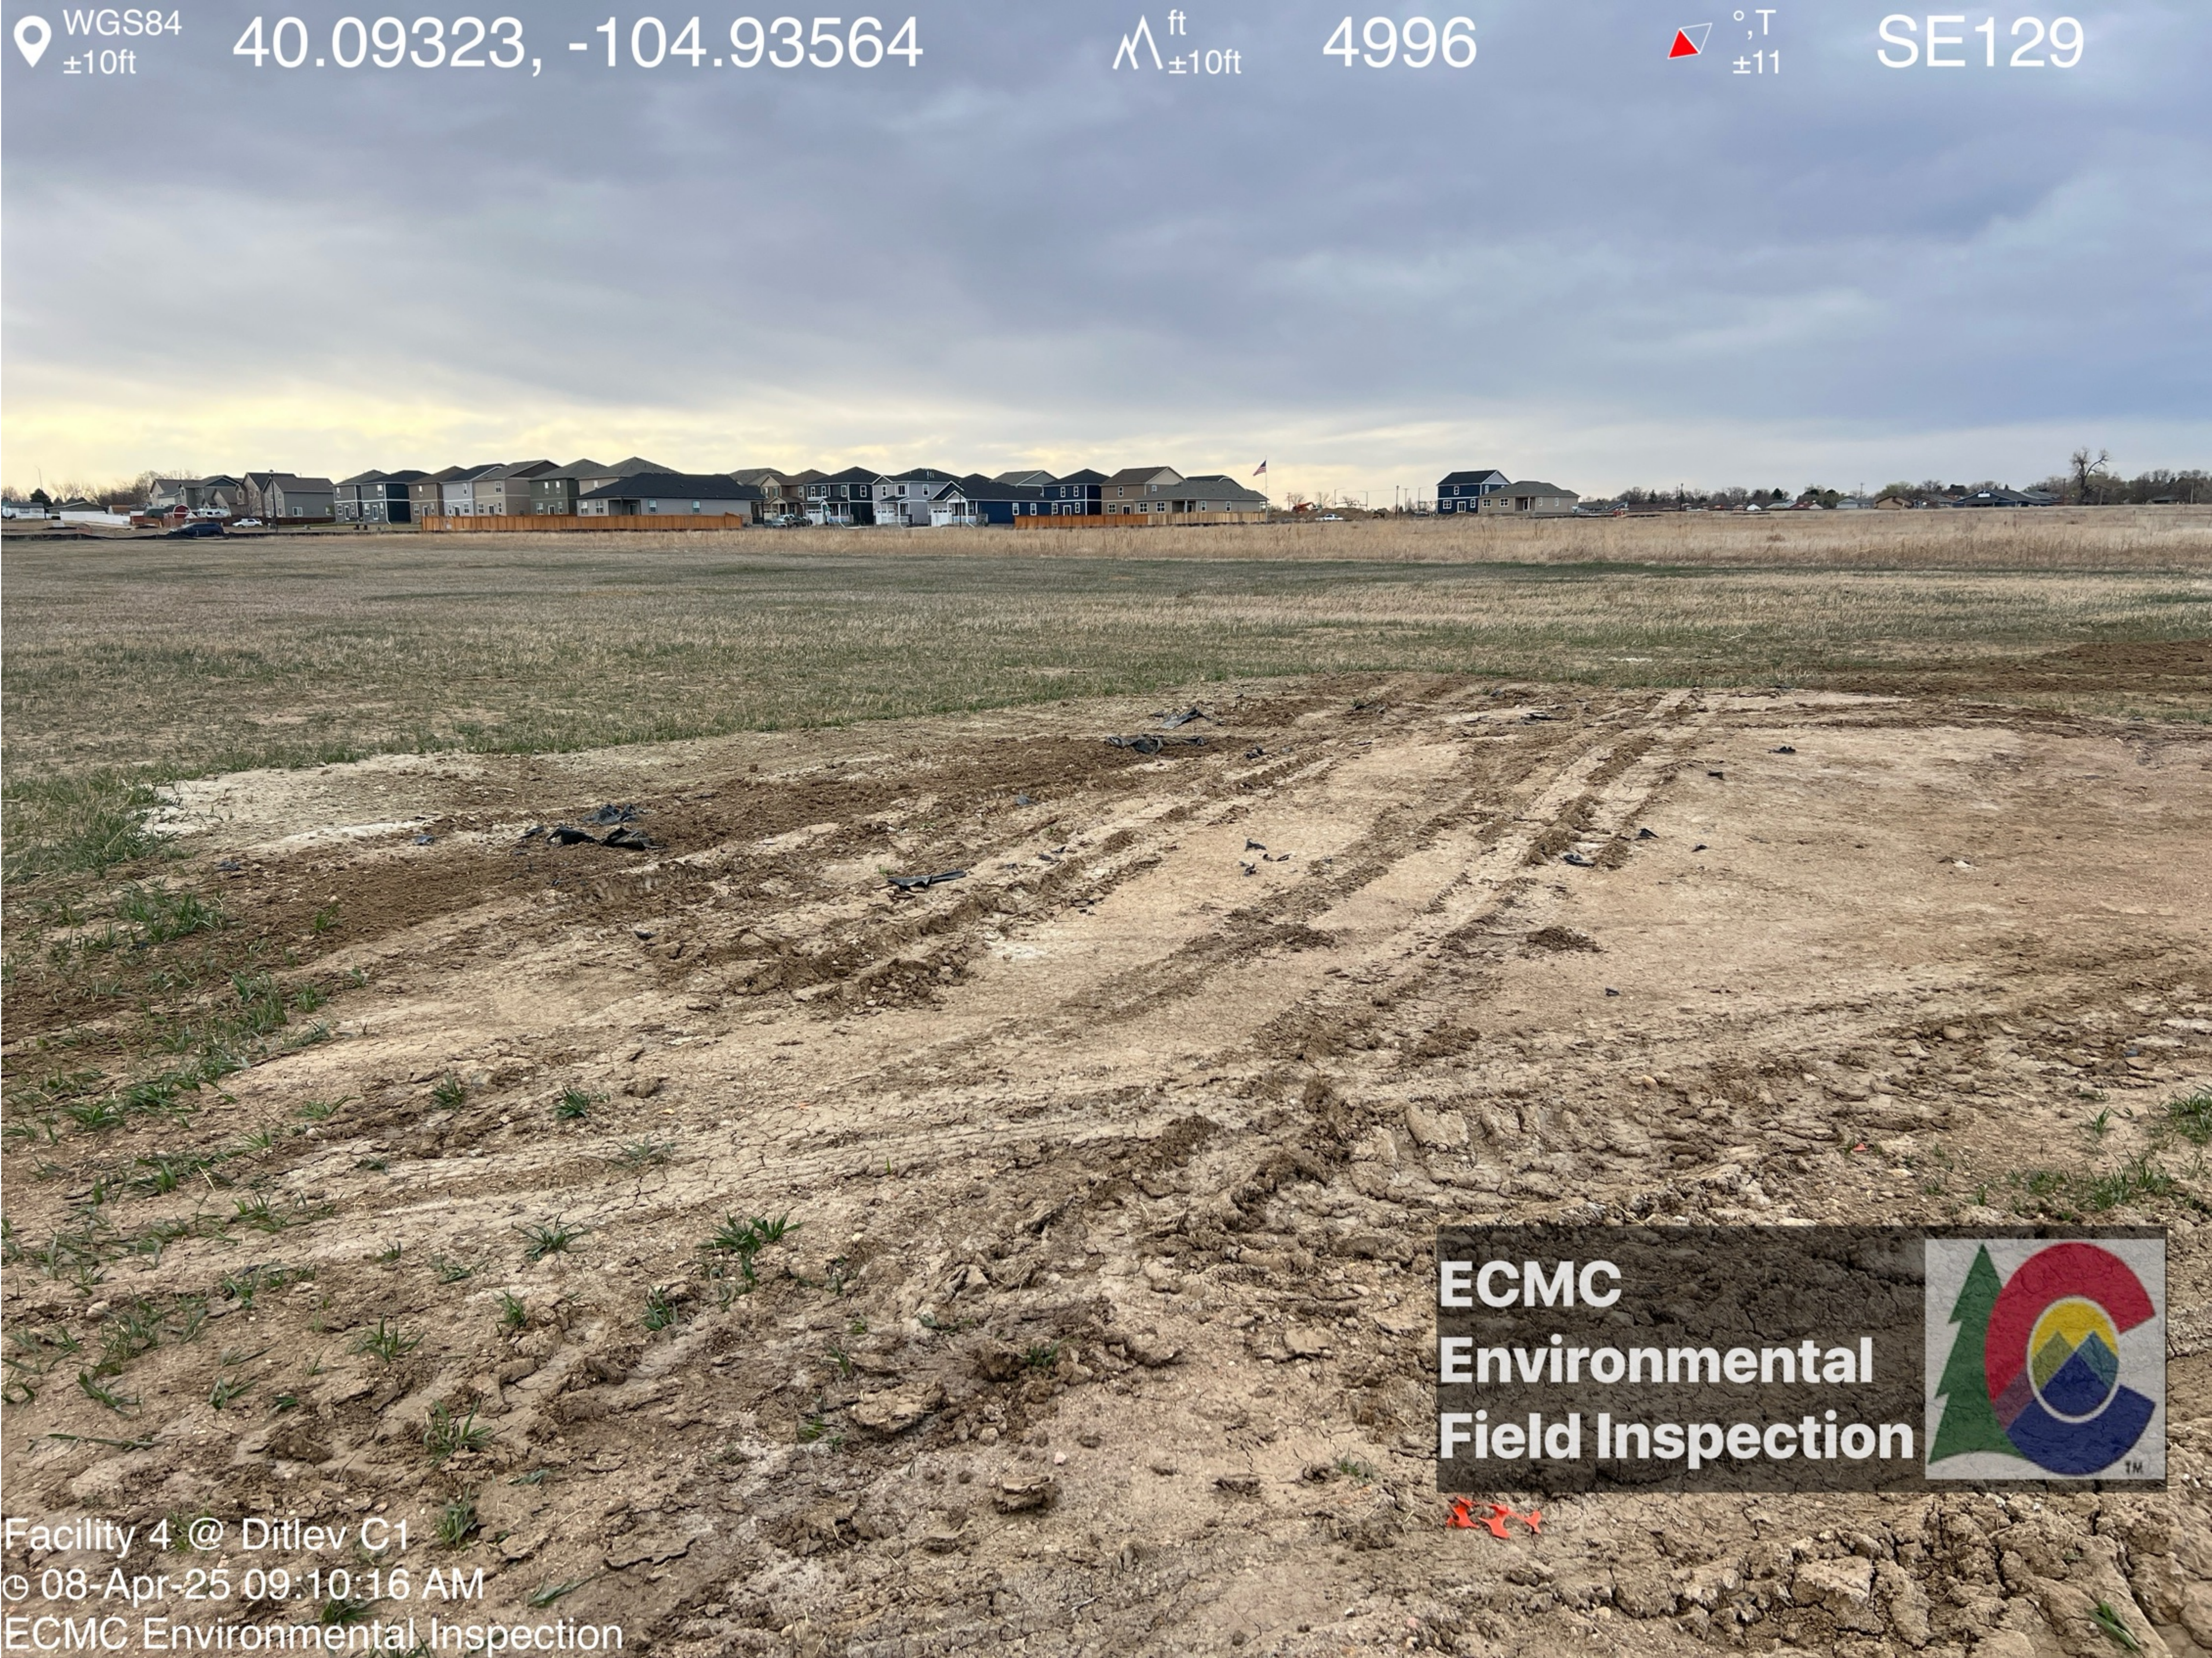
Former stockpile location. Trash/Debris - Pieces of former soil stockpile liner embedded in soil throughout location.

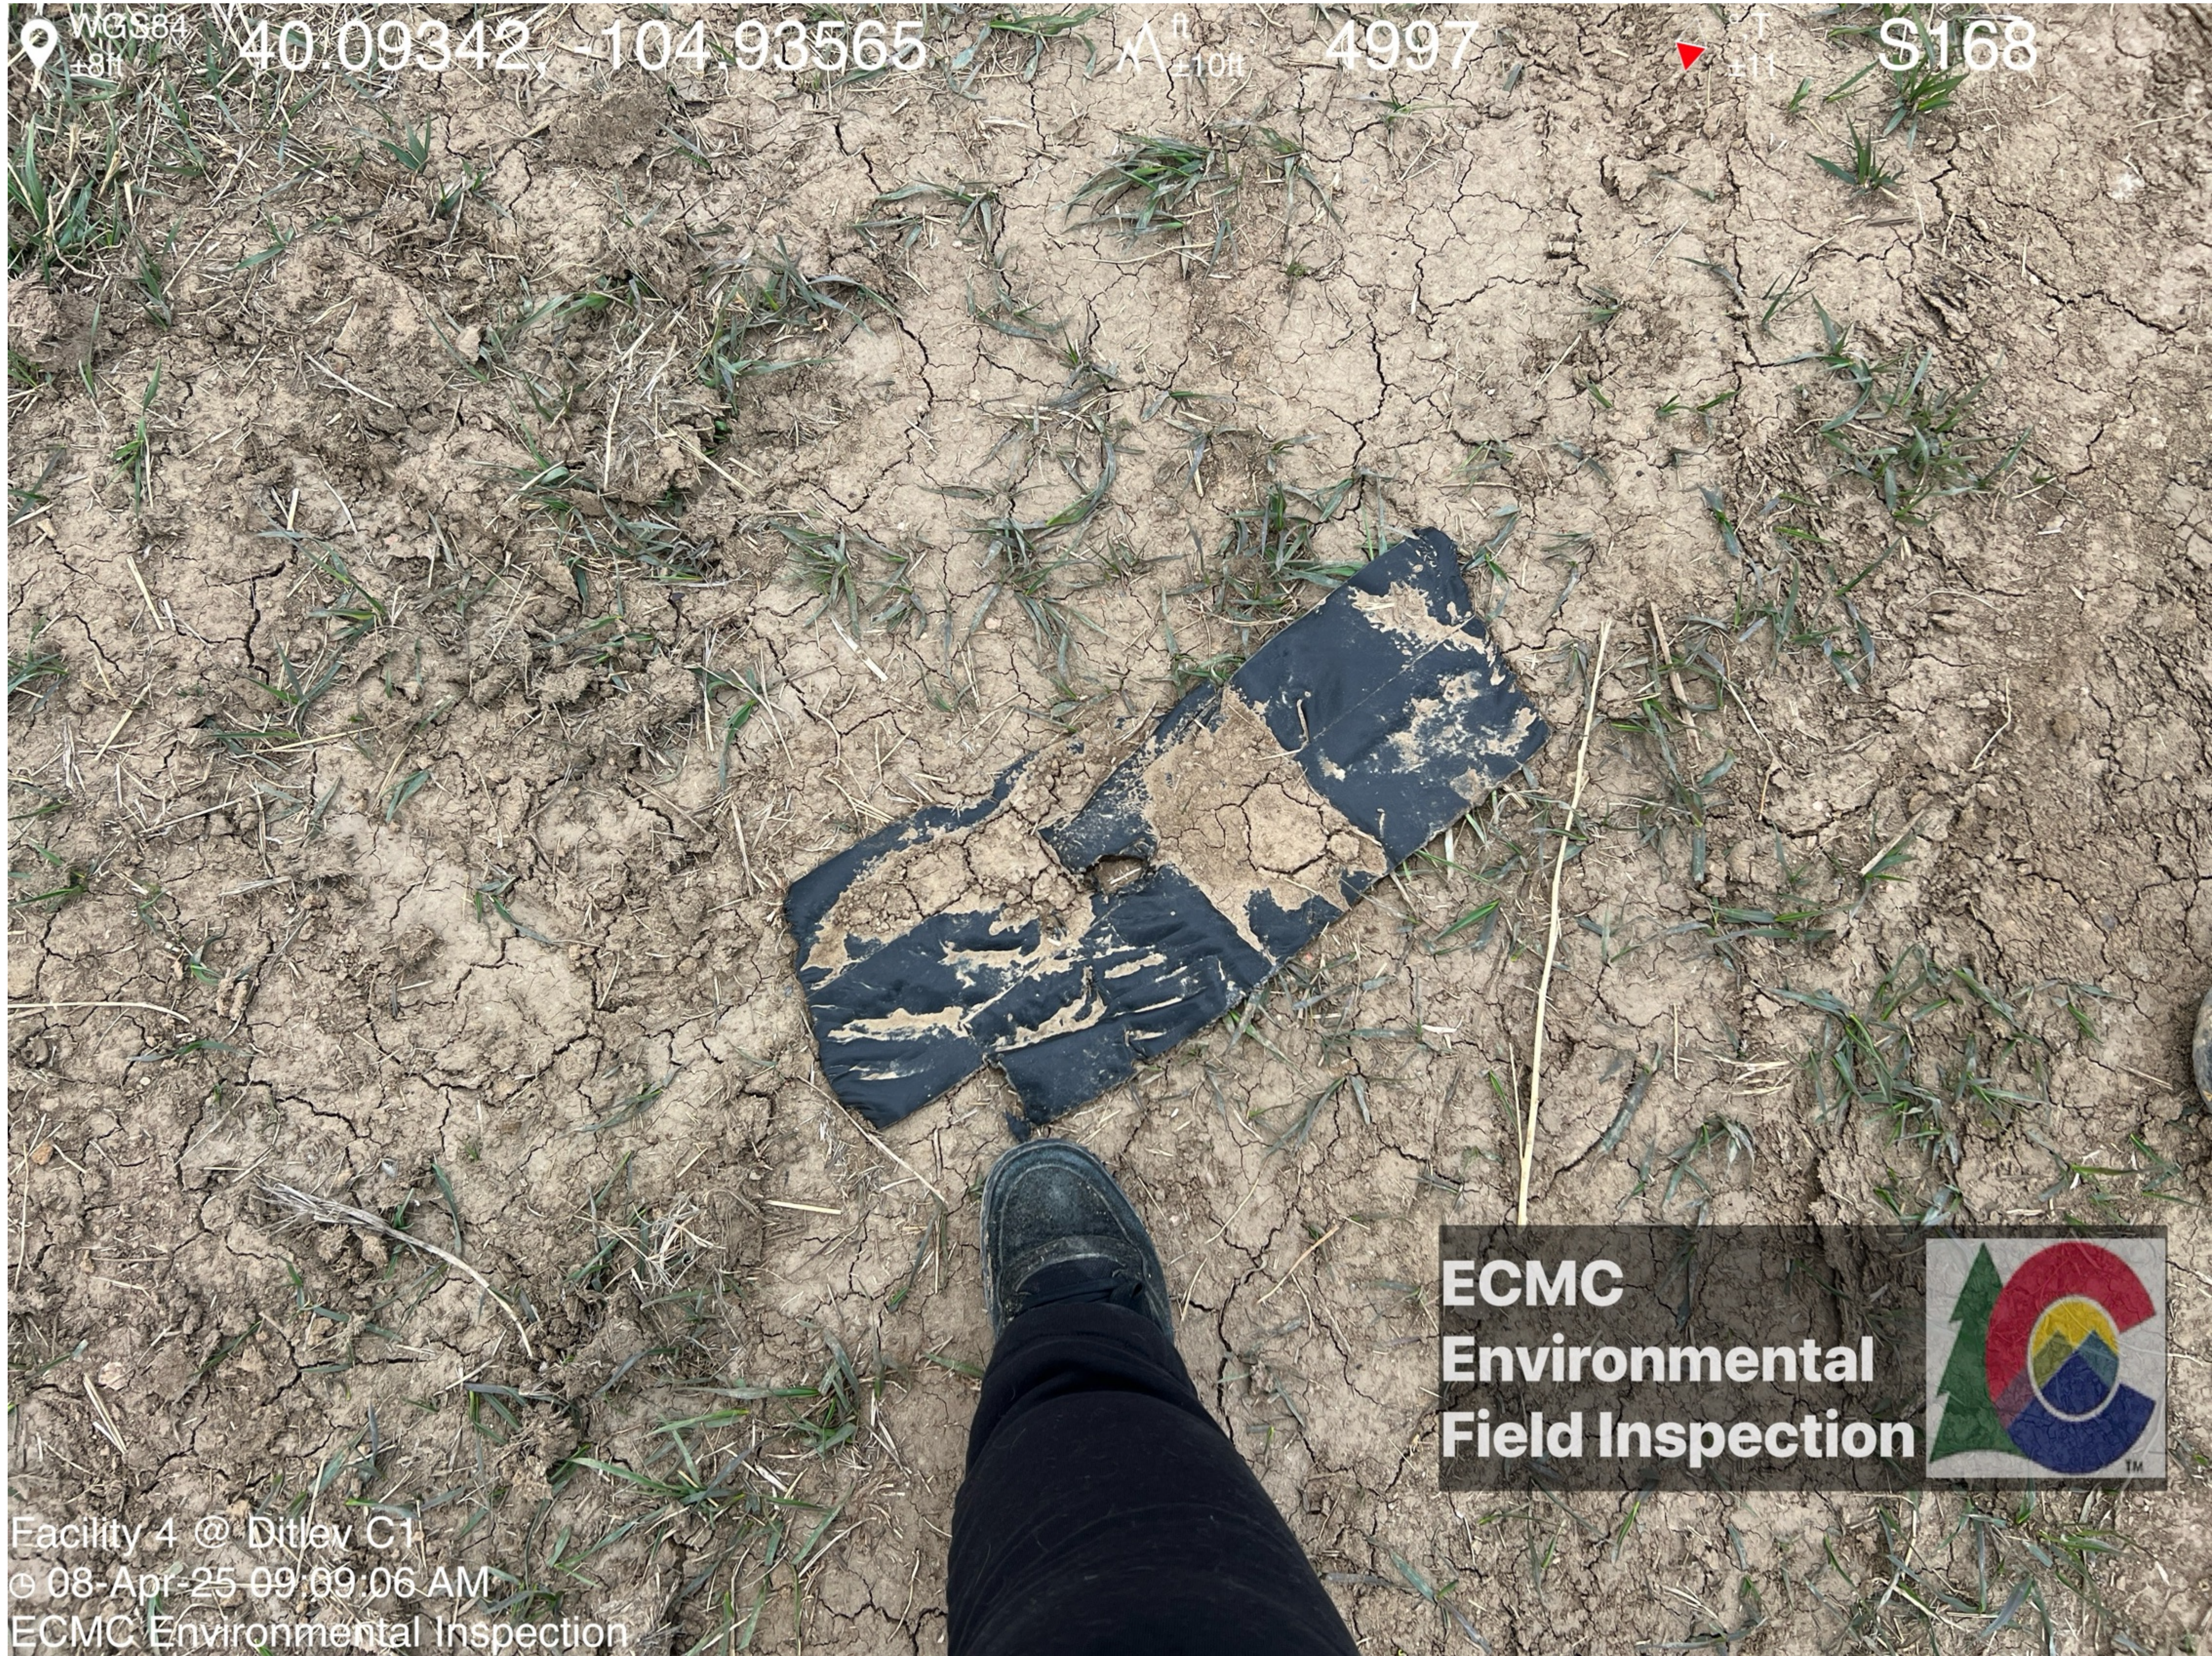
Trash/Debris - Pieces of stockpile liner embedded in soil throughout location
