# Interim Reclamation and Stormwater Inspection

Date: 04/07/2025

Operator: IMPERTO RESOURCES LLC - 10690

Location ID: 317278

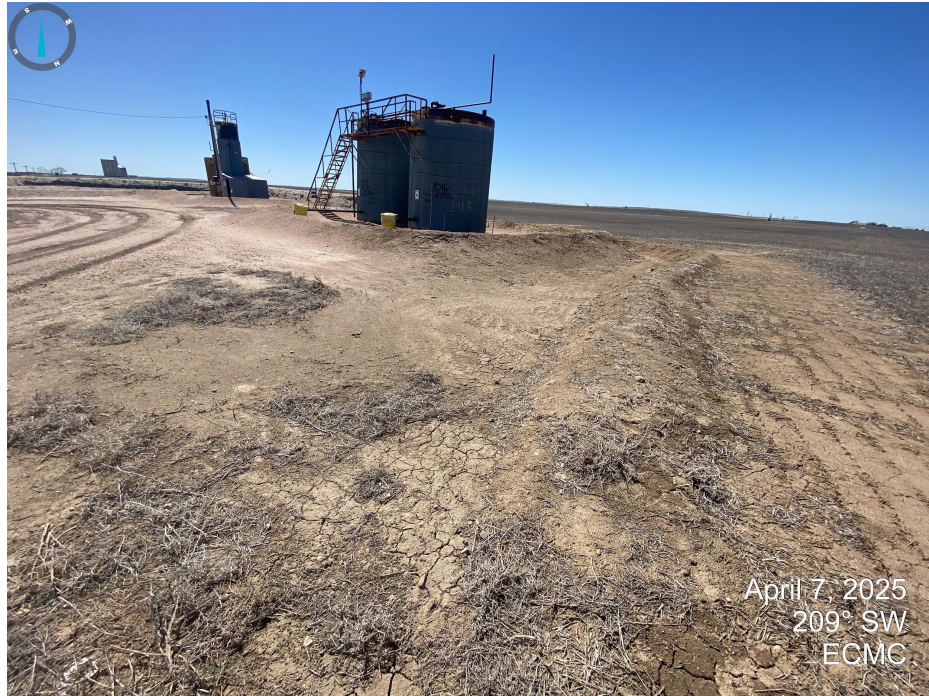
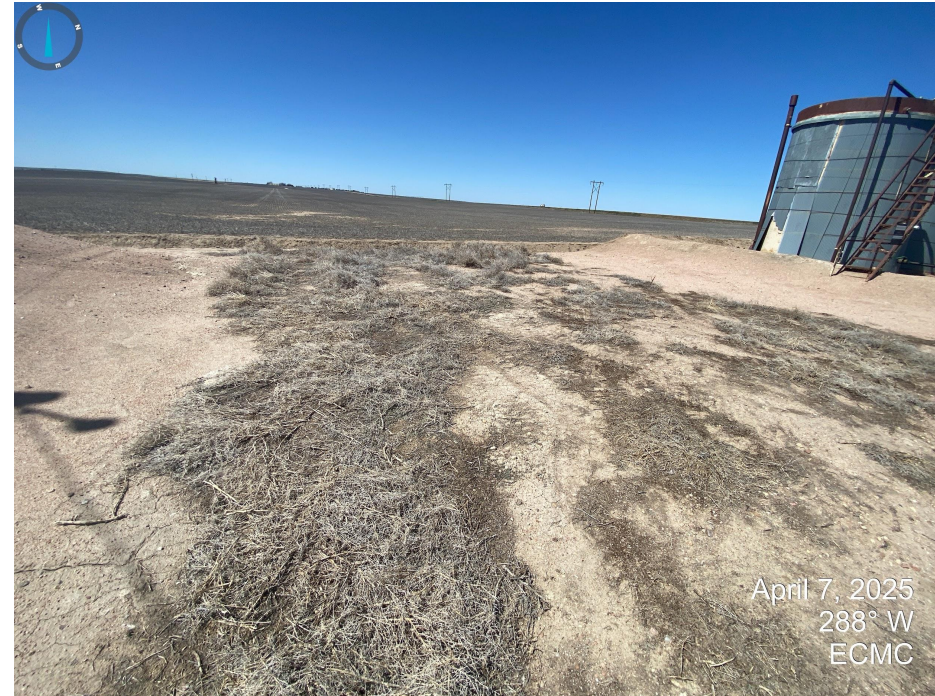
**Photos 1 & 2.** Undesirable vegetation previously documented appears to have been managed for. Operator shall continue to monitor and manage the location for undesirable vegetation.

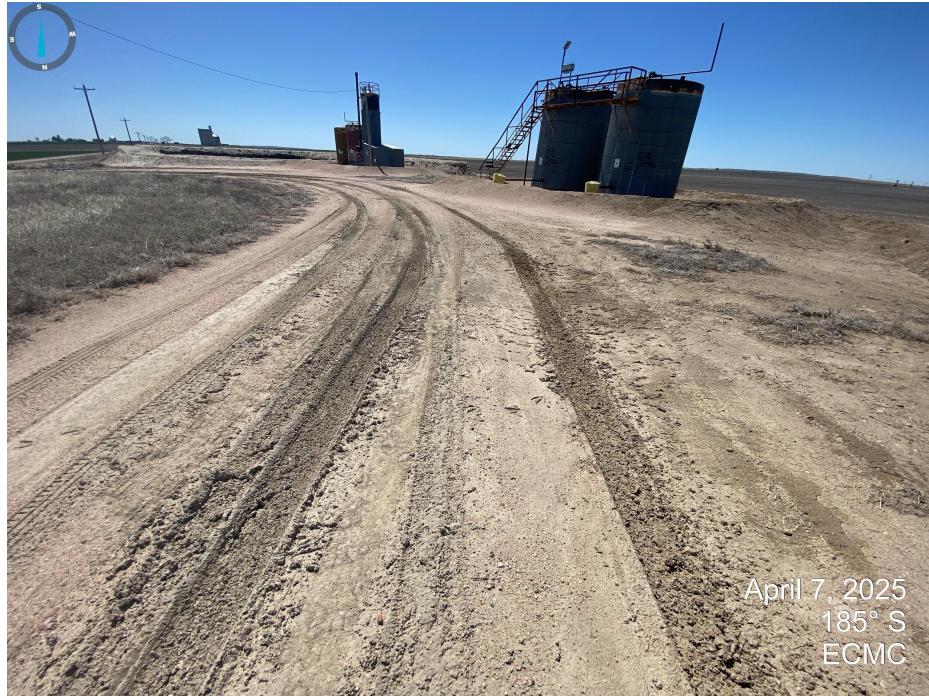
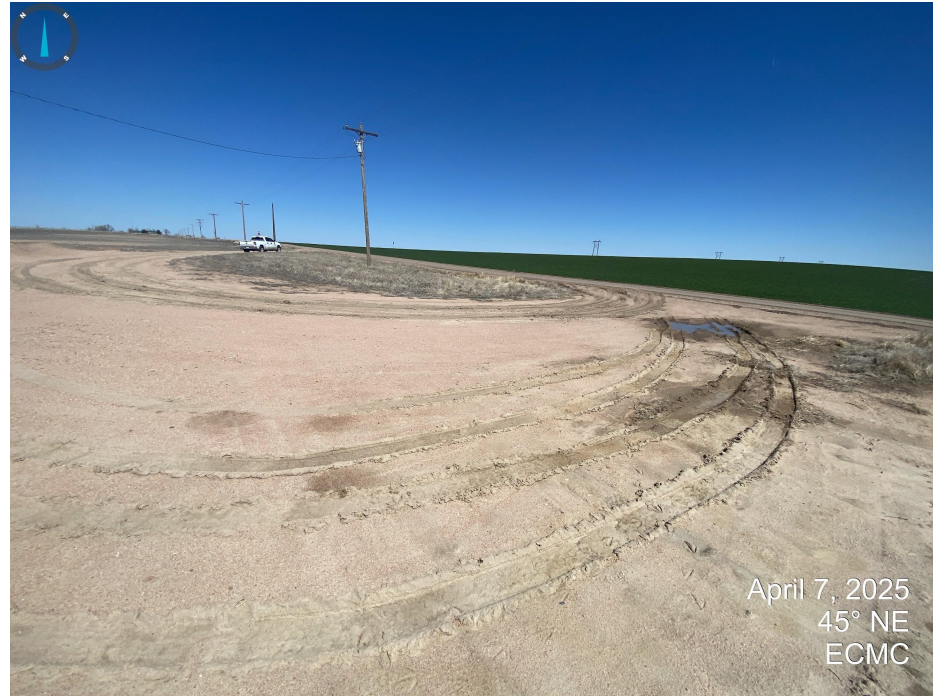
**Photos 3 & 4.** Maintenance advised on access points/production areas.

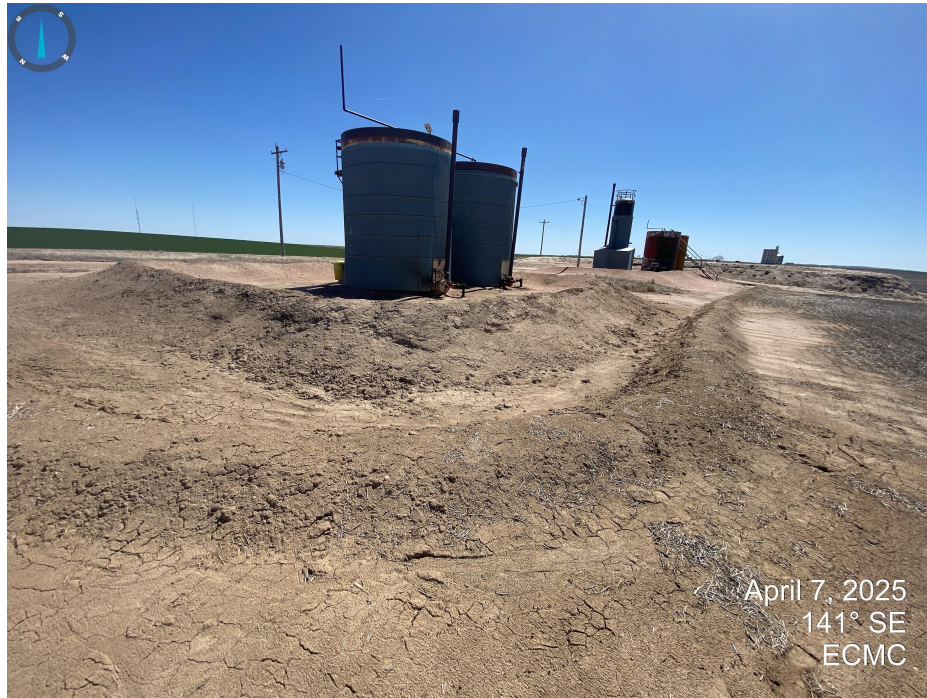
**Photos 5 & 6.** Photo 5 (left) illustrates that a perimeter ditch has been installed along the western portion of the location. Photo 6 (right) illustrates that erosion degradation previously observed near the separator does not appear to have been repaired or stabilized.

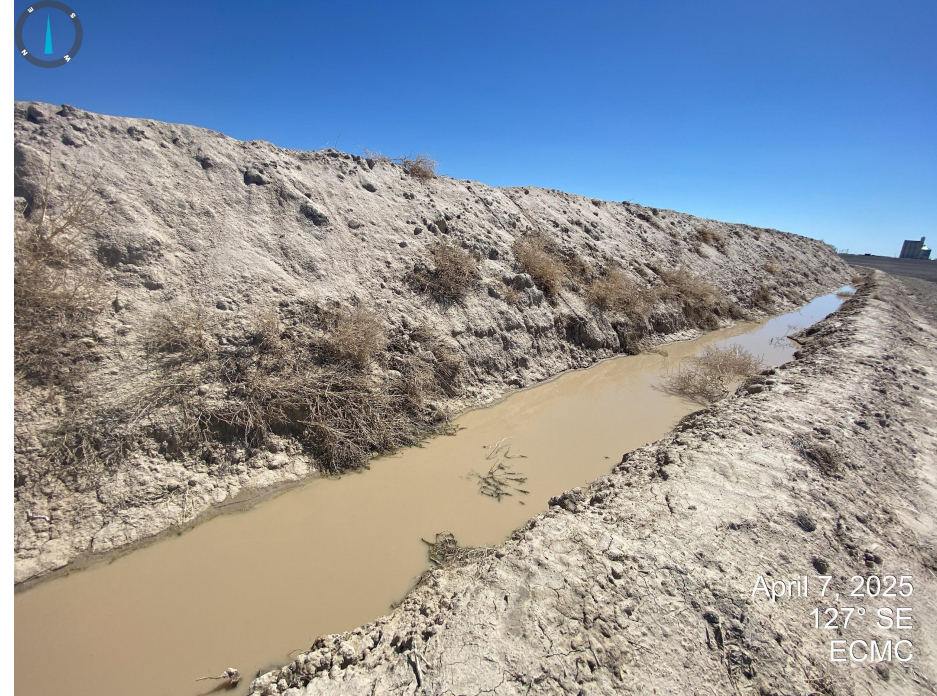
**Photos 7 & 8.** Photos illustrate that perimeter stormwater controls appear to be properly functioning. Photo 8 (right) illustrates weedy debris on pit walls.

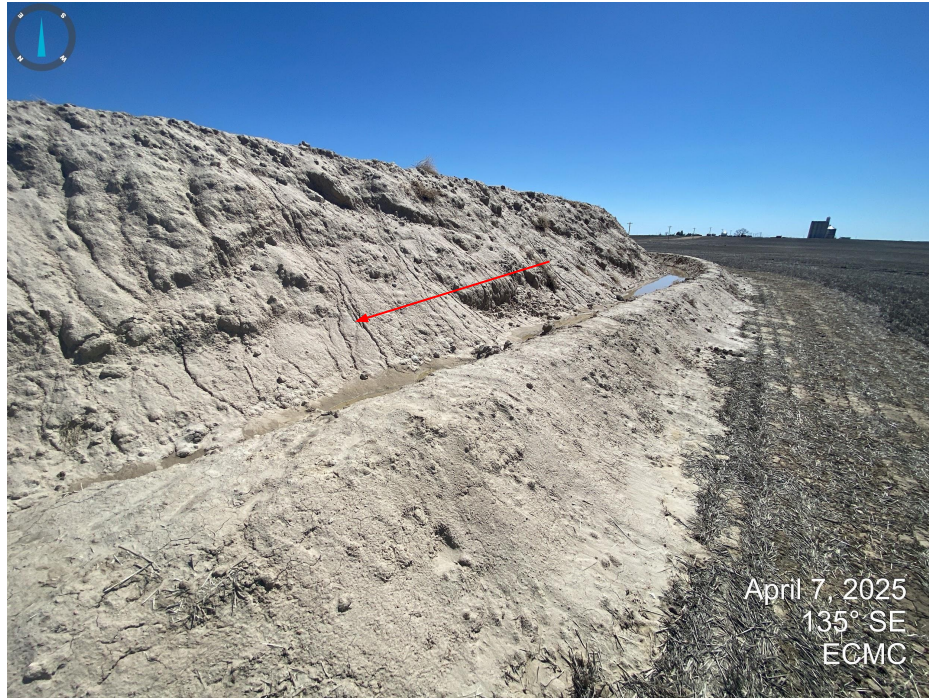
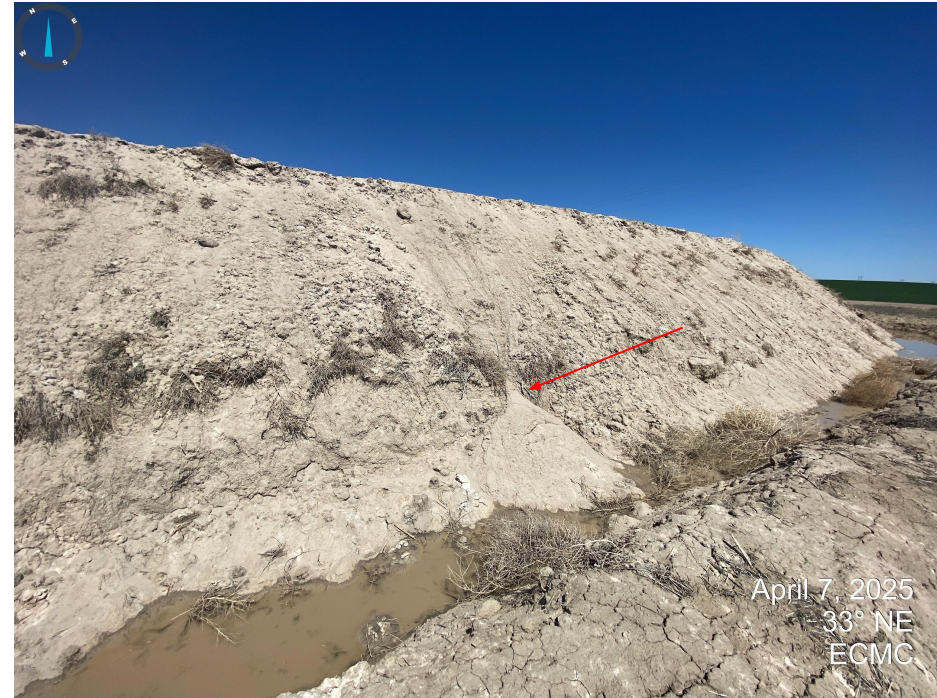
**Photos 9 & 10.** Evidence of erosion degradation observed at the pit walls.

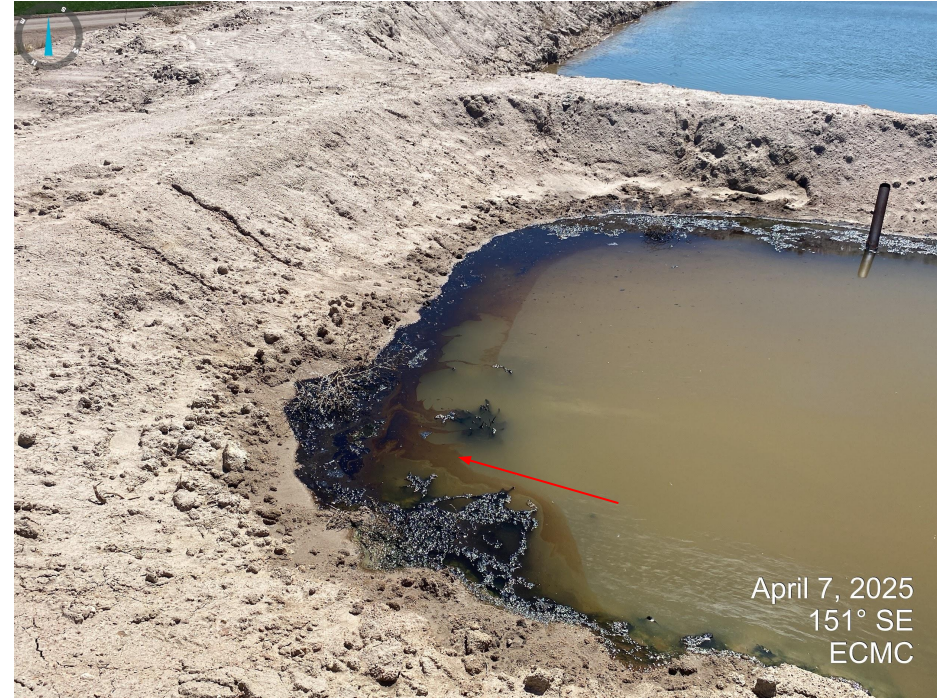
**Photos 11 & 12.** Visible hydrocarbons observed on the surface of skim pit with visible sheen evident.

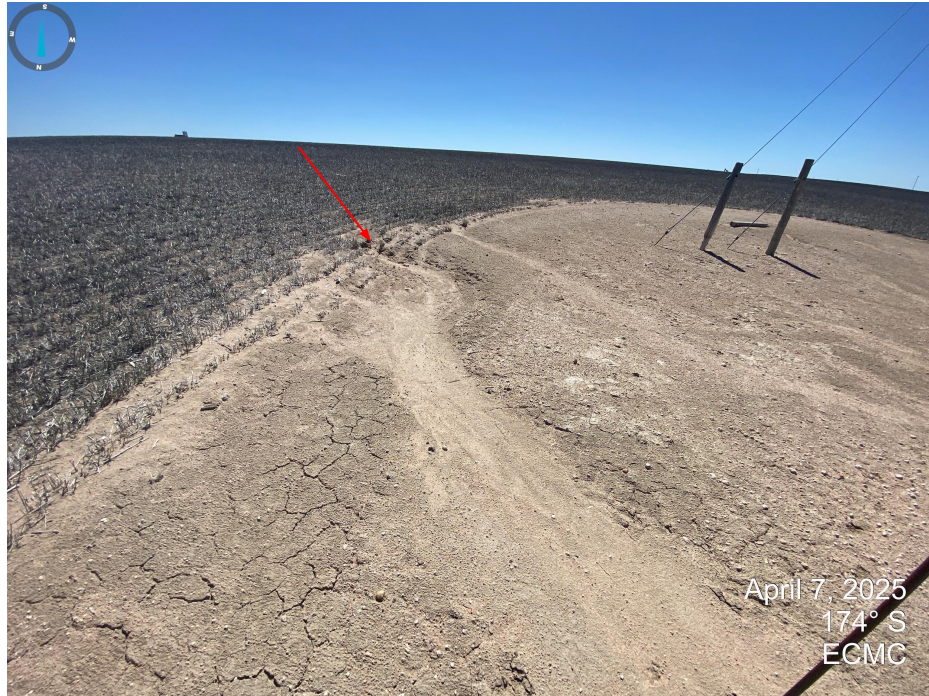
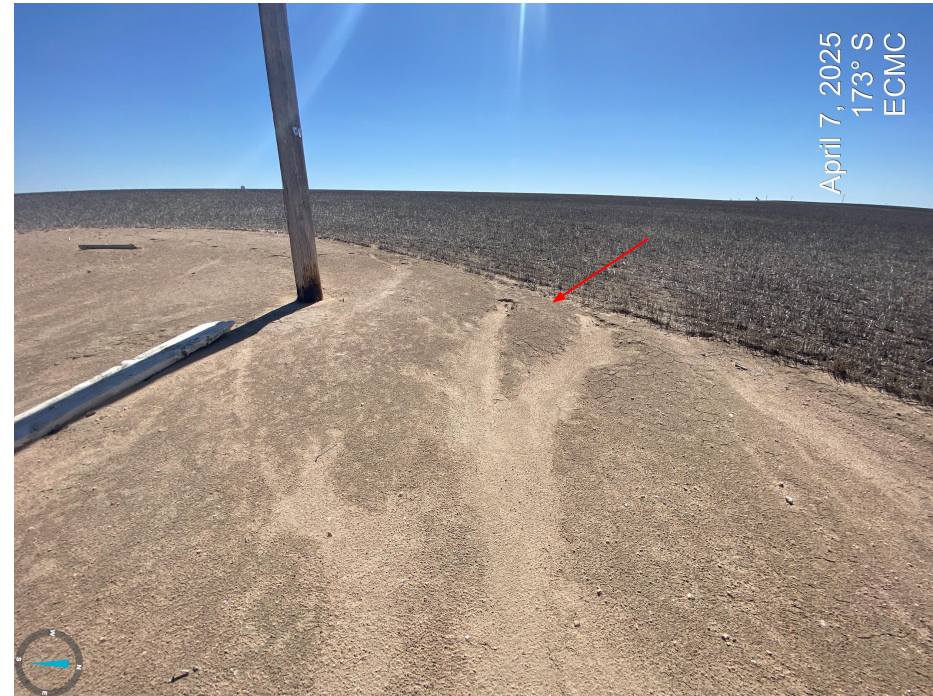
**Photos 13 & 14.** Erosion degradation previously observed near the well location does not appear to have been repaired or stabilized to prevent reoccurrence.
