Interim Reclamation and Stormwater Inspection

Date: 04/07/2025

Operator: WESTERN OPERATING COMPANY - 95620

Location ID: 317040

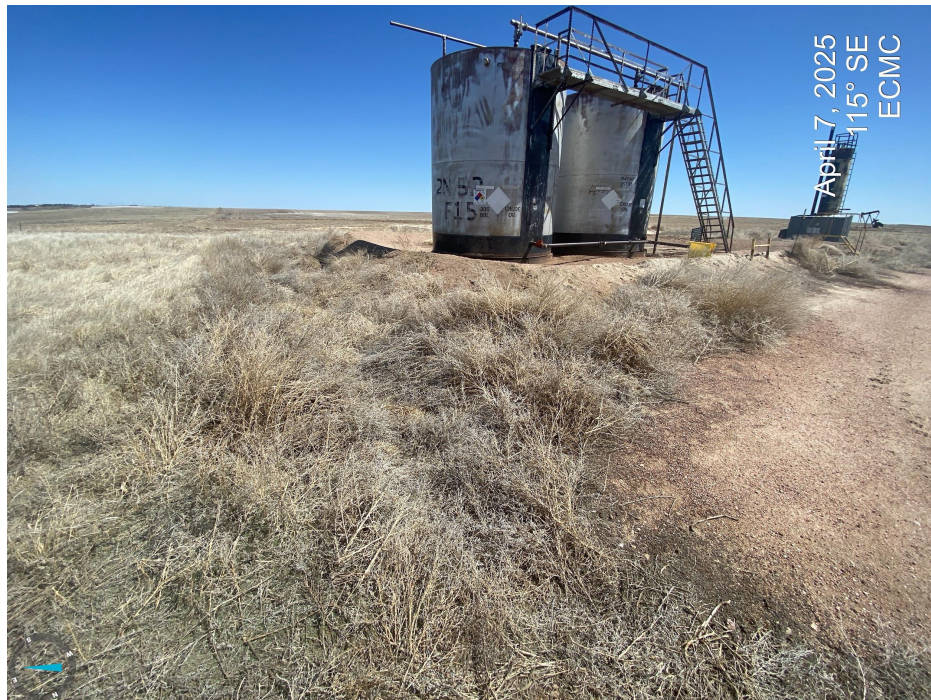
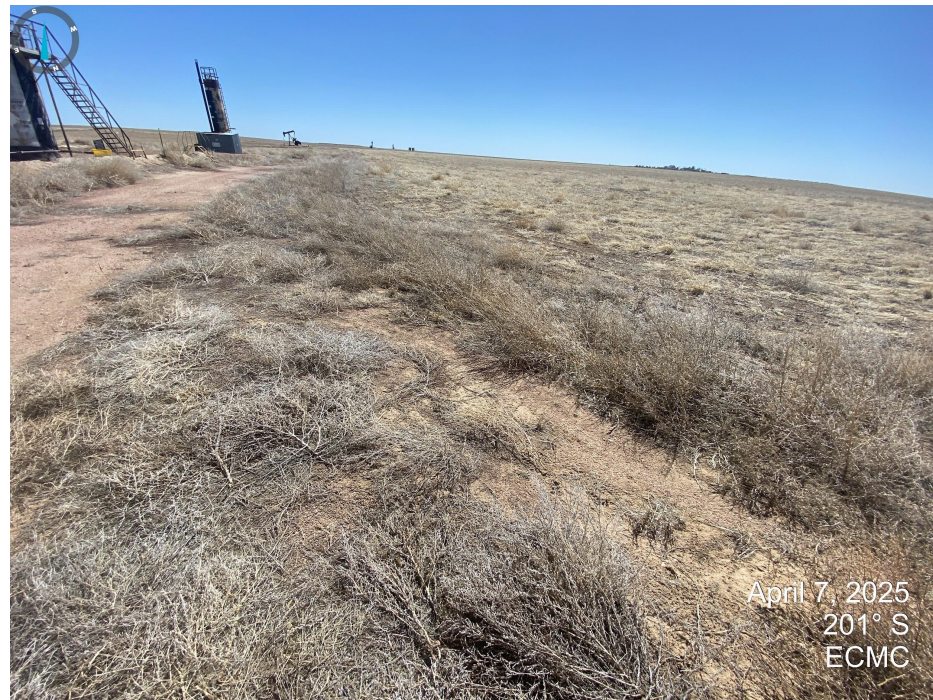
Photos 1 & 2. Taken near the location entrance of the location. Undesirable vegetation was observed throughout.

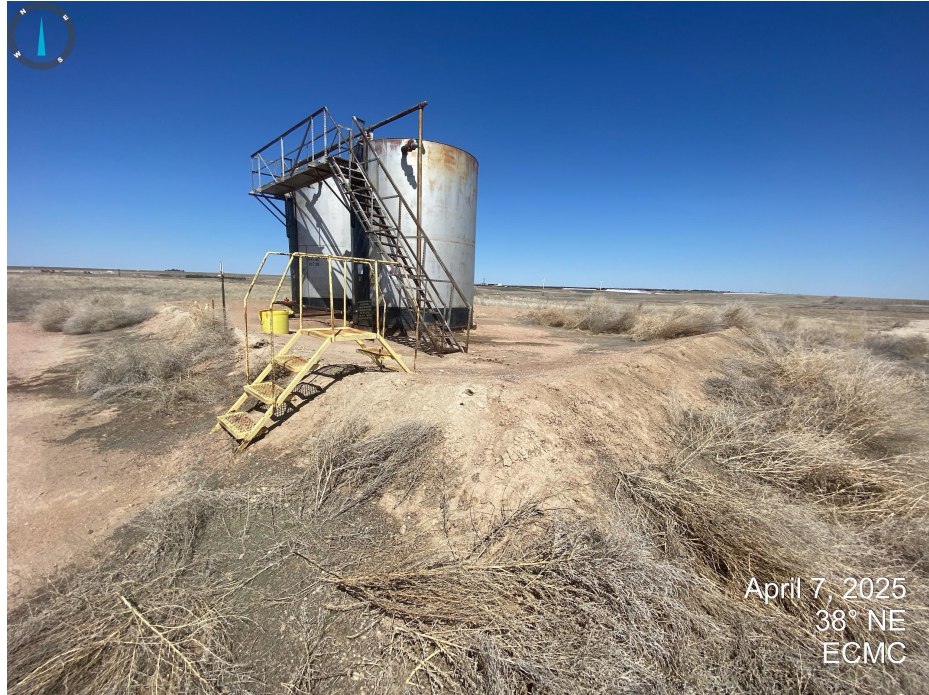
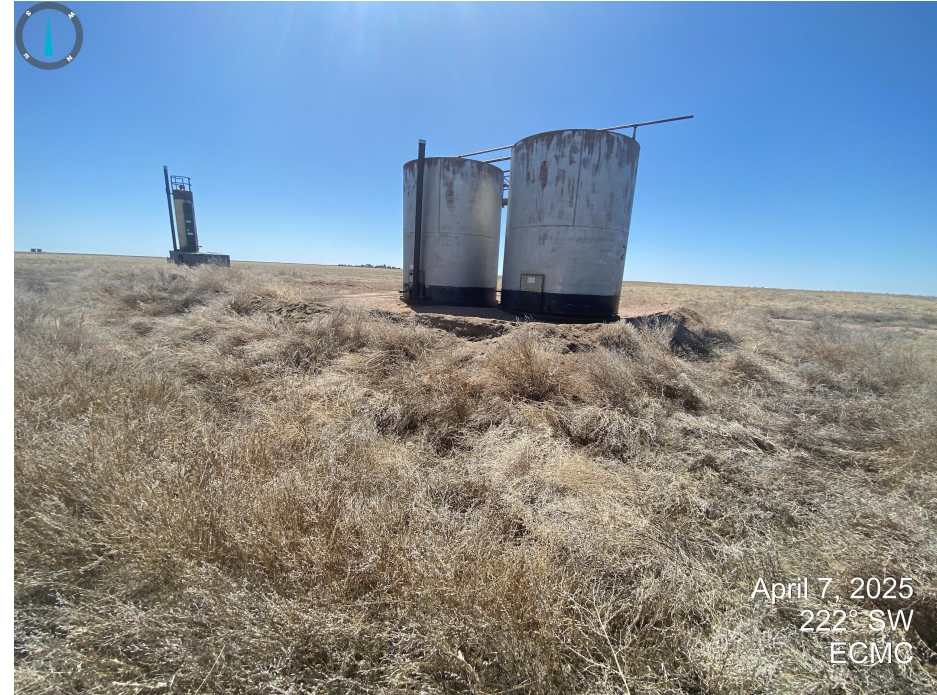
Photos 3 & 4. Undesirable vegetation around tank battery.

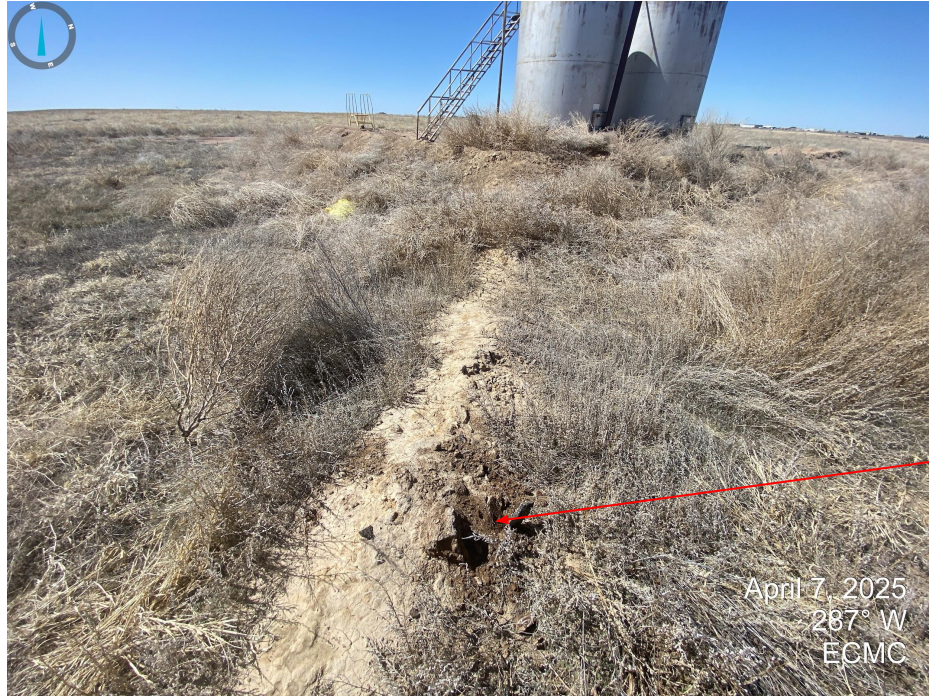
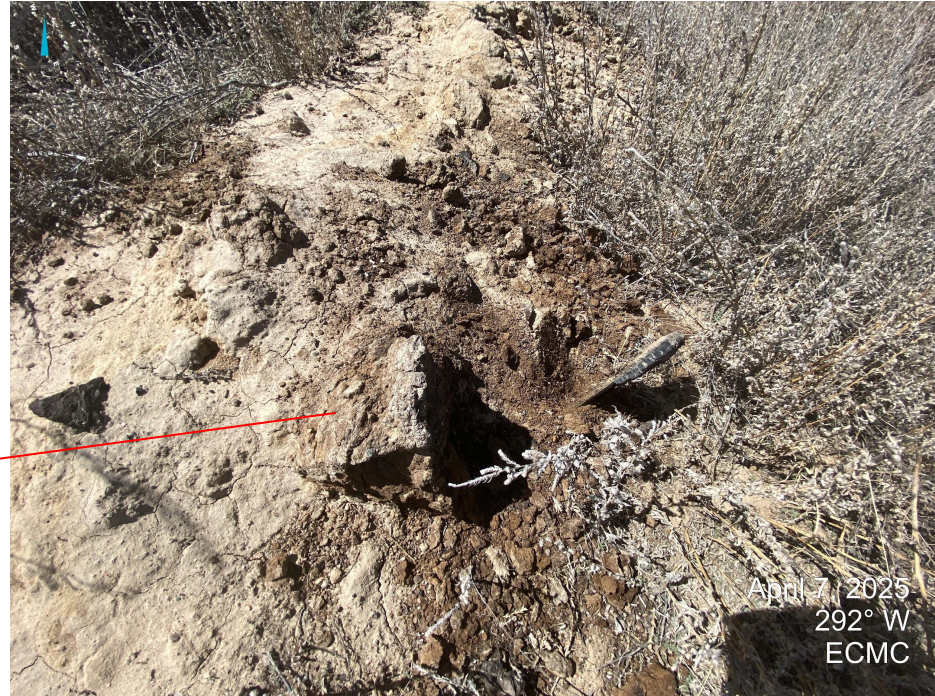
Photos 5 & 6. Stained soils observed near tank battery.

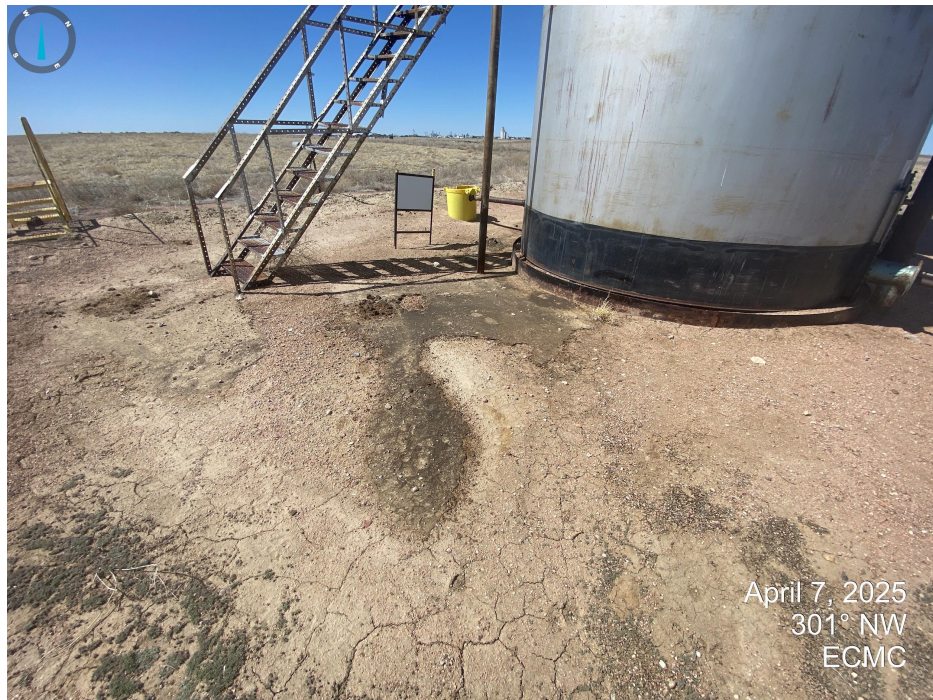
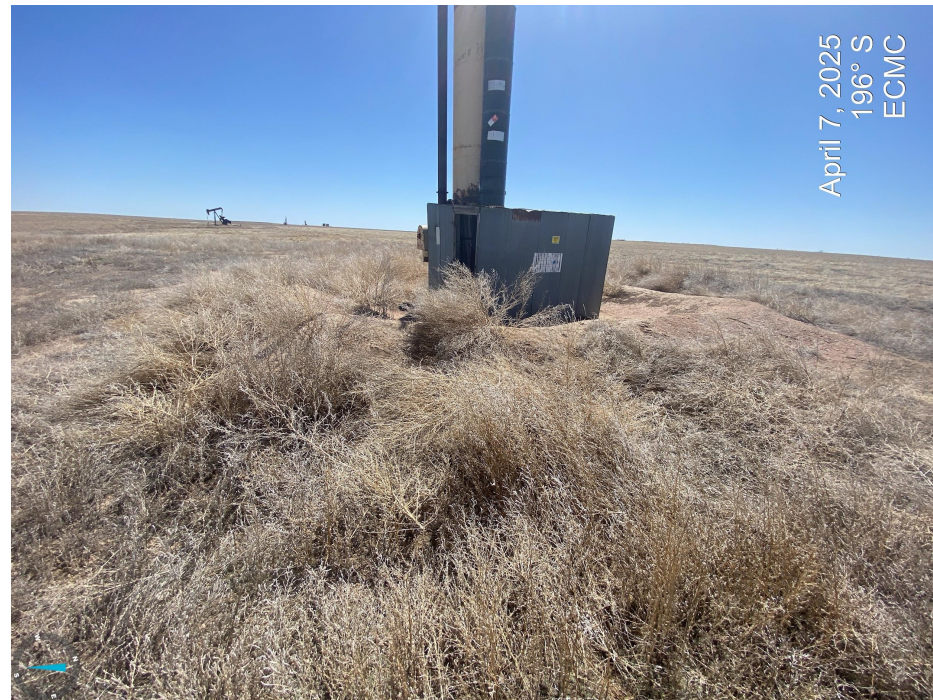
Photos 7 & 8. Stained soil at tank battery (Photo 7; left) and undesirable vegetation at separator (Photo 8; right).

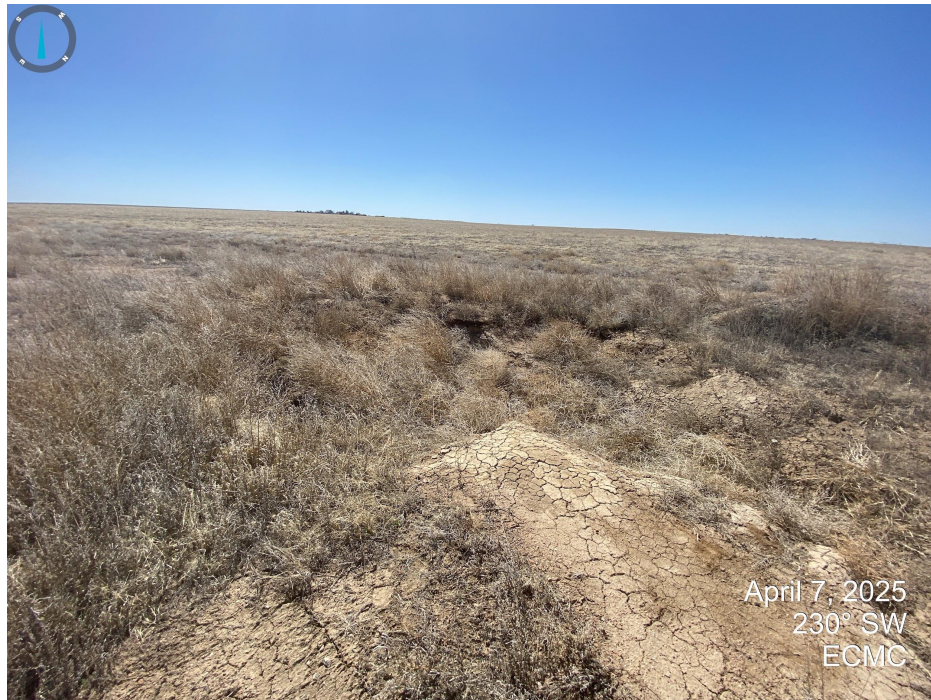
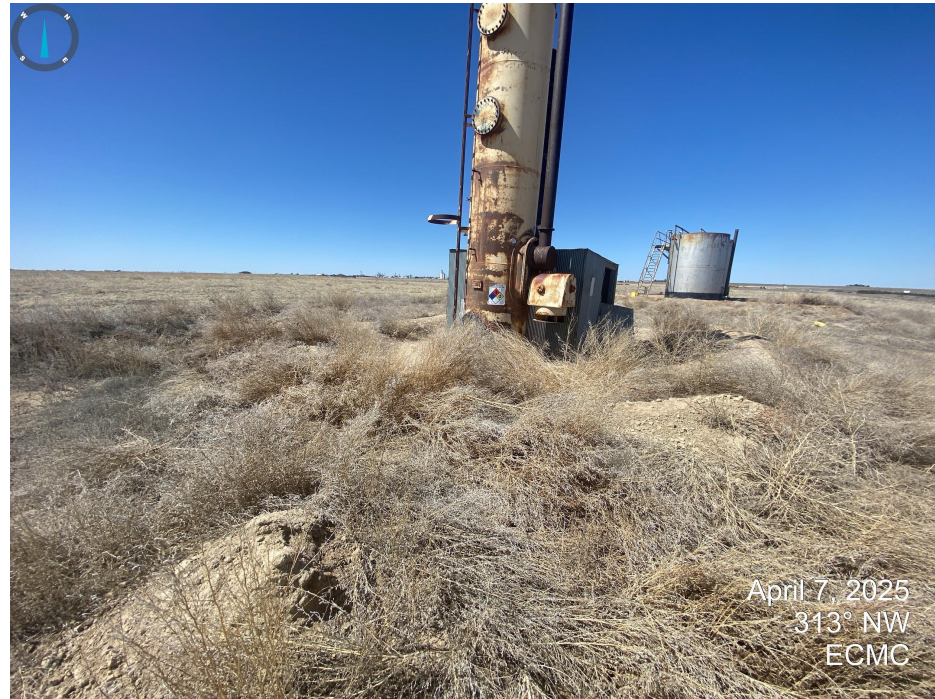
Photos 9 & 10. Undesirable vegetation and open excavation with no fencing observed near the separator (Photo 9; left).

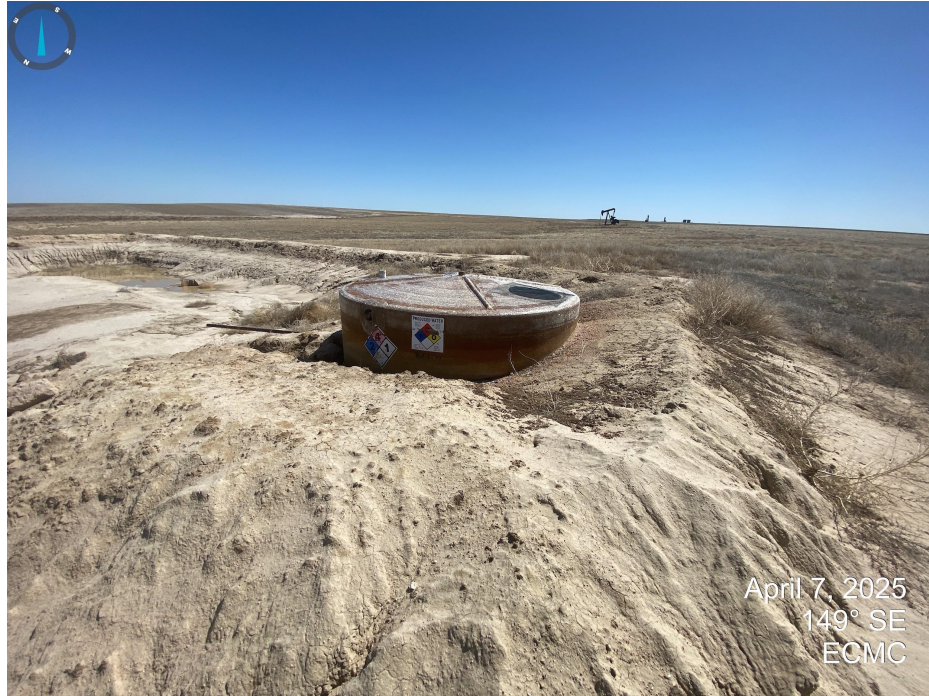
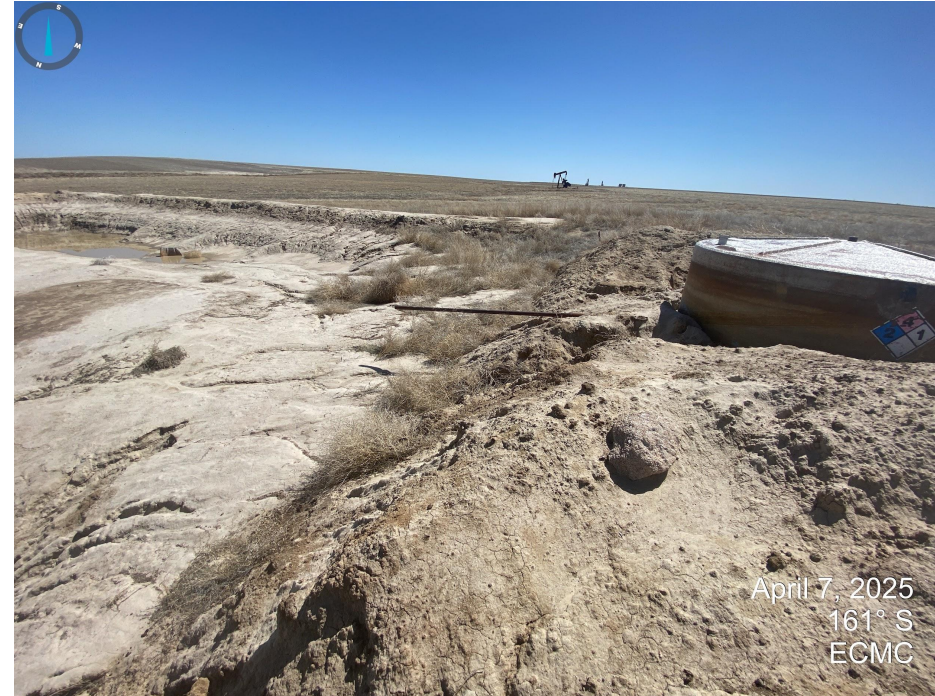
Photos 11 & 12. Unstabilized soils and erosion degradation evident at pits. Undesirable vegetation observed throughout pits.

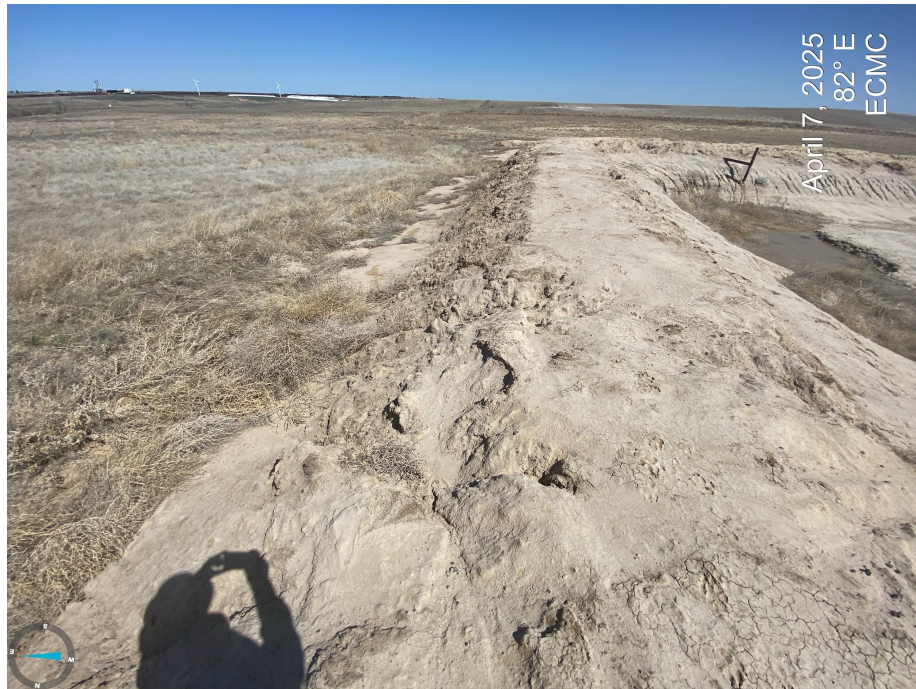
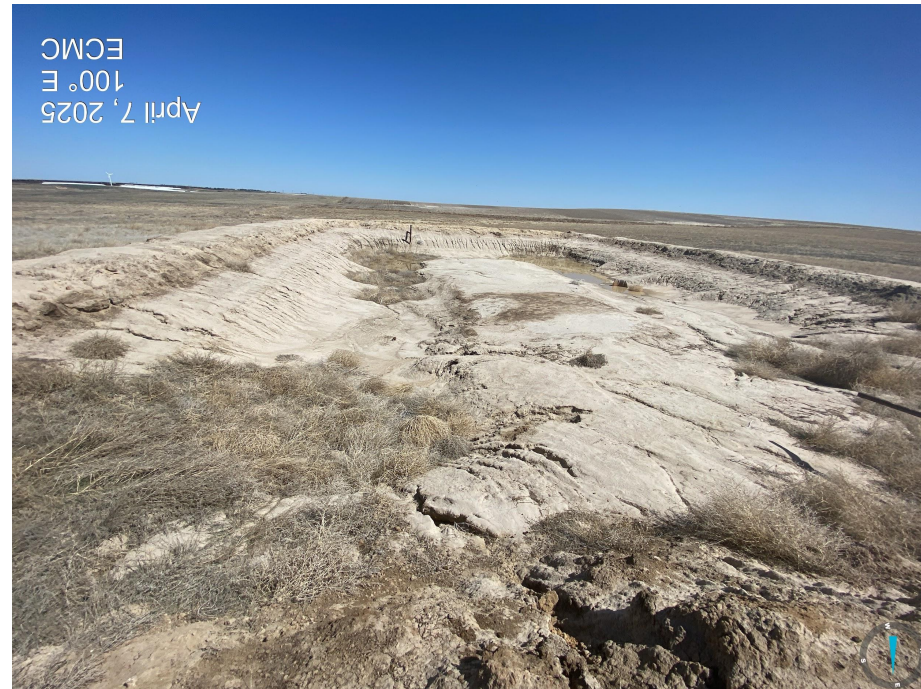
Photos 13 & 14. Unstabilized soils and erosion degradation evident at pits. Undesirable vegetation observed throughout pits.

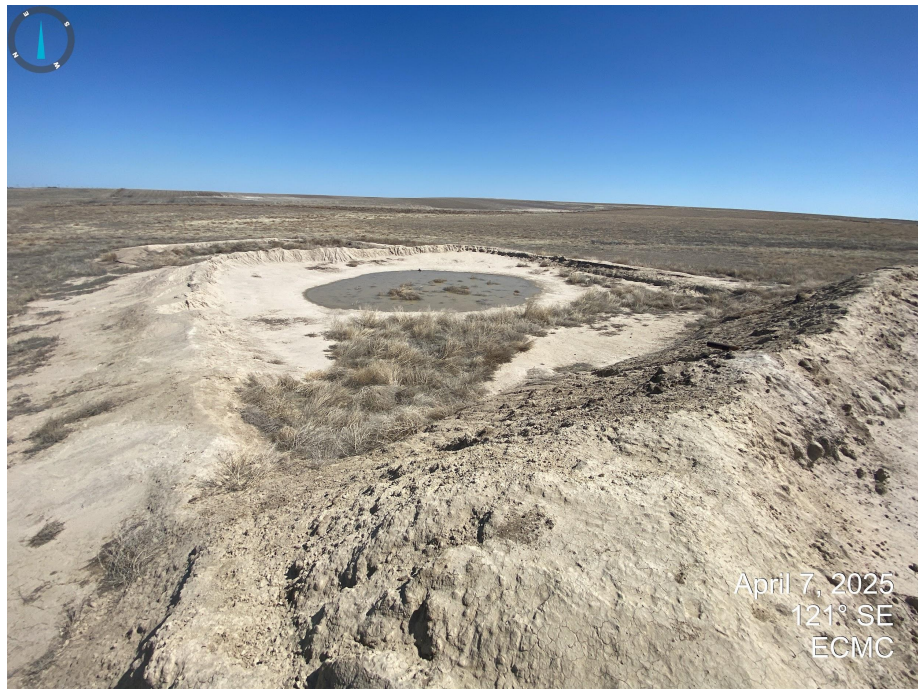
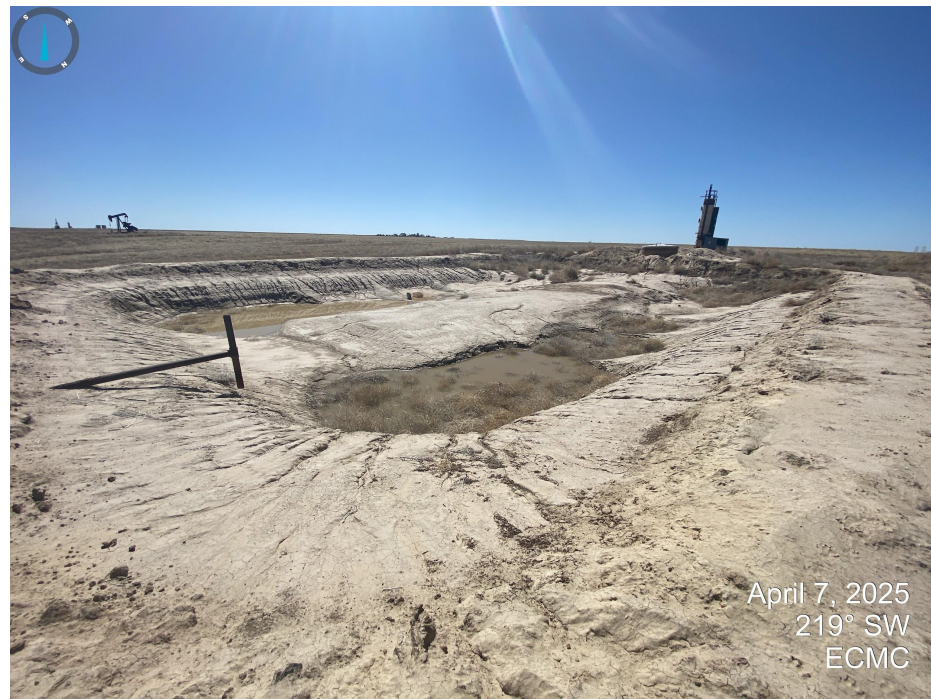
Photos 15 & 16. Unstabilized soils and erosion degradation evident at pits. Undesirable vegetation observed throughout pits.

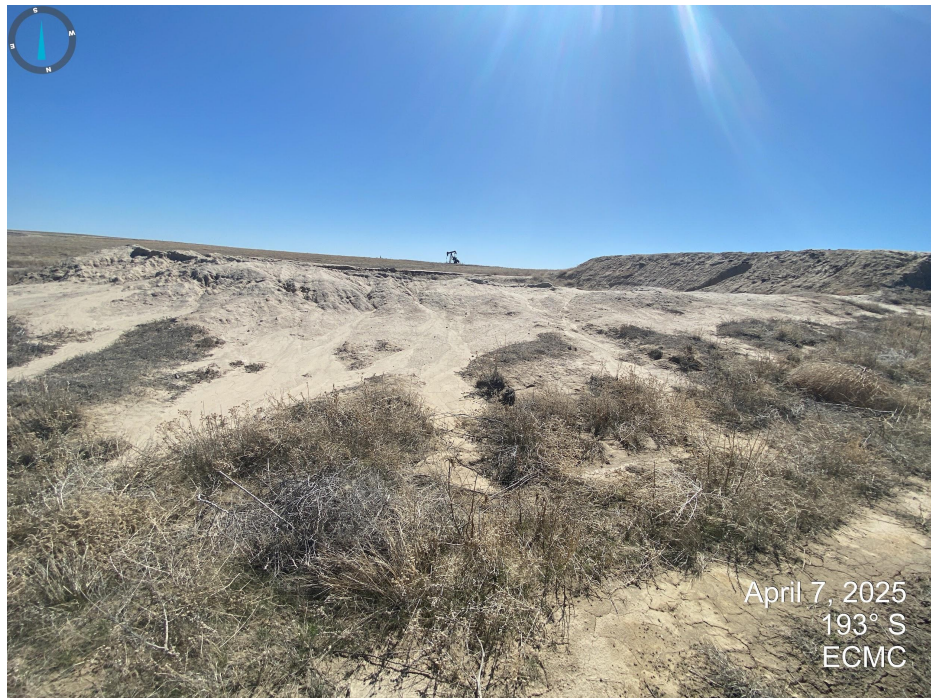
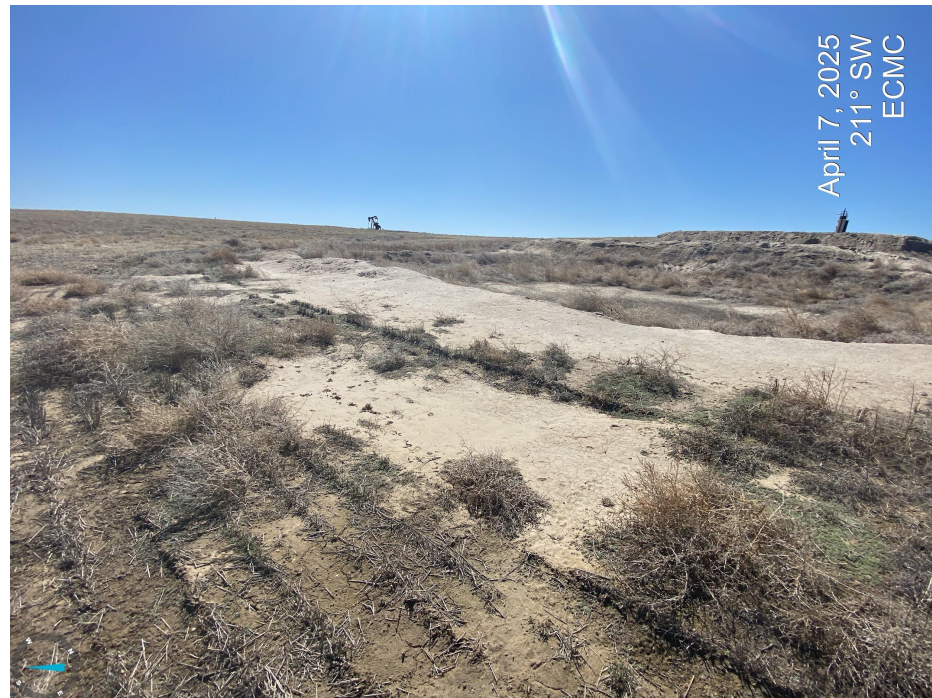
Photos 17 & 18. Sediment migration and erosion degradation observed at the unstabilized pit berms.

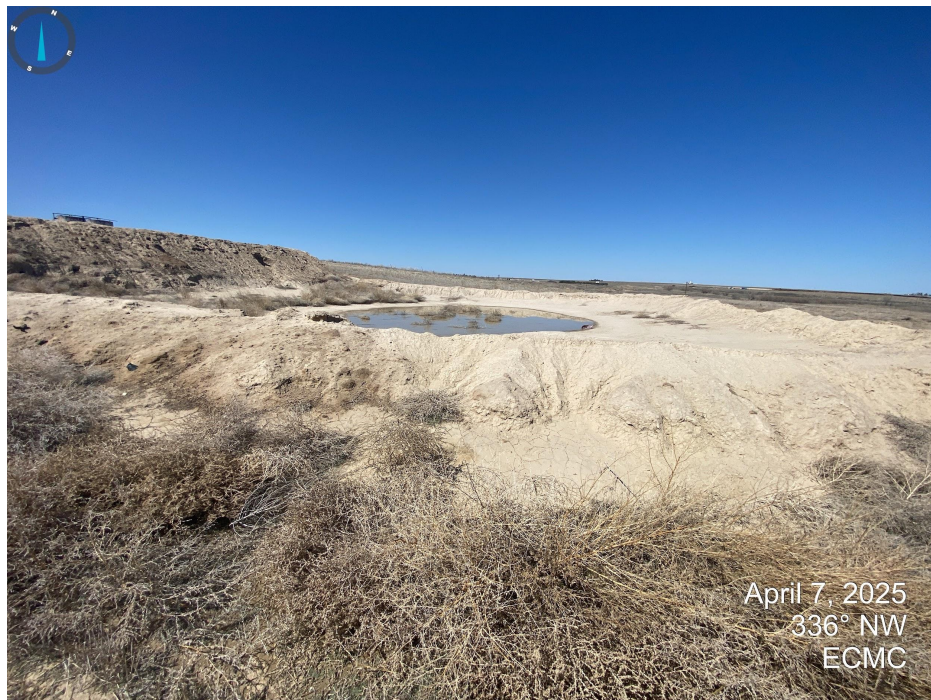
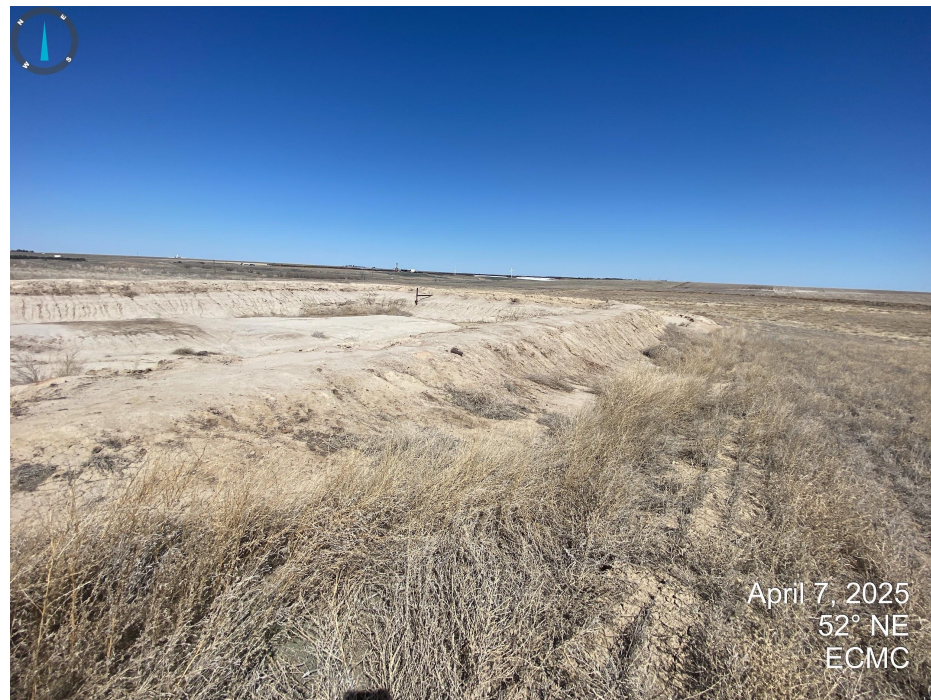
Photos 19 & 20. Undesirable vegetation, sediment migration and erosion degradation observed at the unstabilized pit berms.

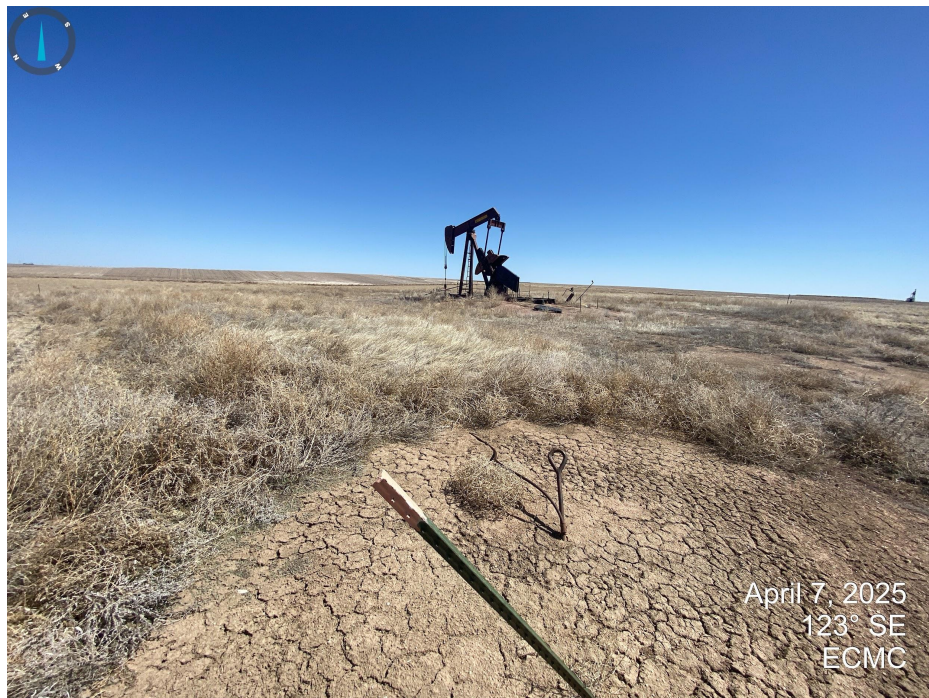
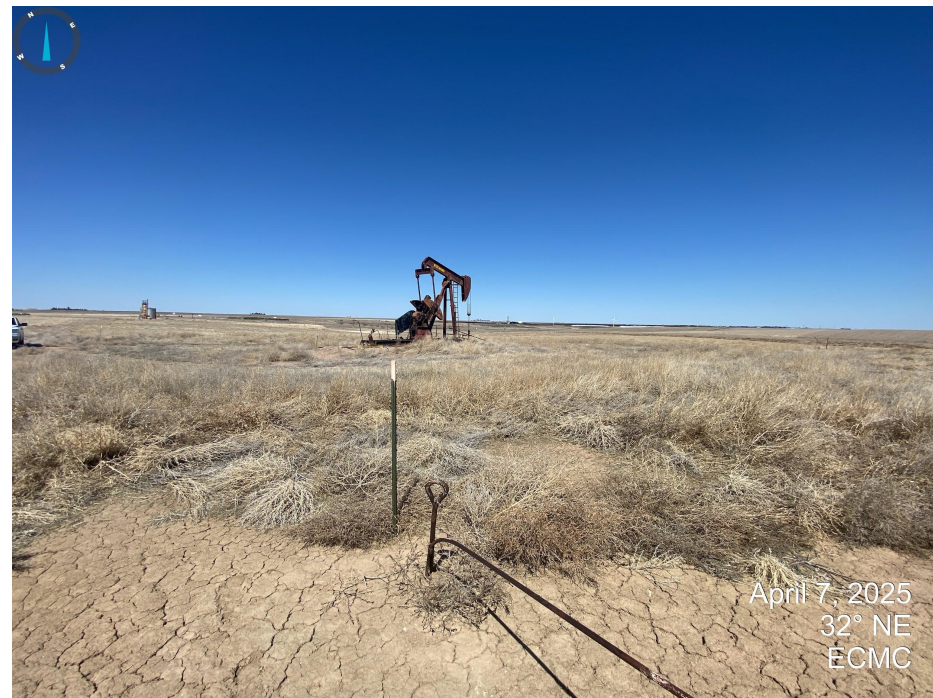
Photos 21 & 22. Taken from the northwest (Photo 21; left) and southwest (Photo 22; right) corners of the well location. Undesirable vegetation was observed throughout the interim and production areas.

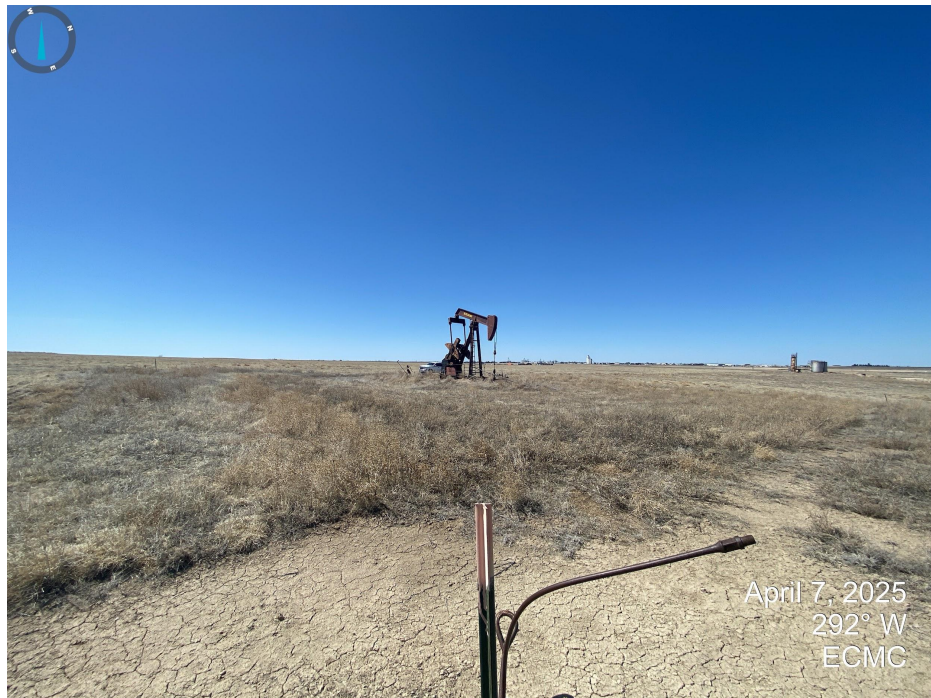
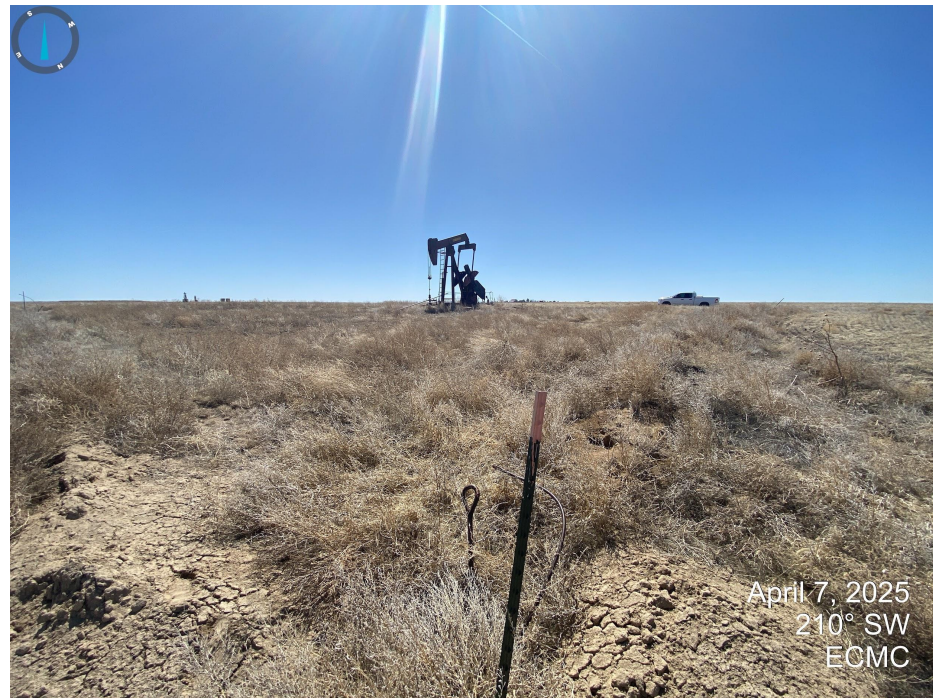
Photos 23 & 24. Taken from the southeast (Photo 23; left) and northeast (Photo 24; right) corners of the well location. Undesirable vegetation was observed throughout the interim and production areas.

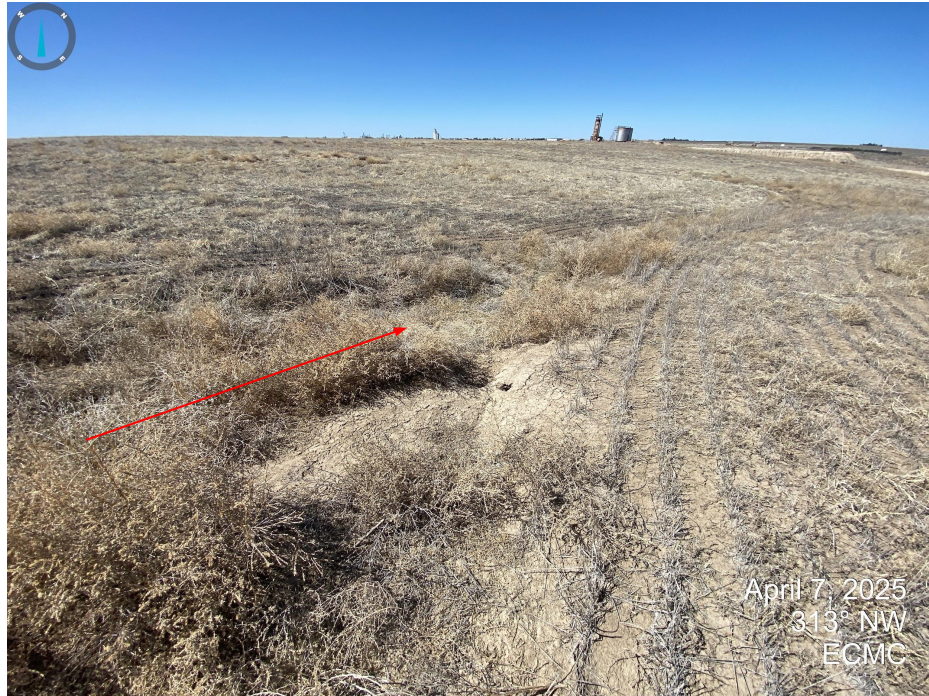
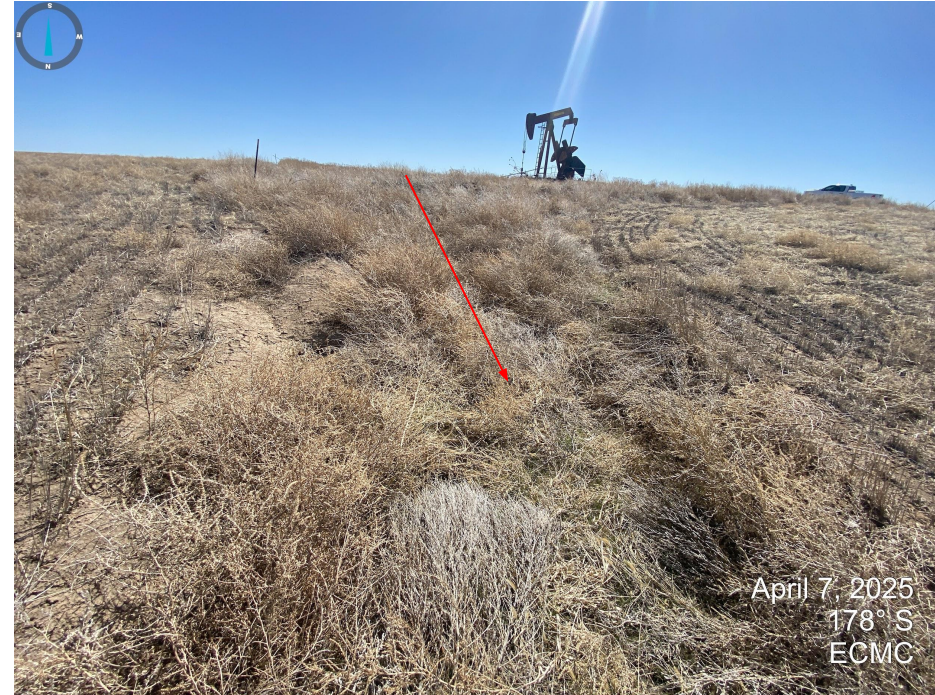
Photos 25 & 26. Erosion degradation observed on the northeast portion of the well location. Gullying obscured by undesirable vegetation.

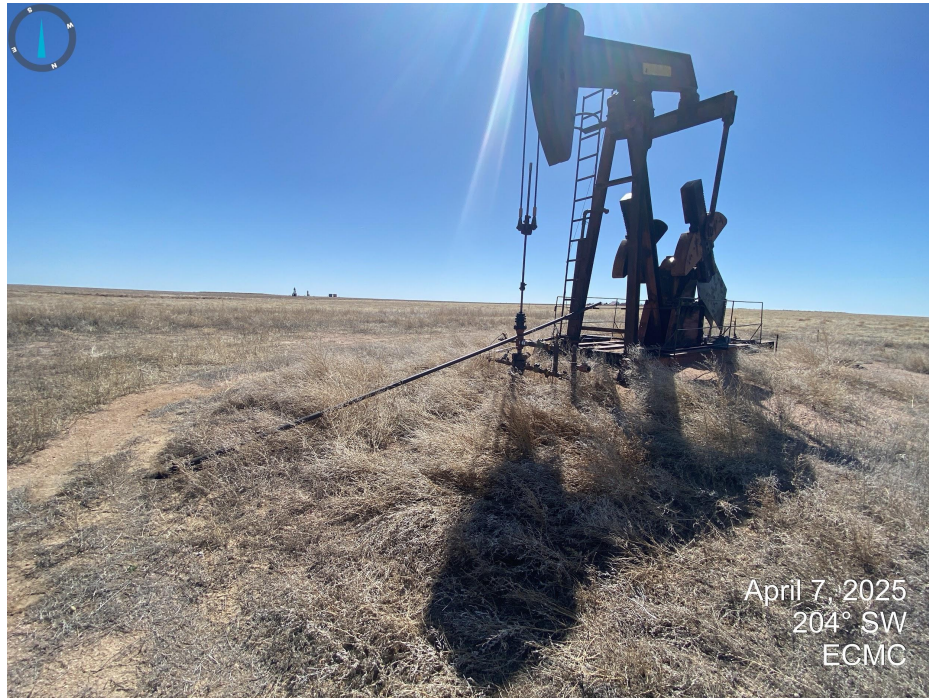
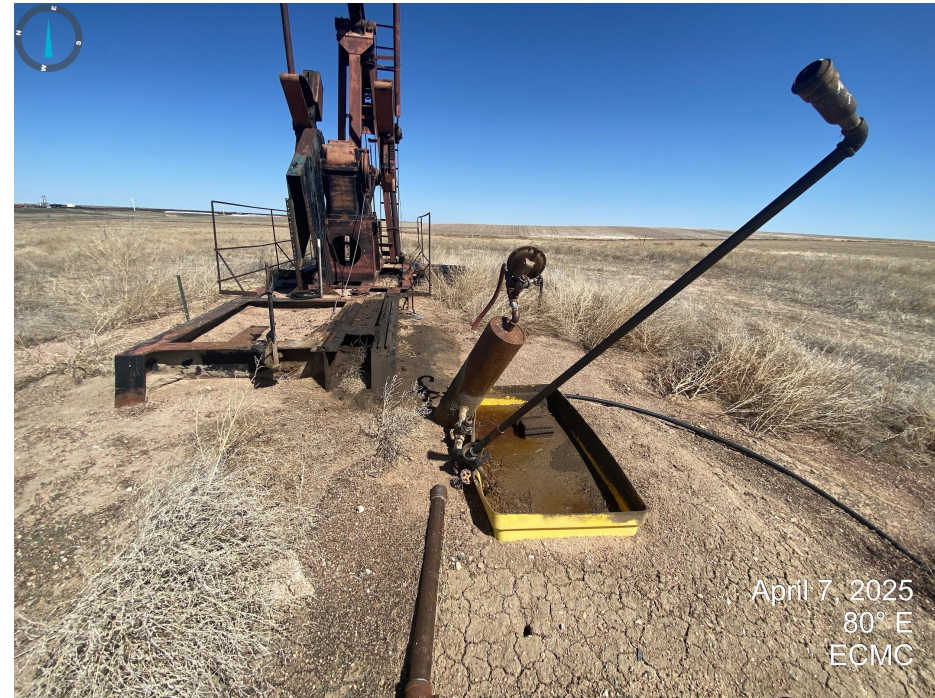
Photos 27 & 28. Unused equipment observed at well location.

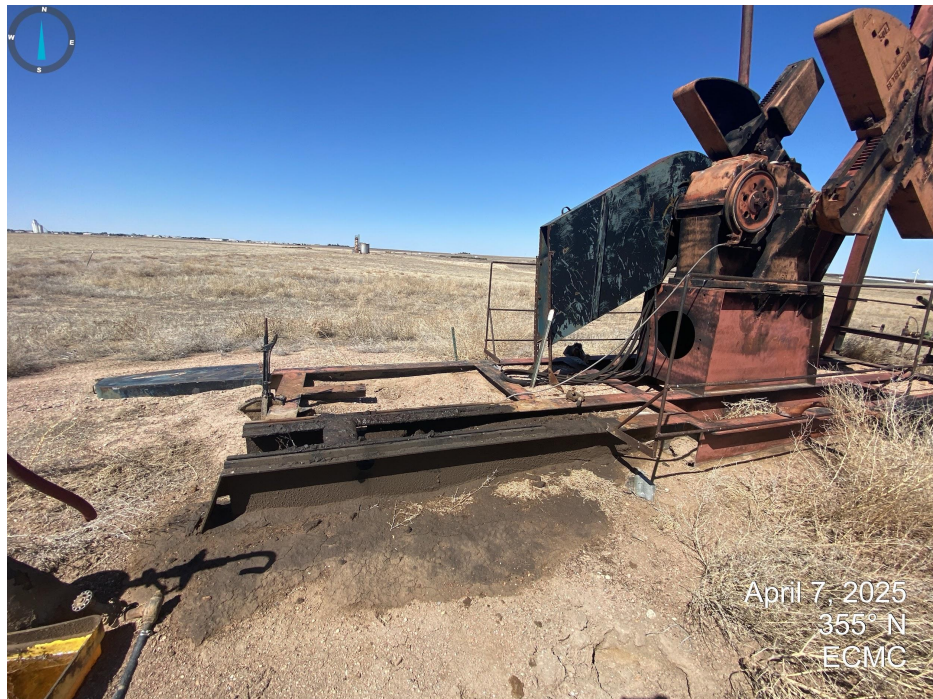
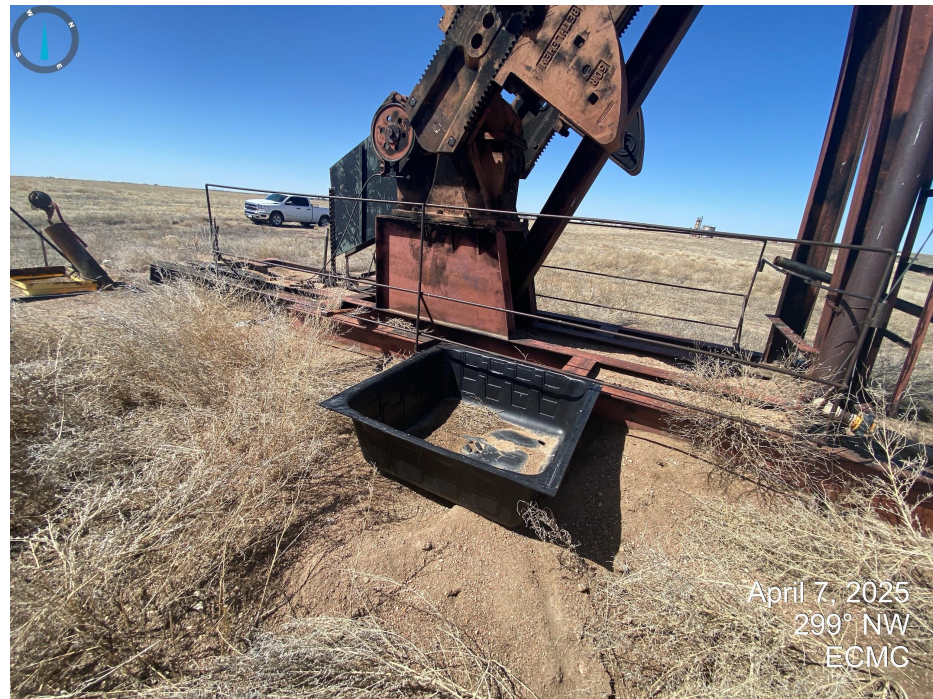
Photos 29 & 30. Stained soil and unused equipment at well location.
