Inspection Photos

Operator: TEP ROCKY MOUNTAIN LLC #96850

Location ID: 335068

Inspection Doc: 718100420

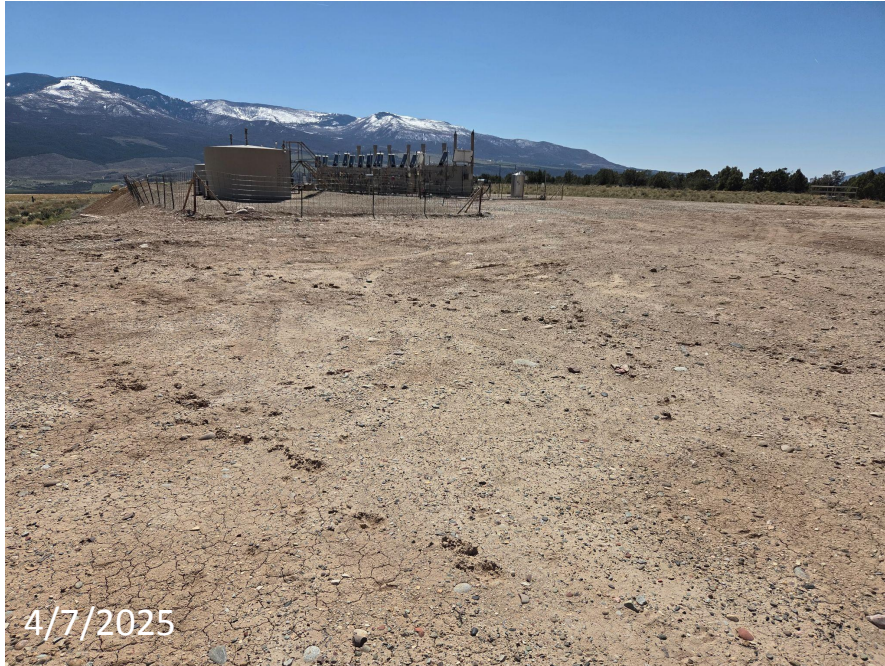
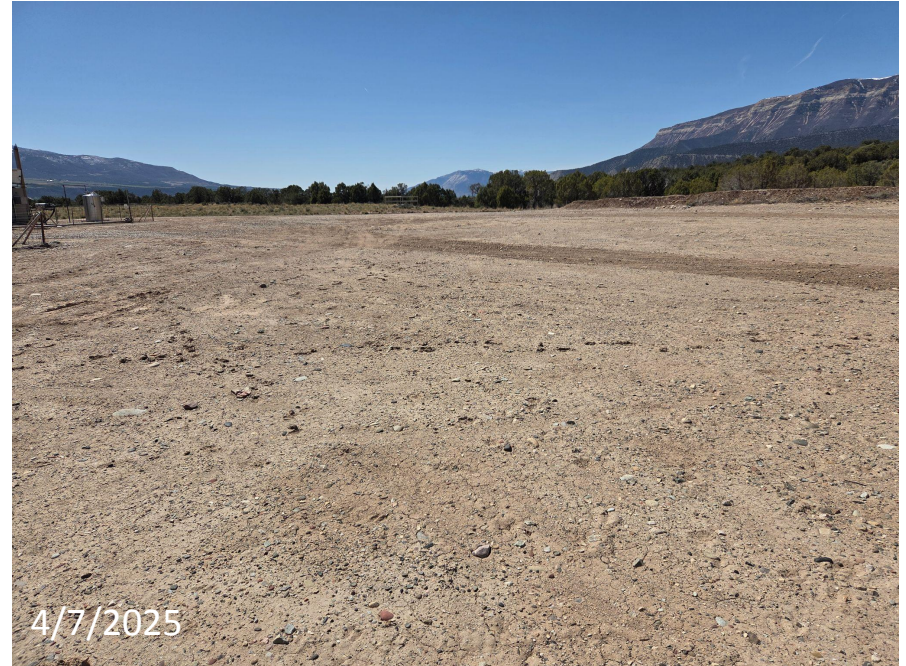
Photo 1: Photos taken from the eastern working pad surface. Photo provides an overview of the pad from south, southwest, northwest to north.

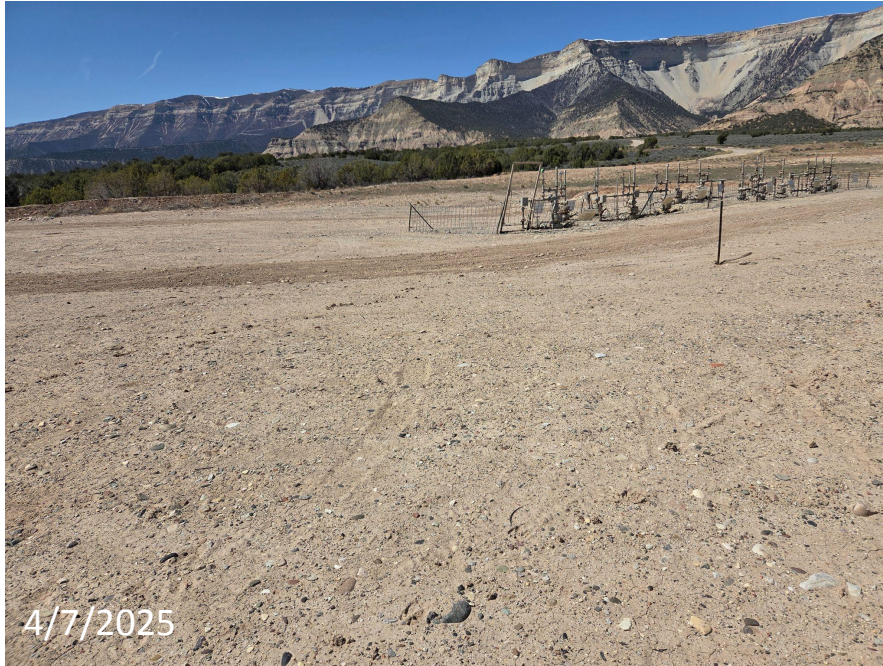
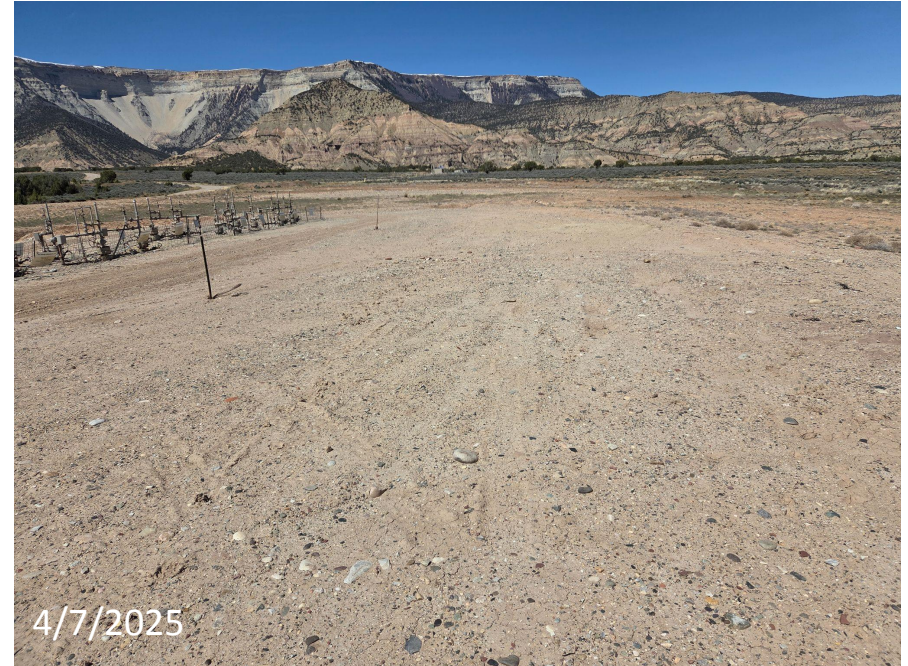
Photo 2: See comments under photo 1.

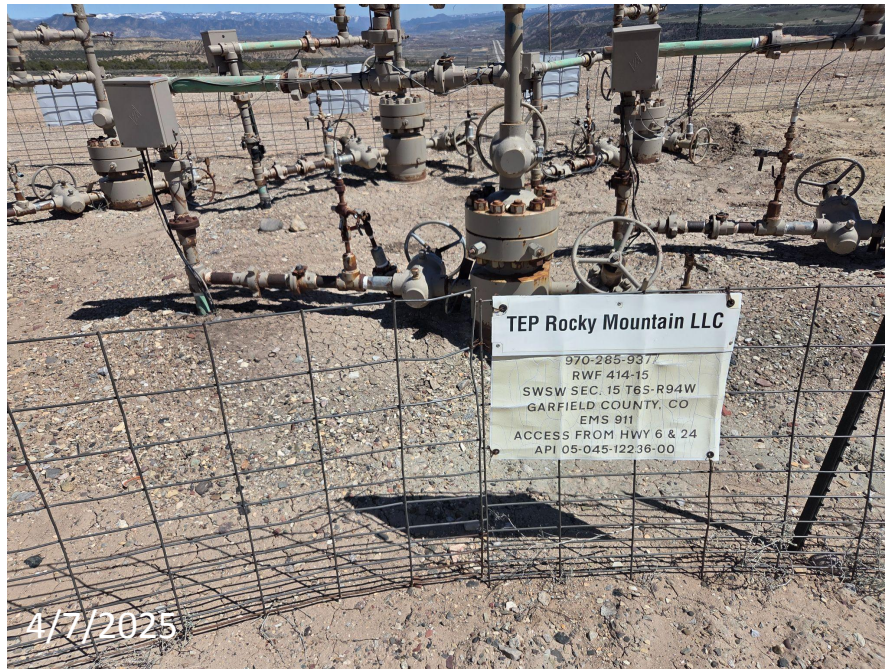
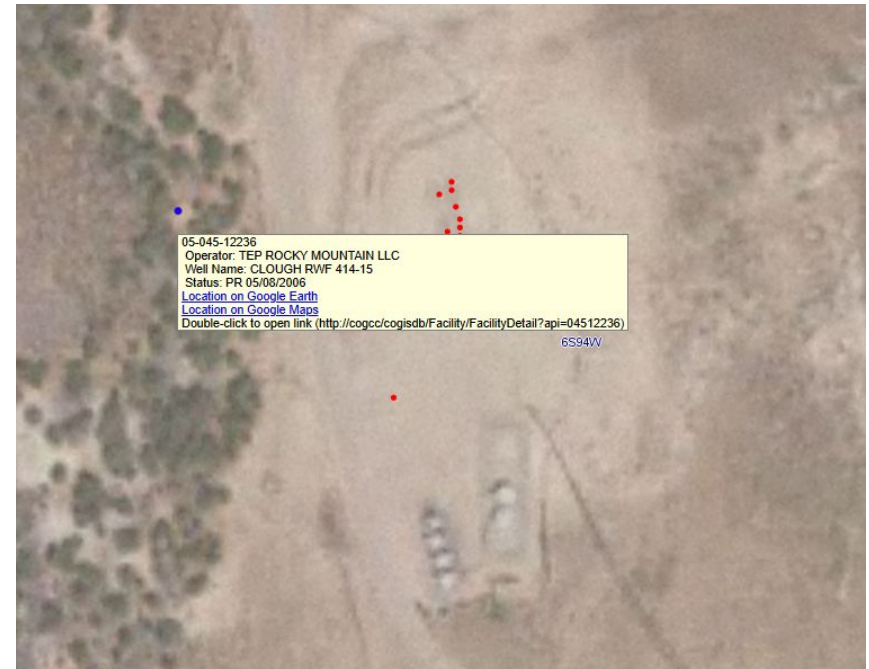
Photo 4: Photo left shows the RWF 414-15 Well (API 05-045-12236). Scout Card “as drilled” records show well is located west of the Location (photo right). Corrected “as drilled” coordinate records require updating.

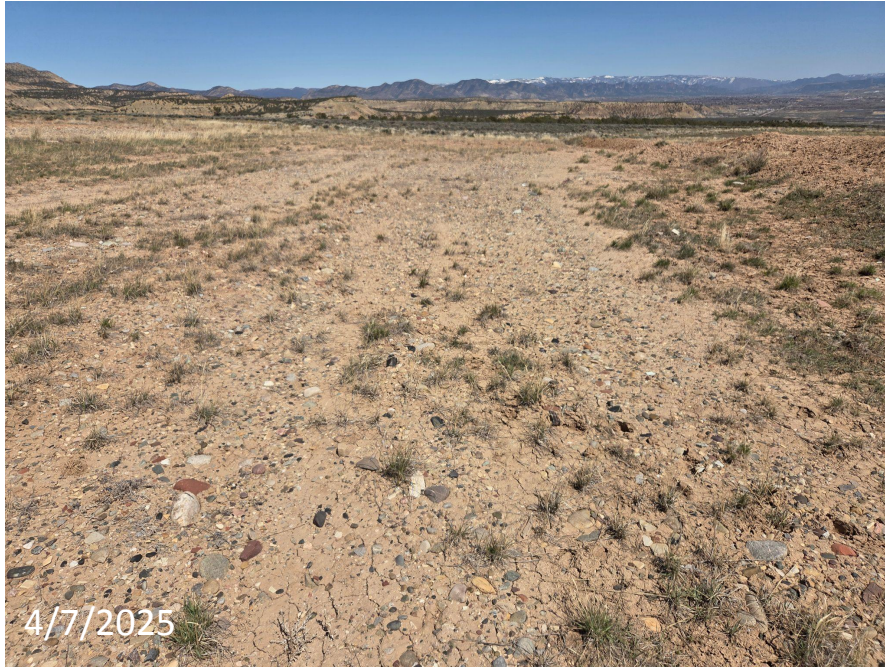
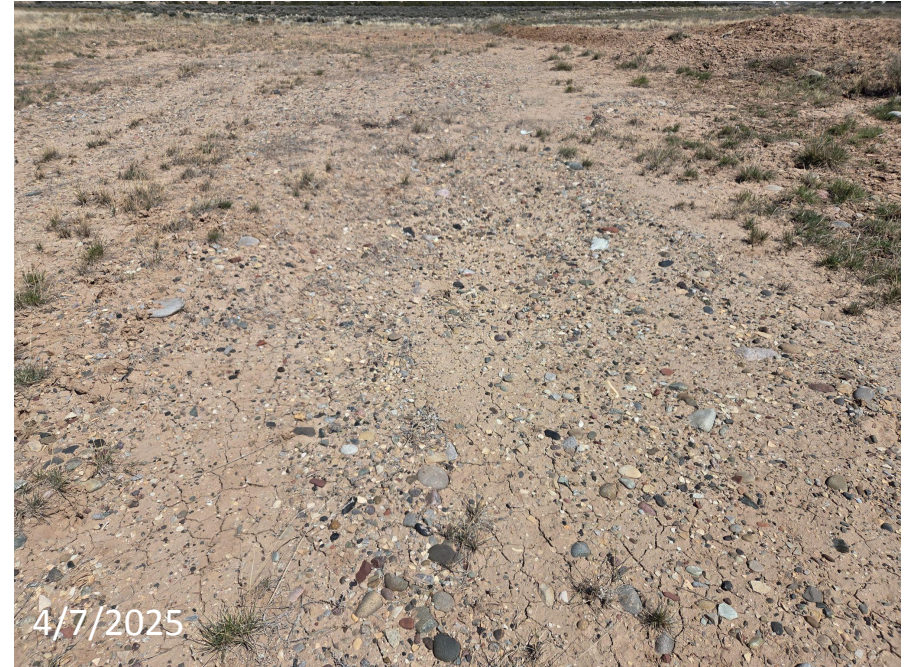
Photo 4: Photos taken from the northern interim areas of the Location. Desirable perennial vegetative establishment is sparse and not progressing towards 1003 uniform requirements. Gravel/road base material remains evident and has not been removed from areas within the north end of the Location, and topsoil does not appear to have been replaced over these areas; material requires removal and topsoil replaced.

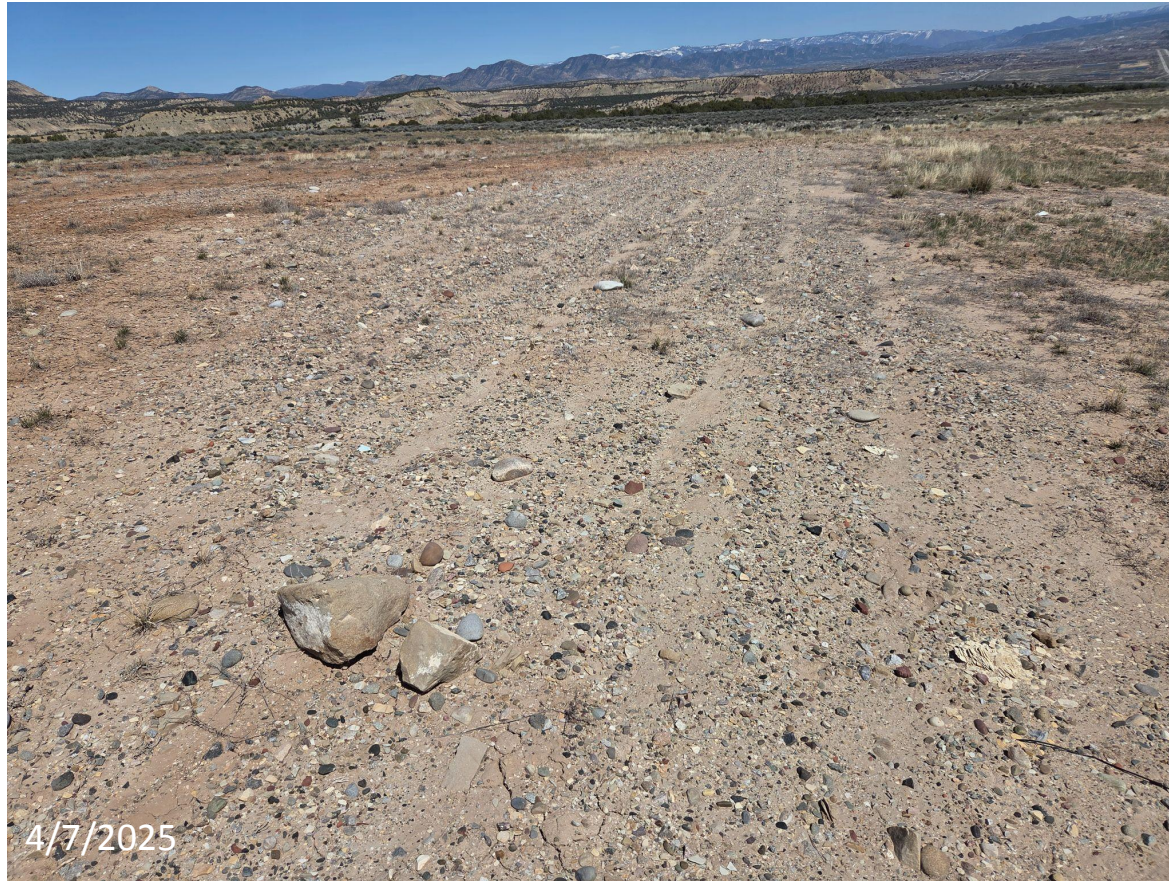
Photo 5: See comments under photo 4.

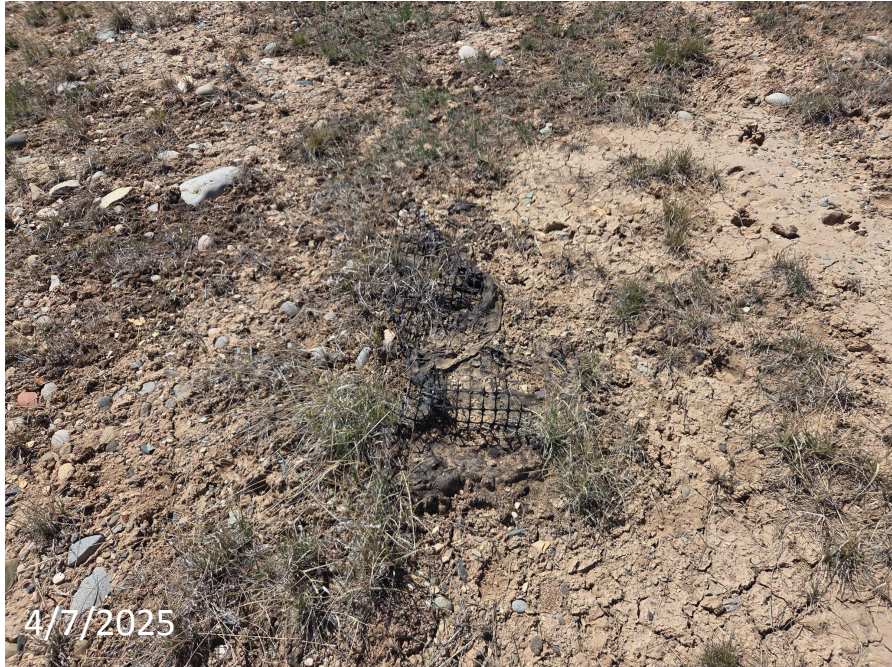
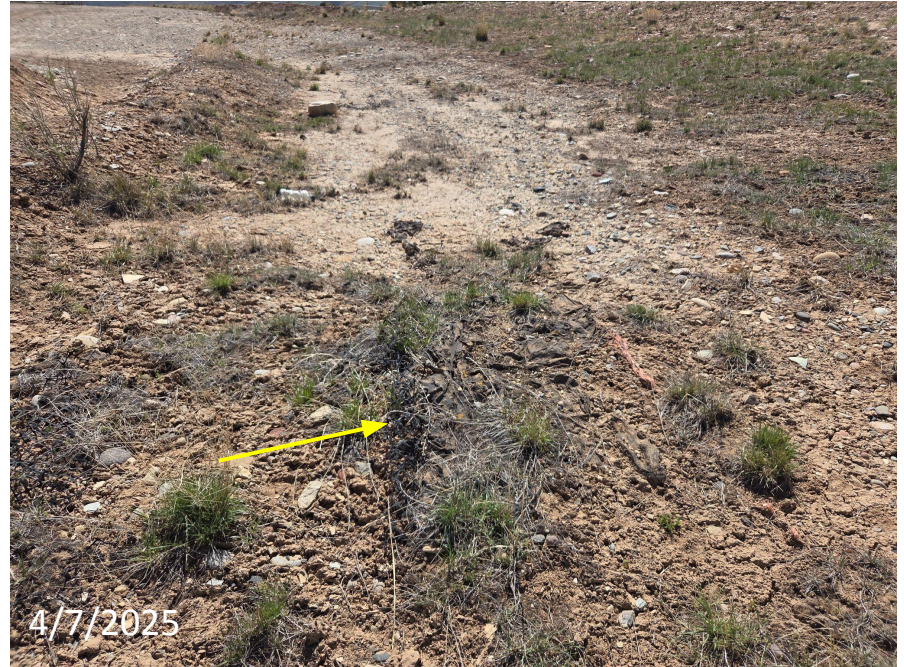
Photo 6: Photos 6-7 taken from the interim areas. Photos examples of trash/debris observed throughout these areas; including old liner material, plastic netting, etc...

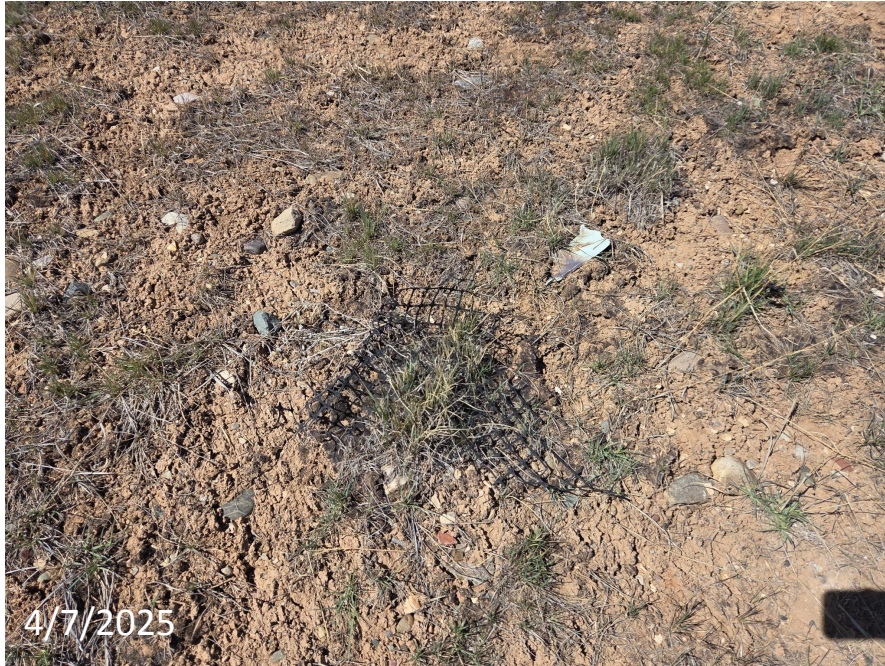
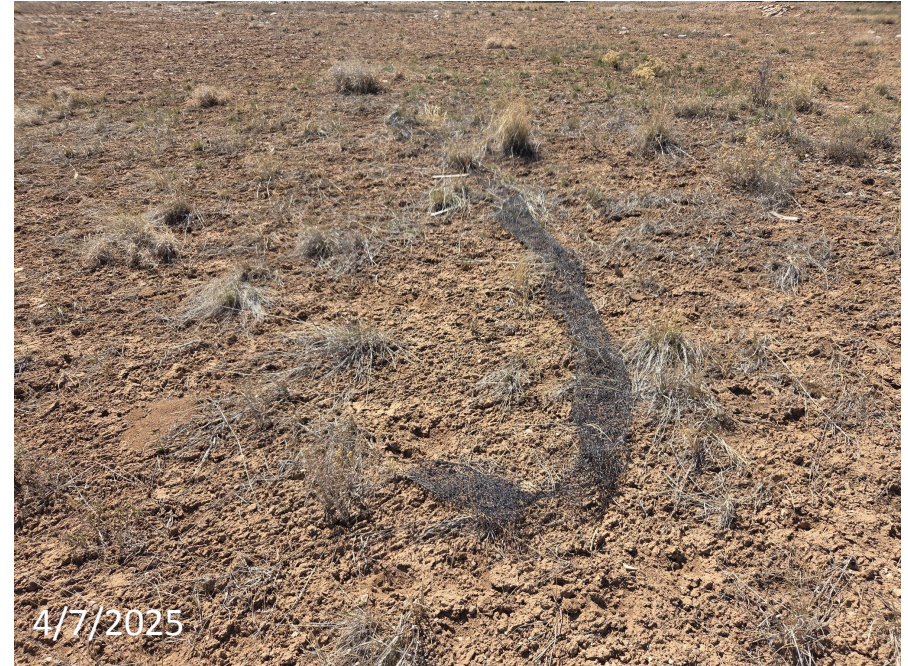
Photo 7: See comments under photo 6.

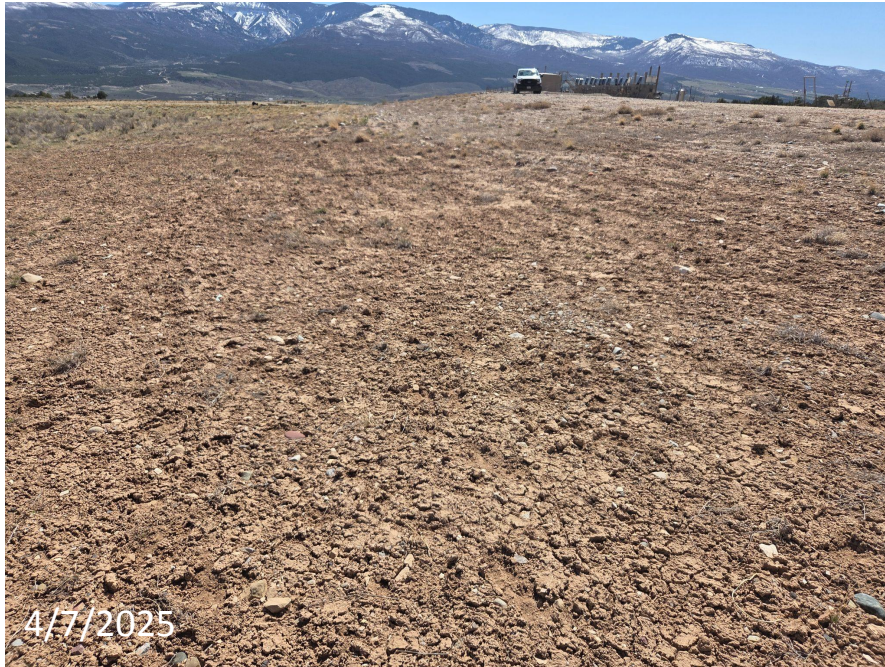
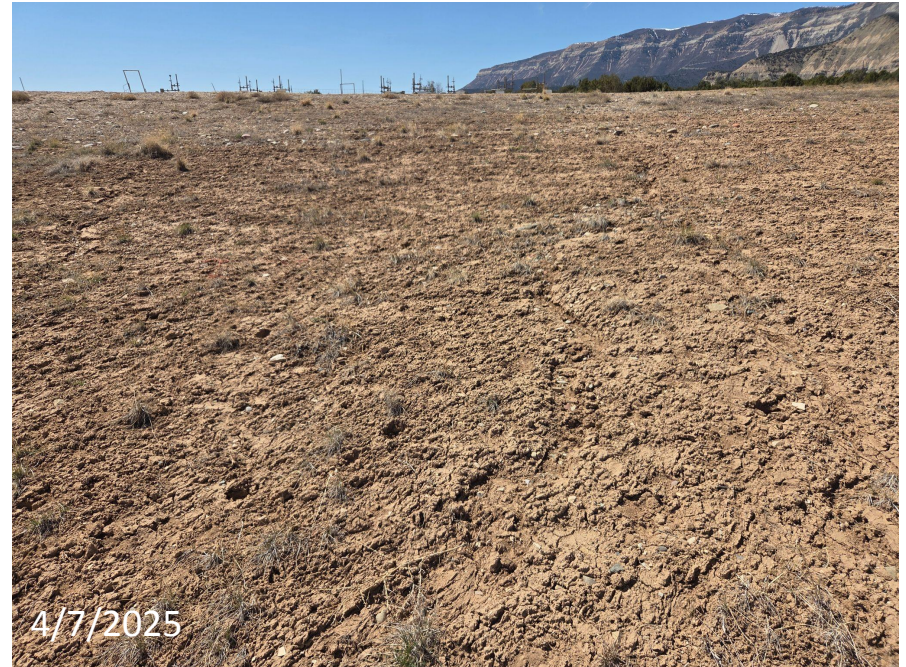
Photo 8: Photos taken from the northeastern interim areas of the Location facing south and west. Desirable perennial vegetative establishment is sparse and not progressing towards 1003 uniform requirements.

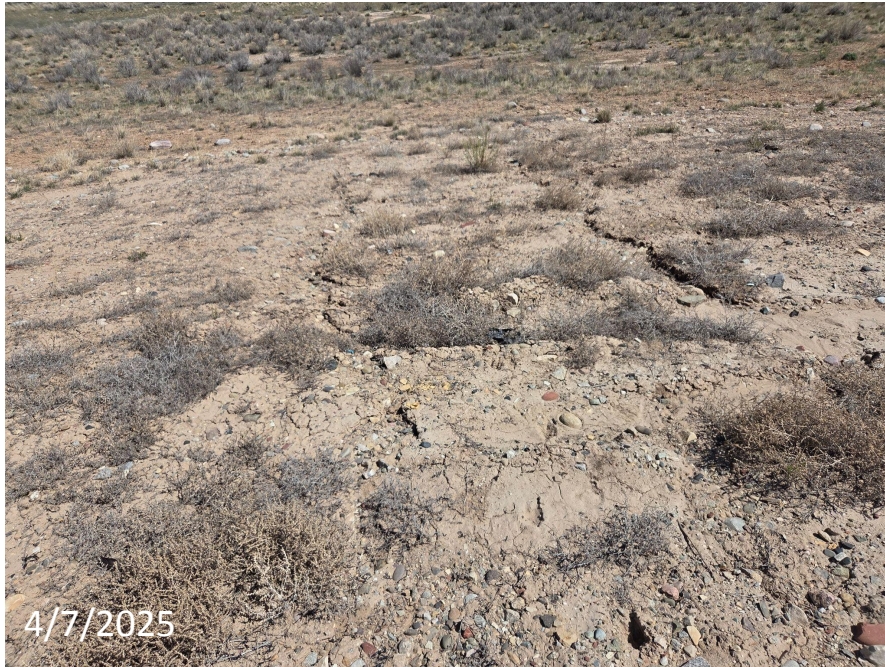
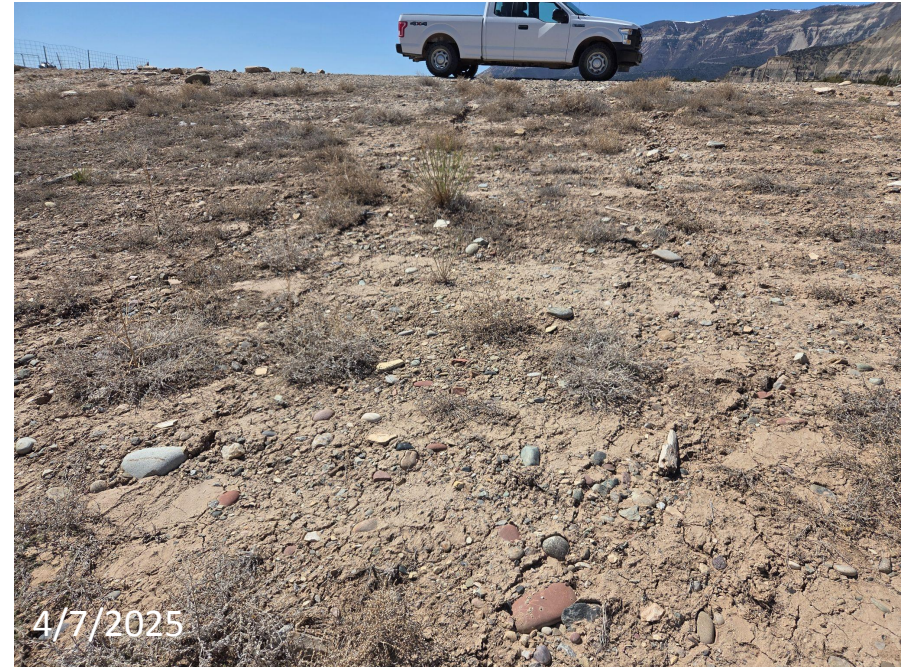
Photo 2: Photos taken from the northeastern interim areas of the Location facing east and west. Desirable perennial vegetative establishment is sparse and not progressing towards 1003 uniform requirements. Photos also show stormwater BMPs to properly manage runoff from the eastern working pad surface are missing or insufficient; runoff has resulted in erosion and degradation to the slopes and interim areas.

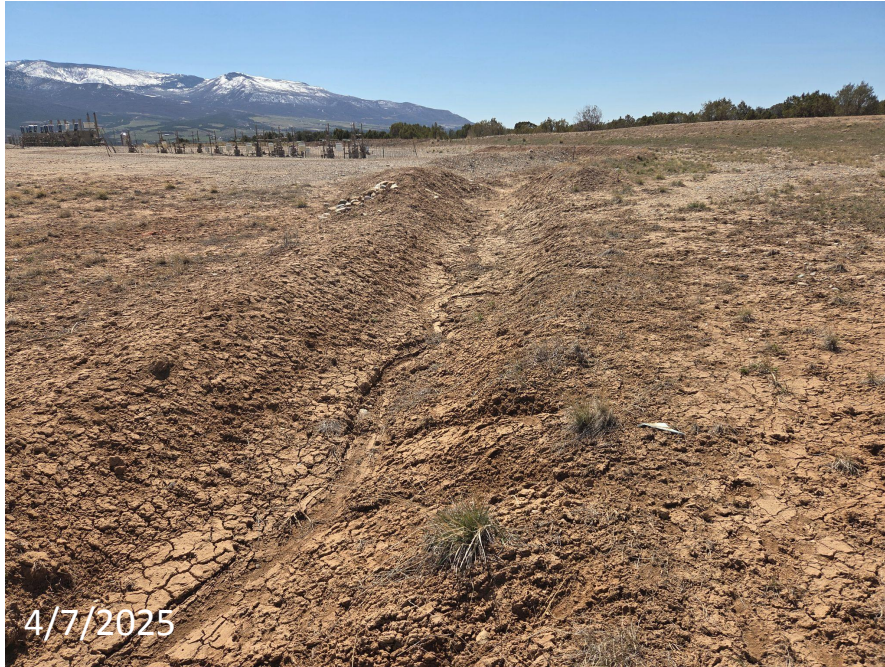
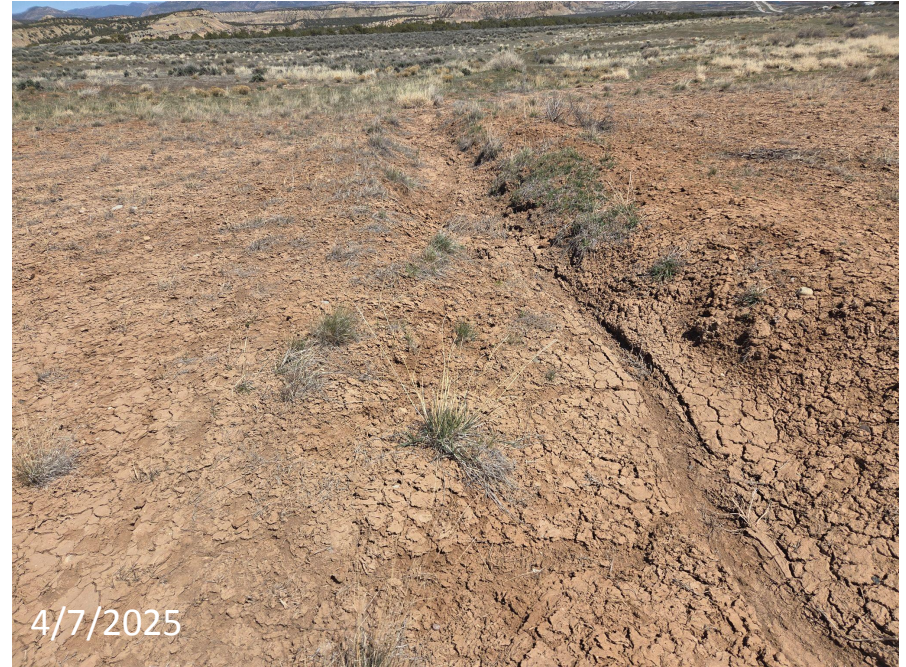
Photo 10: Photos taken from the stormwater diversion ditch on the northeast end of the Location. BMPs to interrupt runoff velocity within the stormwater diversion ditch not observed; degradation (incising) within the ditch is evident. Additionally, runoff from the diversion ditch has resulted in degradation and sediment deposition within the interim areas; the ditch has not been constructed with a properly engineered outlet that allows for sediment-laden free stormwater discharge.

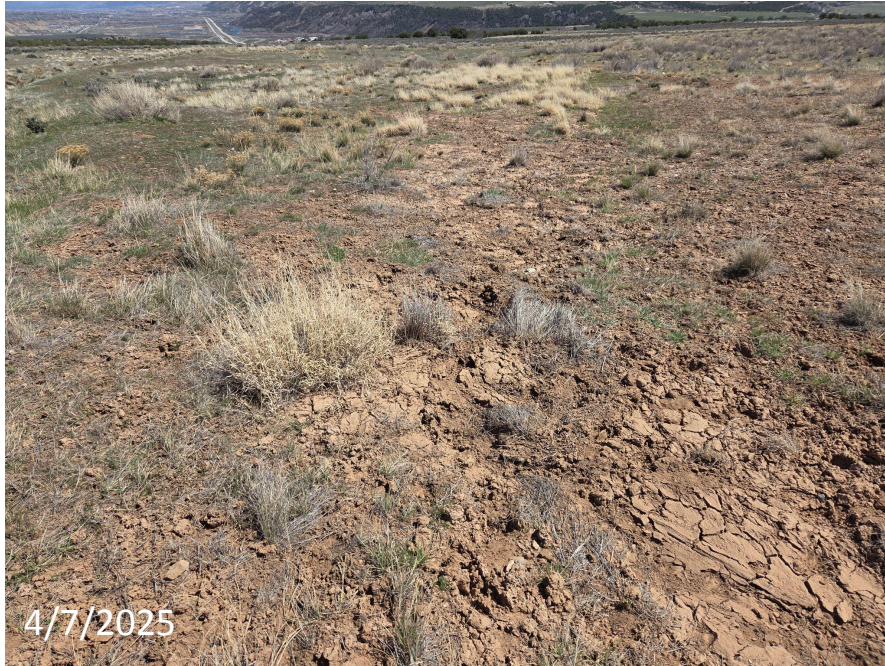
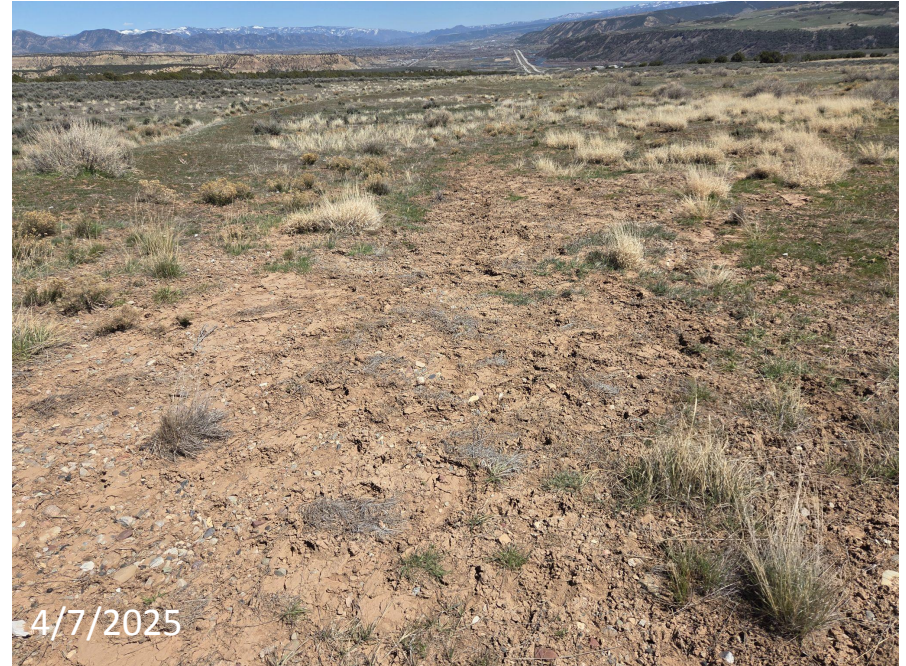
Photo 11: Continued from photo 10. Runoff from the diversion ditch has resulted in degradation and sediment deposition within the interim areas; the ditch has not been constructed with a properly engineered outlet that allows for sediment-laden free stormwater discharge.
