Interim Reclamation and Stormwater Inspection

Operator: TIMKA RESOURCES LTD - 88370

Location ID: 317129

Inspection Photos
Location Name: Theurer Farms 22-28
Location ID: 317129

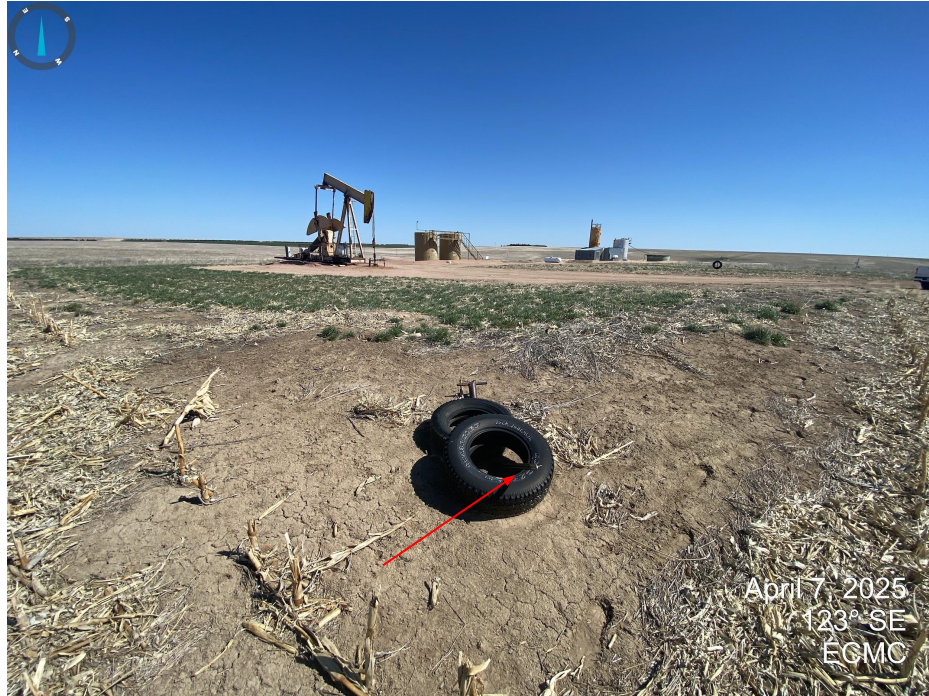
Photos 1 & 2. Northwest guyline anchor (Photo 1; left) requires reinstallation. Wildlife netting at secondary containment (Photo 2; right) near well location requires maintenance.

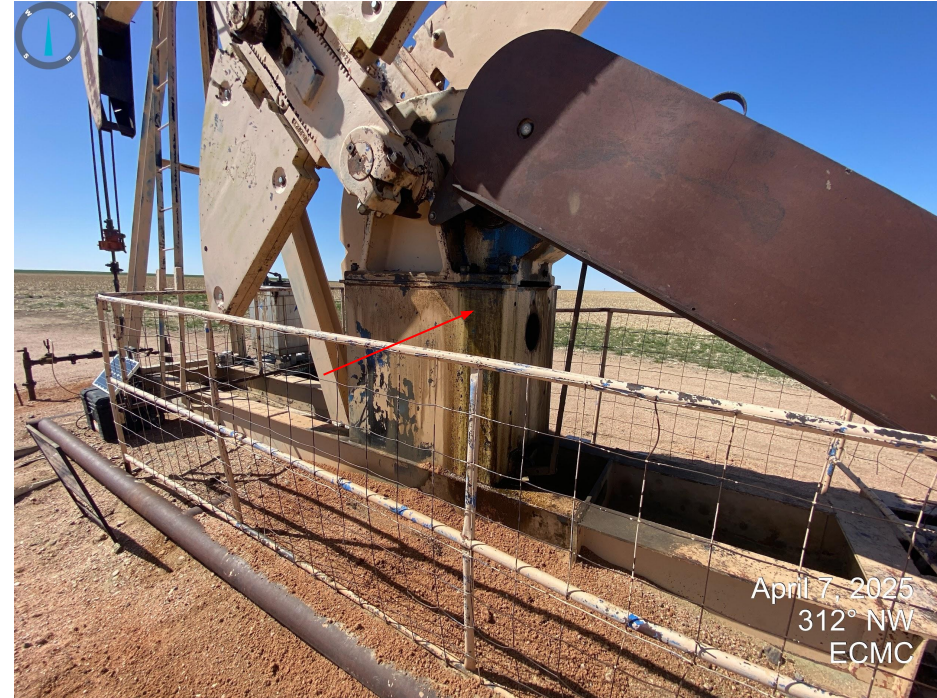
Photos 3 & 4. Visible leaks observed at the wellhead and pump jack unit.

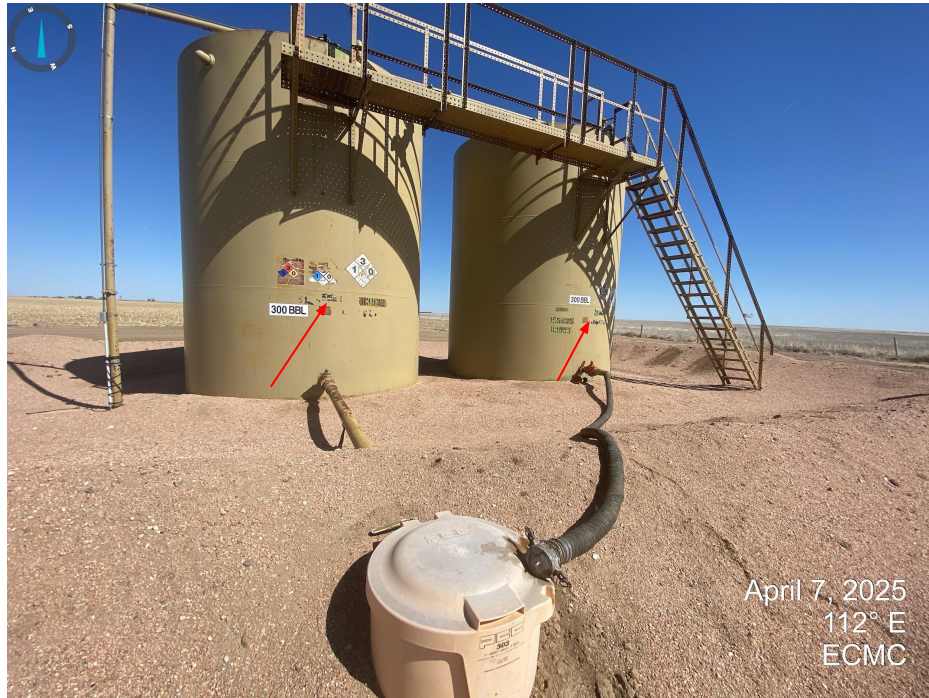
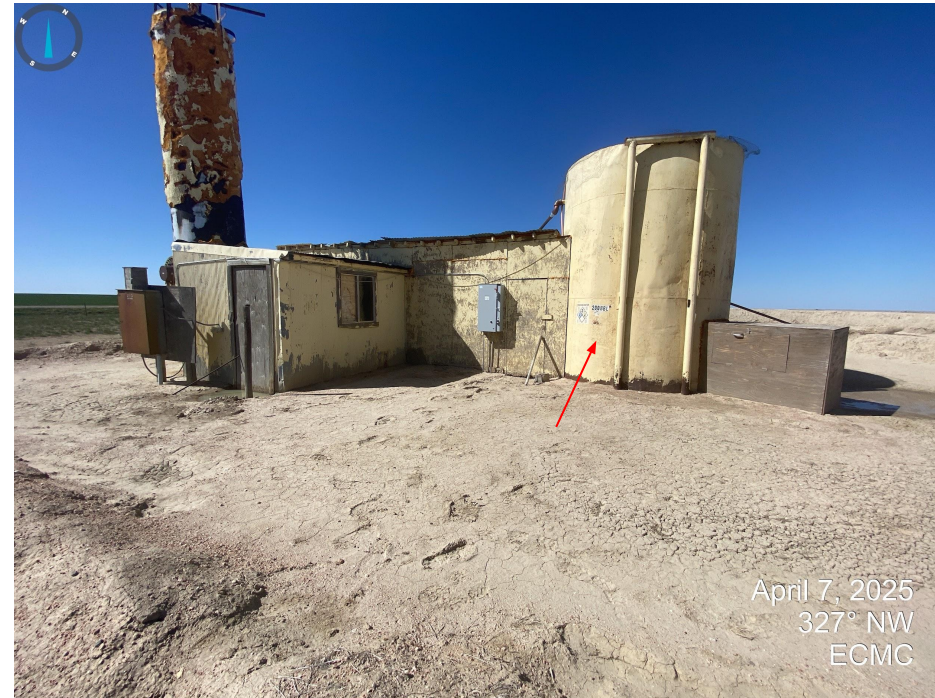
Photos 5 & 6. Tank labels/NFPA placards are not legible (e.g. peeling, faded, cracked, etc) and require replacement.

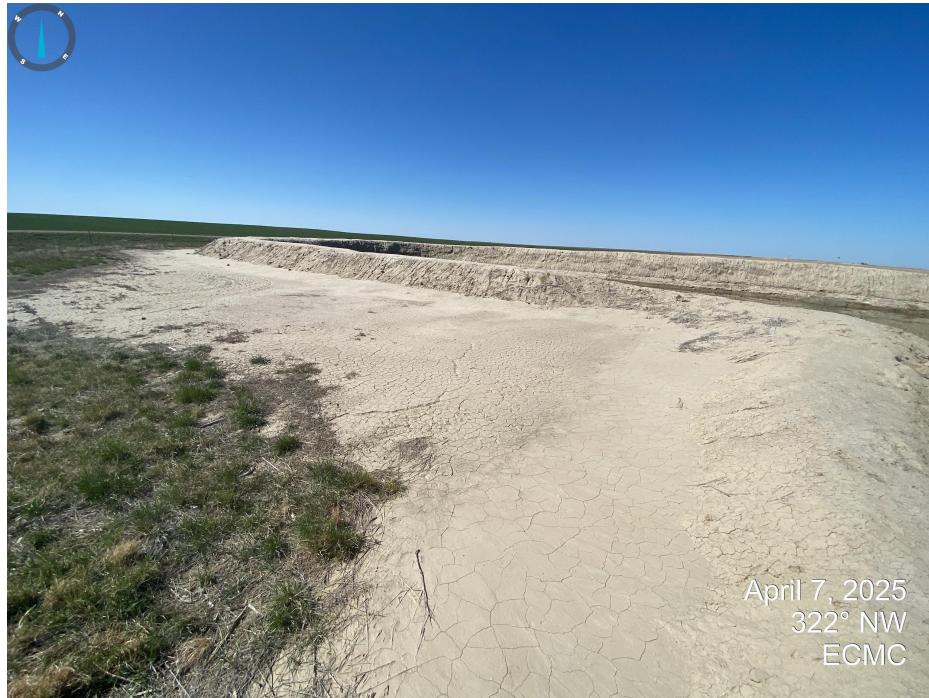
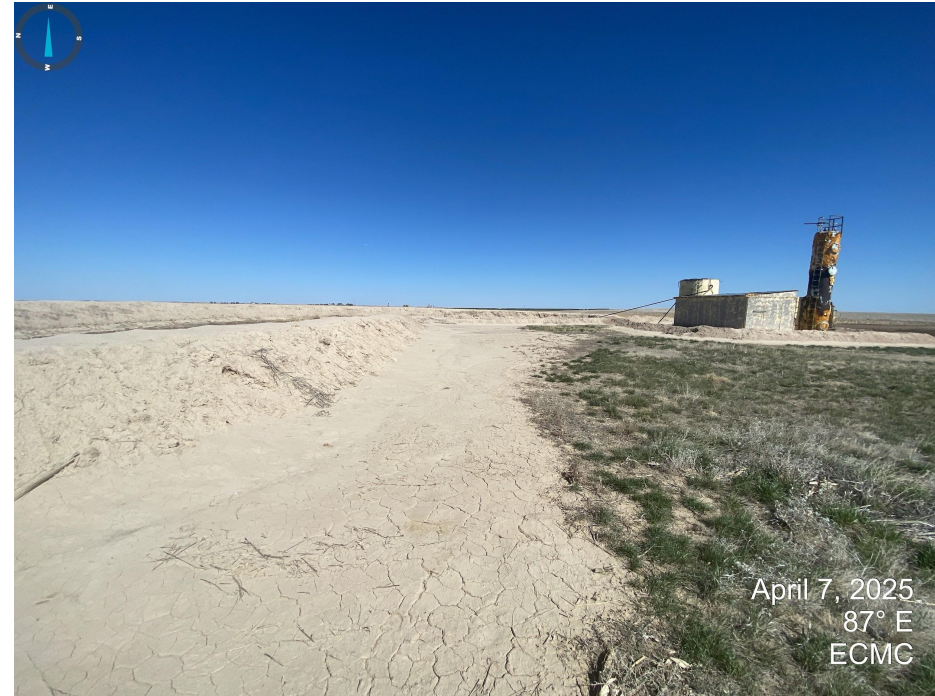
Photos 7 & 8. Southwest portion of pit. Pit berms do not appear to be properly stabilized with evidence of erosion degradation and sediment transport occurring. Additional stormwater control measures are required.

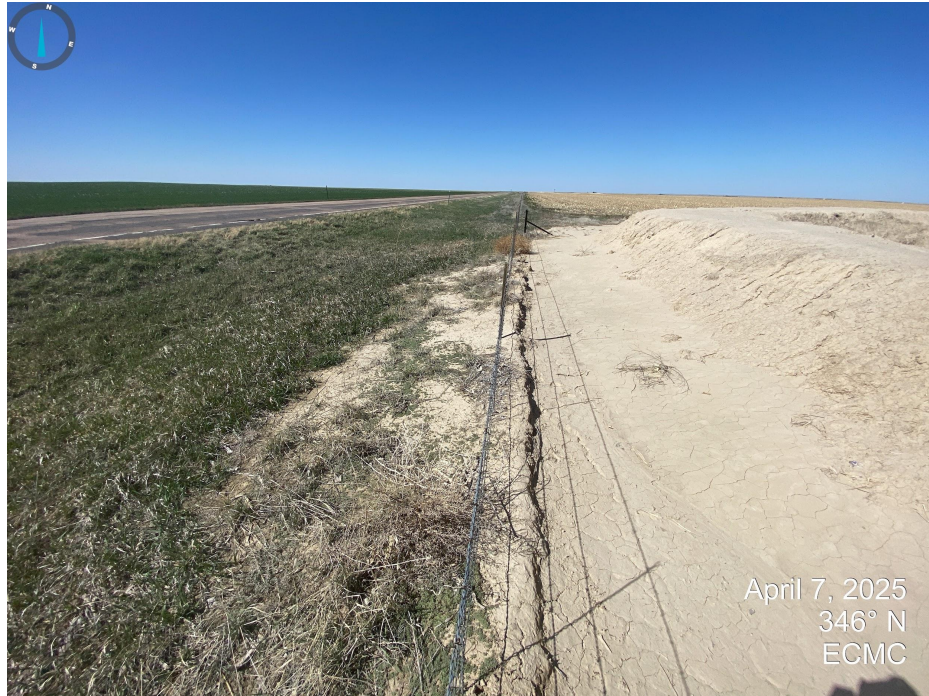
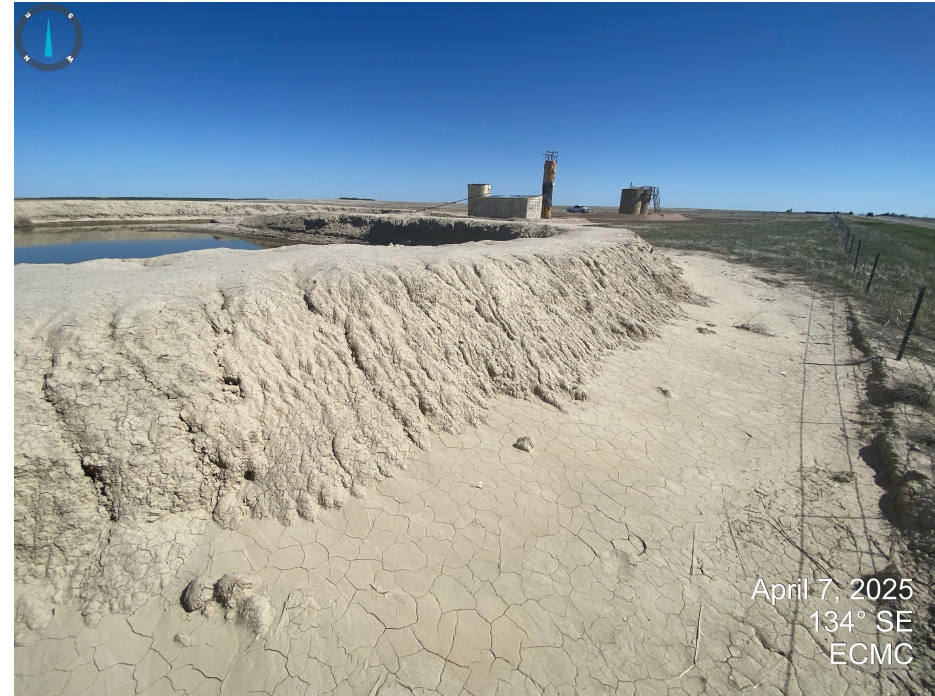
Photos 9 & 10. Western portion of pit. Pit berms do not appear to be properly stabilized with evidence of erosion degradation and sediment transport occurring. Additional stormwater control measures are required.

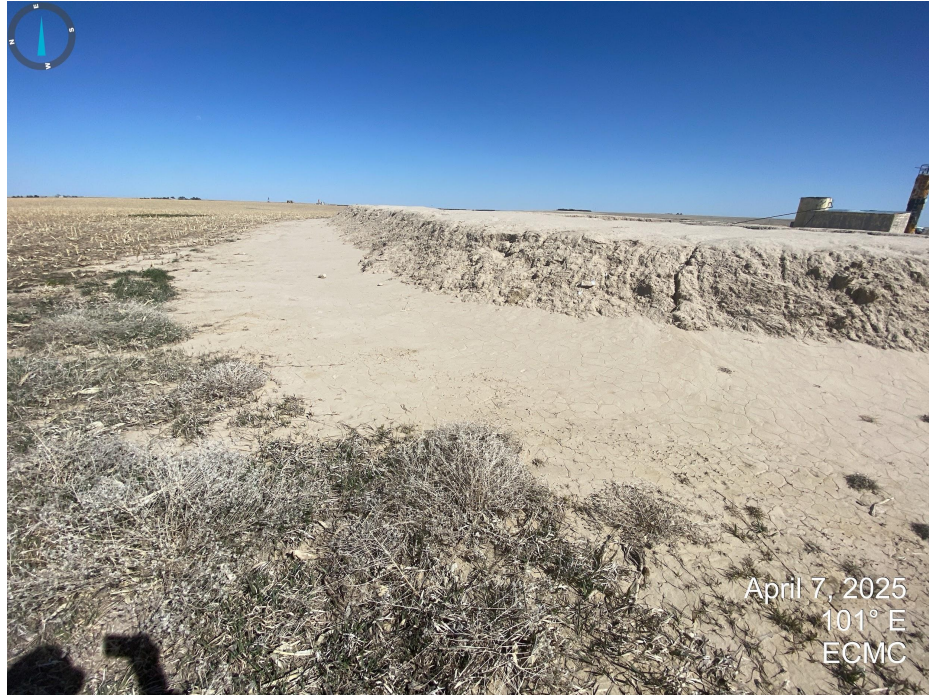
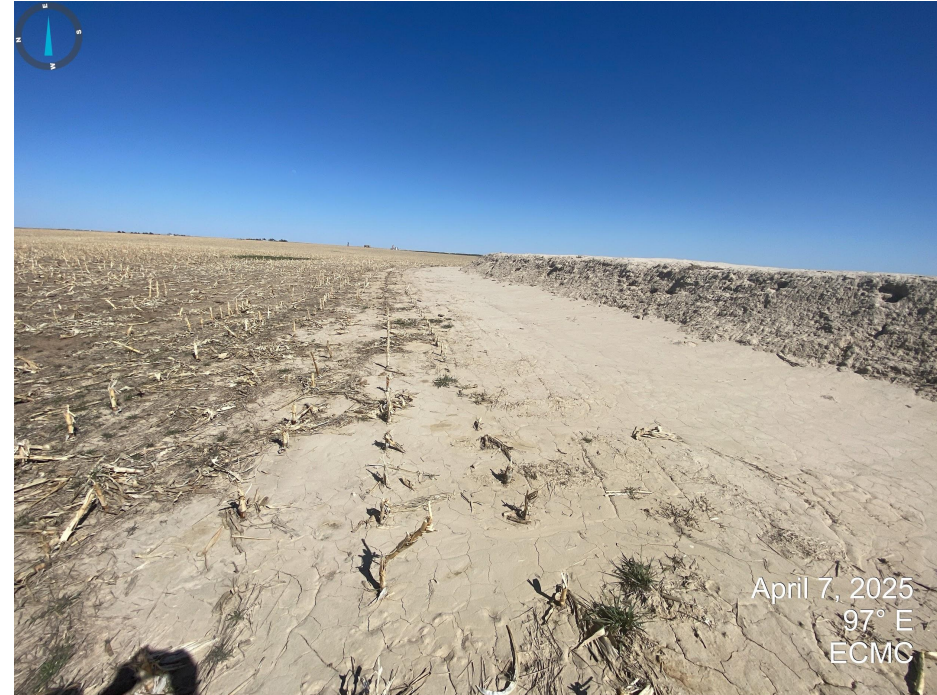
Photos 11 & 12. Northern portion of pit. Pit berms do not appear to be properly stabilized with evidence of erosion degradation and sediment transport occurring. Additional stormwater control measures are required.

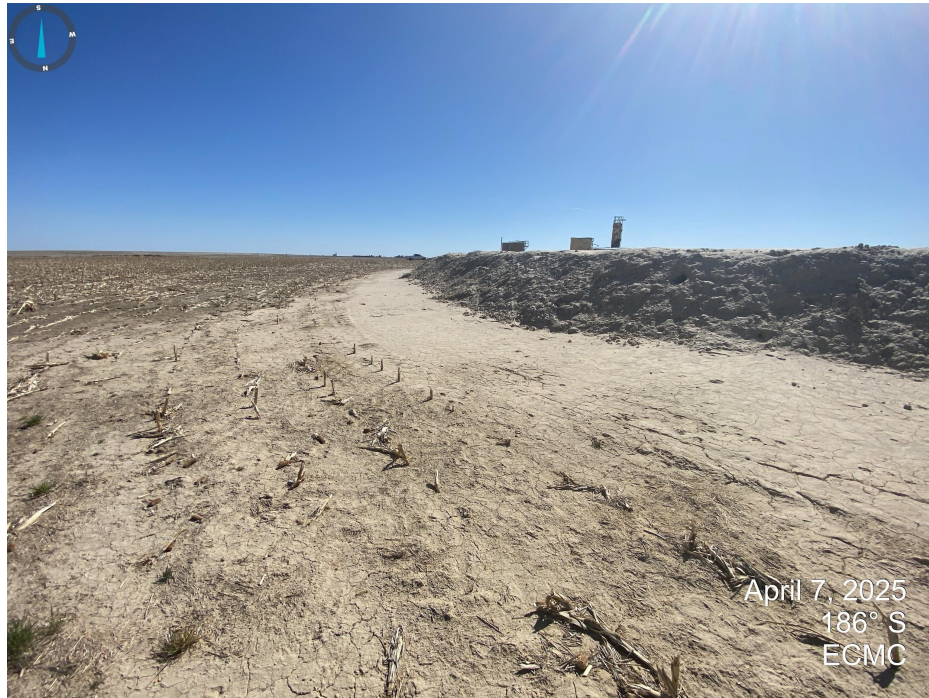
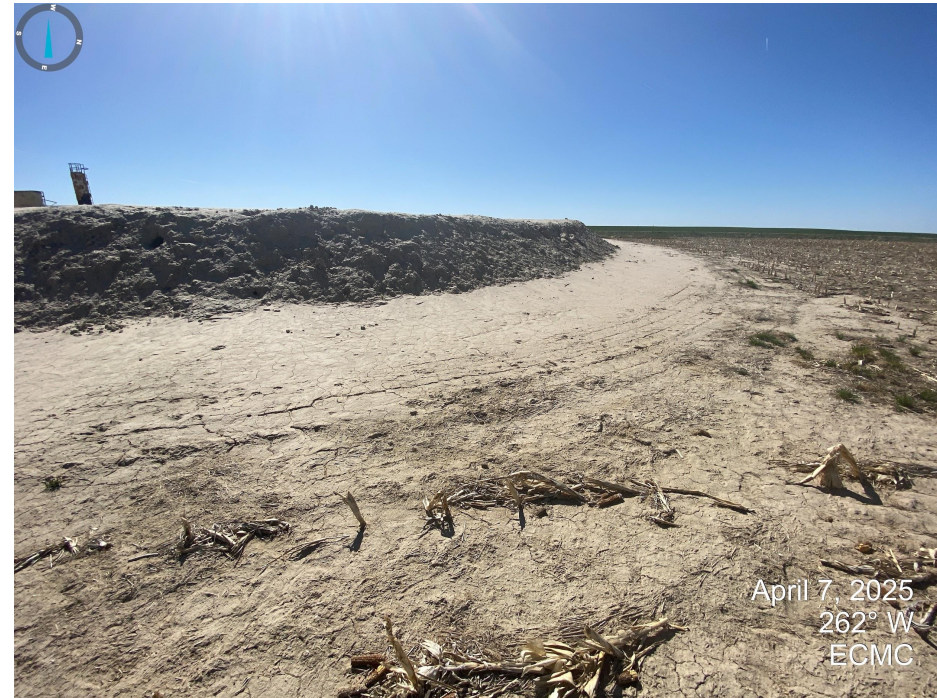
Photos 13 & 14. Northeastern portion of pit. Pit berms do not appear to be properly stabilized with evidence of erosion degradation and sediment transport occurring. Additional stormwater control measures are required.

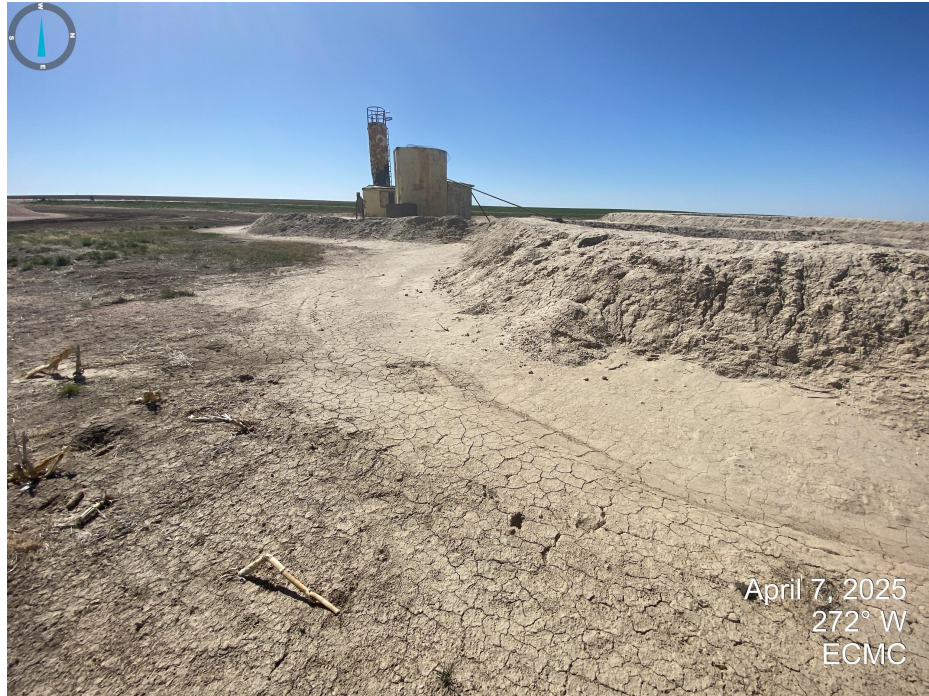
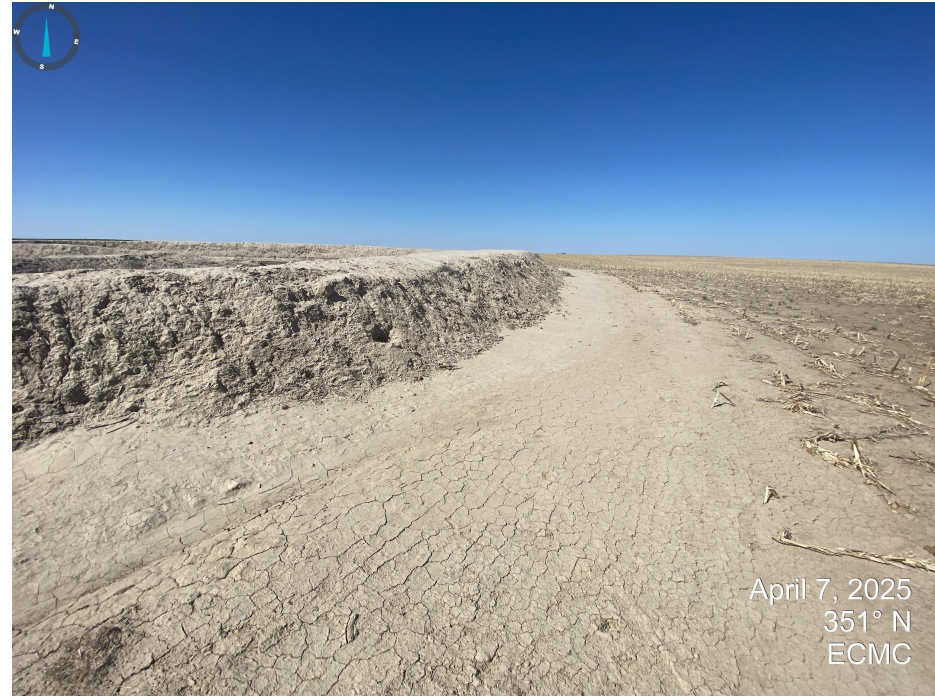
Photos 15 & 16. Southeastern portion of pit. Pit berms do not appear to be properly stabilized with evidence of erosion degradation and sediment transport occurring. Additional stormwater control measures are required.
