Inspection/Audit Photos

Location Name: TEP ROCKY MOUNTAIN LLC NORTH BANK B Pad

Location ID: 311621

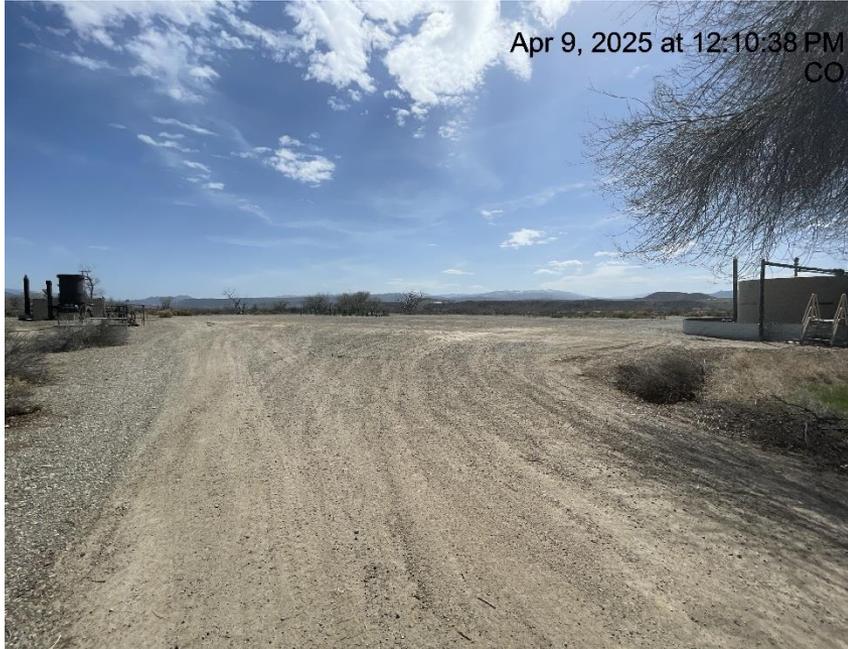
Photo # 9514 From entrance to location

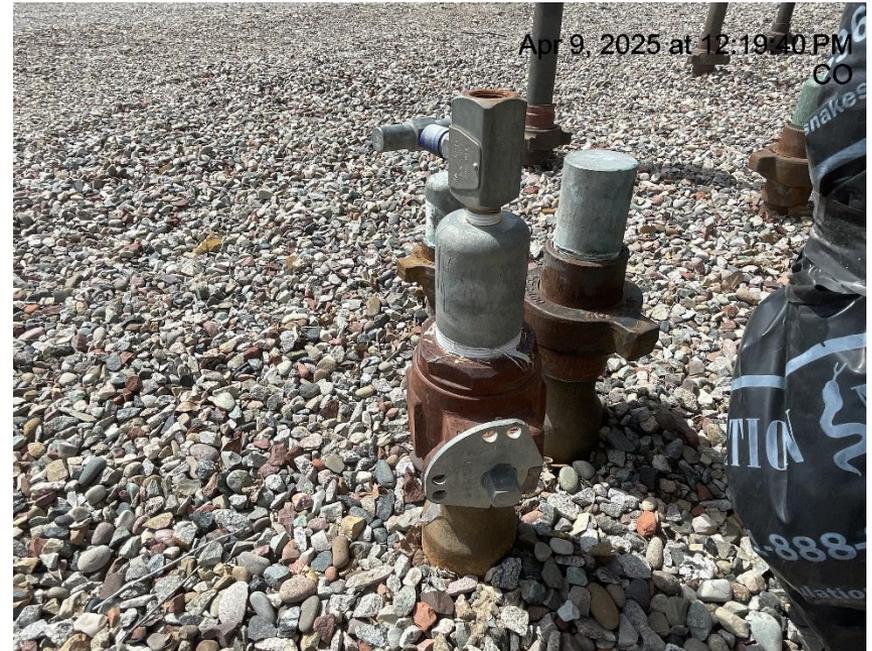
Photo # 9519 Unused flowlines at separators lack lockout tagout (OOSLAT)

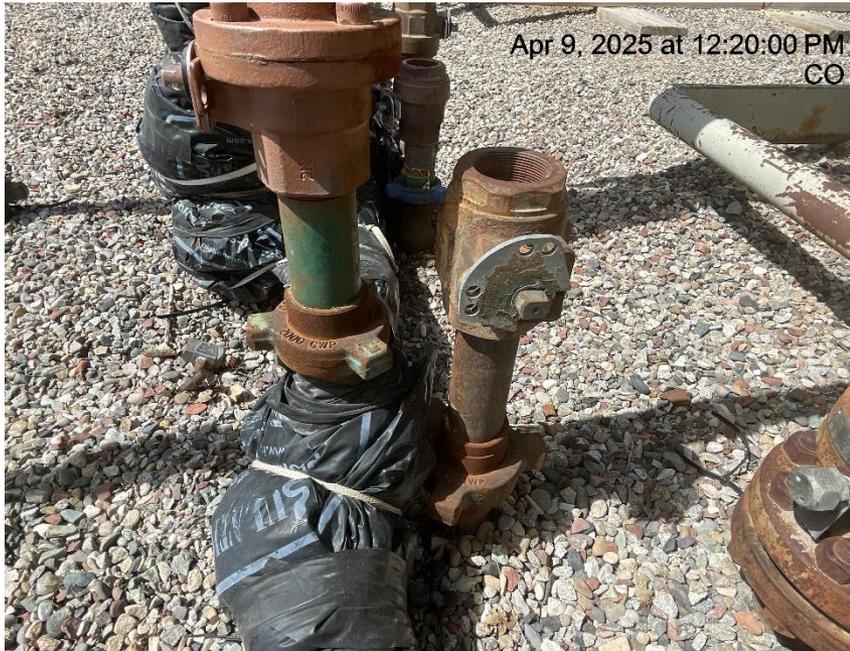
Photo # 9520 Unused flowline at separators lacks lockout tagout (OOSLAT)

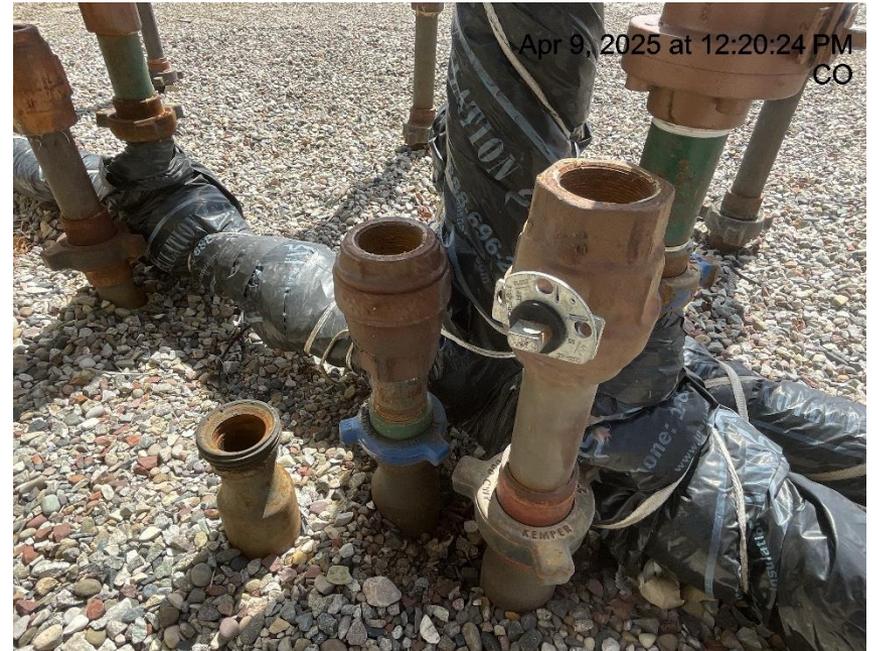
Photo # 9521 Unused flowlines at separators lack lockout tagout (OOSLAT) & additionally open ended line is a wildlife hazard

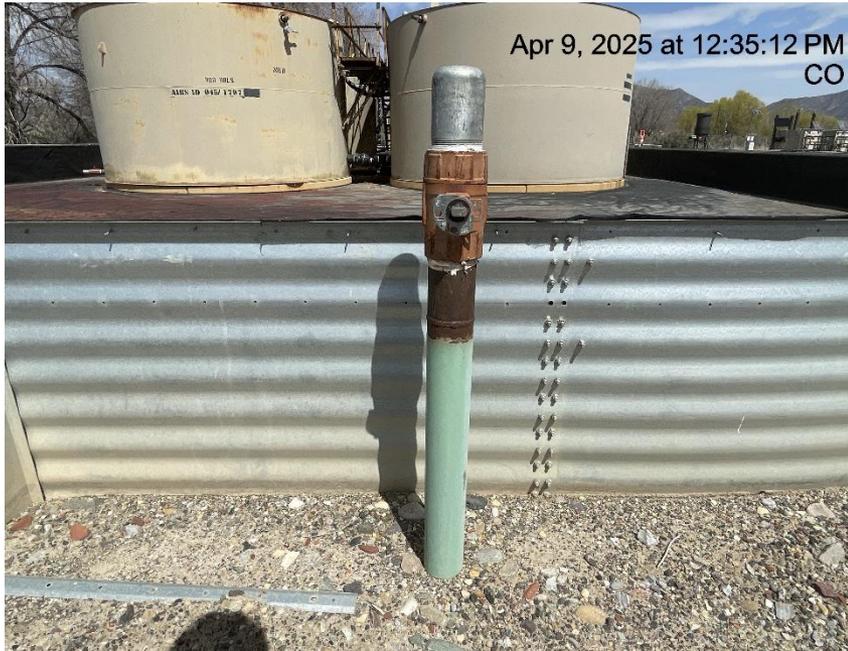
Photo # 9522 Unused flowline at tank battery lacks lockout tagout (OOSLAT)

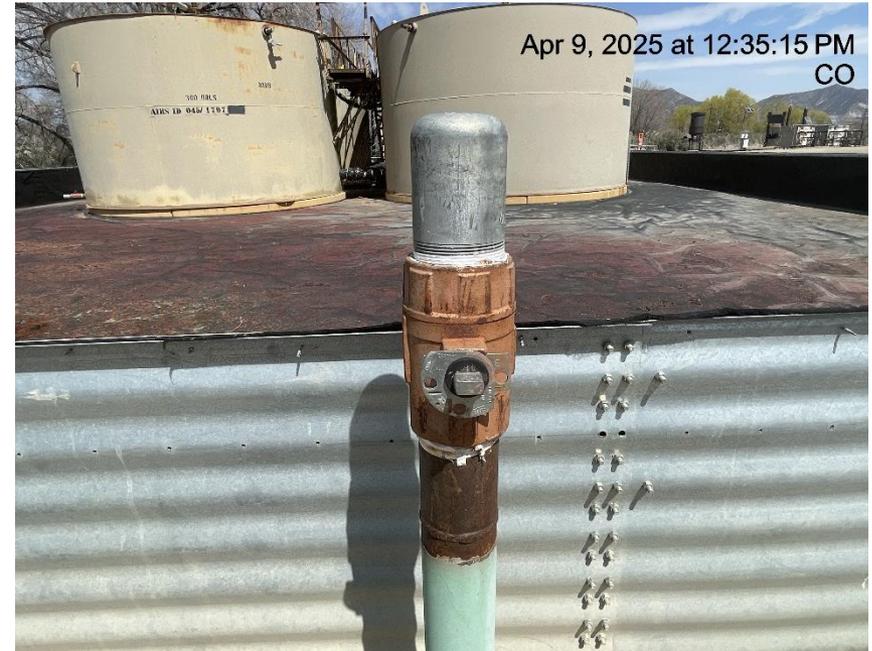
Photo # 9523 Unused flowline at tank battery lacks lockout tagout (OOSLAT)

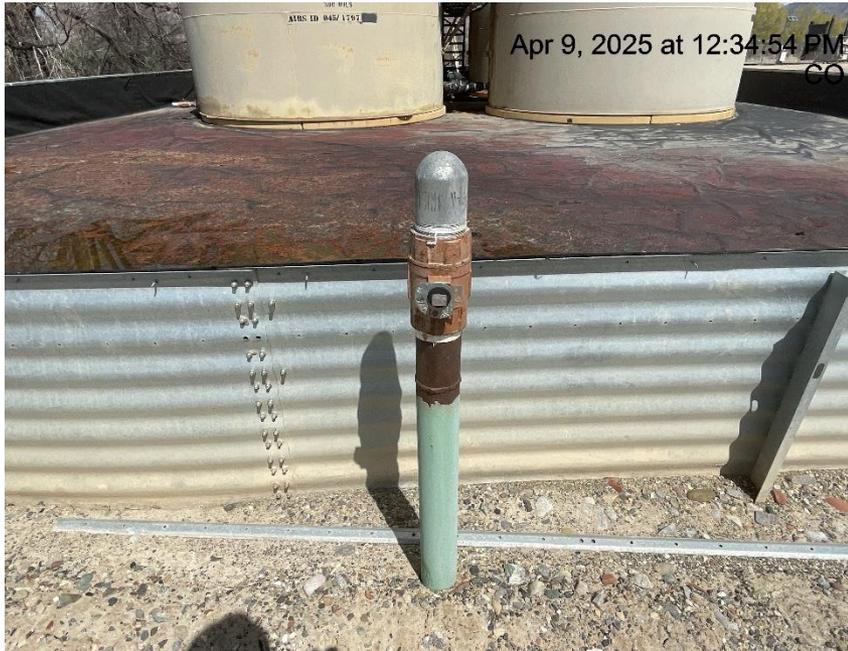
Photo # 9524 Unused flowline at tank battery lacks lockout tagout (OOSLAT)

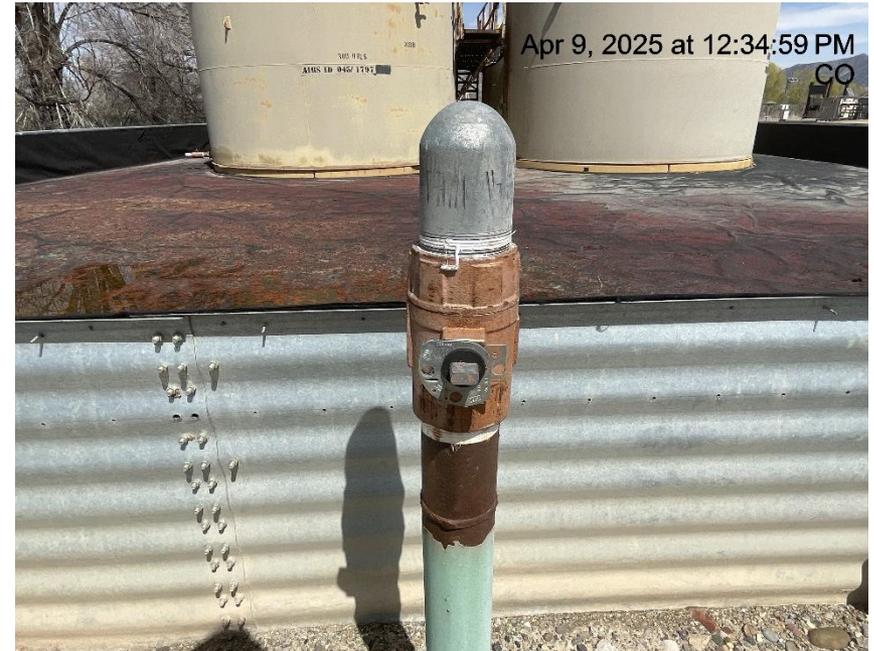
Photo # 9525 Unused flowline at tank battery lacks lockout tagout (OOSLAT)

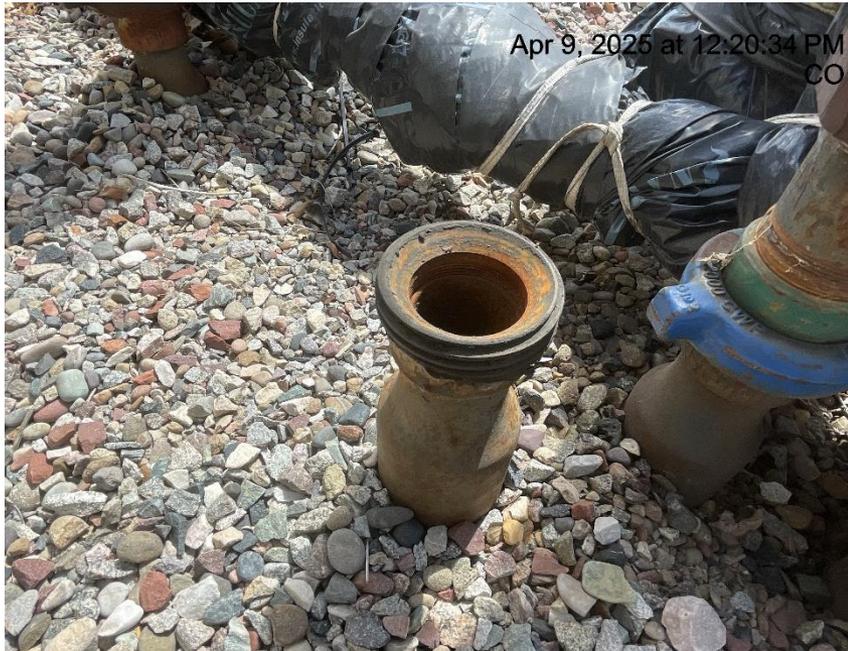
Photo # 9526 Unused flowline at separators lacks lockout tagout (OOSLAT) & additionally open ended line is a wildlife hazard/available for entry by wildlife

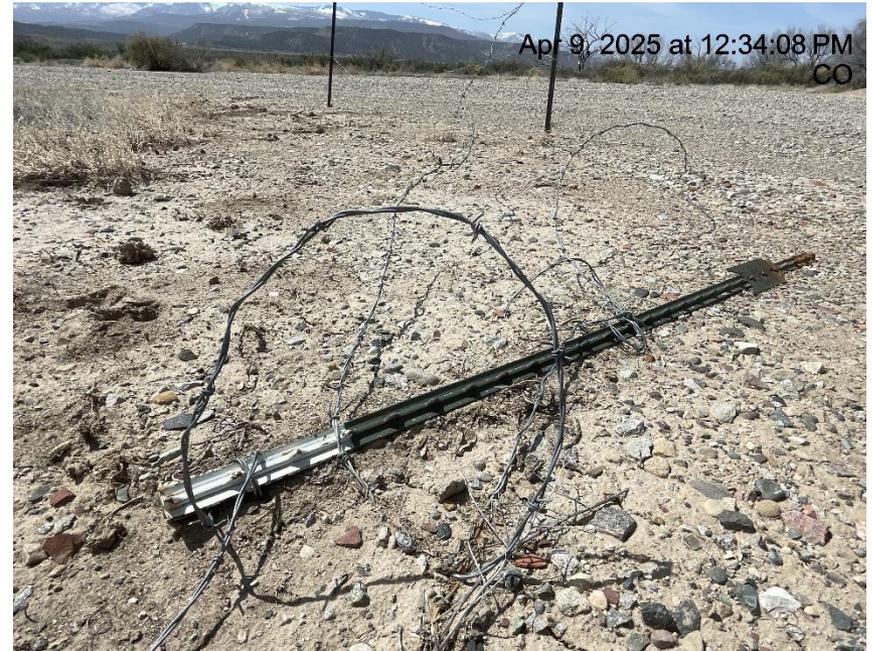
Photo # 9527 Barbed wire fence needs maintenance/wildlife hazard & trip hazard

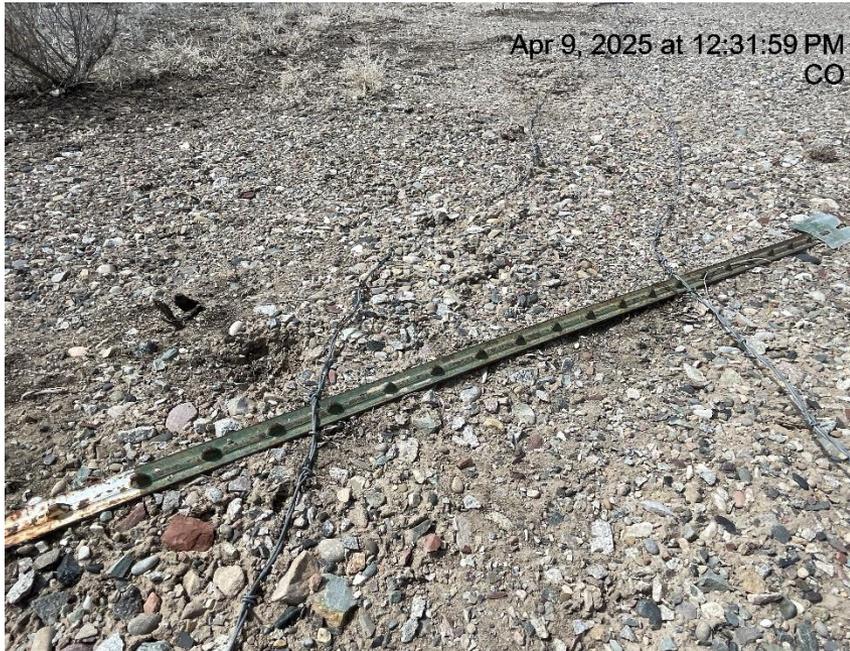
Photo # 9528 Barbed wire fence needs maintenance/wildlife hazard & trip hazard

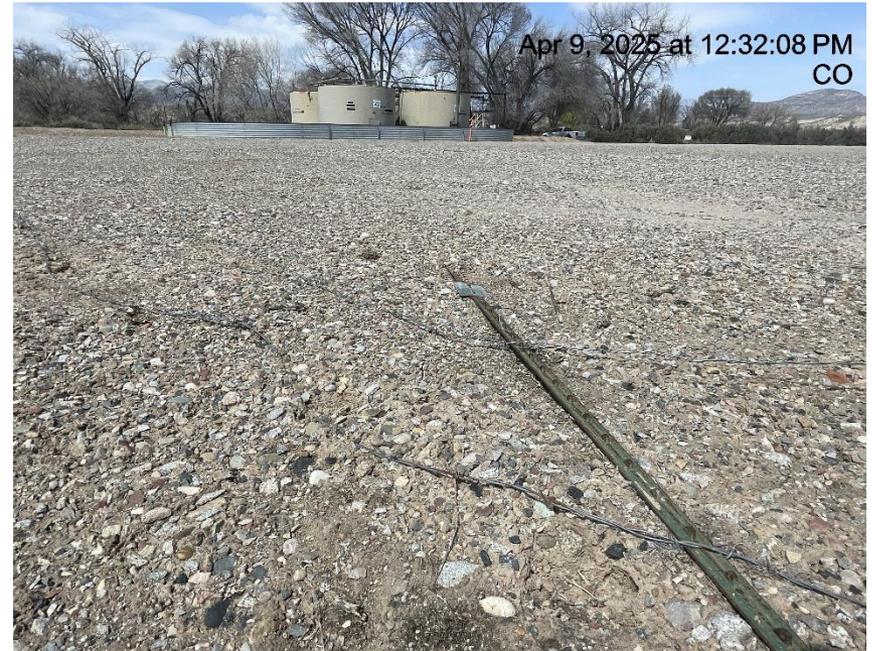
Photo # 9529 Barbed wire fence needs maintenance/wildlife hazard & trip hazard

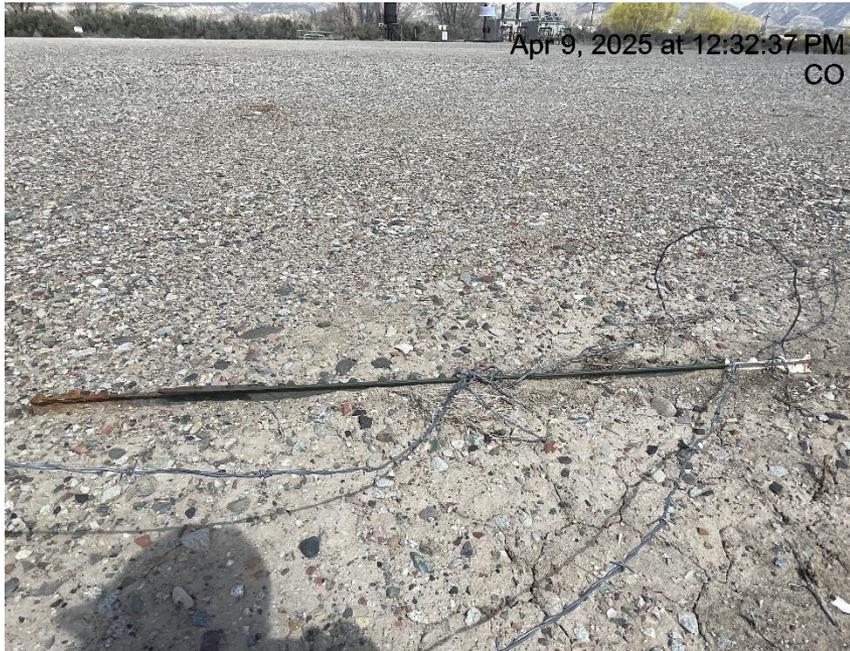
Photo # 9530 Barbed wire fence needs maintenance/wildlife hazard & trip hazard

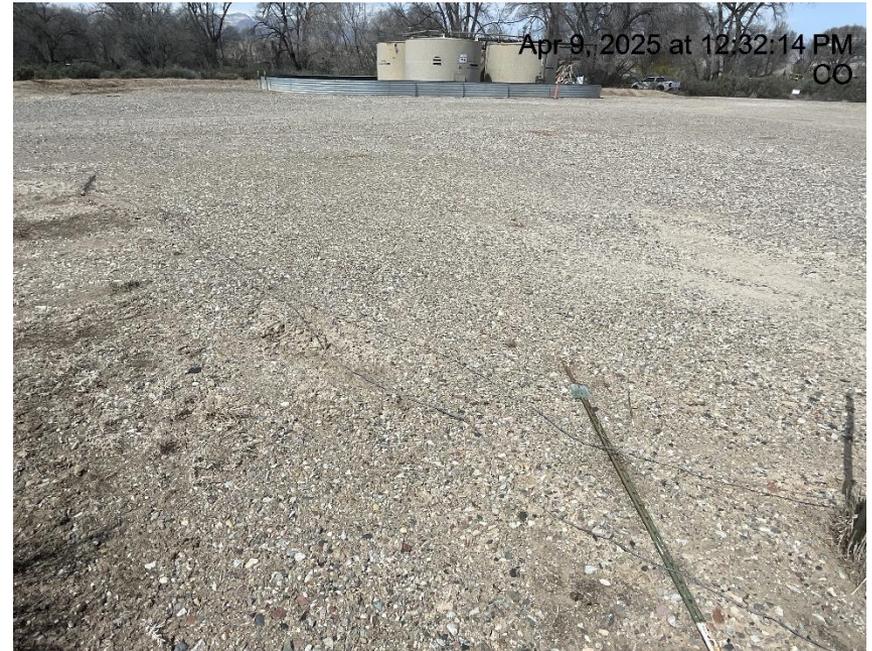
Photo # 9531 Barbed wire fence needs maintenance/wildlife hazard & trip hazard

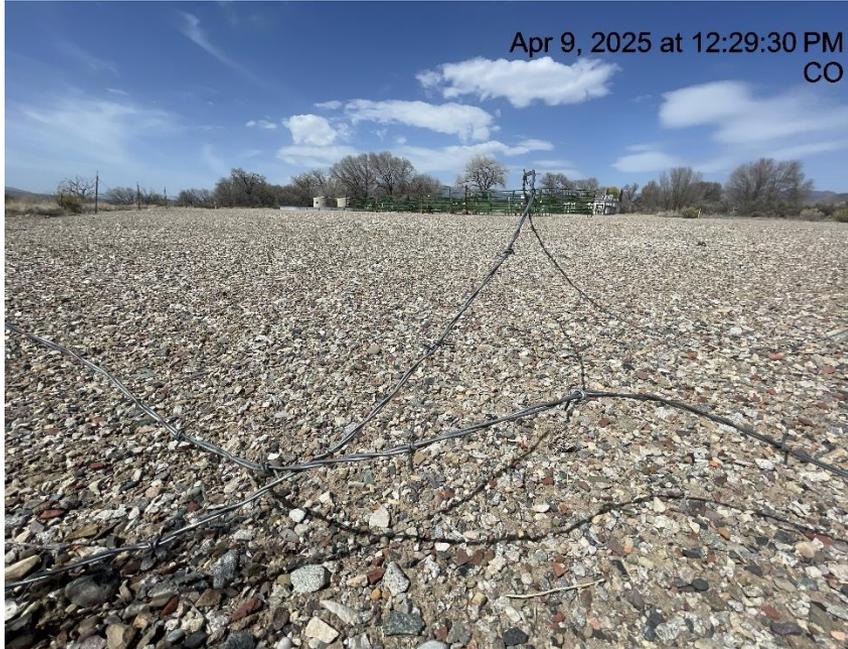
Photo # 9532 Barbed wire fence needs maintenance/wildlife hazard & trip hazard

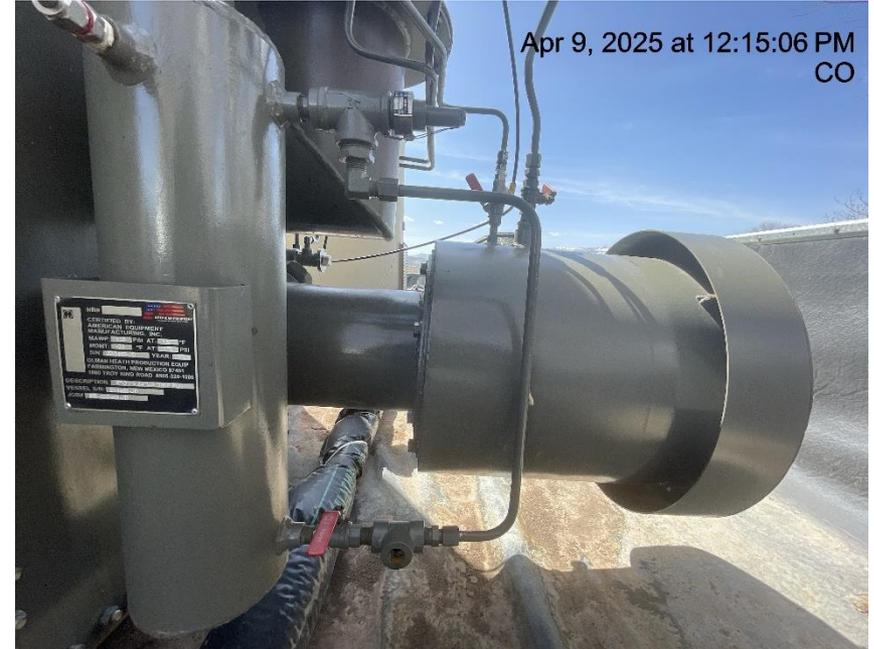
Photo # 9533 PRV vent line does not comply with CECMC pressure safety device rules or general safety rules

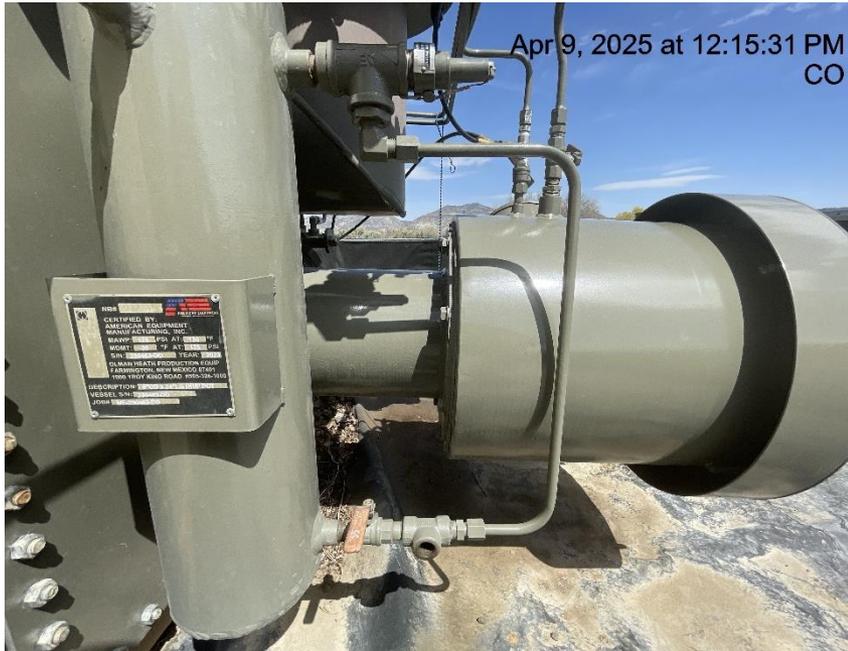
Photo # 9534 PRV vent line does not comply with CECMC pressure safety device rules or general safety rules
