# Inspection Photos

Loc: 321831

Operator: **P O & G OPERATING LLC**

Inspection Date: 4/10/2025

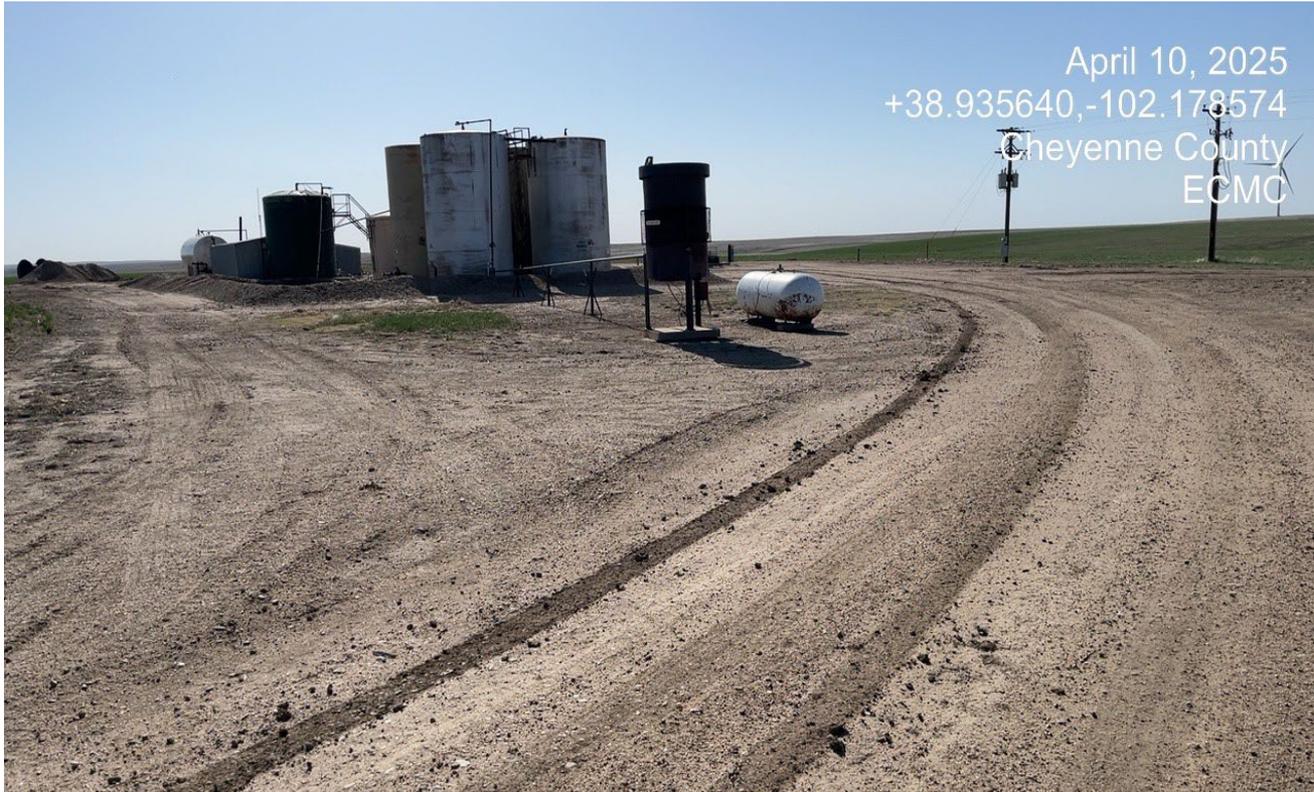
**Photo 1.** Facing southeast toward the tank battery.

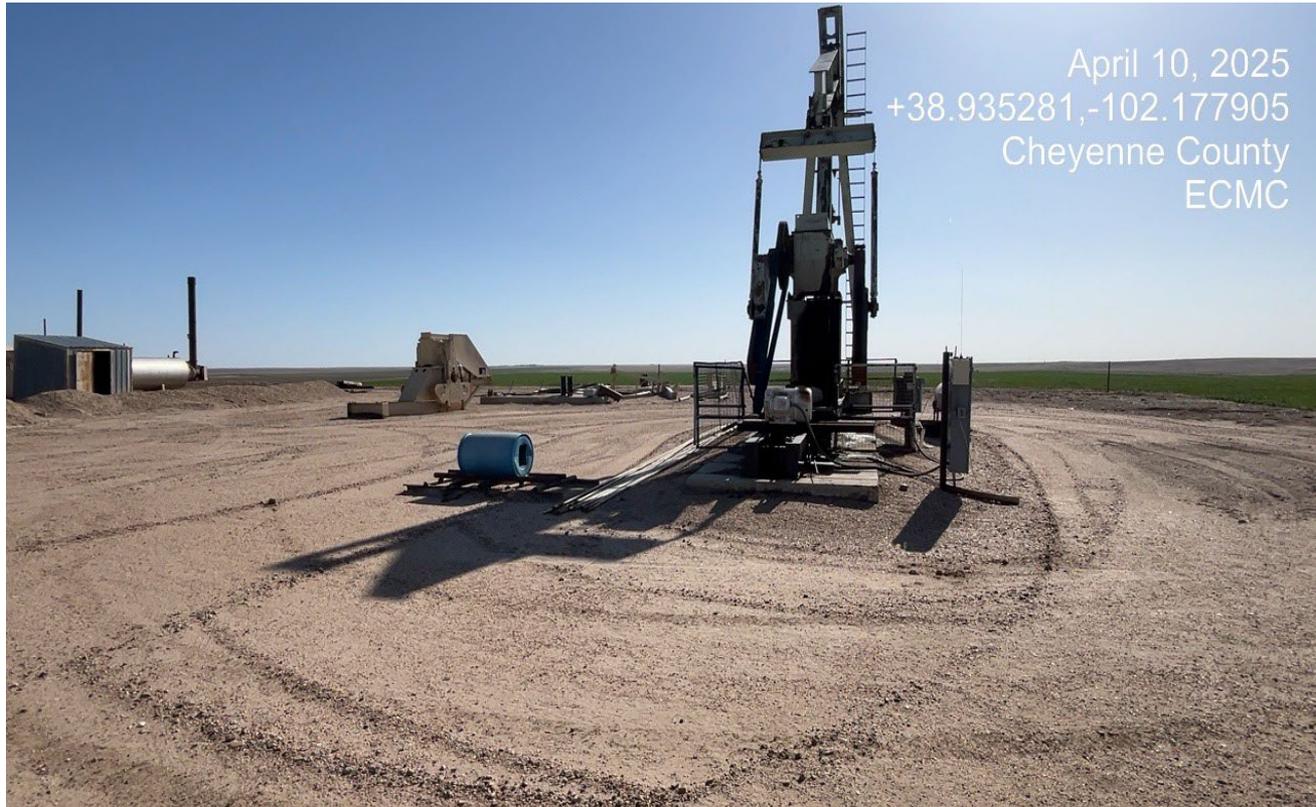
**Photo 2.** Facing east toward the well site and pumpjack.

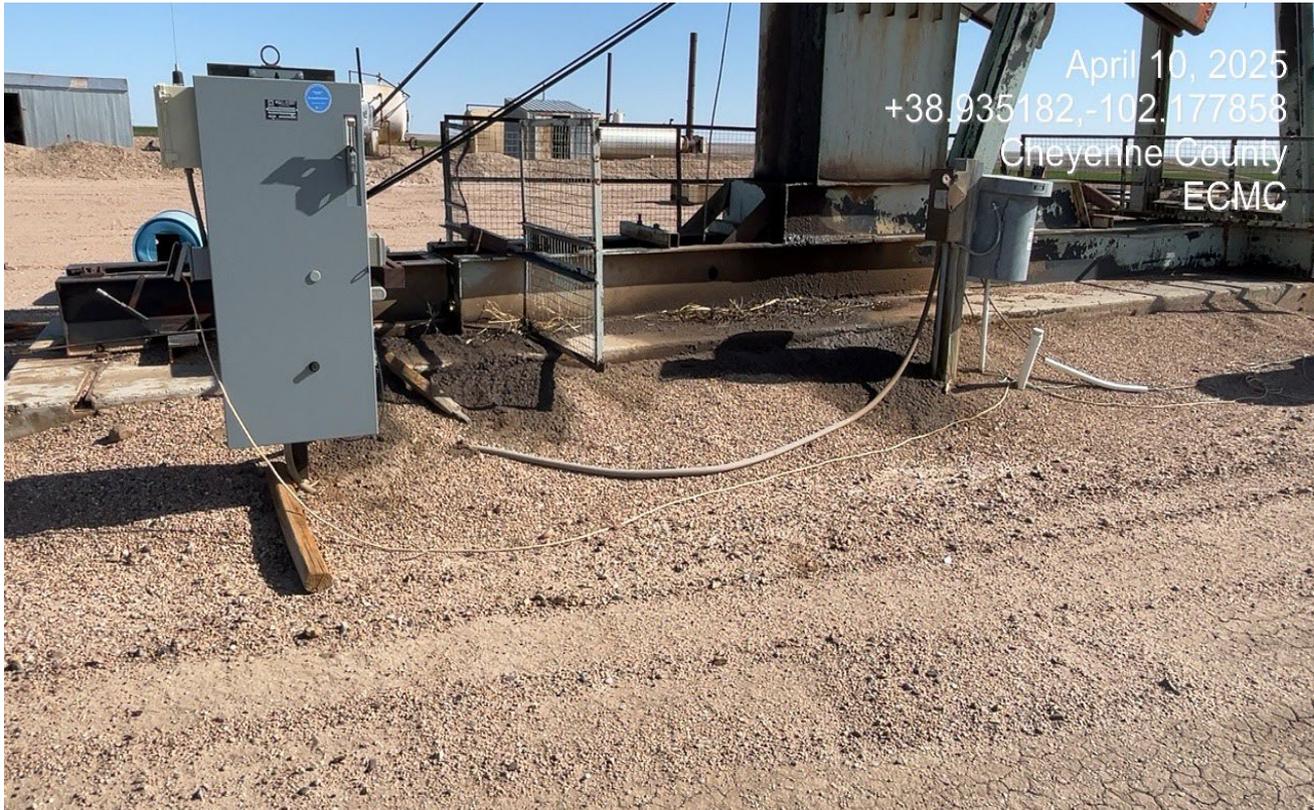
**Photo 3.** There are oil stained soils at the base of the pumpjack that need to be cleaned up and properly disposed.

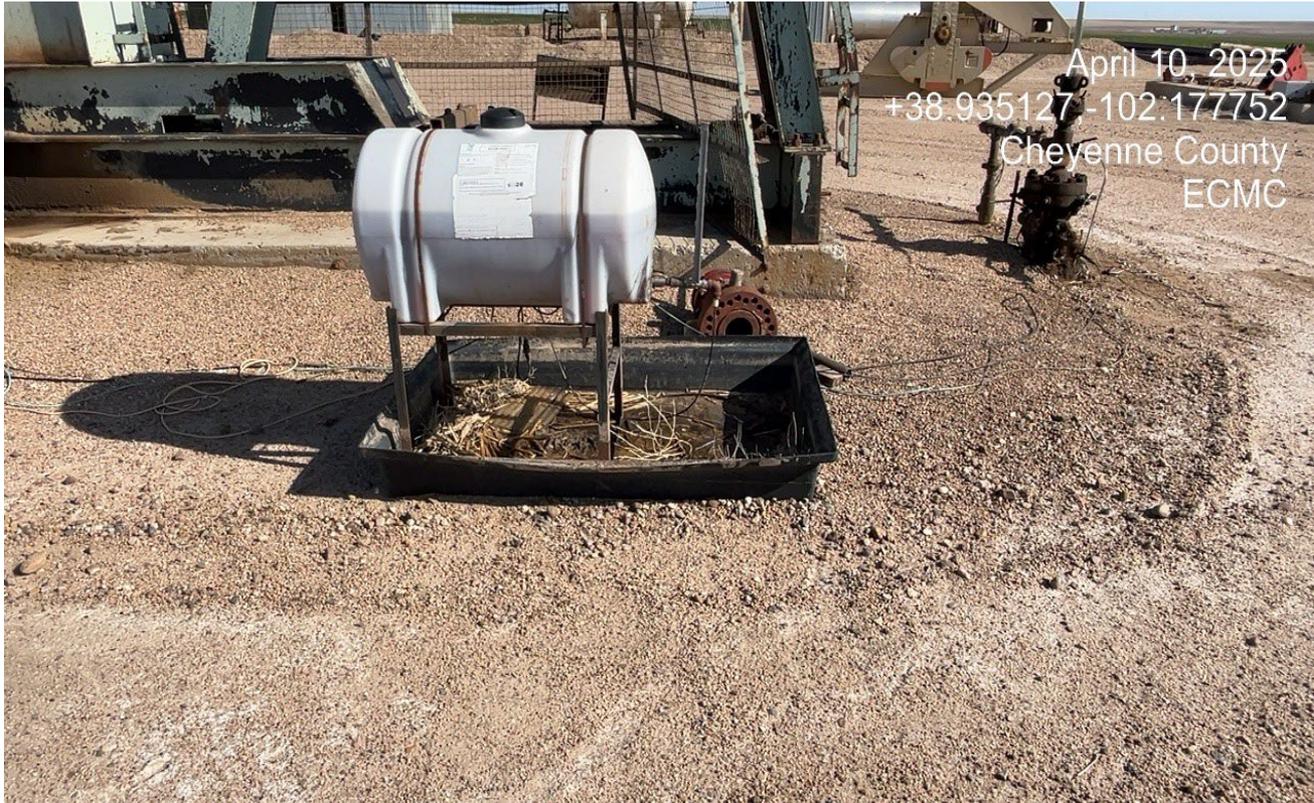
**Photo 4.** There is oily fluid in this secondary containment of the chemical barrel with no wildlife protections. This needs to be netted to prevent wildlife entry.

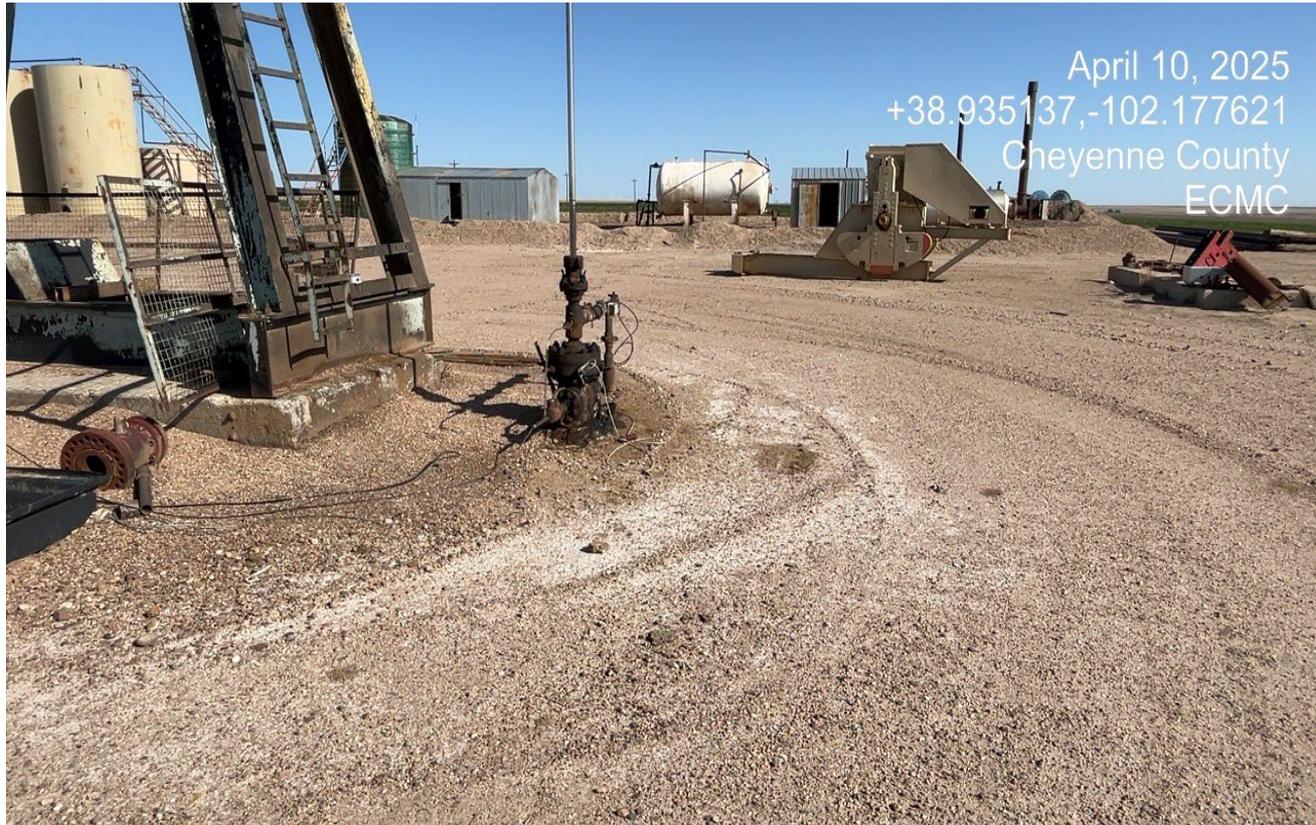
**Photo 5.** There is stained soils at the wellhead that need to be cleaned up and properly disposed. Also there is unused equipment stored in the upper right of the photo which needs to be removed.

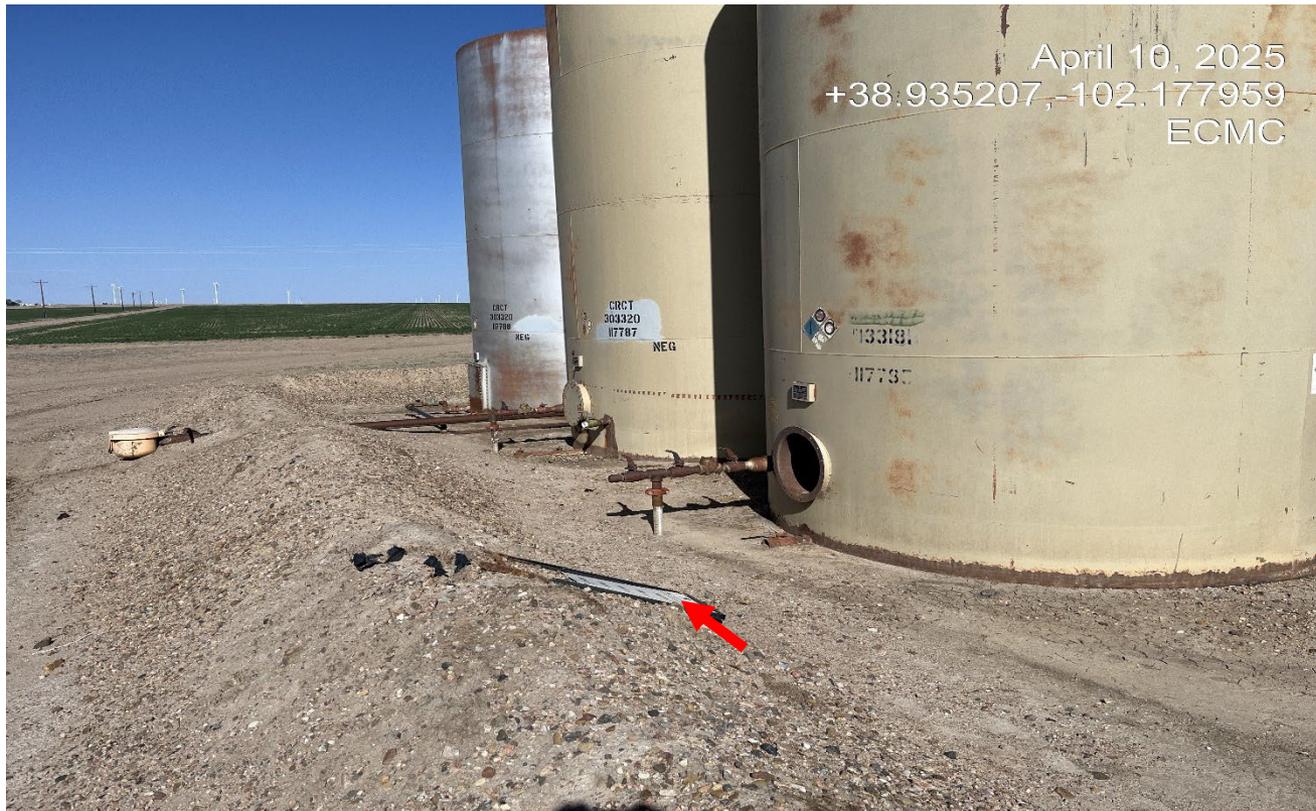
**Photo 6.** The tank battery sign has fallen over and the tank labels are faded.

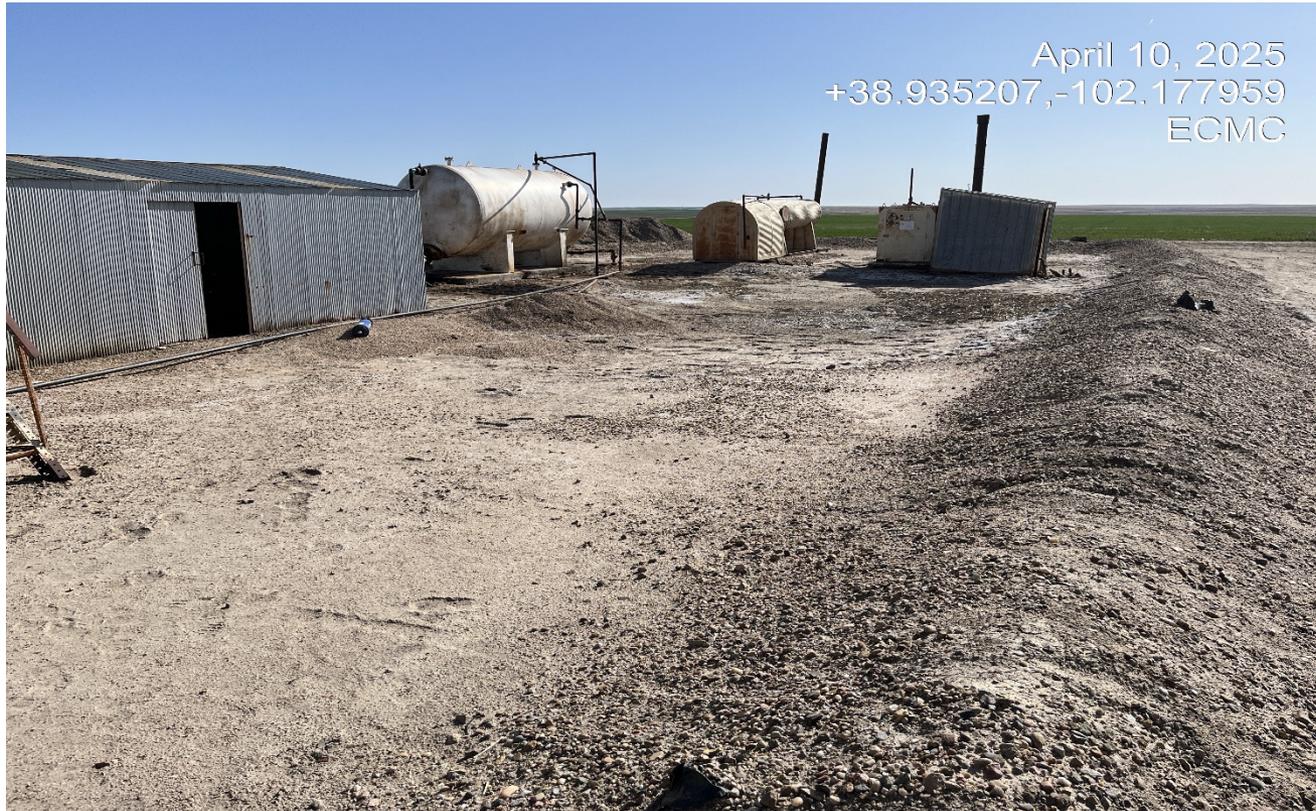
**Photo 7.** Facing northeast at the tank battery facility.

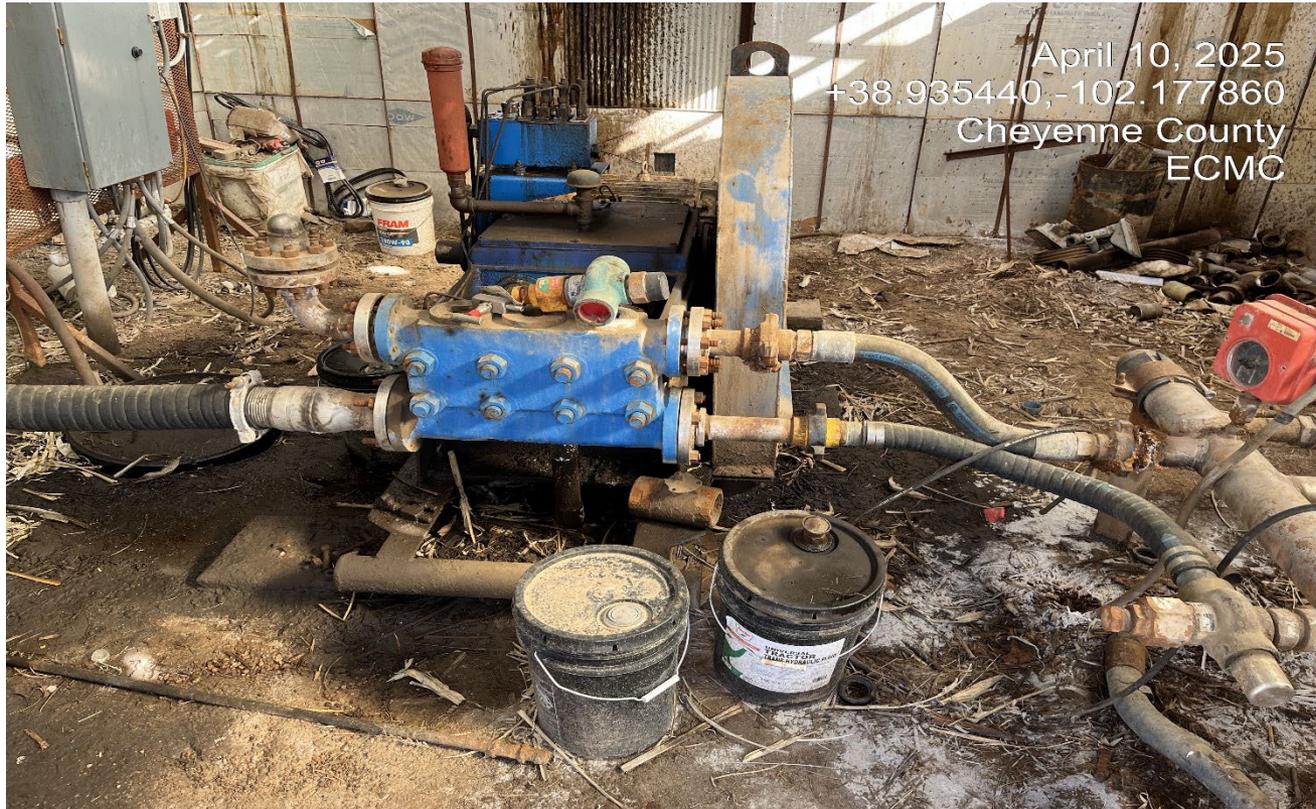
**Photo 8.** View of inside the shed shows oil stained soils and improper spill containment.

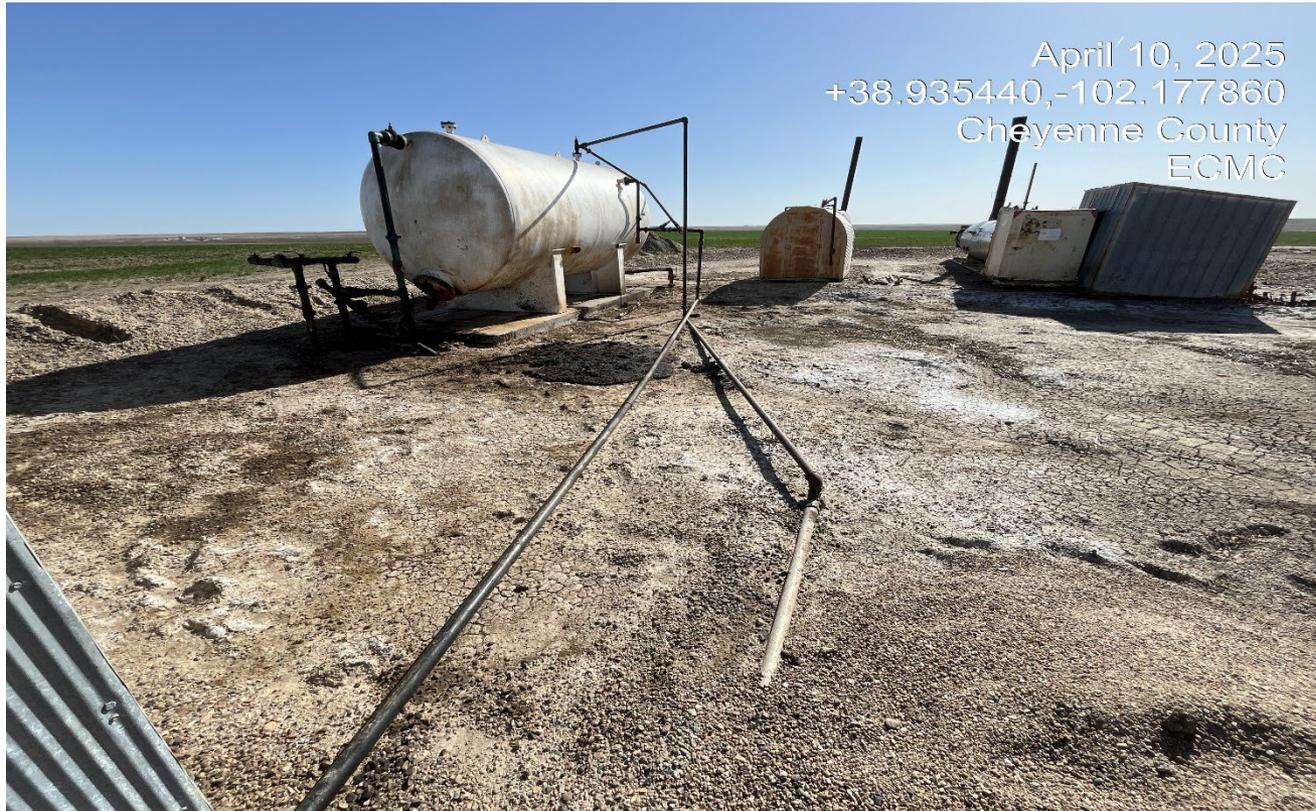
**Photo 9.** Facing northeast past the shed. There was a spill that occurred which leaked out both inside and outside of secondary containment in this area.

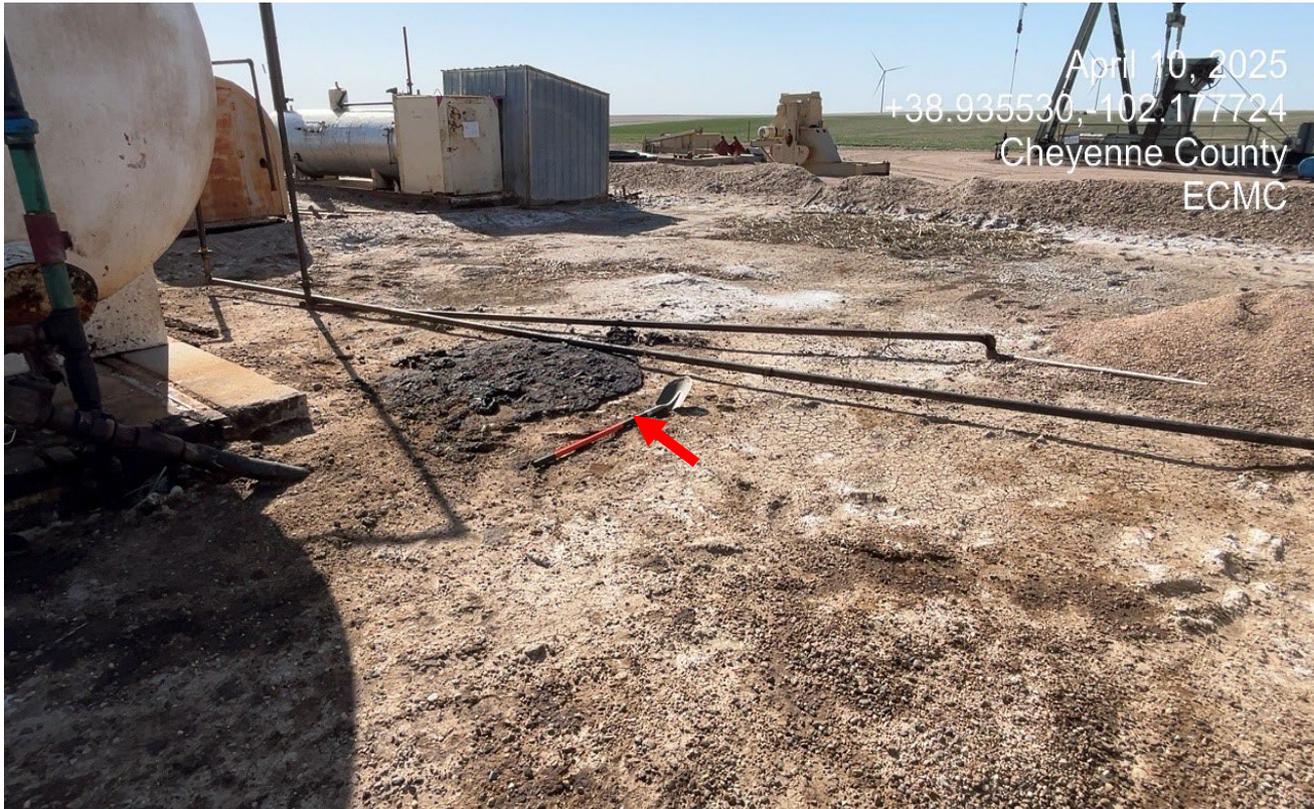
**Photo 10.** Facing southeast inside the tank battery. The is stained soil from a leak that occurred. The red arrow points to 4.5 ft. shovel for scale.

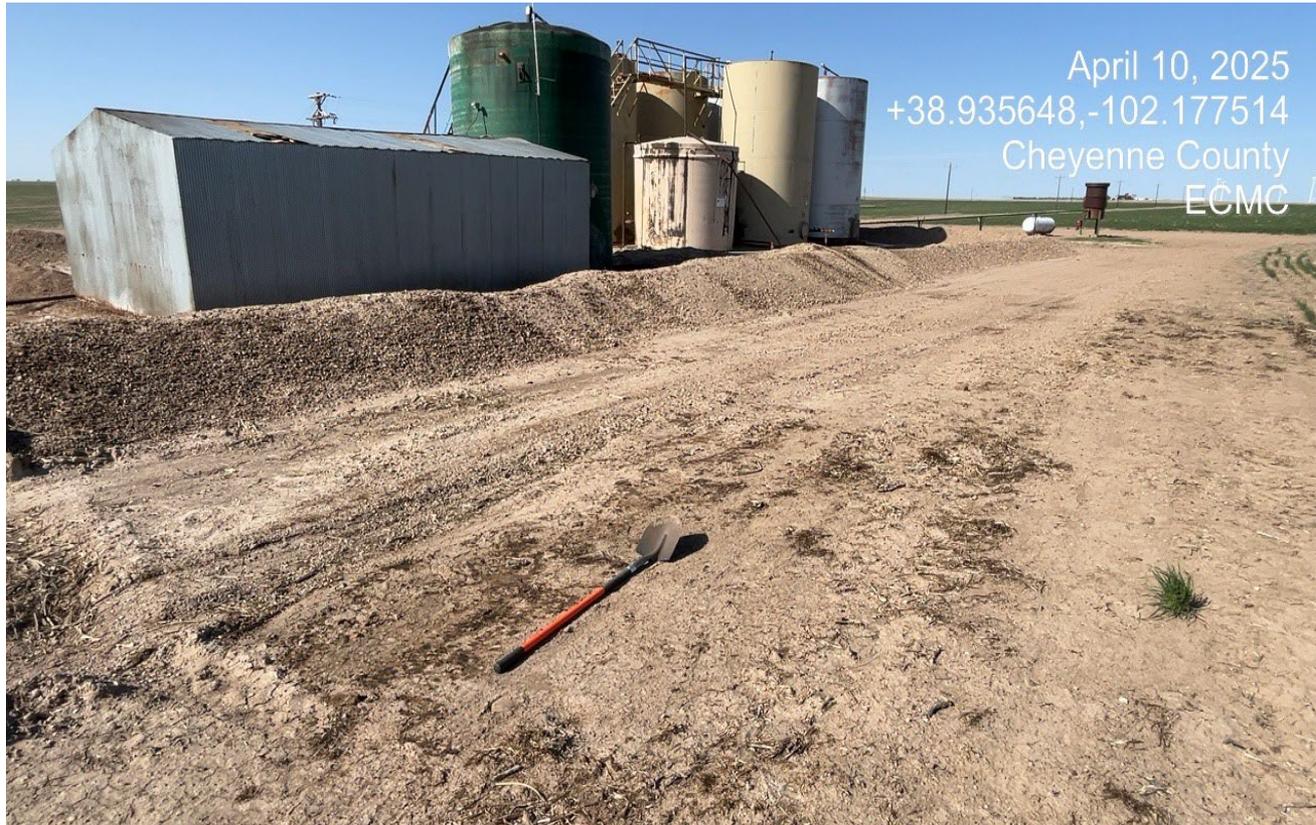
**Photo 11.** There is also oil stained soils that went outside of containment at the north side of the location. The shovel was placed by the stained soils for scale.

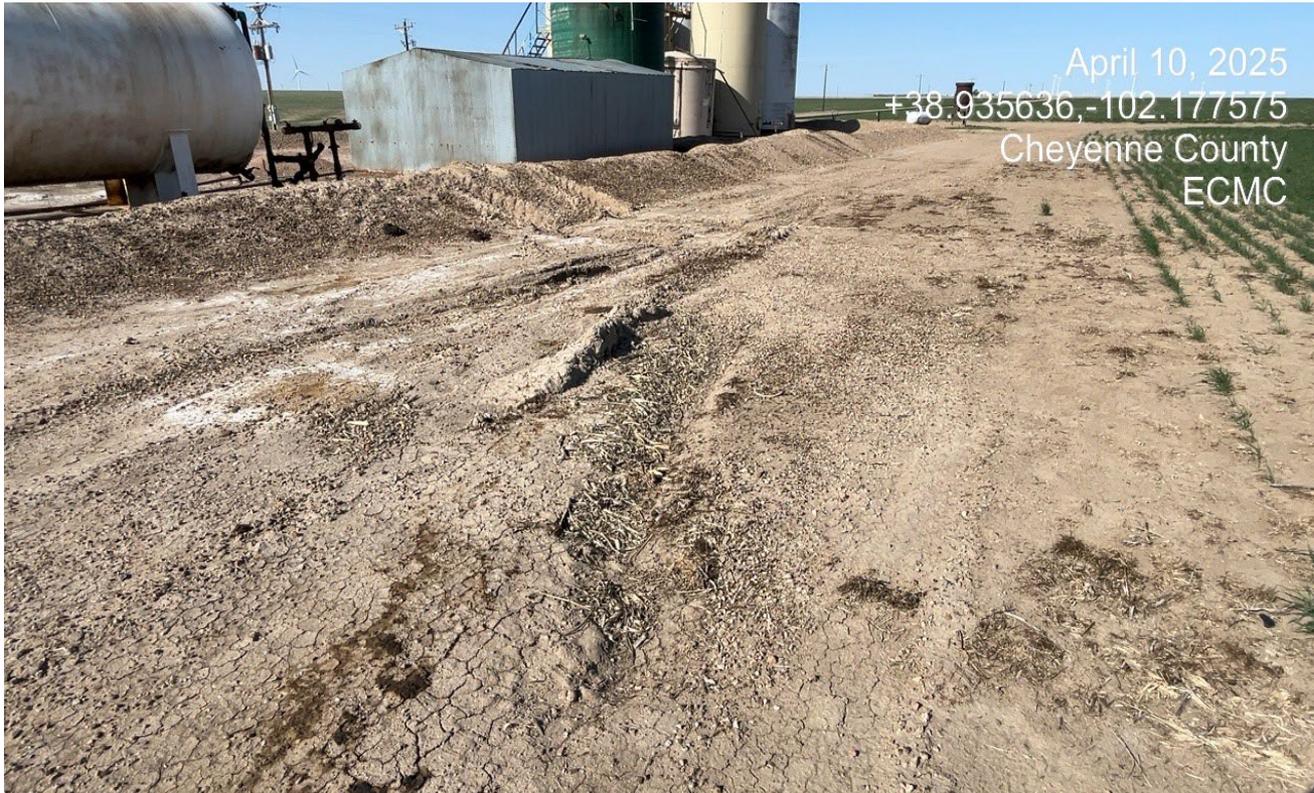
**Photo 12.** Facing southwest at the north side of the location where the spill occurred outside of containment..

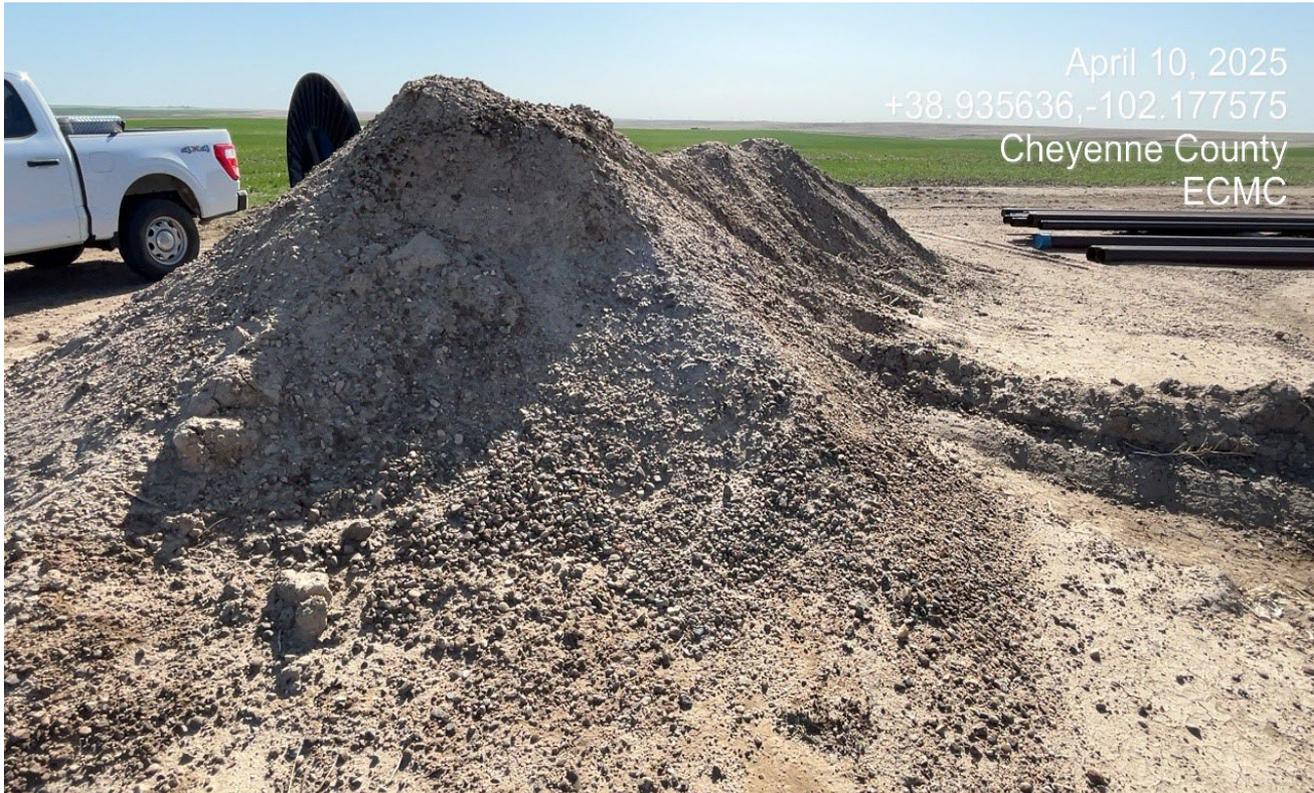
**Photo 13.** There is a pile of gravelly sand material stored at the northeast corner of the location. There is stained material incorporated into the pile. E&P waste must be stored with containment and liner.

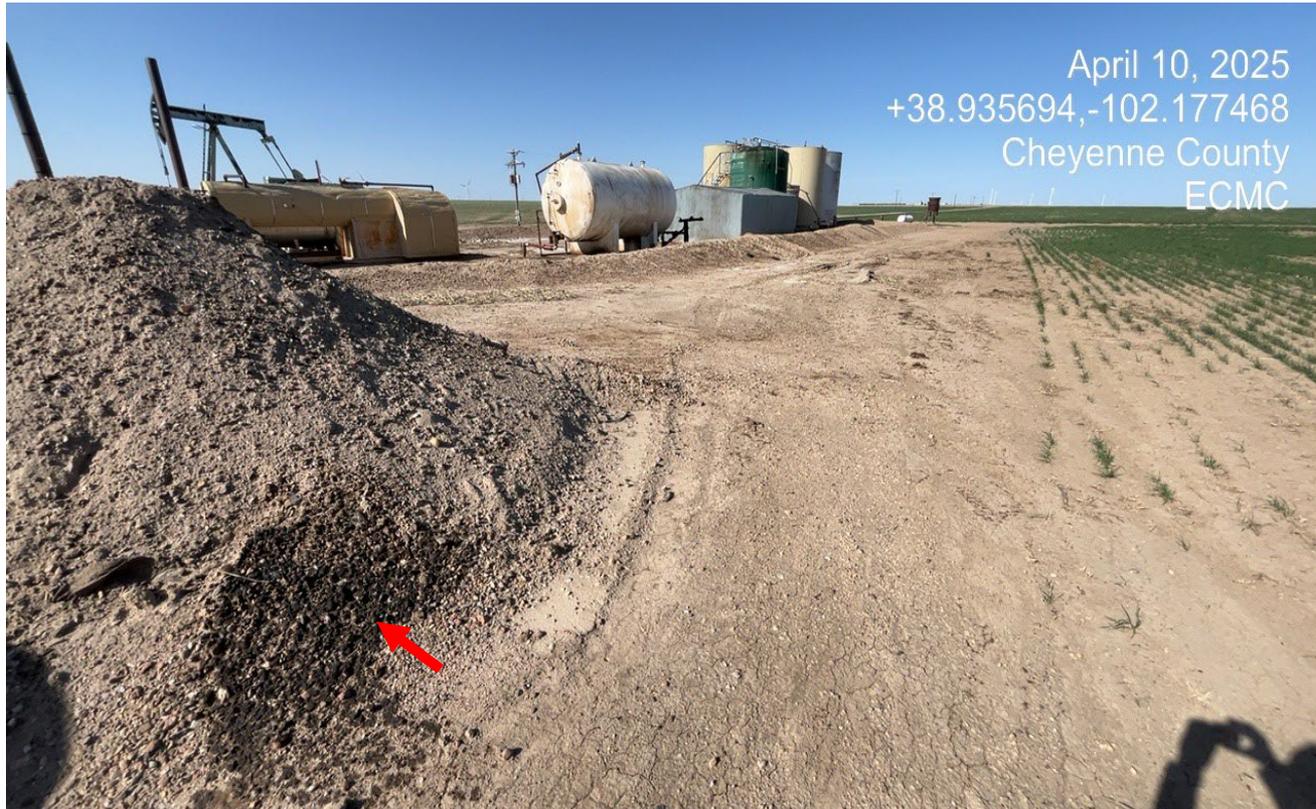
**Photo 14.** Northeast corner of the location facing southwest. Red arrow points to blackened stains soil at the pile shown previous photo.
