Inspection Photos

API: 017-07112

Operator: **P O & G OPERATING LLC**

Inspection Date: 4/10/2025

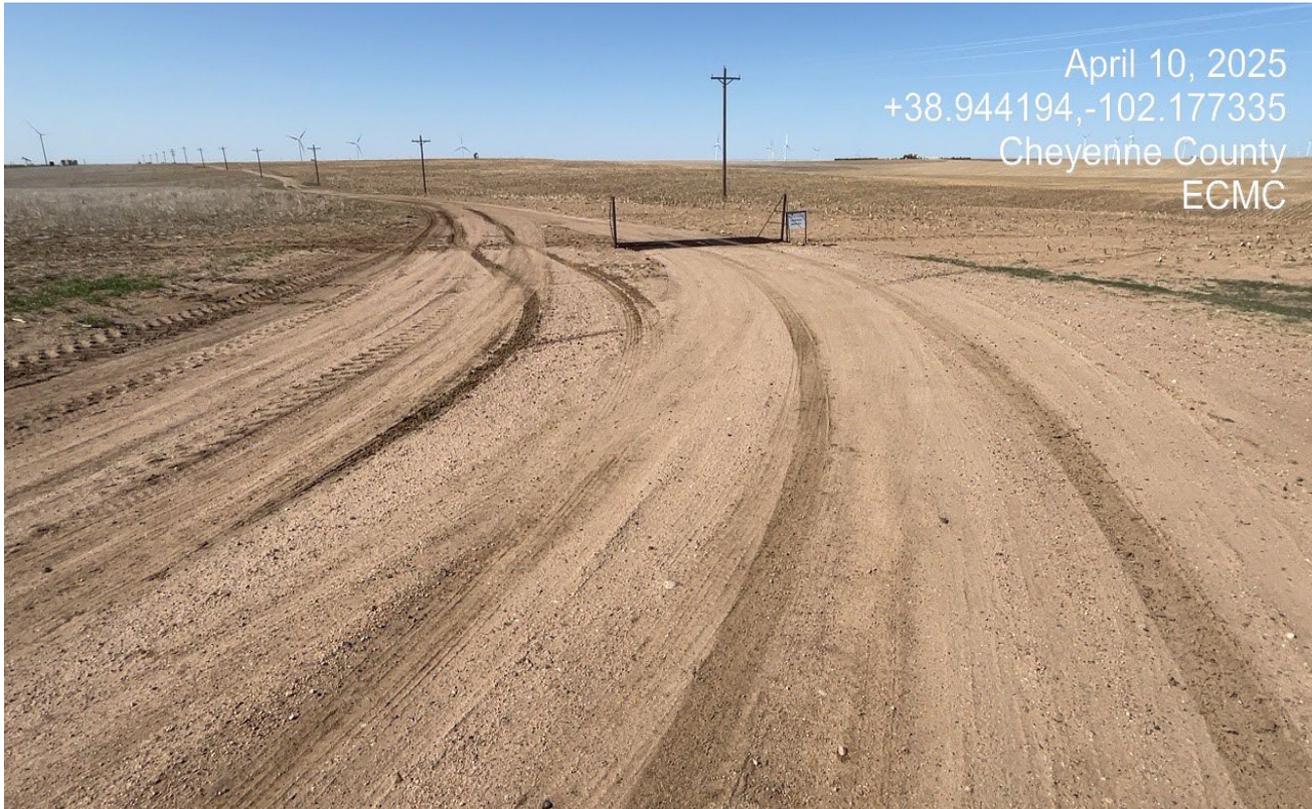
Photo 1. Facing southwest at the beginning of the access road. There is vehicle traffic going around the cattleguard causing widening of the road and unnecessary surface disturbance.

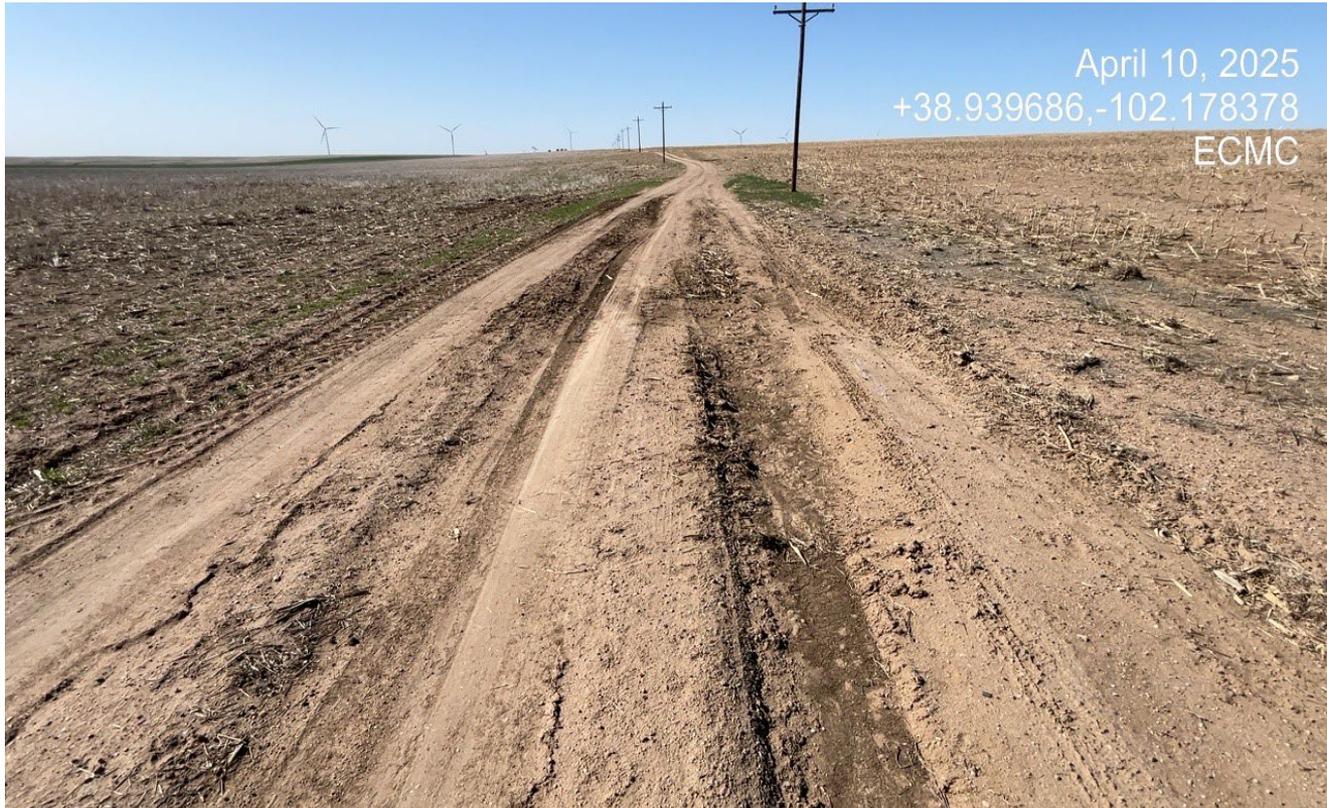
Photo 2. Facing south along the access road. The access road is rutted and not maintained in this area. Vehicle are widening the road at this area.

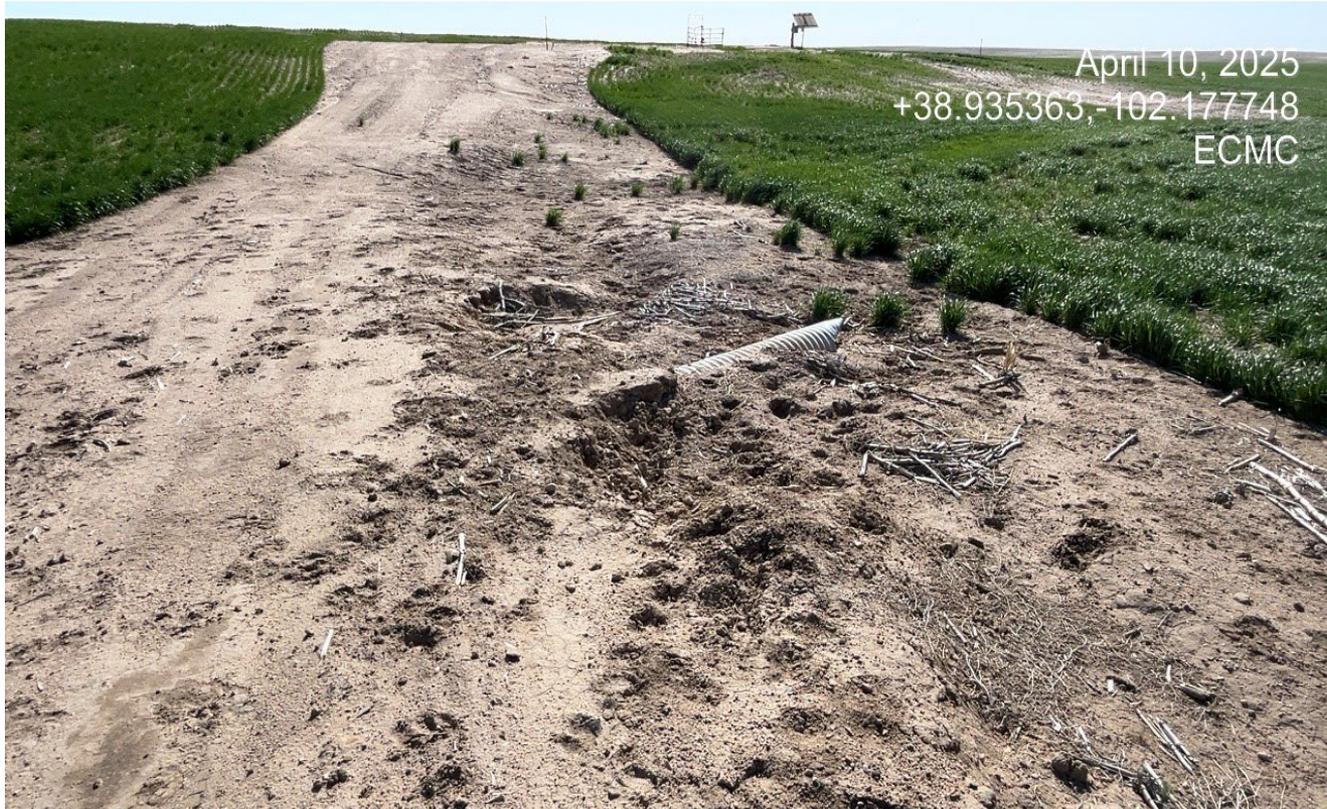
Photo 3. The culvert along the access road near the wellsite has washed out and needs to be repaired.

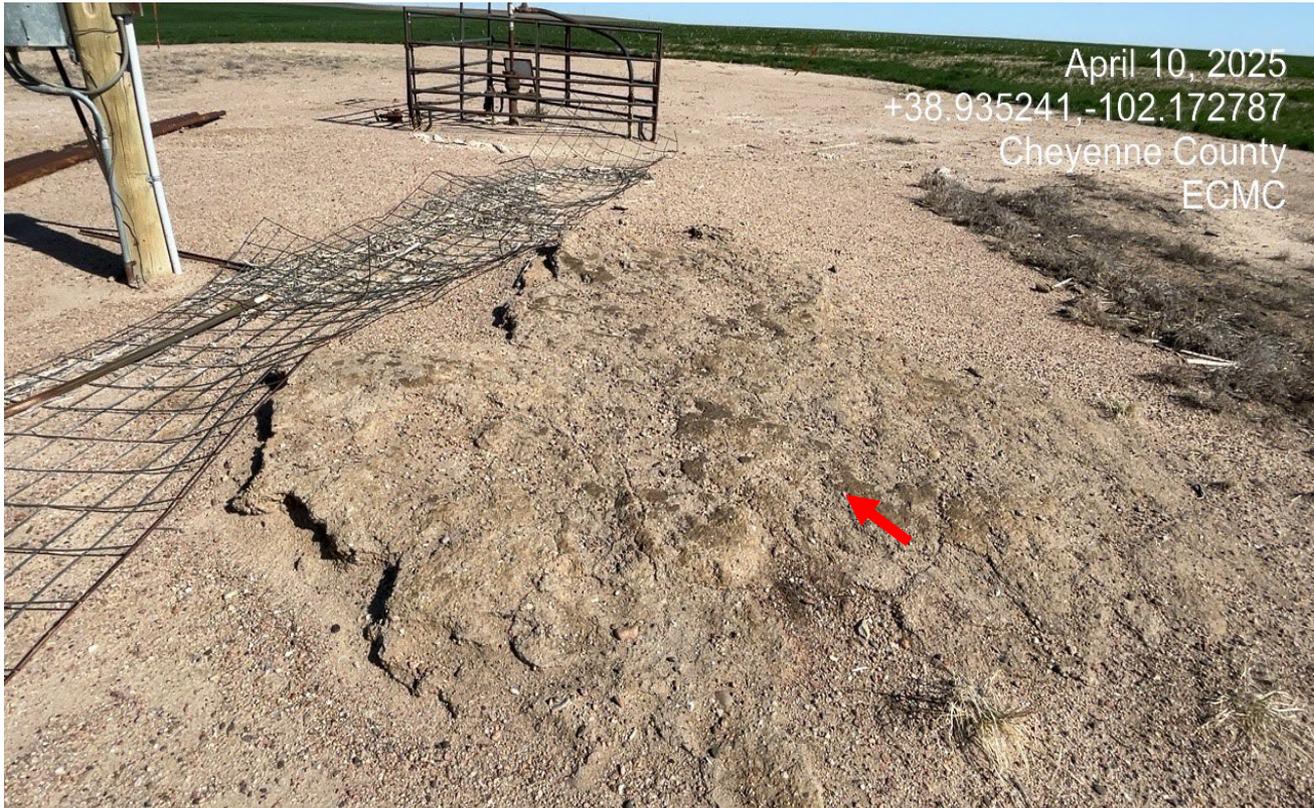
Photo 5. The pumpjack has been removed and there is hardened oil stained soil shown at red arrow. Also the fence panels need to be removed.

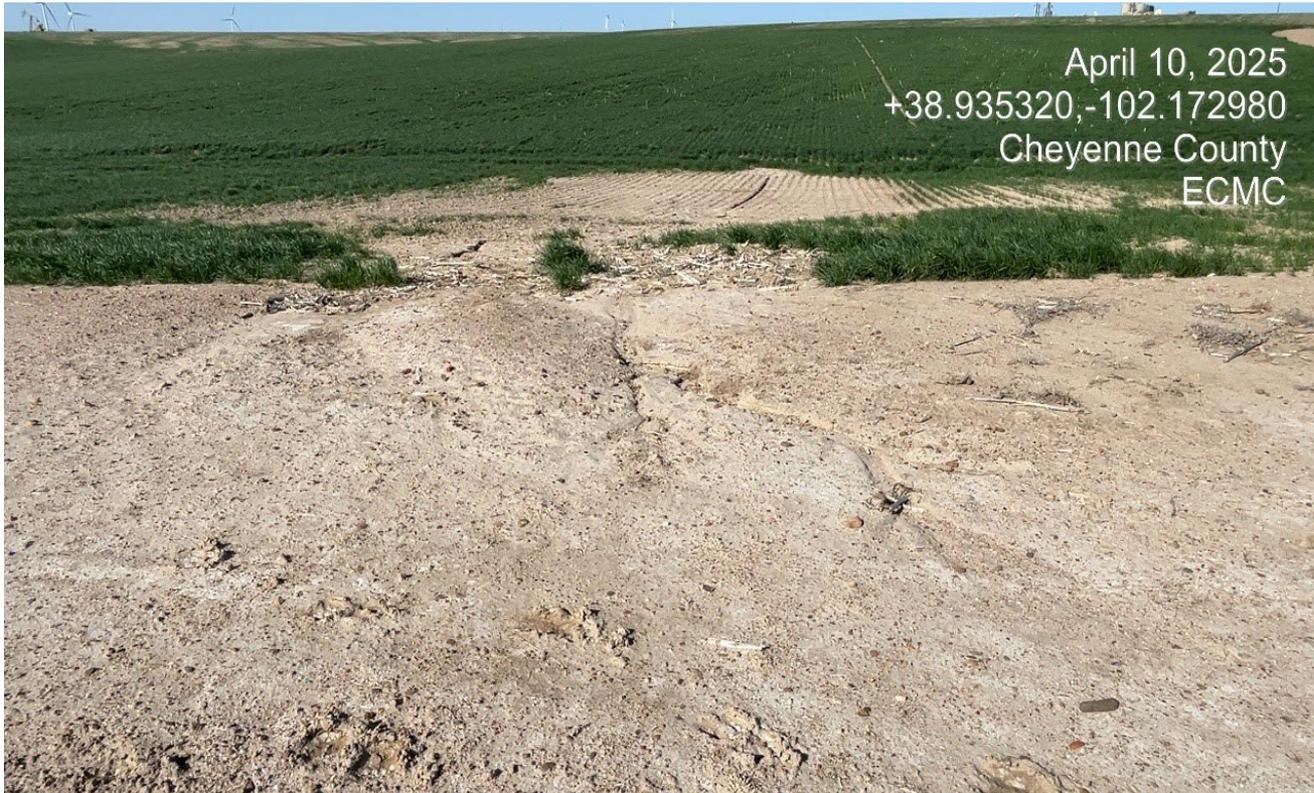
Photo 6. Facing west from the wellsite. There appears to have been a previous leak that occurred downhill from the wellhead which has impacted crop growth.

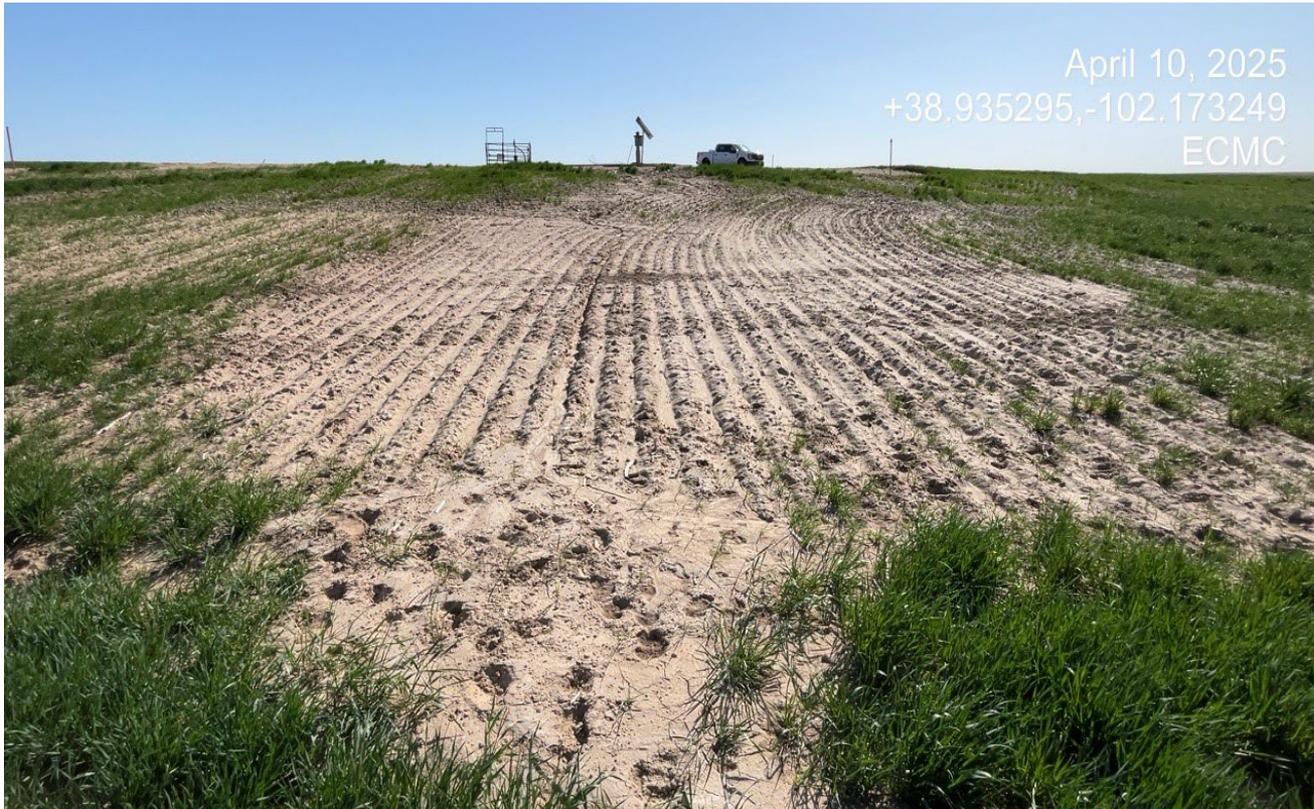
Photo 7. Facing east at the edge of the deficient crop growth. This is approximately 150 ft. downhill from the wellhead.
