## Inspection/Audit Photos

Location Name: TEP ROCKY MOUNTAIN LLC NORTH BANK C Pad

Location ID: 336013

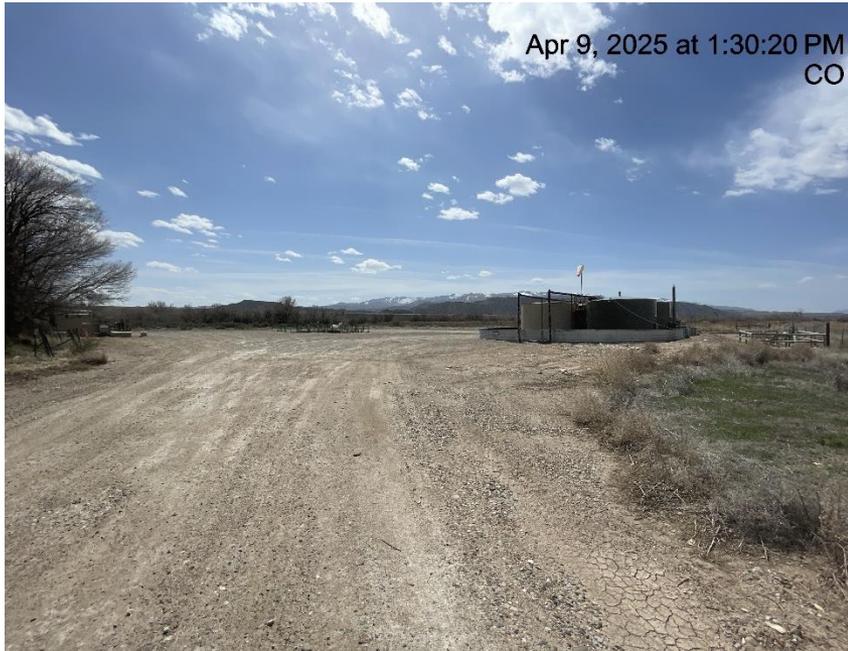
Photo # 9782 From entrance to location

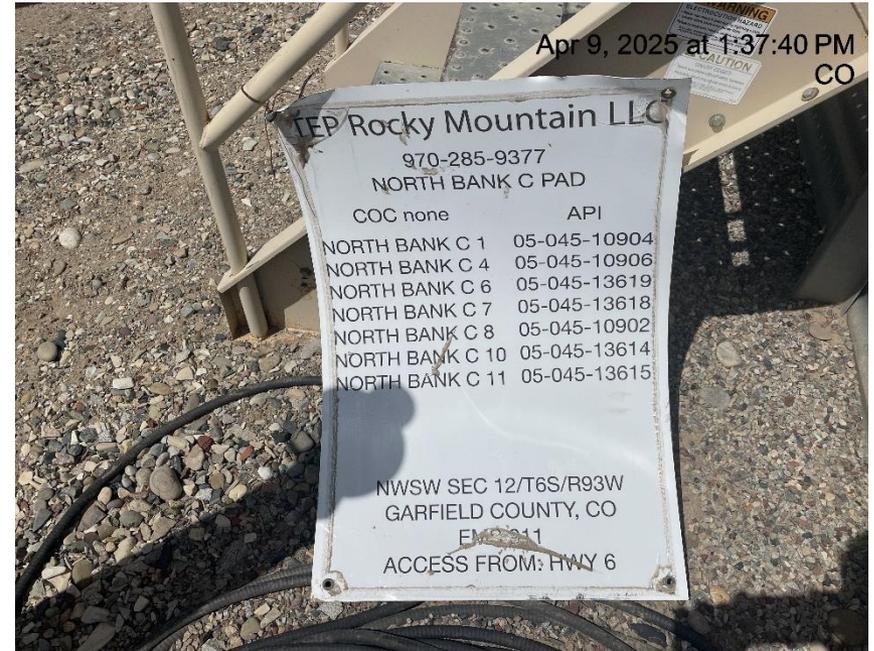
Photo # 9783 Location

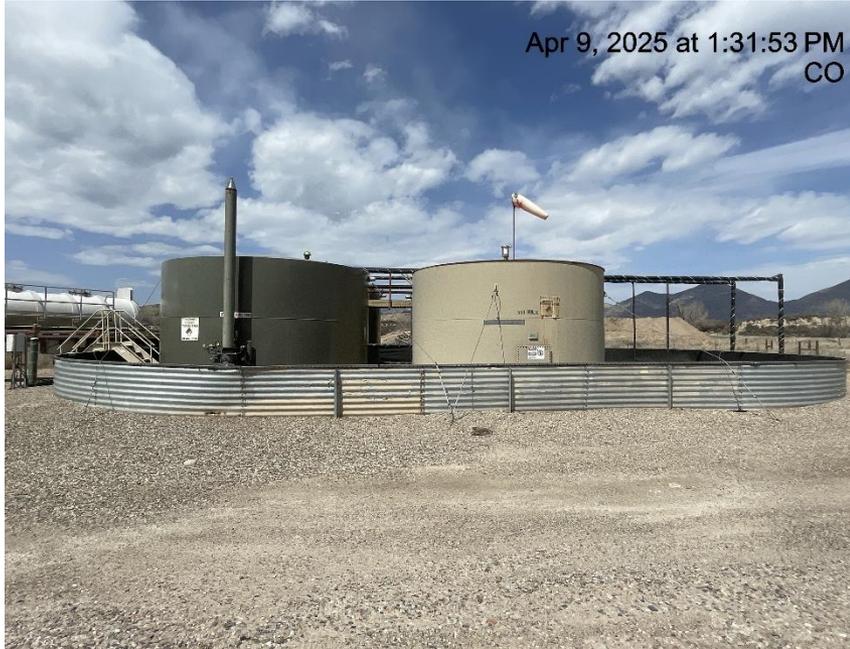
Photo # 9784 Location

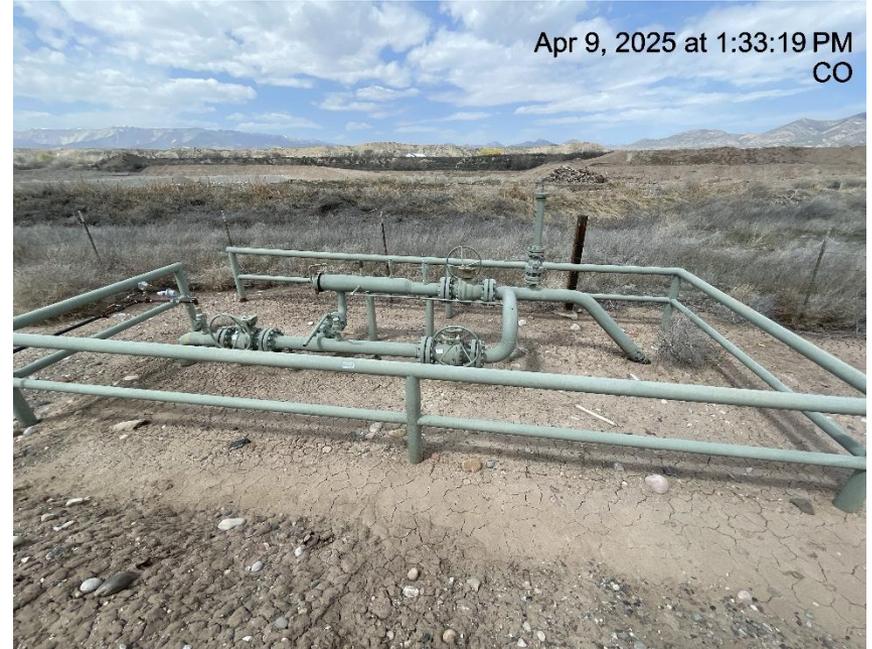
Photo # 9785 Location

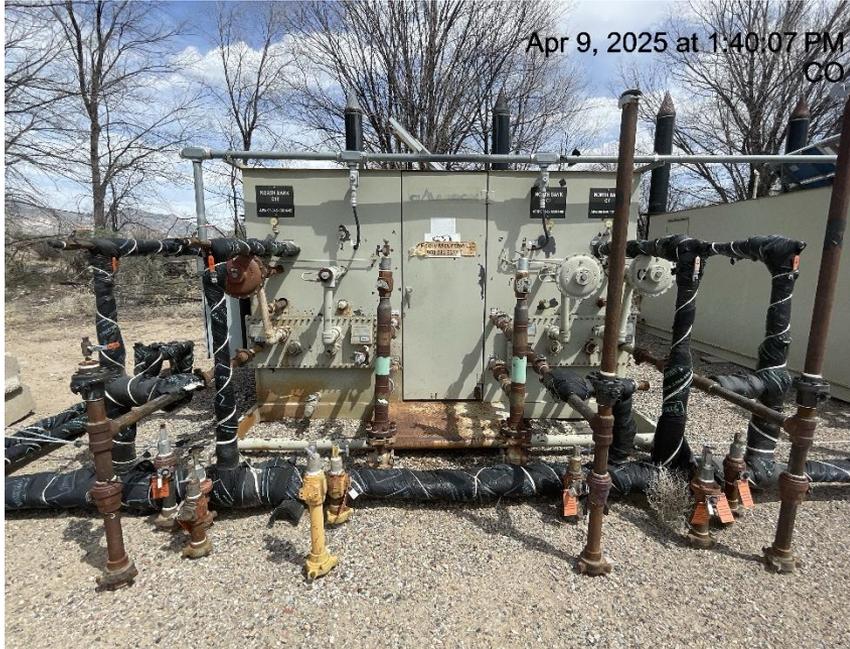
Photo # 9786 Location

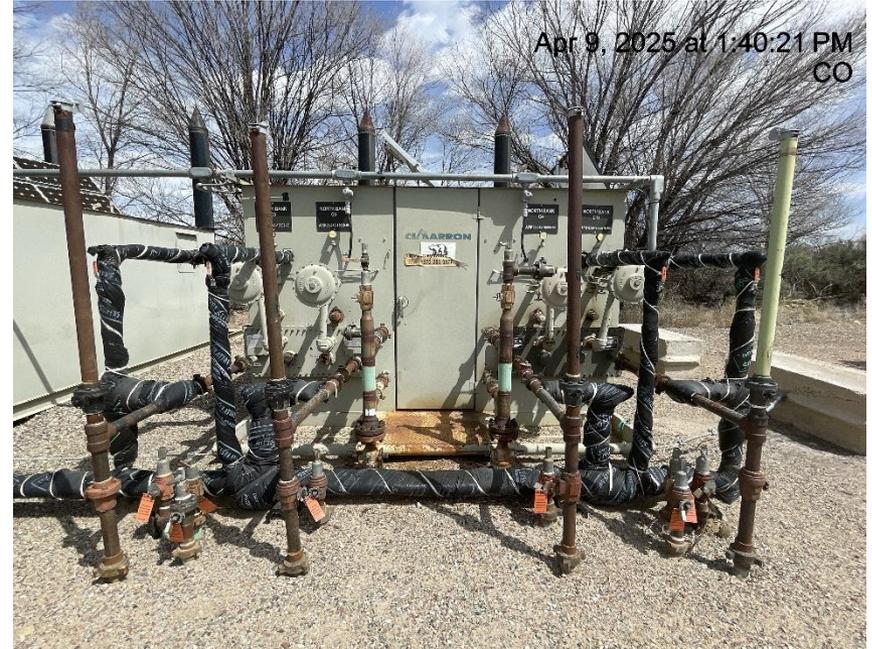
Photo # 9787 Location

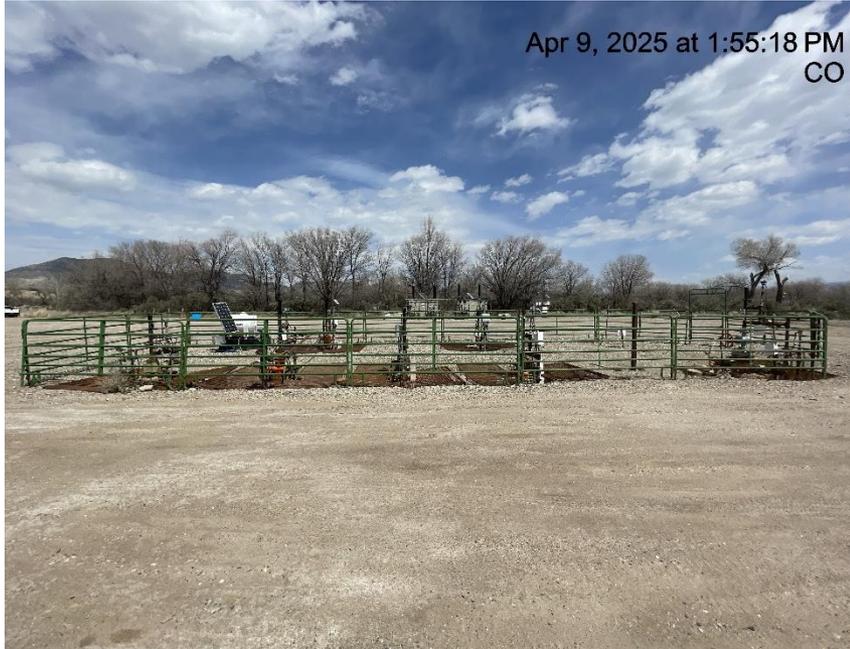
Photo # 9788 Location

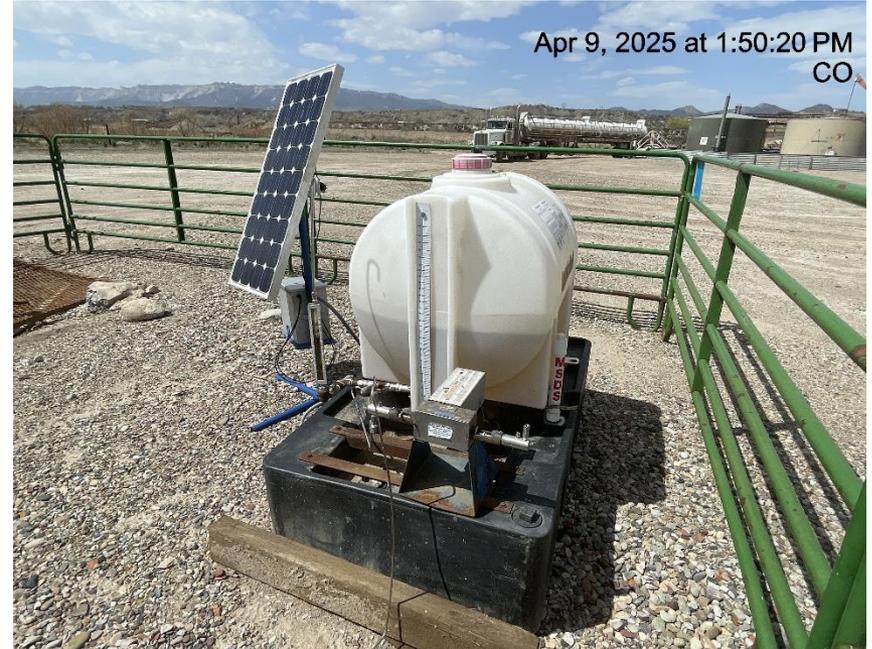
Photo # 9789 Location

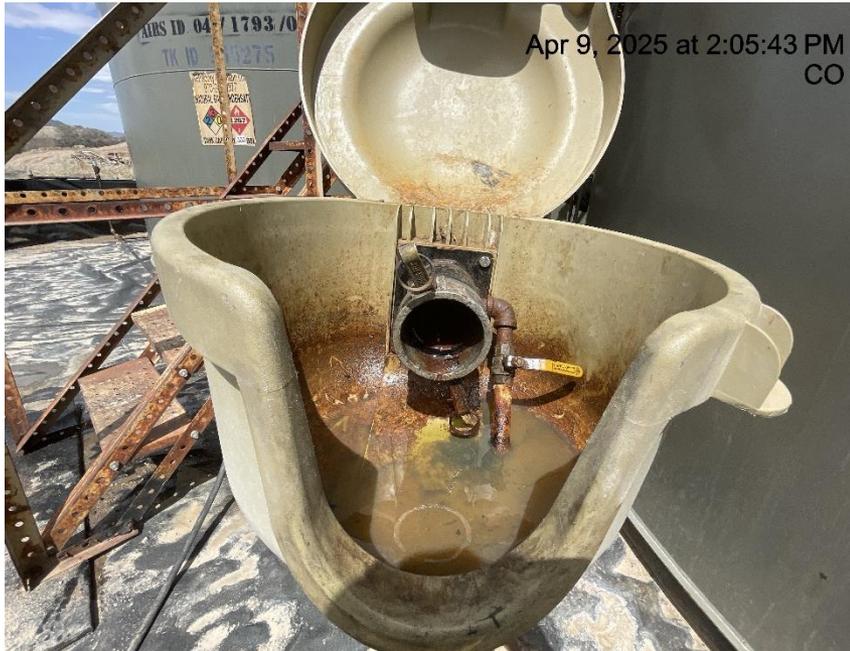
Photo # 9790 Open ended load line

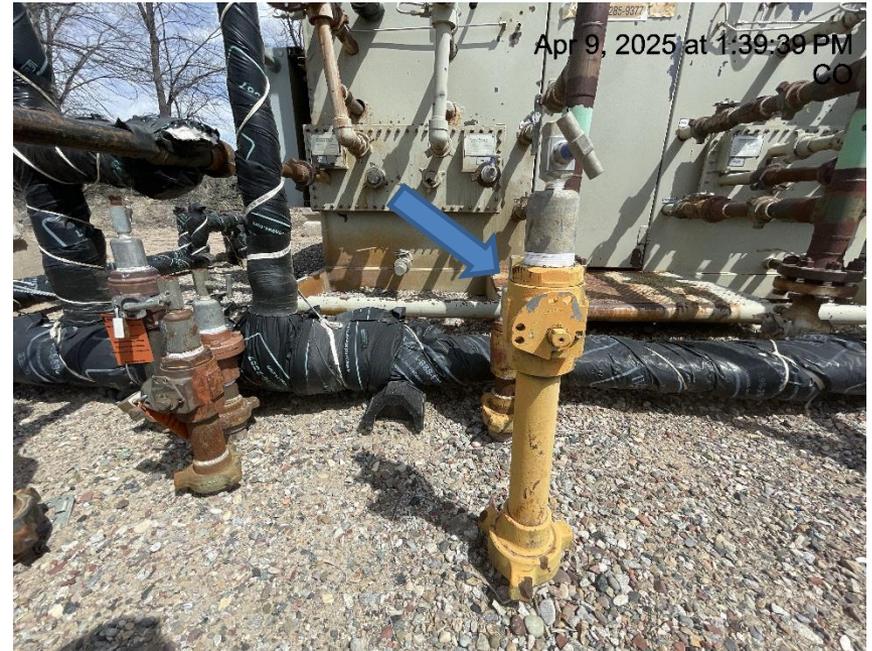
Photo # 9791 Unused flowline at separators lacks lockout tagout (OOSLAT)

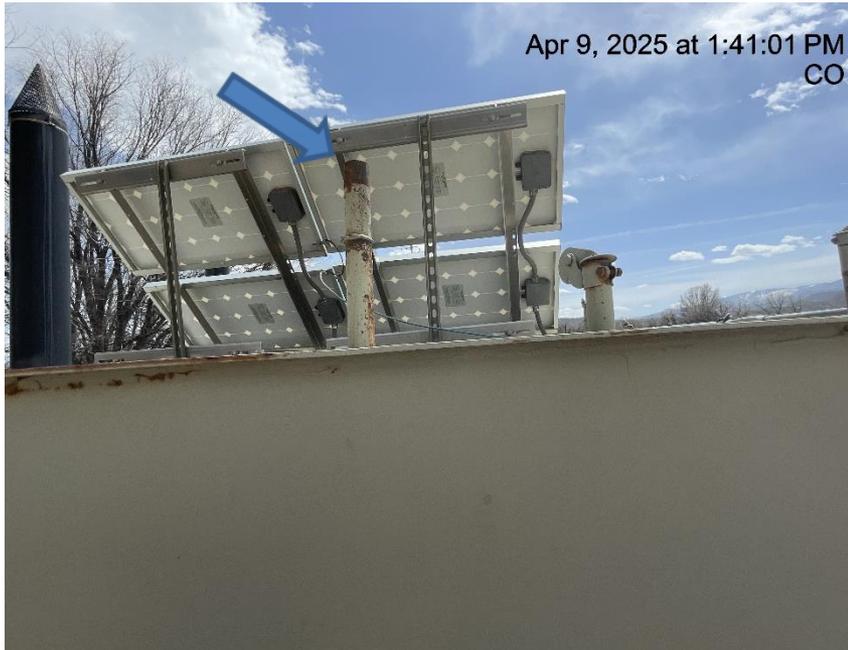
**Photo # 9792 PRV vent line does not comply with CECMC pressure safety device rules**

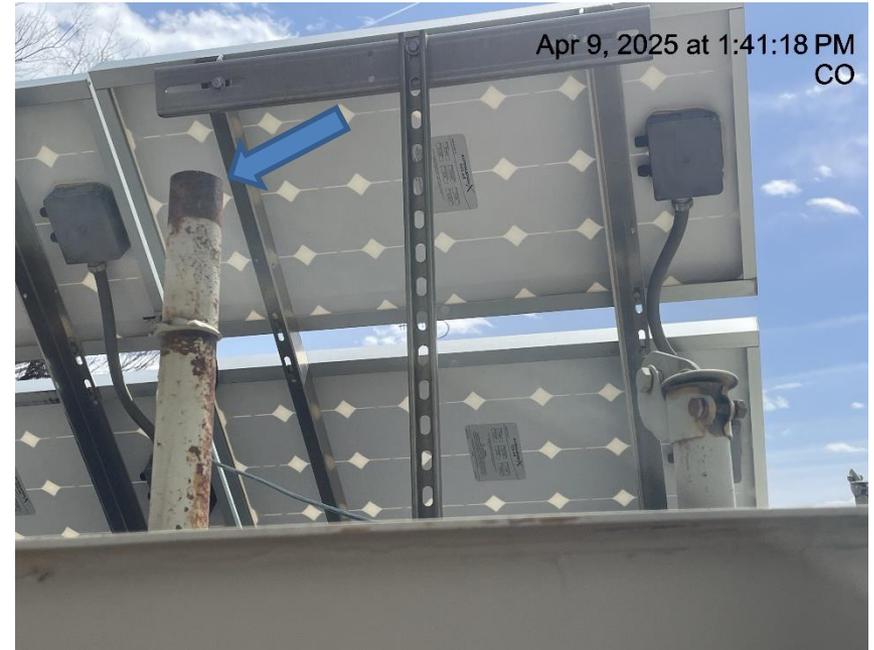
**Photo # 9793 PRV vent line does not comply with CECMC pressure safety device rules**

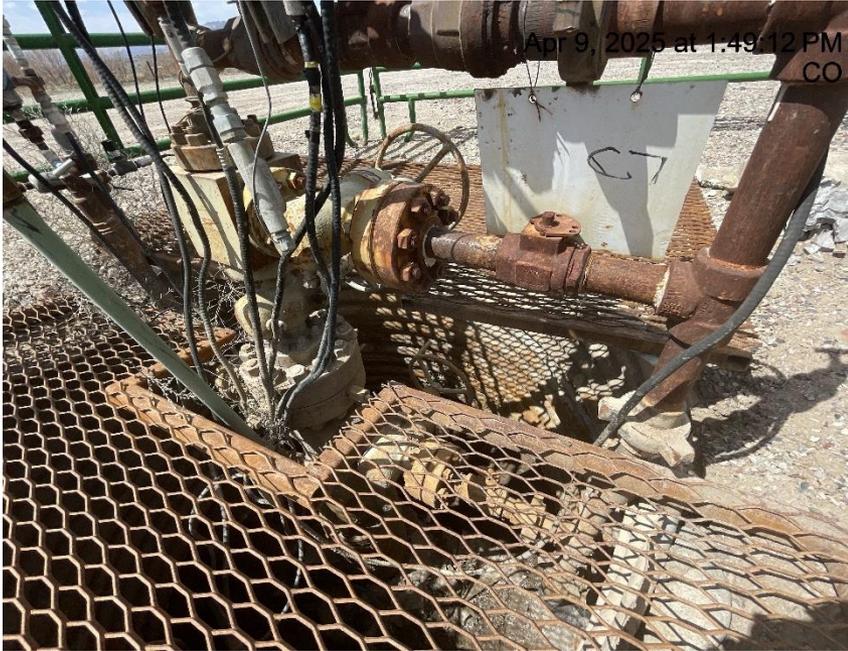
Photo # 9794 Wellhead cellar lacks wildlife egress

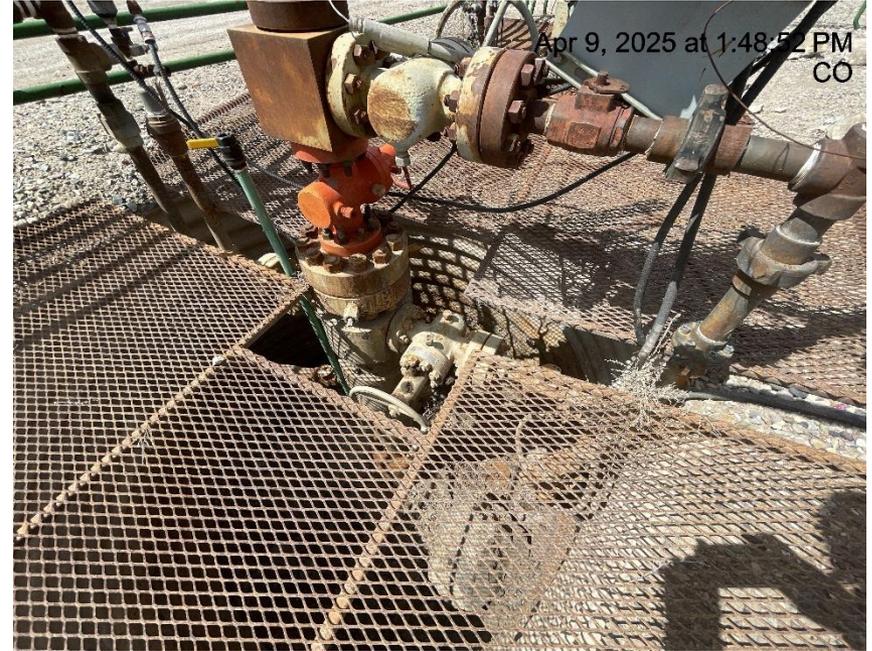
Photo # 9795 Wellhead cellar lacks wildlife egress

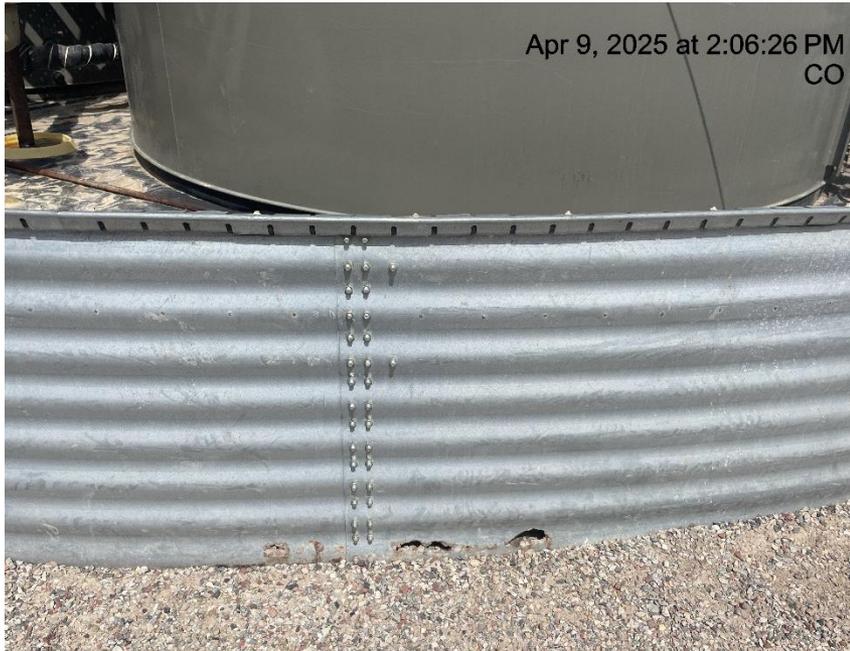
**Photo # 9796 Secondary containment metal tank ring rusted /damaged & needs maintenance**

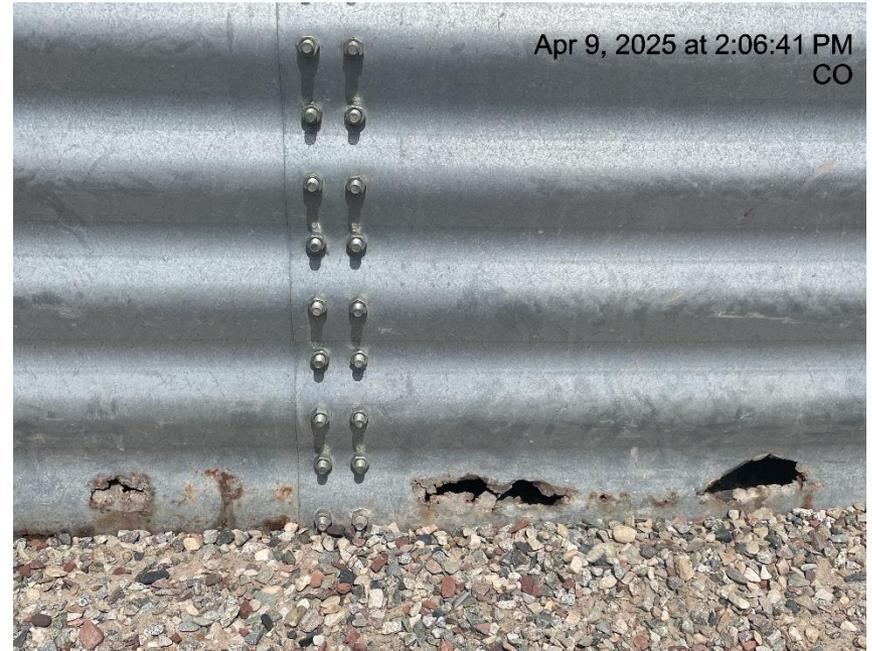
**Photo # 9797 Secondary containment metal tank ring rusted /damaged & needs maintenance**

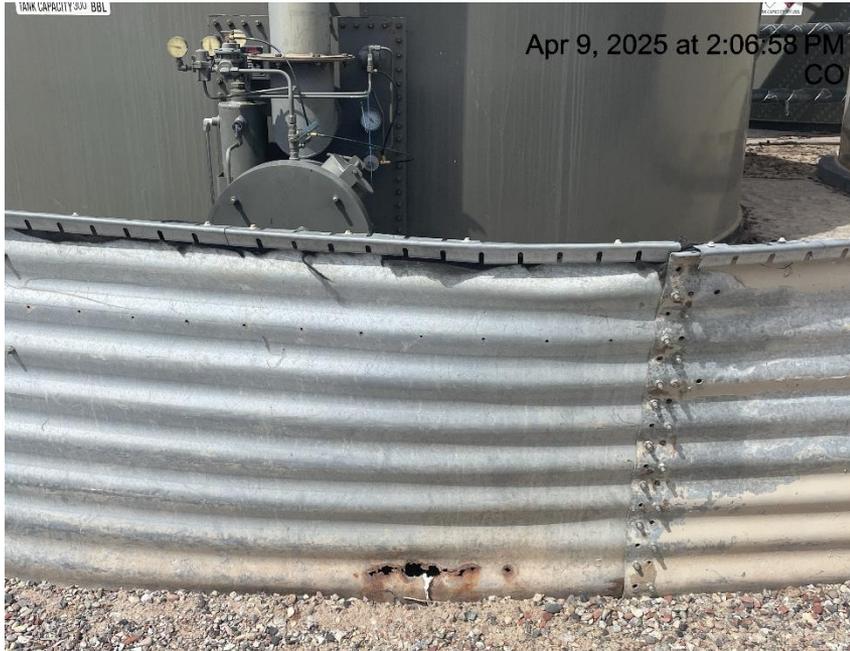
**Photo # 9798 Secondary containment metal tank ring rusted /damaged & needs maintenance**

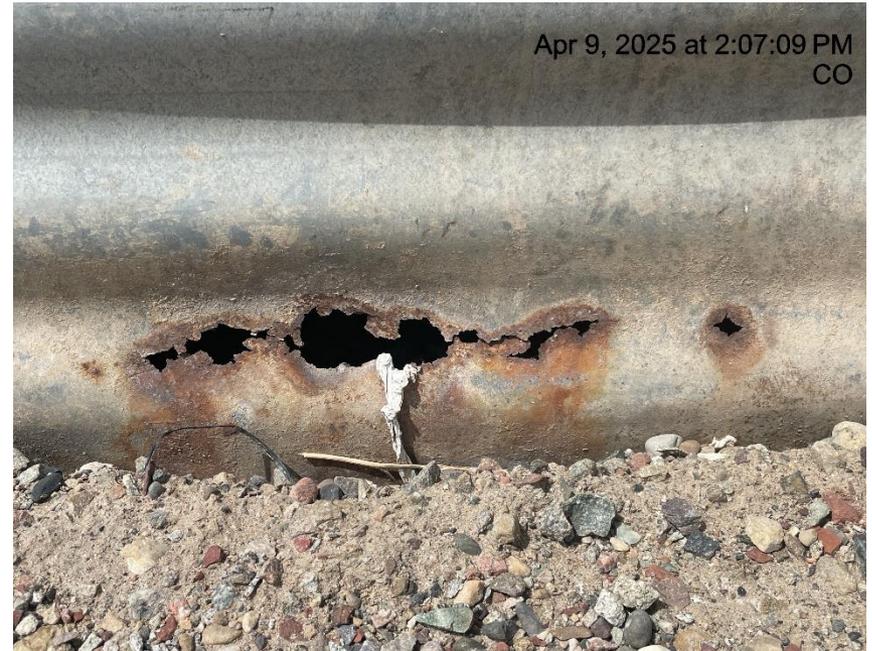
**Photo # 9799 Secondary containment metal tank ring rusted /damaged & needs maintenance**
