Inspection/Audit Photos

Location Name: TEP ROCKY MOUNTAIN LLC GIBSON GULCH UNIT 10-30 D Pad

Location ID: 324013

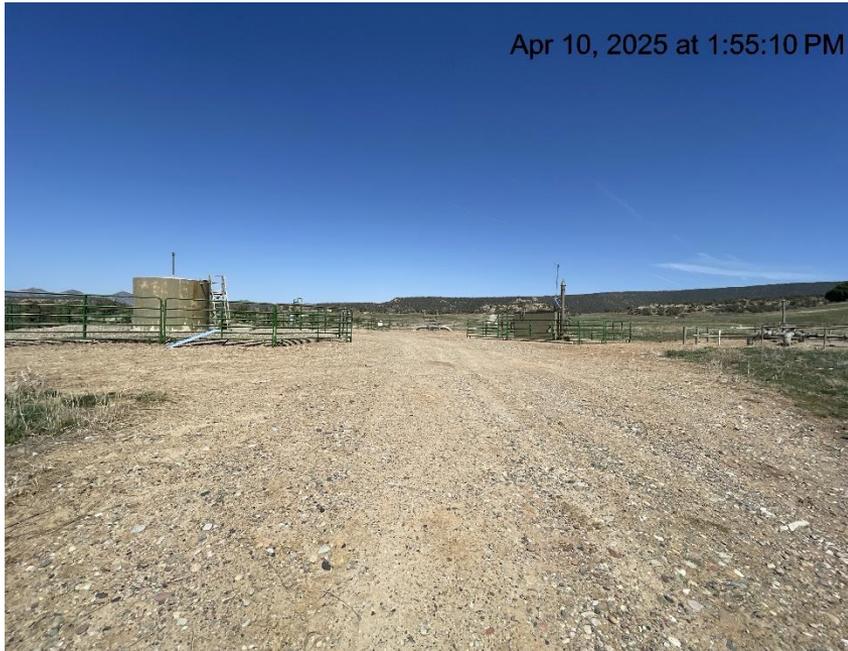
Photo # 468 From entrance to location

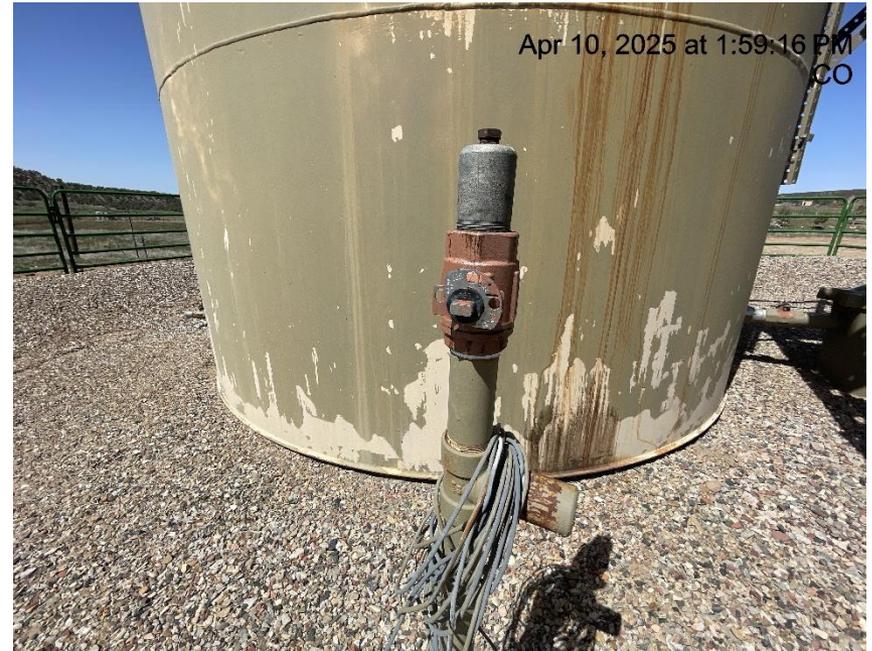
Photo # 475 Unused flowline lacks lockout tagout (OOSLAT)

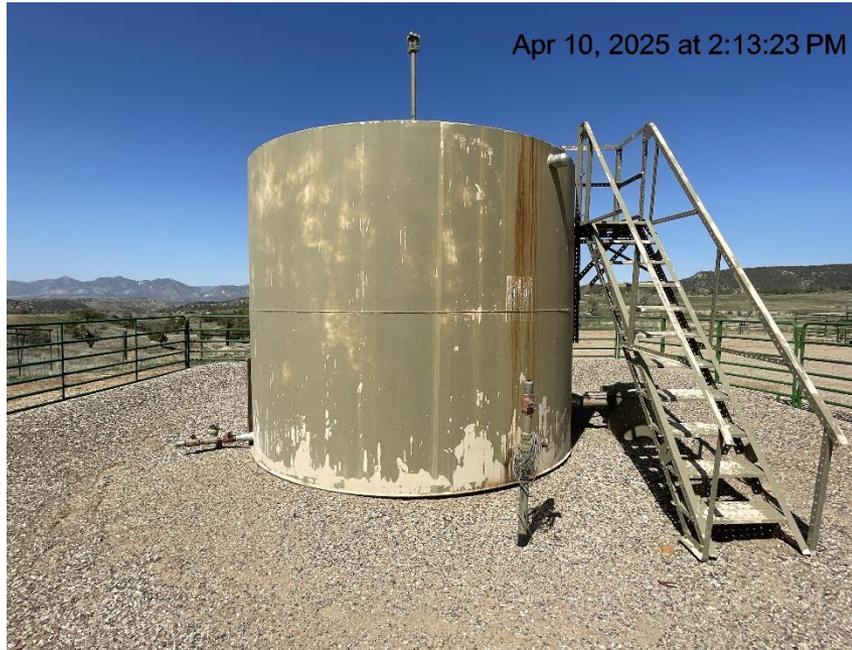
Photo # 476 Tank is disconnected & not in use/unused equipment

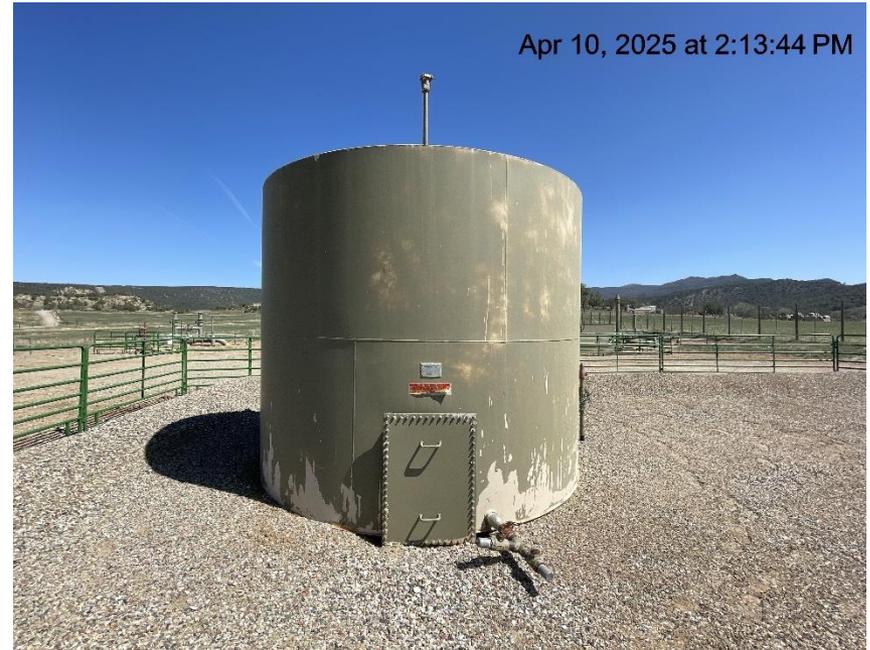
Photo # 477 Tank is disconnected & not in use/unused equipment

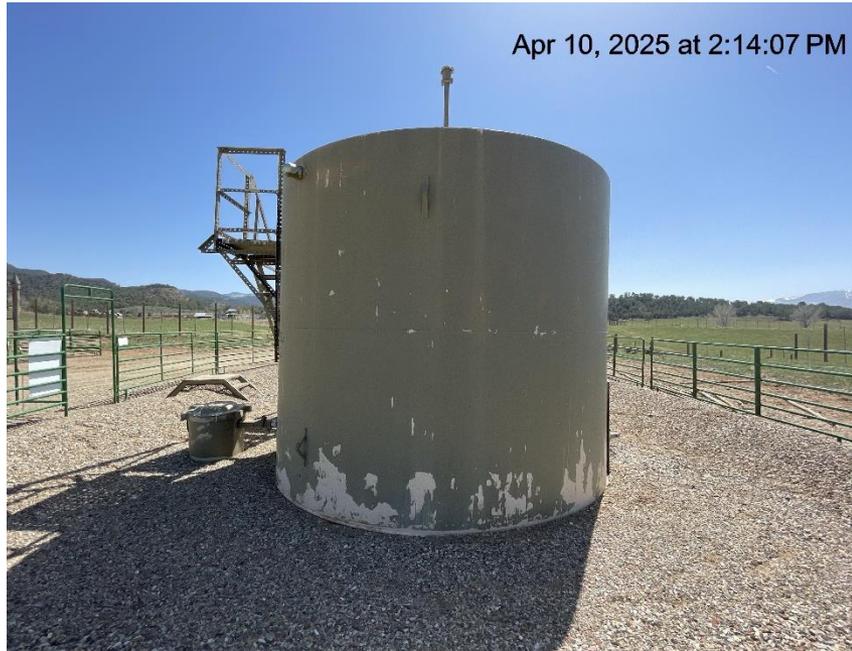
Photo # 478 Tank is disconnected & not in use/unused equipment

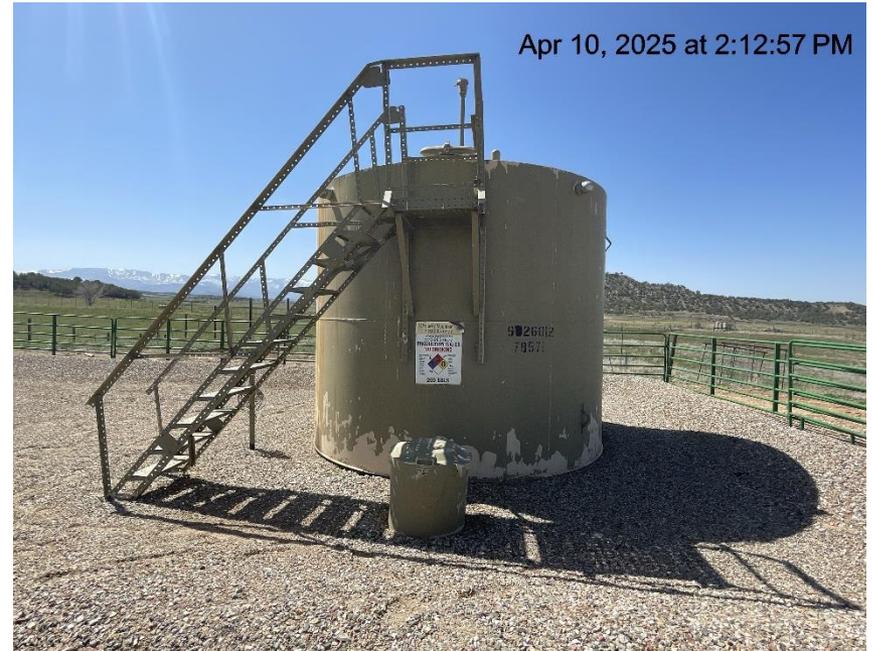
Photo # 479 Tank is disconnected & not in use/unused equipment

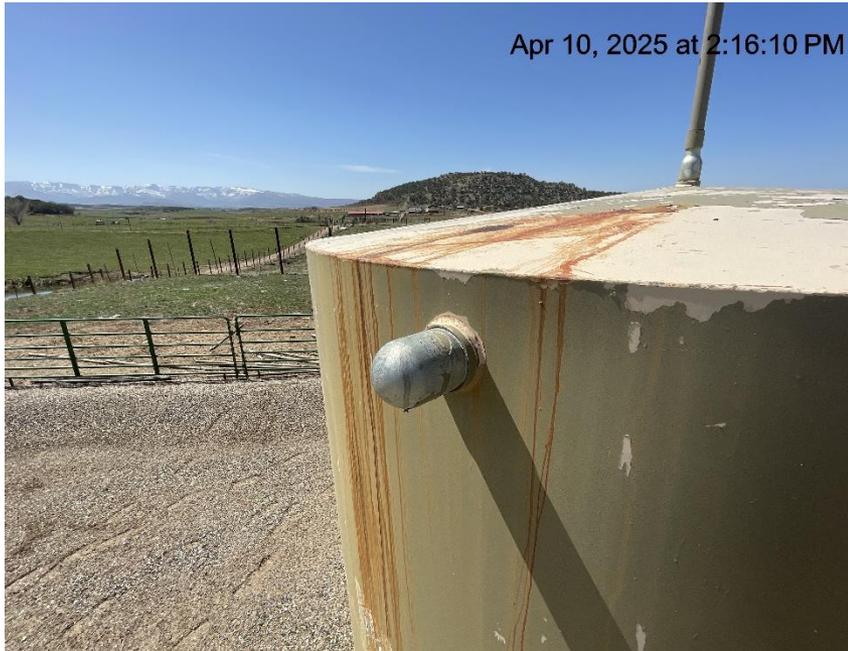
Photo # 480 Staining on top of tank & down the side of tank that indicates the tank may lack integrity.

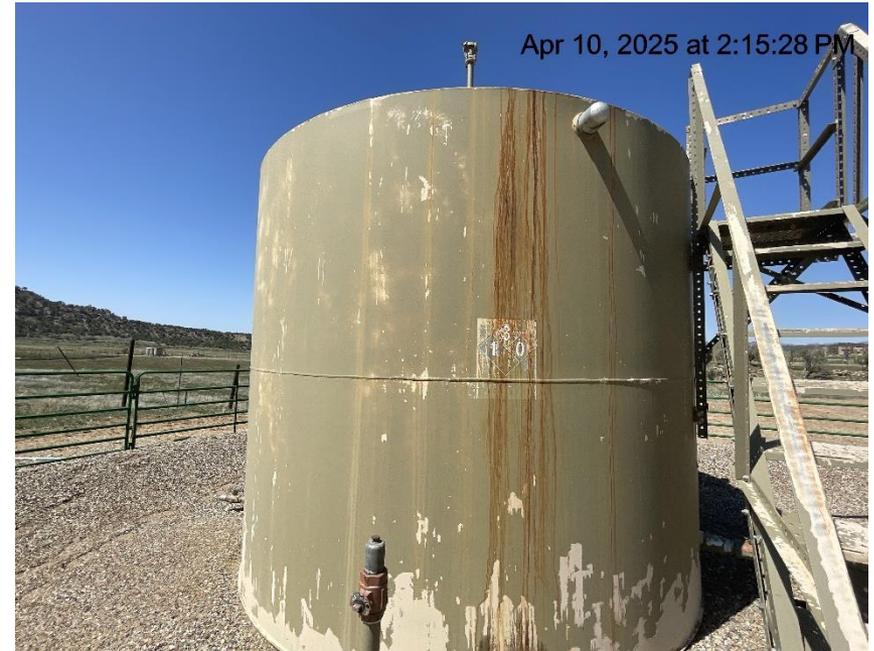
Photo # 481 Staining down side of tank

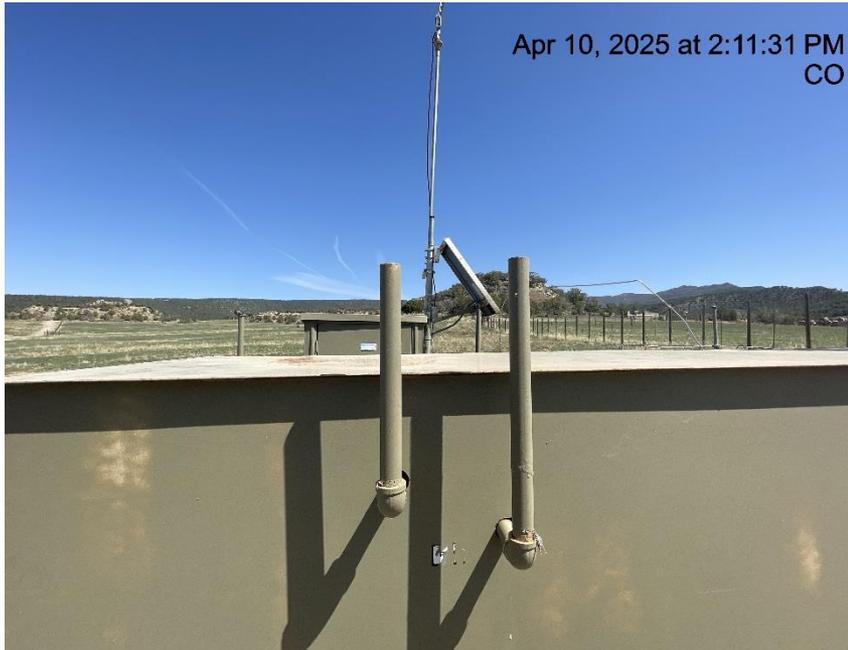
Photo # 482 PRV & rupture disc vent lines do not comply with CECMC pressure safety device rules

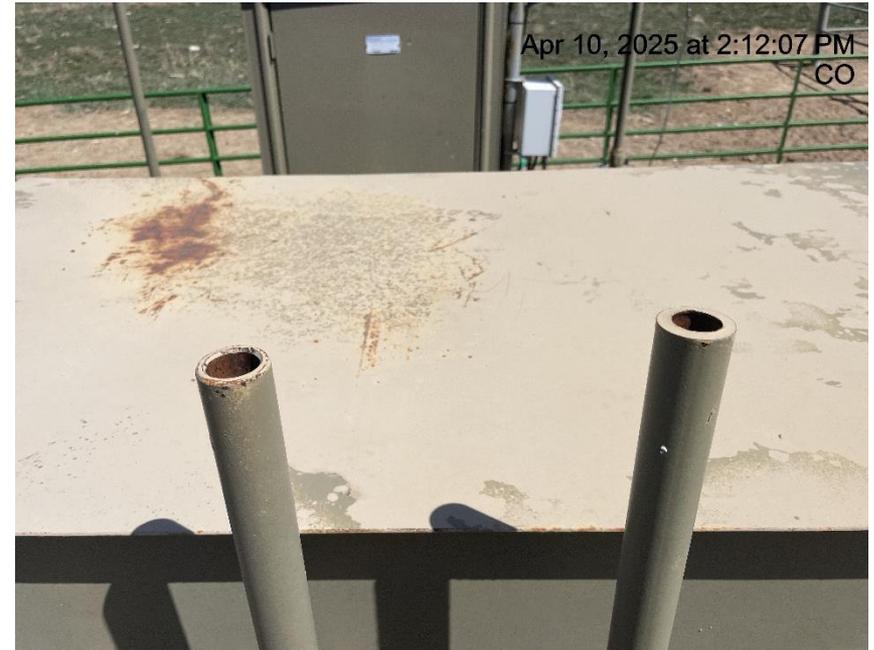
Photo # 483 PRV & rupture disc vent lines do not comply with CECMC pressure safety device rules

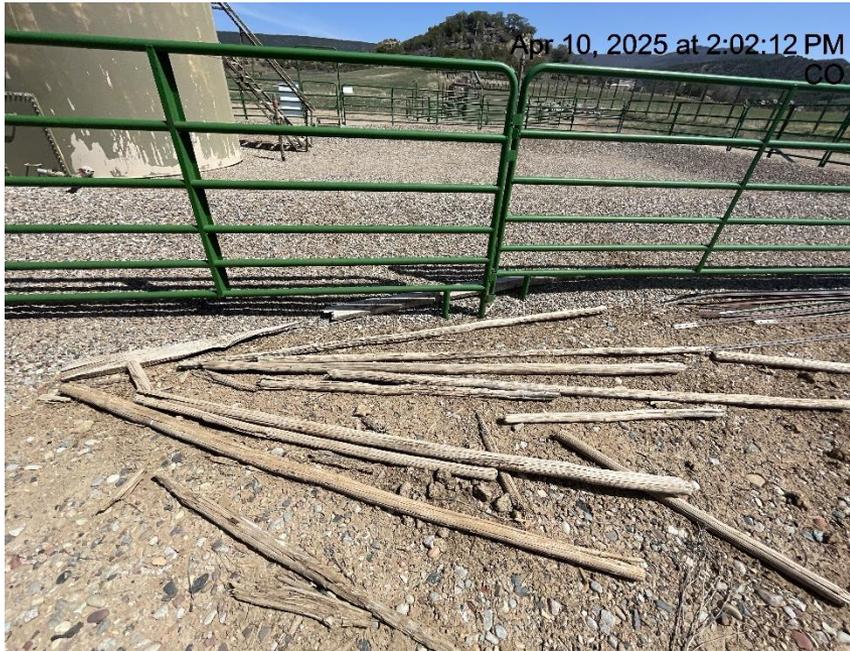
Photo # 484 Debris

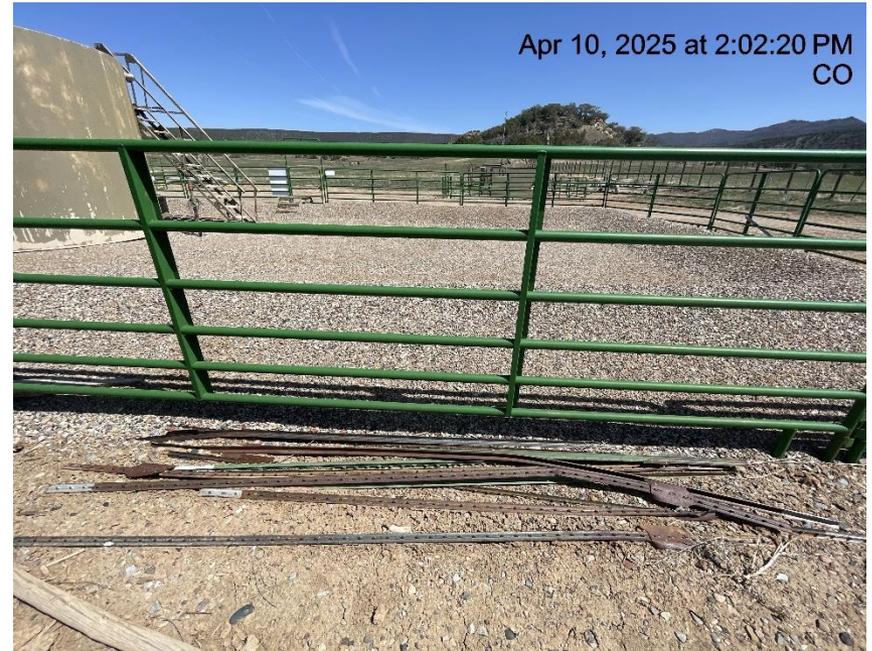
Photo # 485 Debris
