Interim Reclamation and Stormwater Inspection

April 9, 2025

Location Name: Peoria Tank Battery/

Inspection Document #: 718600476

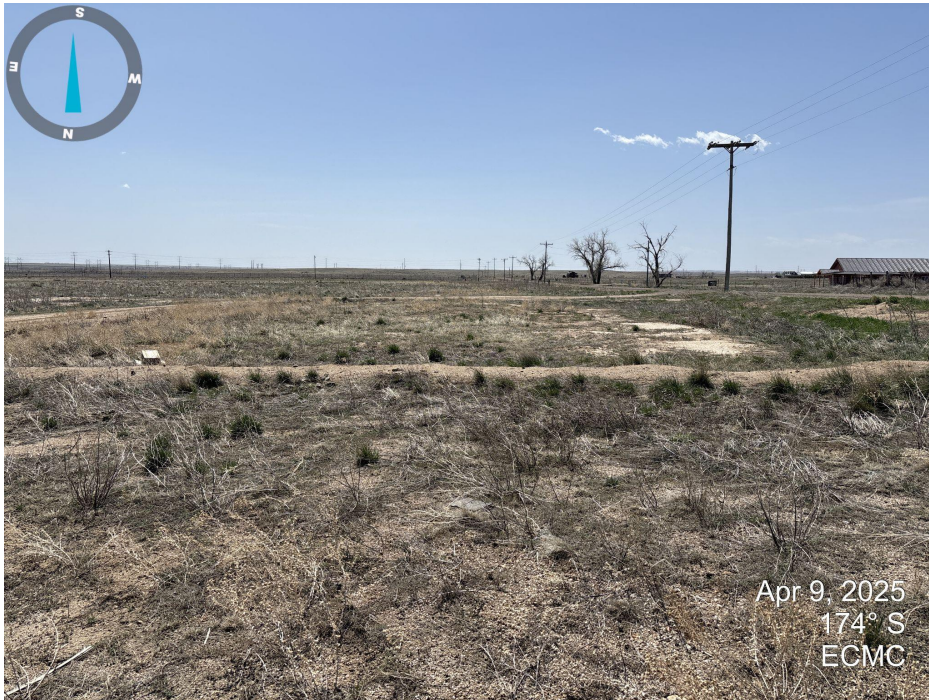
Photo 1. Looking south across west side of the location. Stormwater BMPs (berm) are present around what appears to be land application sites.

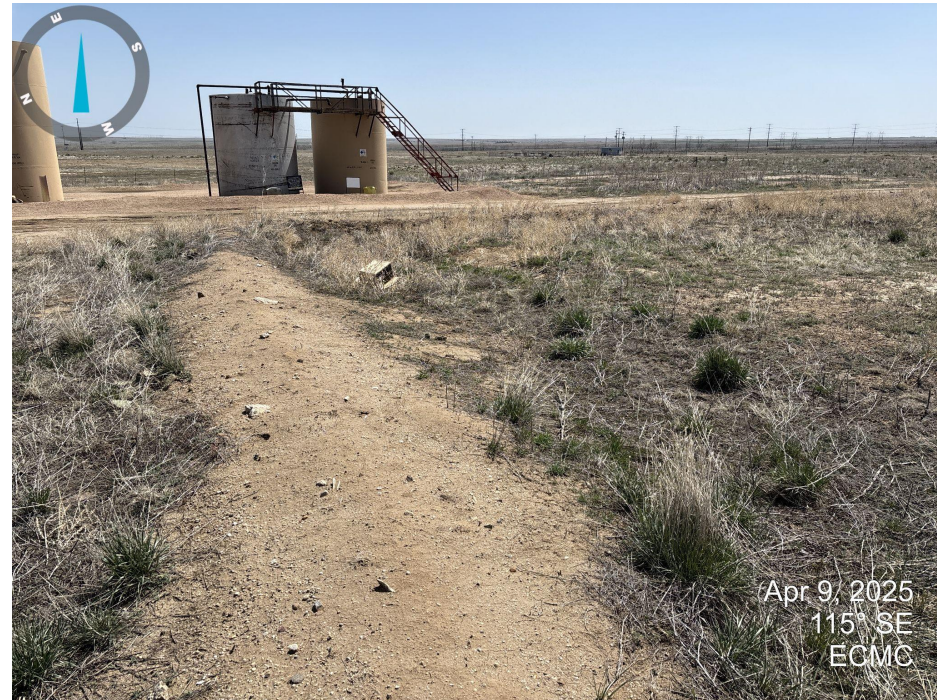
Photo 2. Looking east along berm towards tank battery.

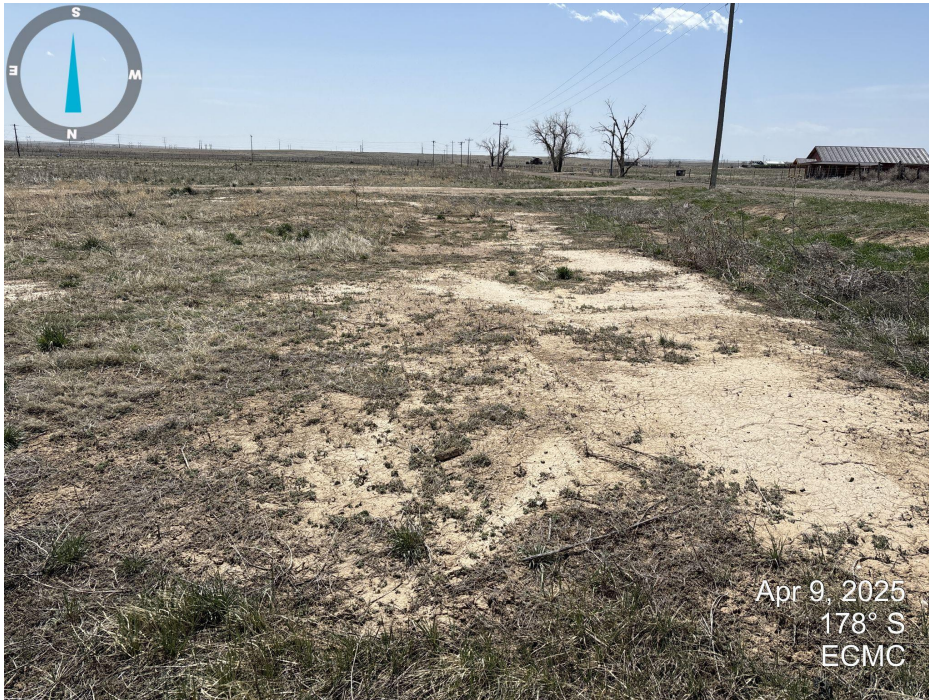
Photo 3. Inside the berm there are large areas of bare soil and vegetation is primarily undesirable weedy vegetation.

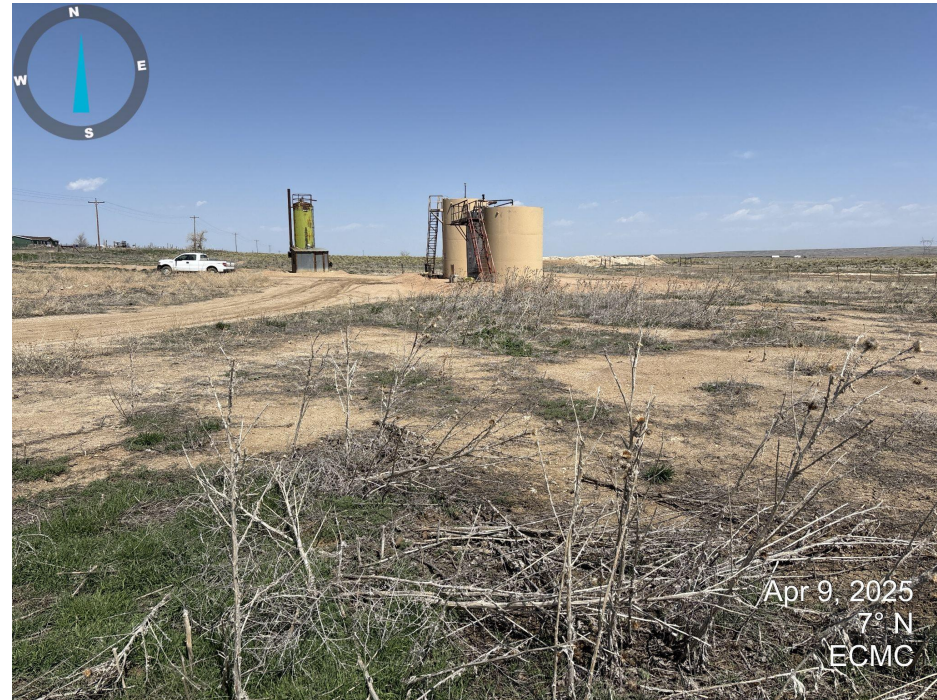
Photo 4. Looking north across the location. List B noxious weed Scotch Thistle is present throughout the location. Large areas of bare soil are present within the location disturbance.

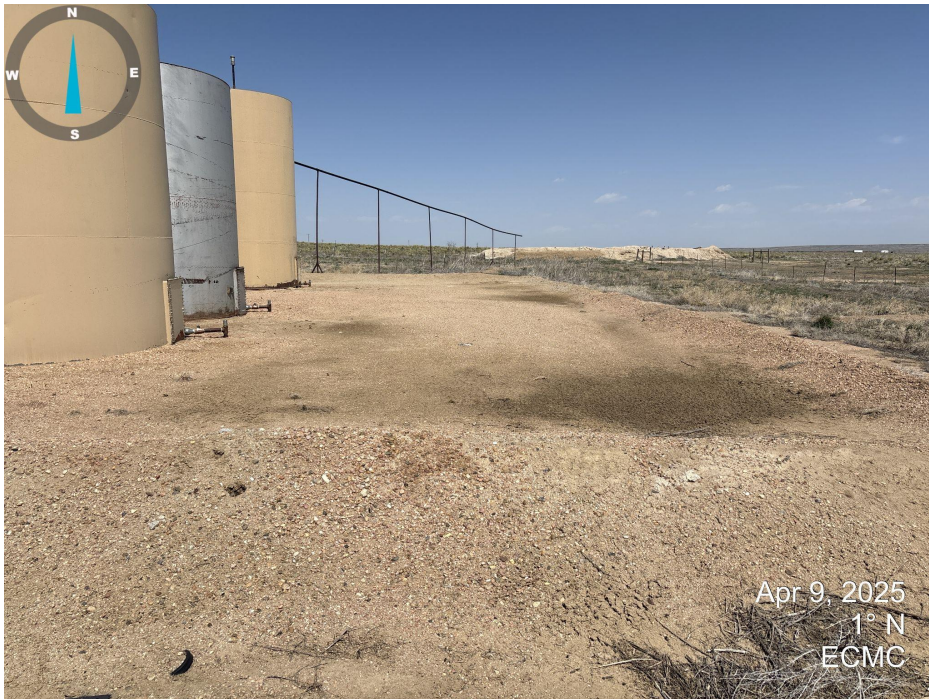
Photo 5. Looking north long the back of the tank battery.

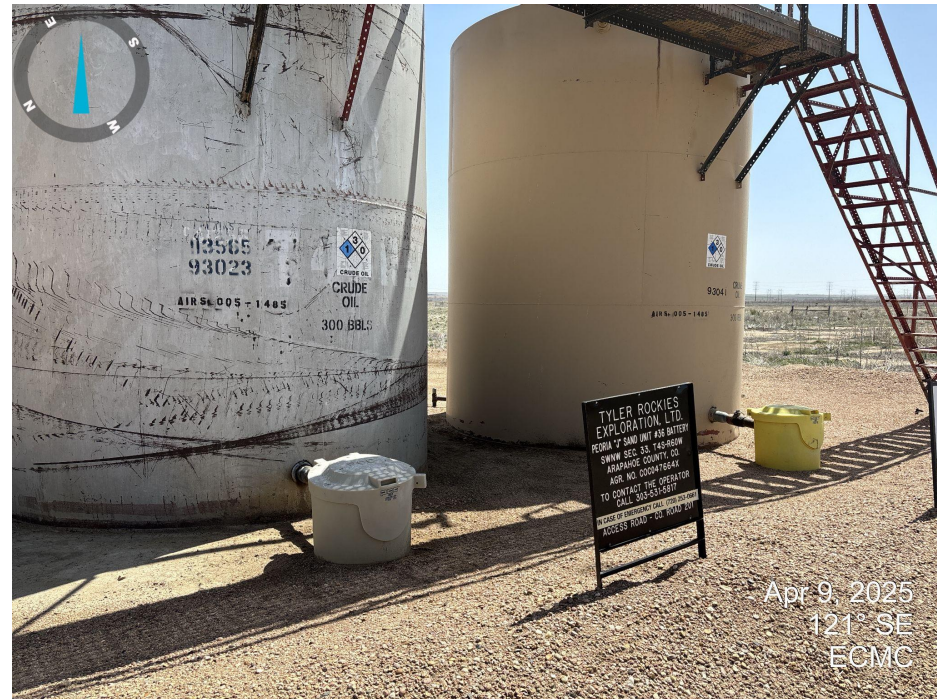
Photo 6. Southern two crude oil tanks and sign.

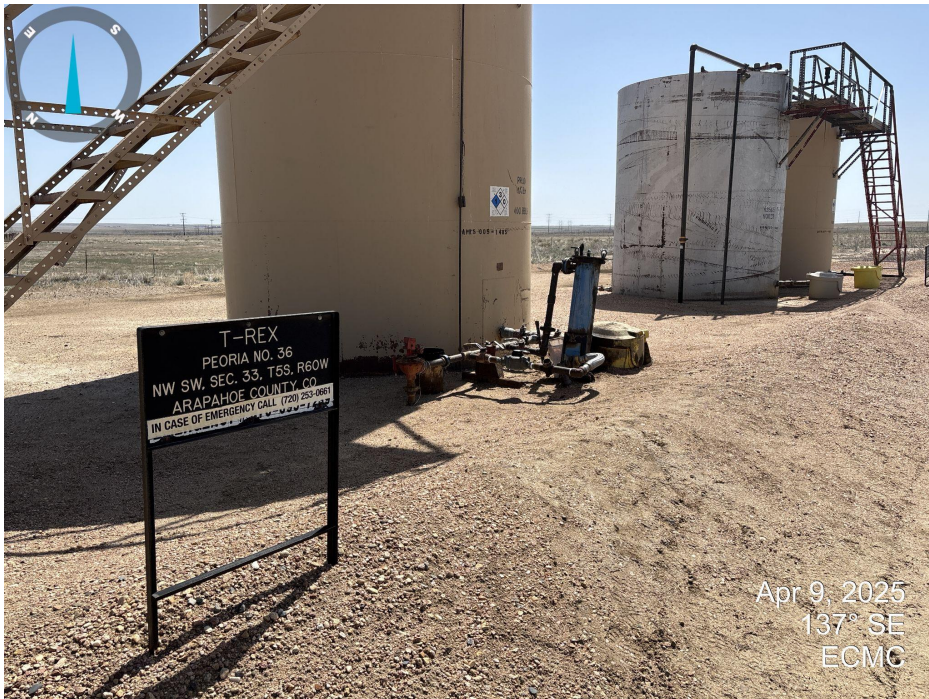
Photo 7. Northern produced water tank and sign.

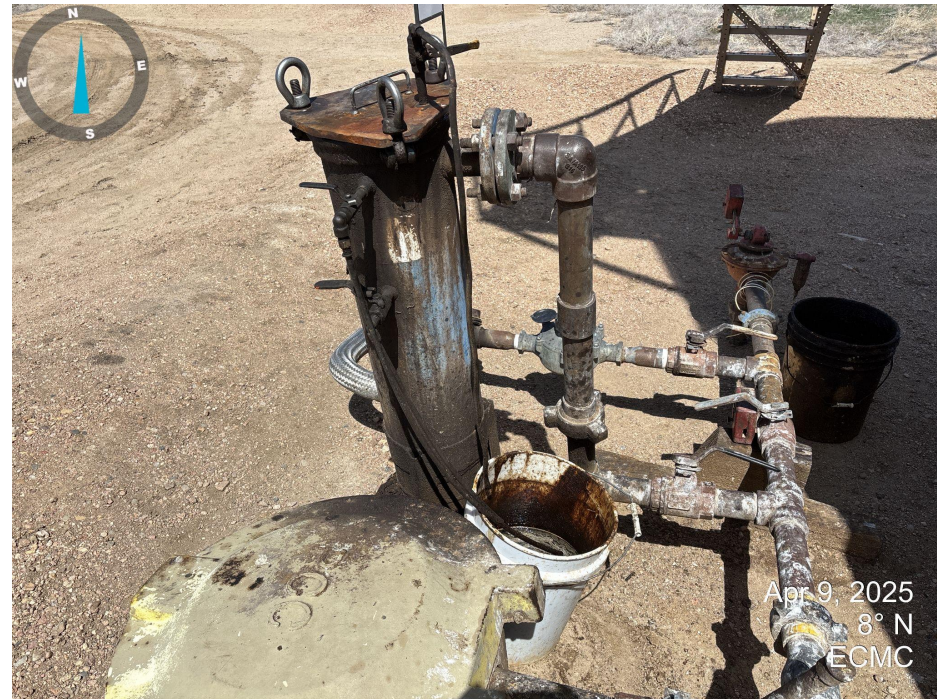
Photo 8. Equipment in front of produced water tank. Two buckets containing oily fluid are present.

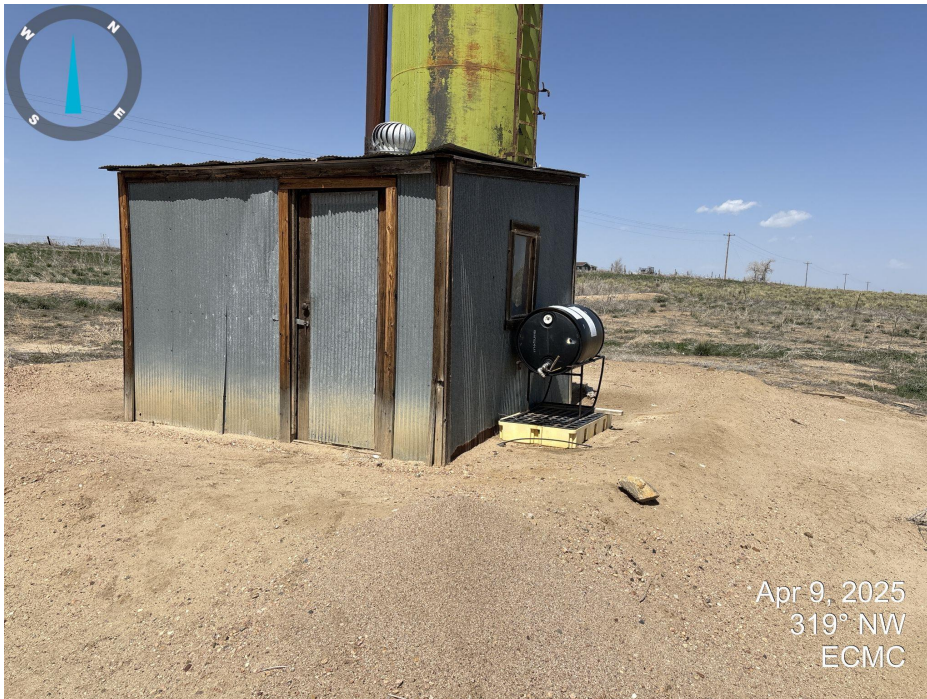
Photo 9. Looking northwest at the separator shed. Barrel secondary containment does not have a wildlife exclusion device installed.

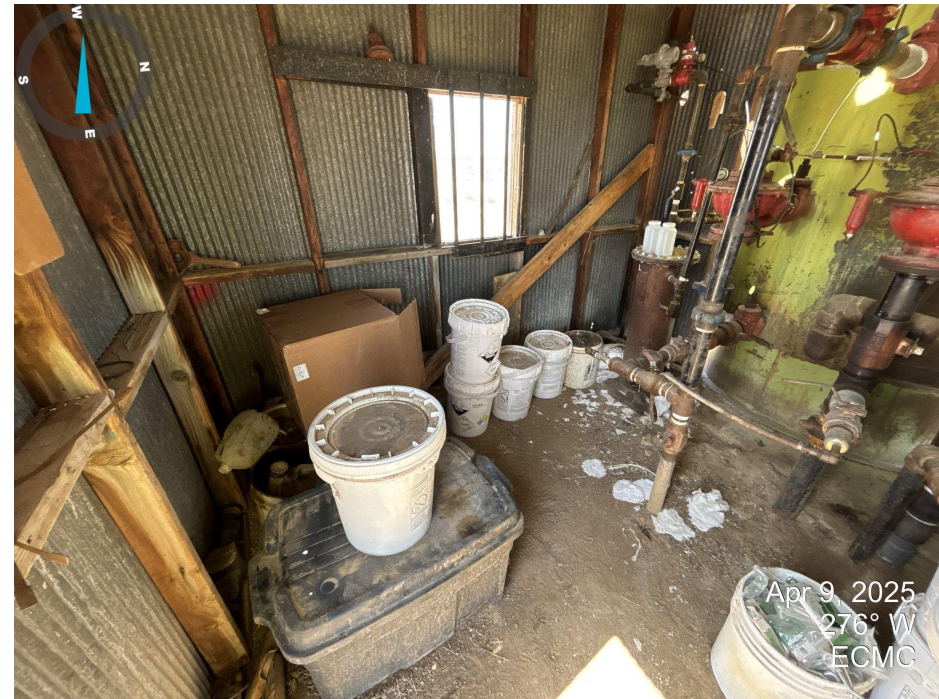
Photo 10. Inside shed. Chemicals and equipment are being stored inside the separator shed.

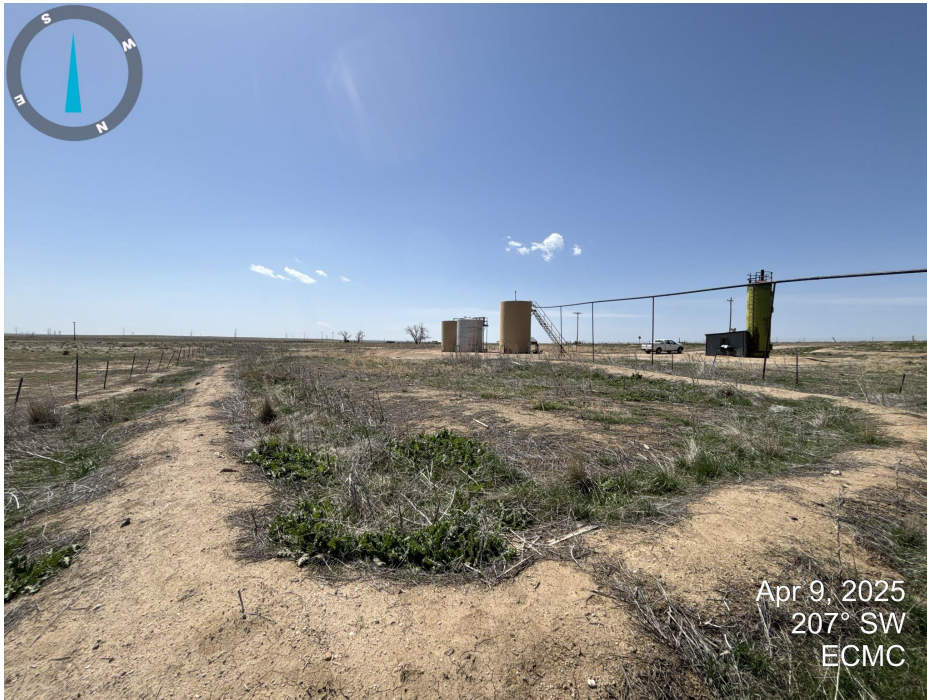
Photo 11. Looking south across tank battery location near eastern potential land application field.

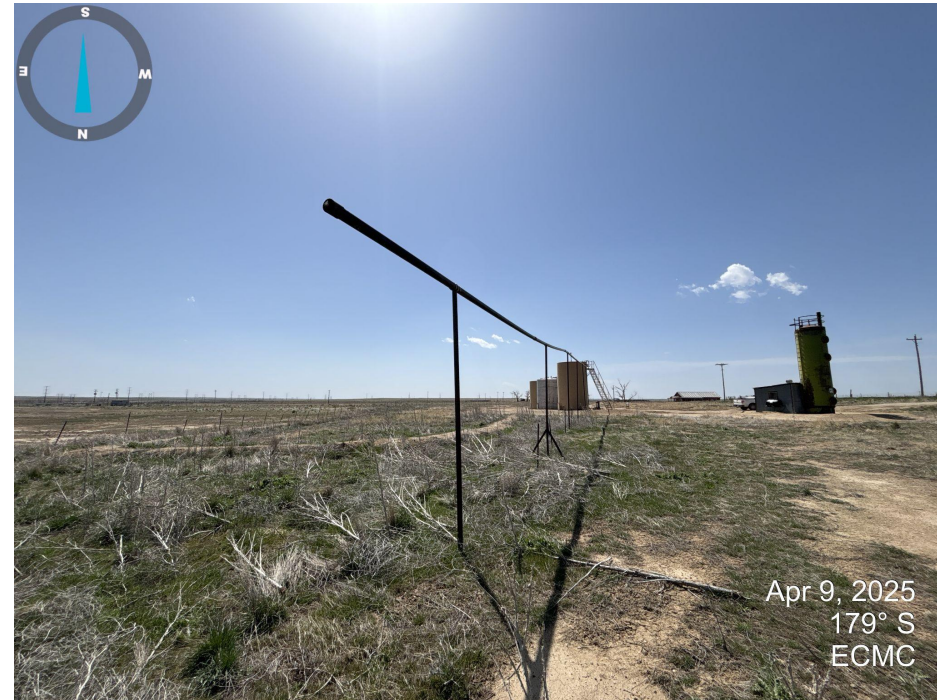
Photo 12. Pipe from produced water tank to evaporation pond is capped off.

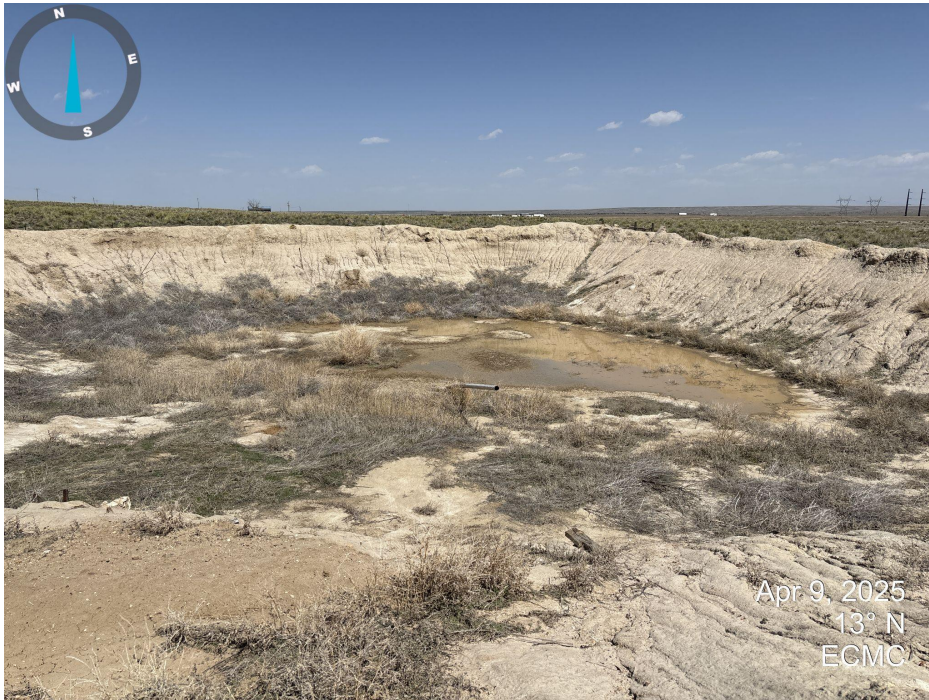
Photo 13. Looking north across evaporation pond. Channel erosion is present around the entire interior of the pond. Standing water is present in pond at the time of inspection.

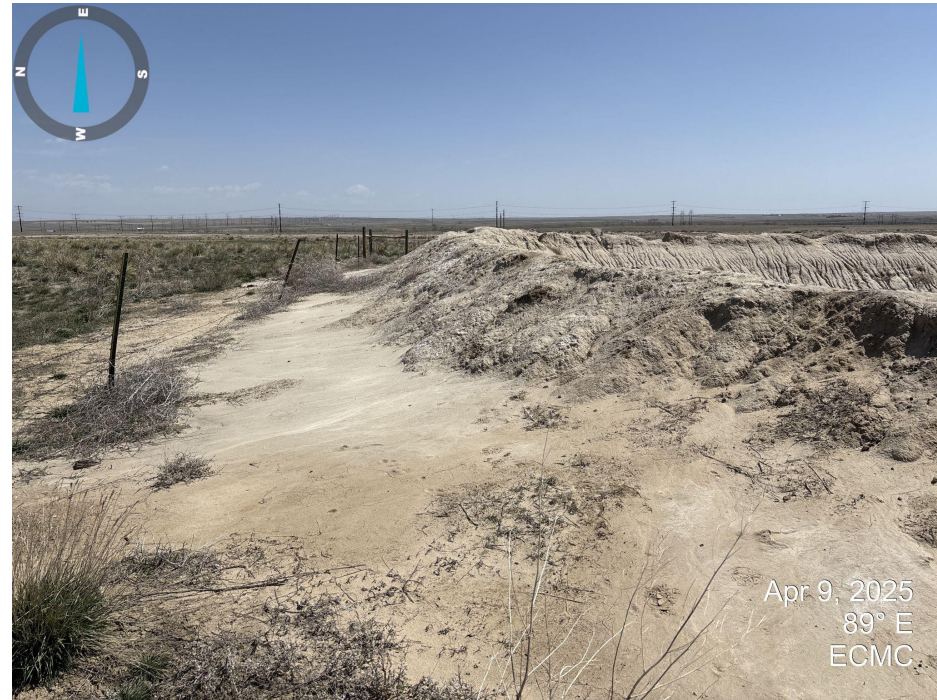
Photo 14. Looking east long north side of pond. Heavy erosion is present on the outside of the berm and sediment is being transported off location by stormwater.

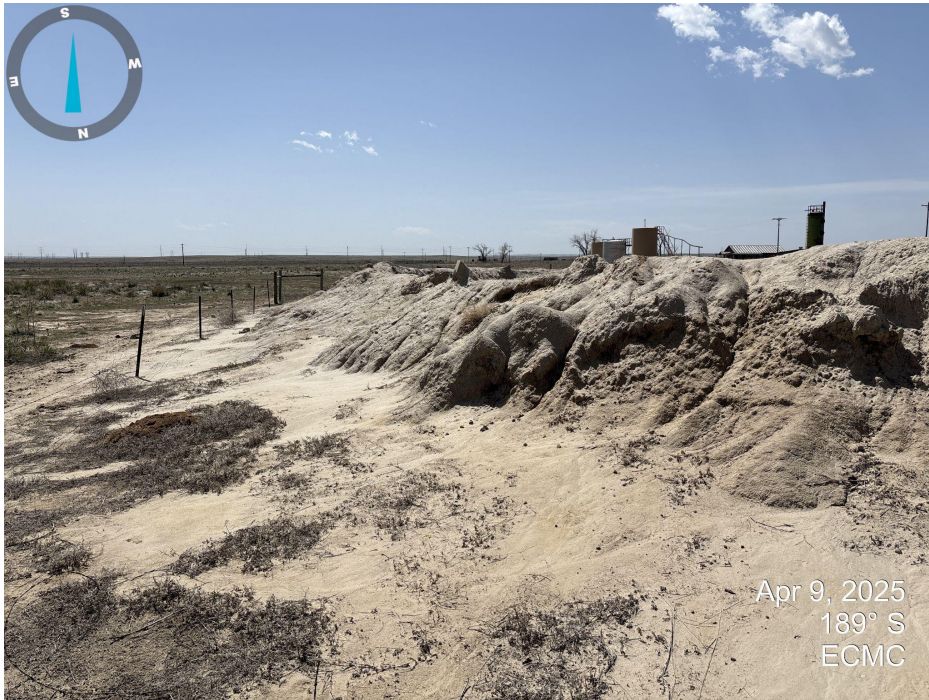
Photo 15. Looking south down east side of pond. See photo 14 comments.

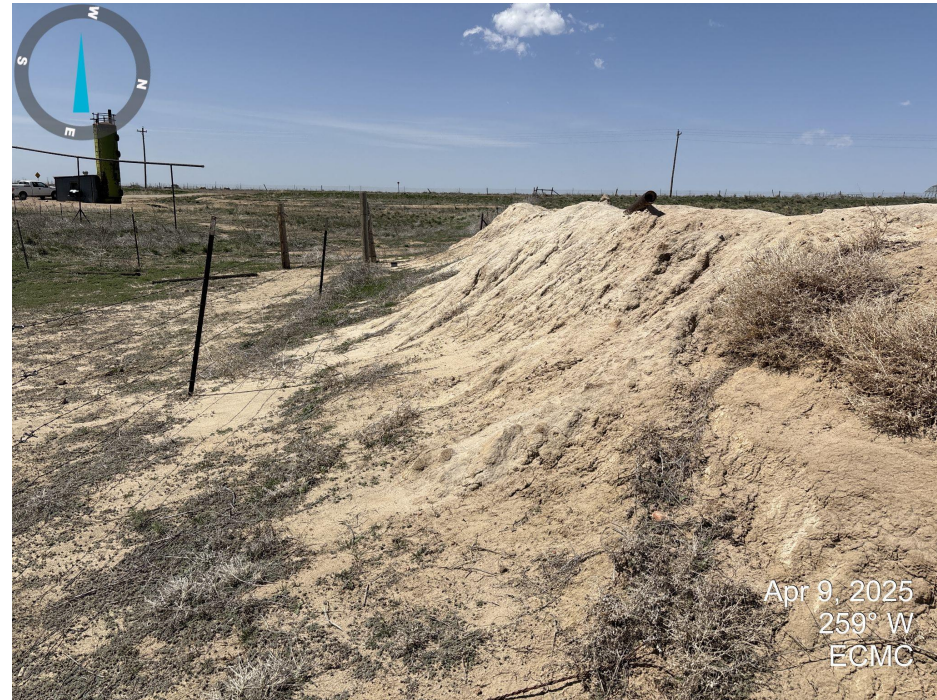
Photo 16. Looking west down south side of pond. See photo 14 comments.

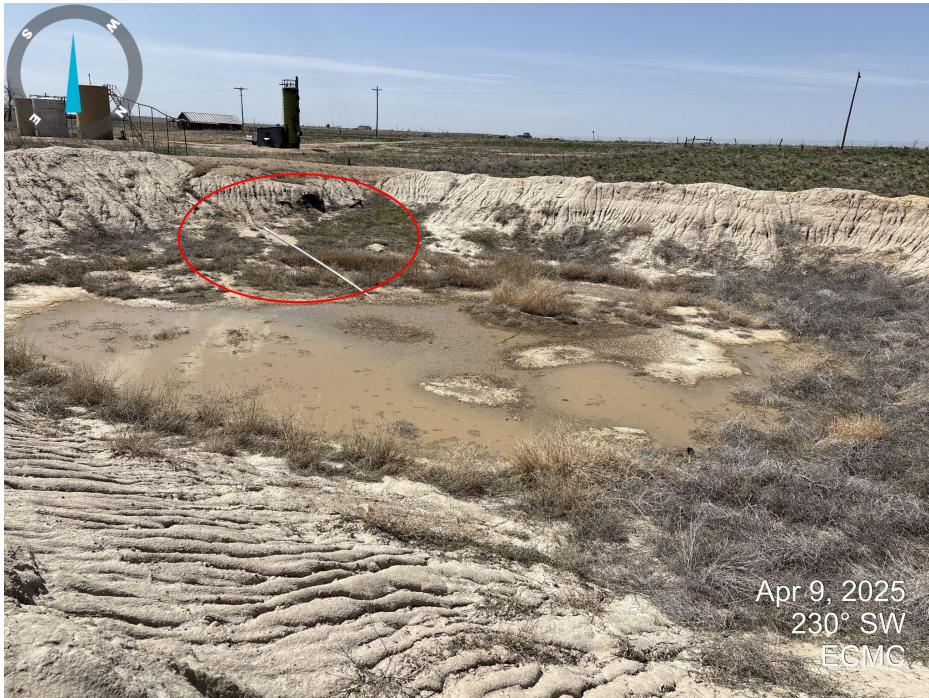
Photo 17. Looking southwest across pond towards former skim pit. Equipment remains in pond (pipes, wood material).

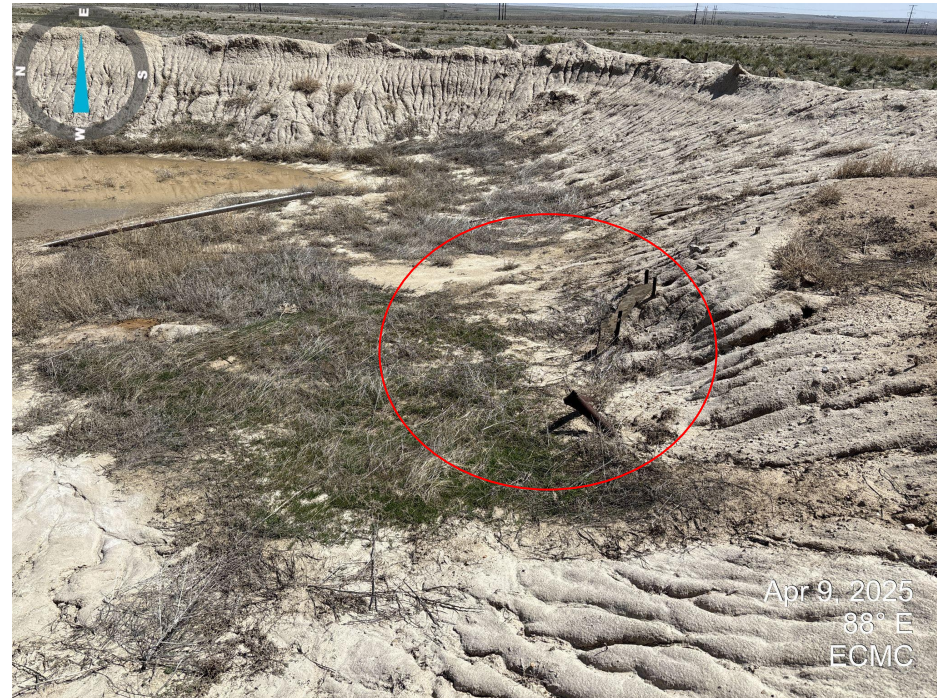
Photo 18. Looking east across inside of pond. See photo 17 comments.

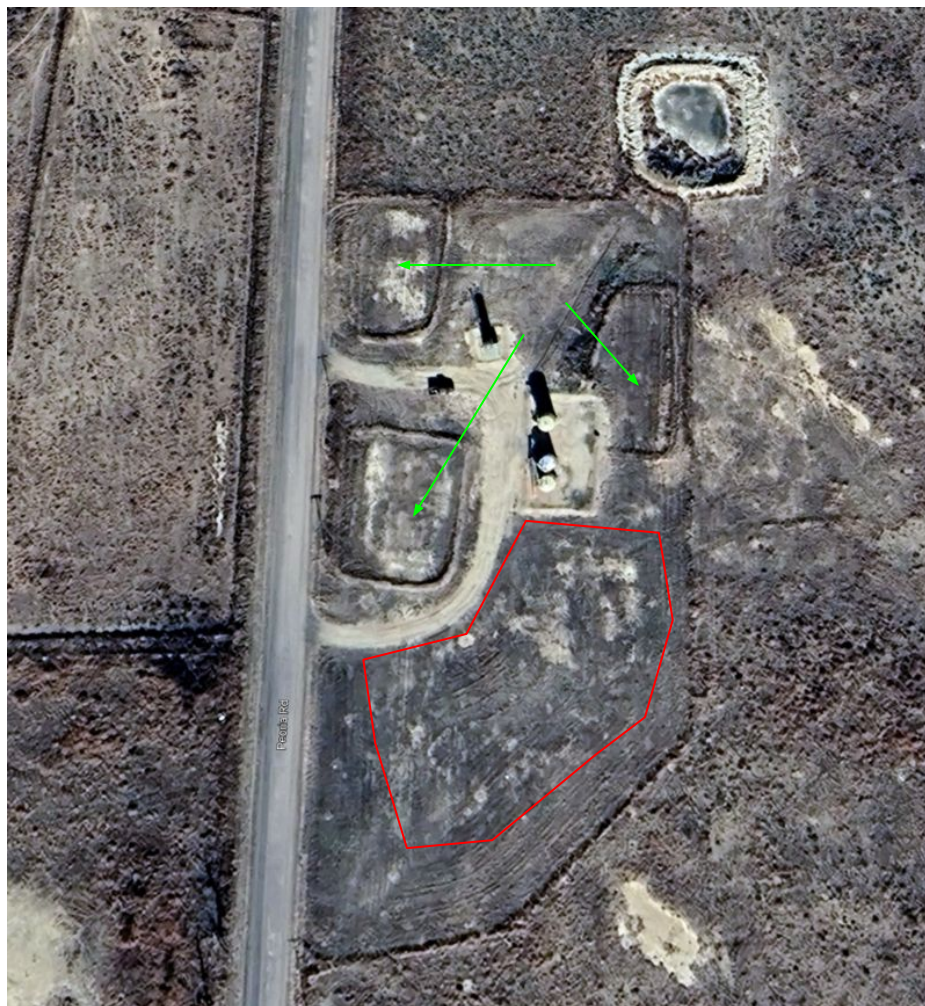
Photo 19. Google earth aerial imagery from 06/2024. Illustrating land treatment areas (green arrows) and area within location disturbance with large areas of bare ground and list B noxious weed scotch thistle (red circle).
