**Operator: CRESTONE PEAK RESOURCES OPERATING LLC**

**Location Name: PURITAN-62N68W 34SWSE**

**Loc ID: 331935**

**Inspection: 718600260**

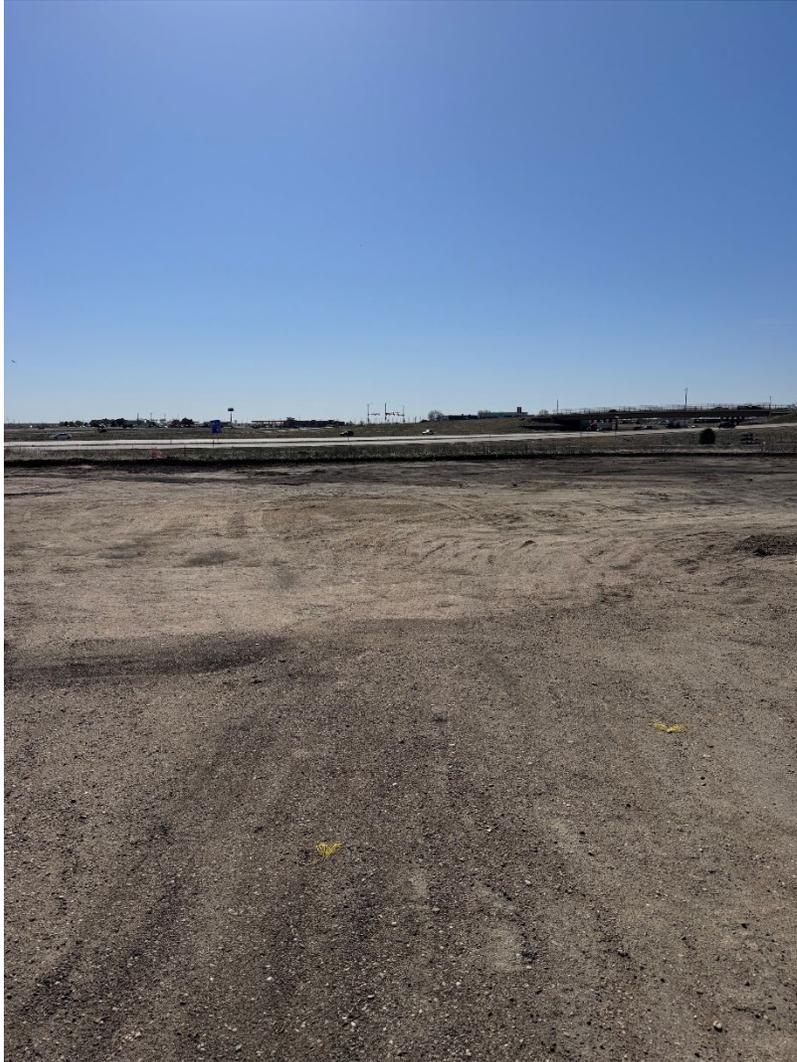
**Exhibit A**

**CA:** An in process Form 44 (Doc Id #402543661) submitted 12/01/2020 indicates the flowline between Puritan #34-34 (Loc ID #331935) and PURITAN/2N68W/34SESE (Loc ID #336413) was flushed and abandoned in place. There is a fenced open excavation at the wellbore. It appears the open excavation may be related to flowline abandonment. See attached photos. Continue to work with ECMC engineering staff for Form 44 approval. Fill and reclaim excavations according to Rule 1004.

**CA:** There is an open excavation on location. Fencing is not adequately installed to prevent entry. See attached photos. Comply with Rule 913.b.5.B.i. Fence excavations to prevent entry.

**CA Resolution:** Operator has backfilled all holes on pad and addressed fencing in order to comply with Rule 1004.

**CA Resolution:** Operator has addressed the issue, in order to comply with Rule 913.b.5.B.i.
