Inspection Photos

API: 017-06622

Operator: **WILLIFORD ENERGY COMPANY**

Inspection Date: 4/9/2025

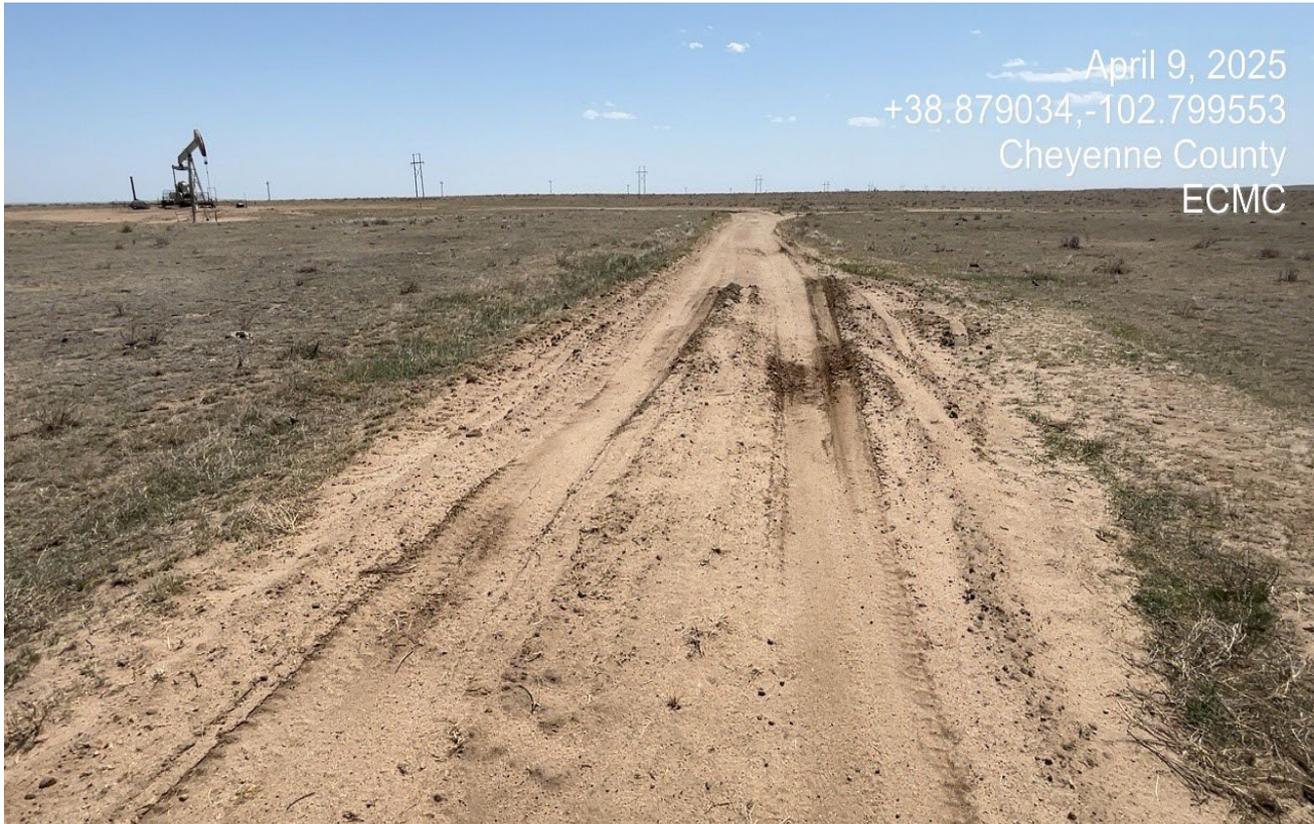
Photo 1. Facing south along the access road. The access road has not been repaired and stabilized. This is a low spot of the road where stormwater accumulates. It does not appear vehicles have been driving outside of this area recently.

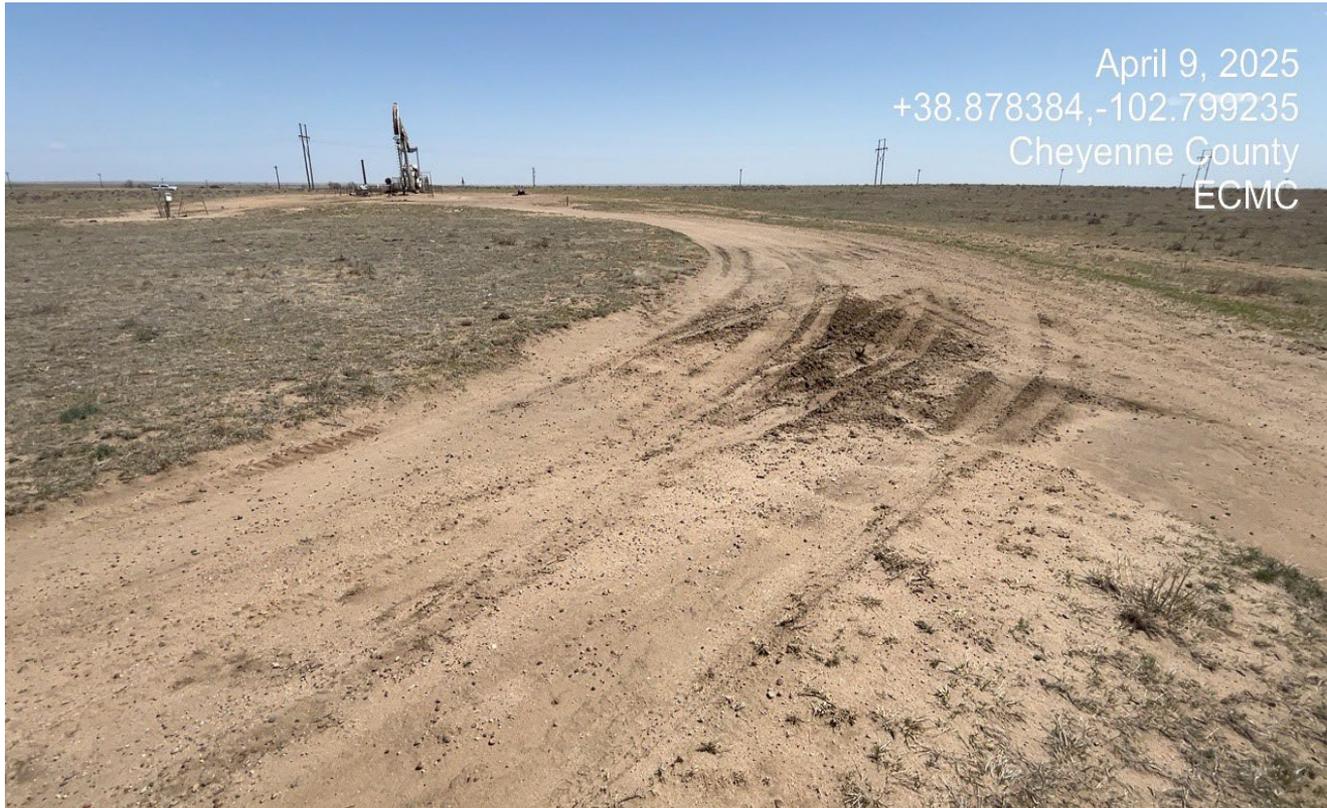
Photo 2. Facing southeast along the access road. The access road has not been repaired and stabilized. This is a low spot of the road where stormwater accumulates.

Photo 13. Drone aerial phot facing west toward the access road and flowline disturbance which must be reclaimed. Red arrow points to the area of road damage that is shown in photo #2.

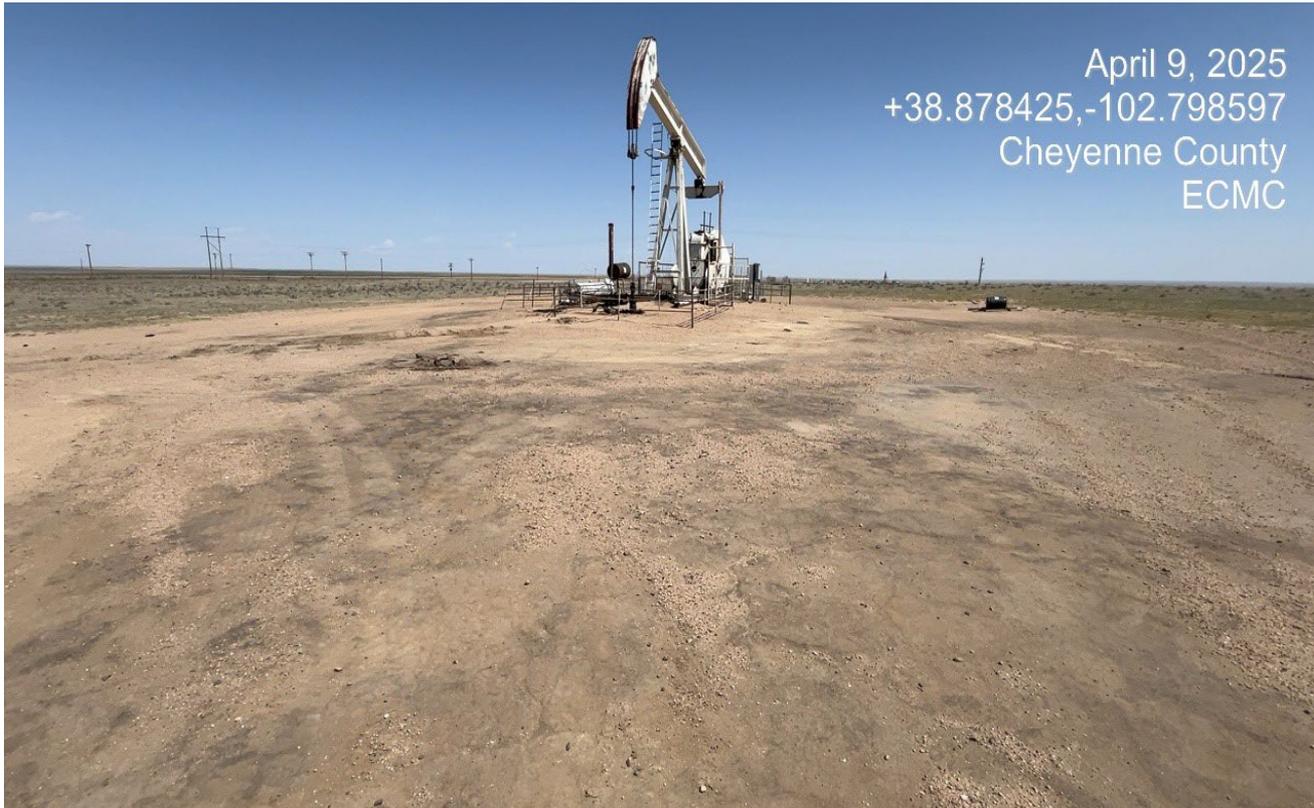
Photo 3. Facing east toward the wellsite.

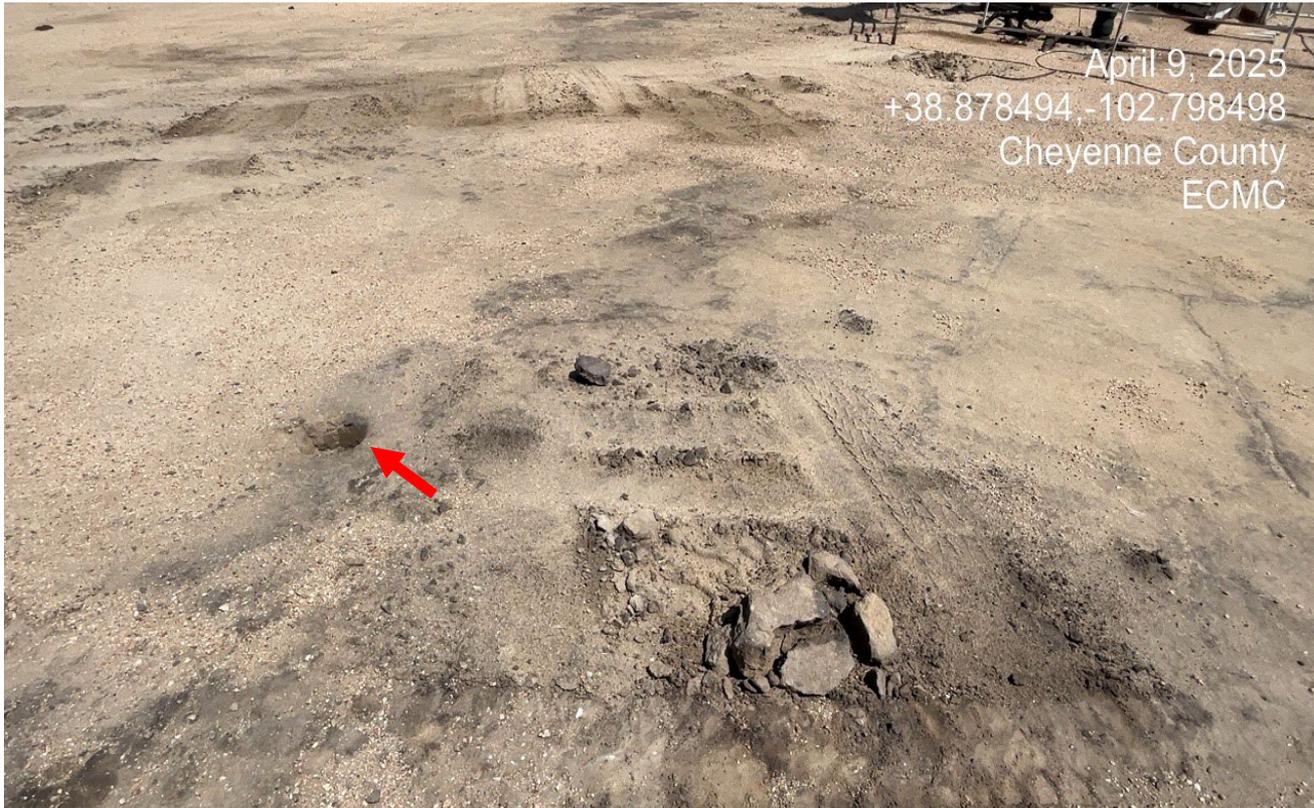
Photo 4. It appears a sample hole was taken shown at red arrow. Two other holes were observed but further delineation of impacts will need to be sampled and evaluated.

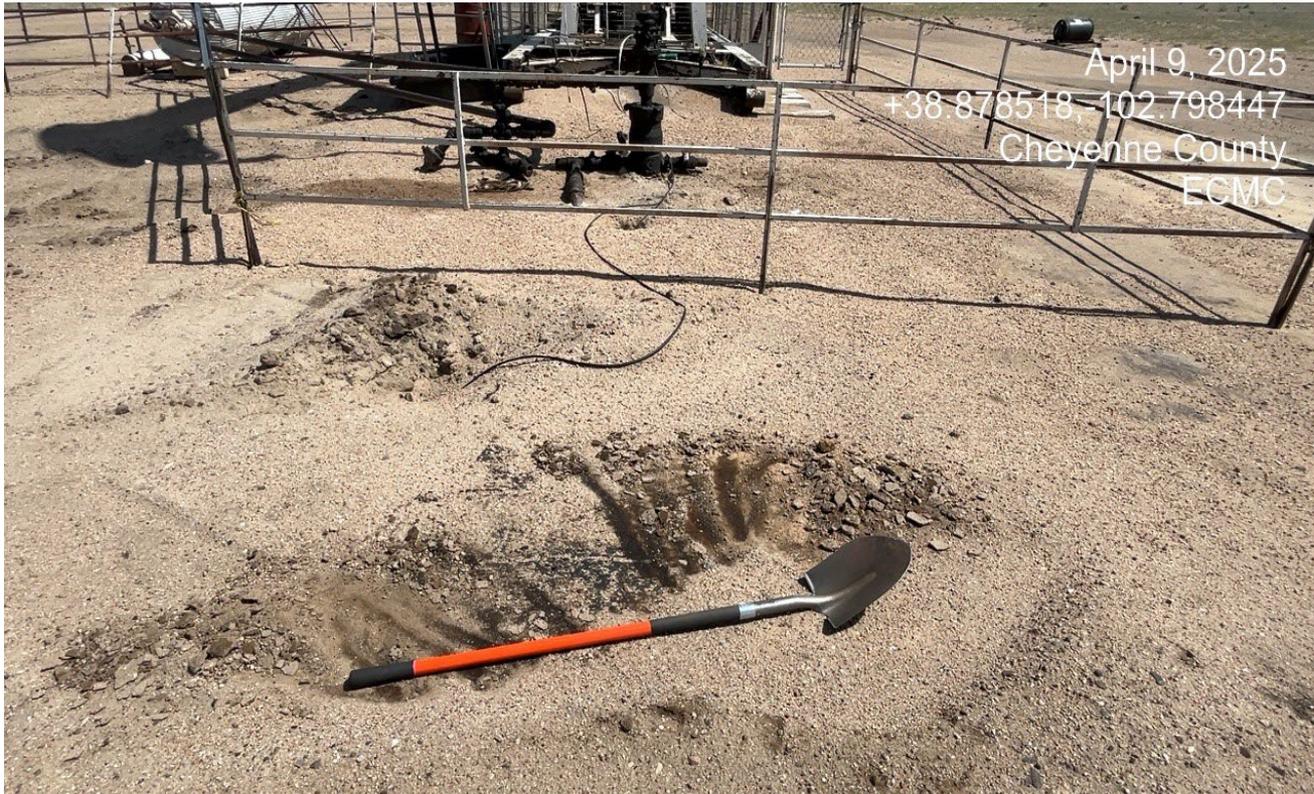
Photo 5. Closer to the well there is hydrocarbon impacts shown where shovel was placed.

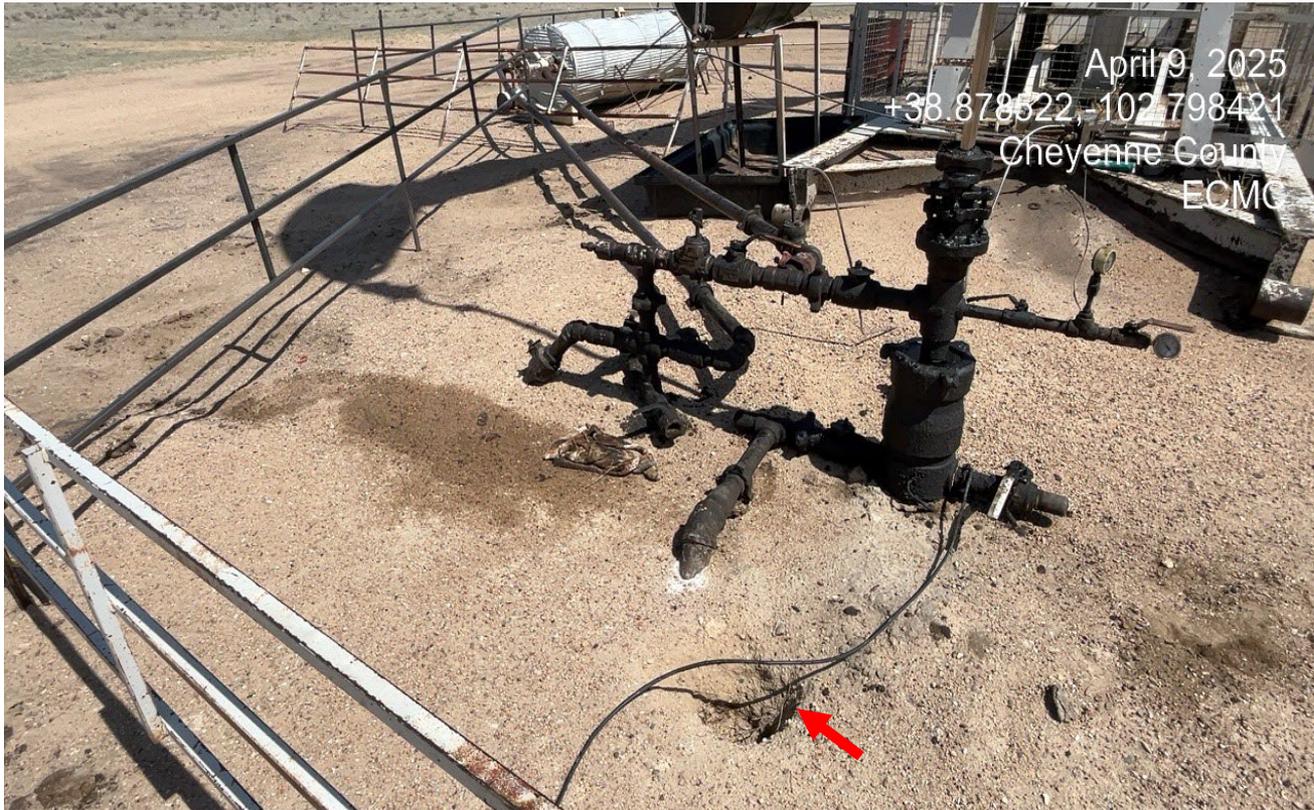
Photo 6. There is an oily rag and stained material next to the well. Another sample hole is shown at red arrow. The hole only goes down to about 6 inches.

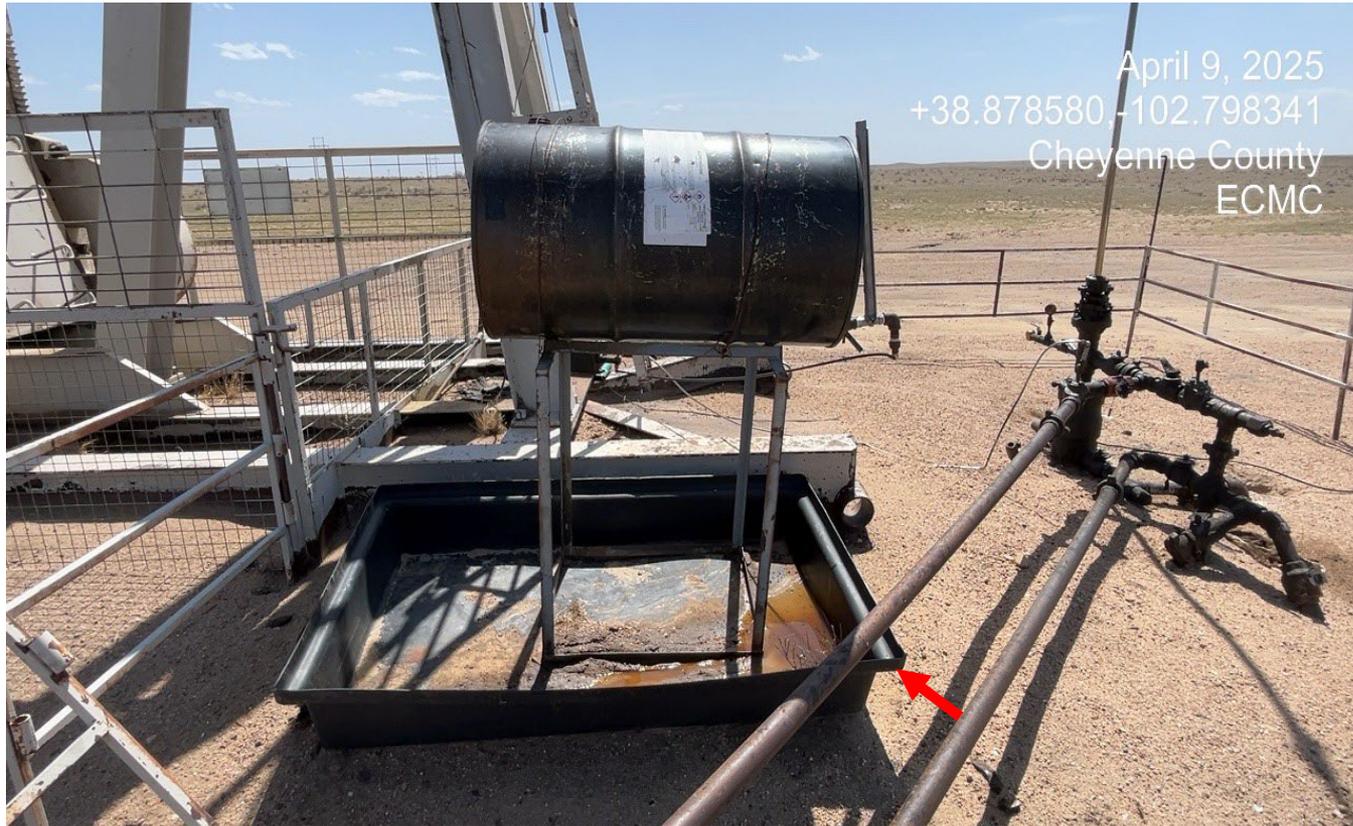
Photo 7. This chemical drum has been placed in secondary containment. The containment has oily fluids and needs to be covered/netted to prevent wildlife entry.

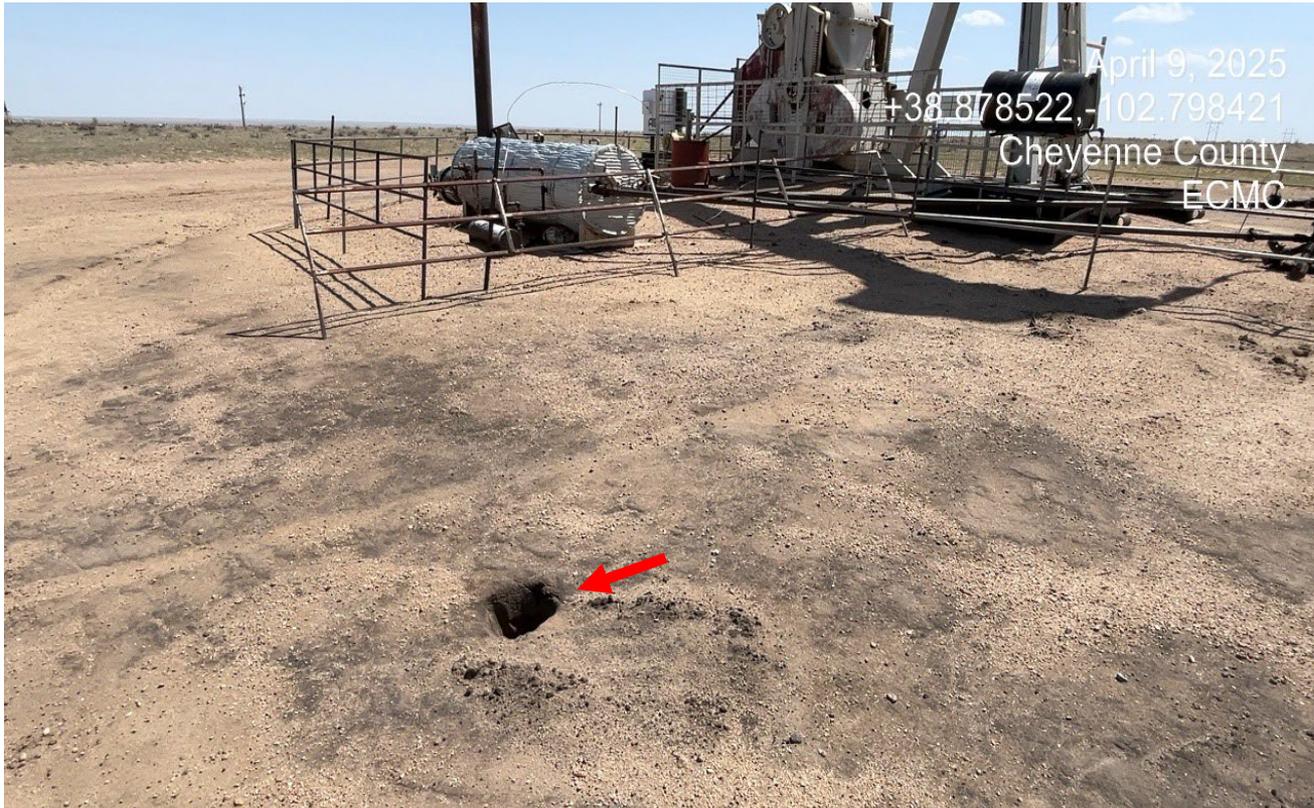
Photo 8. There is another sample hole about 20 ft. north of the well. The hole should be filled in to prevent tripping.

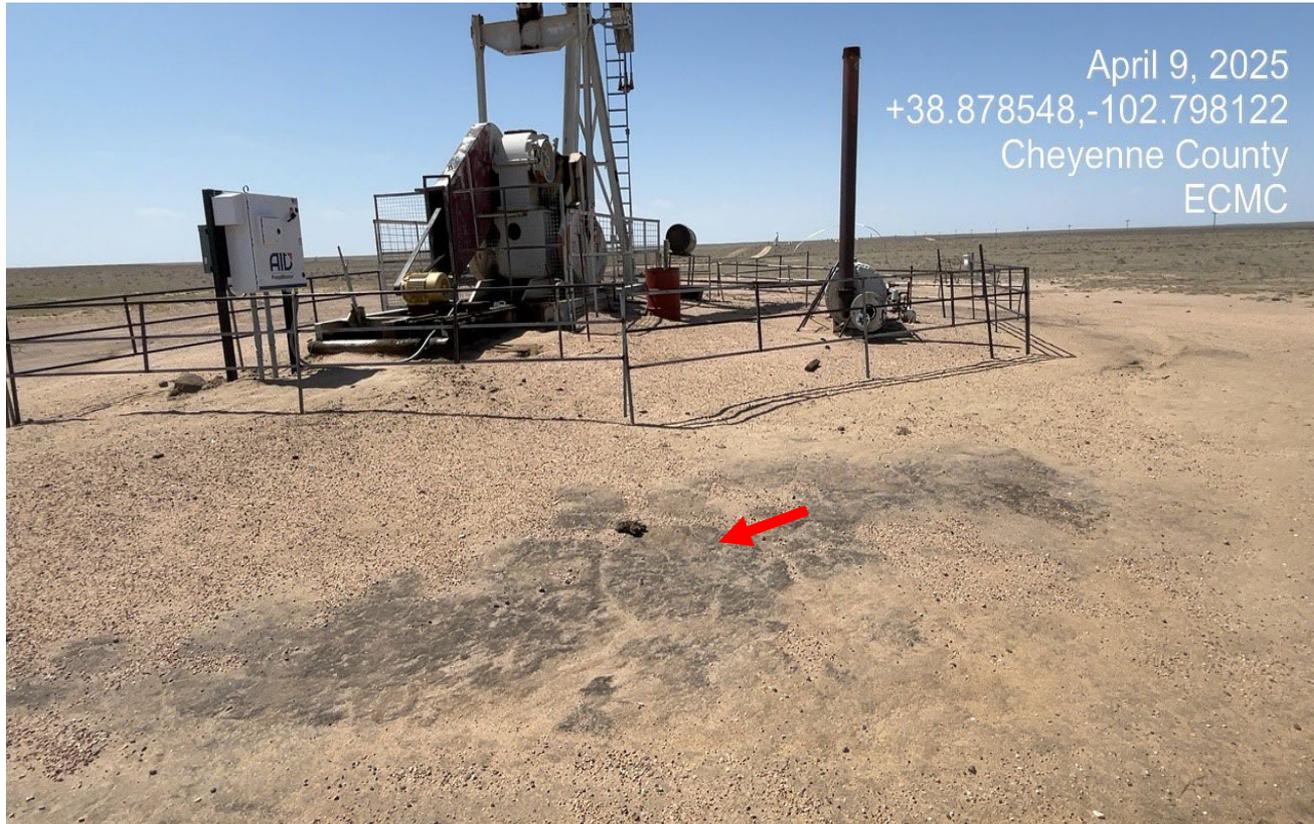
Photo 9. East side of the pumpjack. There is black hardened hydrocarbon material shown at red arrow. All impacted soils must be cleaned up and removed.

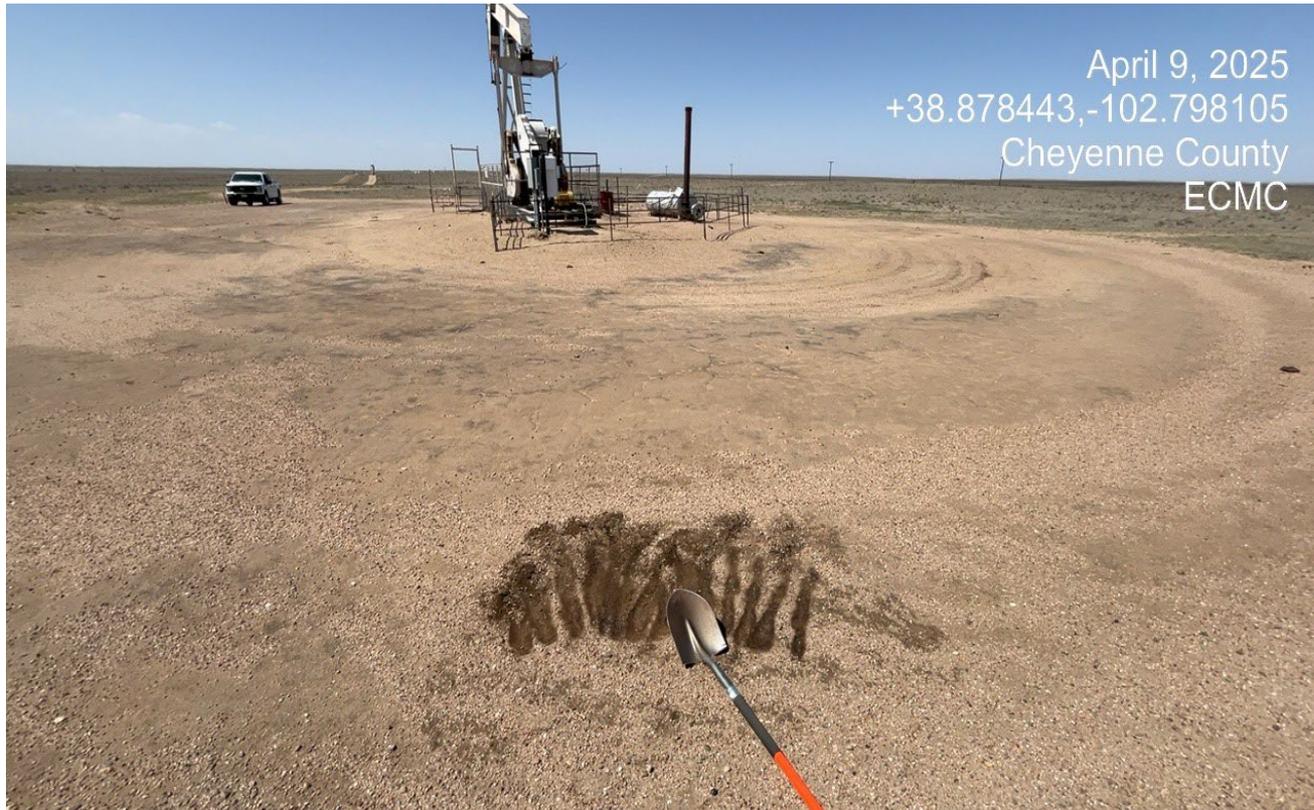
Photo 10. Further east away from the pumpjack is additional blackened hydrocarbon material where shovel scraped off the sand. Further delineation of impacts will be required both horizontally and vertically.

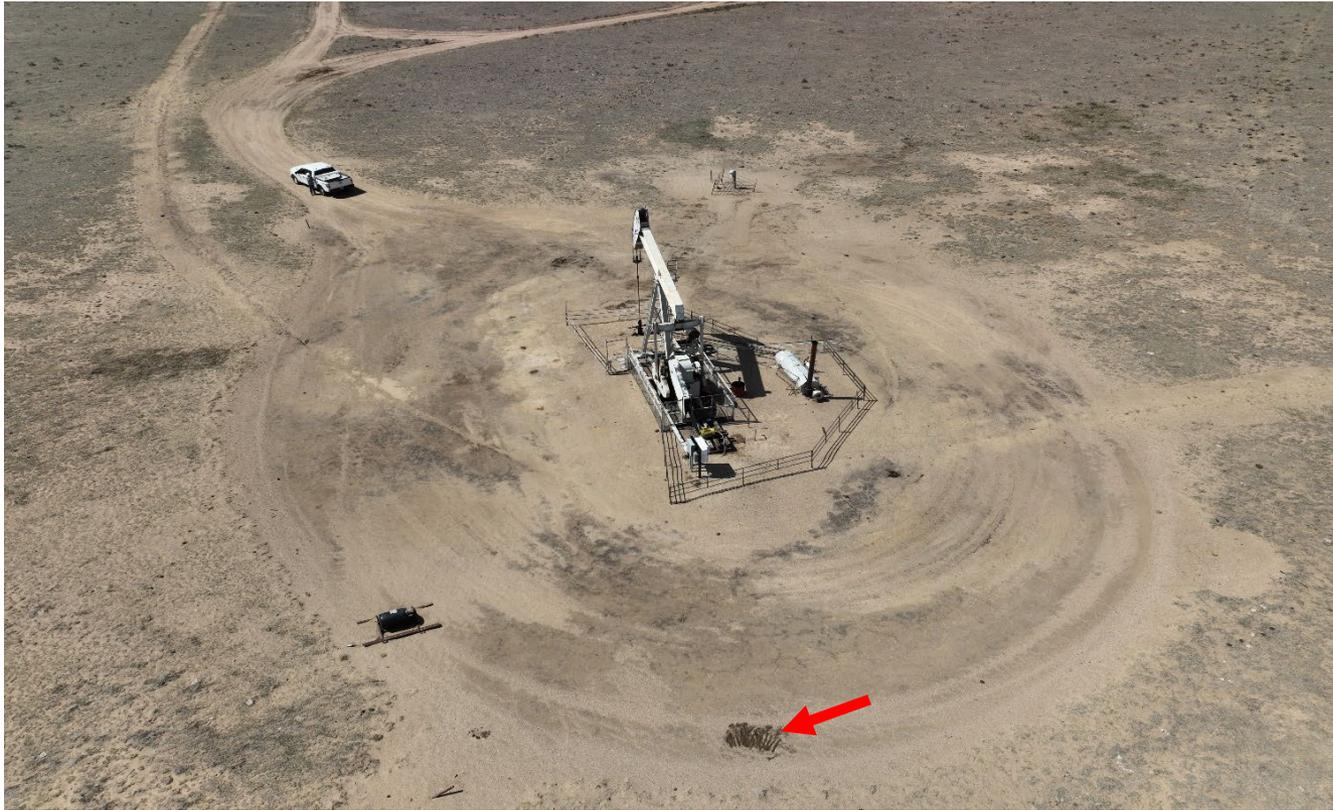
Photo 11. Drone aerial photo facing northwest down toward the wellsite. The area of impacted soil shown in previous photo can be seen at red arrow for reference.

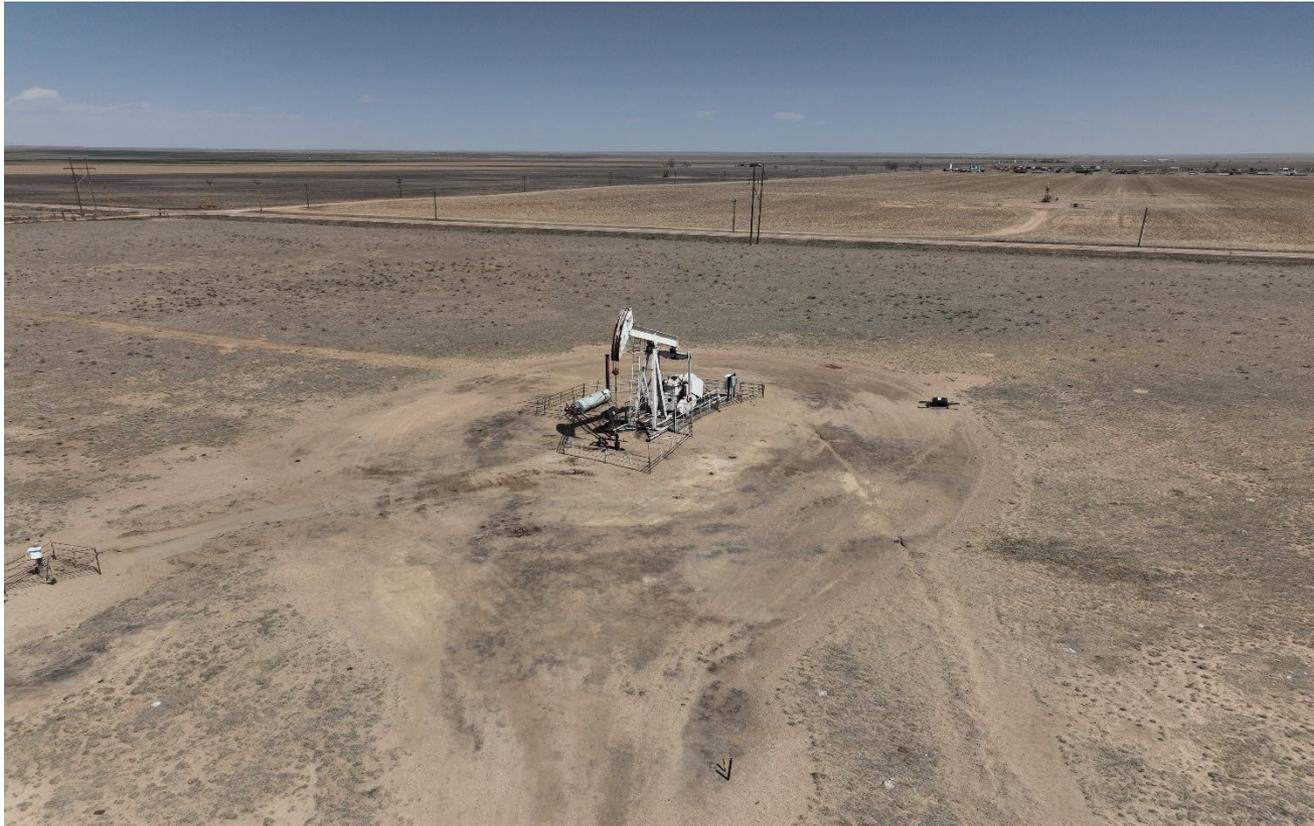
Photo 12. Drone aerial photo facing northeast toward the wellsite.

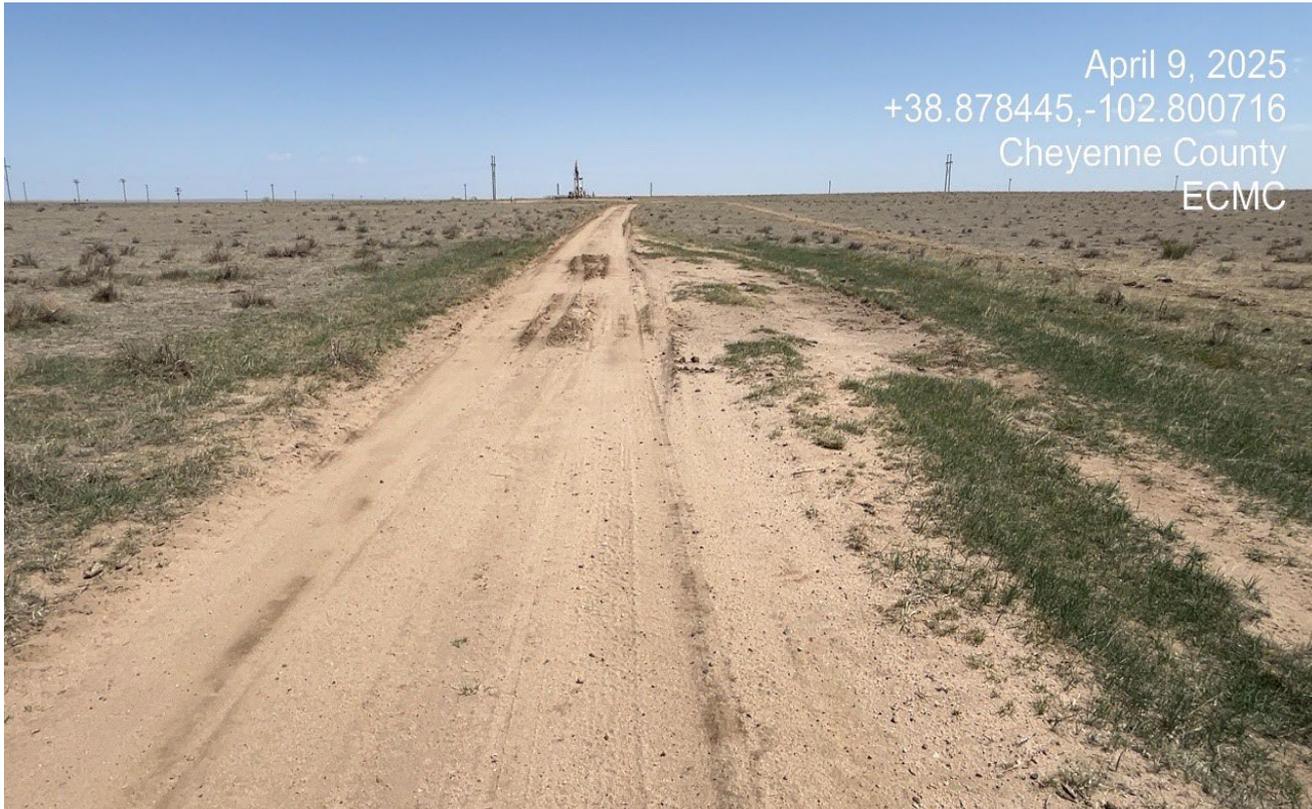
Photo 14. Facing east along the access road. Vehicles are causing unnecessary disturbance driving outside of the access road due to stormwater pooling on the road. The access road must be maintained and shall not drive outside of the access road boundary.
