Inspection Photos

API: 017-06625

Operator: **WILLIFORD ENERGY COMPANY**

Inspection Date: 4/9/2025

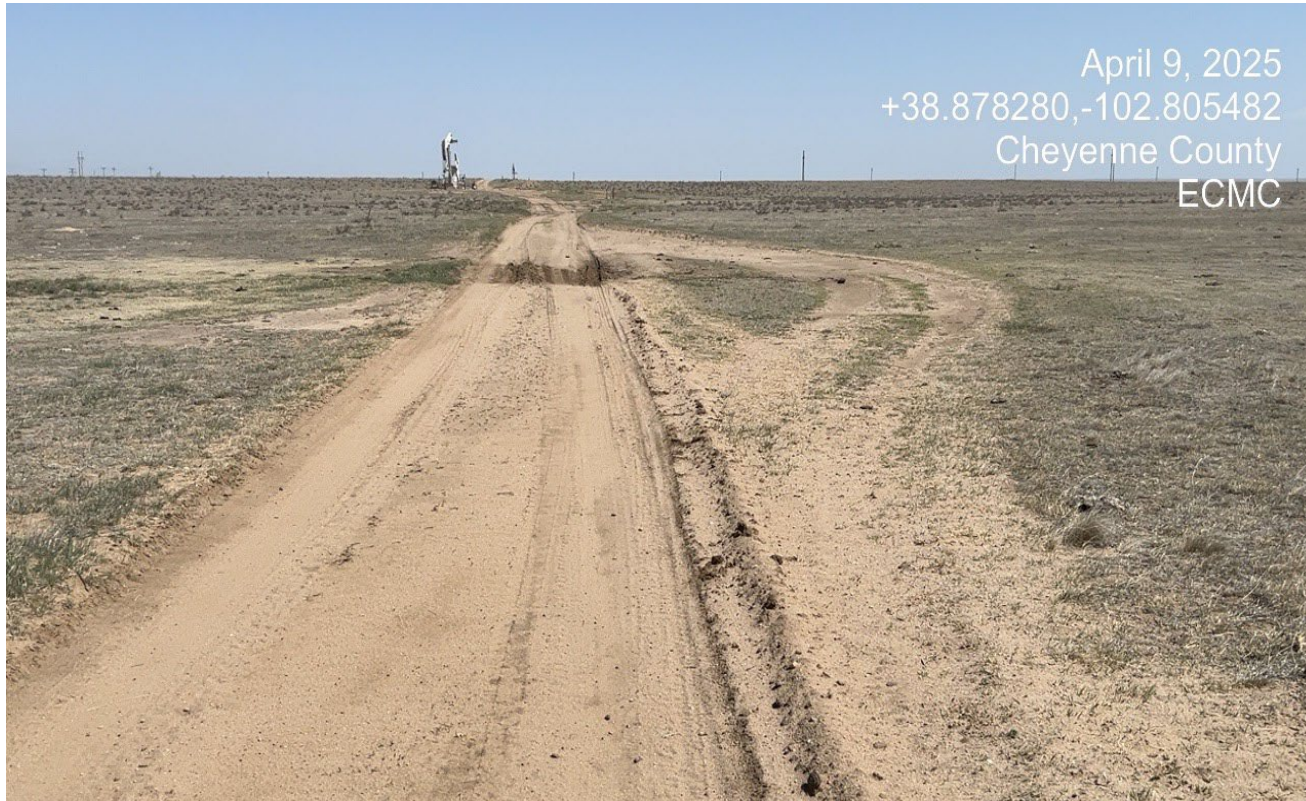
Photo 1. Facing east along the access road. Vehicles are causing unnecessary disturbance driving outside of the access road due to stormwater pooling on the road. The access road must be maintained and shall not drive outside of the access road boundary.

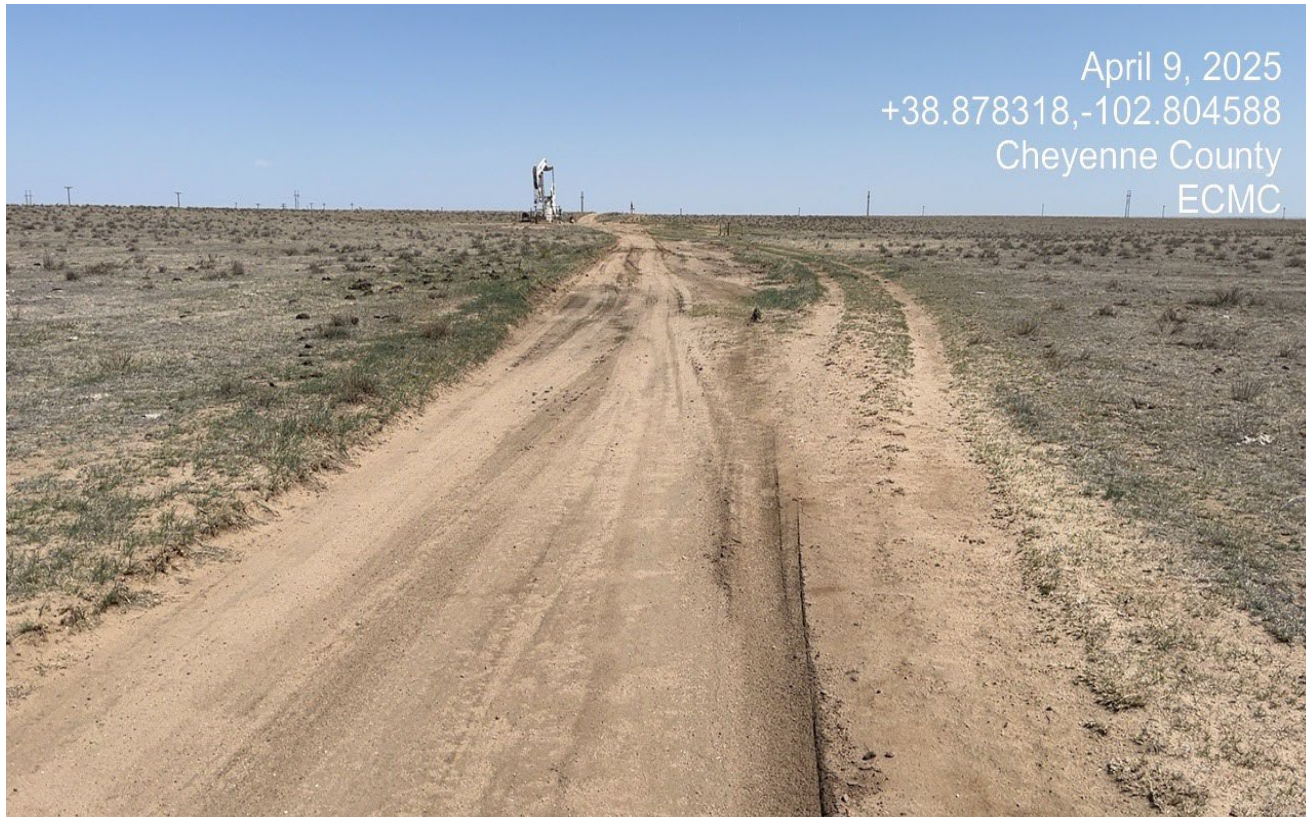
Photo 2. Facing east along the access road. Vehicles are causing unnecessary disturbance driving outside of the access road due to stormwater pooling on the road. The access road must be maintained and shall not drive outside of the access road boundary.

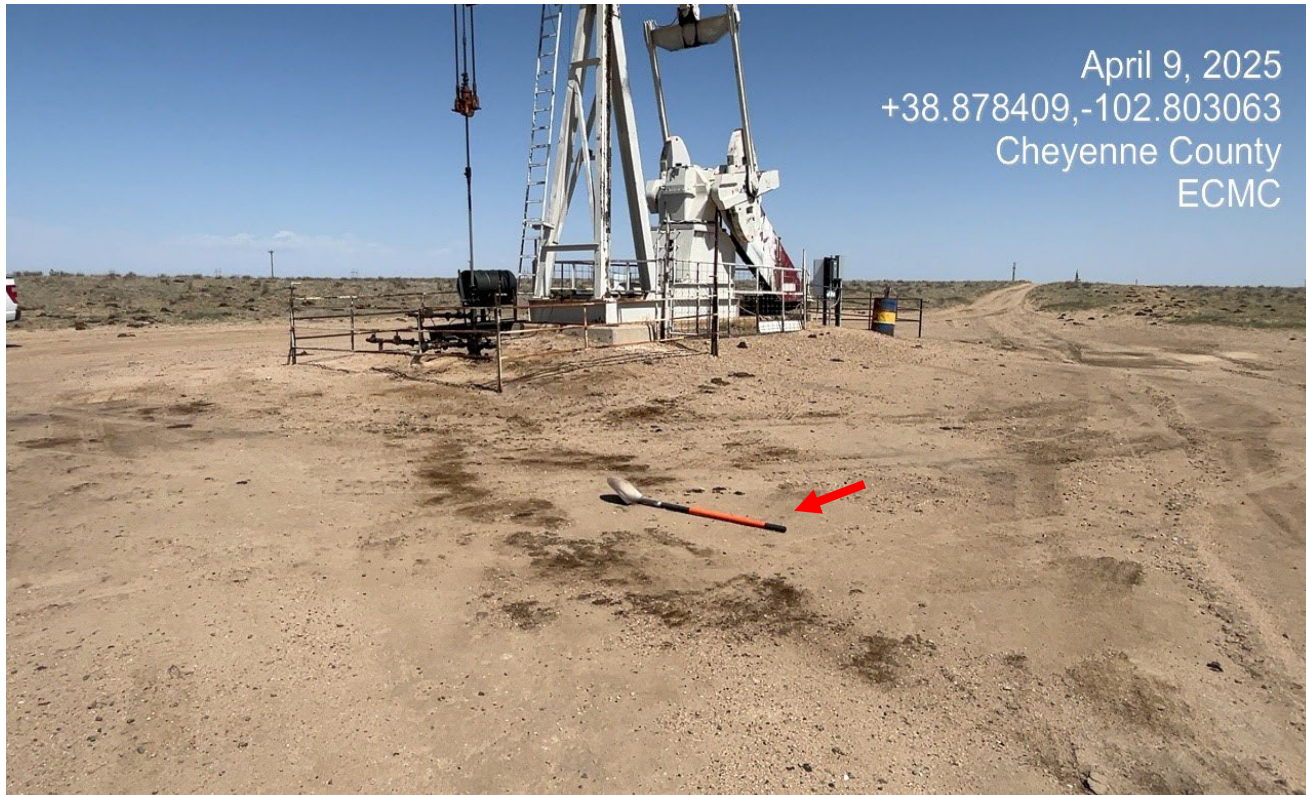
Photo 3. Facing northeast toward the wellsite. There are oil stained soils near the wellhead that have not been cleaned up since the previous inspection. Red arrow points to the 4.5 ft shovel for scale.

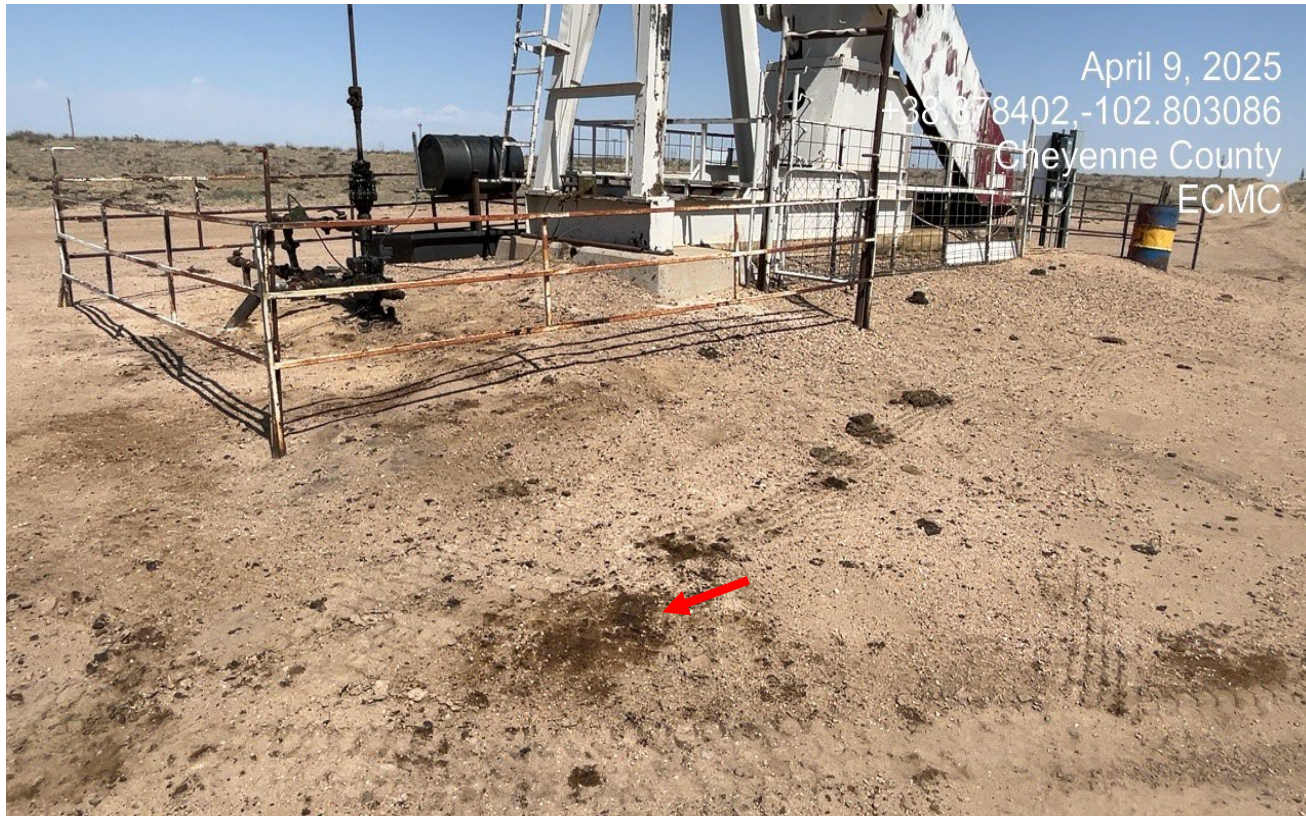
Photo 4. There are stained oily soils from a leak at the wellhead. Stained soils have not been cleaned up since the previous inspection.

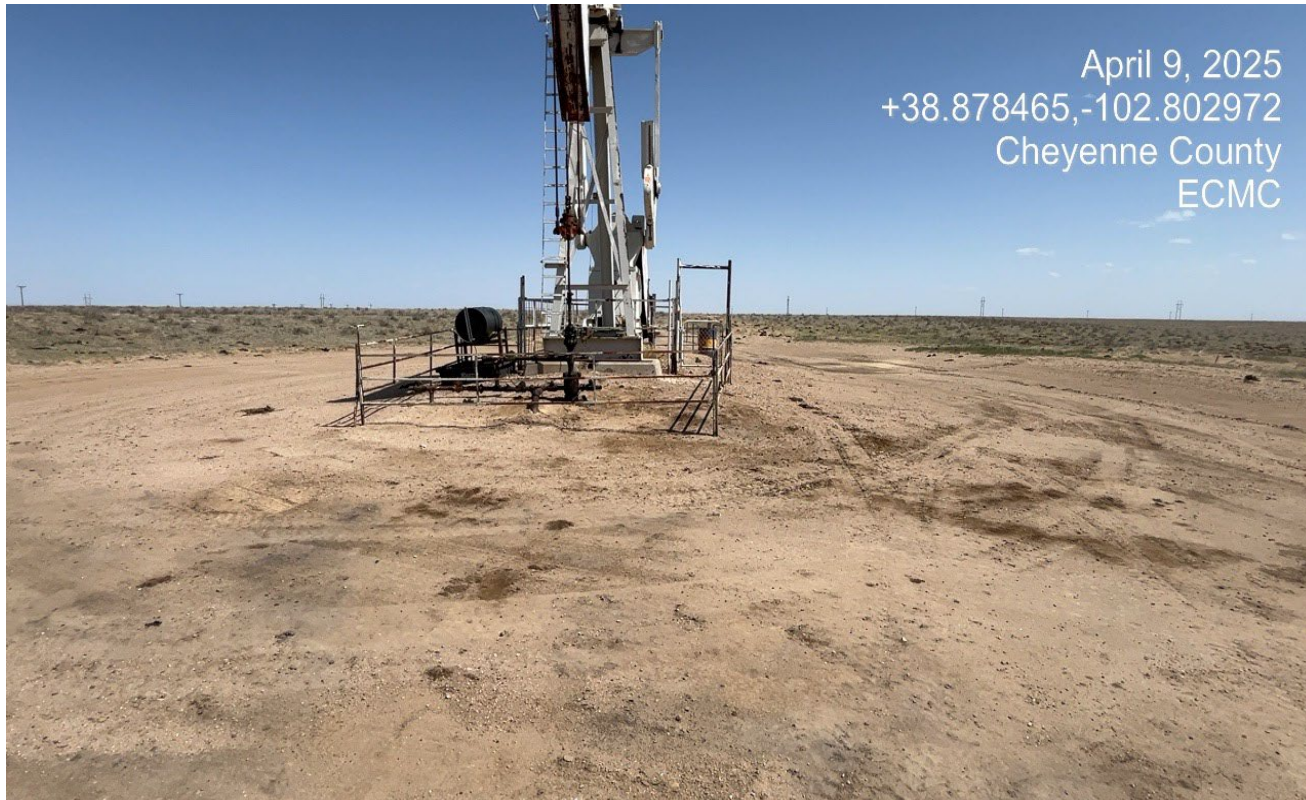
Photo 5. Facing east toward the wellhead. There are oil stained soils which have not been cleaned up since the previous inspection.

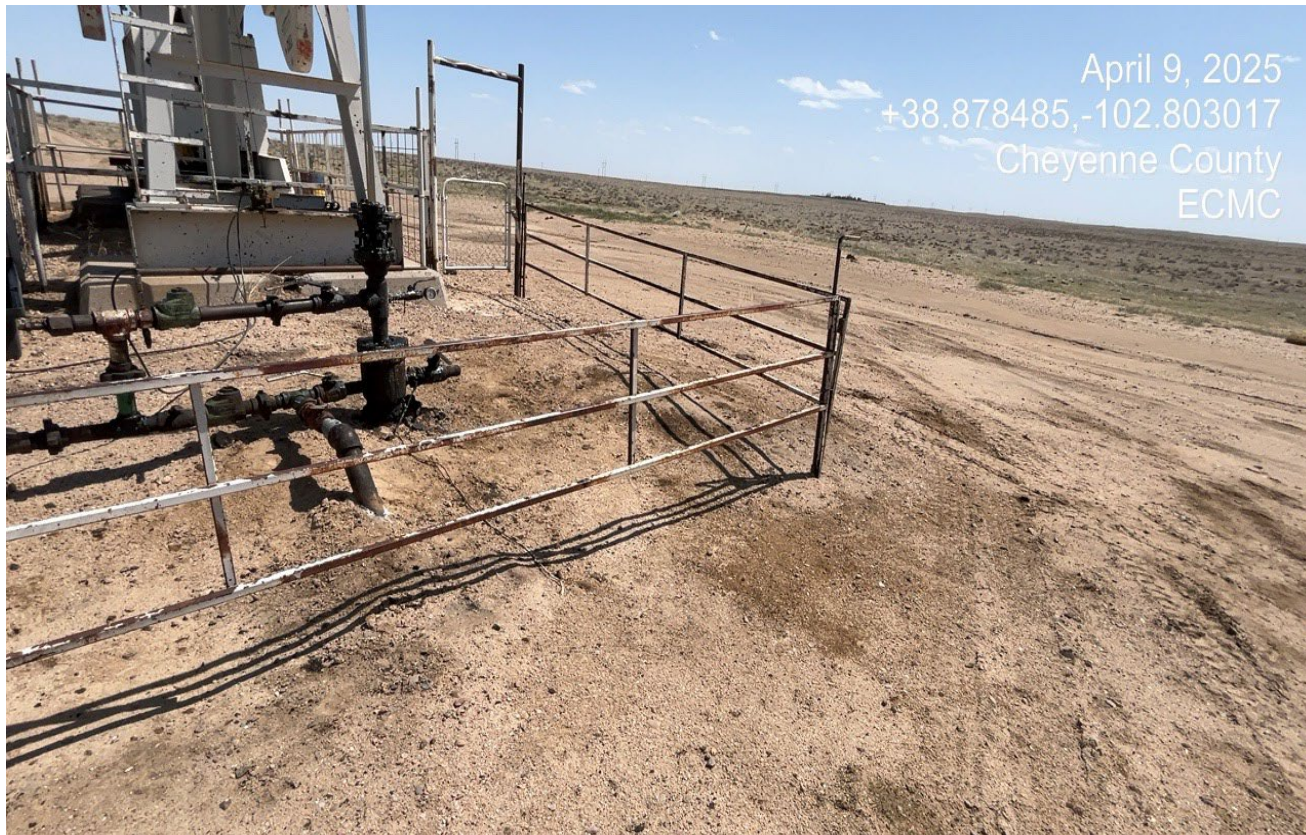
Photo 6. View of wellhead shows stained soils which were previously covered up with sand. Stained soils have not been cleaned up since the previous inspection.

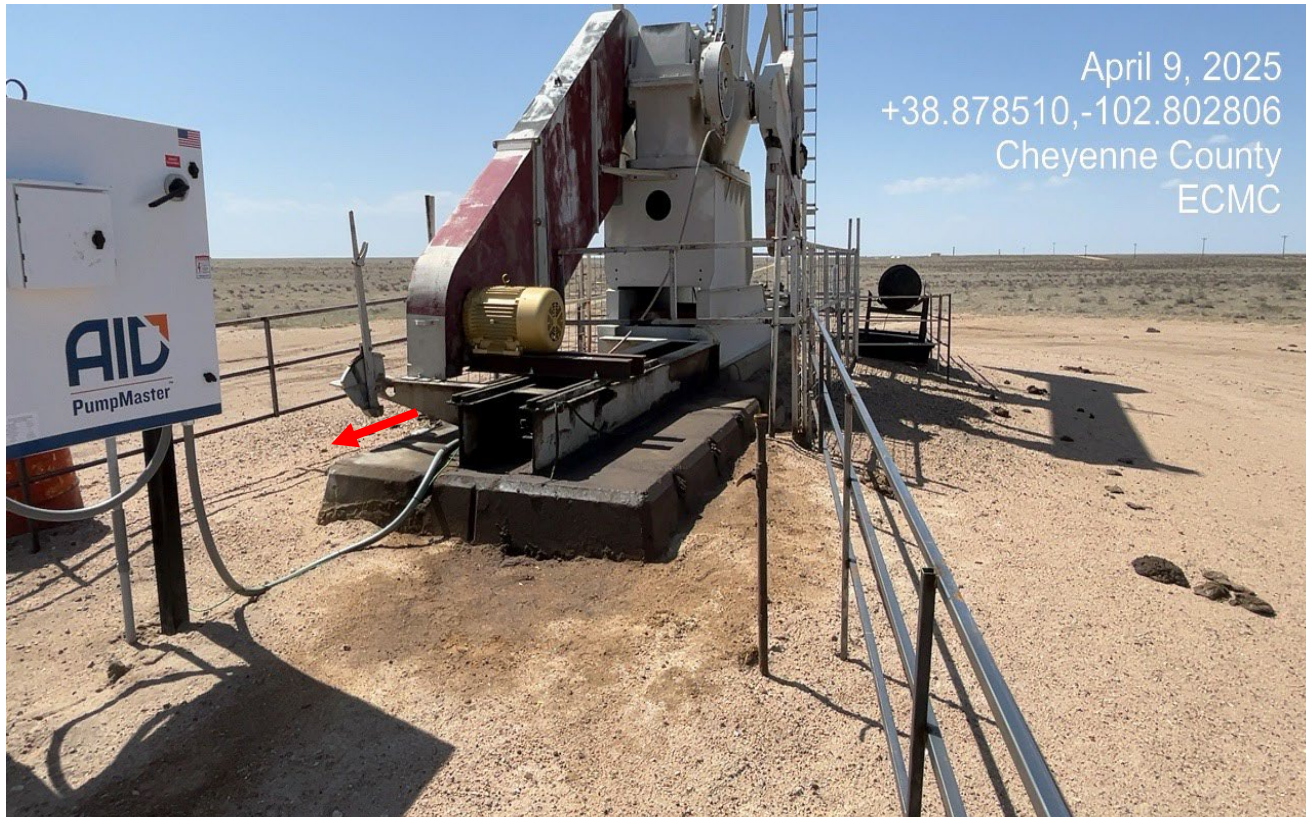
Photo 7. There are still oil stained soils at the pumpjack that have not been cleaned up. Previous corrective action was not completed.

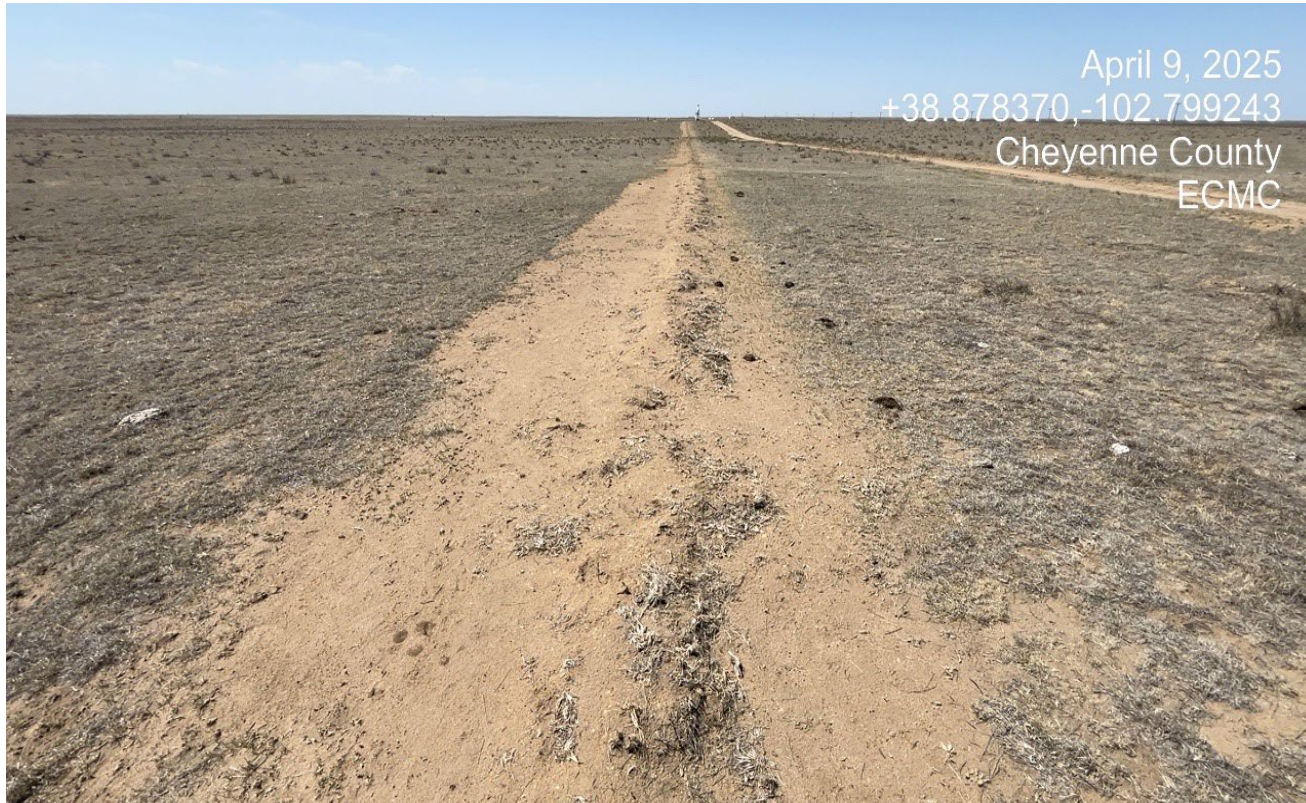
Photo 9. There has been new disturbance from a buried electric line to service the new electric motor at the pumpjack. The disturbed area will need to be reclaimed. Previous corrective action was not completed.
