Inspection Photos

API: 017-06632

Operator: **WILLIFORD ENERGY COMPANY**

Inspection Date: 4/9/2025

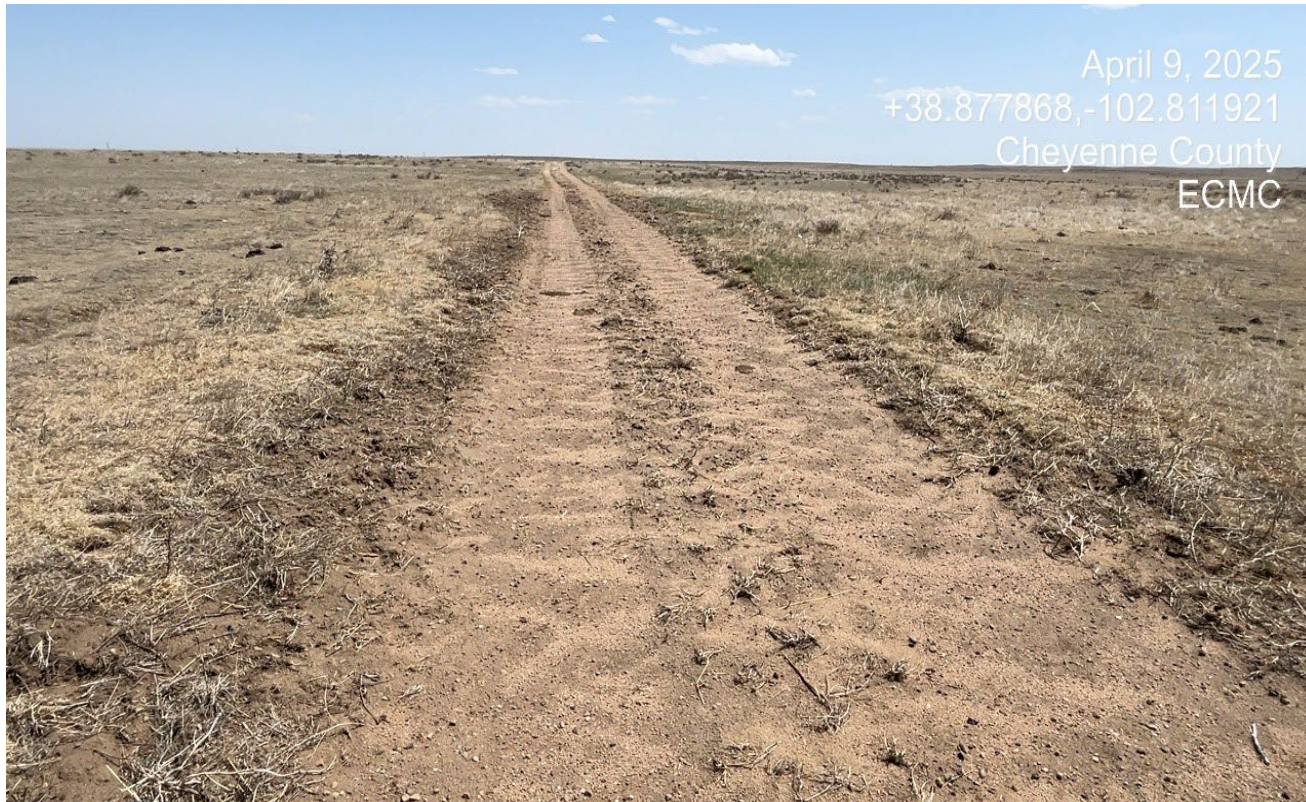
Photo 1. Facing southeast toward the access road. The access road is eroded and will need to be regraded to match the surrounding contours which may require imported topsoil.

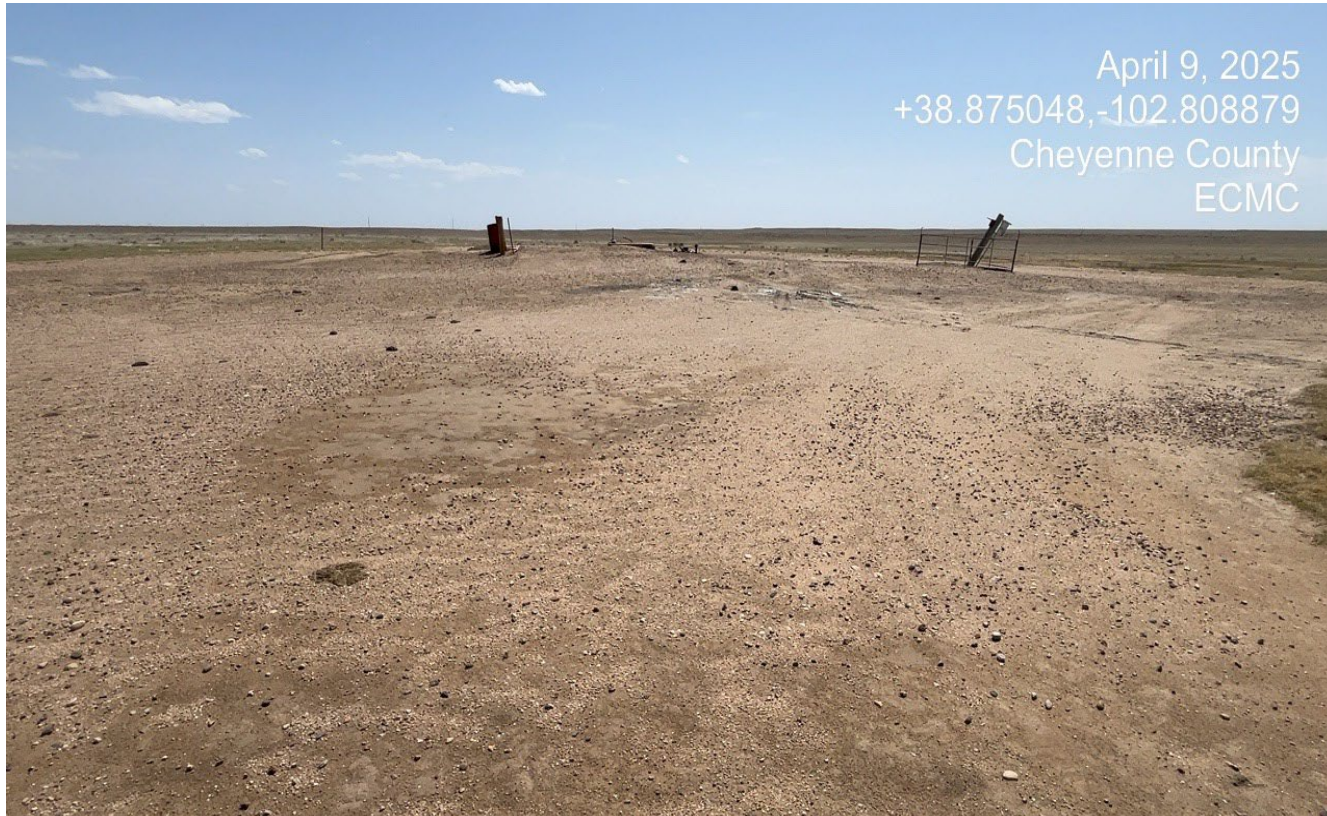
Photo 2. Facing southeast toward the location. It appears the well was recently plugged and abandoned.

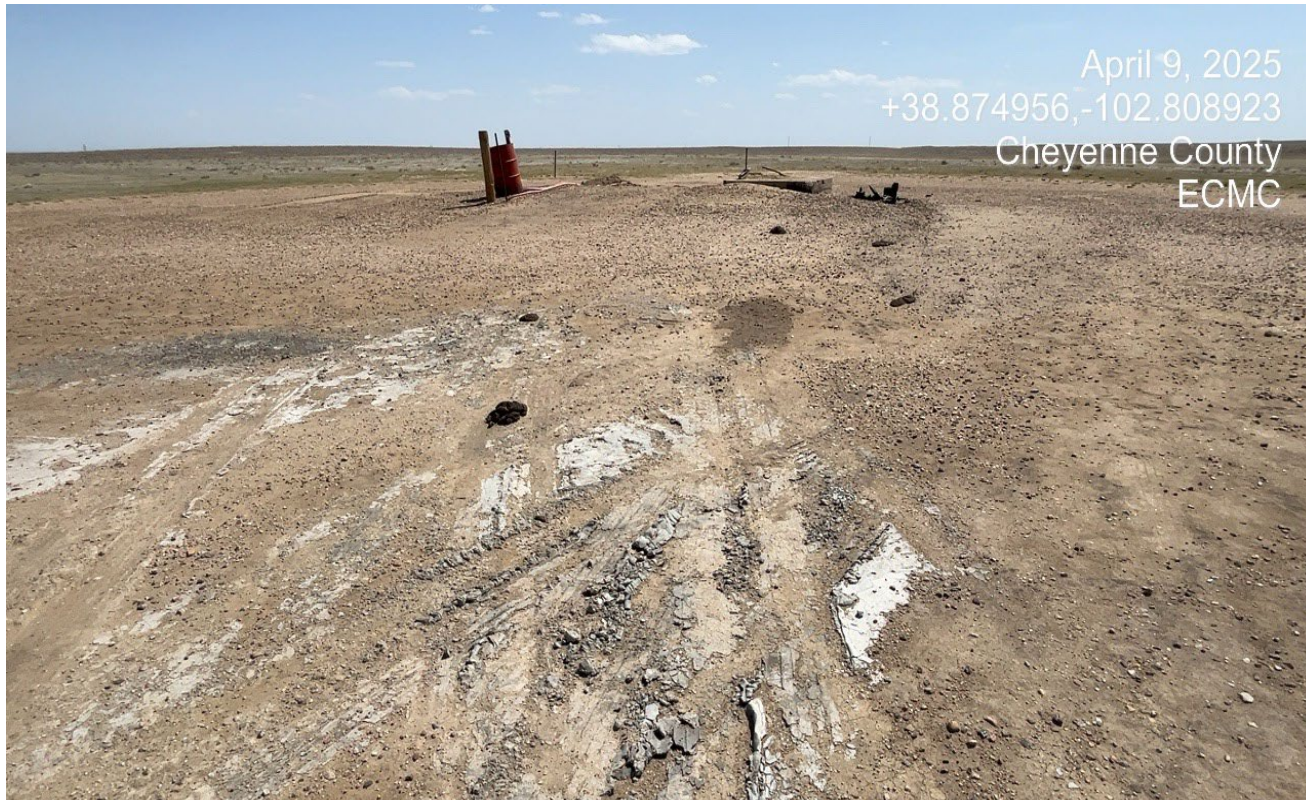
Photo 3. There is stained soils and cement spilled on location that will need to be cleaned up. Previous CA was not completed.

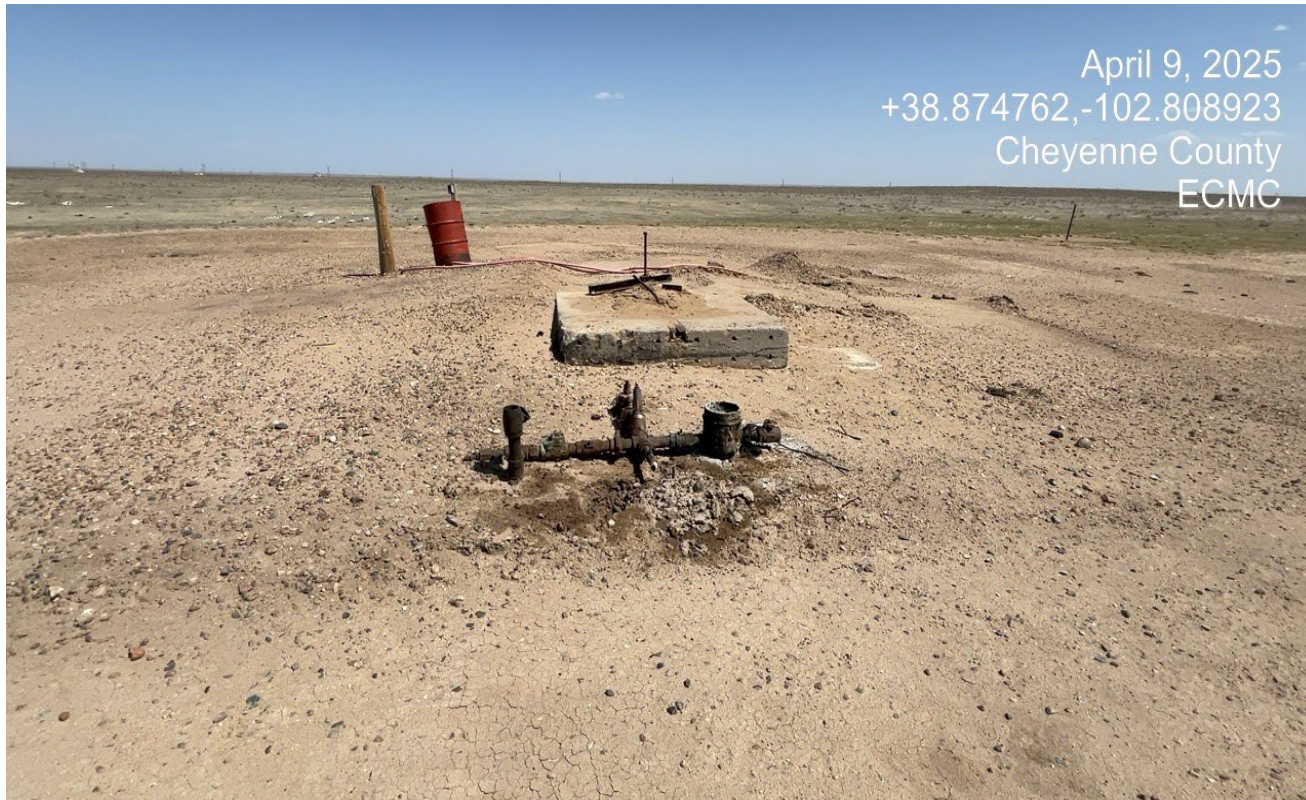
Photo 4. Facing toward the wellhead. There are stained soil at the wellhead. This area will need to be sampled and remediated for decommissioning of the well.

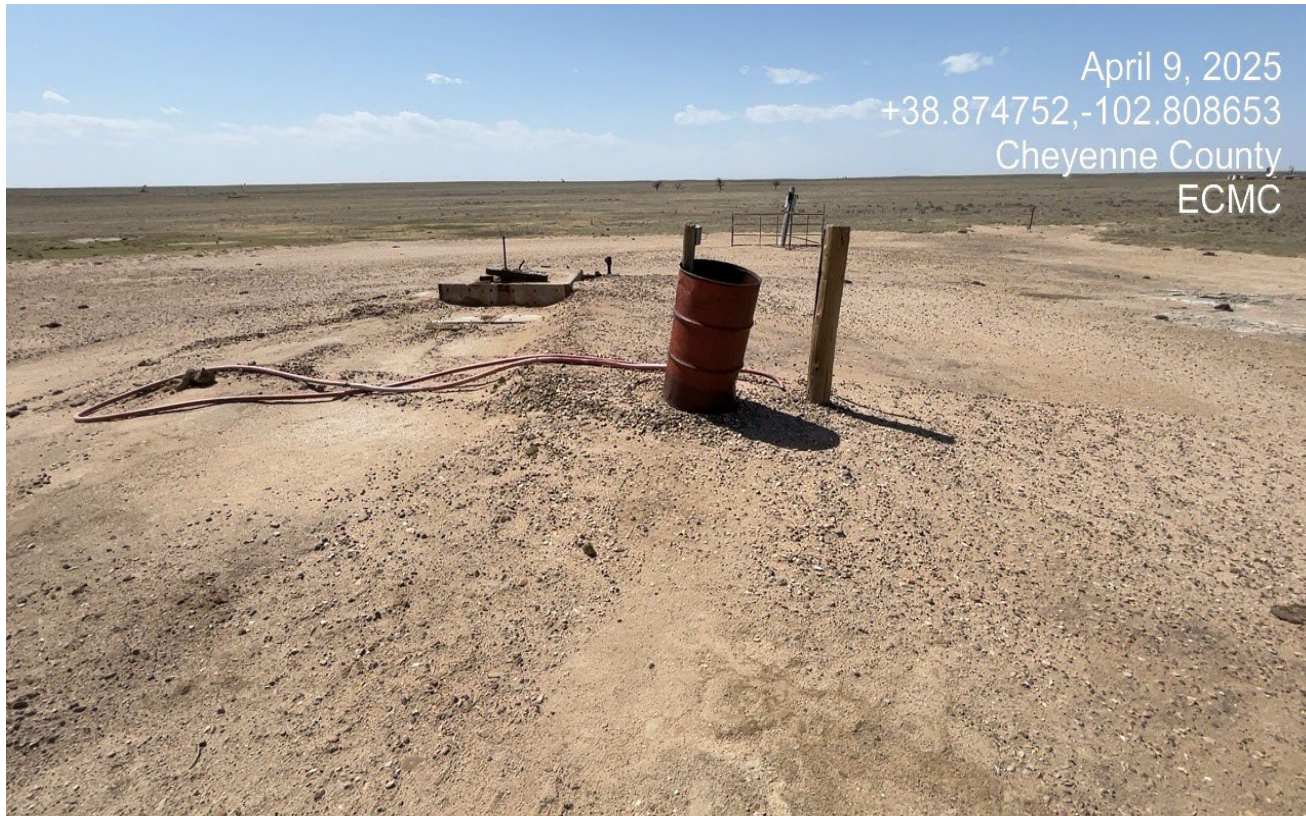
Photo 5. Facing west toward the area where the pumpjack was located. All equipment, risers, and debris must be removed within 3 months of abandonment.

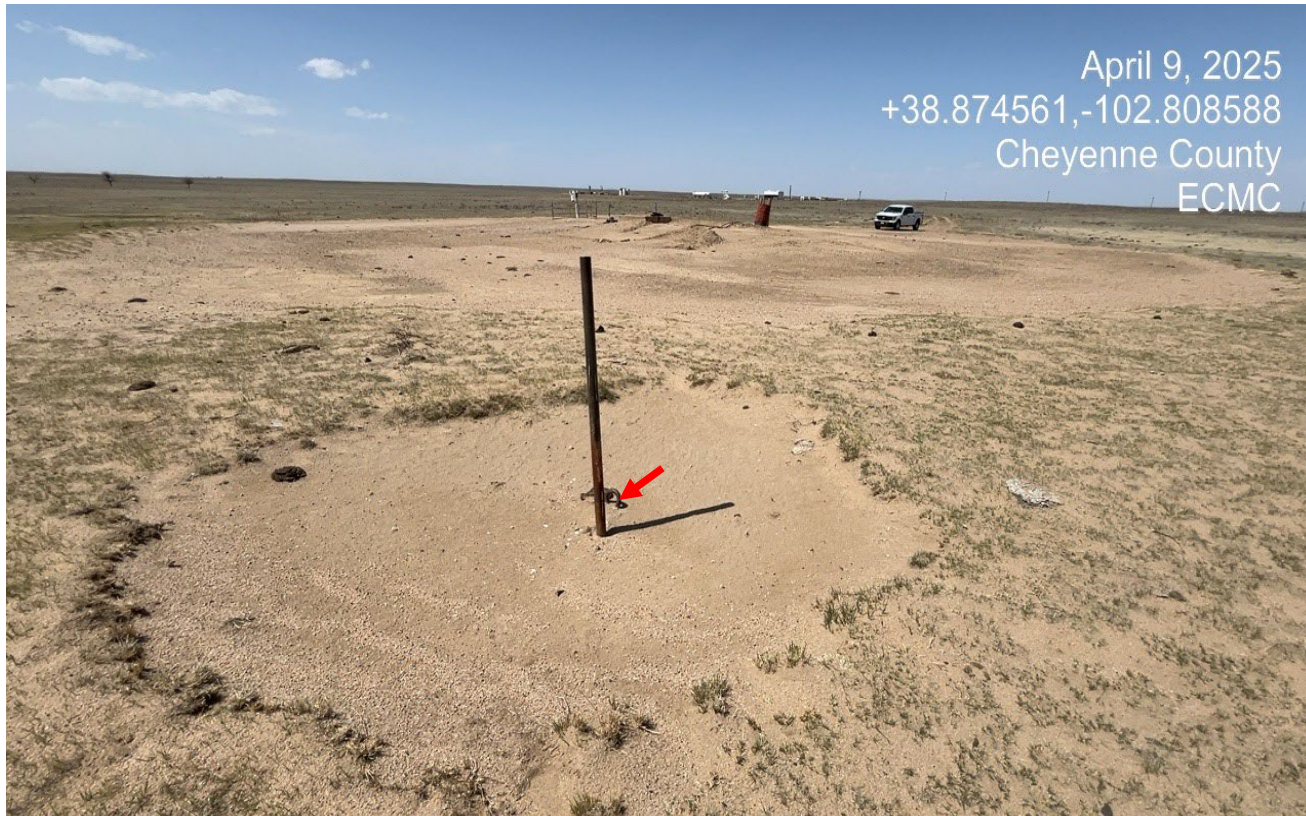
Photo 6 . There are 4 guyline anchors that remain at the location that must be removed within 3 months of abandonment

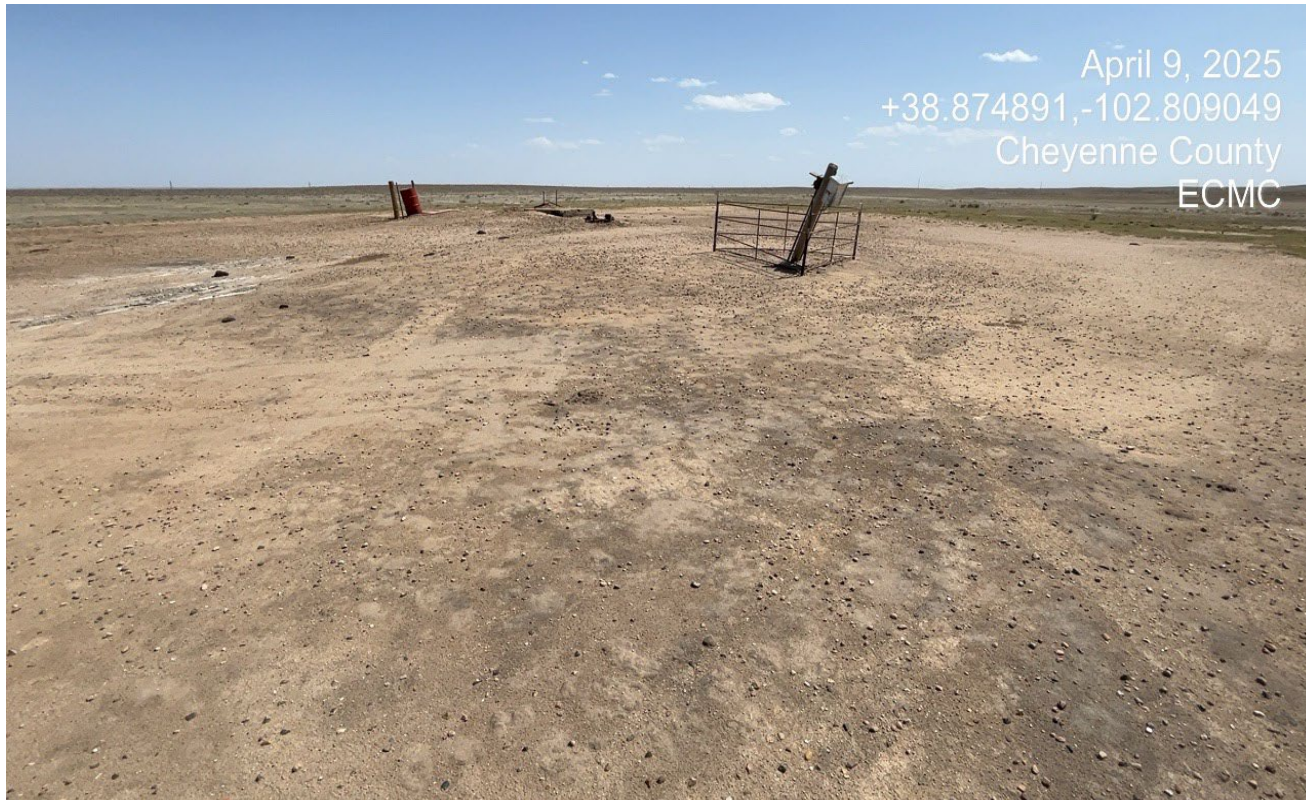
Photo 7. Facing southeast at the location. There are blacked and compacted soils throughout the location which maybe impacts from historic spills.
