Inspection Photos

API: 017-06629

Operator: **WILLIFORD ENERGY COMPANY**

Inspection Date: 4/9/2025

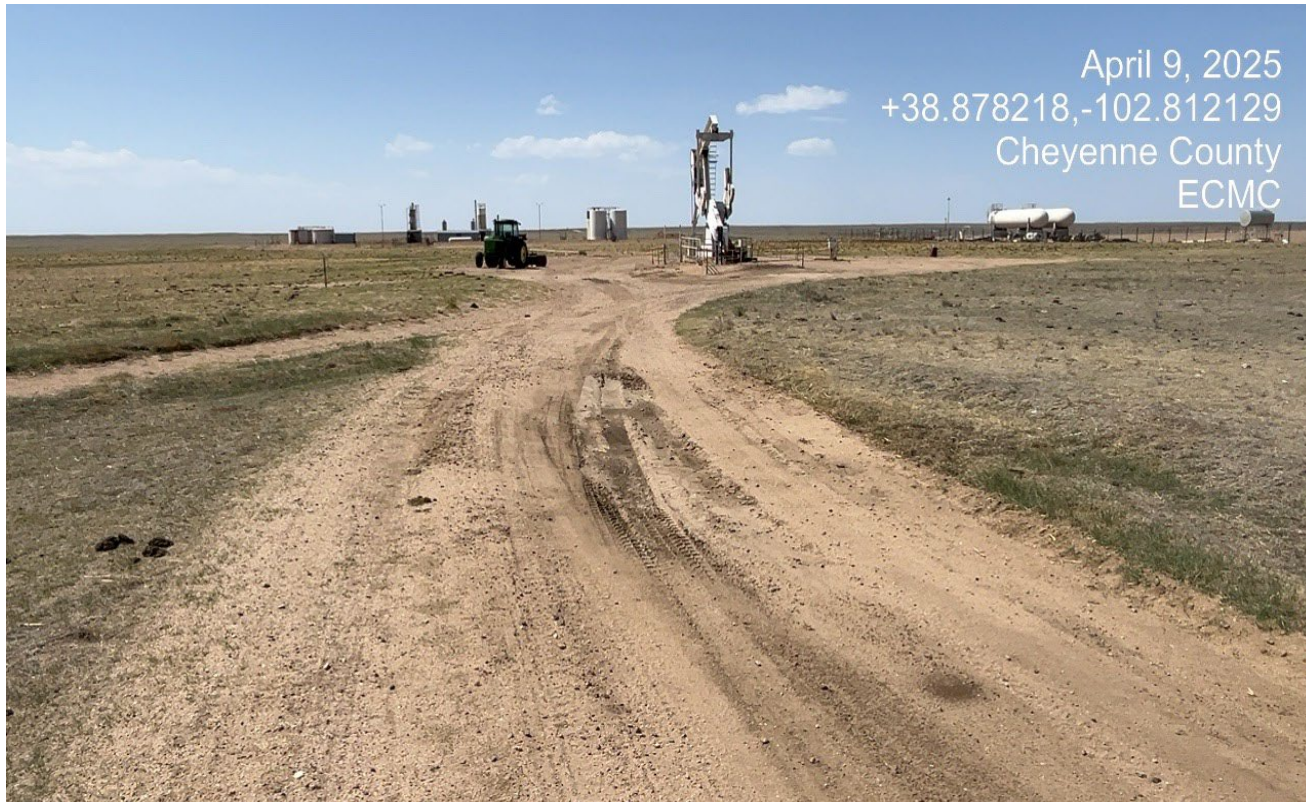
Photo 1. Facing west along the access road. Vehicles are causing unnecessary disturbance driving outside of the access road due to stormwater pooling on the road. The access road has not been repaired.

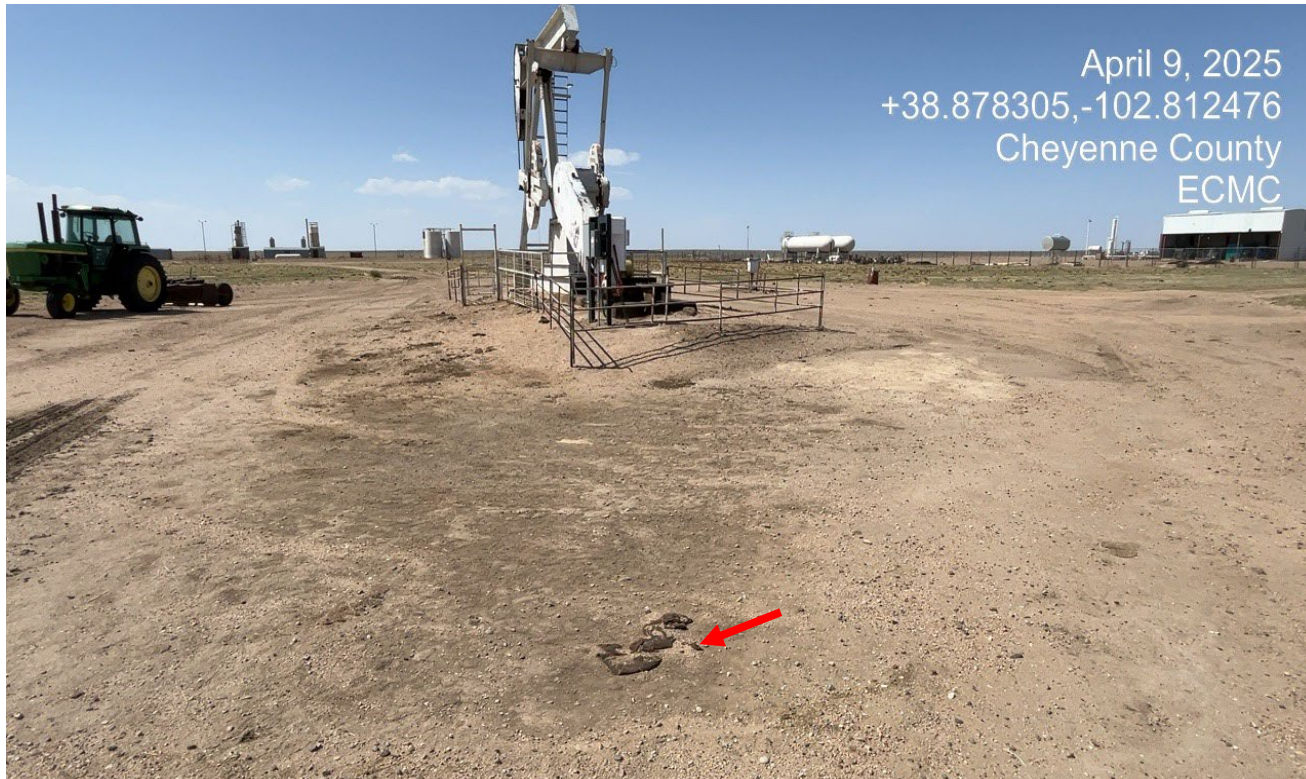
Photo 2. There are oily rags at shown at red arrow and stained soils. This must be removed and properly disposed. Previous CA was not completed.

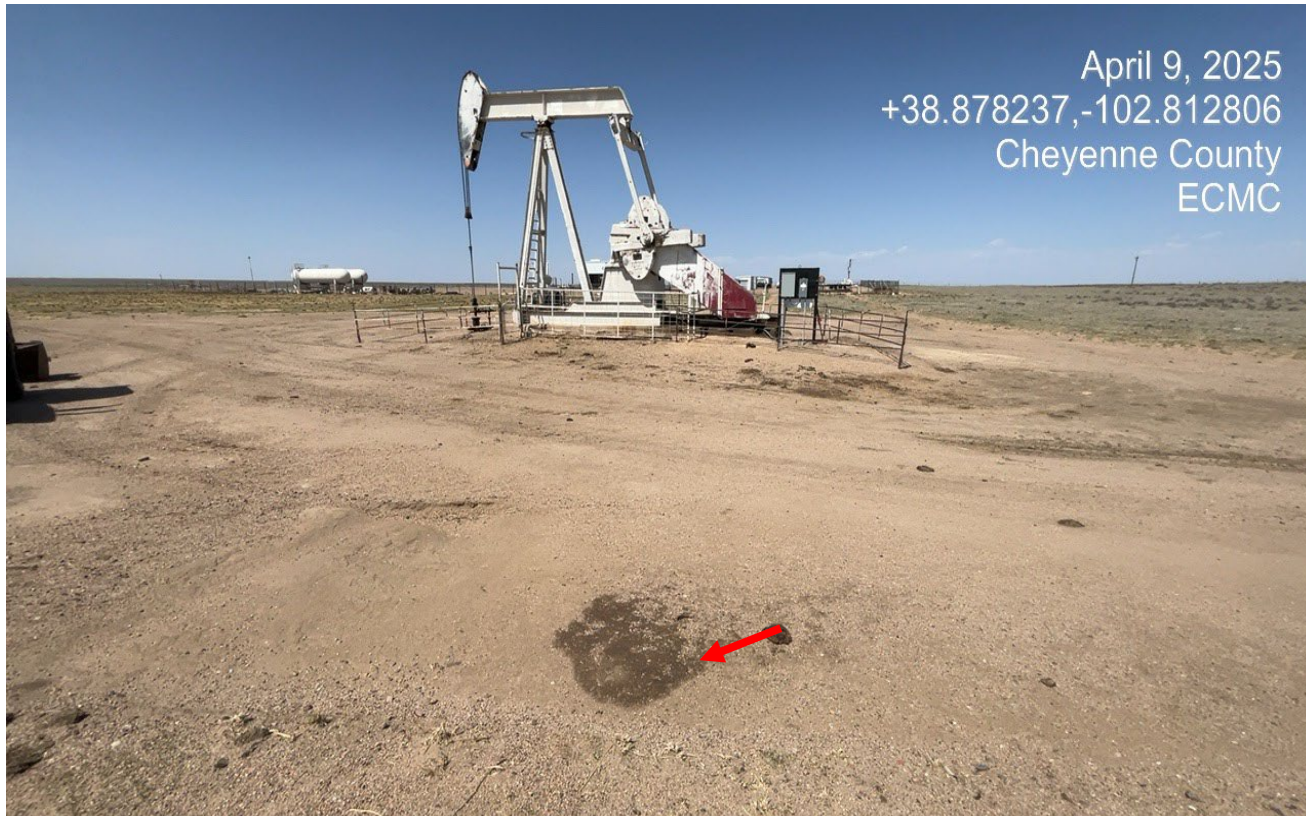
Photo 3. Facing northwest at the werllsite. There are oil stained soils shown at red arrow.

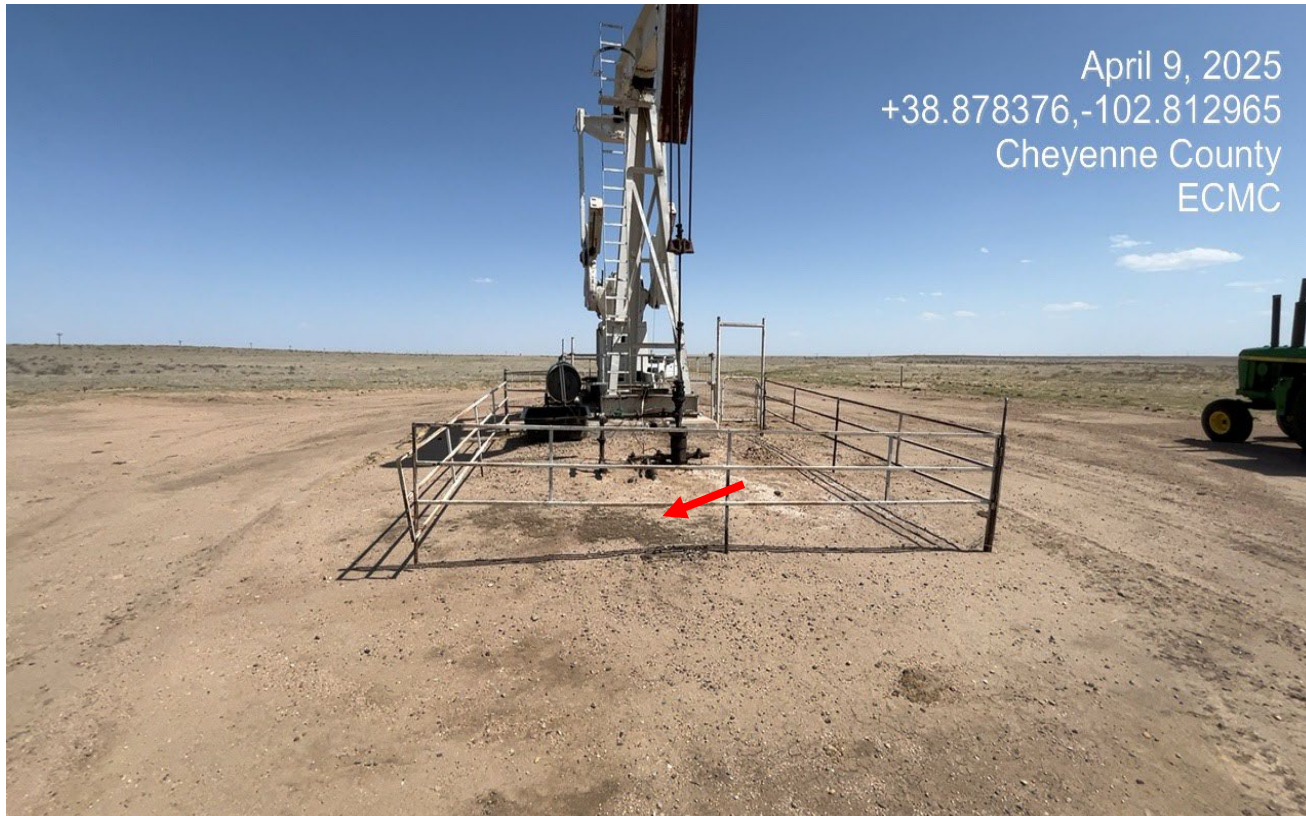
Photo 4. Facing toward the wellhead. There are stained soils by the wellhead. Previous CA was not completed.

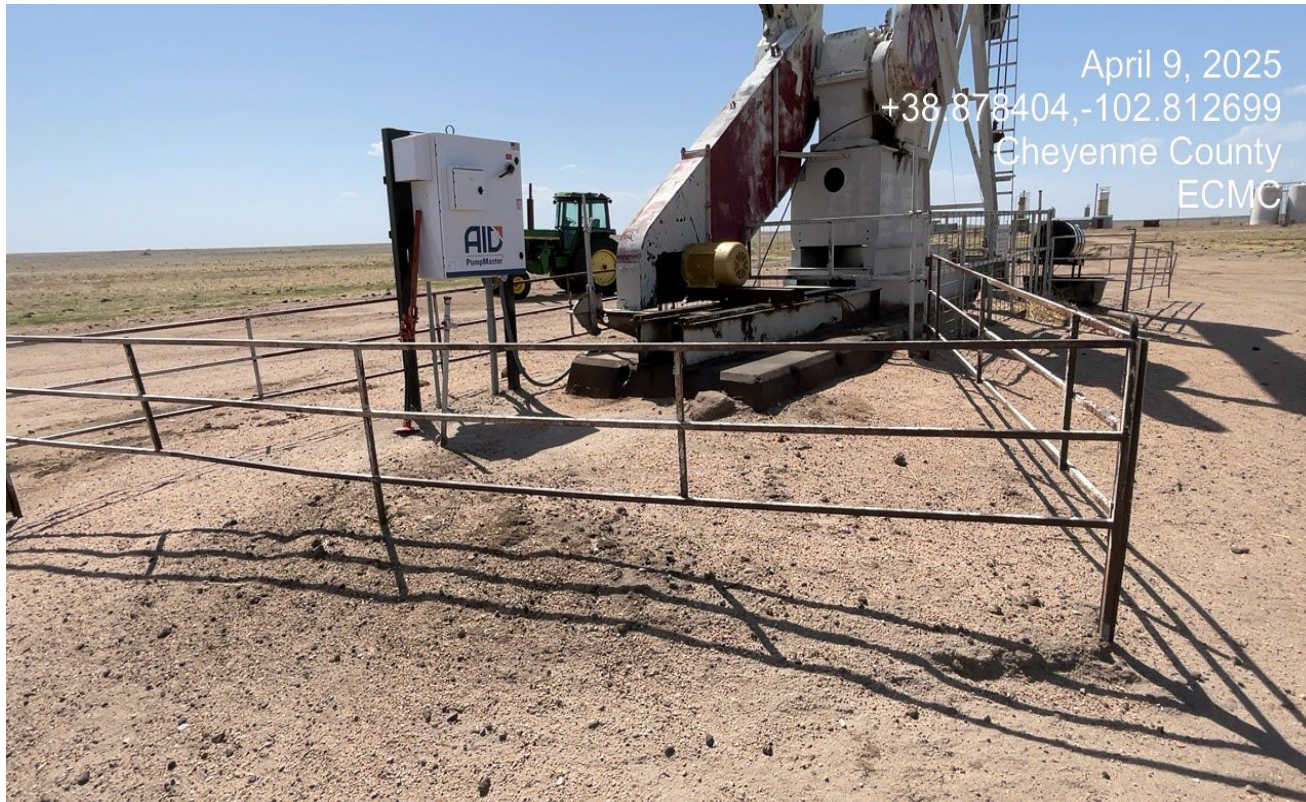
Photo 5. Facing toward the pumpjack. The engine has been replaced with an electric motor. It is unknown if oil saturated soils were cleaned up due to sand previously spread over this area.

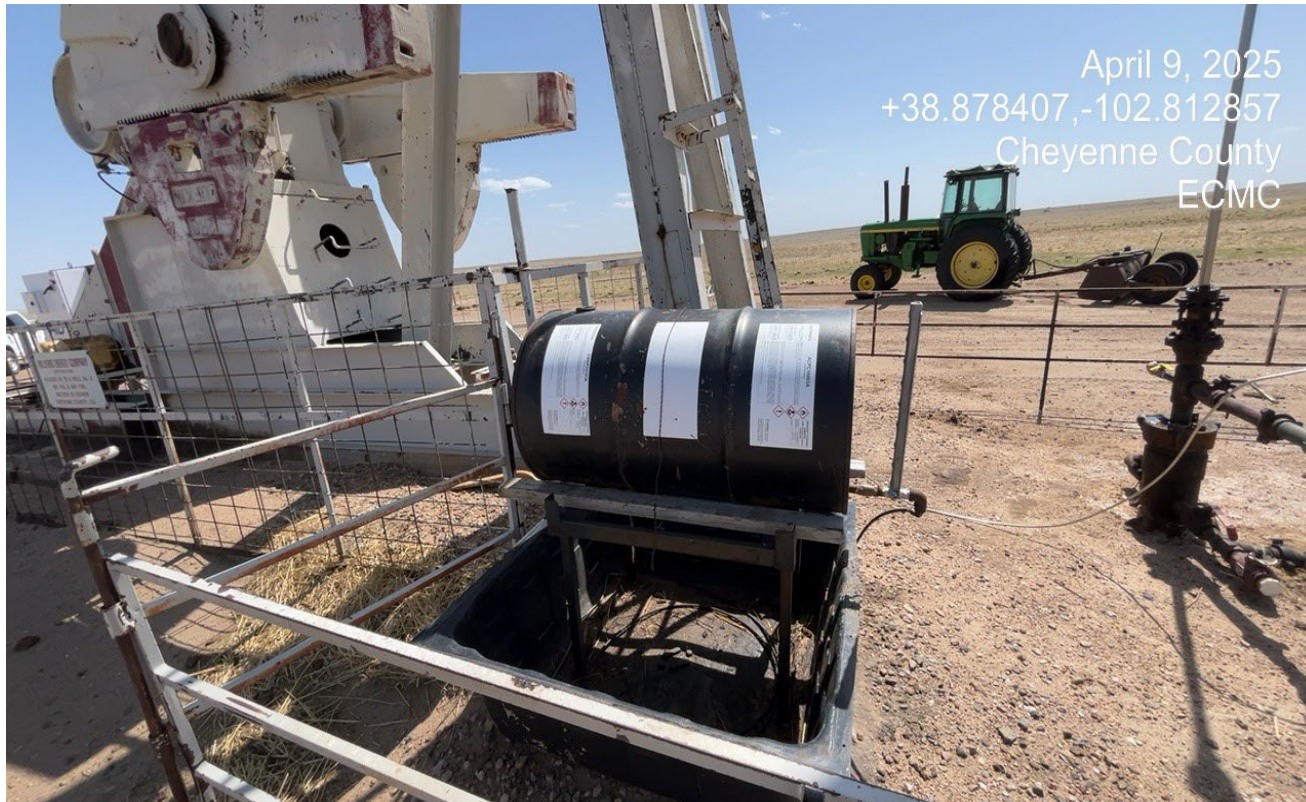
Photo 6. The labeling on the chemical barrel has been updated..
