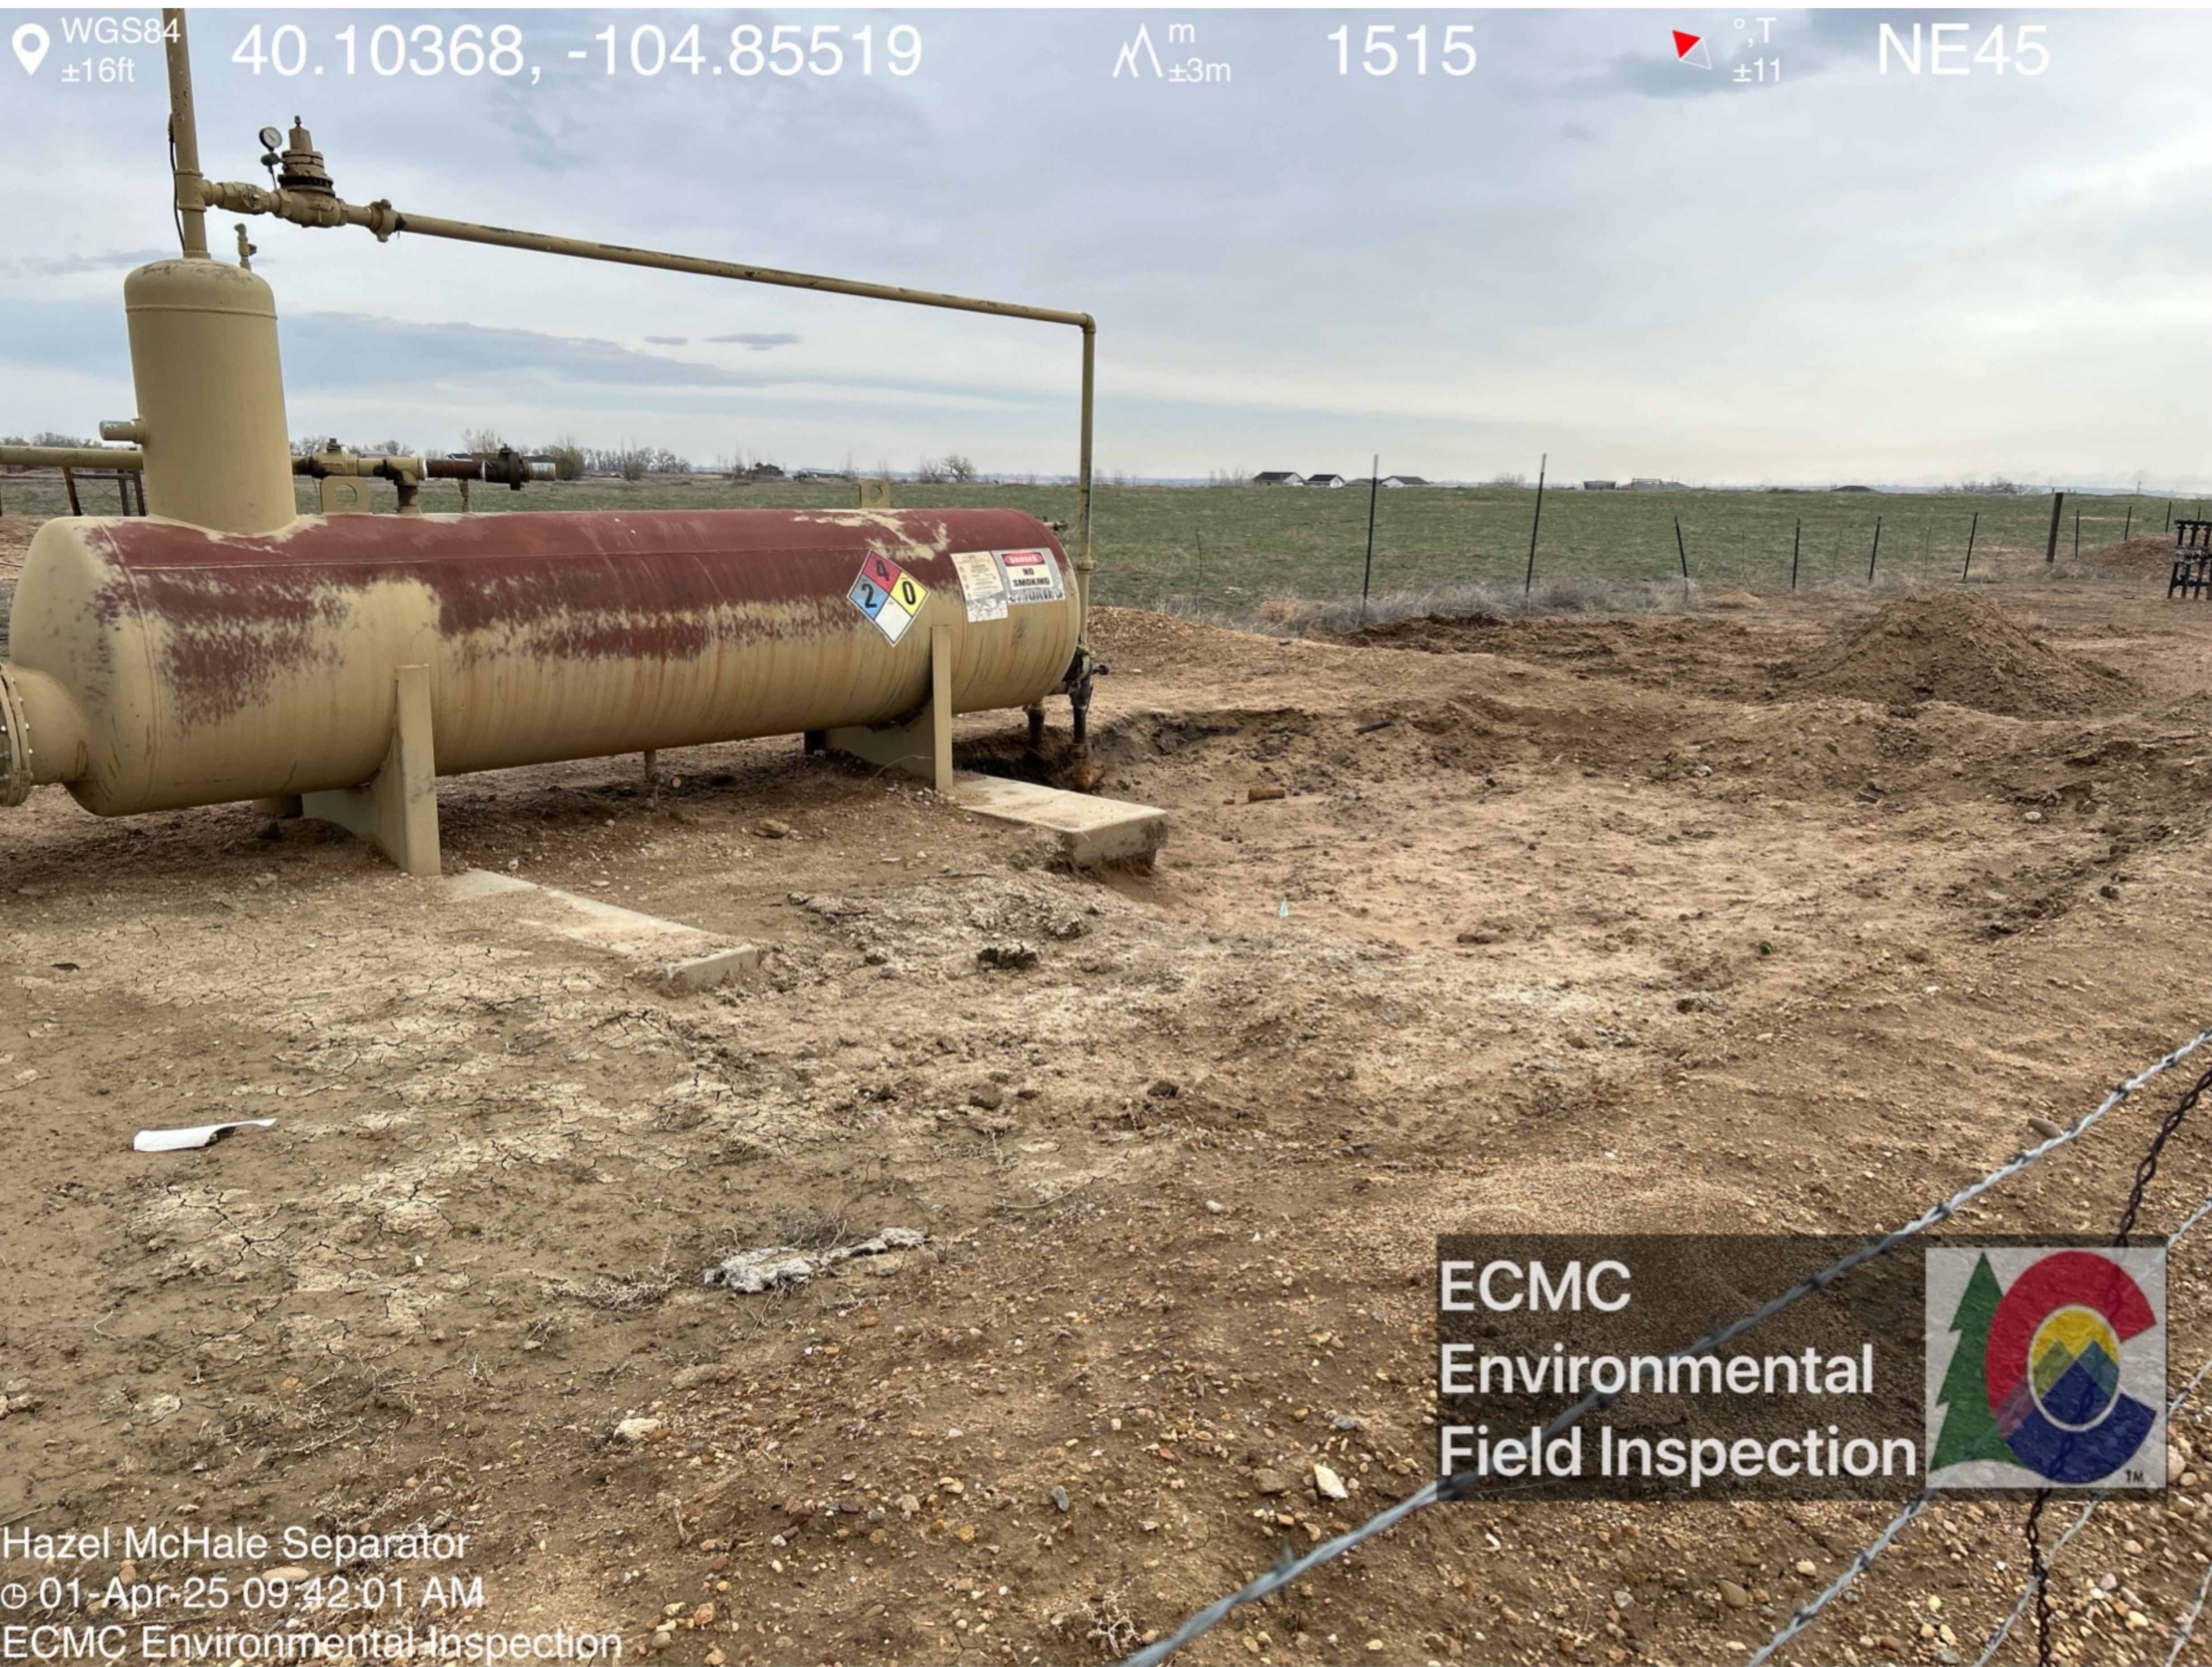
An excavation at a depth of approximately one foot below ground surface remains open at the location of Spill ID 489249.

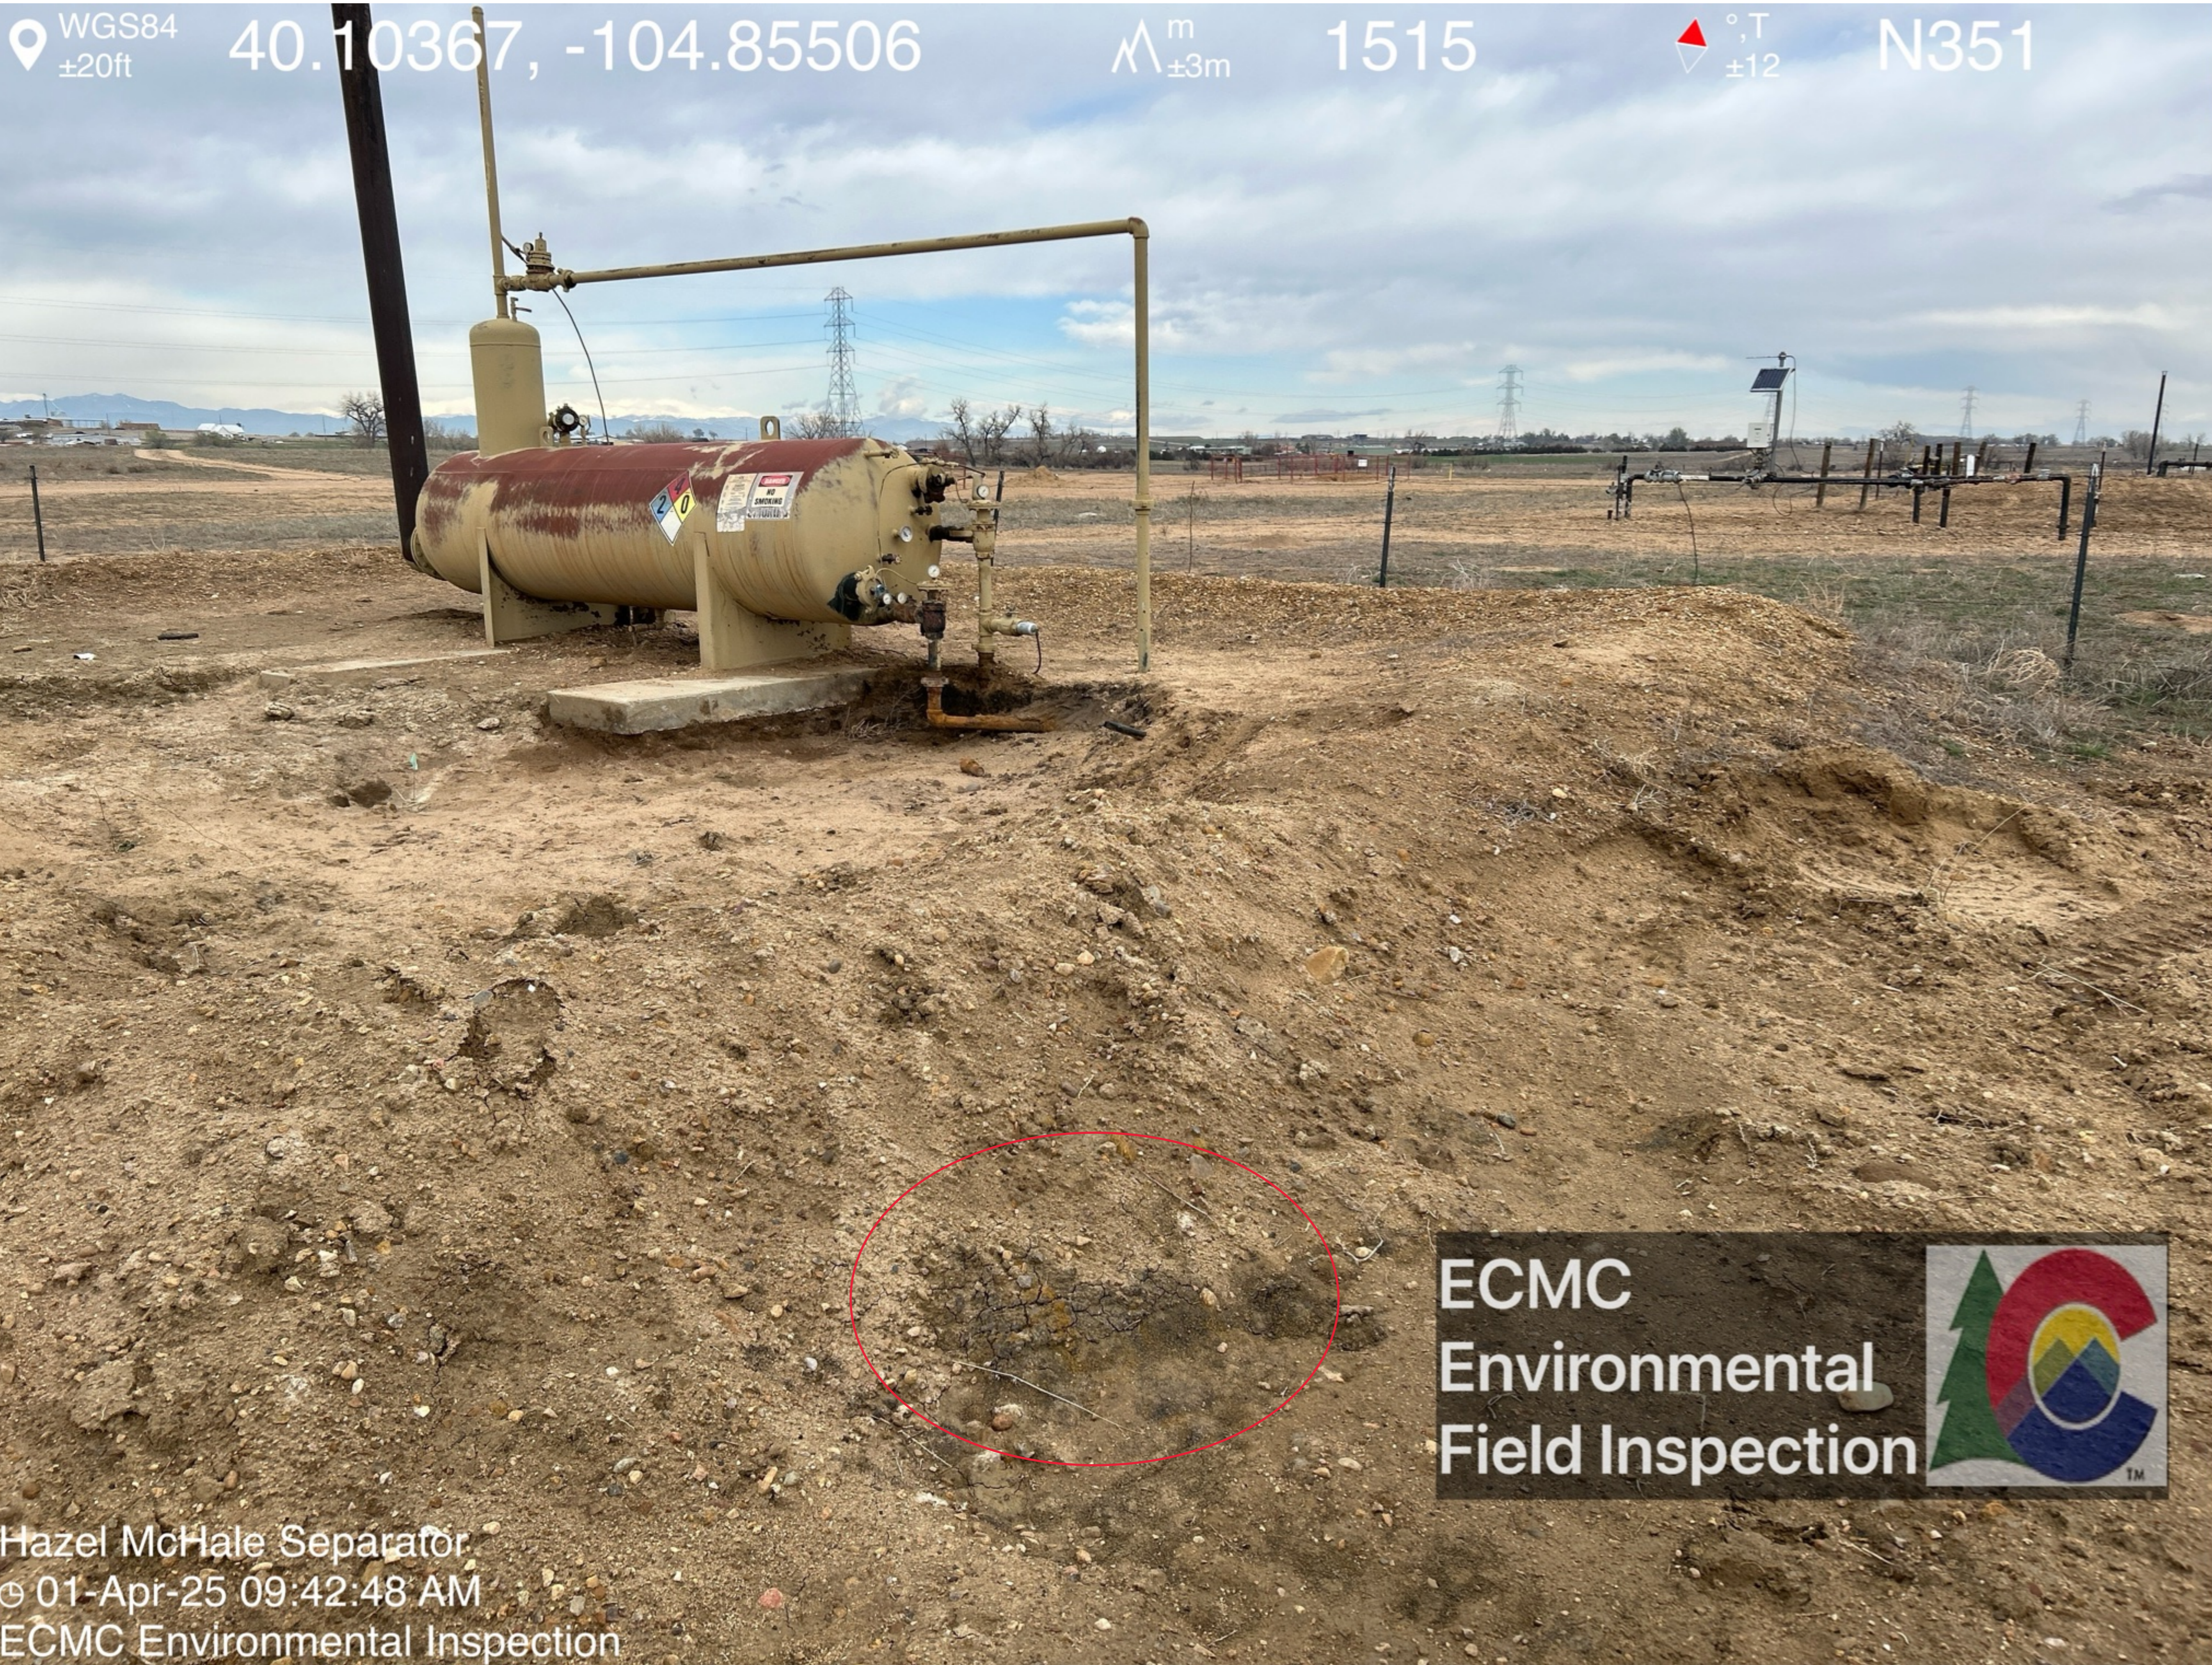
Gray staining is visible outside of the separator berm.

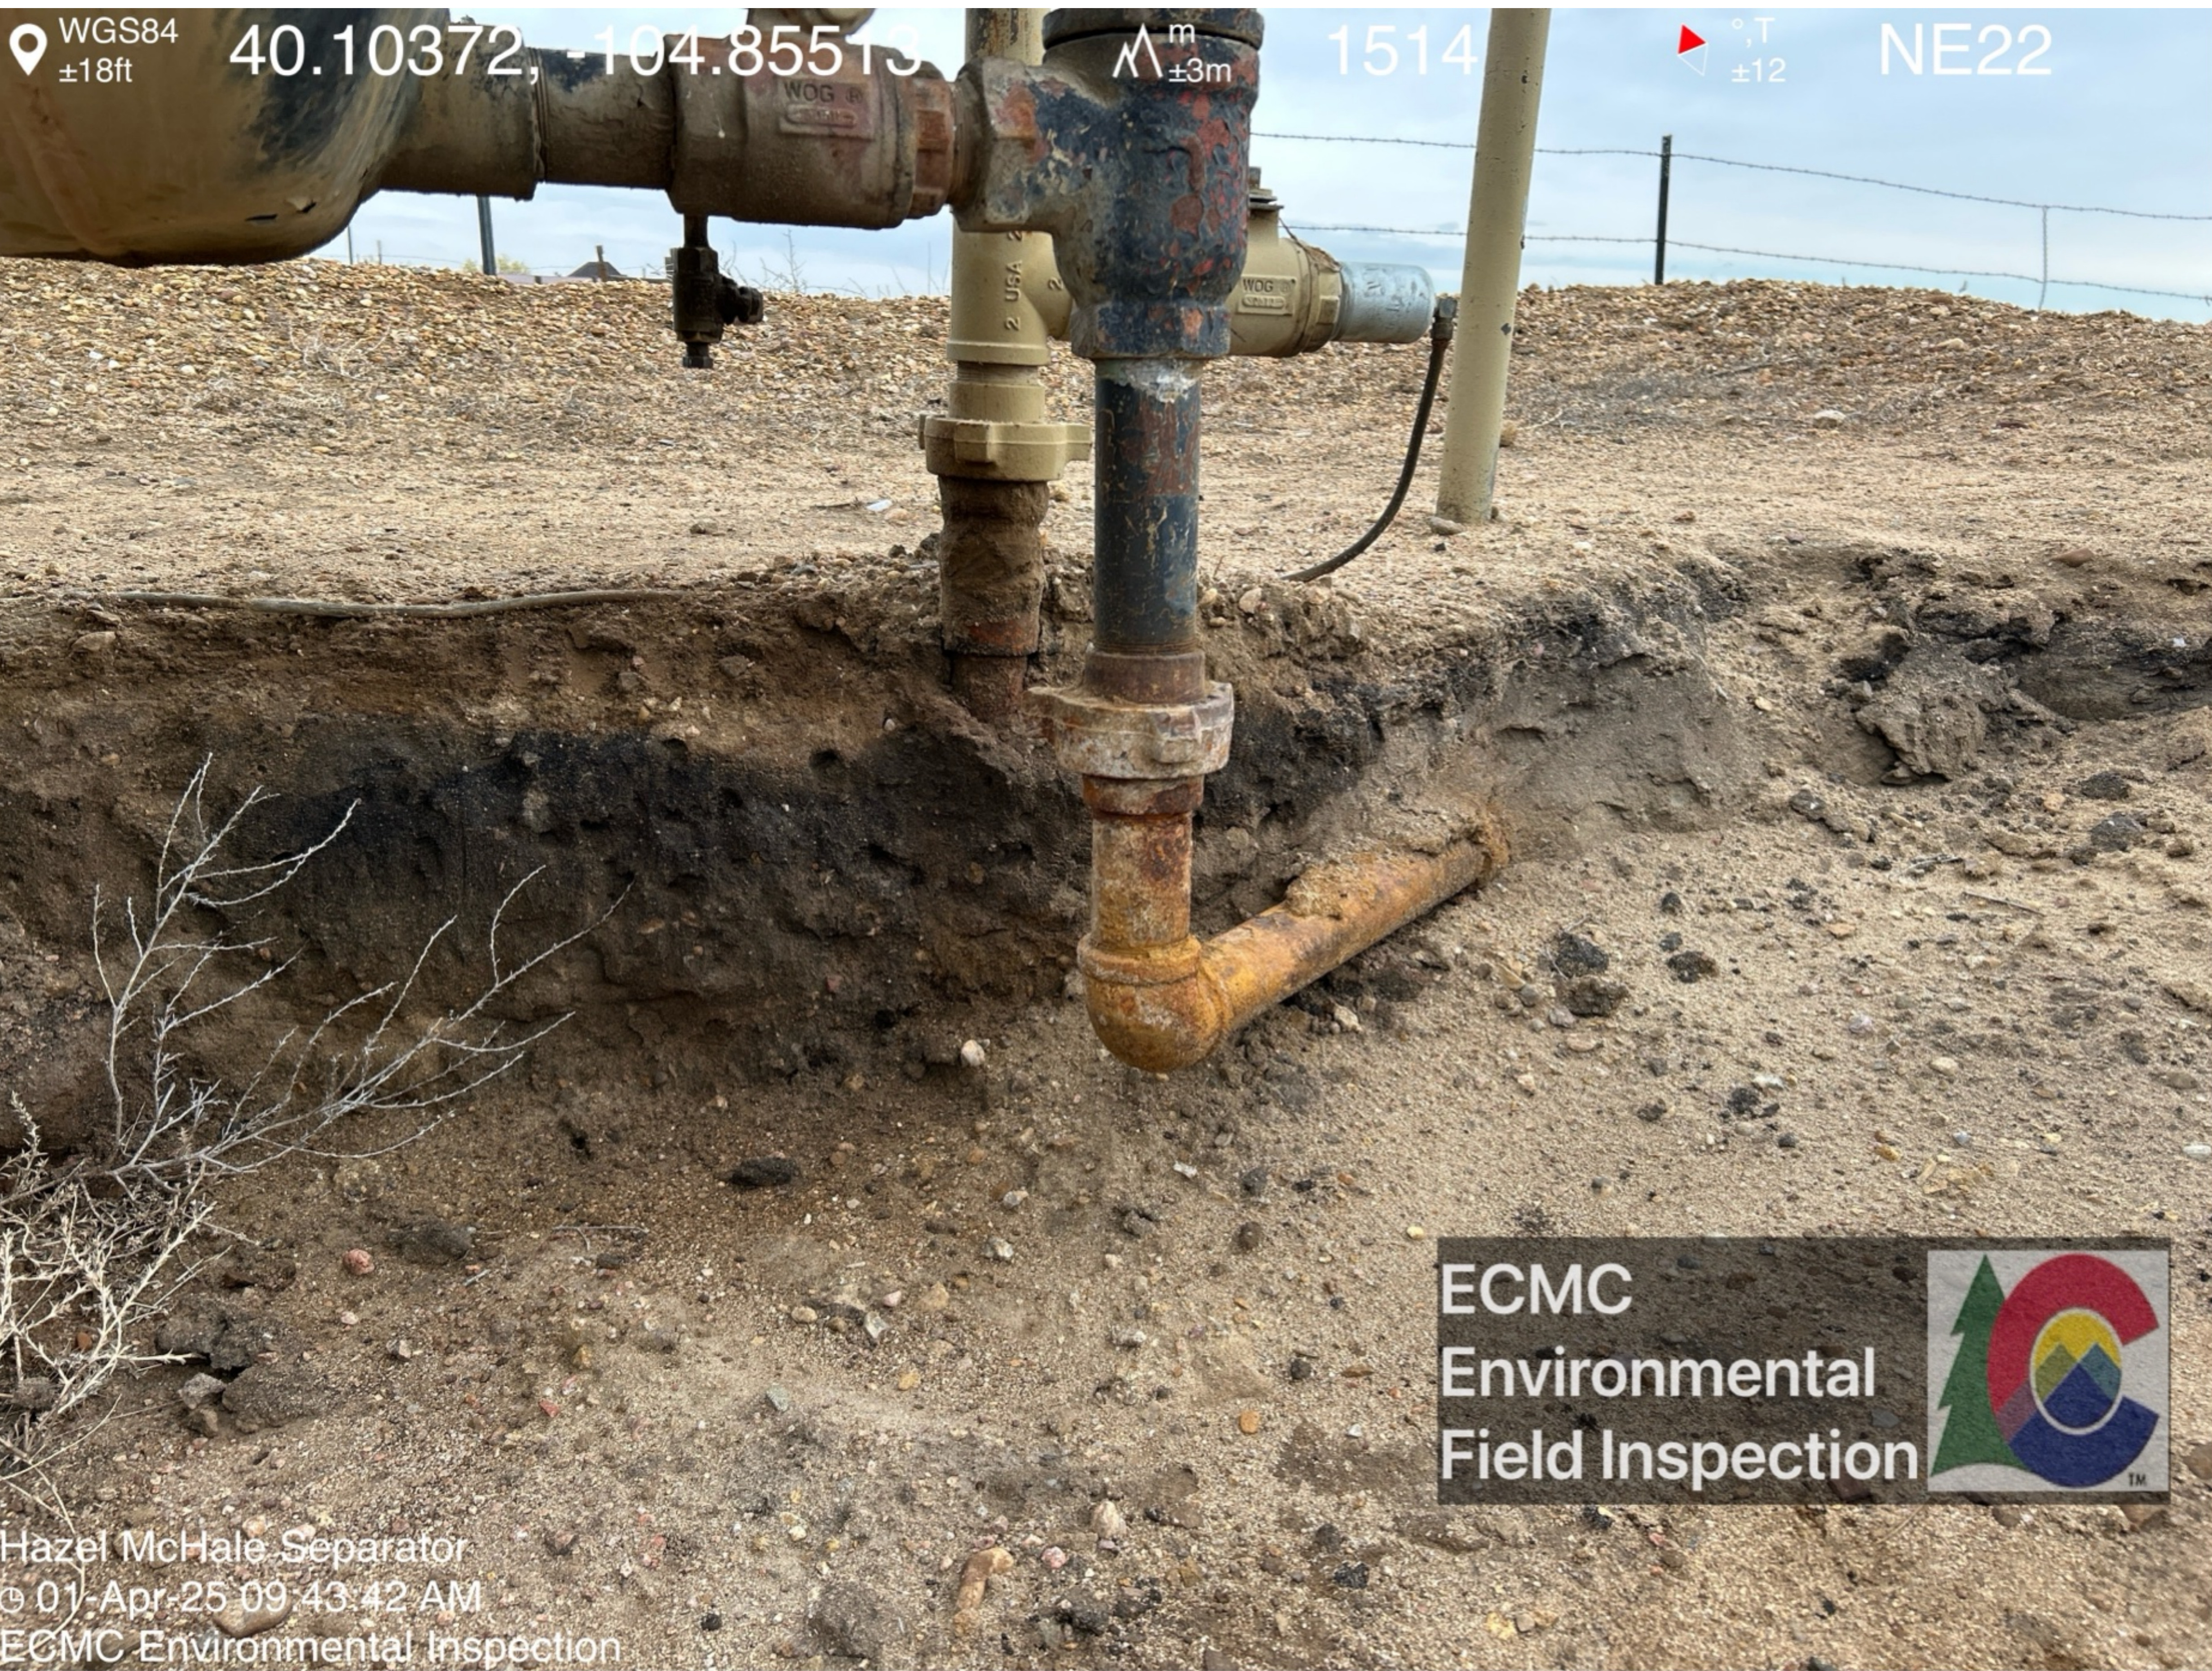
Gray to black petroleum hydrocarbon staining is visible in situ in the area of Spill ID 489249. Petroleum hydrocarbon odor was observed when the stained soil was disturbed.

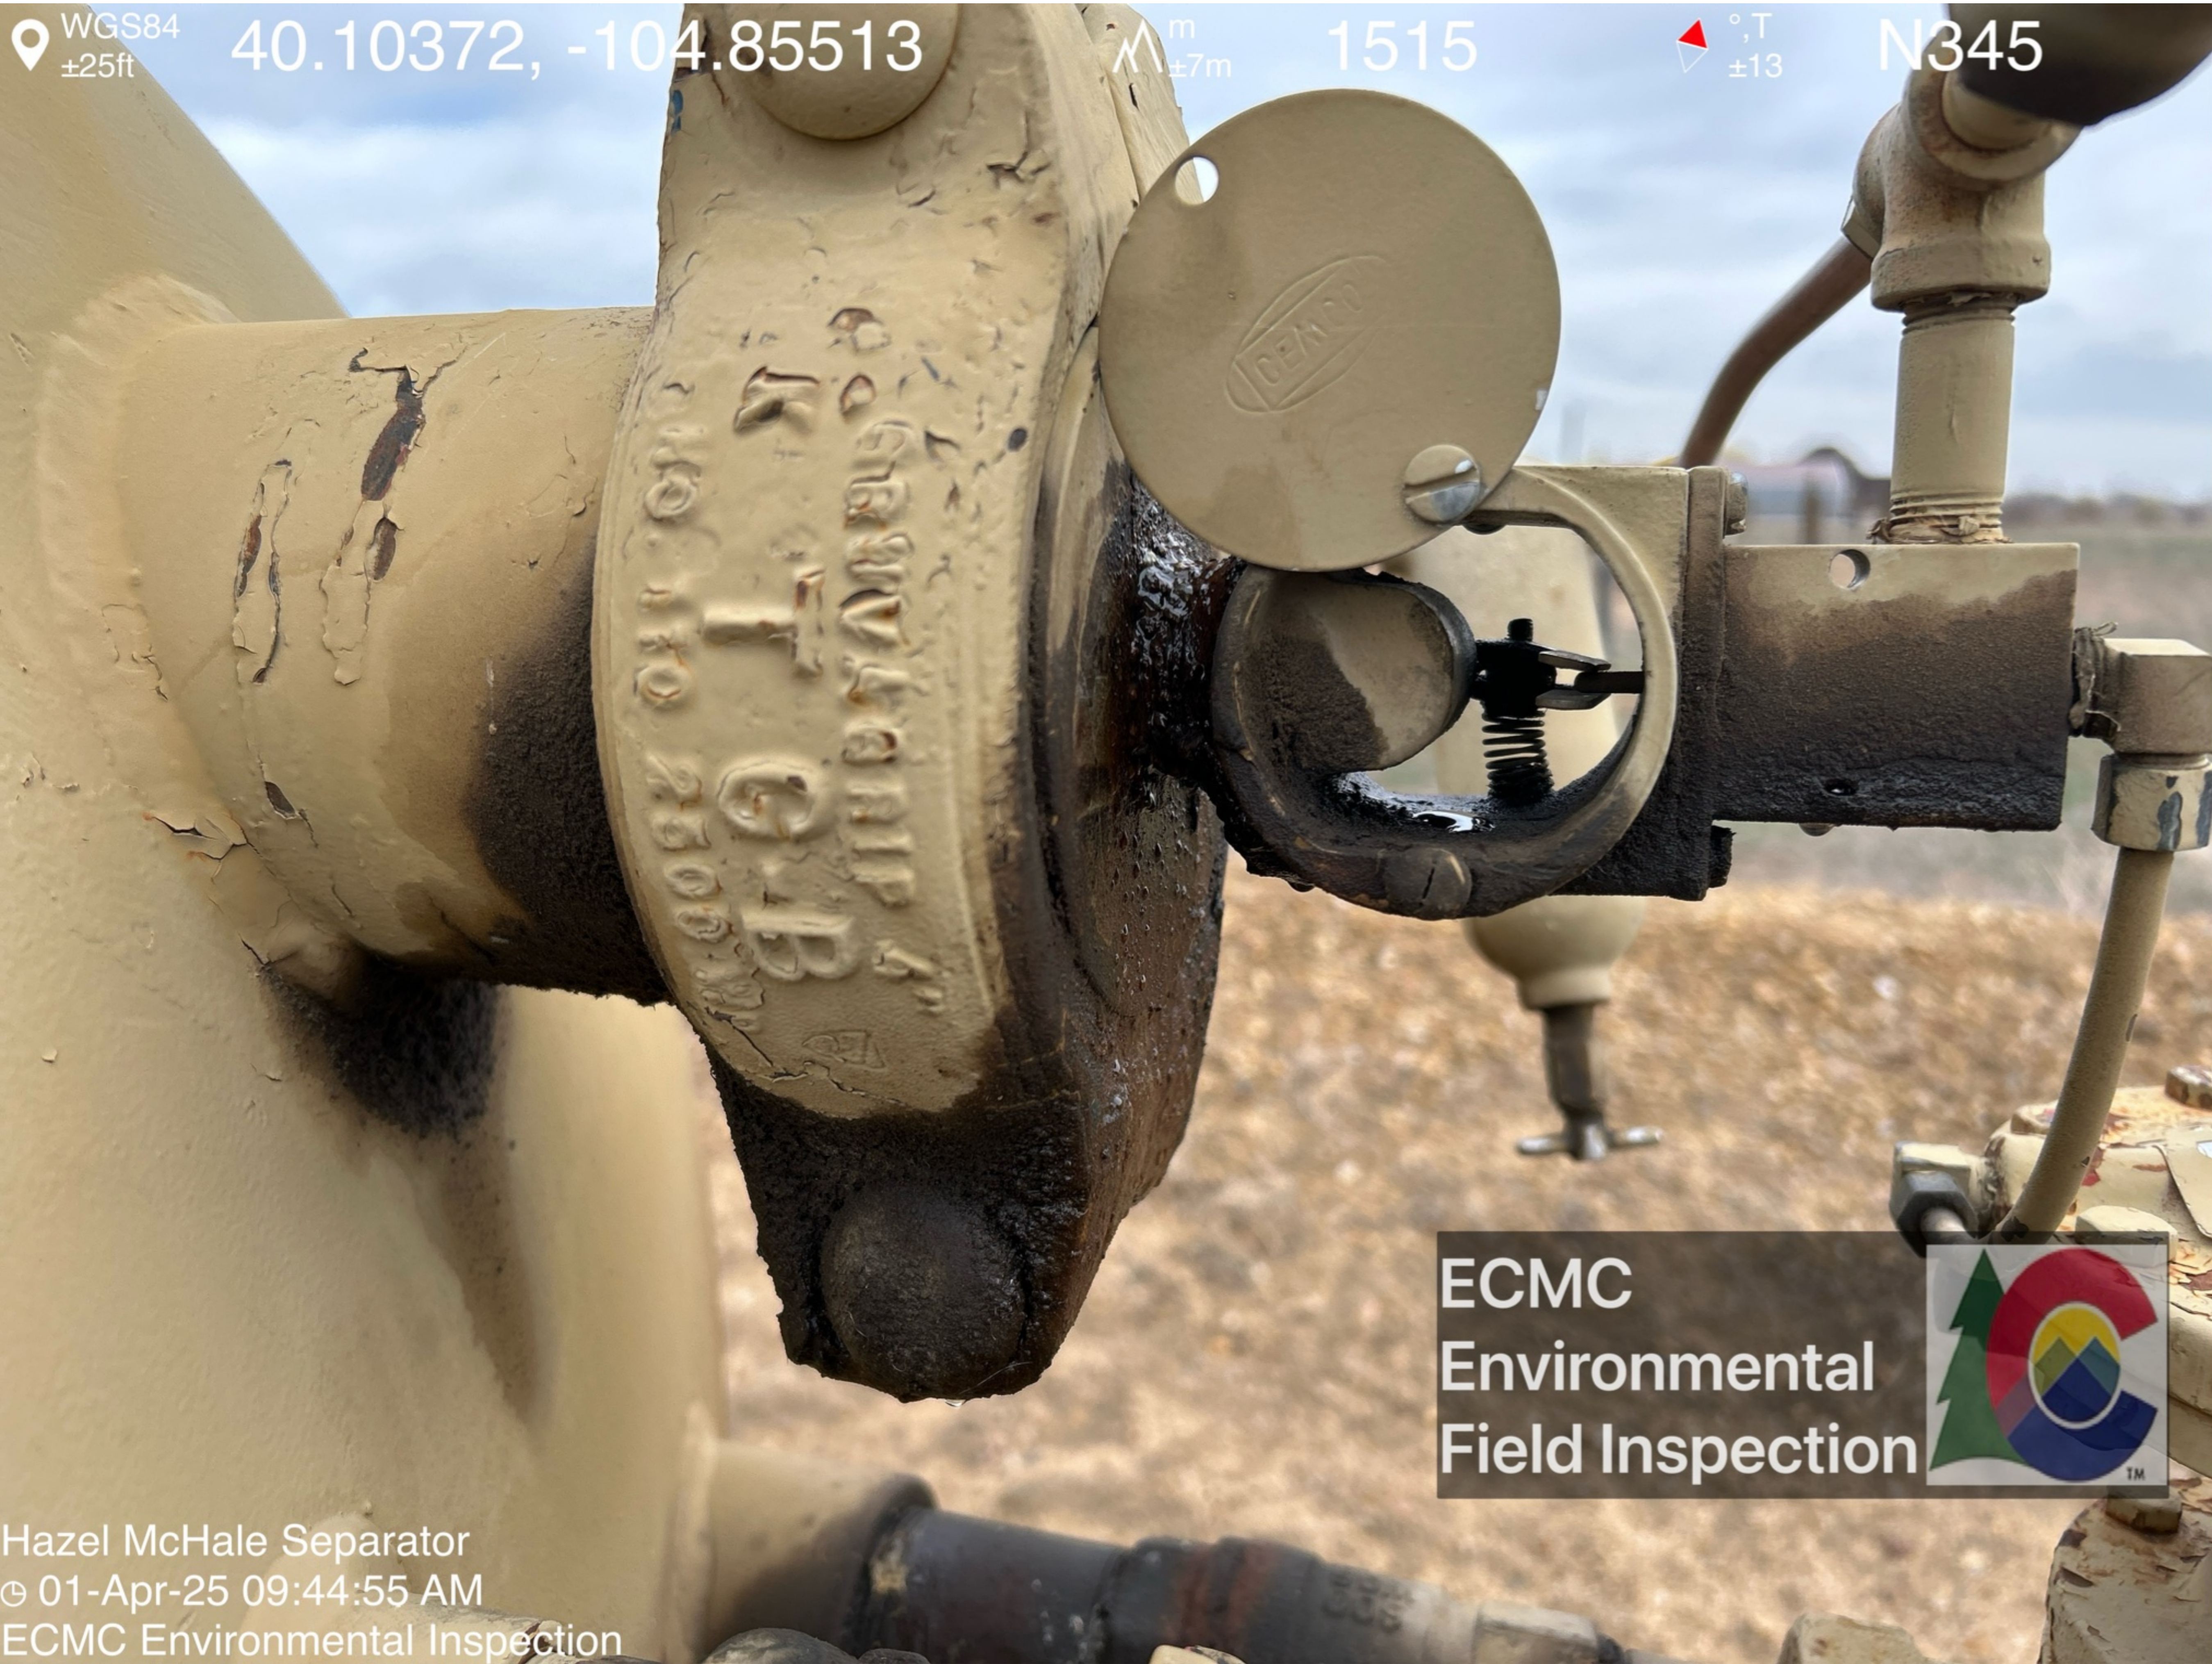
Petroleum hydrocarbon staining is visible on the surface of the separator above the impacted soil.

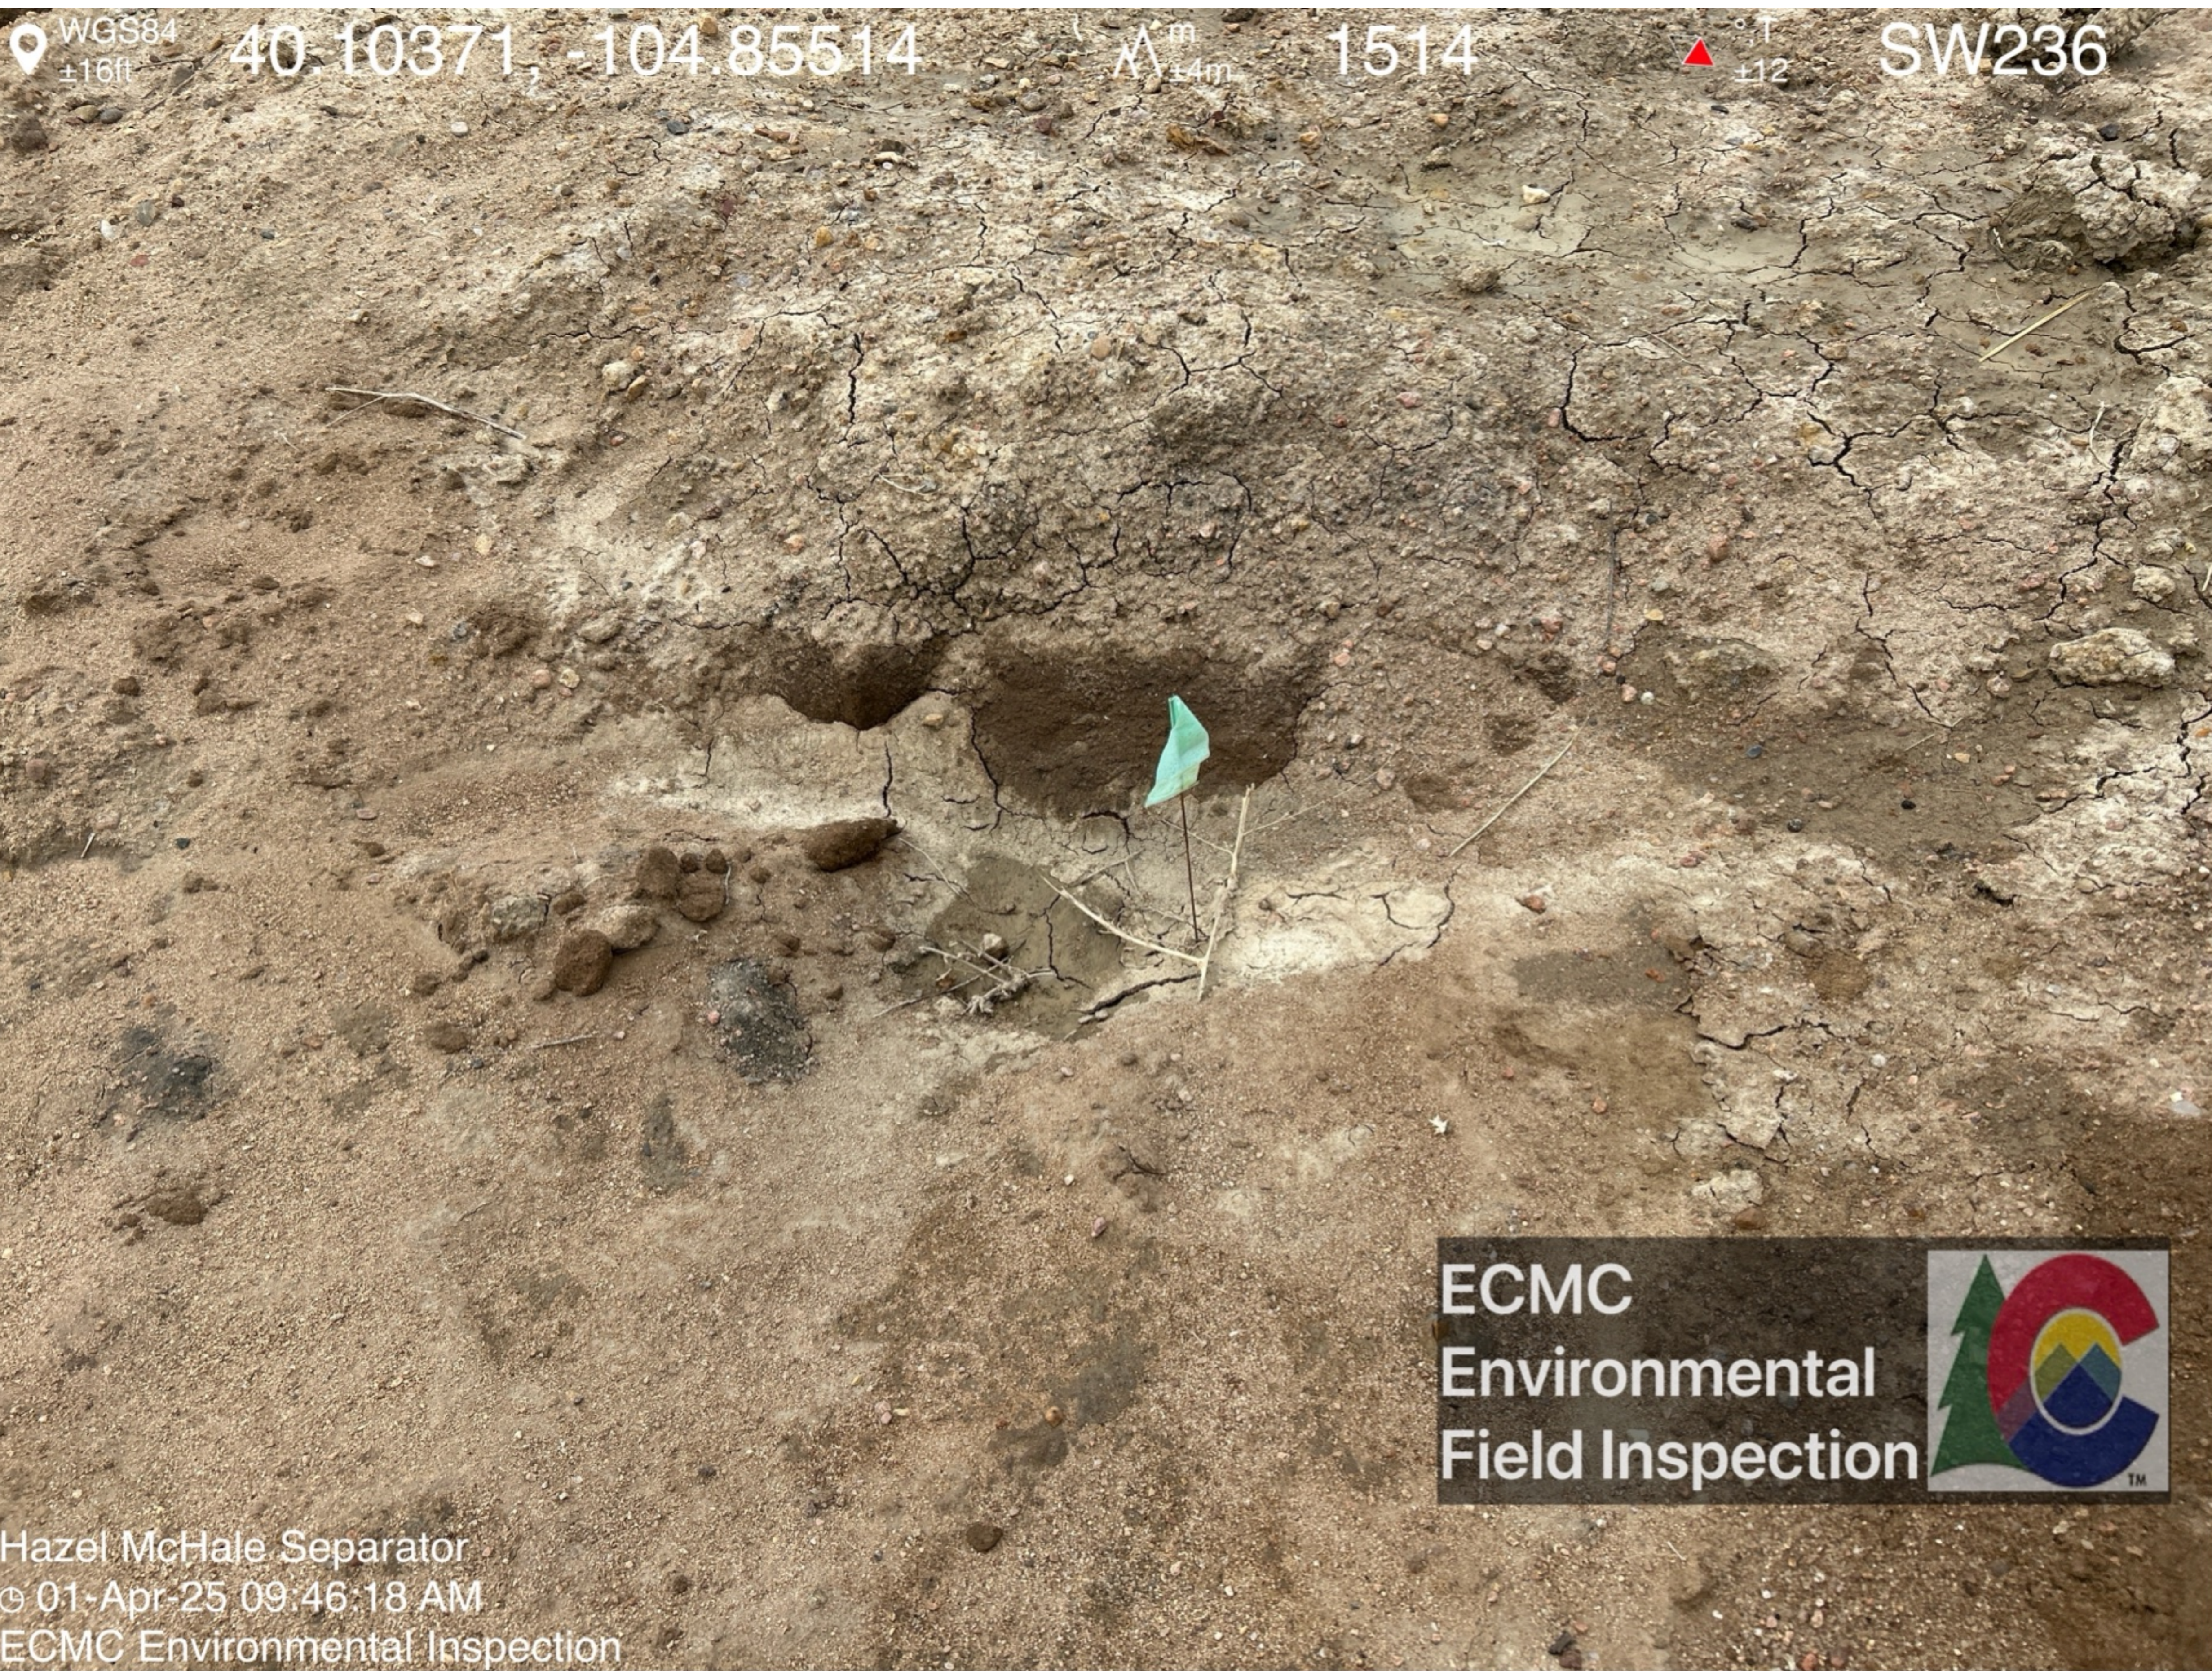
Petroleum hydrocarbon staining was visible at the edge of the excavation; petroleum hydrocarbon odor was observed.

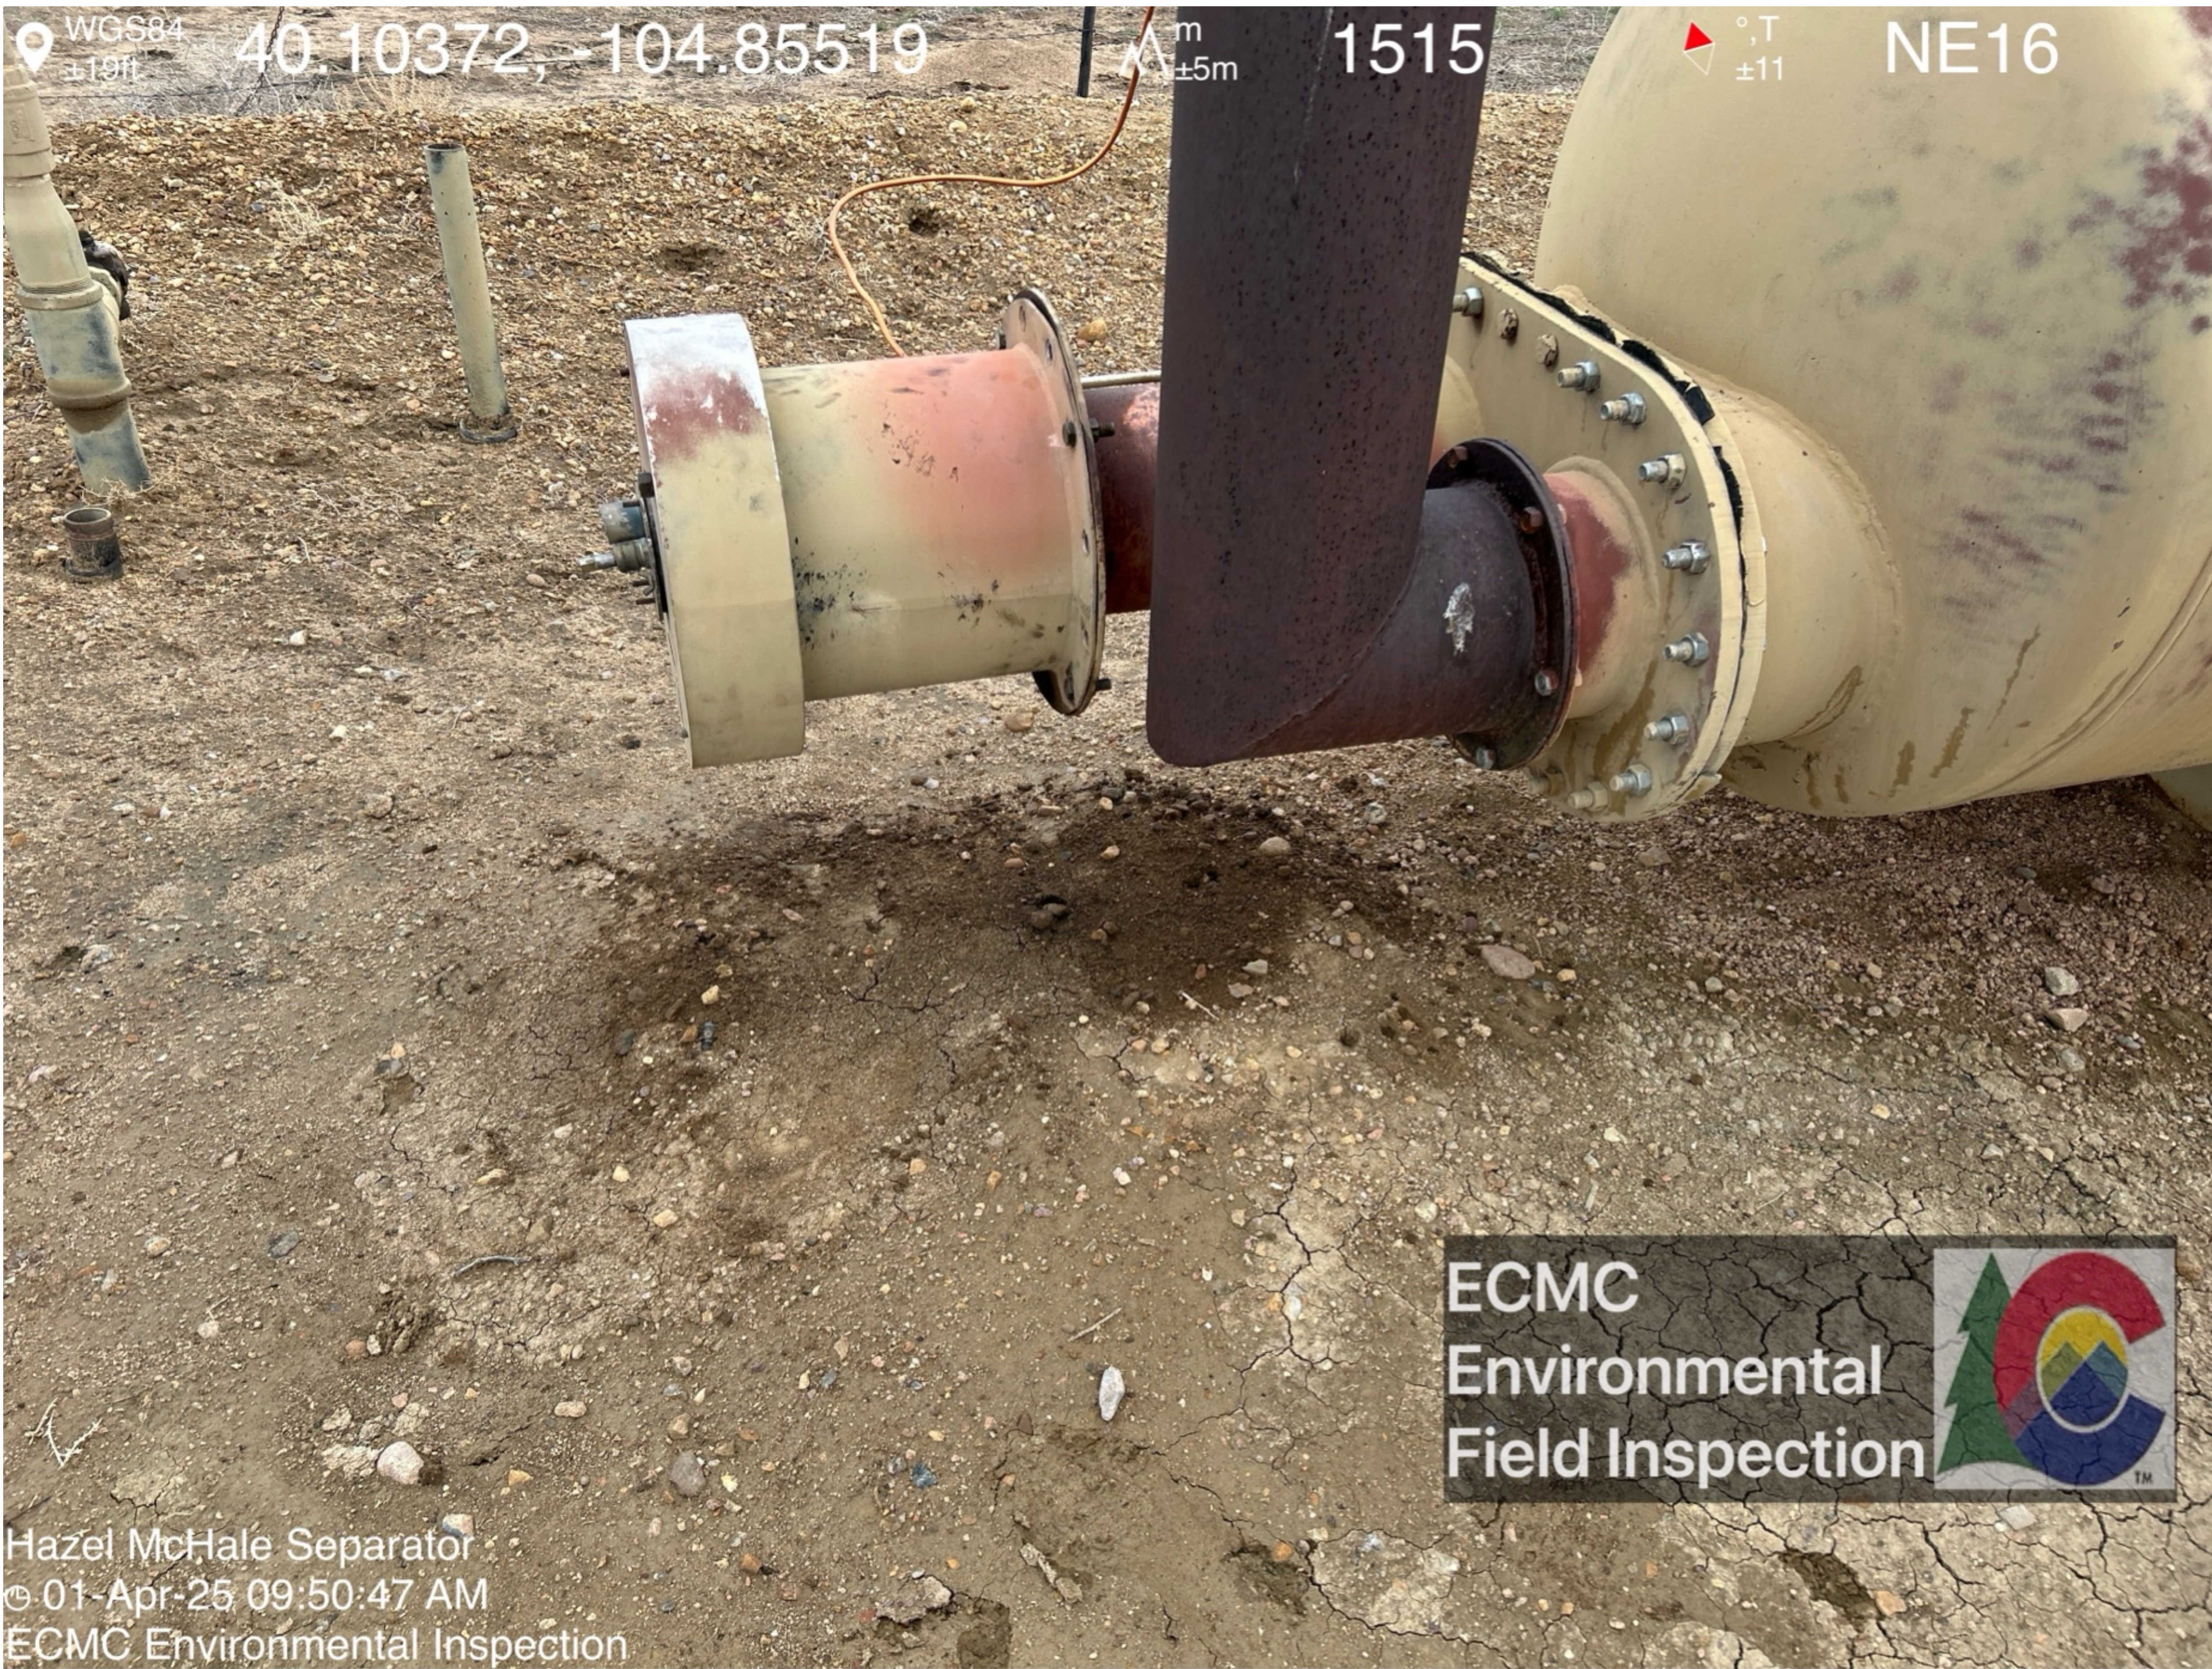
Petroleum hydrocarbon staining is visible in a separate area beneath the west side of the separator; a strong petroleum hydrocarbon odor was observed when stained soil was disturbed.
