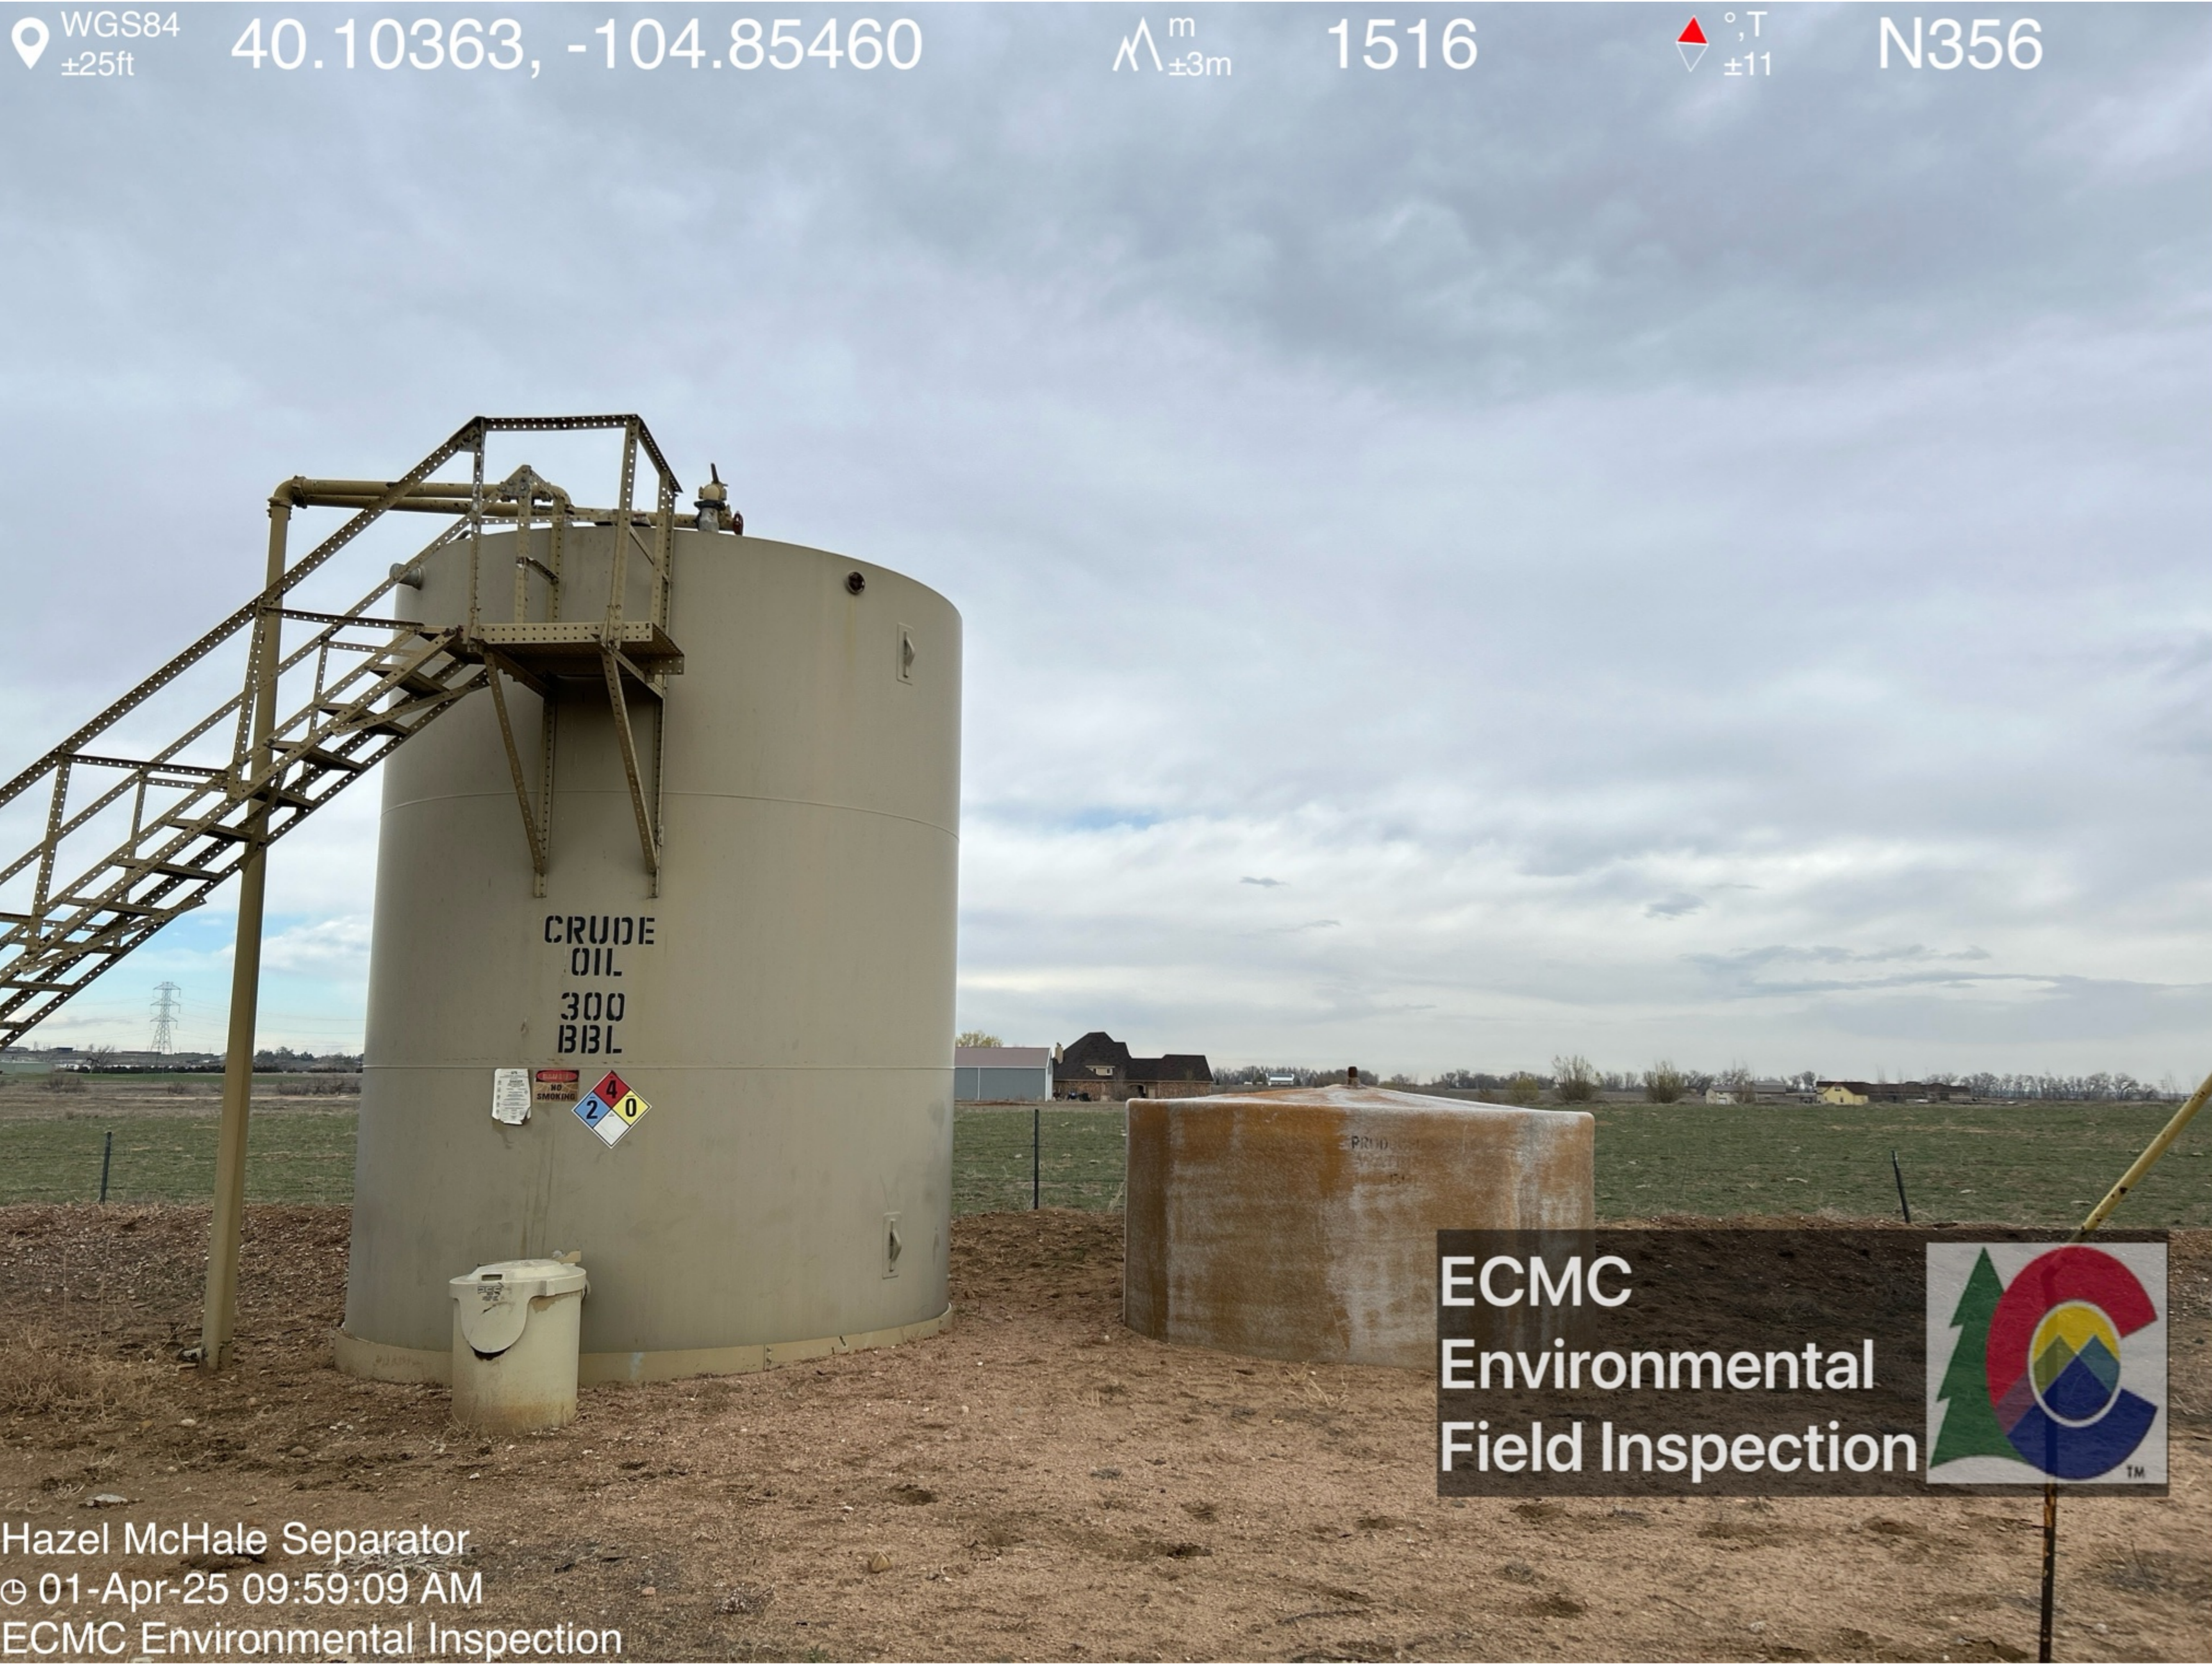
Fiberglass tank label has faded and is no longer legible. A strong petroleum hydrocarbon odor was observed immediately downwind of the tanks. Livestock tracks are visible.

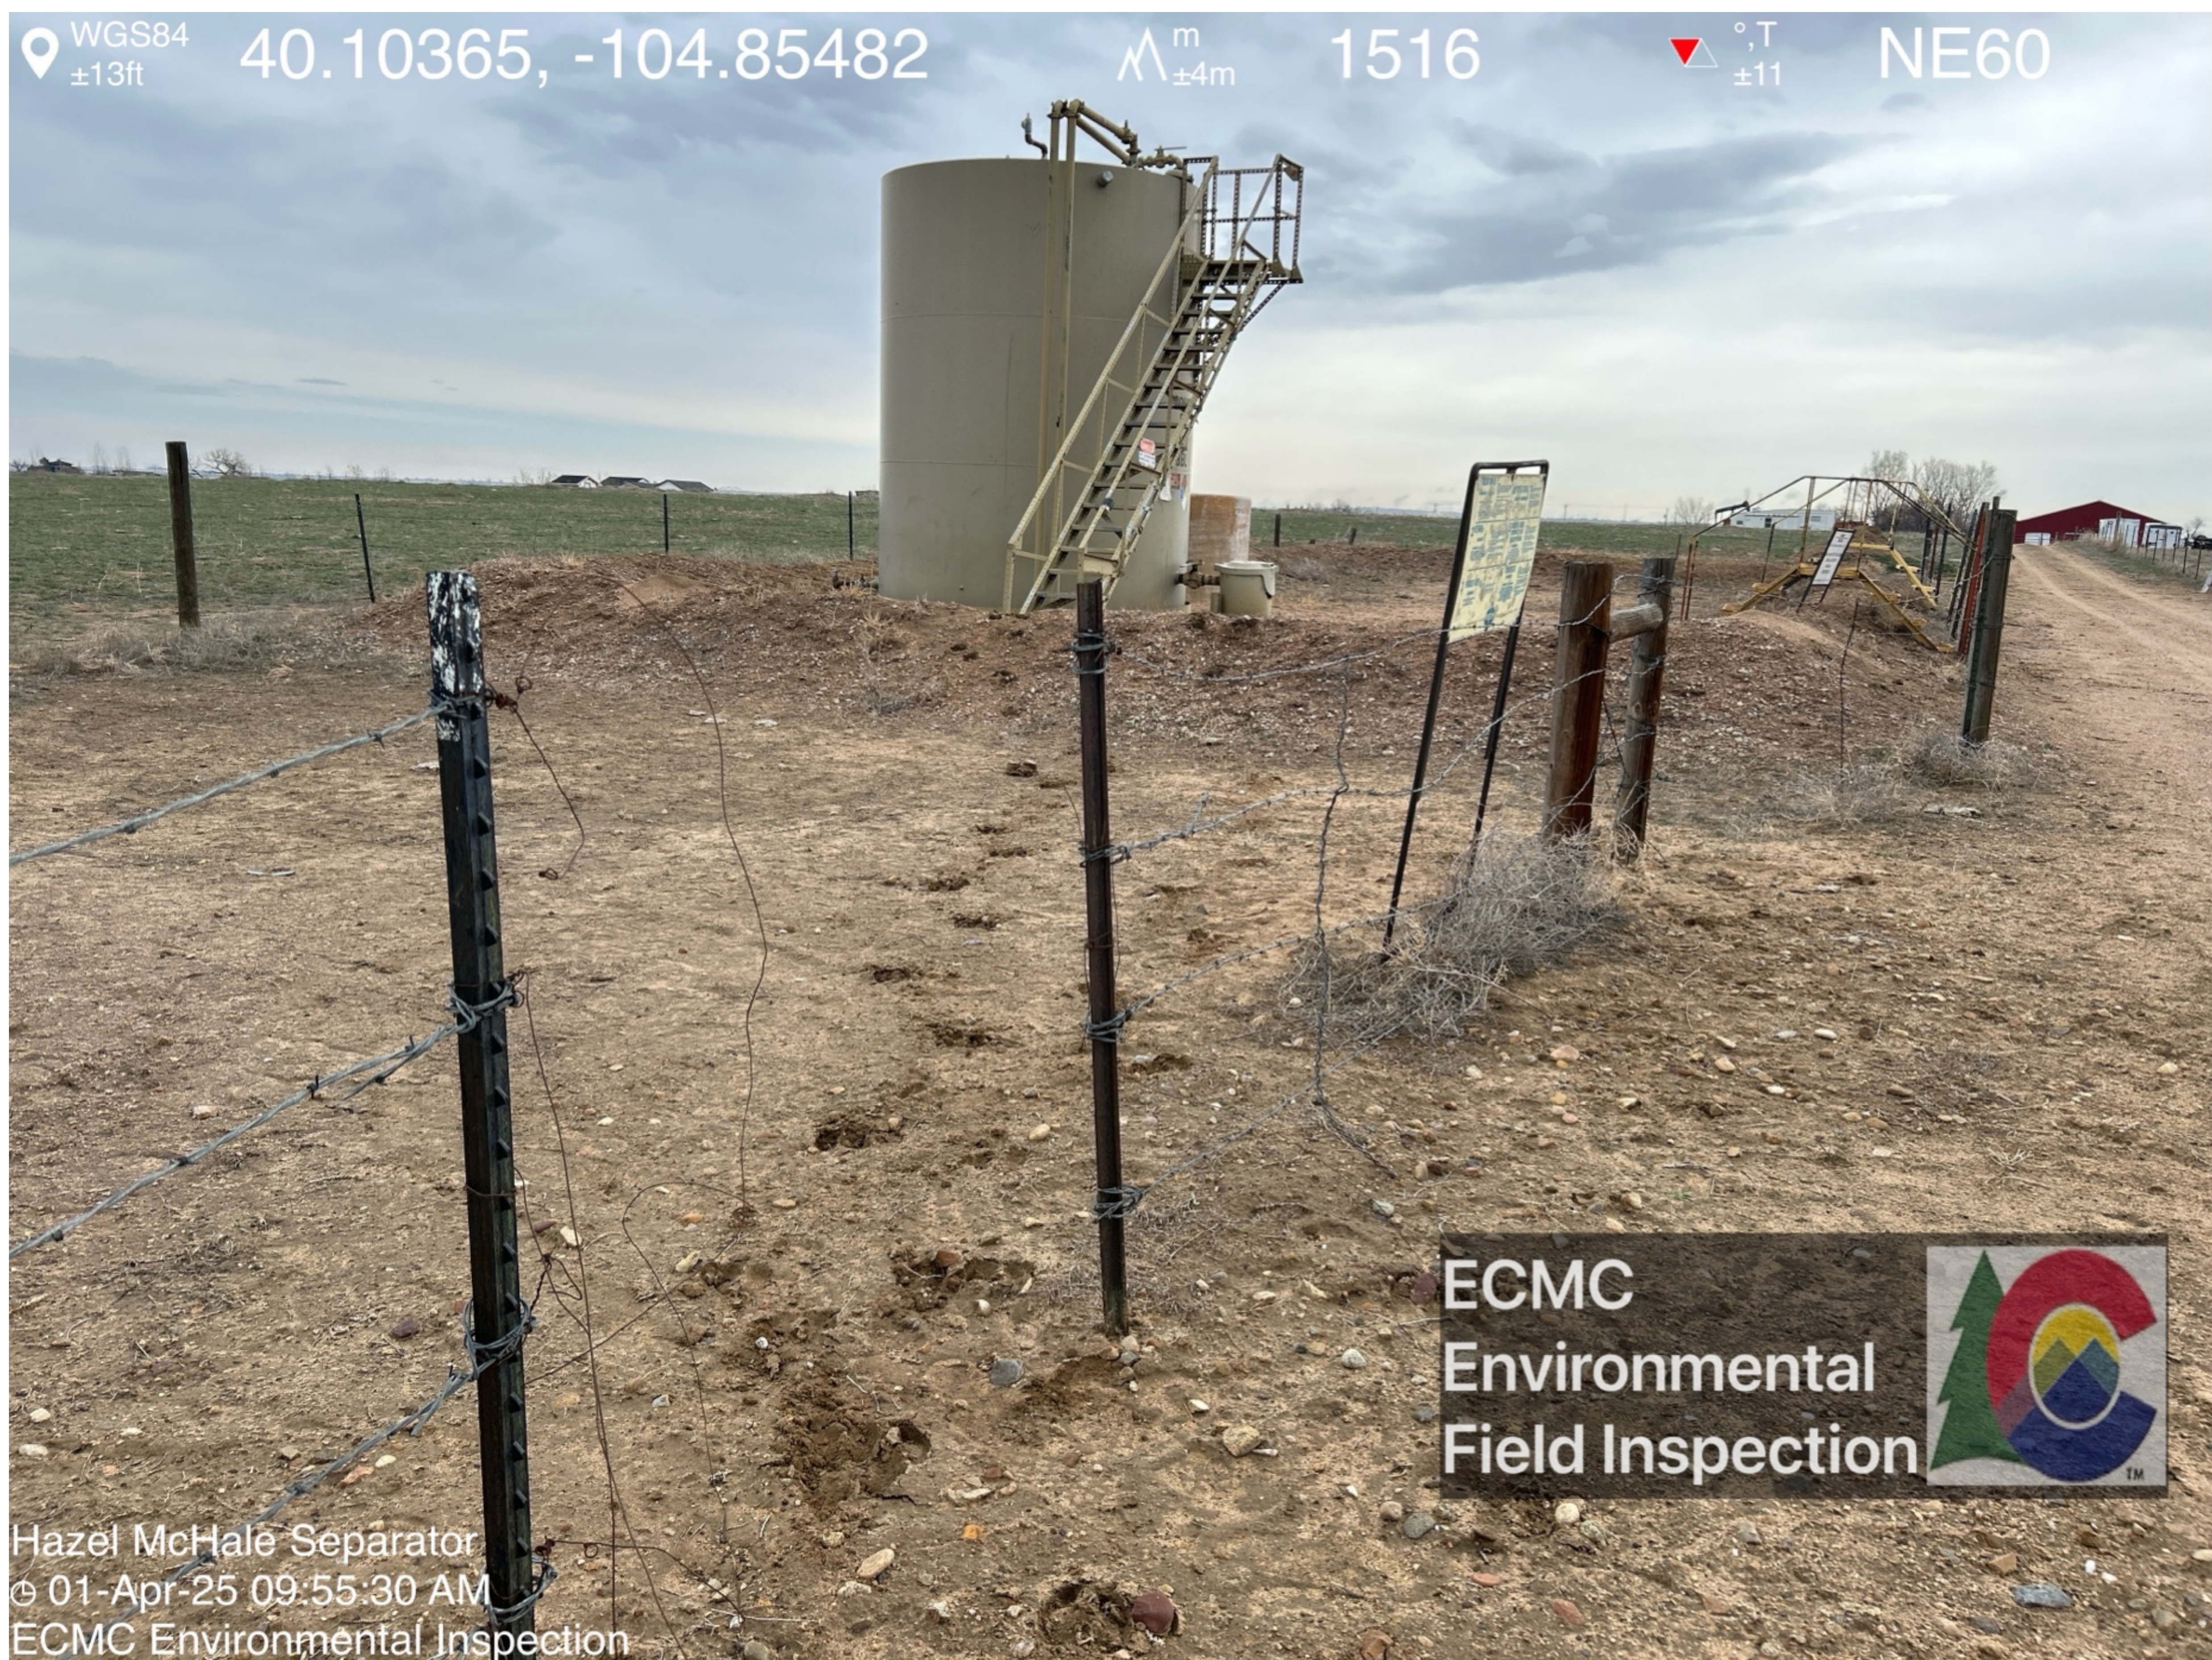
Livestock tracks are visible through the gap in the fencing, and on and within the tank containment berm. Separator and tank share fencing. Sign in foreground is not legible and does not reflect current Operator. Sign in background references Operator Emergency Contact Number is (303) 825-4822. Debris is visible.

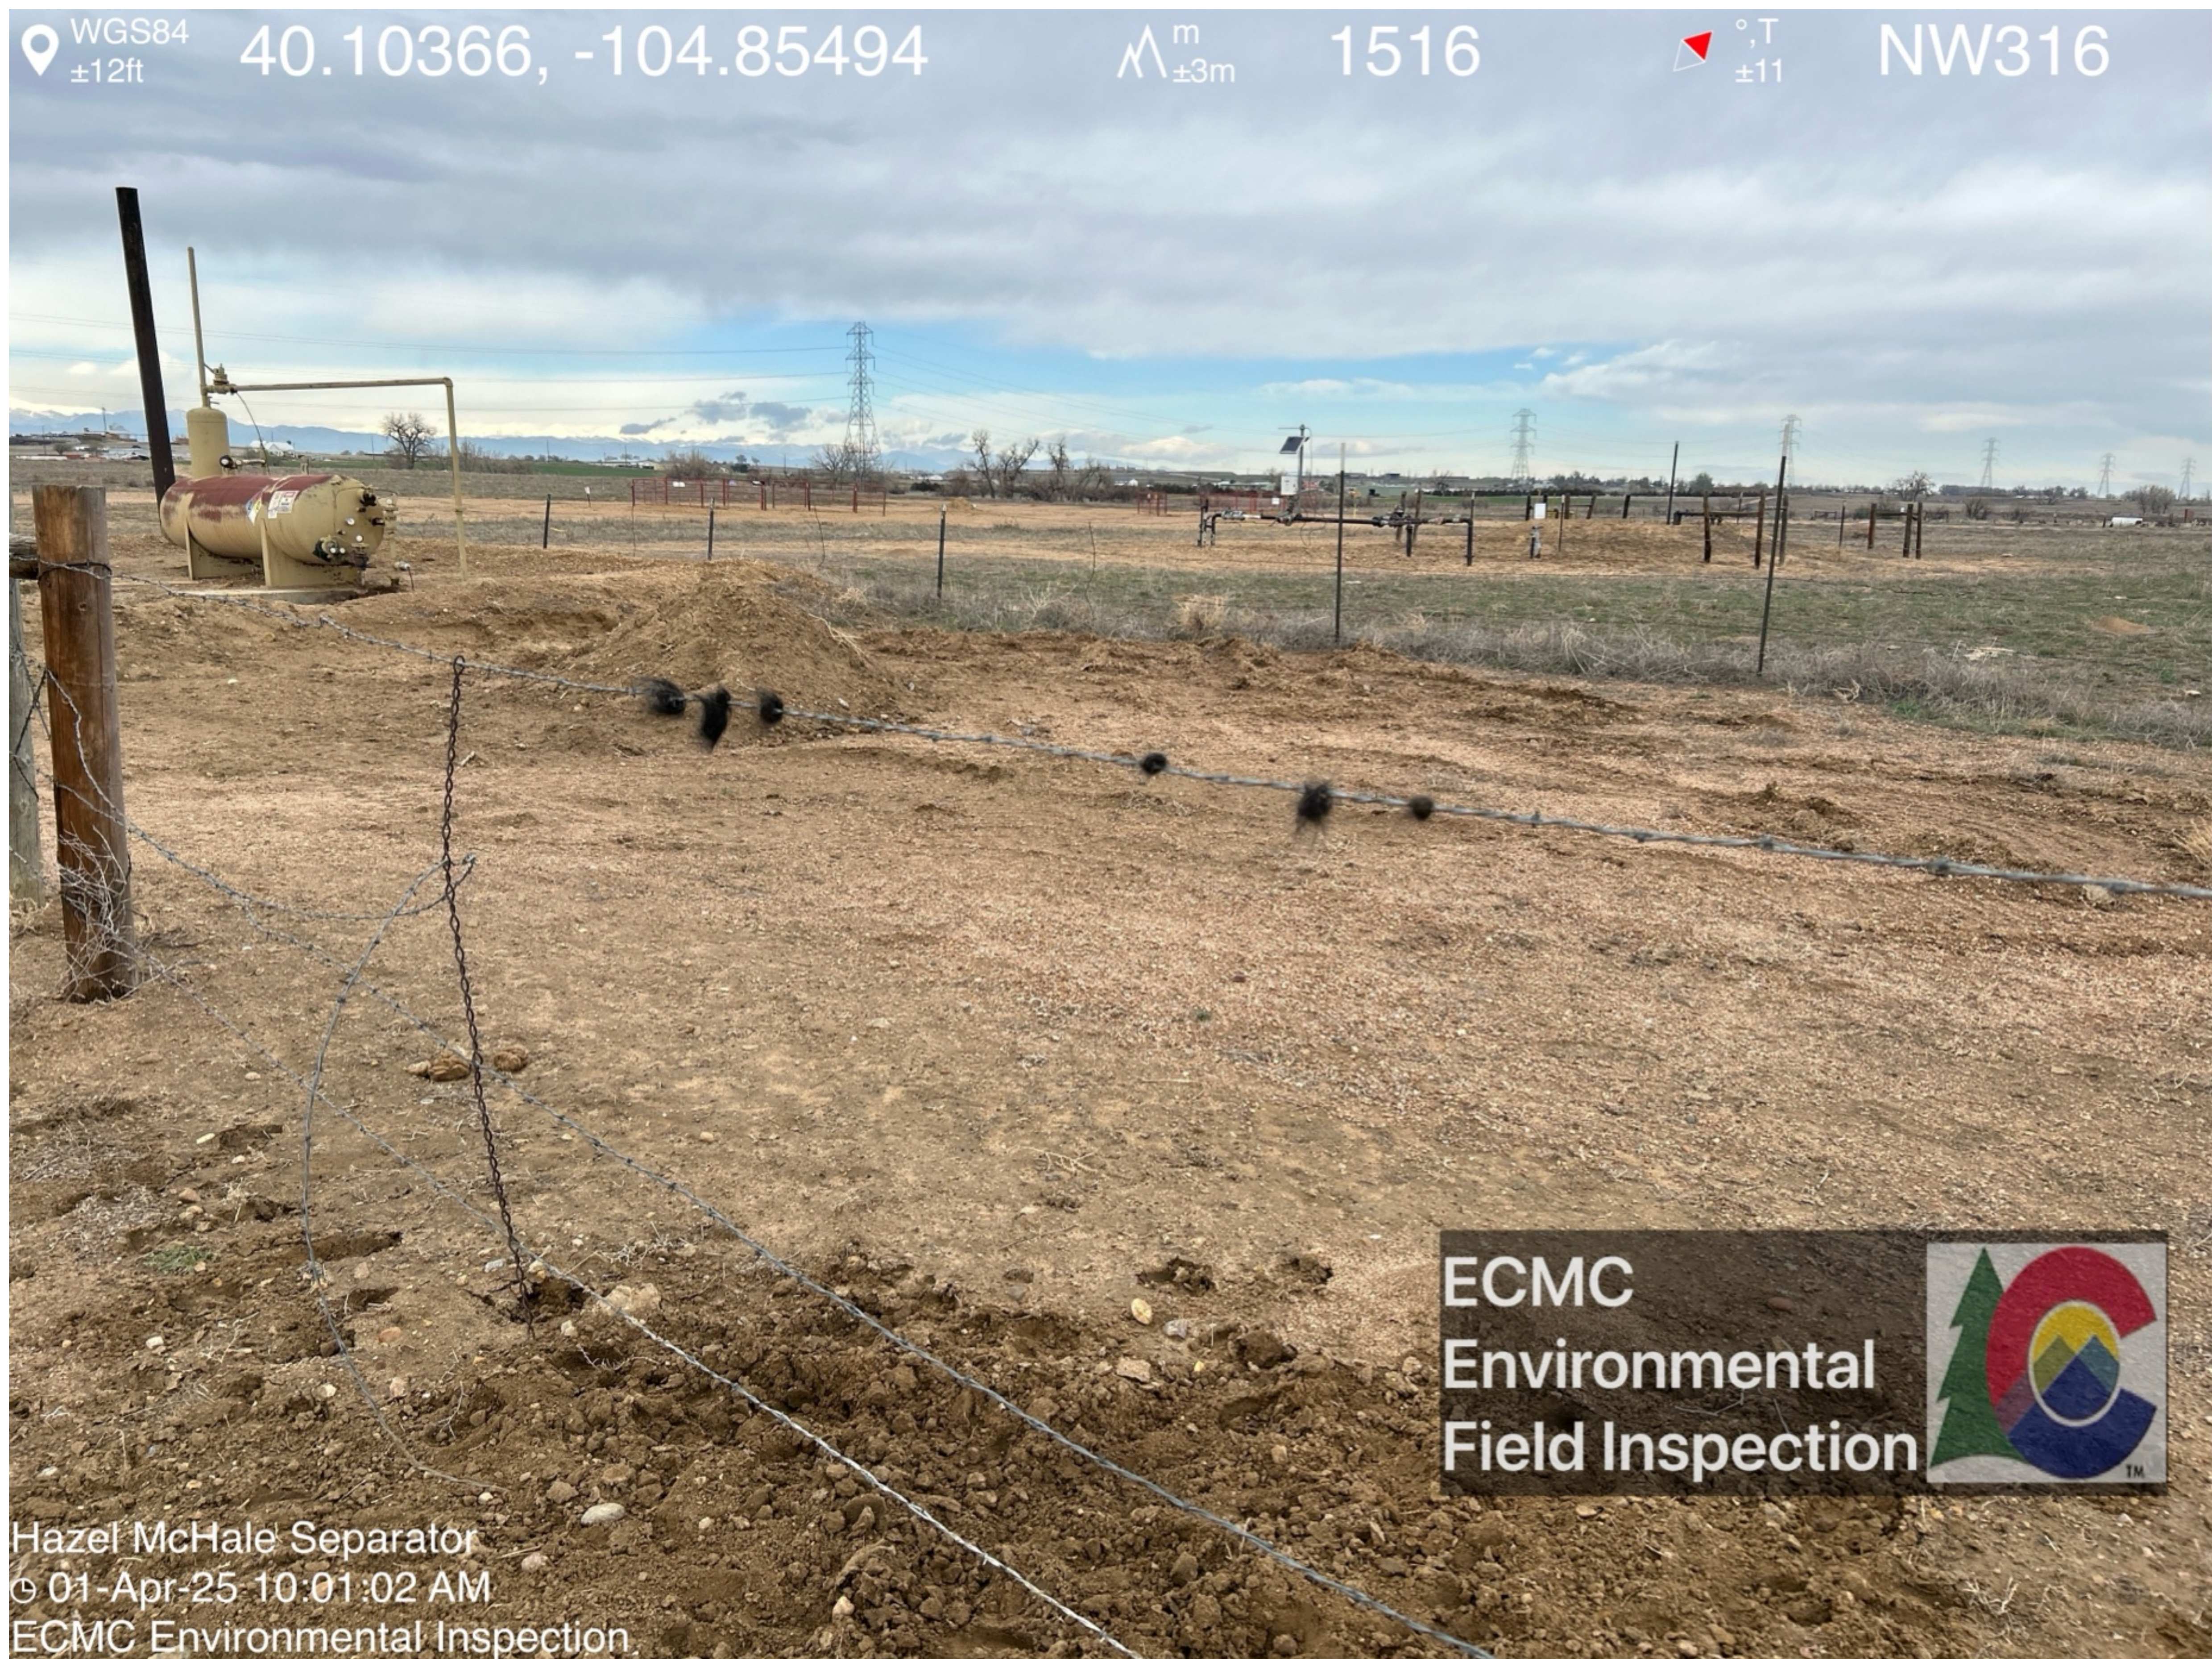
Tufts of livestock fur are visible on the barbed wire stretched above a gap in the fencing.
