Inspection Photos

Loc: 476137

Operator: **WILLIFORD ENERGY COMPANY**

Inspection Date: 4/9/2025

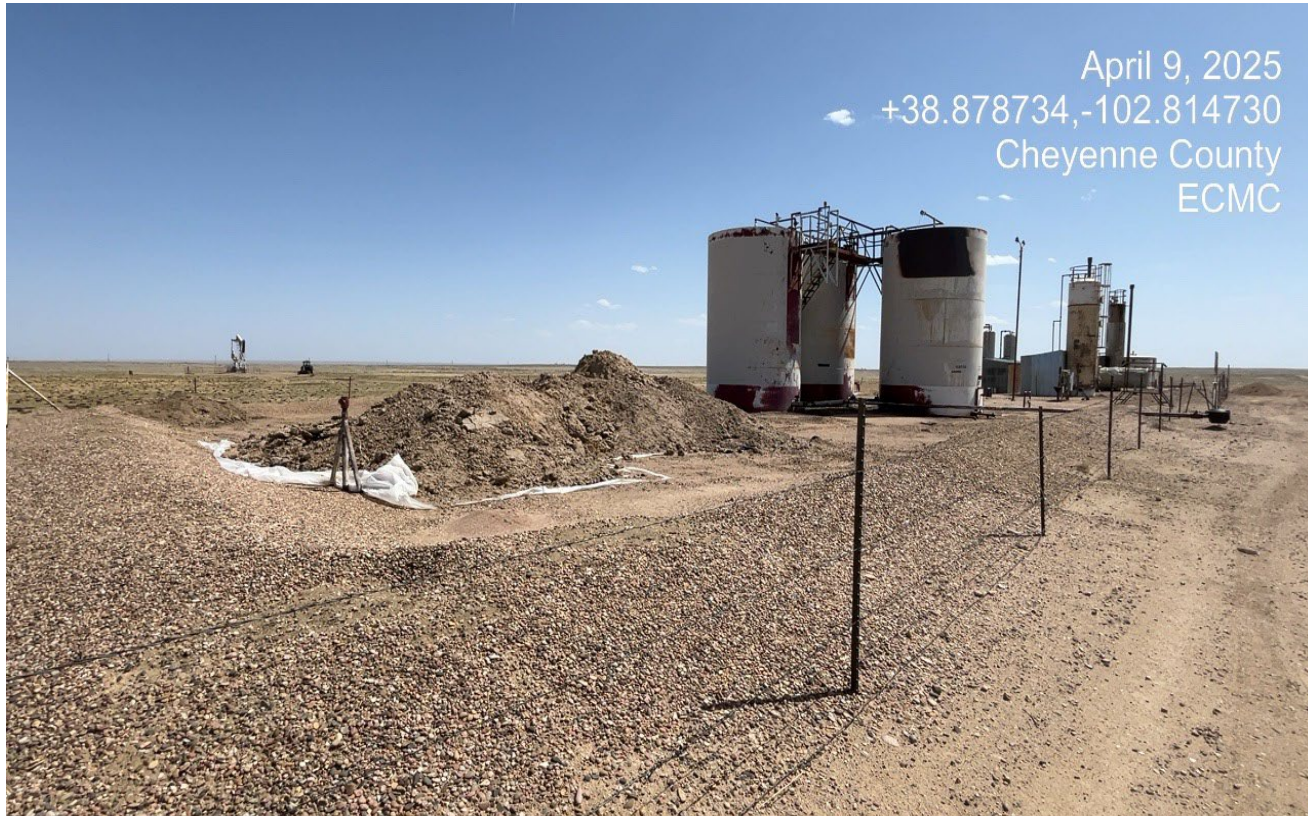
Photo 1. Facing southeast toward the tank battery. The E&P waste from the previously observed spill has been placed on a plastic liner at the north side of the tank battery.

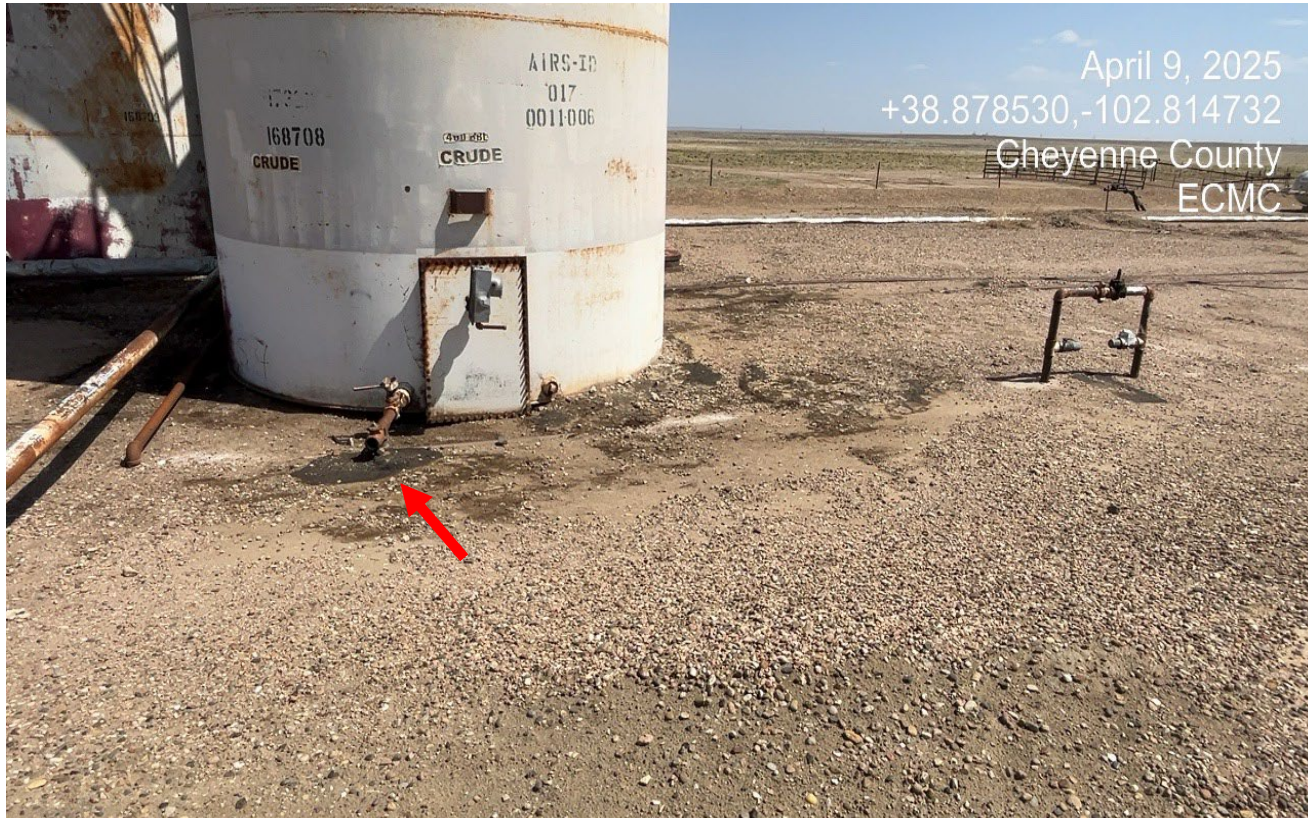
Photo 2. Facing northeast toward the tank battery. The oil stained waste remains around the tanks. Some of the tanks were removed since the previous inspection.

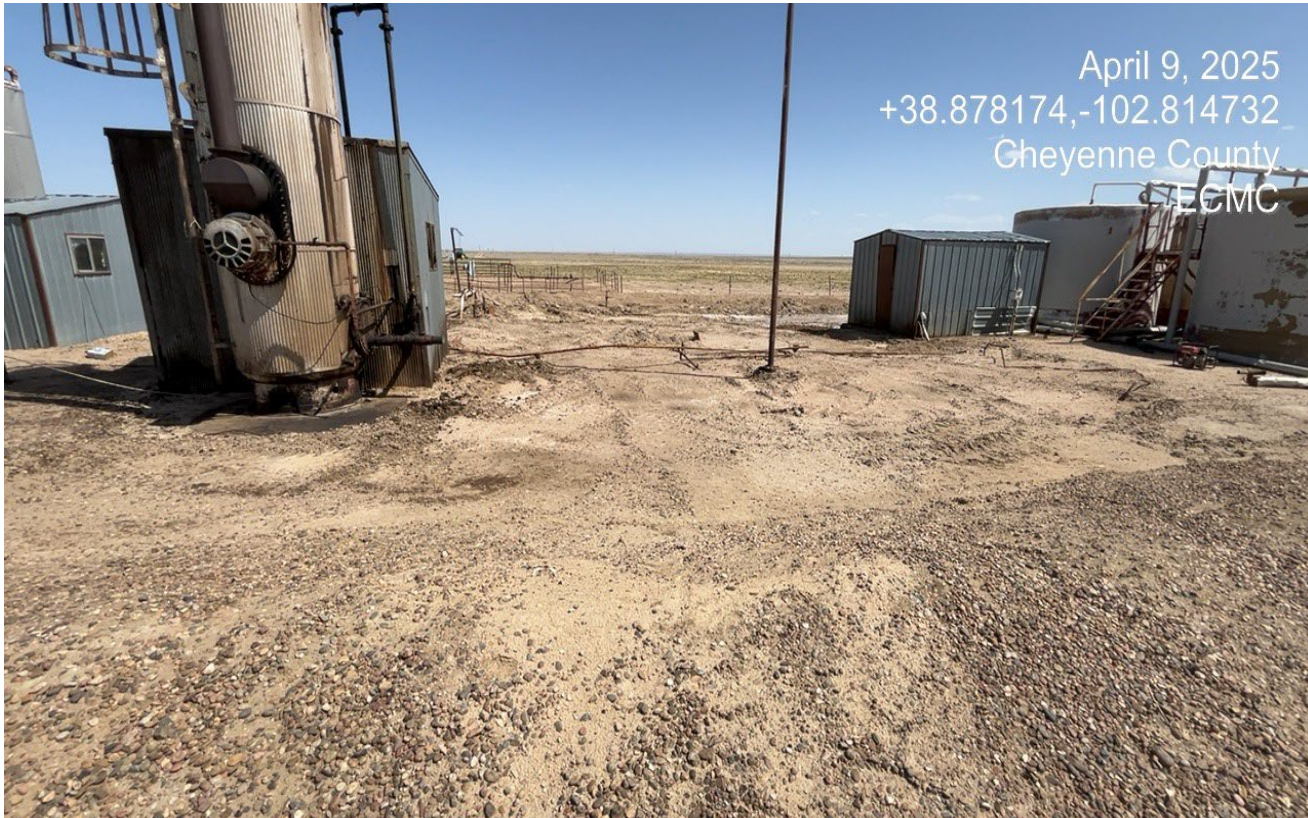
Photo 3. The previously observed that occurred near the heater treater. The surface and equipment was/is blackened from a hydrocarbon mist that occurred.

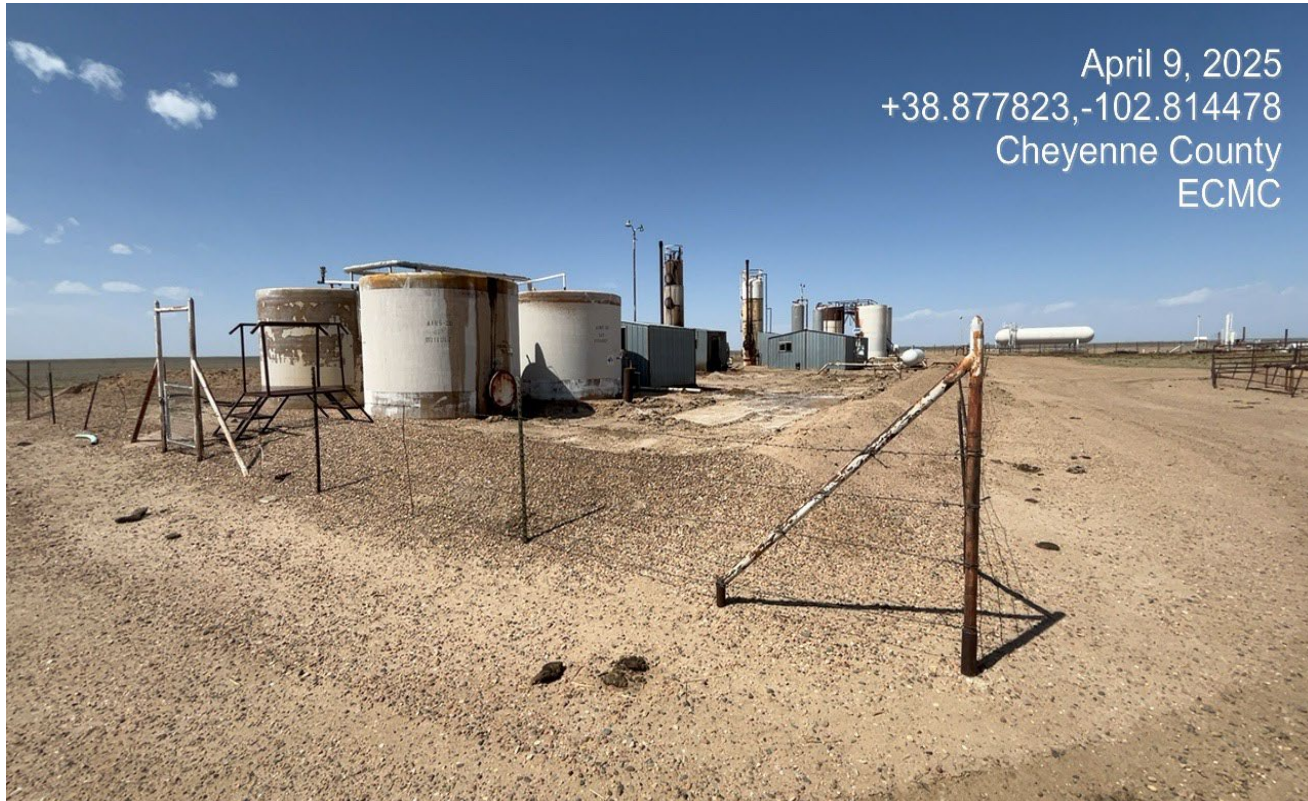
Photo 4. Southeast corner of the location facing northwest toward the tank battery facility. The previous spill had overtopped this corner with visible impacts shown in the previous inspection photos on 1/28/25.

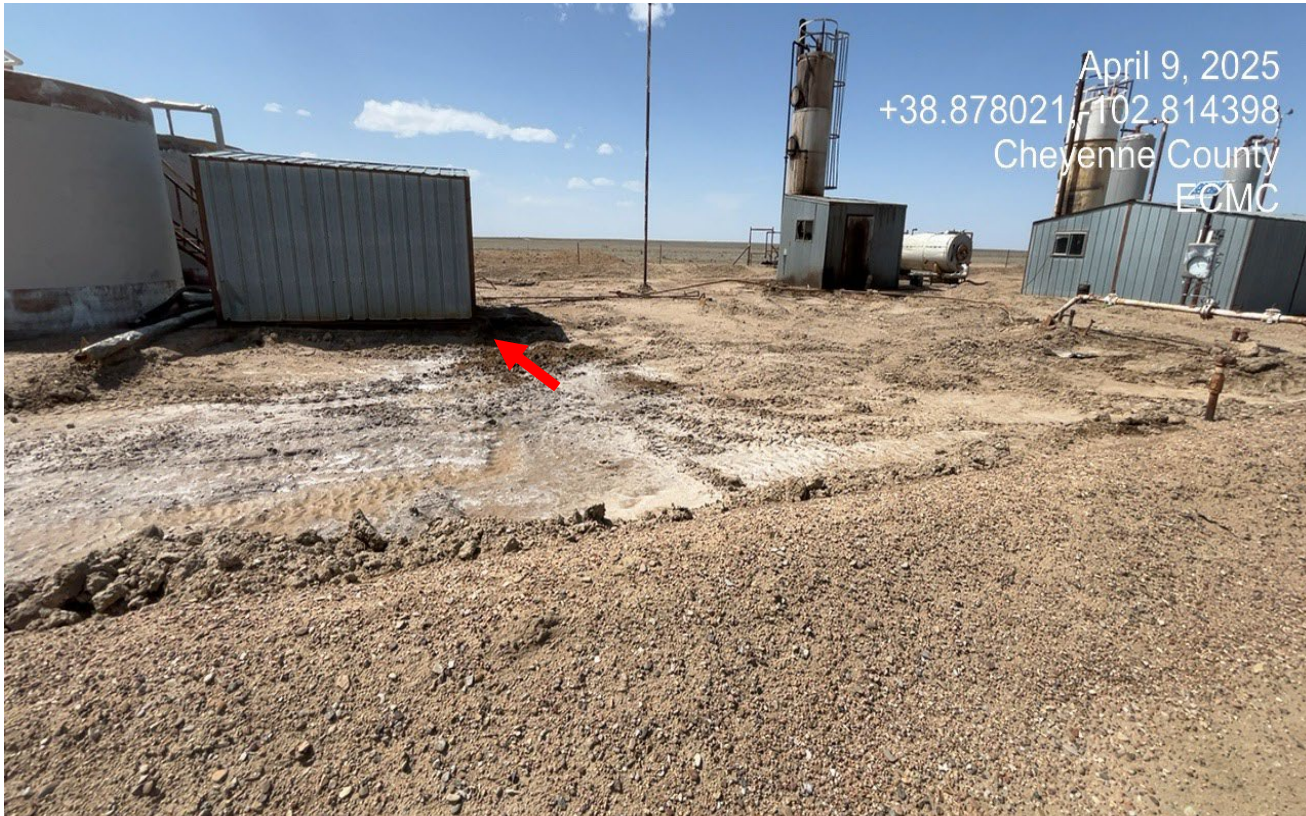
Photo 5. It appears there was also a condensate leak that flowed from the shed at red arrow.

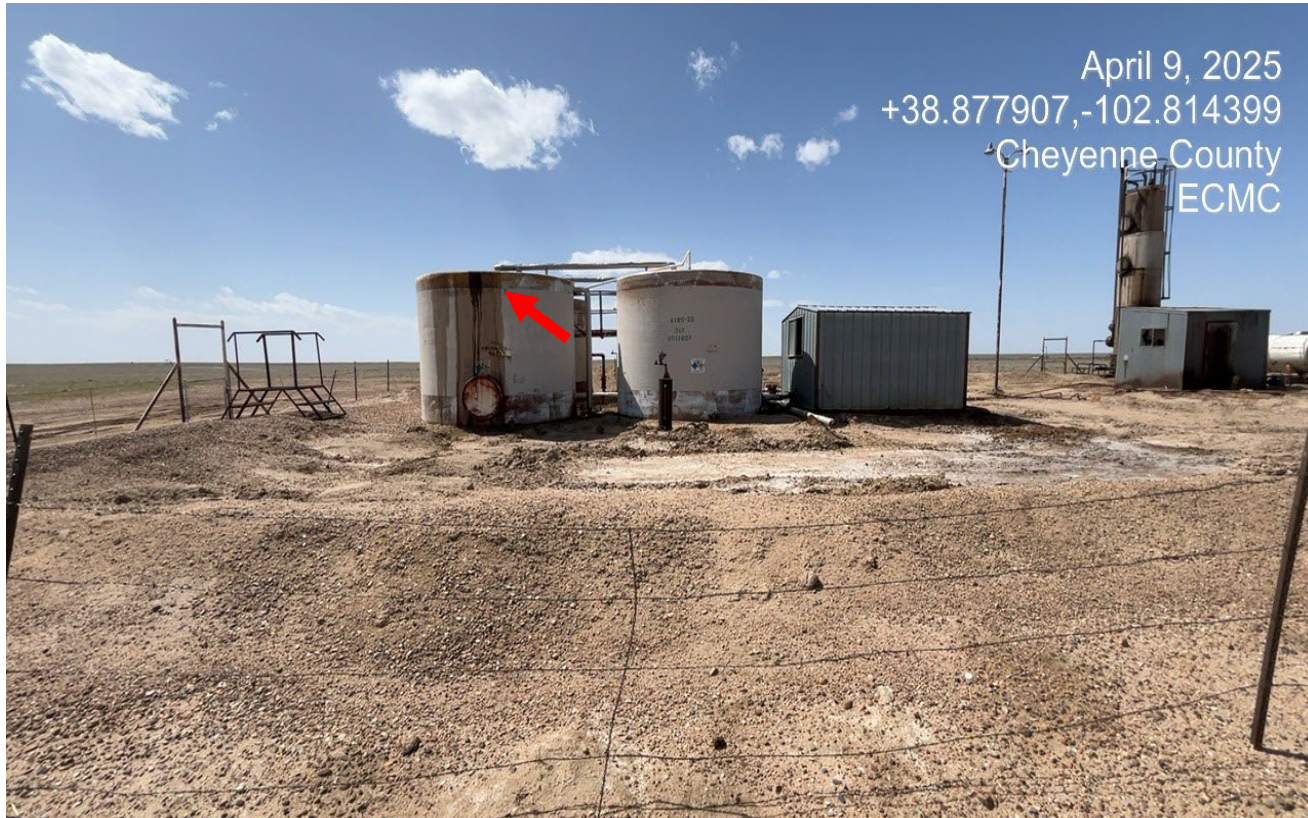
Photo 6. There are signs of a leak at the top of the fiberglass tank shown at red arrow.

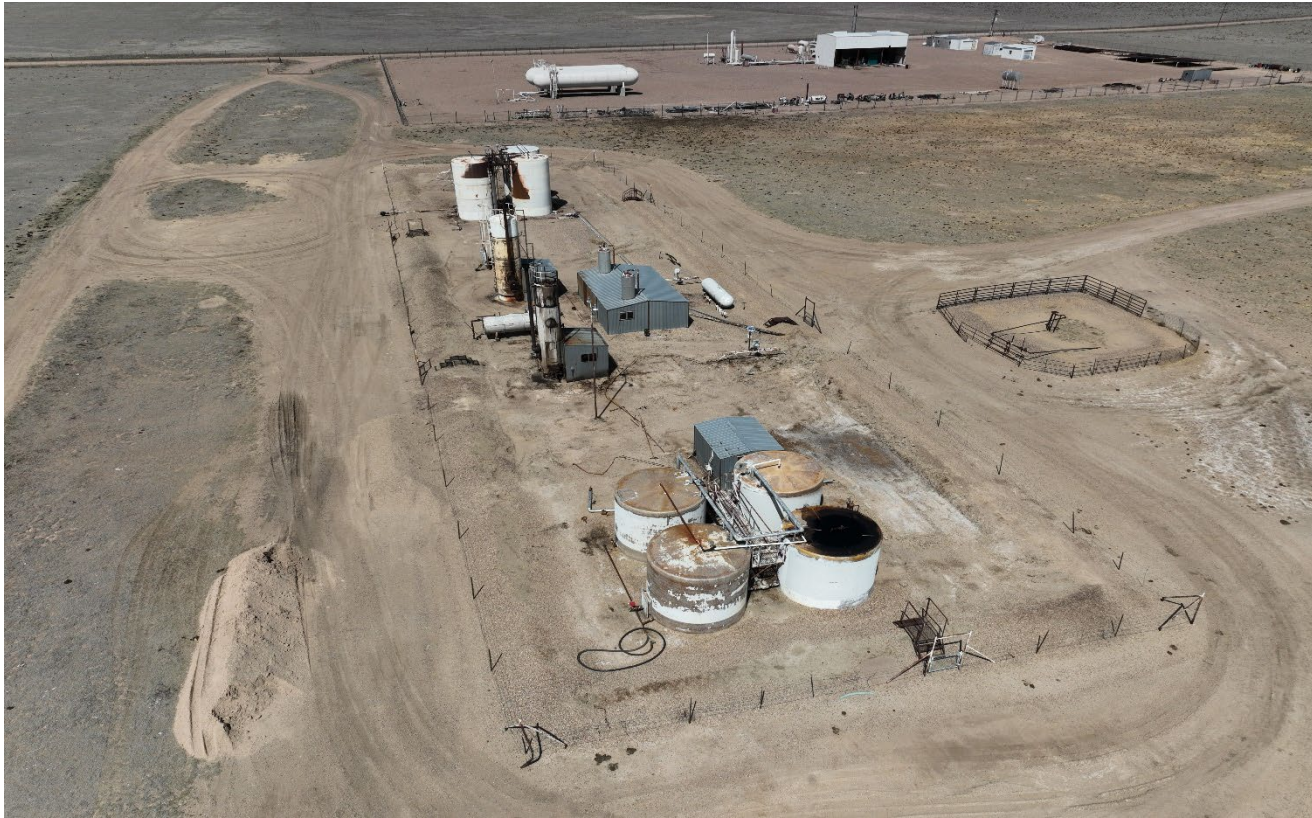
Photo 7. Drone aerial photo facing northeast toward the tank battery facility.

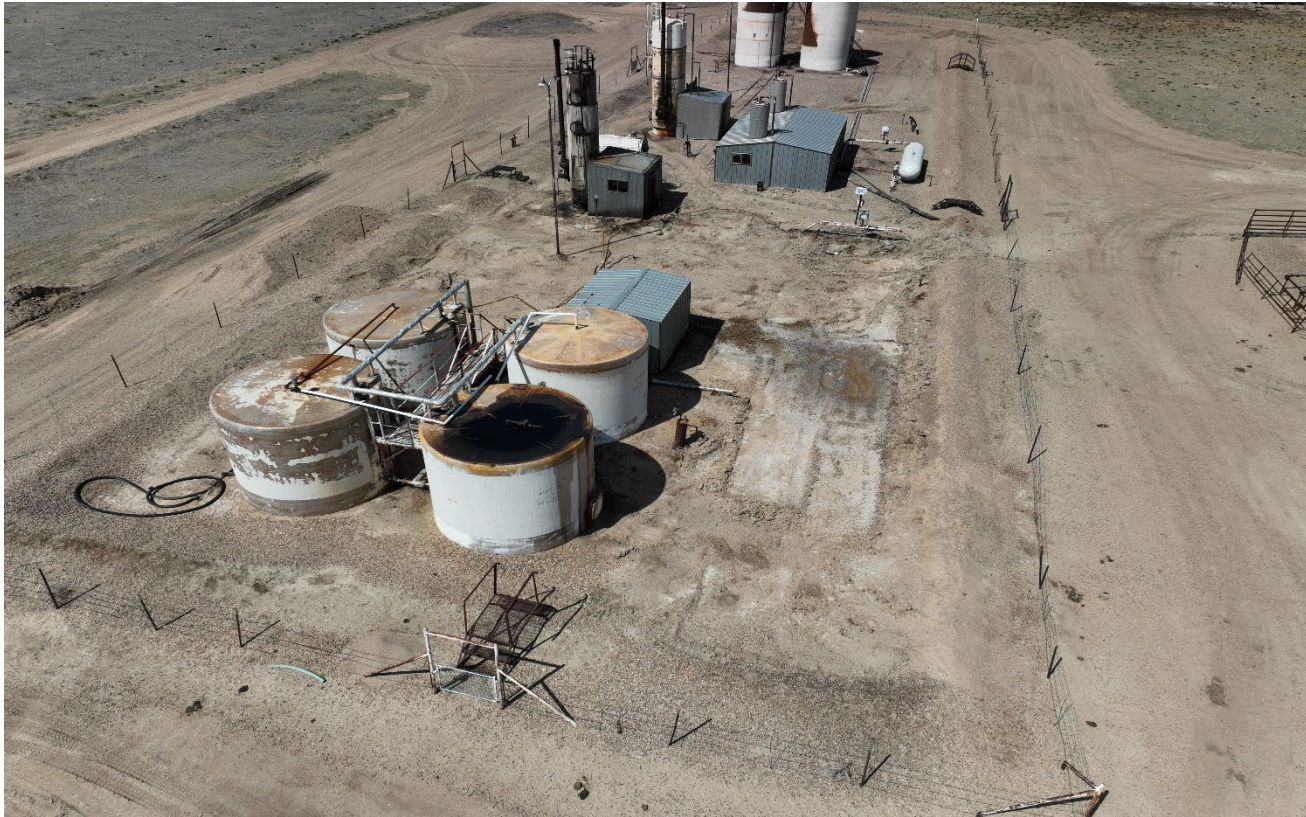
Photo 8. Drone aerial photo facing northwest toward the tank battery facility. The previous spill that occurred flowed to this southeast corner and overtopped the berm.

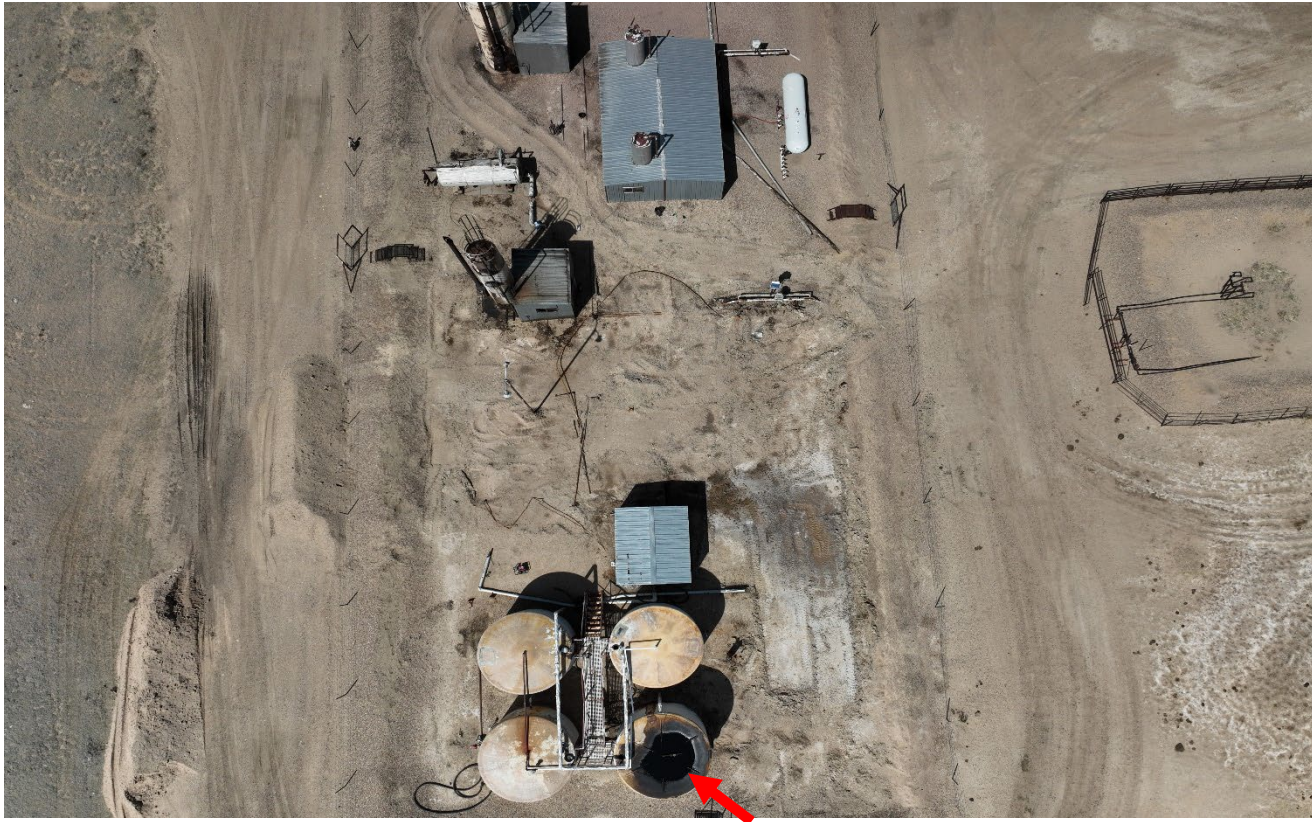
Photo 9. Drone aerial photo facing down toward the south side of the tank battery. There is oily liquid shown on top of the tank at red arrow which need to be cleaned up and properly disposed.

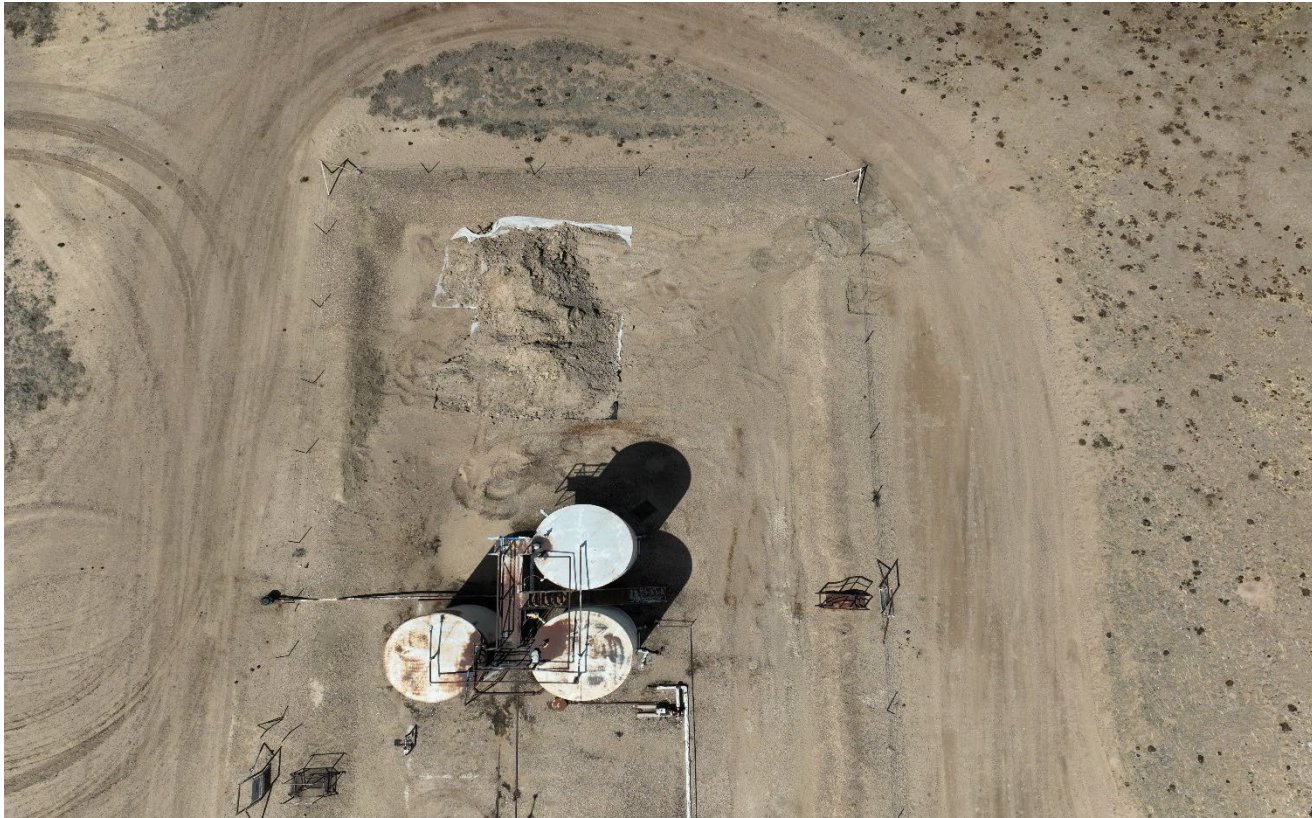
Photo 10. Drone aerial photo facing down toward the north side of the tank battery.

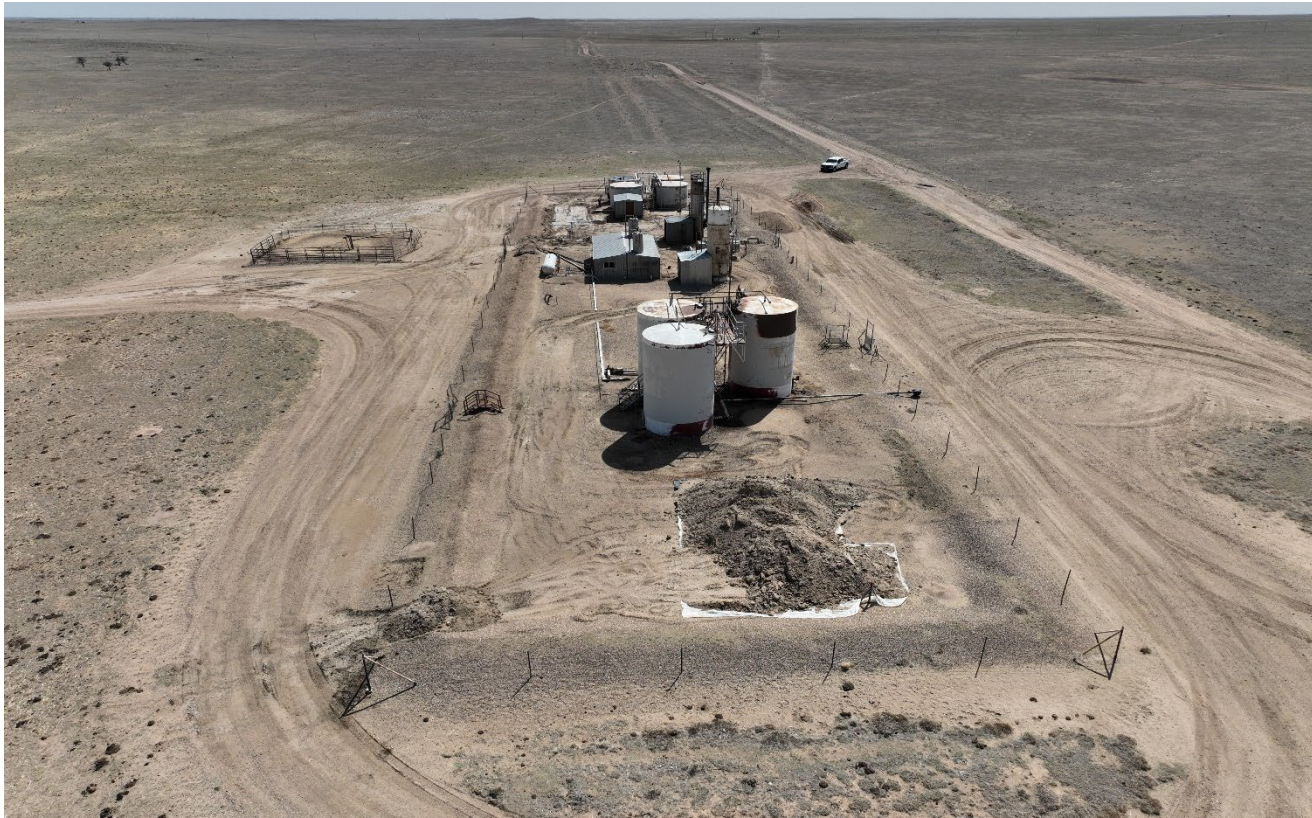
Photo 11. Drone aerial photo facing south toward the tank battery facility.
