Inspection Photos

API: 017-06636

Operator: **WILLIFORD ENERGY COMPANY**

Inspection Date: 4/9/2025

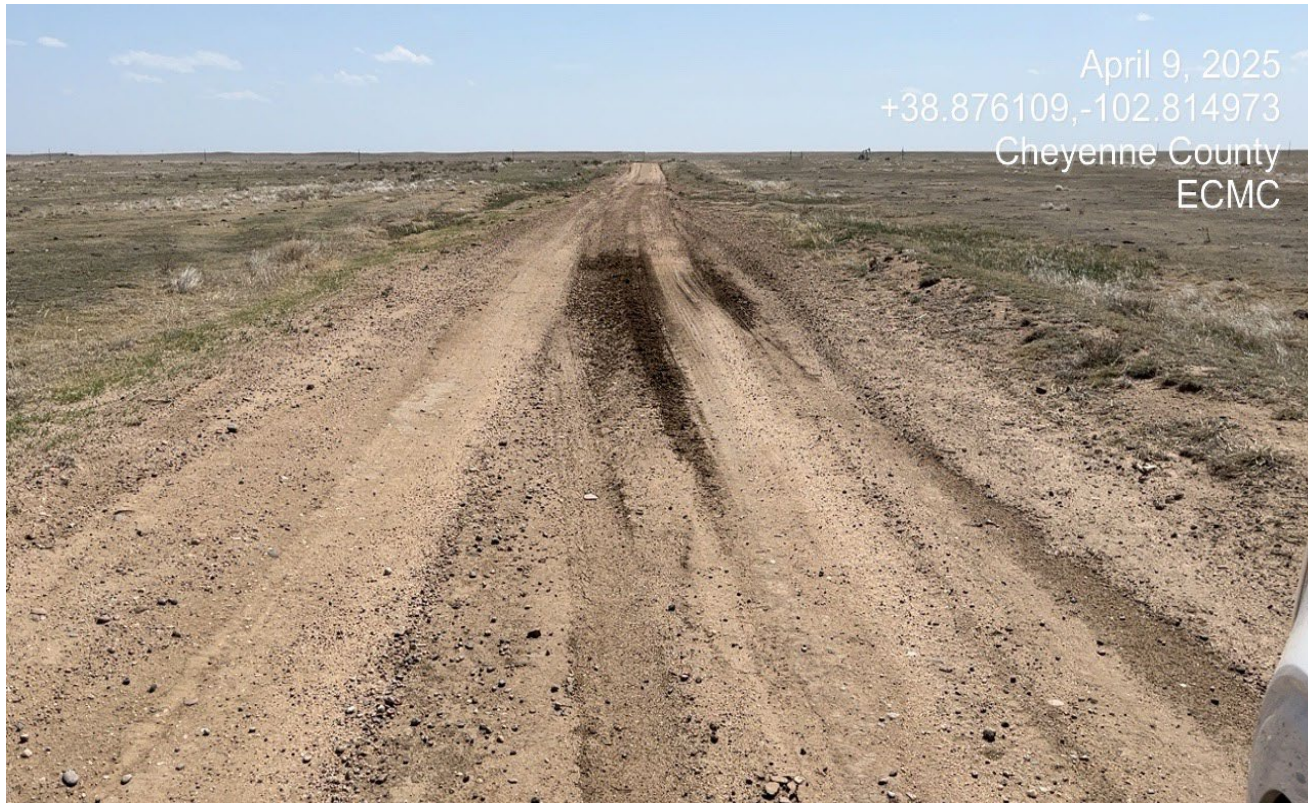
Photo 1. Facing south along the access road. Vehicles are causing unnecessary disturbance driving outside of the access road due to stormwater pooling on the road. The access road must be maintained and vehicles shall not drive outside of the access road boundary. Previous corrective action was not completed.

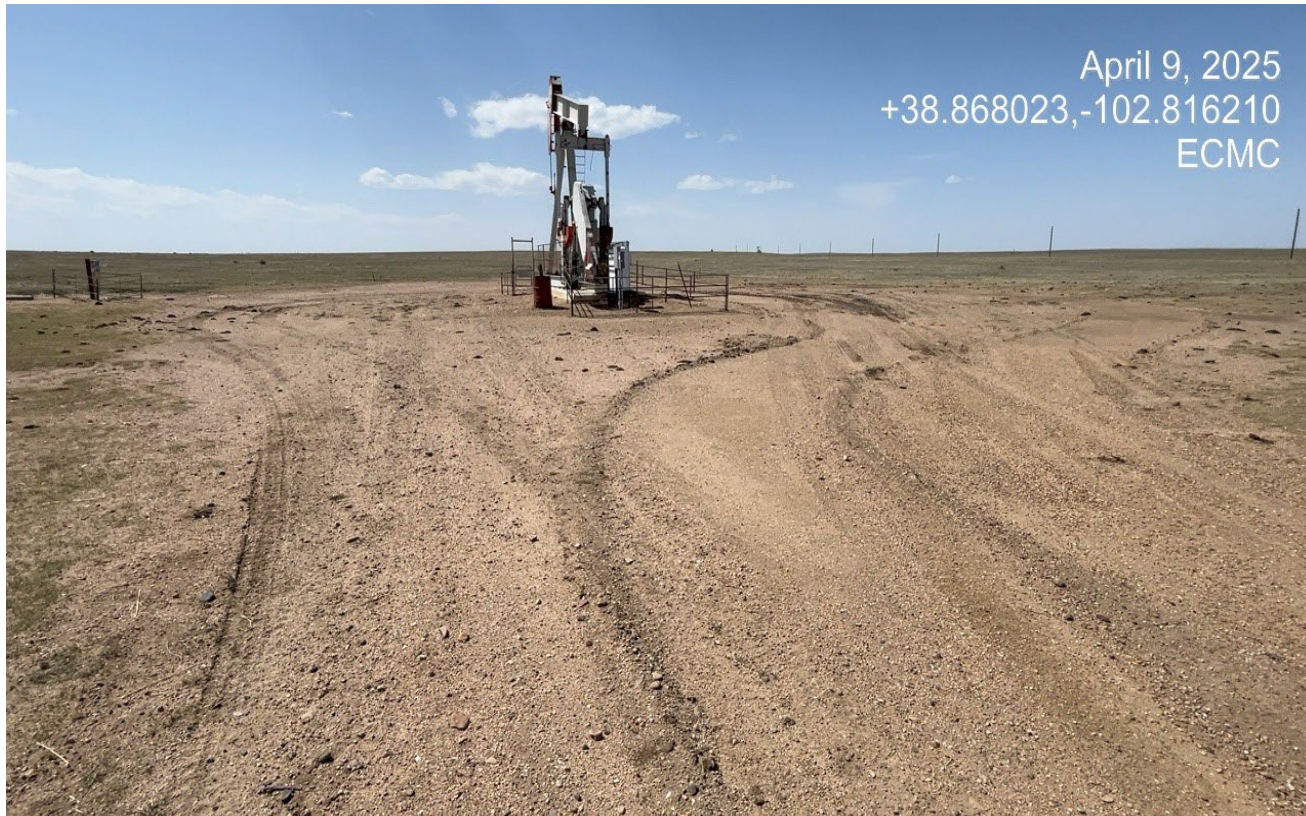
Photo 2. Facing west along the road toward the wellsite. There has been gravel spread along the area where erosion channel was previously observed.

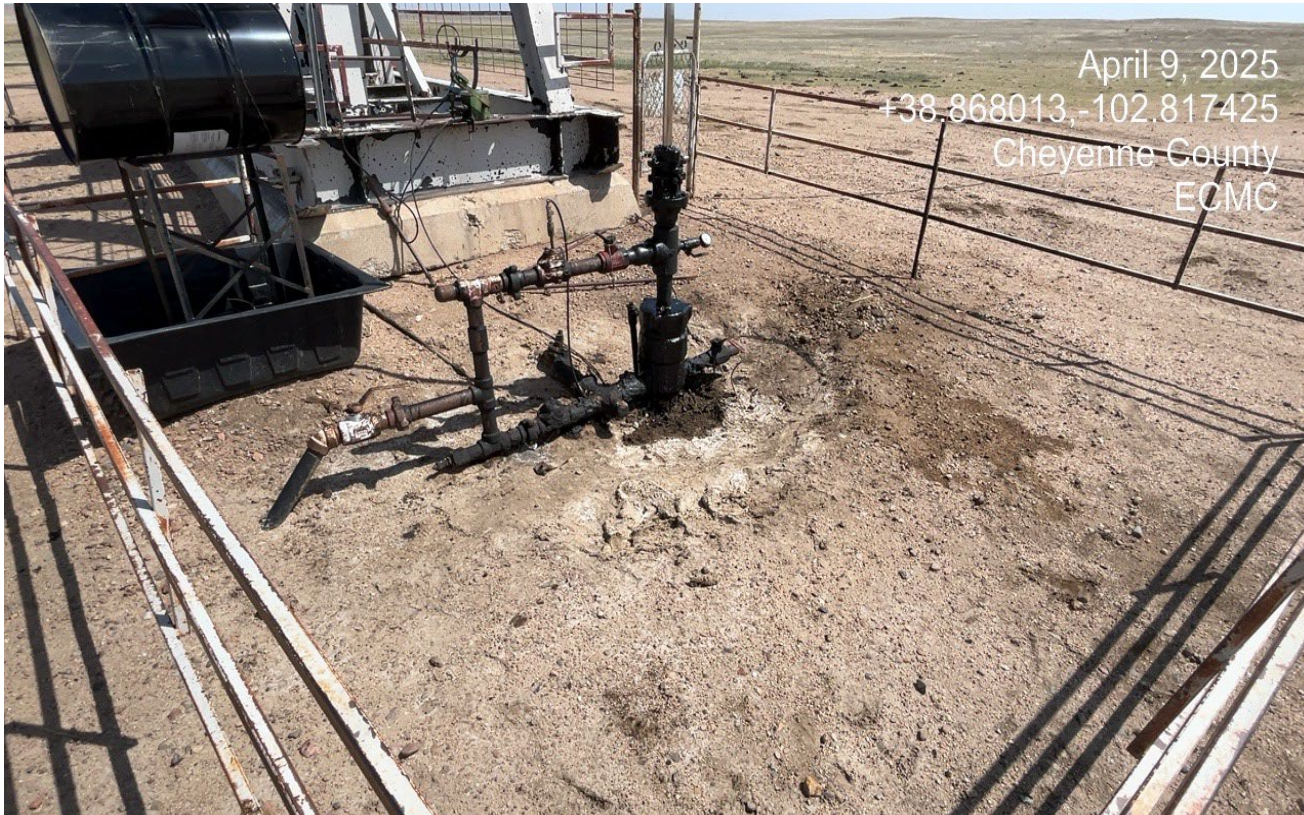
Photo 3. There are oil stained soils at the wellhead that need to be cleaned up and properly disposed.

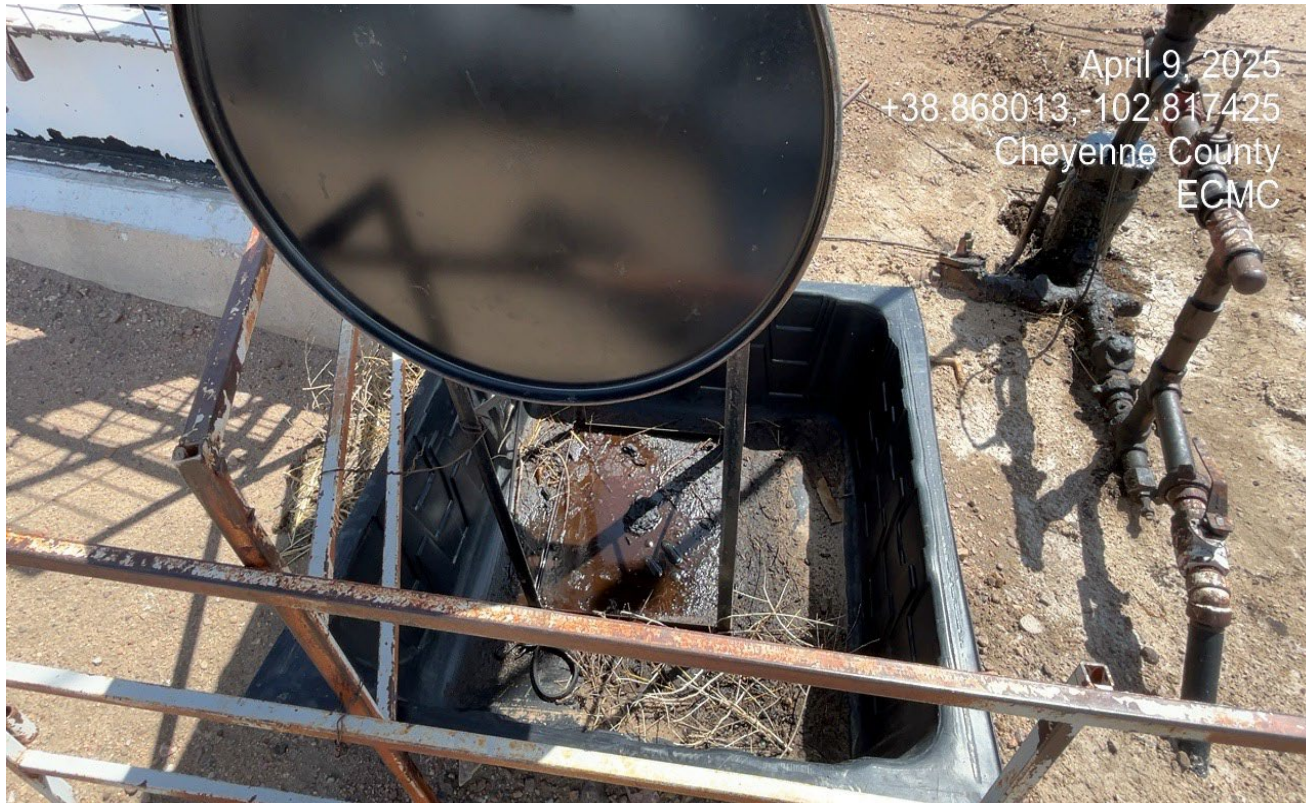
Photo 4. The chemical barrel has been repositioned into the secondary containment. There is oily fluids inside the containment and there are no wildlife protections to prevent entry.

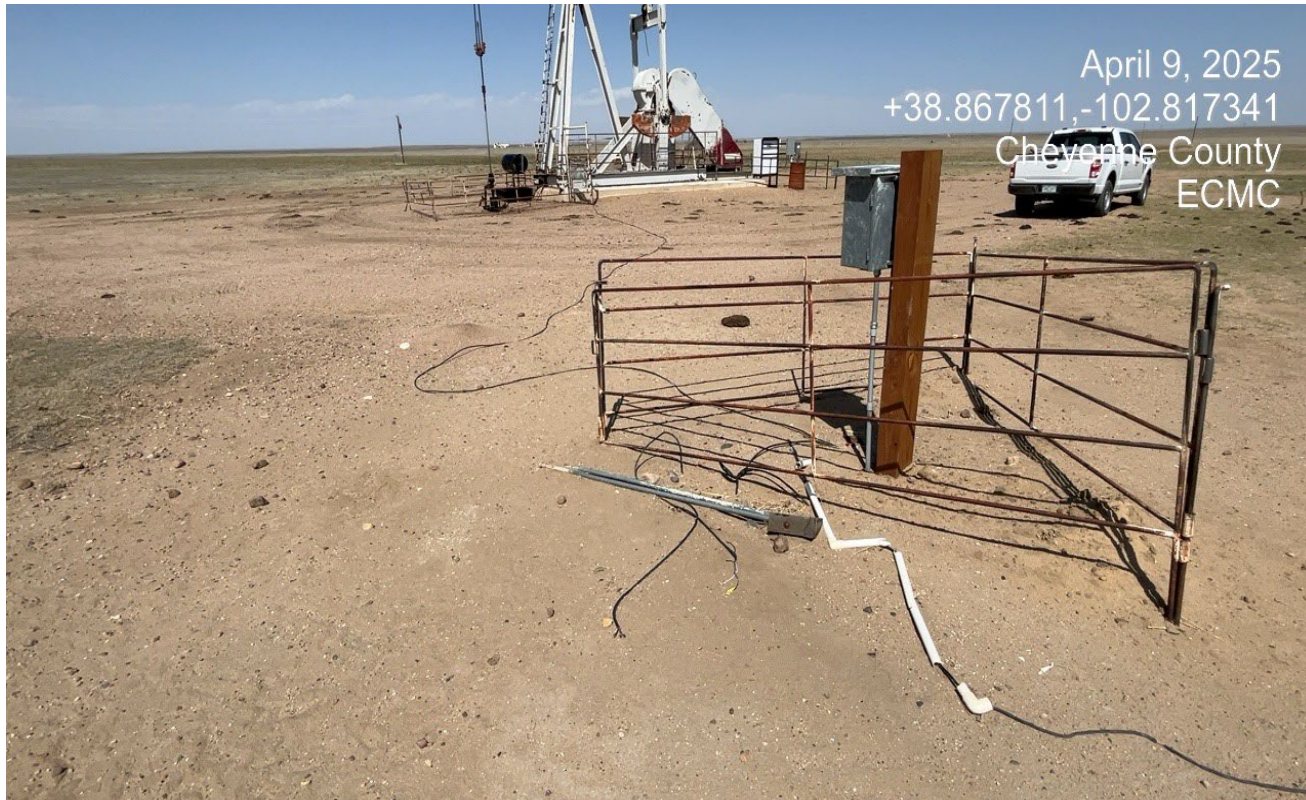
Photo 5. Facing toward the electric utility just south of the well. The electric utility was repaired but the wire and debris on the ground needs to be removed.
