Inspection Photos

Loc: 381172

Operator: CITATION OIL & GAS CORP

Inspection Date: 4/9/2025

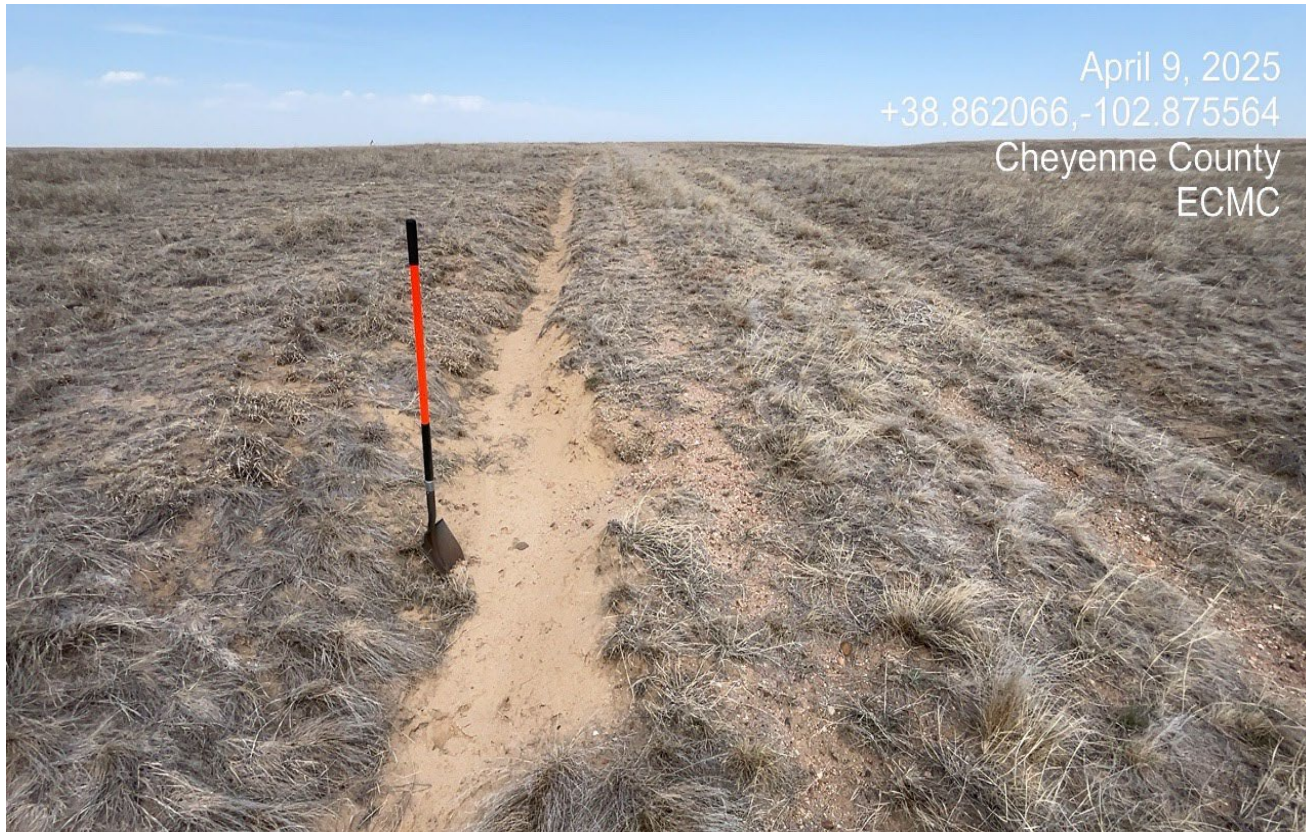
Photo 1. Facing northeast along the two track access road. There is an erosion channel along the road closer to the location that needs to be repaired.

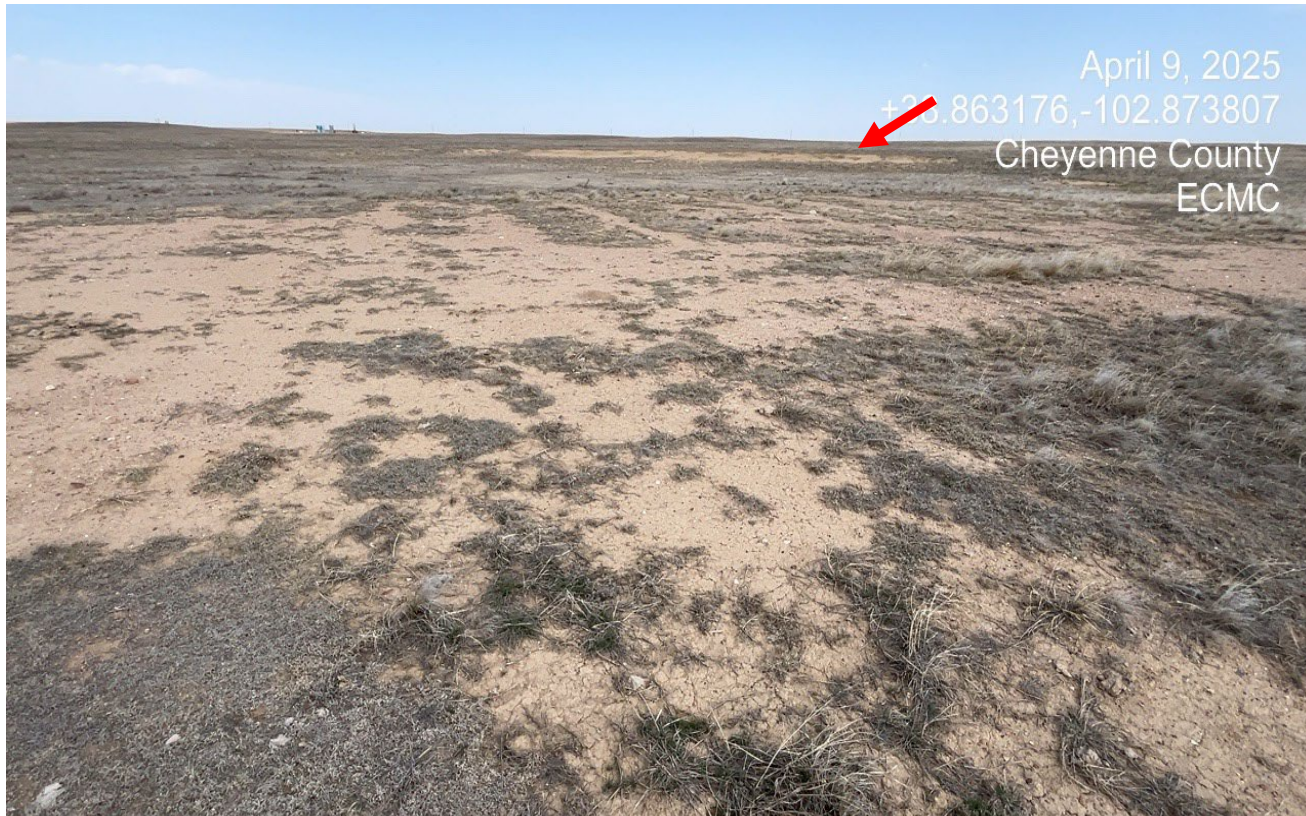
Photo 2. Facing northeast at the location. The location has not been reclaimed and there are areas bare of vegetation. The cut slope can be seen at the red arrow.

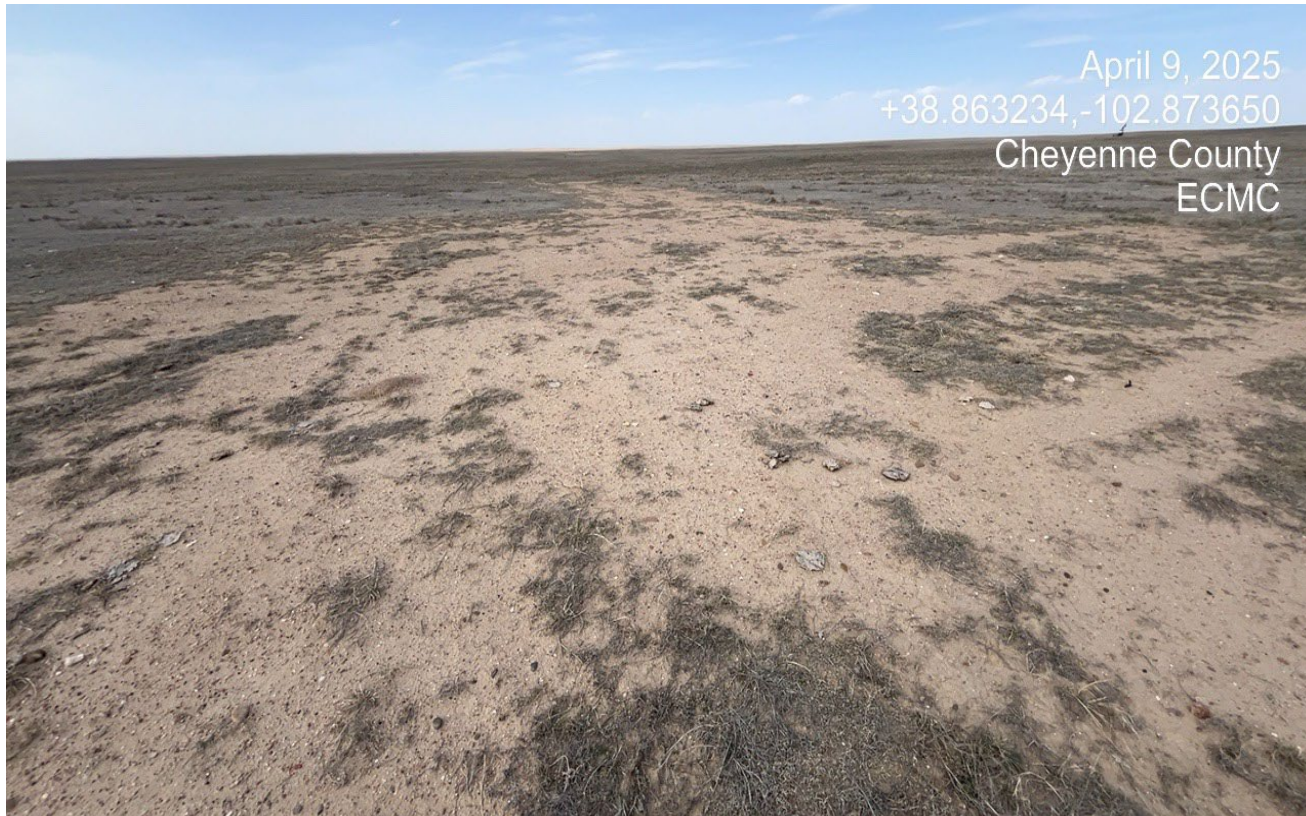
Photo 3. Facing northwest at the location. This is the approximate area of the well and pumpjack. This area is mostly bare of vegetation which indicates possible soil impacts.

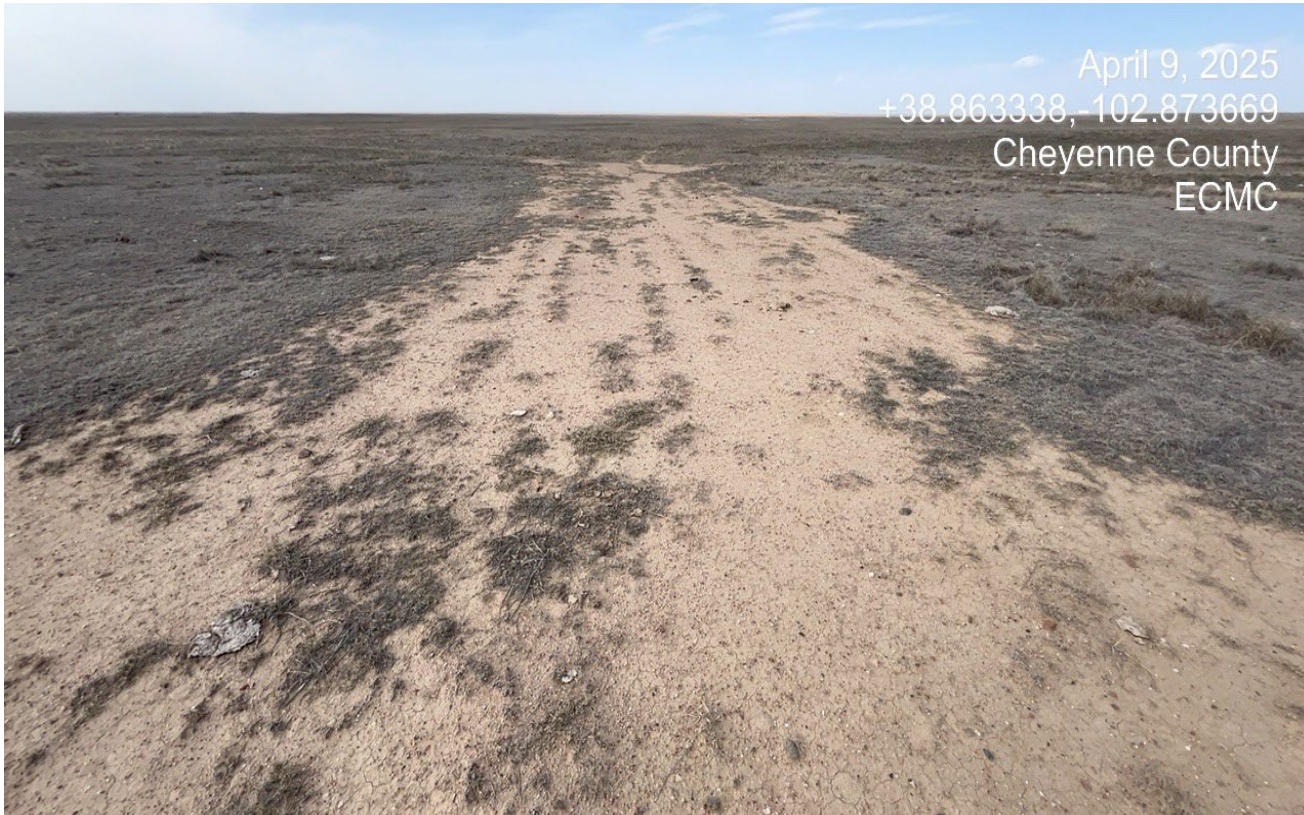
Photo 4. Further downhill to the northwest from the abandoned well the vegetation impacts are evident.

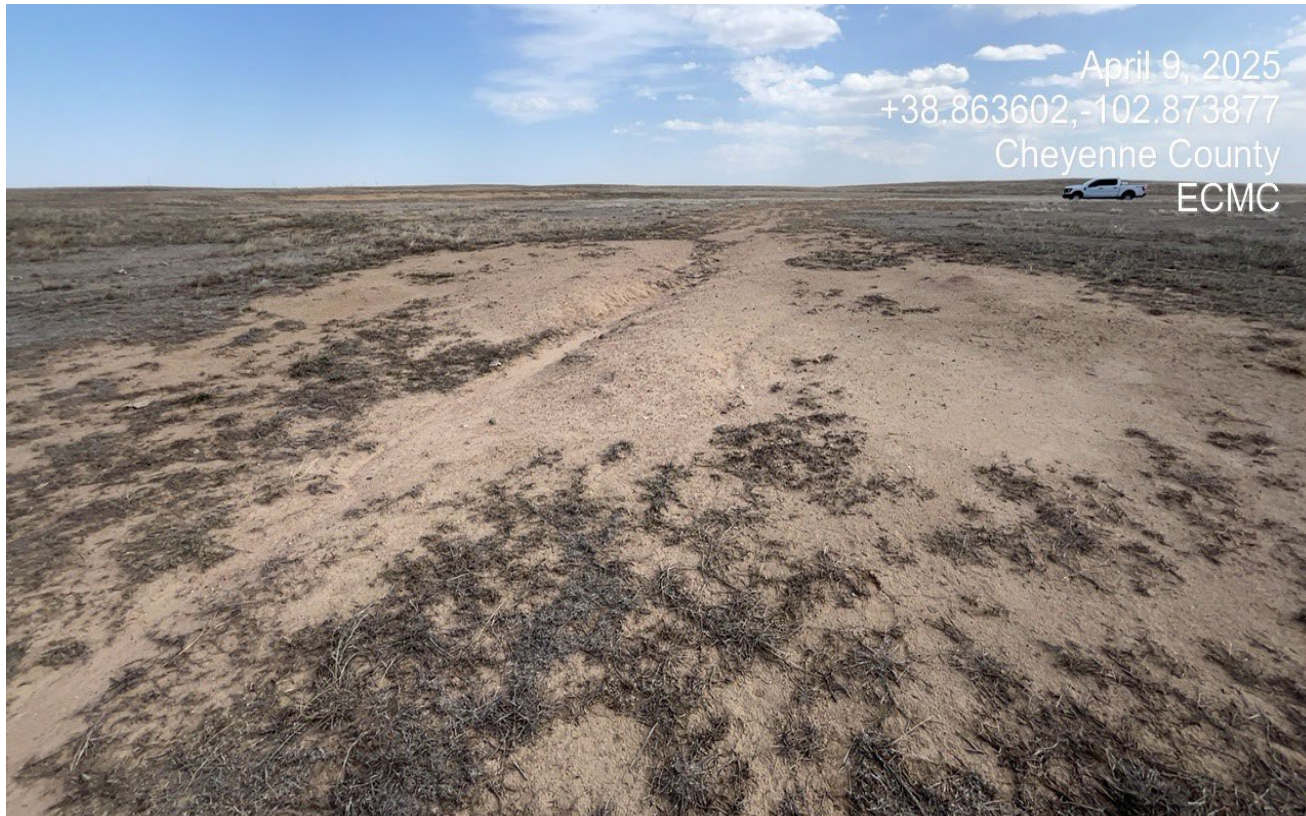
Photo 5. Facing back to the southwest. There is an erosion channel along this area and soils are bare of vegetation.

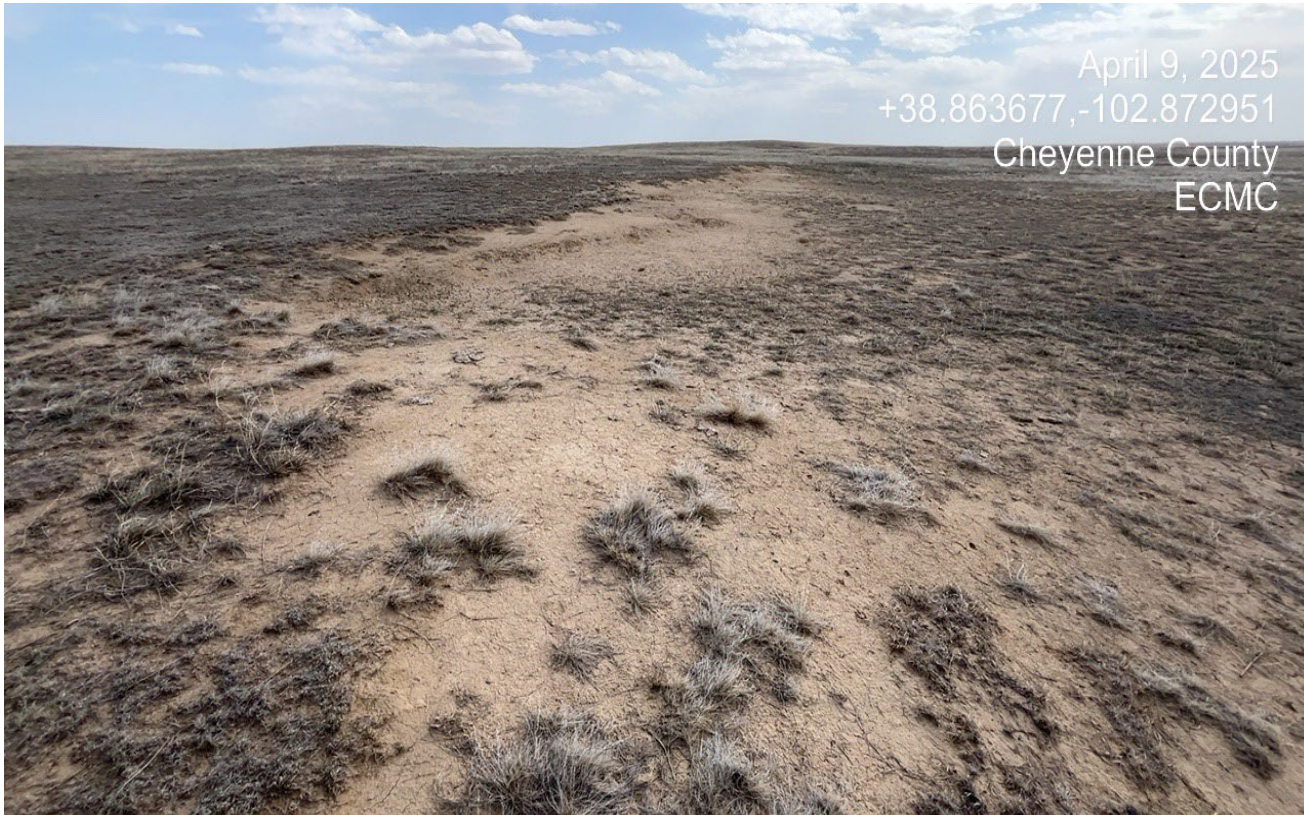
Photo 6. Facing south along the cut slope. The cut slope is approximately 2-3 ft. and needs to be resloped with topsoil and revegetated.

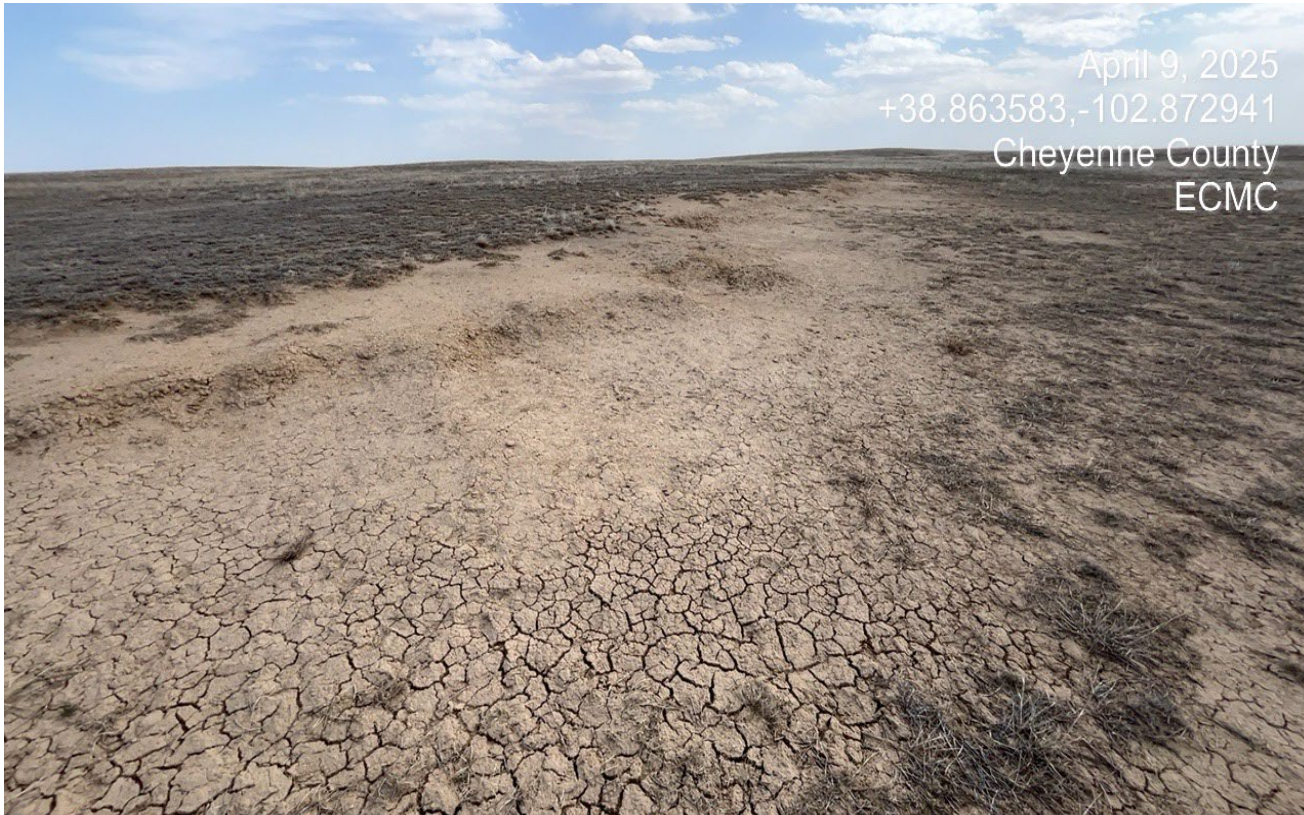
Photo 7. Facing south along the cut slope. The cut slope is approximately 2-3 ft. and needs to be resloped with topsoil and revegetated.
