Inspection Photos

Location Name: MUSTANG RESOURCES LLC DOWNING 24-22-6S-94W Pad

Location ID: 323818

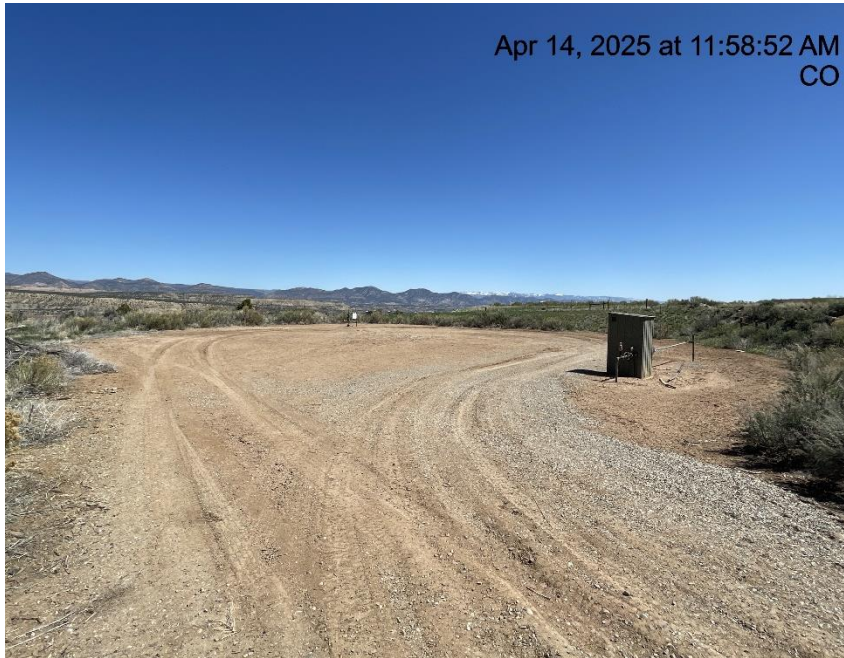
Photo # 1134 From entrance to location
