Interim Reclamation and Stormwater Inspection

Operator: TIMKA RESOURCES LTD - 88370

Location ID: 312211

Inspection Photos
Location Name: Kirk Lynch 1
Location ID: 312211

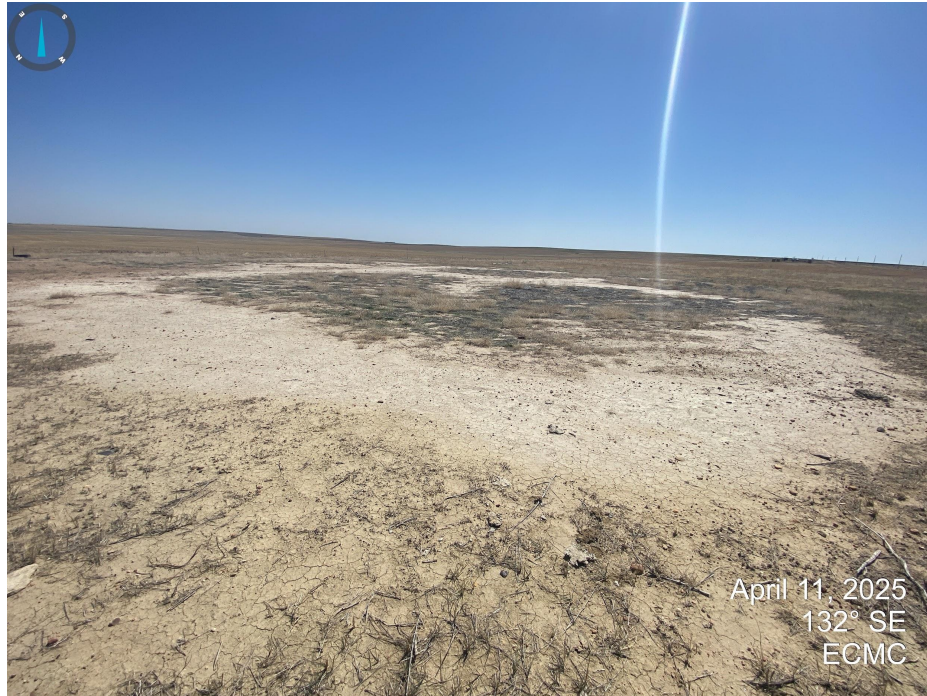
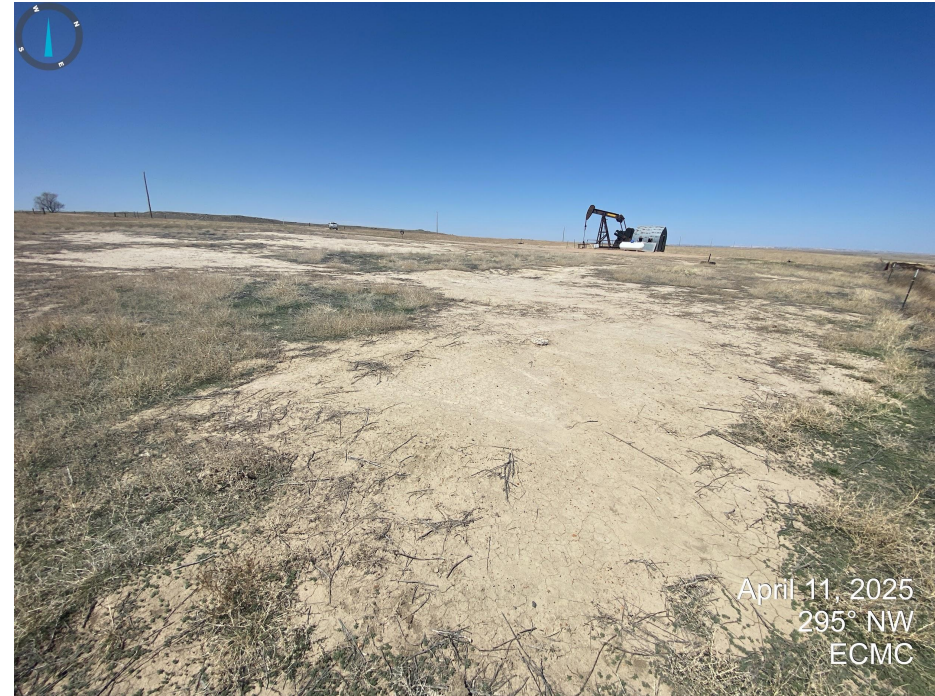
Photos 1 & 2. The former pit near the well location does not appear to be progressing towards Rule 1003 standards and regulations with evidence of bare/unstabilized soils and undesirable vegetation.

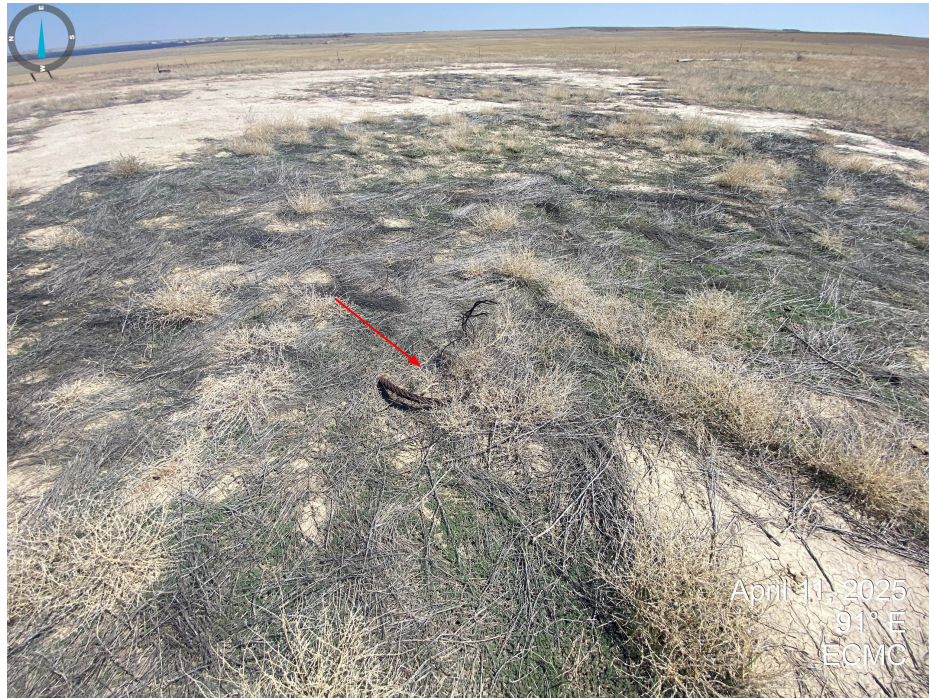
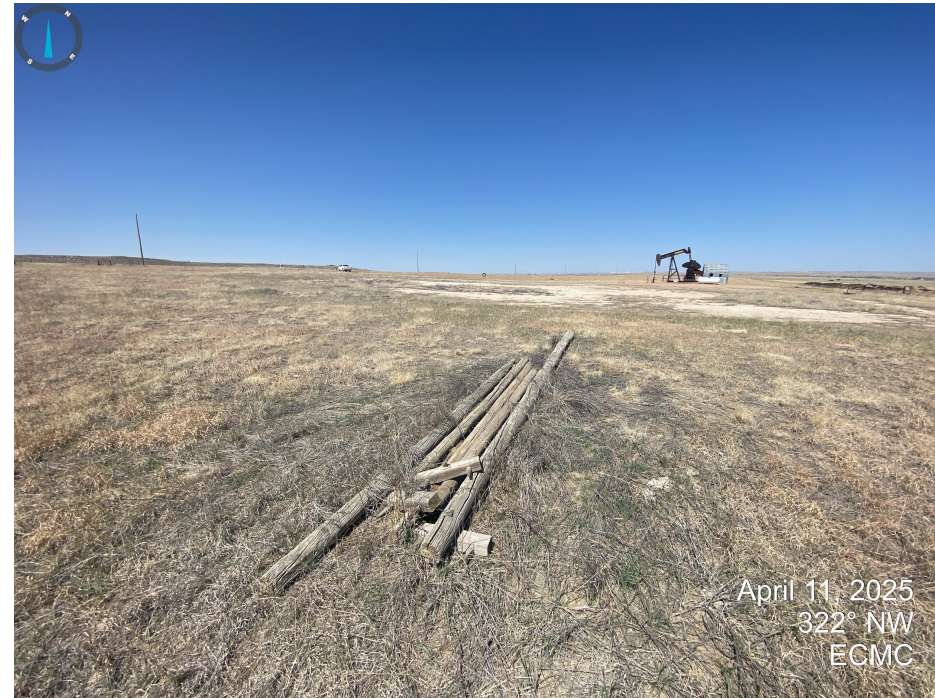
Photos 3 & 4. Trash and debris observed around the former pit.

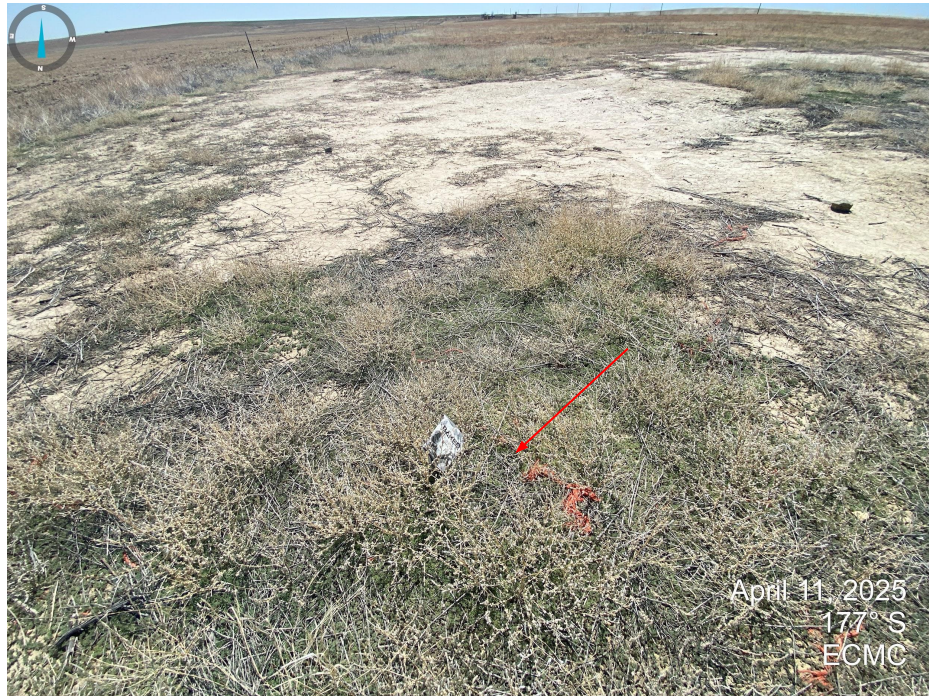
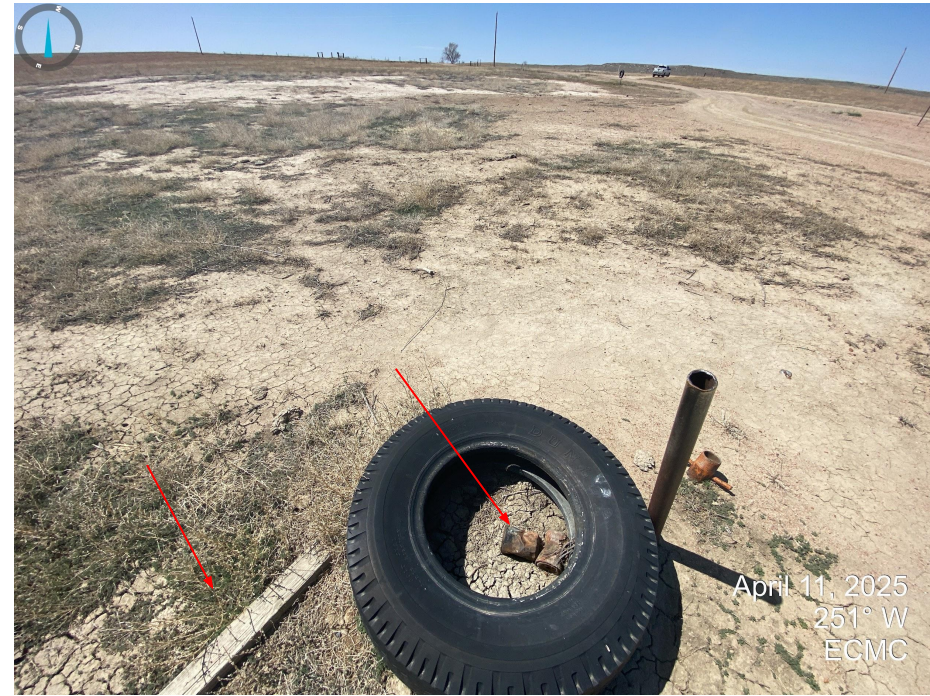
Photos 5 & 6. Trash and debris observed around the former pit.

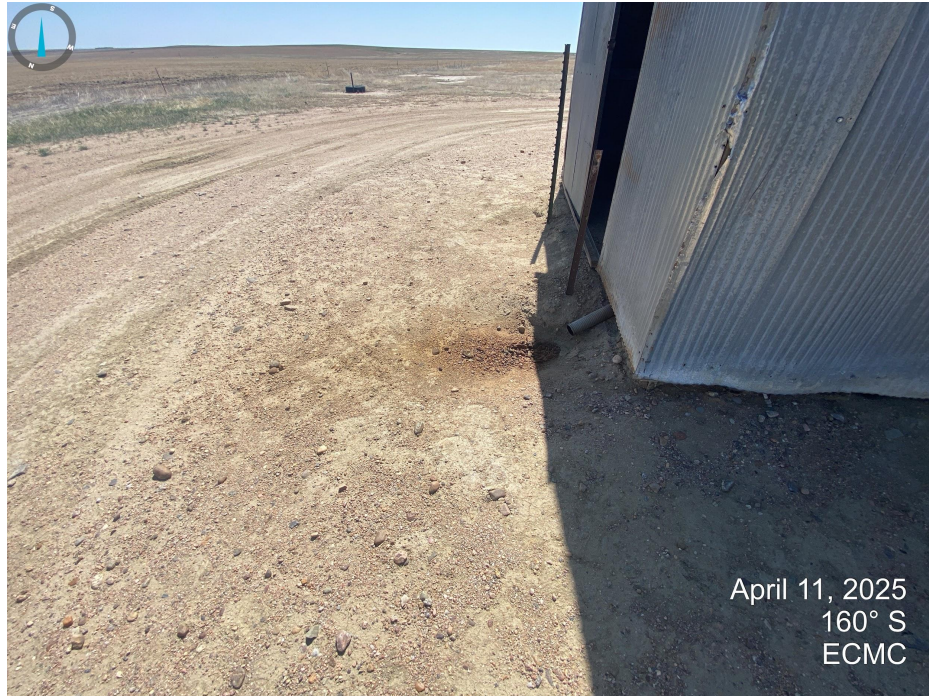
Photos 9 & 10. Stained soil observed around the pump jack (Photo 9; left) and guy line anchor needs to be reinstalled (Photo 10; right).

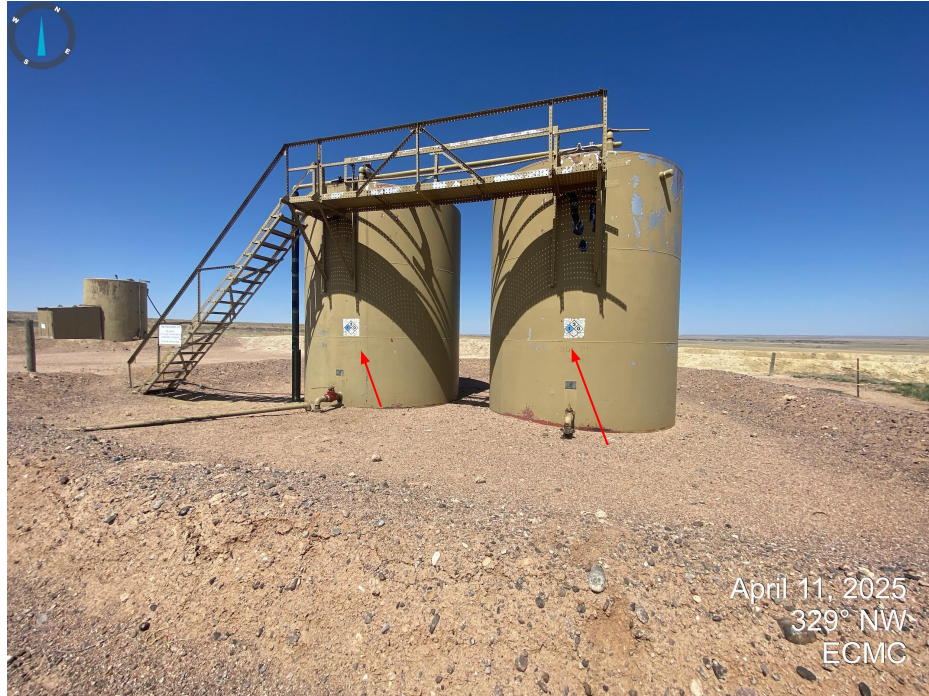
Photos 11 & 12. Tank labels are not adequate (Photo 11; left) and unused equipment west of tank battery (Photo 12; right).

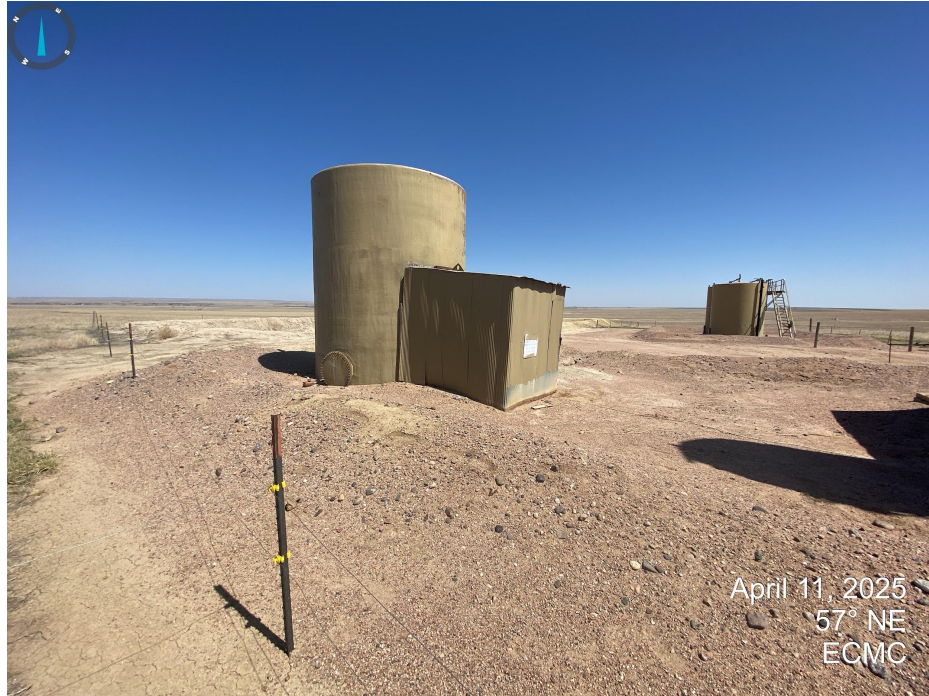
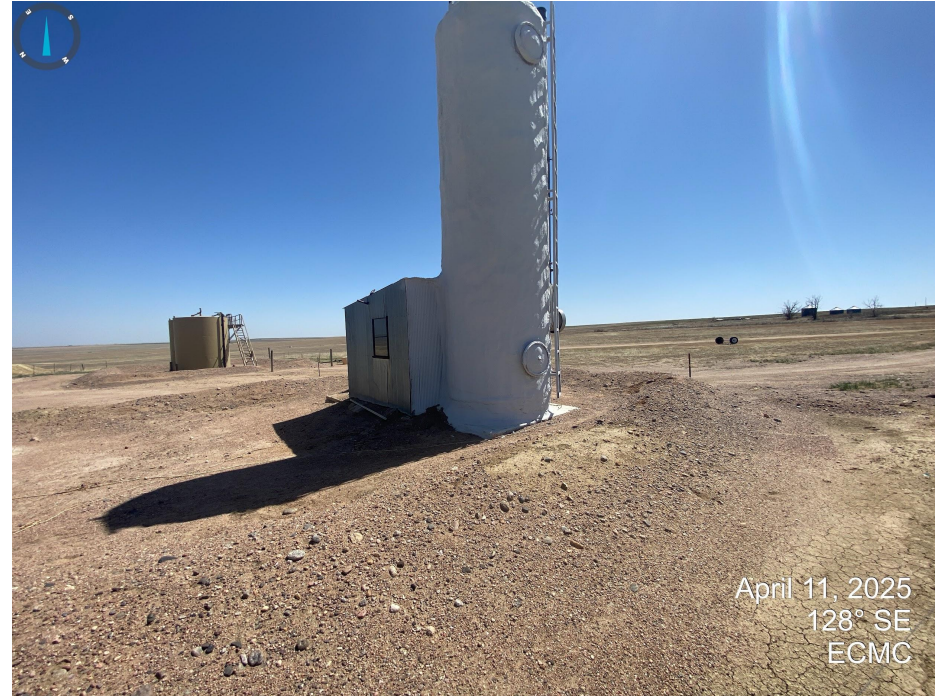
Photos 13 & 14. NFPA placards or tank labels were not observed at equipment.

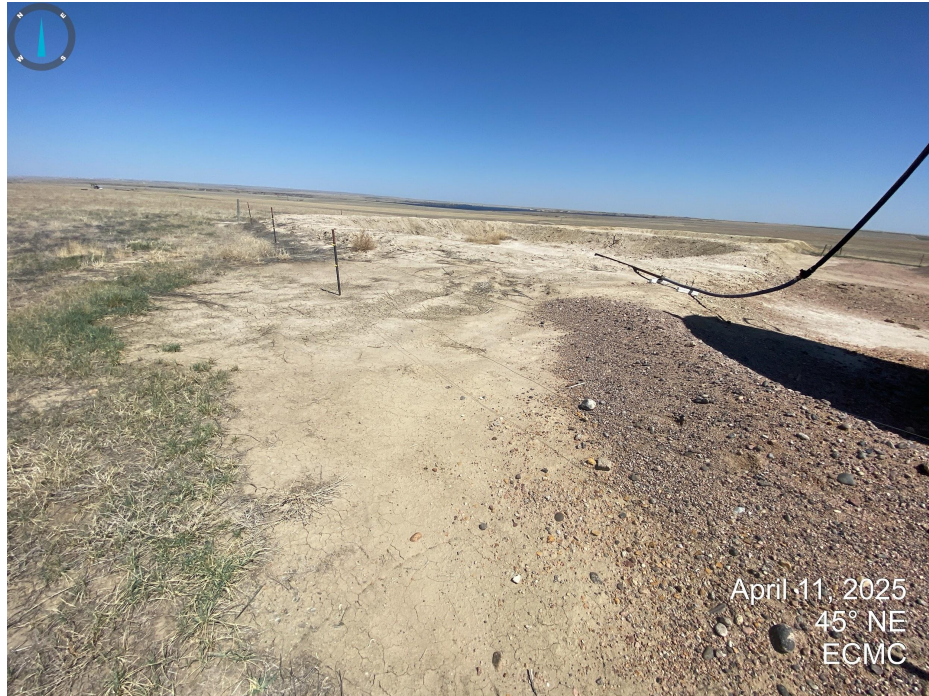
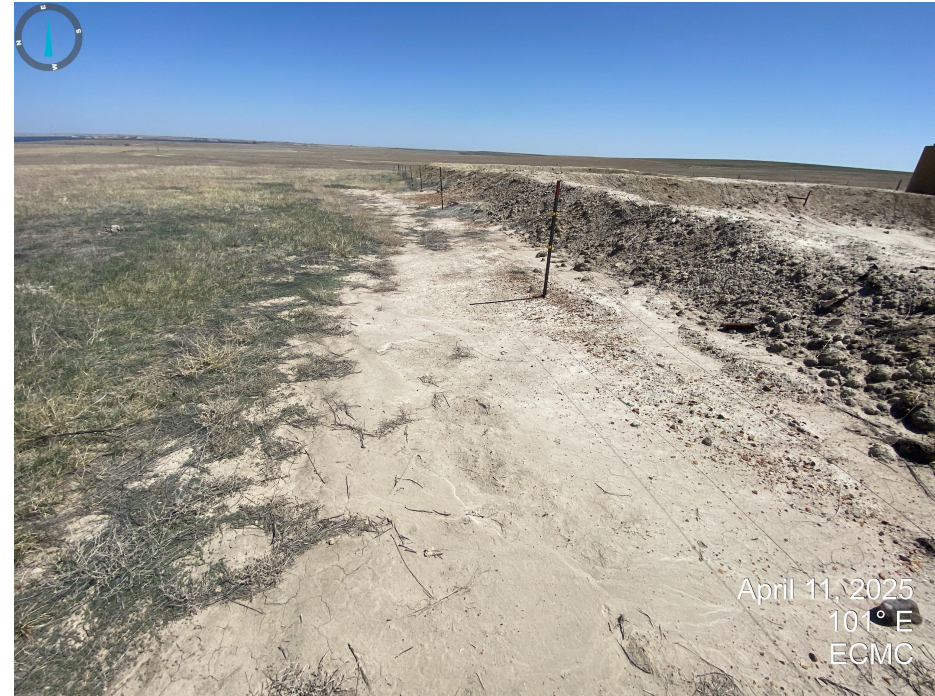
Photos 15 & 16. Evidence of erosion degradation and sediment transport observed around the pit at the tank battery facility.

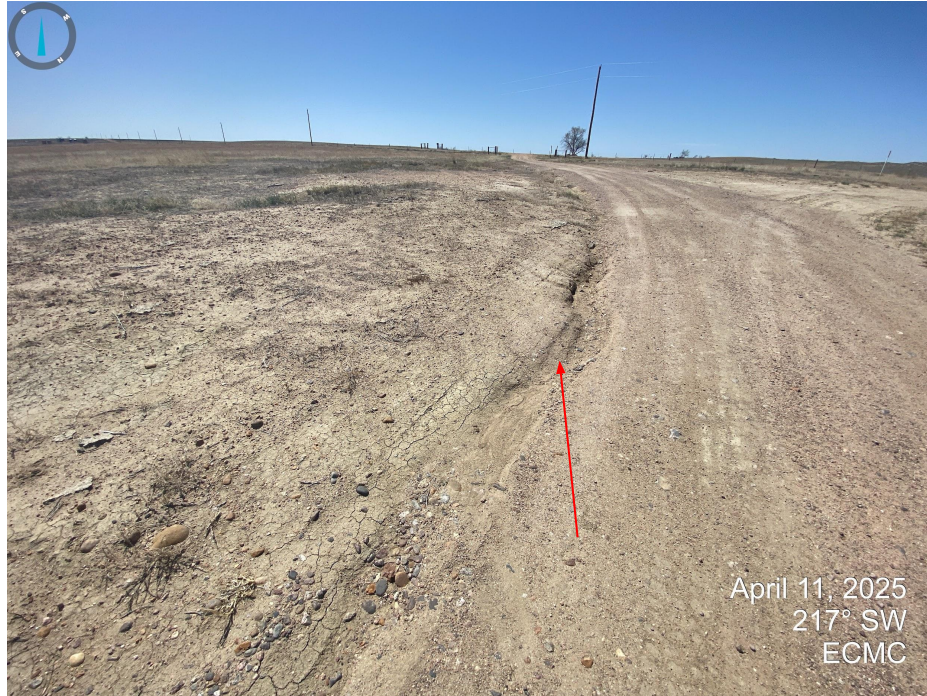
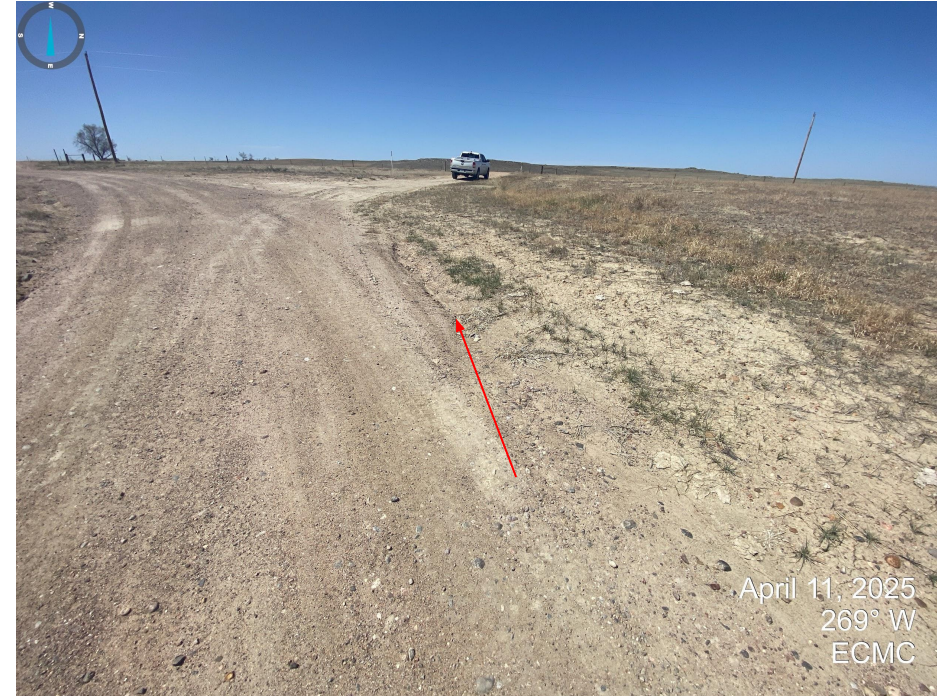
Photos 17 & 18. Erosion degradation observed along the access road at the well location.

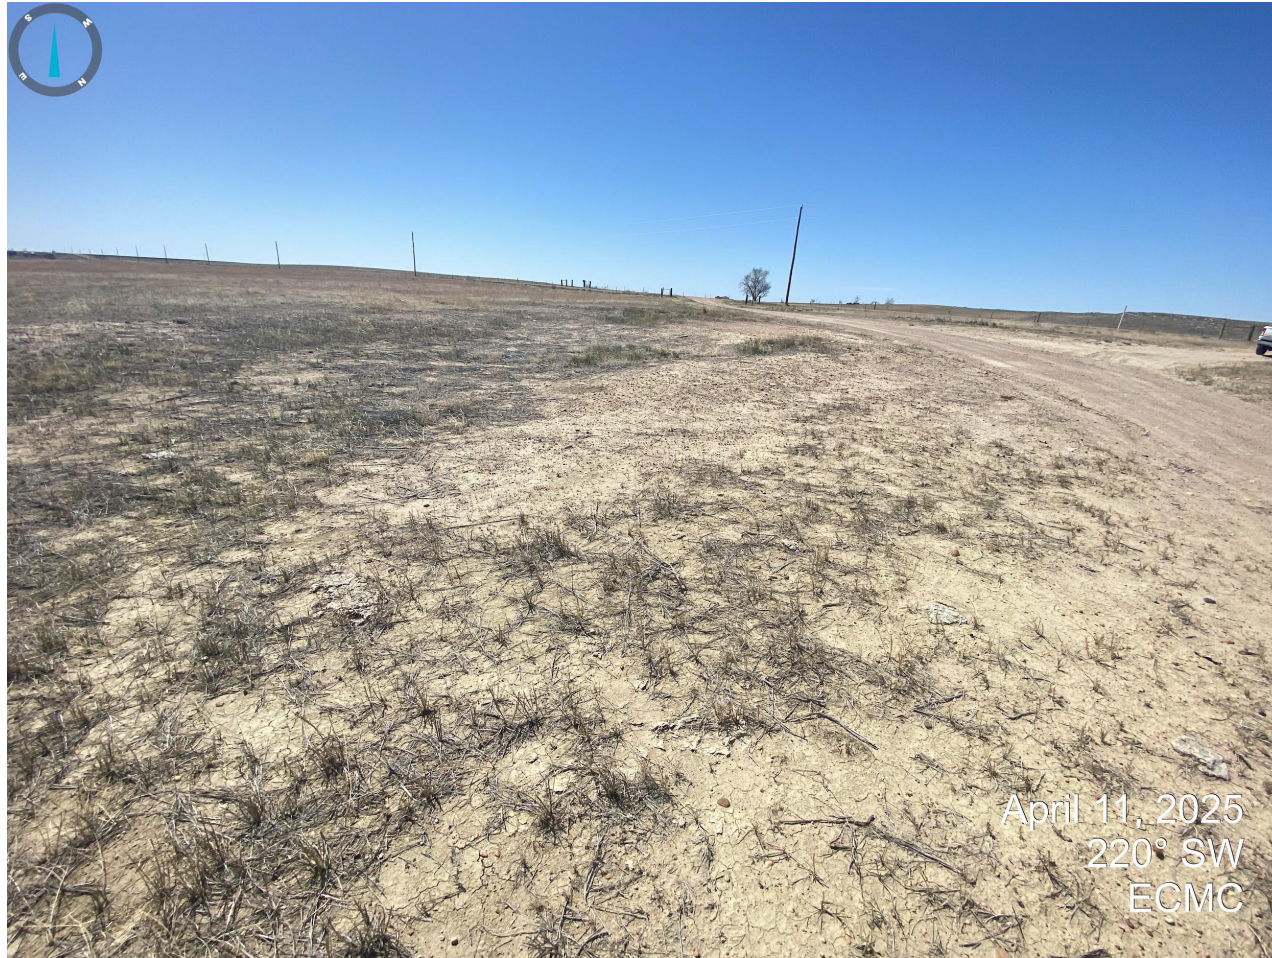
Photo 19. Portions of the interim areas at the well location do not appear to be progressing towards Rule 1003 standards or regulations with bare/unstabilized soils evident.
