Inspection Photos

API: 011-05055

Operator: RENEGADE OIL & GAS COMPANY LLC

Inspection Date: 4/10/2025

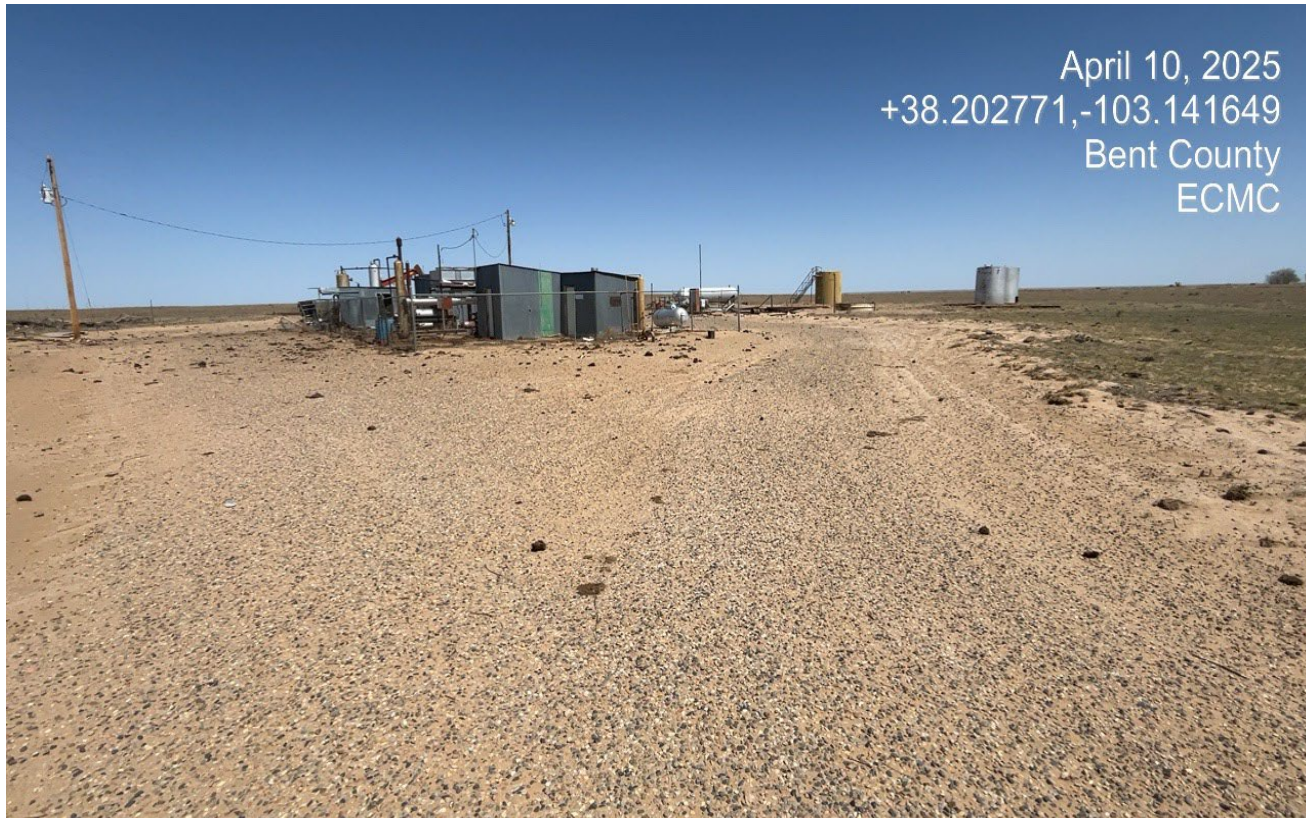
Photo 1. Facing northeast toward the GAS PROCESSING PLANT and Wellsite.

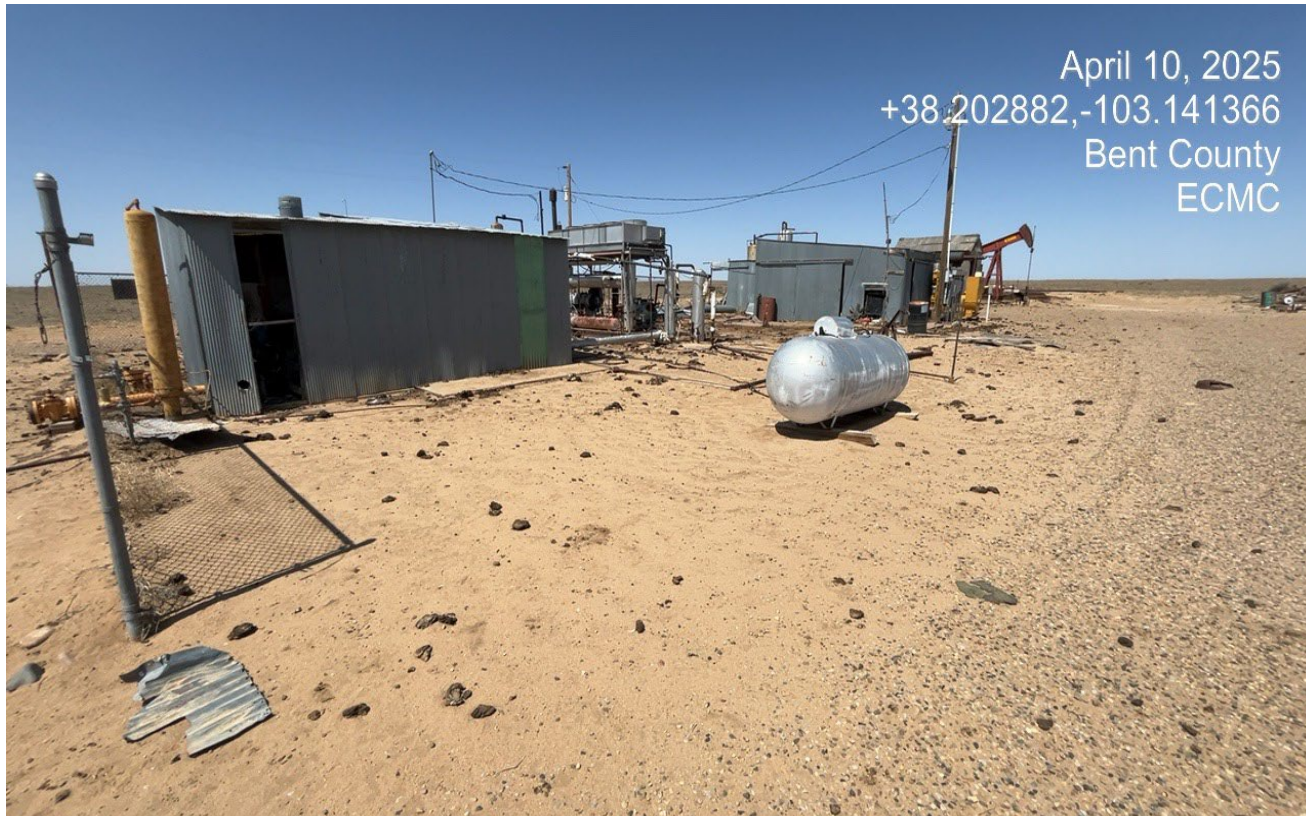
Photo 2. Facing northwest toward the GAS PROCESSING PLANT and Wellsite.

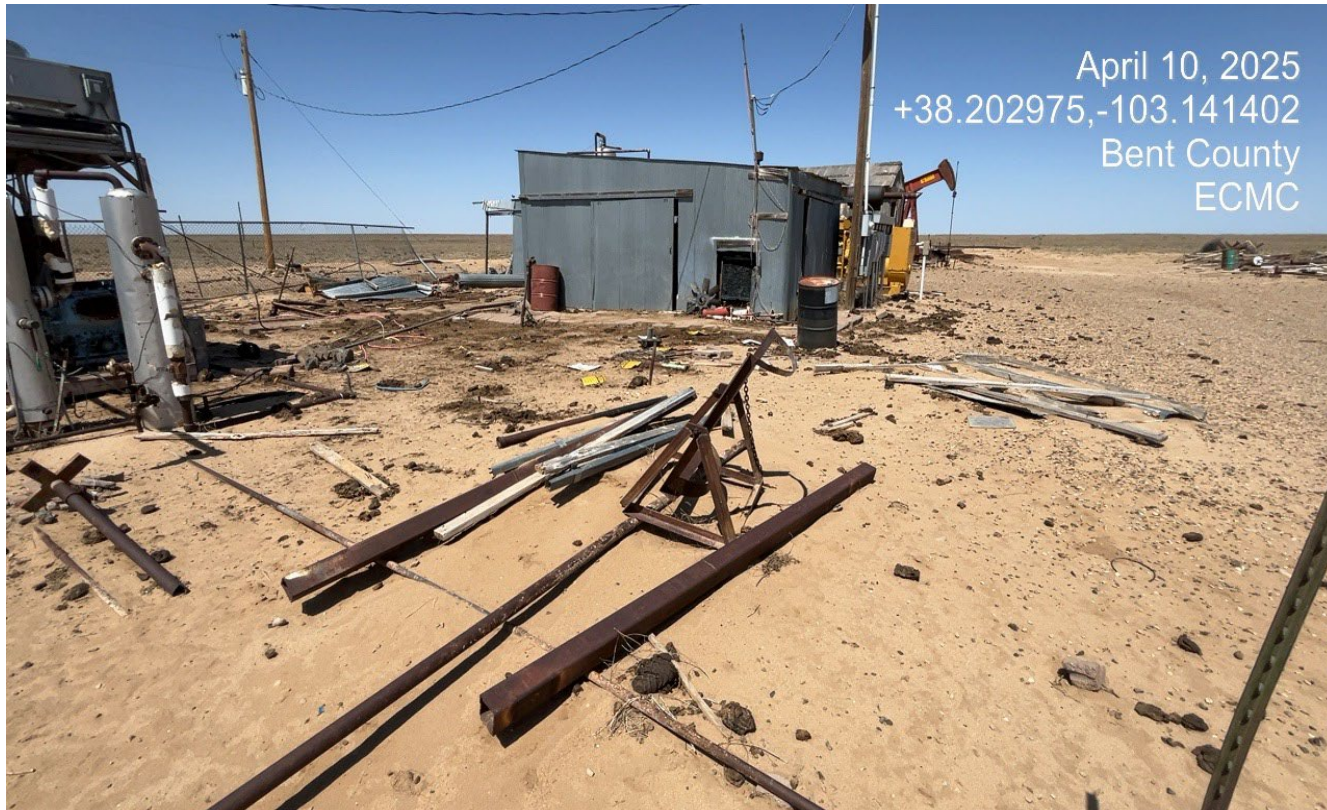
Photo 3. Facing northwest toward the GAS PROCESSING PLANT and Wellsite. There is various supplies and debris scattered throughout the location.

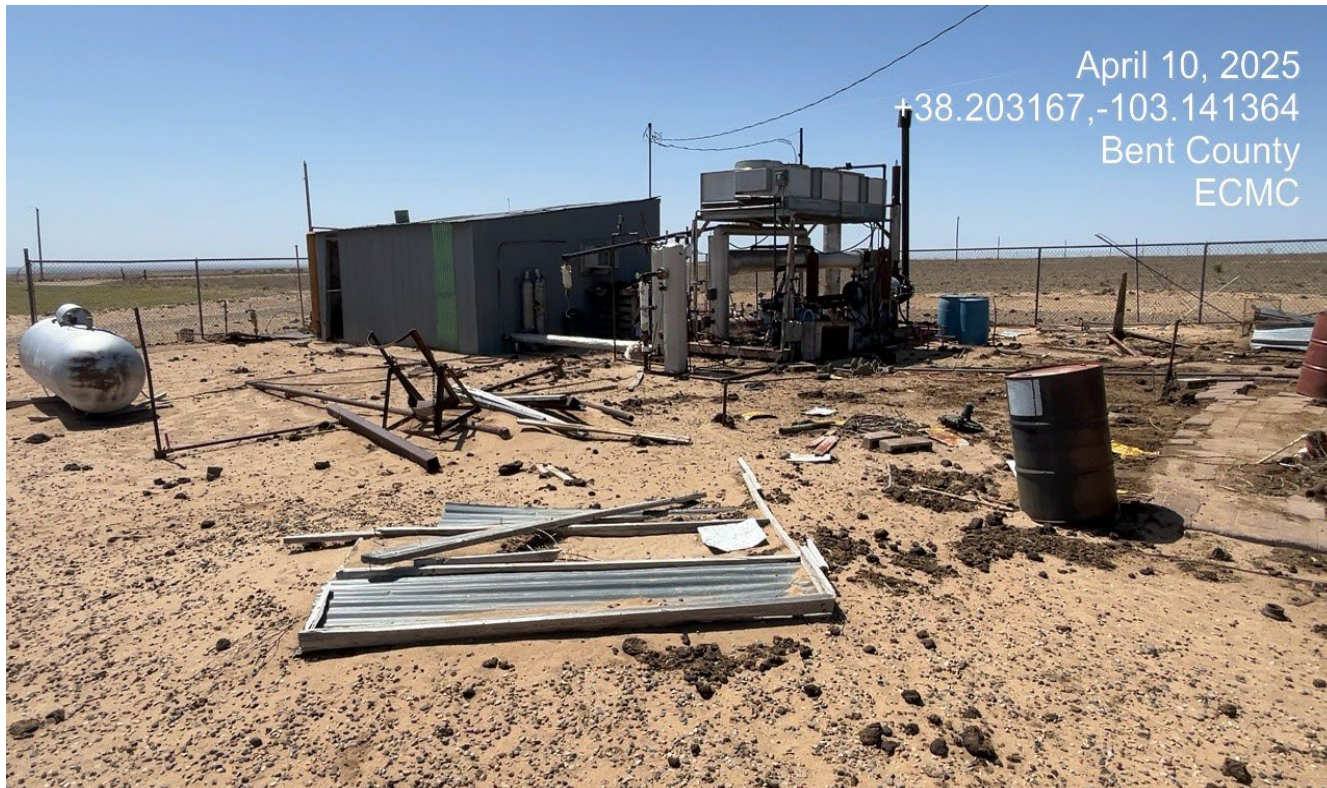
Photo 4. Facing southwest at the sheds and various equipment which are in disrepair. There is chemical barrels with no containment and various debris laying on the ground.

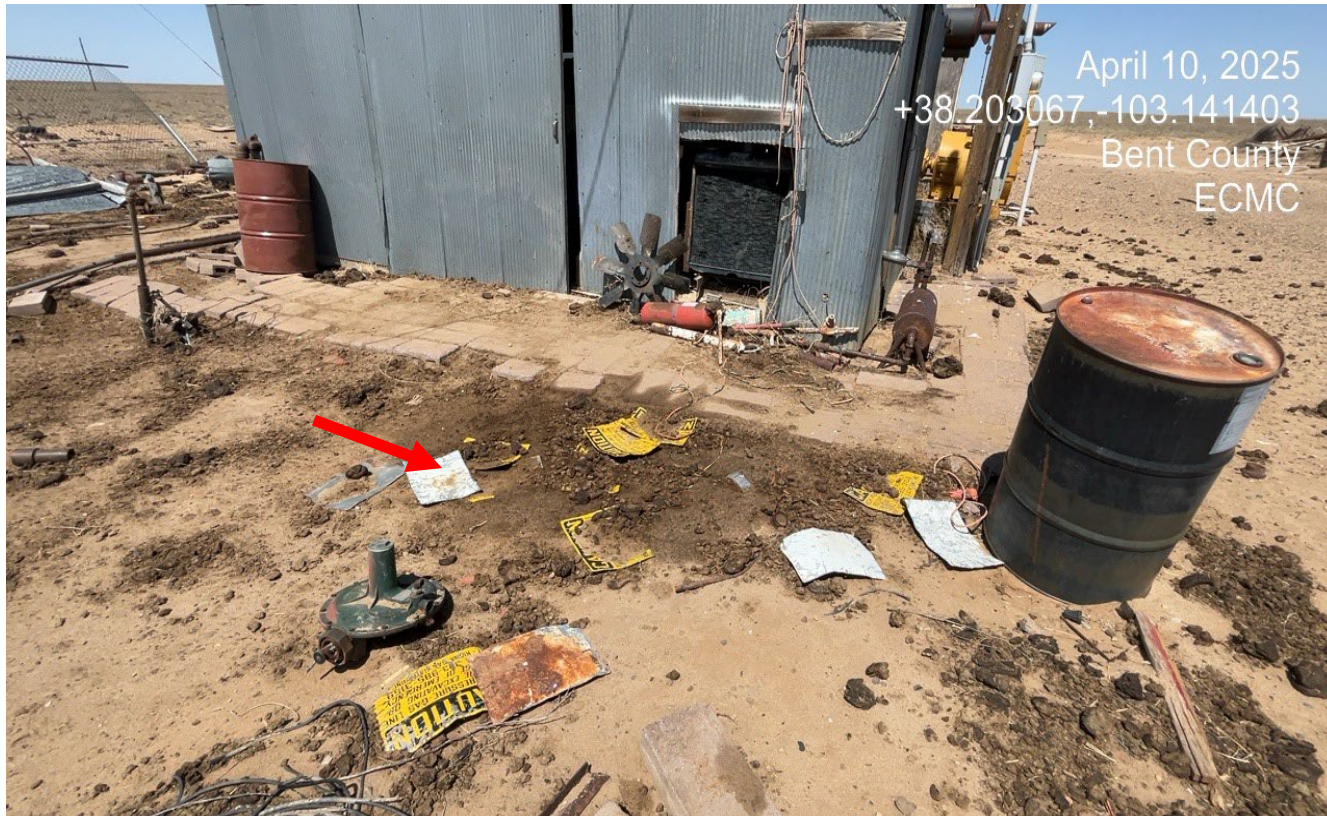
Photo 5. Facing northwest at the sheds and various equipment which are in disrepair. There is still oil stained soils from the barrel that leaked out shown at red arrow.

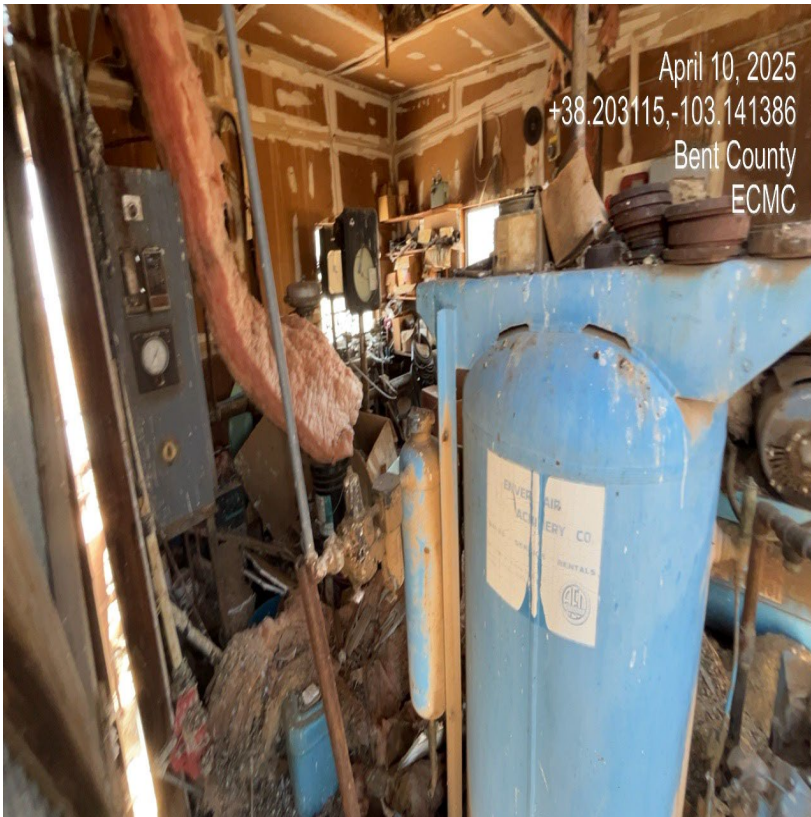
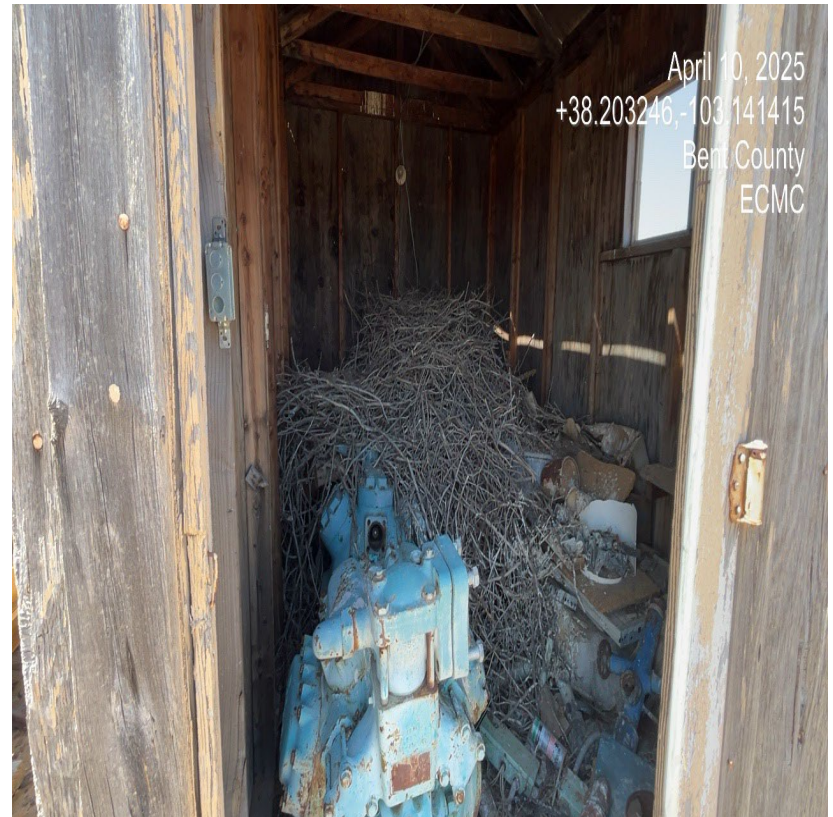
Photo 6&7. There are sheds in disrepair with large bird nests. Operator will need to consult with USFS and CPW regarding time restrictions and relocation of any migratory bird nests.

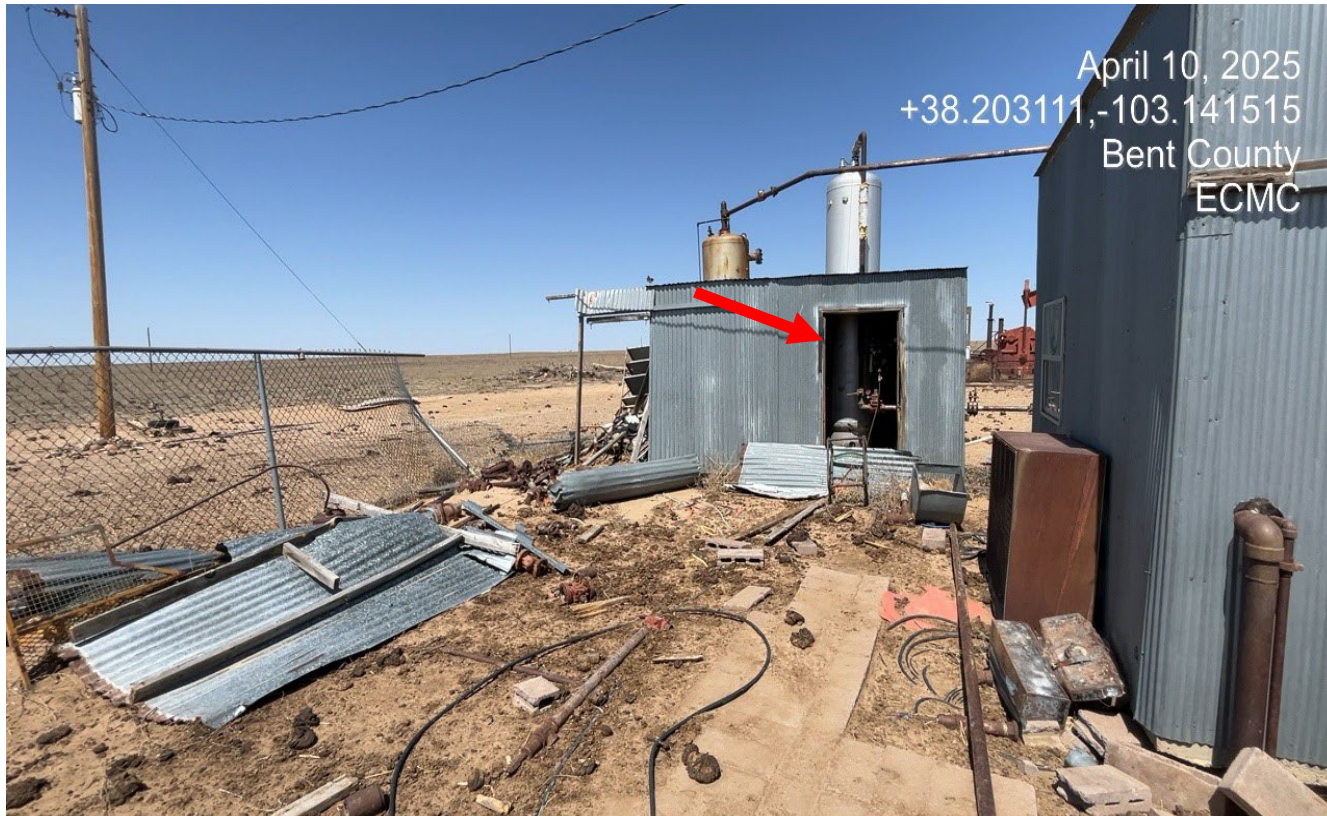
Photo 8. Facing northwest at the sheds and equipment which are in disrepair. There was an audible gas leak coming from this shed and separator shown at red arrow.

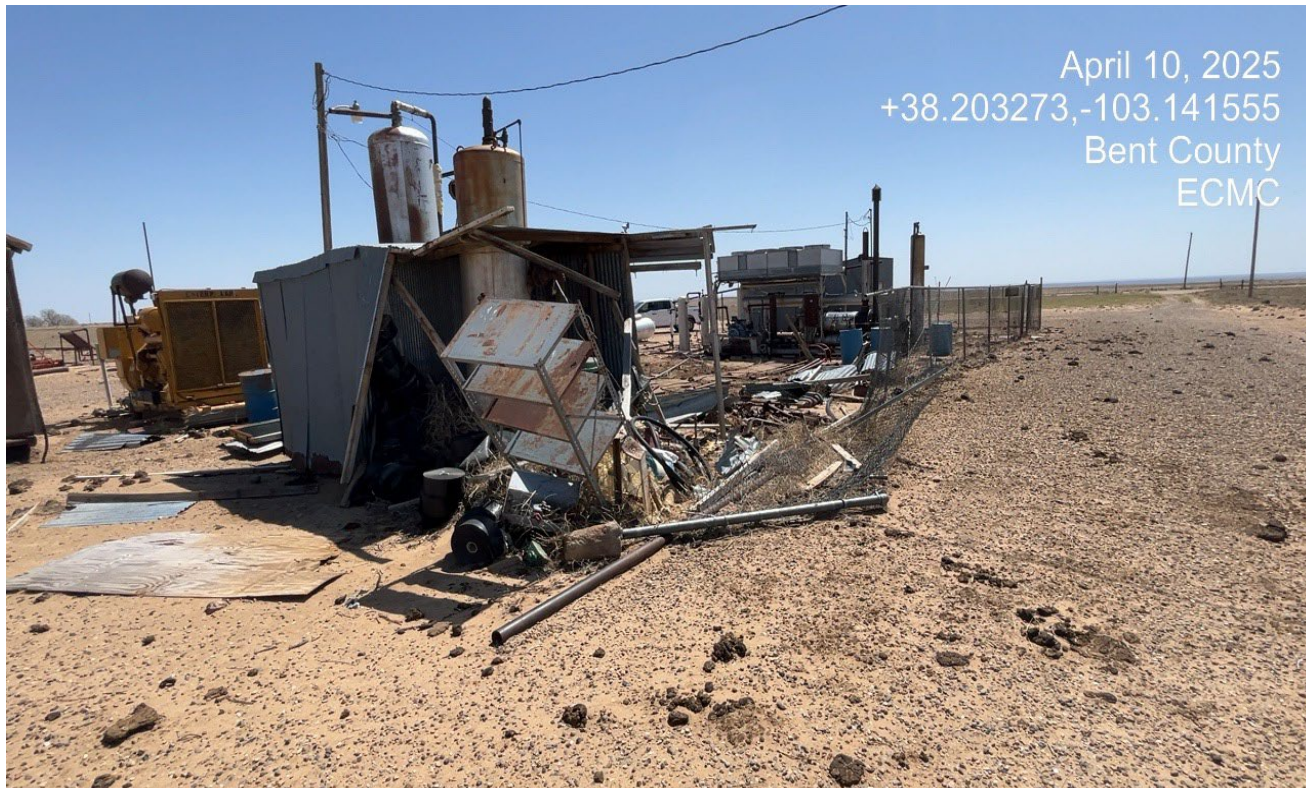
Photo 9. Facing southeast at the west side of the location. This shed and fence are in disrepair with supplies have fallen out of the dilapidated shed.

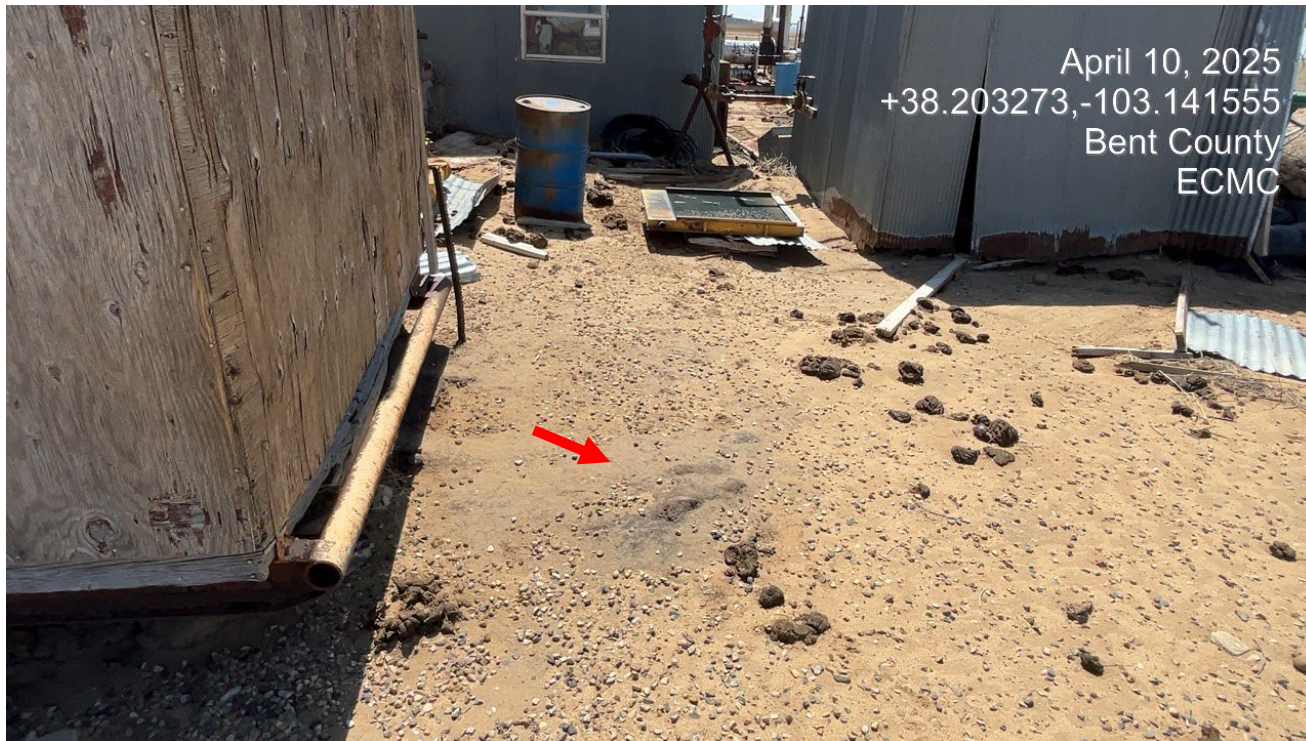
Photo 10. There is panels, boards, and a blue barrel laying on the ground which has leaked out fluids onto the ground. There is also impacted soils shown at red arrow.

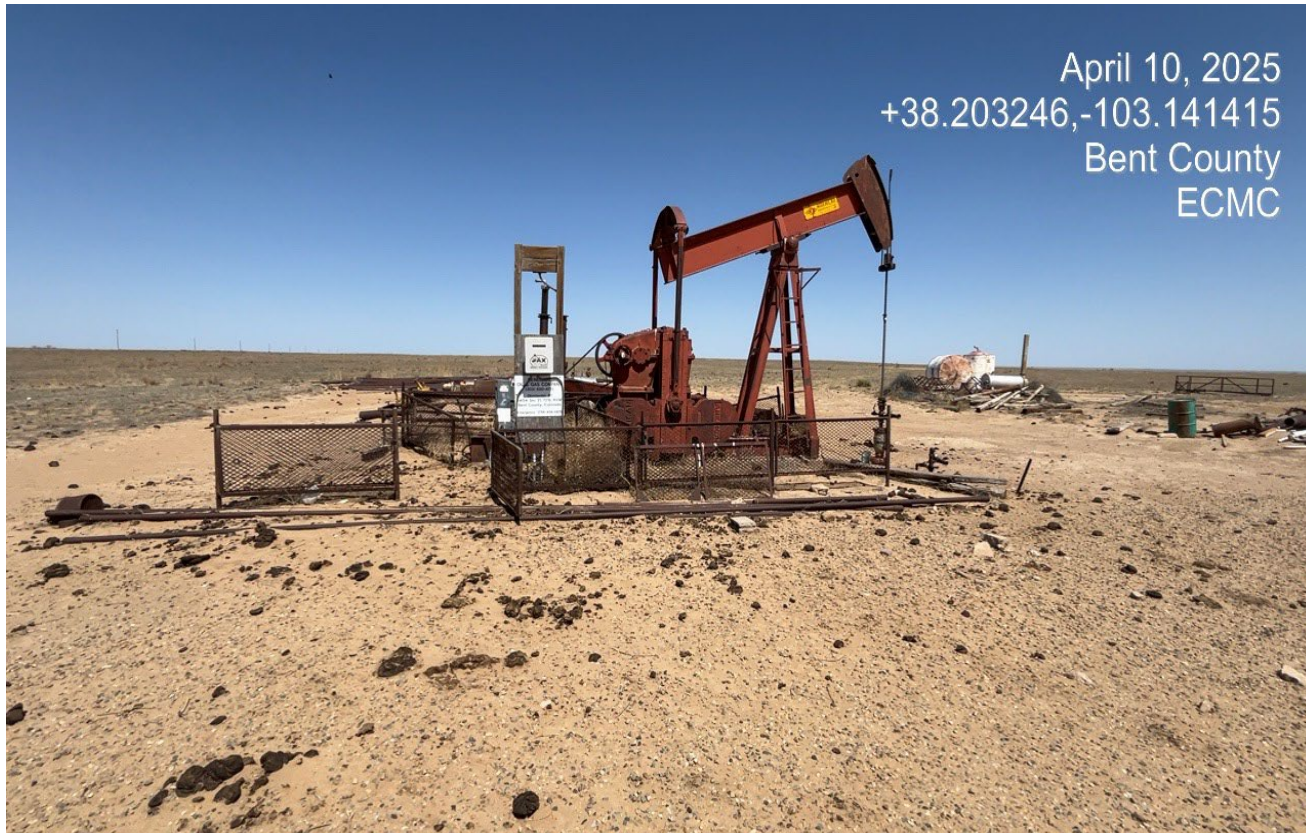
Photo 11. Facing northeast toward the well. The fence around the pumpjack is in disrepair and there is unused equipment stored near the well.

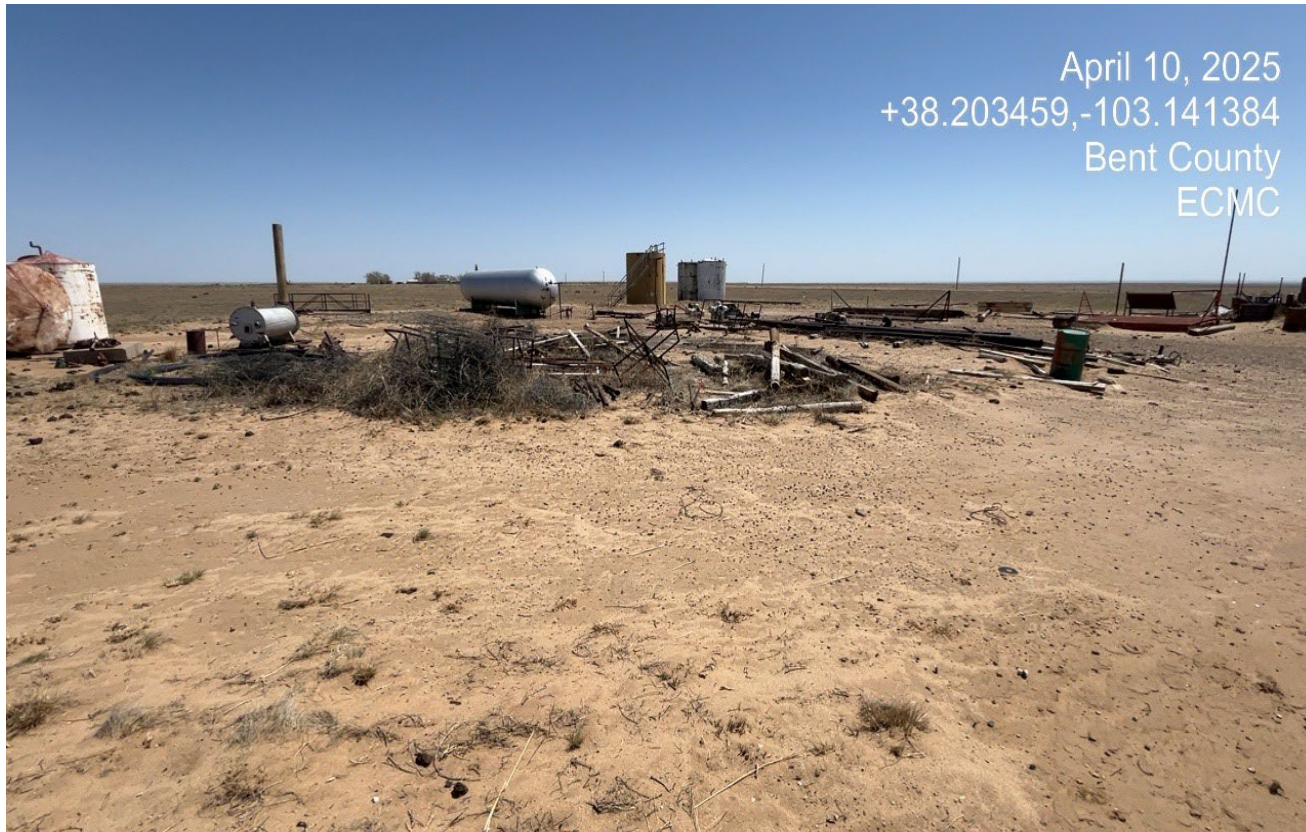
Photo 12. Facing southeast at the location. There are various unused equipment, wire, and debris stored on location that needs to be removed.

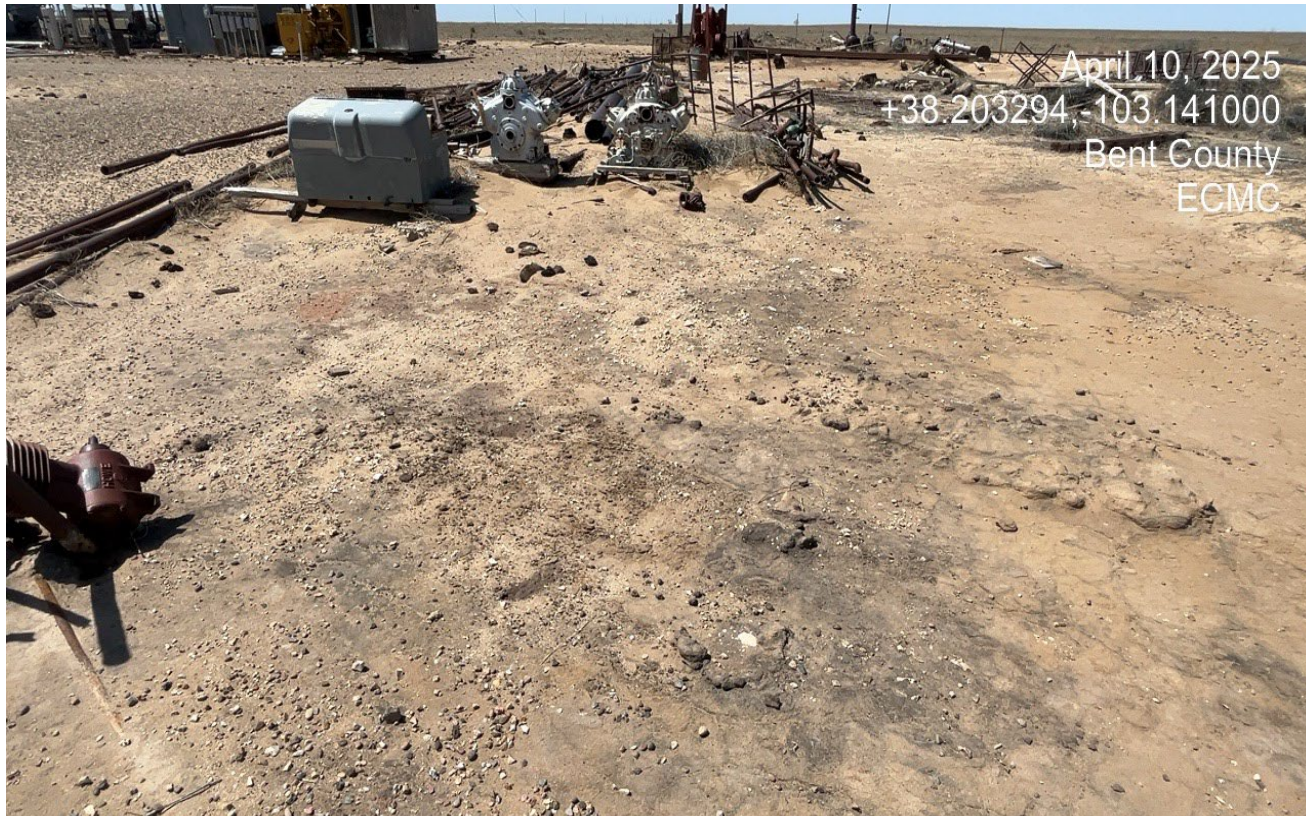
Photo 13. Facing west at the location. There is various unused equipment, supplies and tanks stored at the location that will need to be removed. The soils in this area are stained with hydrocarbon impacts from historic spill.

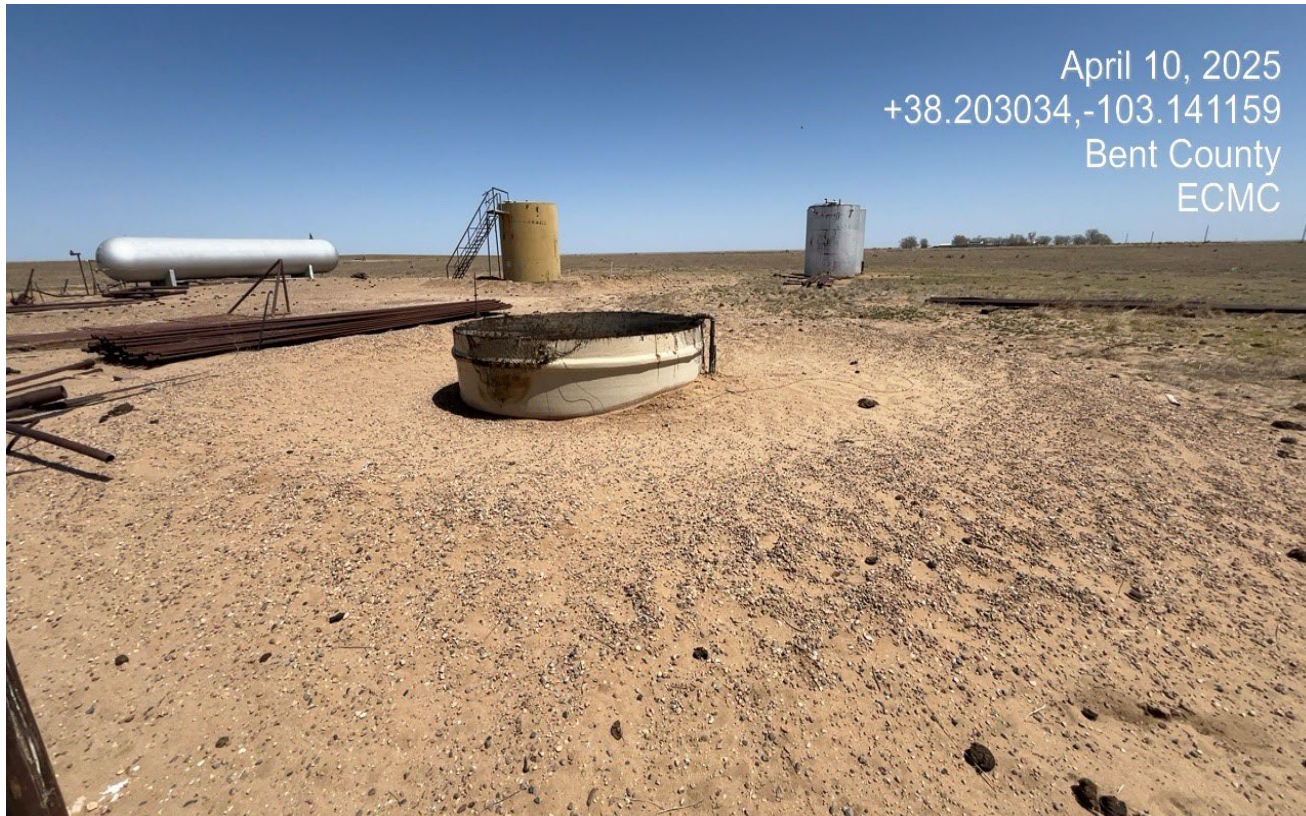
Photo 14. Facing east at the south side of the location. This open top tank remains with oily fluids.

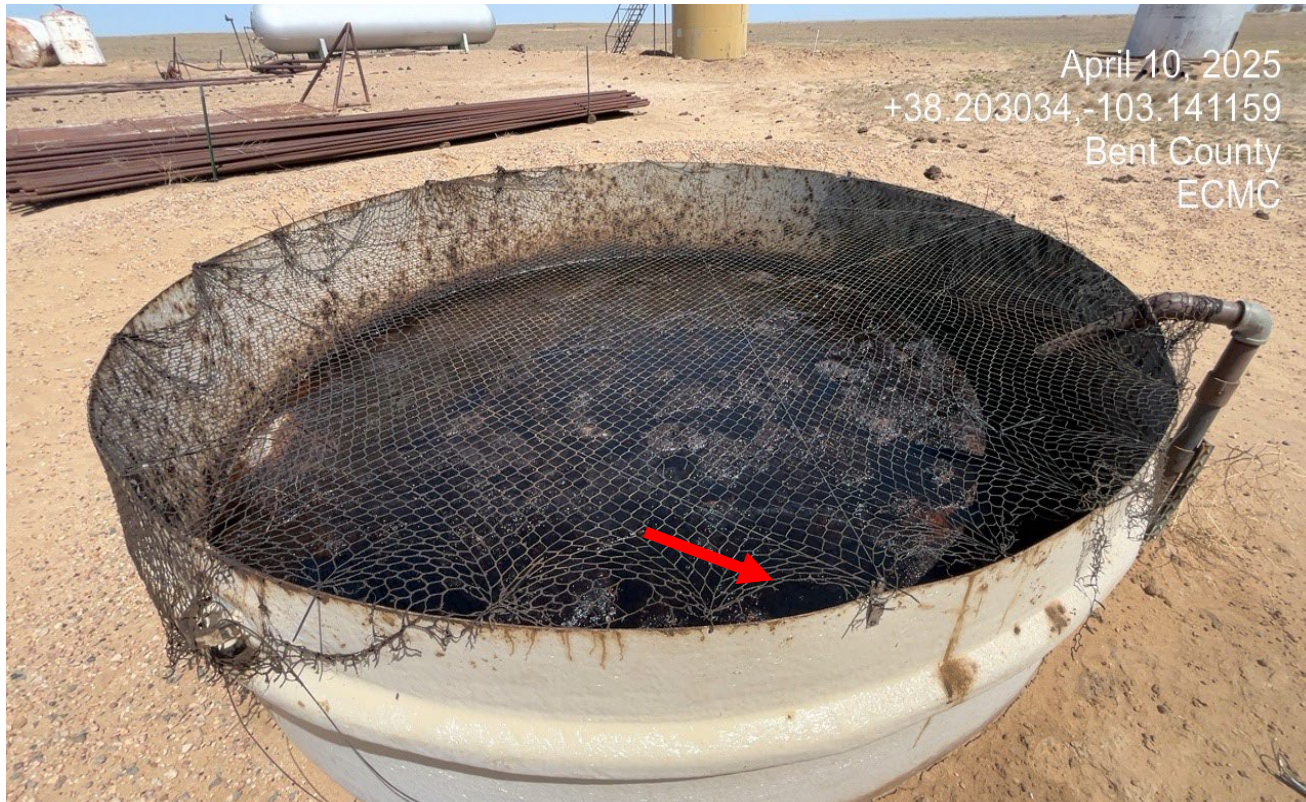
Photo 15. Facing toward the open top tank which has oil condensate inside the tank. Netting has now been installed over the tank. There are still opening on the sides that are large enough for birds to get into the tank.

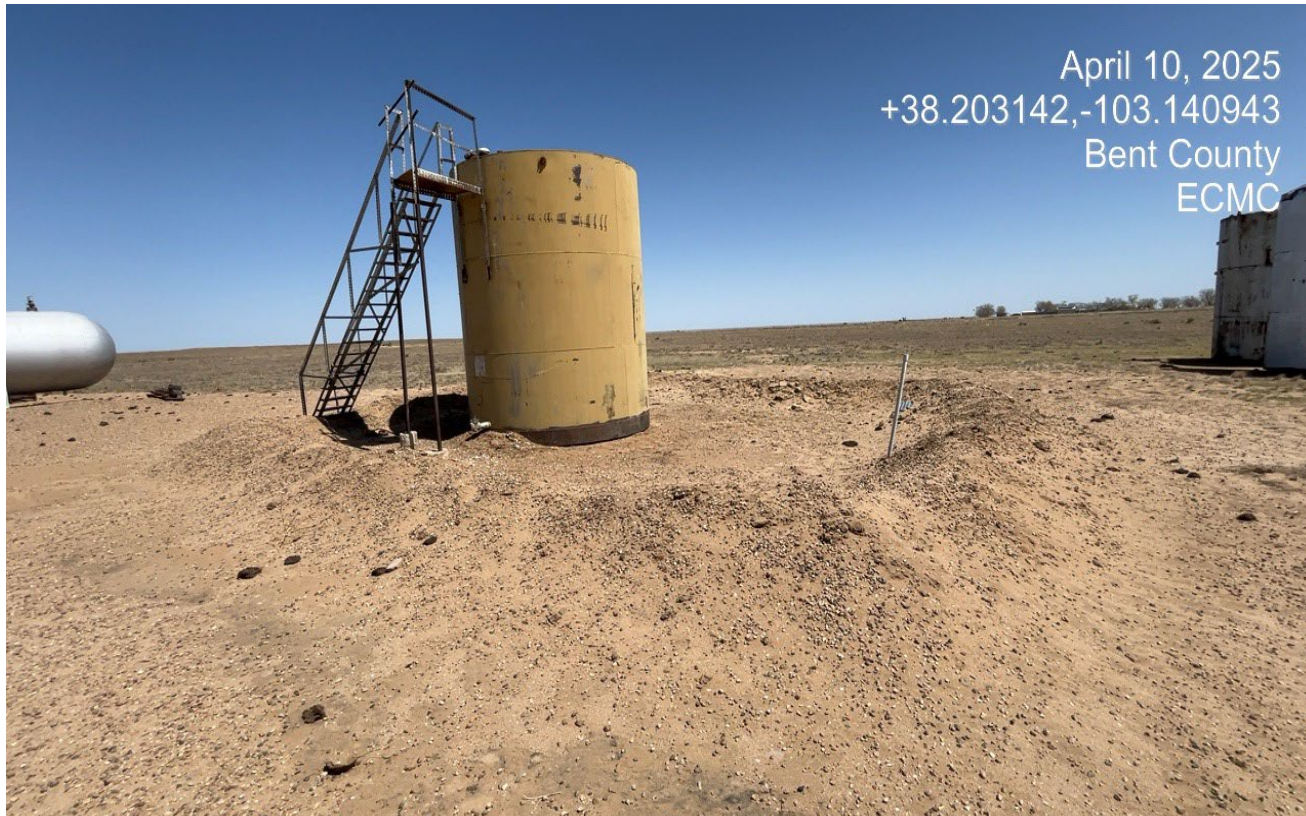
Photo 16. Facing northeast at the location. This tank was installed since the 8/7/24 inspection.

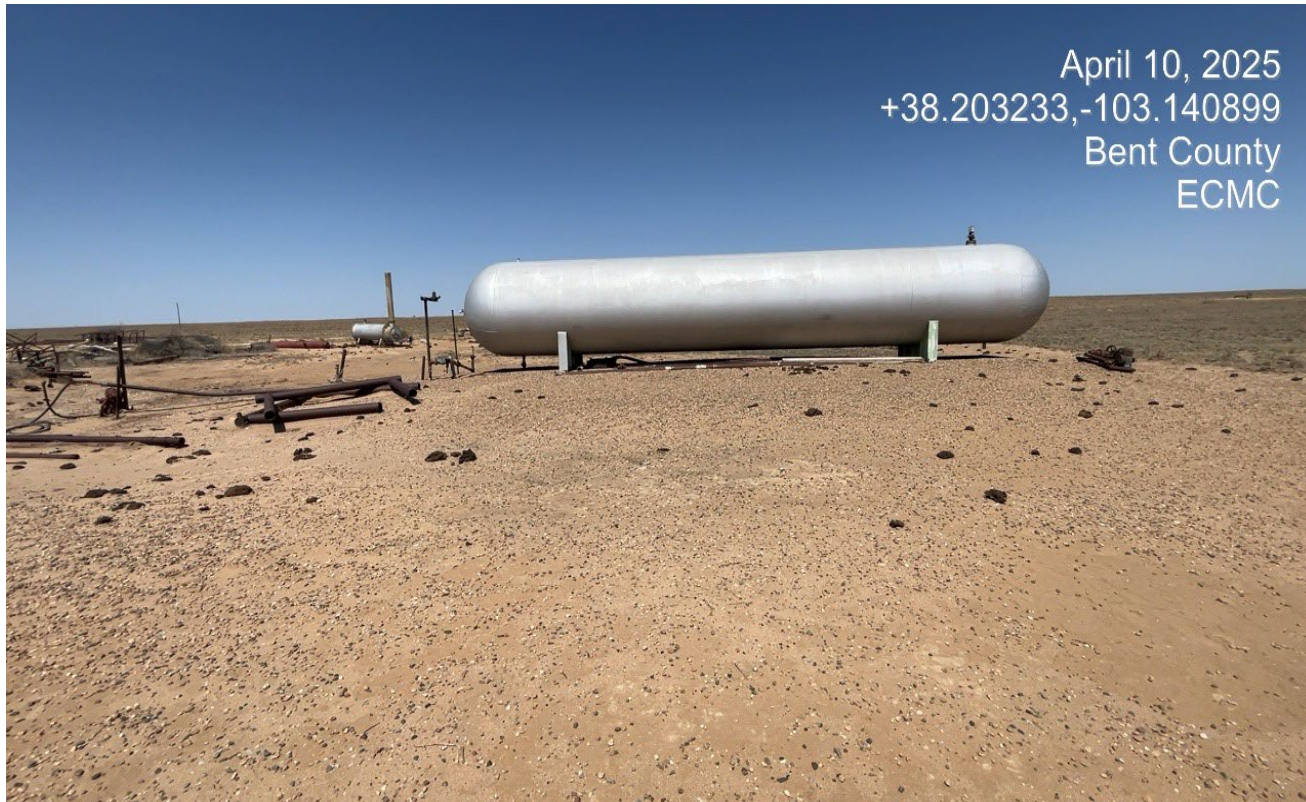
Photo 17. East side of the location facing north. There is a large tank at the east side which does not appear to be in use.

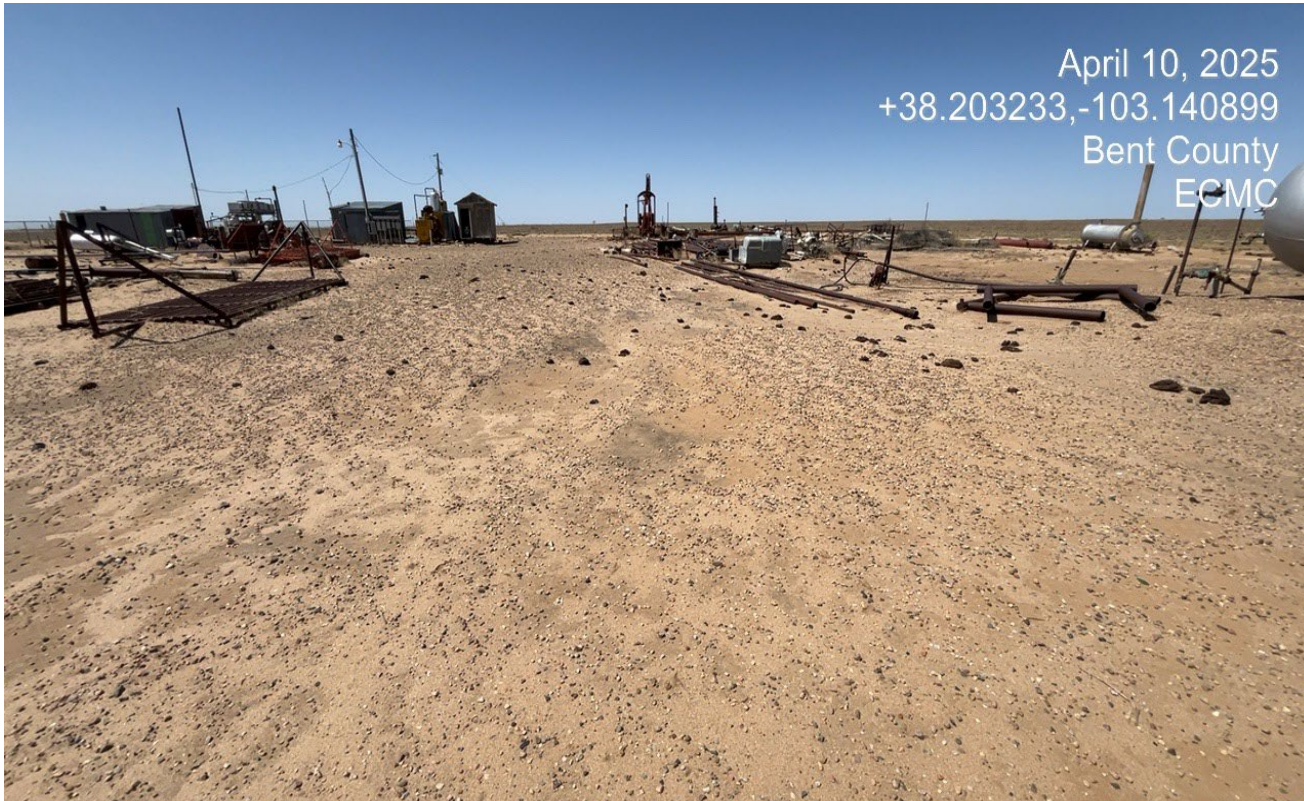
Photo 18. East side of the location facing west.

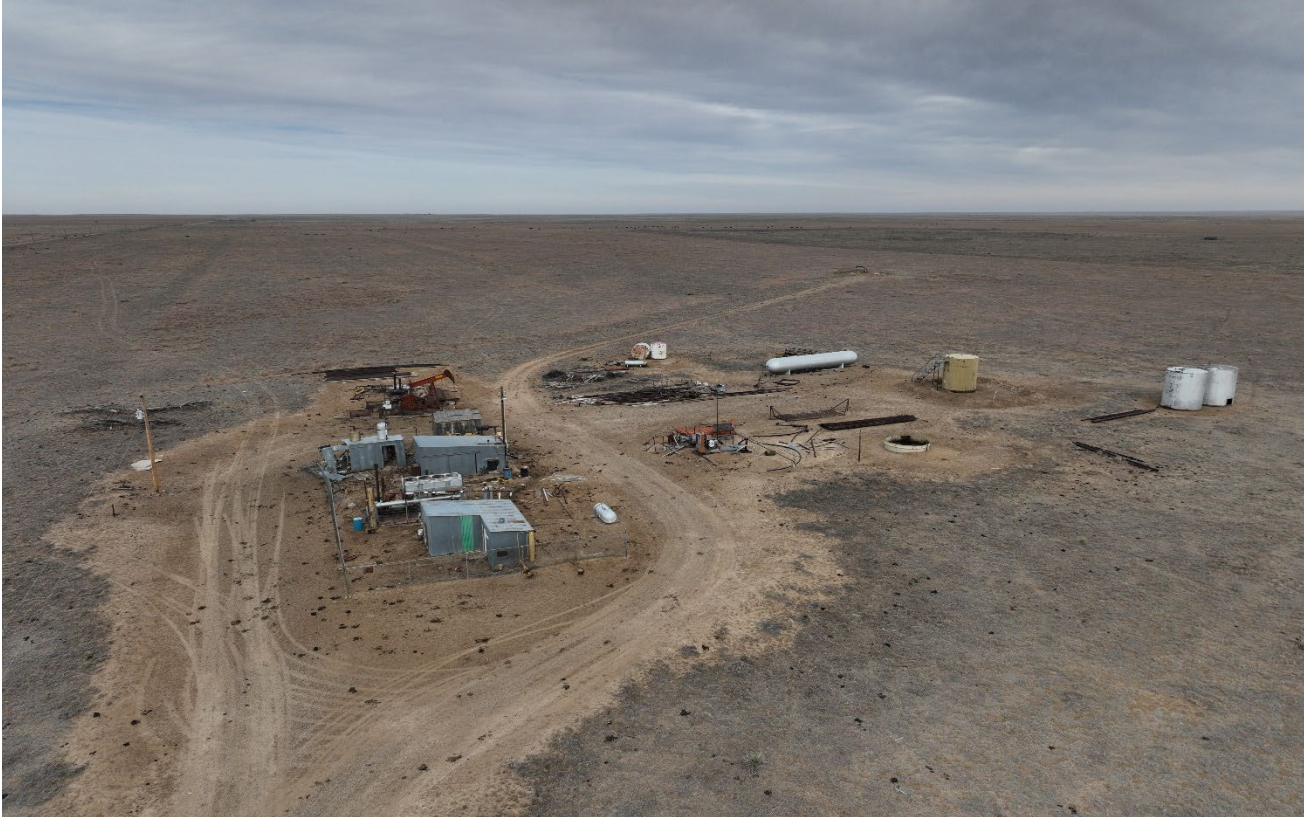
Photo 19. Drone aerial photo taken on 2/4/2025. Facing northeast toward the GAS PROCESSING PLANT and Wellsite.

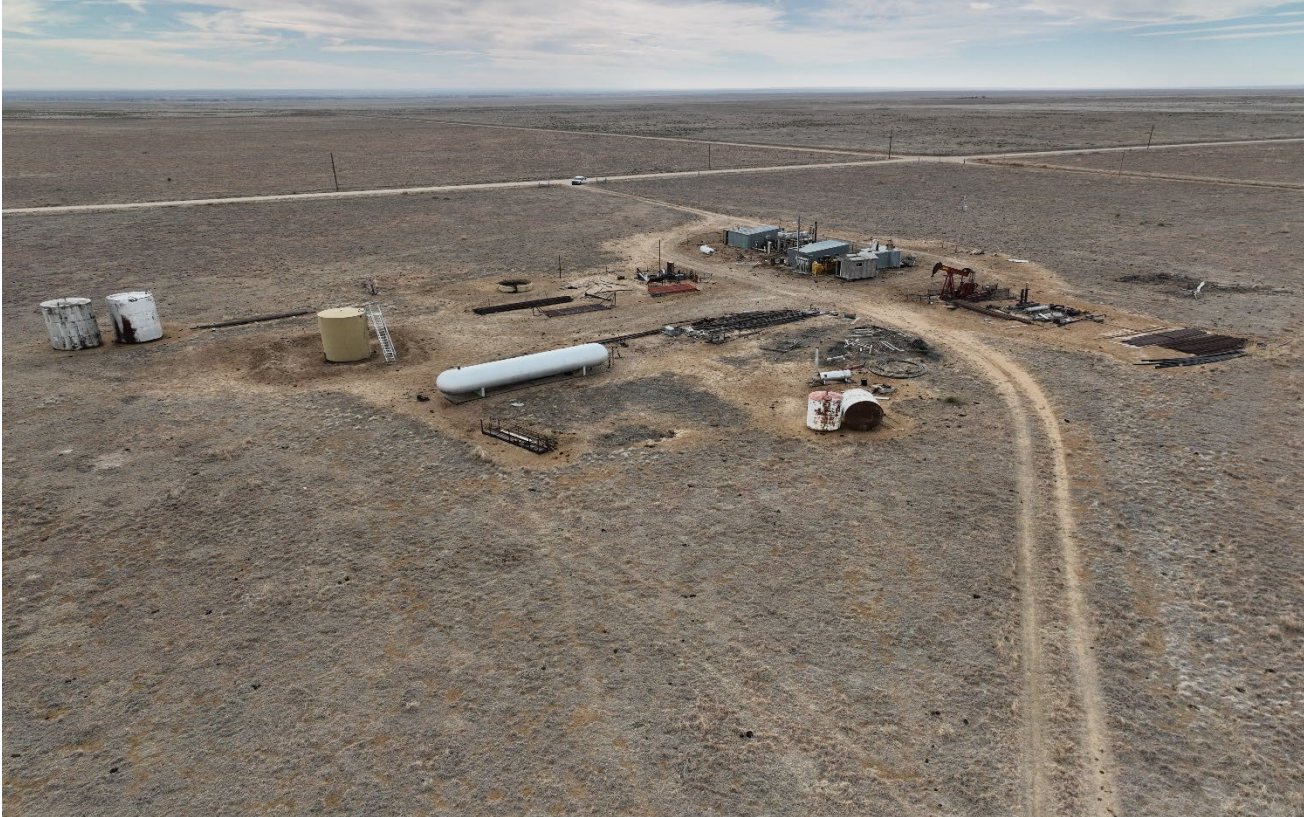
Photo 20. Drone aerial photo taken on 2/4/2025. Facing southwest toward the GAS PROCESSING PLANT and Wellsite.
