Inspection Photos

API: 011-05057

Operator: RENEGADE OIL & GAS COMPANY LLC

Inspection Date: 4/10/2025

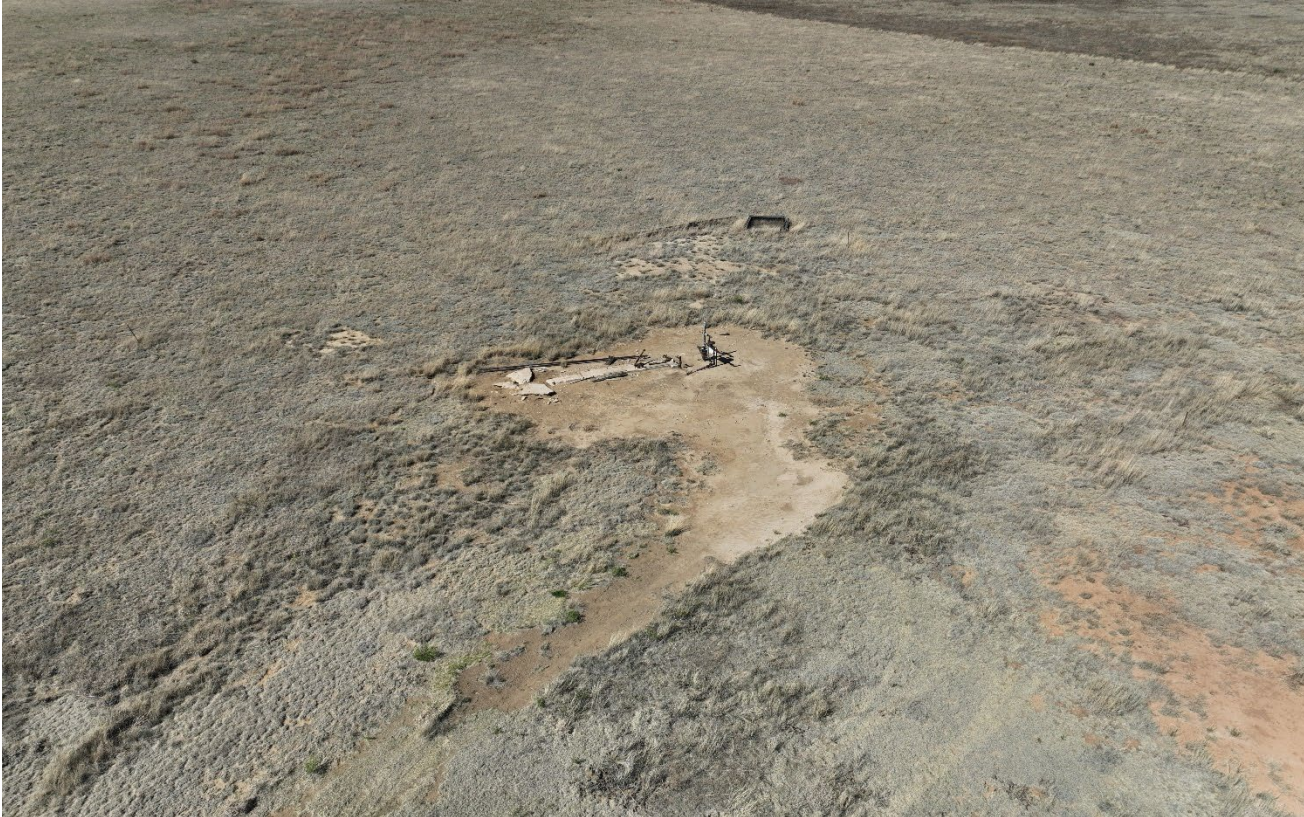
Photo 1. Drone photo (taken on 5/8/24) facing down toward the wellsite. There is an area with no vegetation which appears impacted soil from a historical spill.

Photo 5. Facing south at the location. This is the area of suspected impacts from the well. See photo #1.

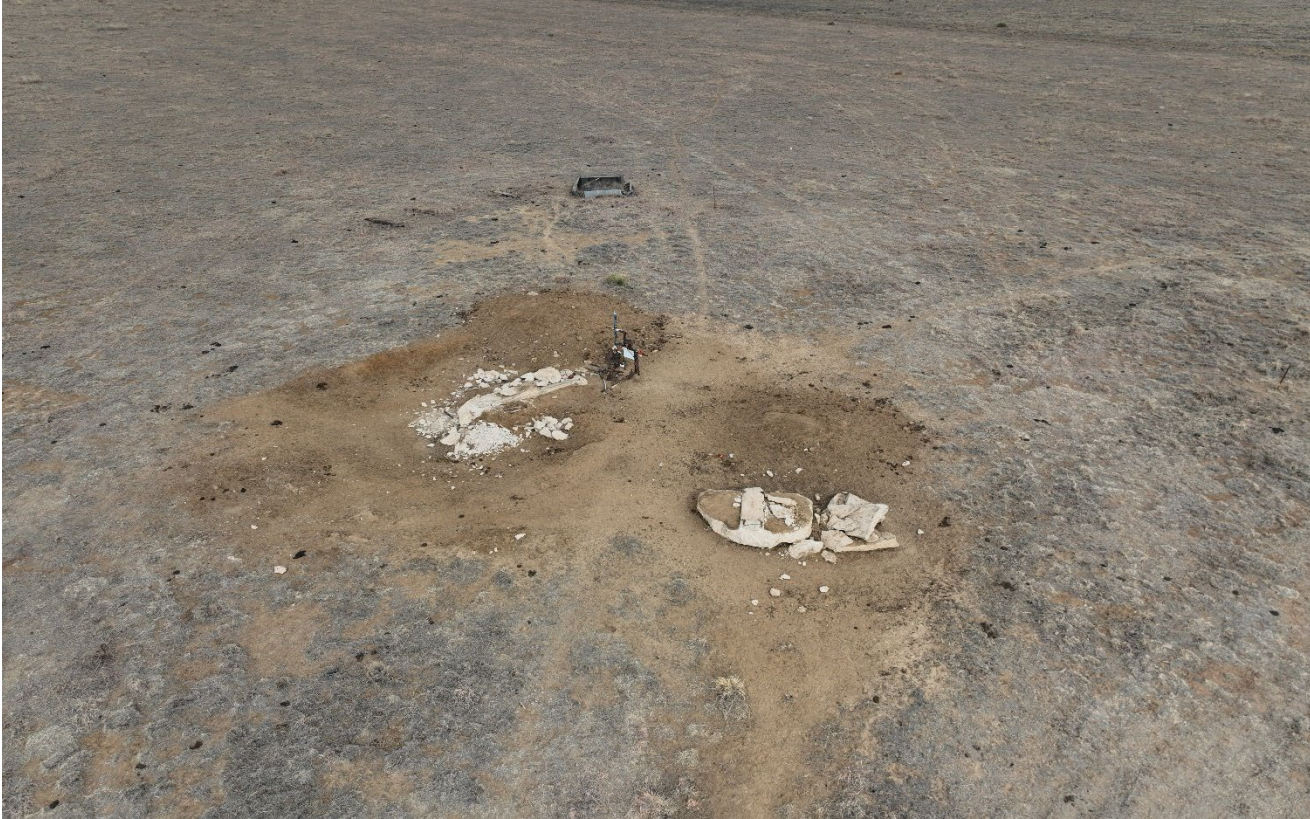
Photo 2. Drone photo (taken on 2/4/25) facing down toward the wellsite.

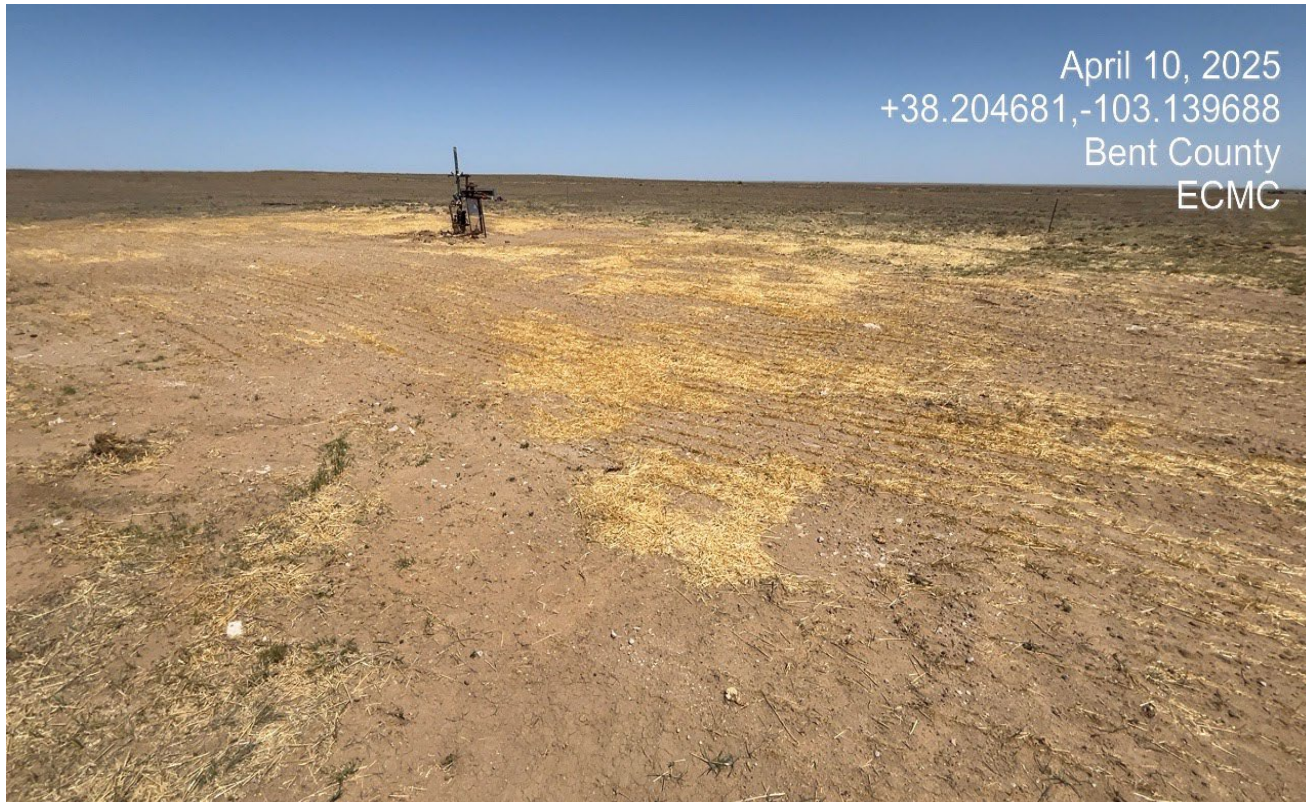
Photo 3. Facing northeast toward the wellsite. The concrete has been removed and the location is seeded and straw mulched. Some of the mulch has blown off.

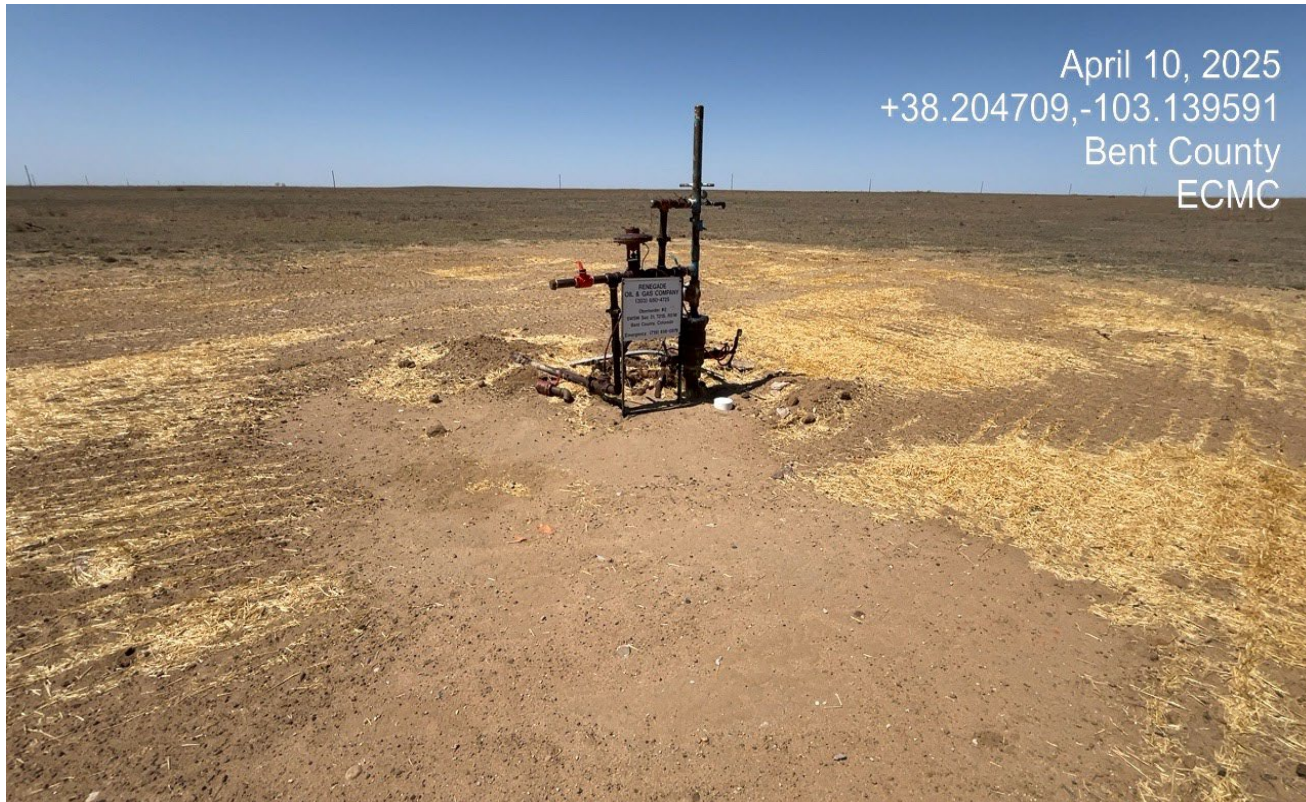
Photo 4. Facing toward the wellhead.

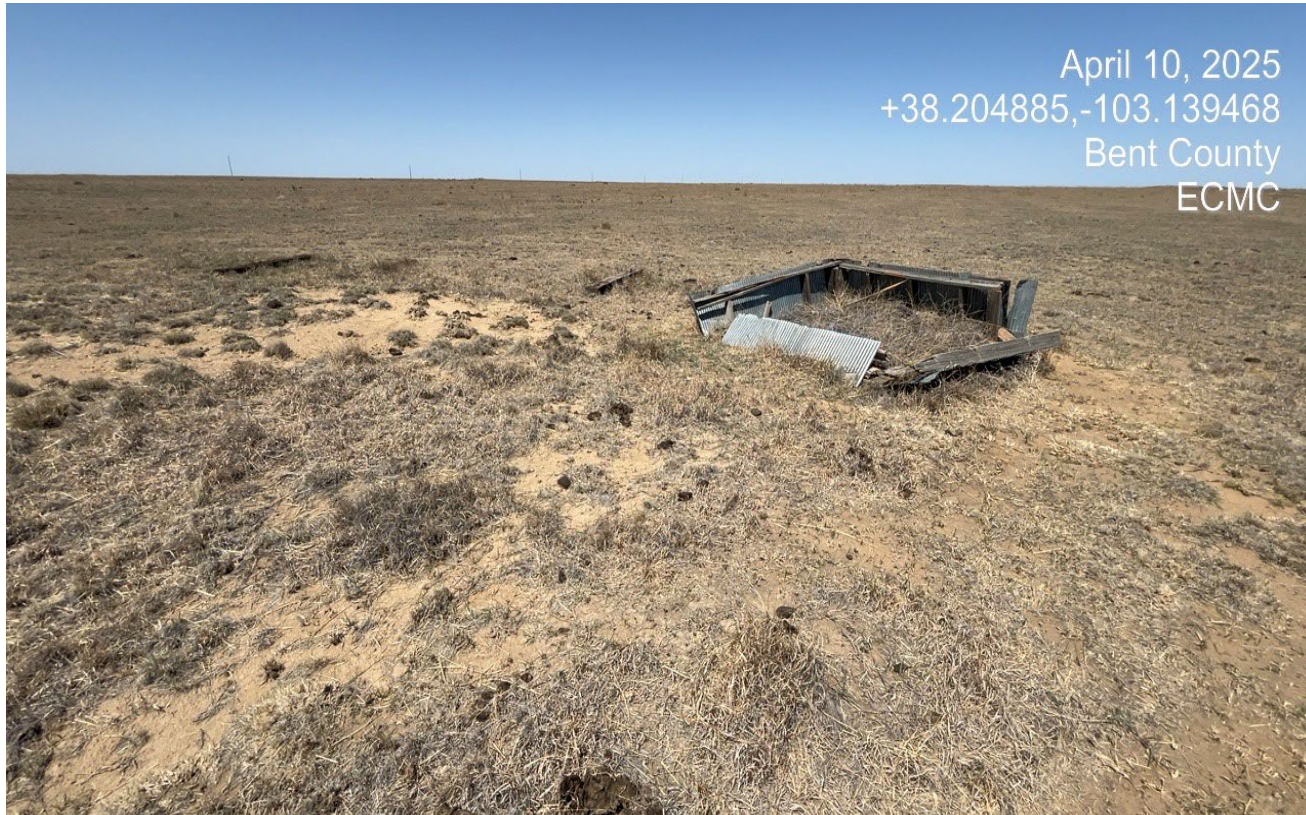
Photo 6. Facing north at the location. There are two wood railroad ties and a partial shed that remain.
