Inspection/Audit Photos

Location Name: TEP ROCKY MOUNTAIN LLC Dry Hollow Interconnect

Location ID: 479290

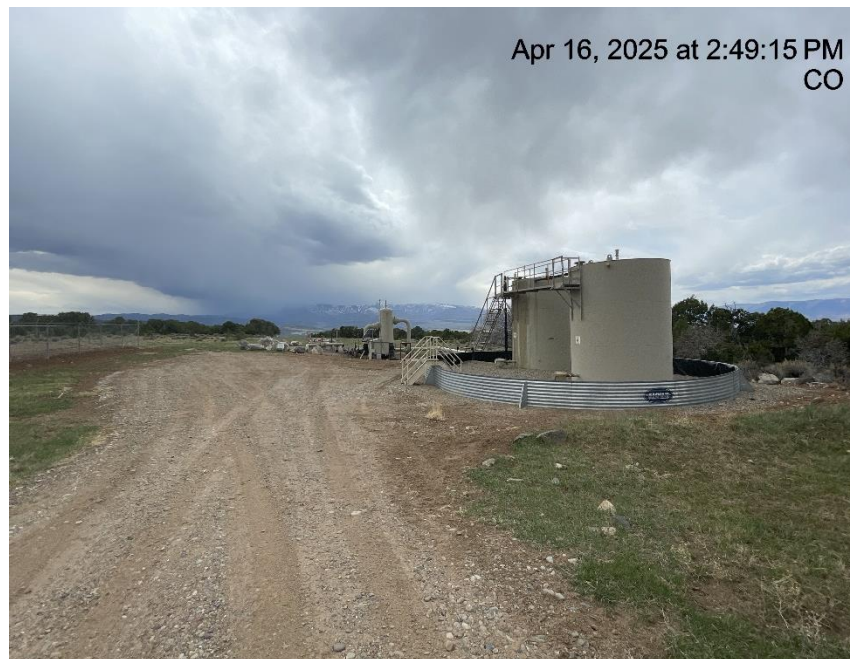
Photo # 2310 From entrance to location

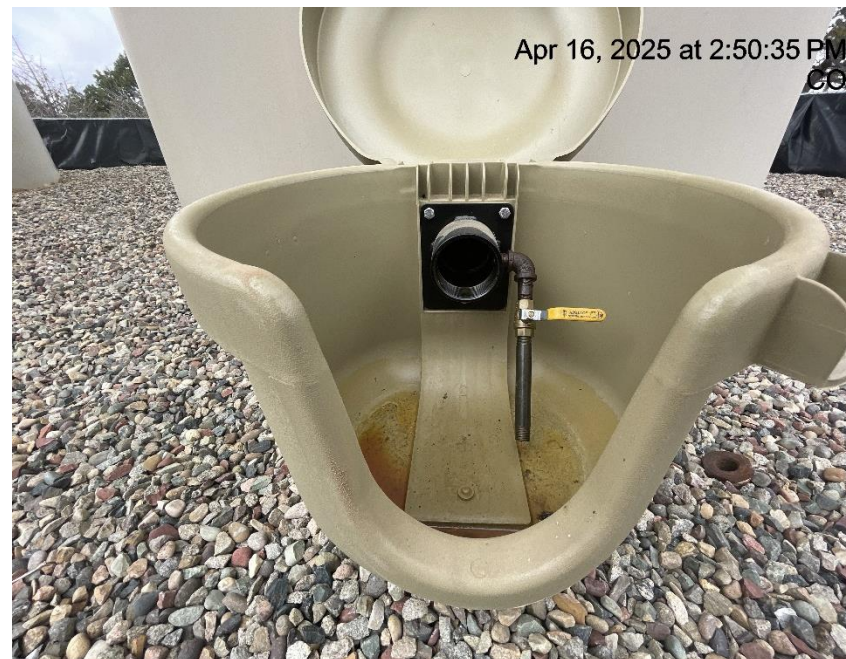
Photo # 2319 Open ended load line

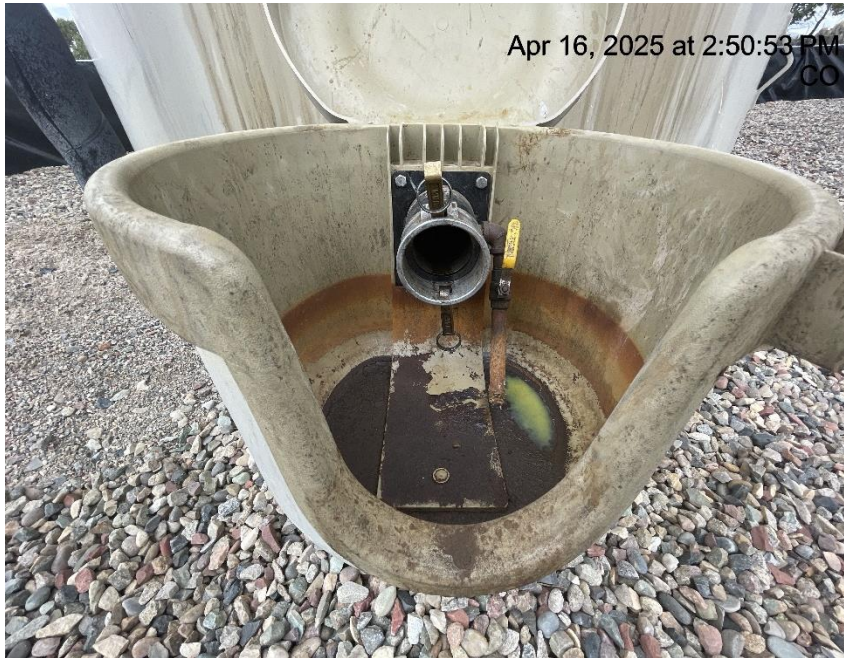
Photo # 2320 Open ended load line

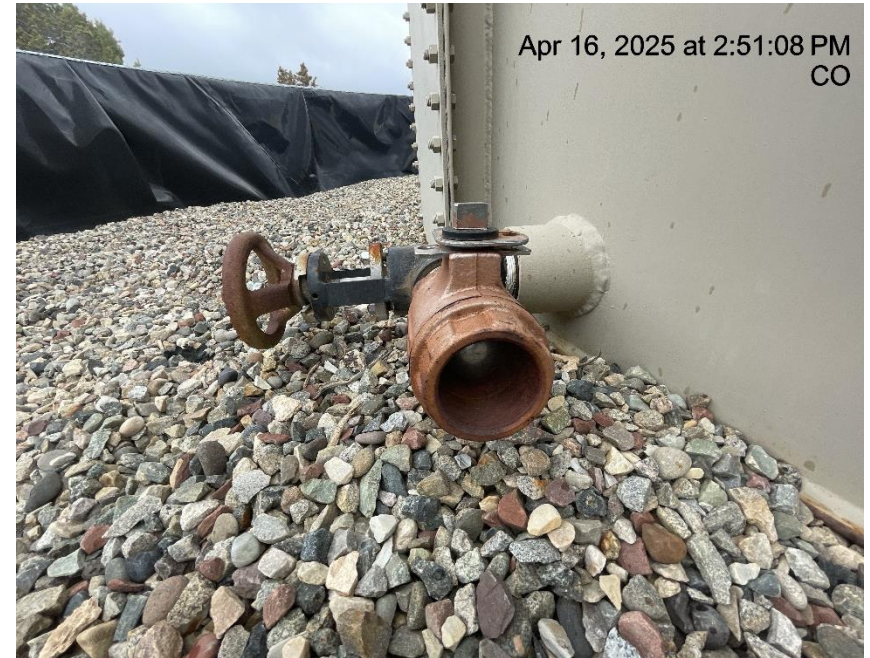
Photo # 2321 Open ended load line

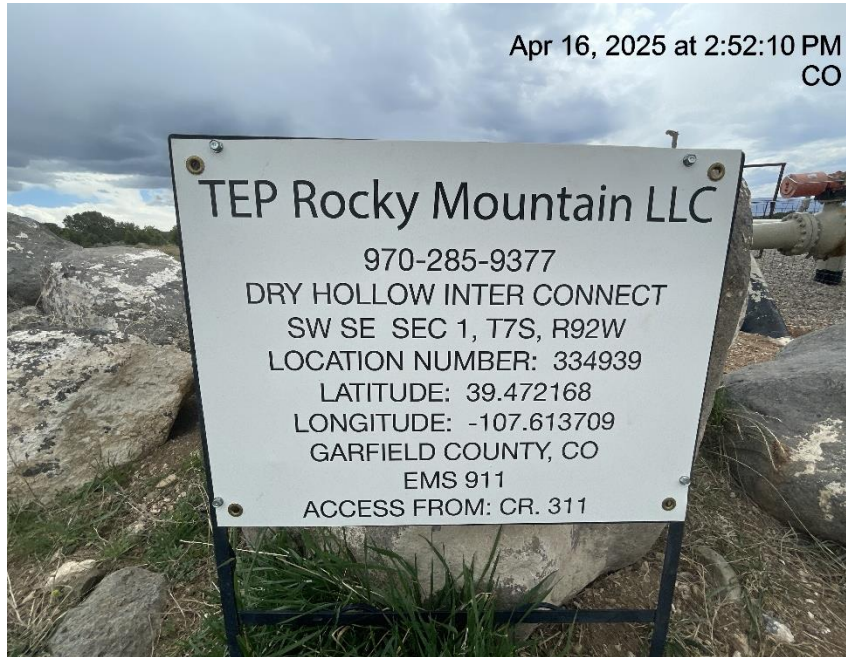
Photo # 2322 Location #, legal location & latitude/longitude on sign are incorrect/not in compliance with CECMC rules
