FIELD SUMMARY – 04/17/2025

ECMC Location Name (ID)	N. Parachute EF P27 595 (335806)
Client Location Name	P27 595 16C-27
ECMC Spill/Release Point ID	489807
Legal Description	SESE Sec. 27 T5S-R95W
Coordinates (Lat/Long)	39.579433/-108.033247
County	Garfield County, Colorado

P27 595 16C-27 Flowline (ECMC Location ID: 335806)

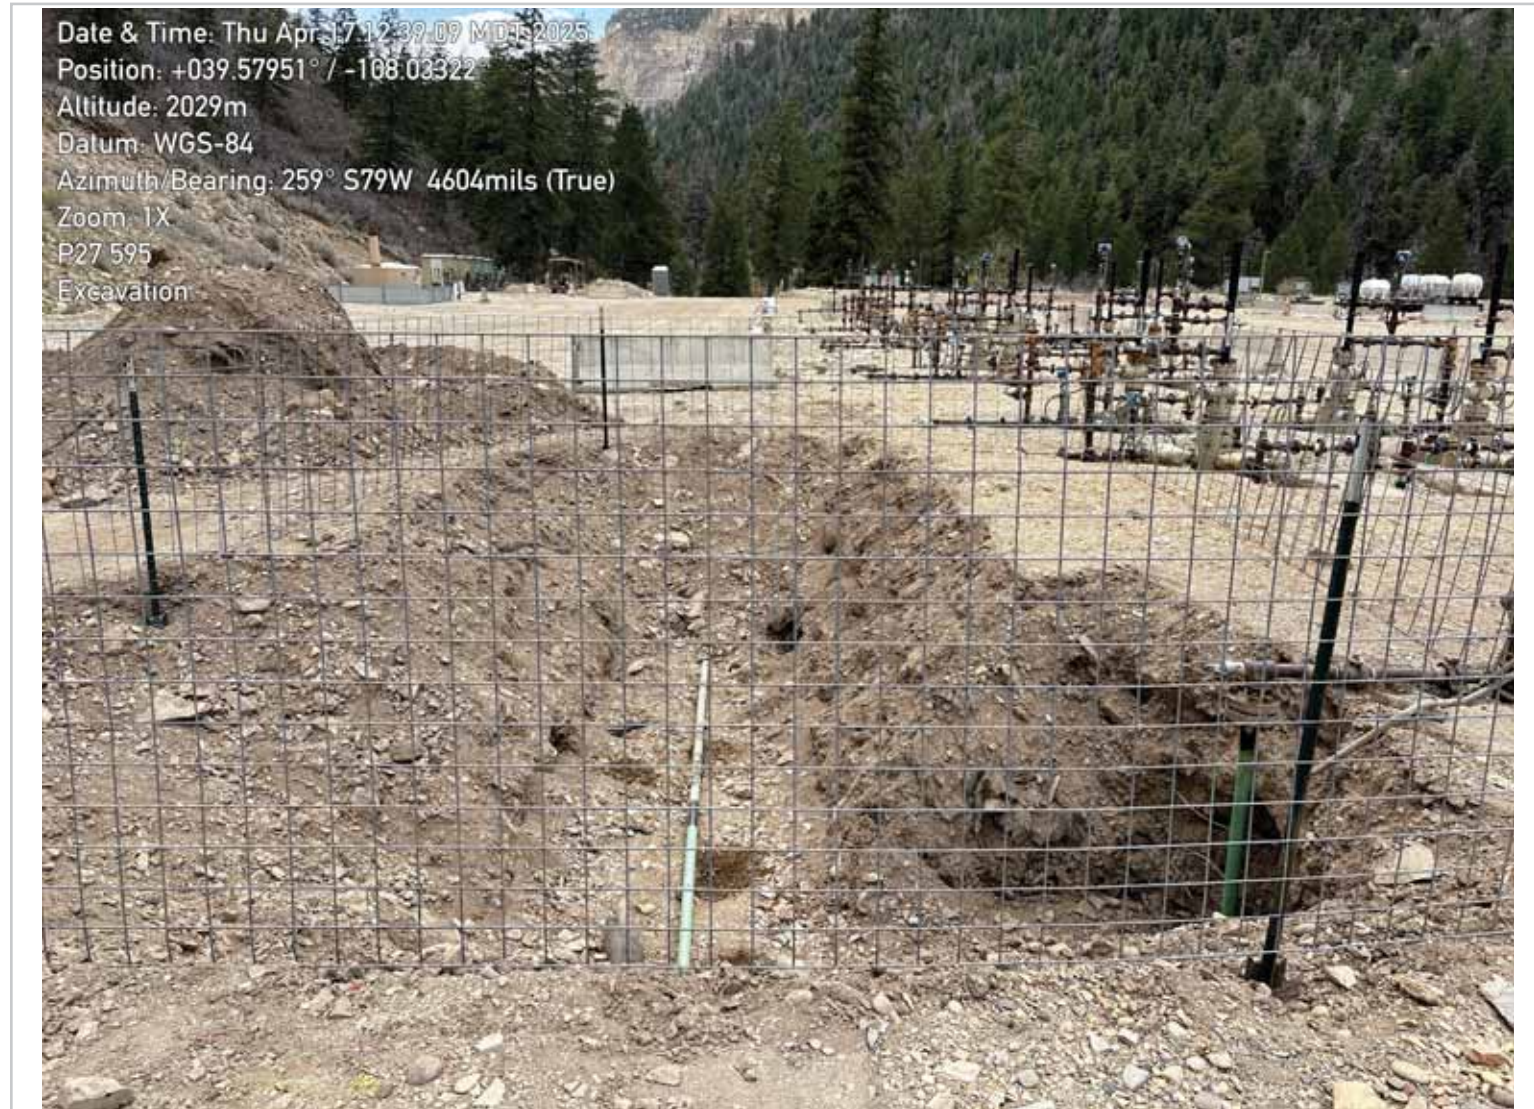
P27 595 16C-27 Excavation: View Southwest

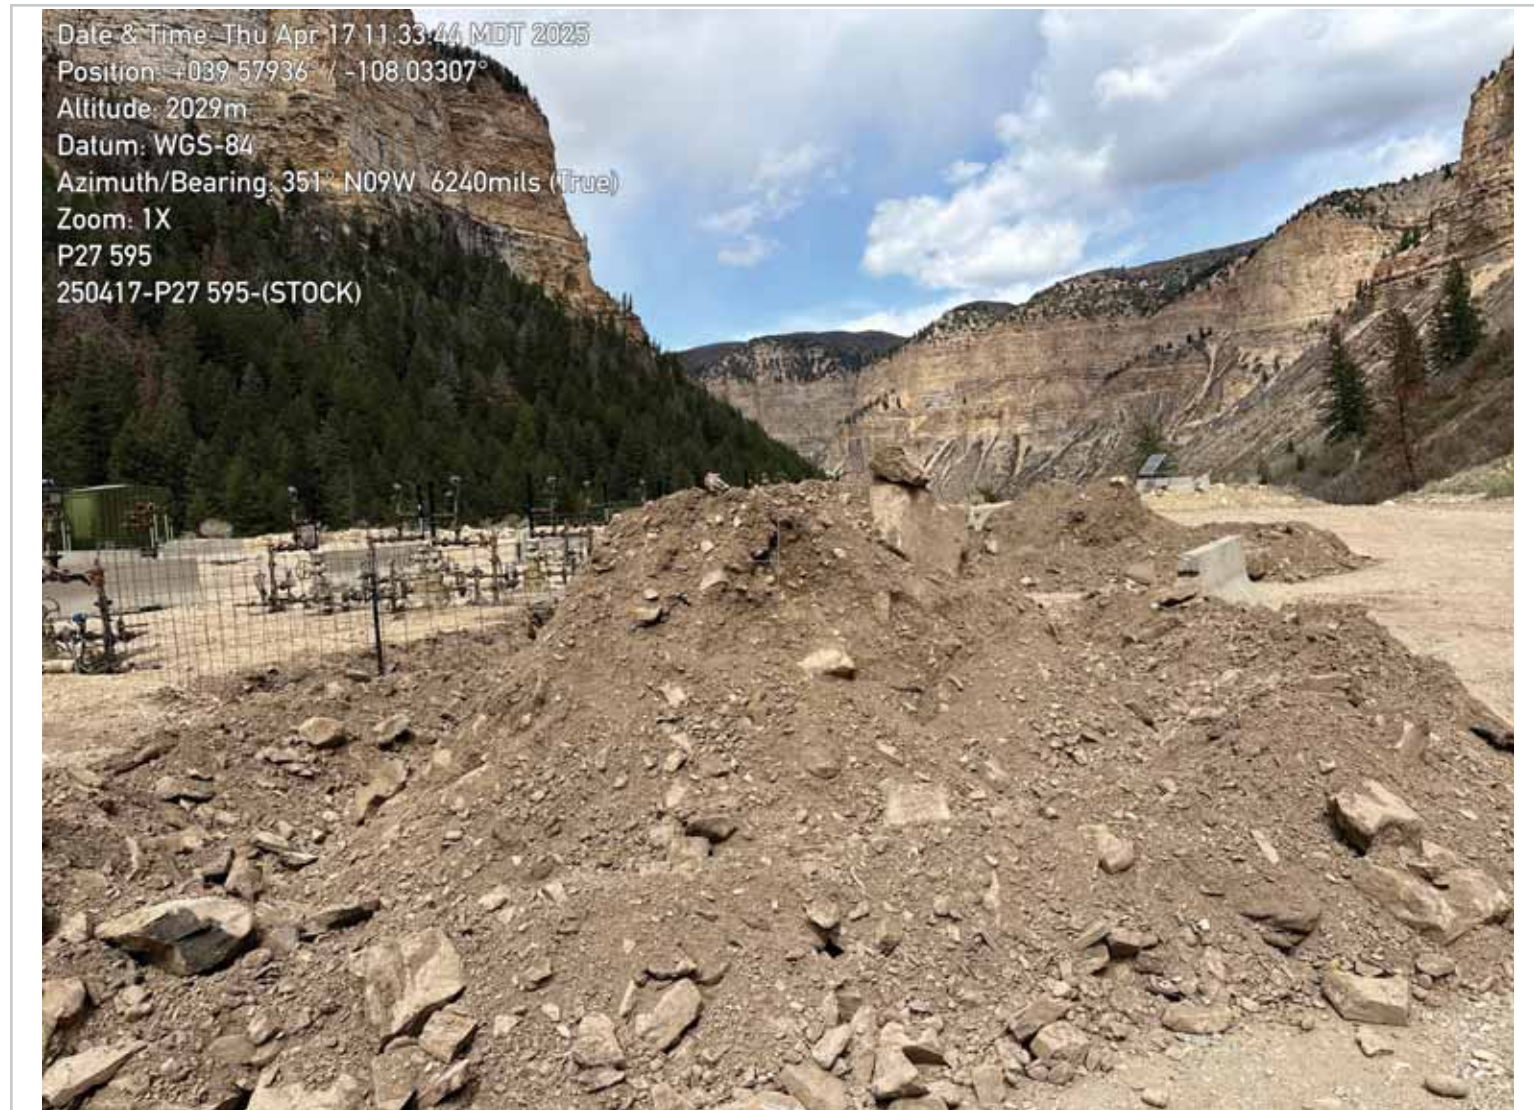
Soil Stockpiles: View Northwest
