# Interim Reclamation and Stormwater Inspection

Operator: WESTERN OPERATING COMPANY - 95620

Location ID: 312292

Inspection Photos  
Location Name: Propst 2  
Location ID: 312292

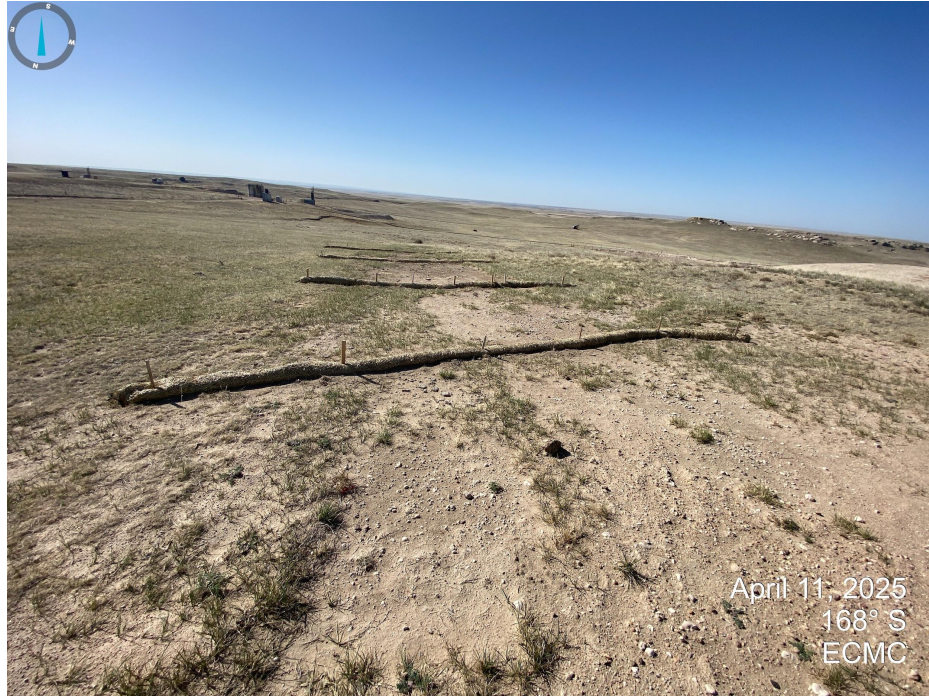
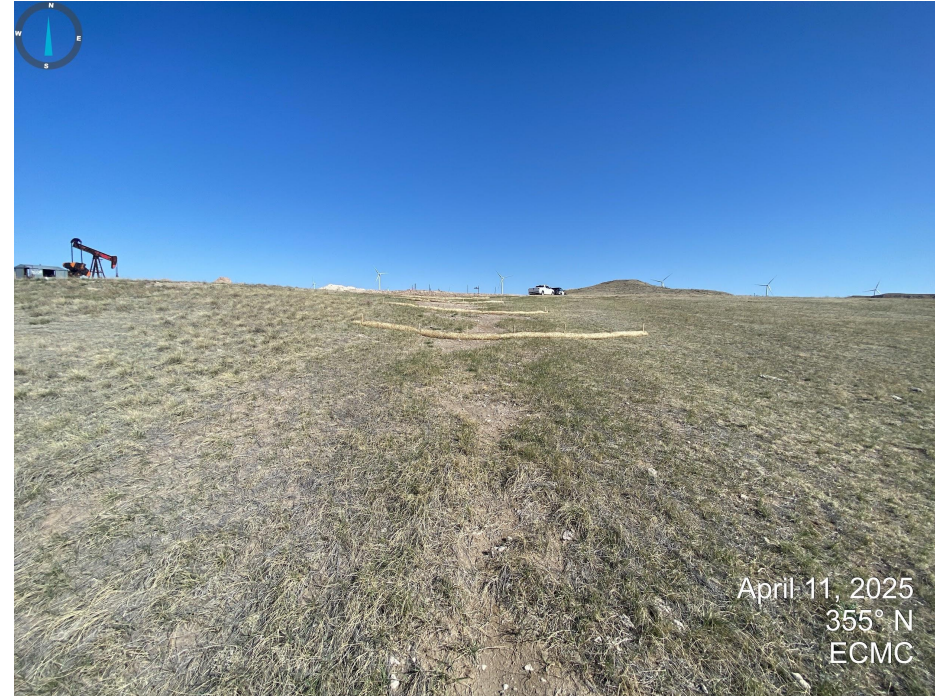
**Photos 1 & 2.** South of former heater treater. Additional reclamation activities are required to stabilize areas experiencing bare soil and/or non-uniform vegetation cover

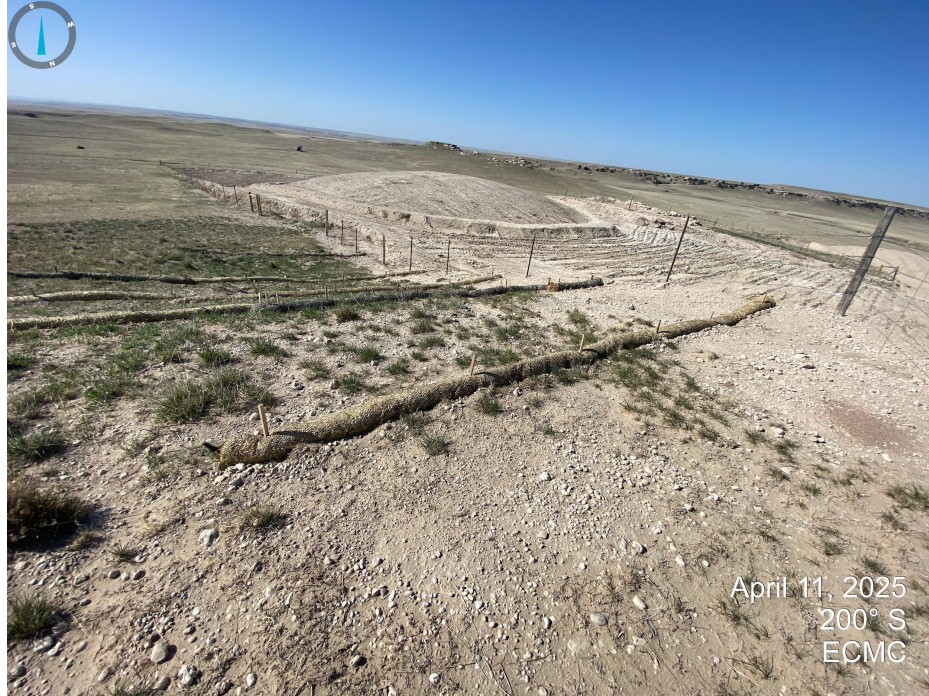
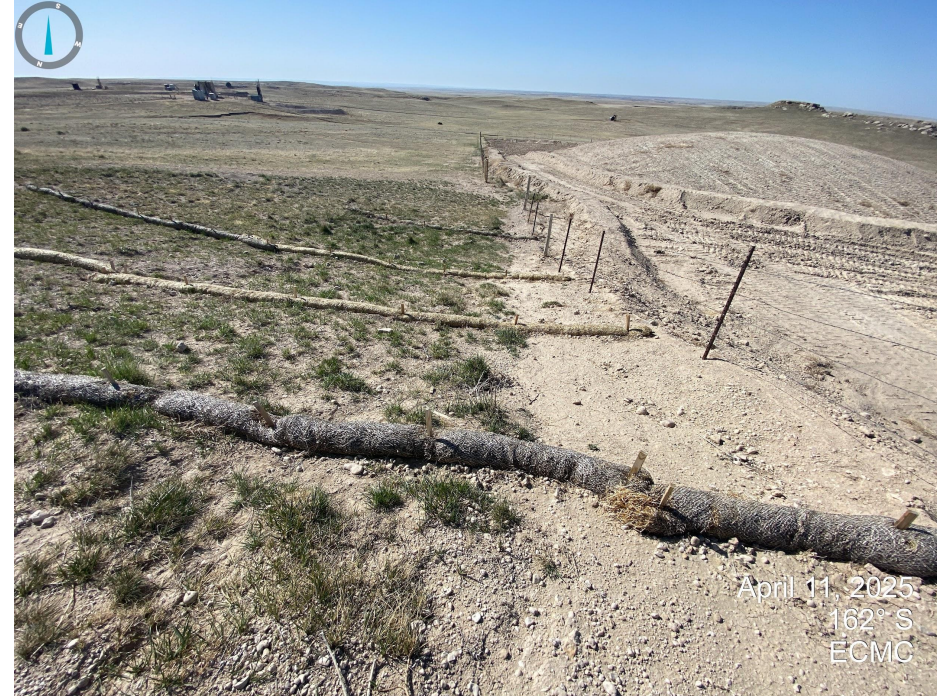
**Photos 3 & 4.** Eastern side of pit. Additional reclamation activities are required to stabilize areas experiencing bare soil and/or non-uniform vegetation cover.

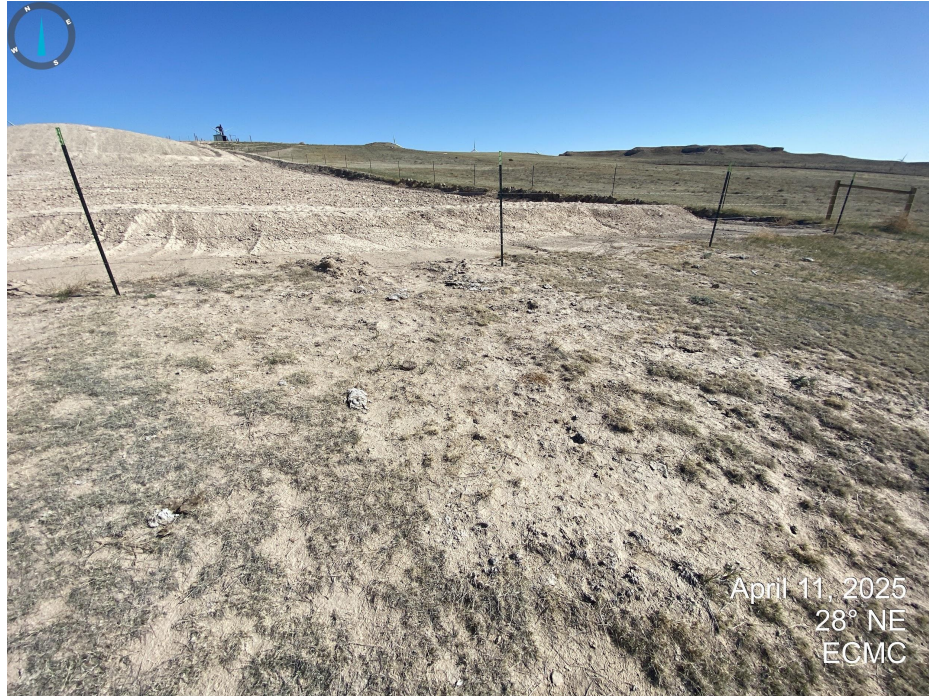
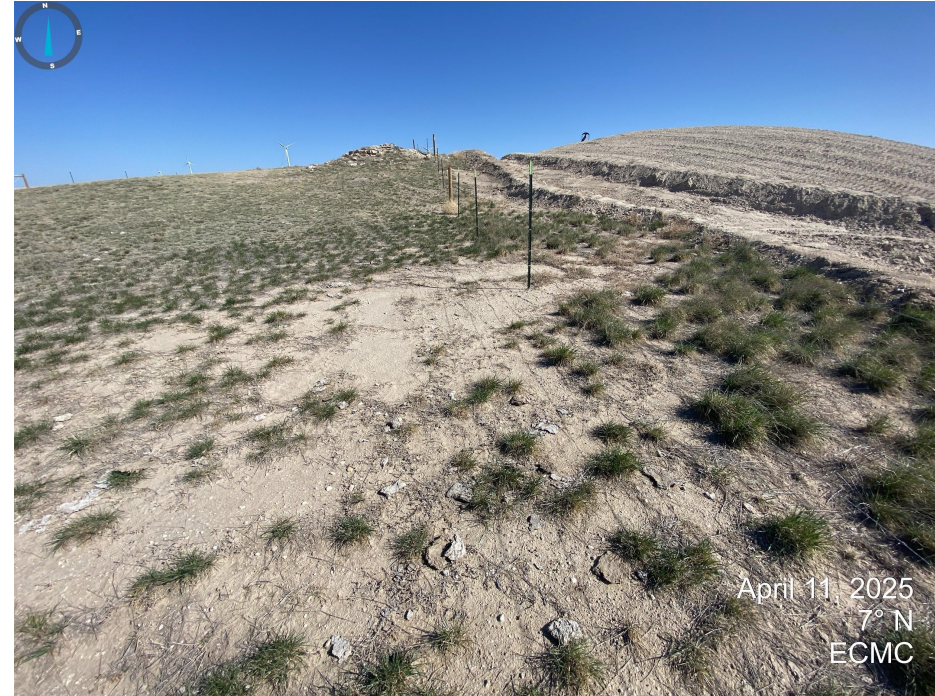
**Photos 5 & 6.** Southern extent of the eastern salt kill excavation (Photo 5; left) and western side of eastern salt kill area excavation (Photo 6; right). Additional reclamation activities are required to stabilize areas experiencing bare soil and/or non-uniform vegetation cover.

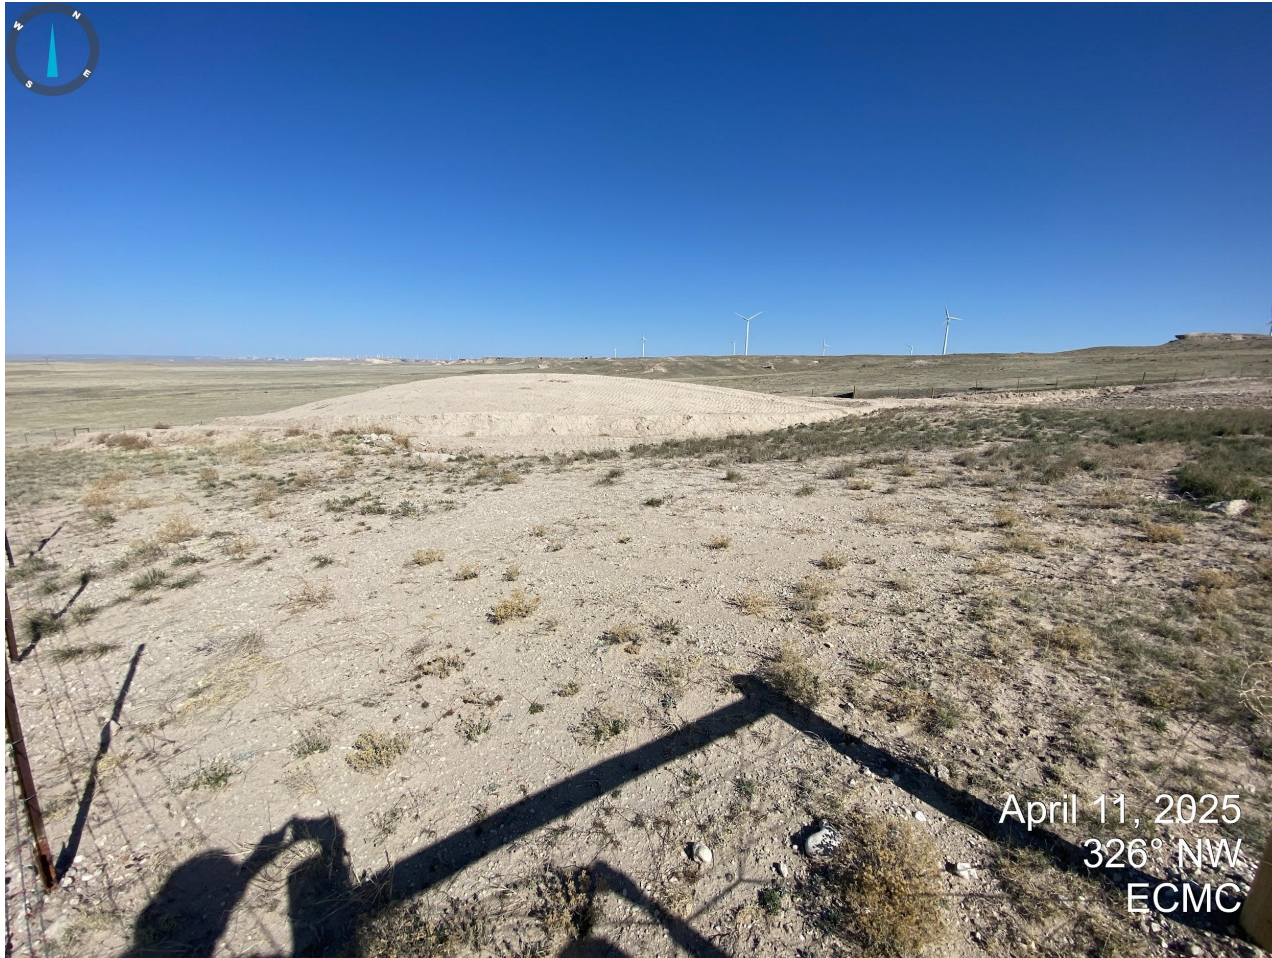
**Photo 7.** Southern extent of the western salt kill excavation. Additional reclamation activities are required to stabilize areas experiencing bare soil and/or non-uniform vegetation cover.

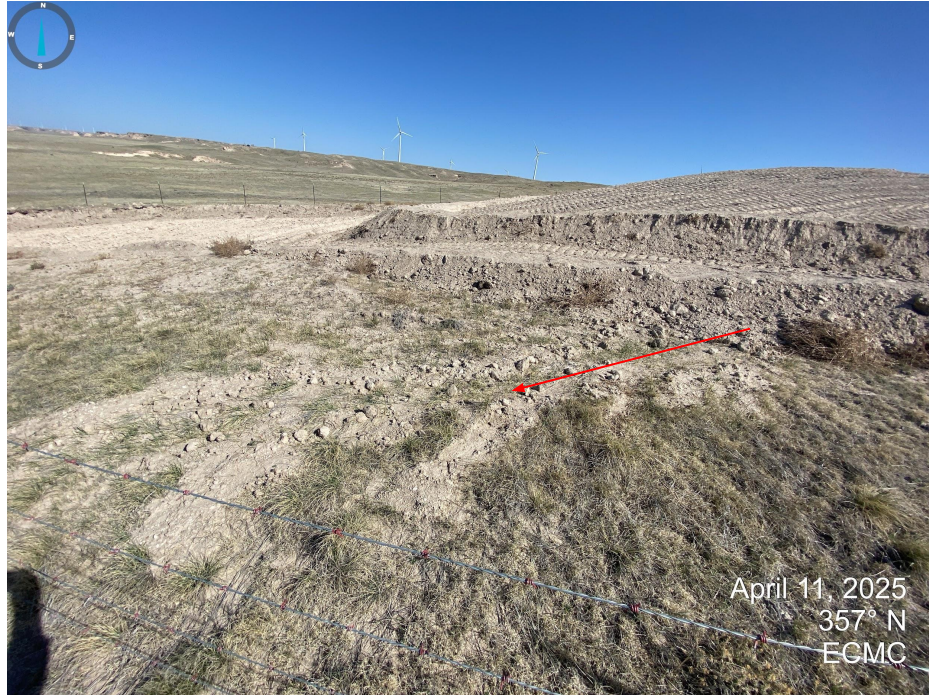
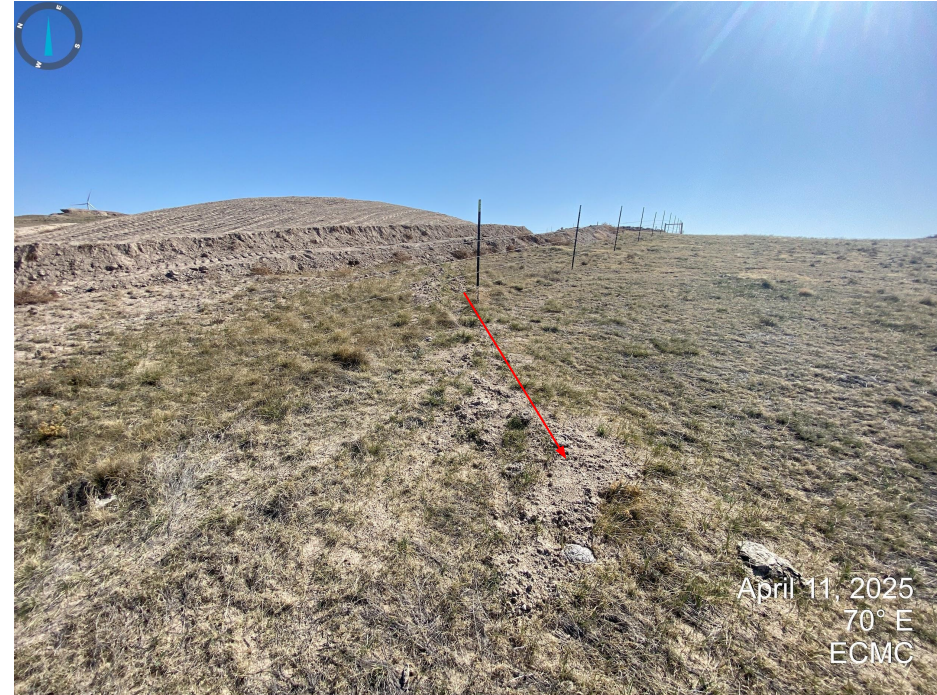
**Photos 8 & 9.** Southern portion of the western excavation/stockpile. Evidence of sediment discharge into the adjacent lands. Stormwater control measures do not appear to be adequate around the perimeter of the excavation.

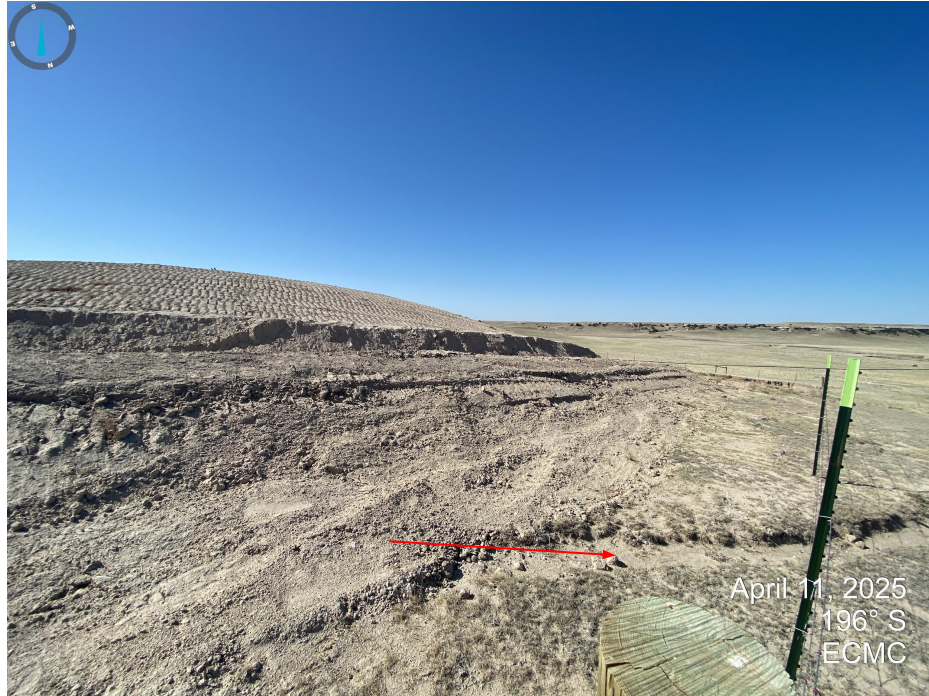
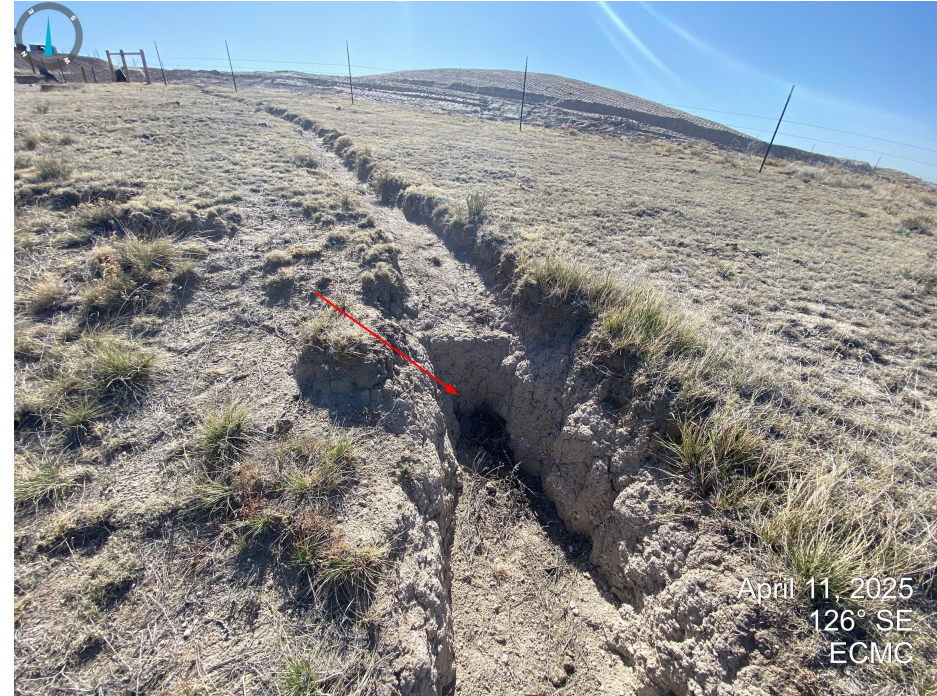
**Photos 10 & 11.** Taken from the northwestern portion of the salt kill excavation. It appears that stormwater runoff from the excavated salt kill area is being channeled through a livestock trail and causing erosion degradation (Photo 11; right). Stormwater control measures do not appear to be adequate around the perimeter of the excavation.

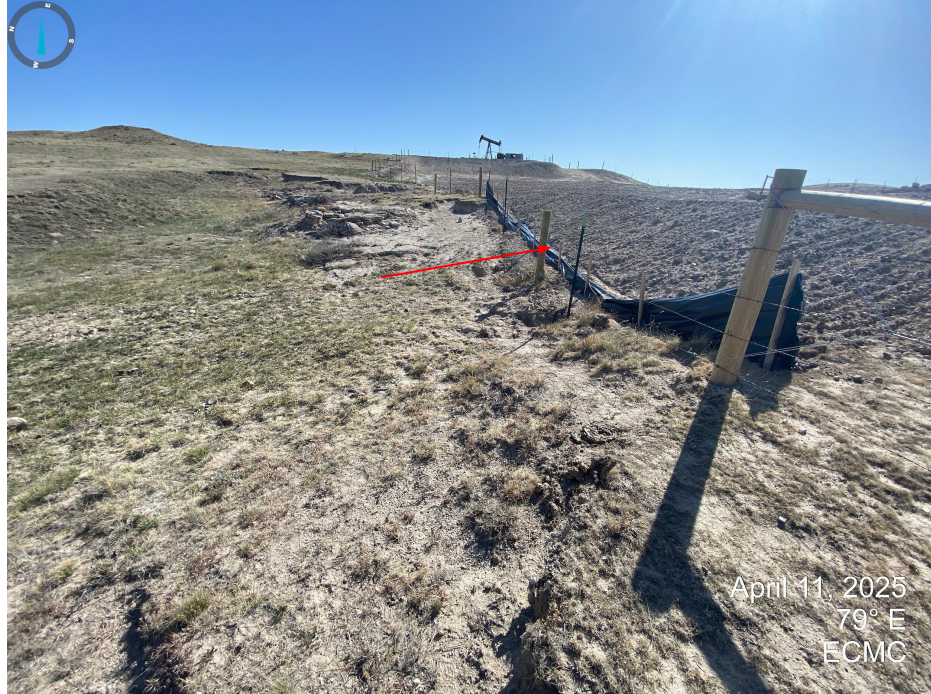
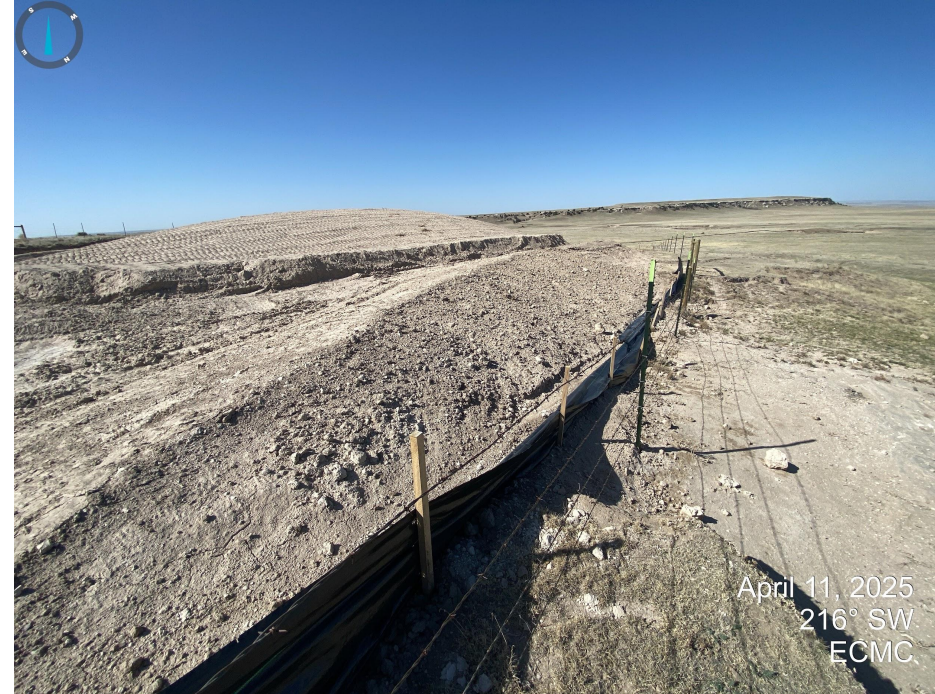
**Photos 12 & 13.** Taken near the northern portion of the salk kill excavation. Silt fence does not appear to be properly maintained.

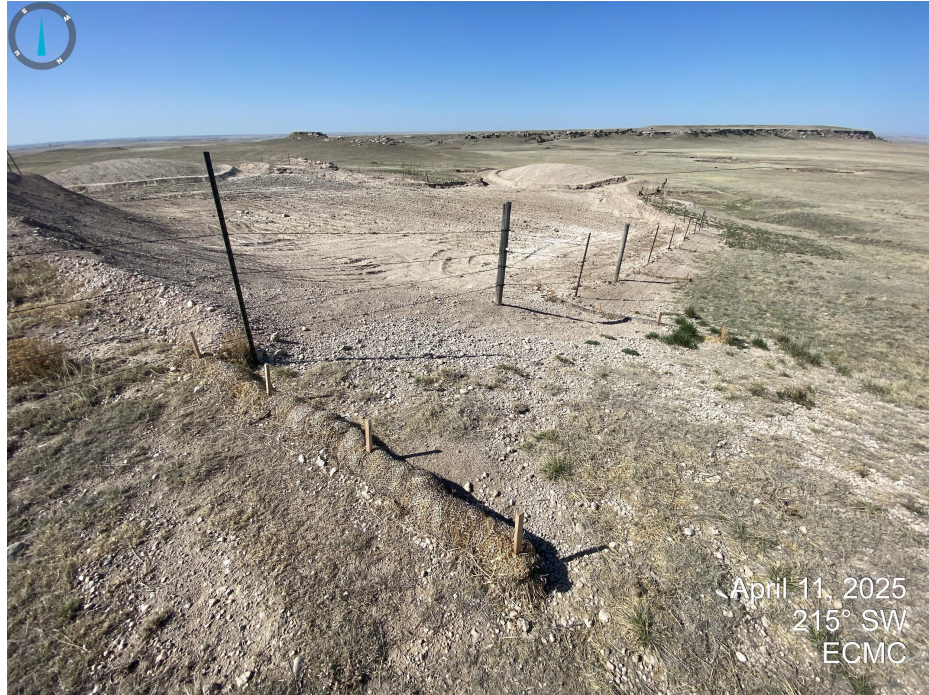
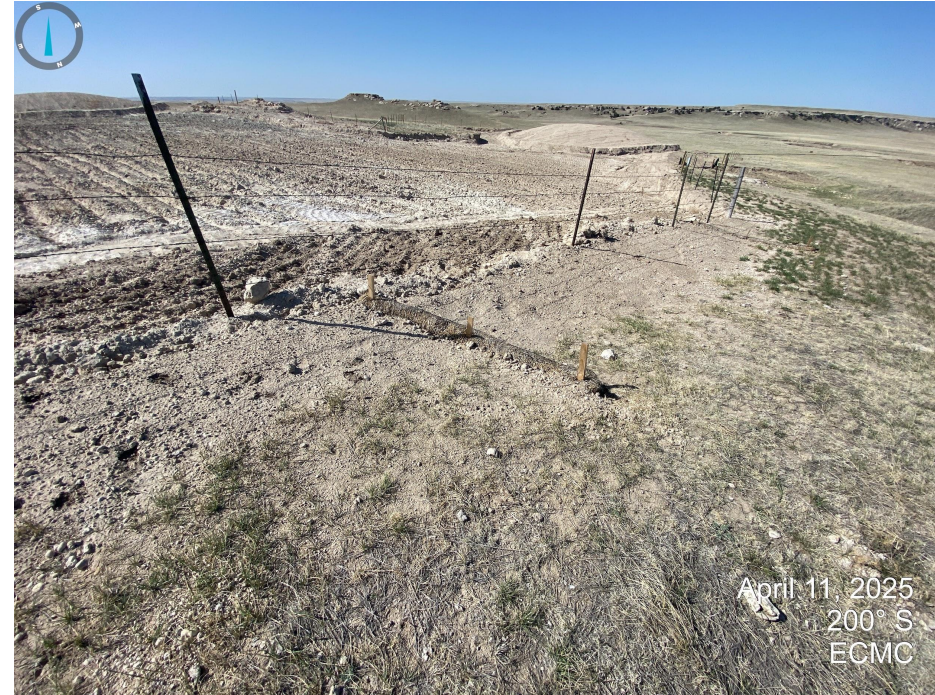
**Photos 14 & 15.** Northeastern corner of pit. Additional reclamation activities are required to stabilize areas experiencing bare soil and/or non-uniform vegetation cover.

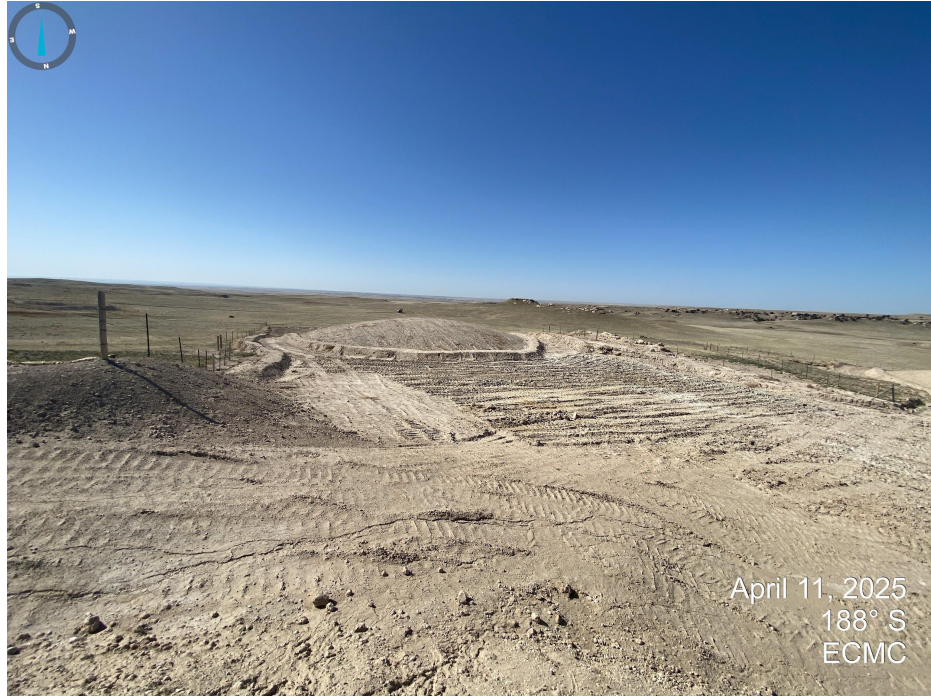
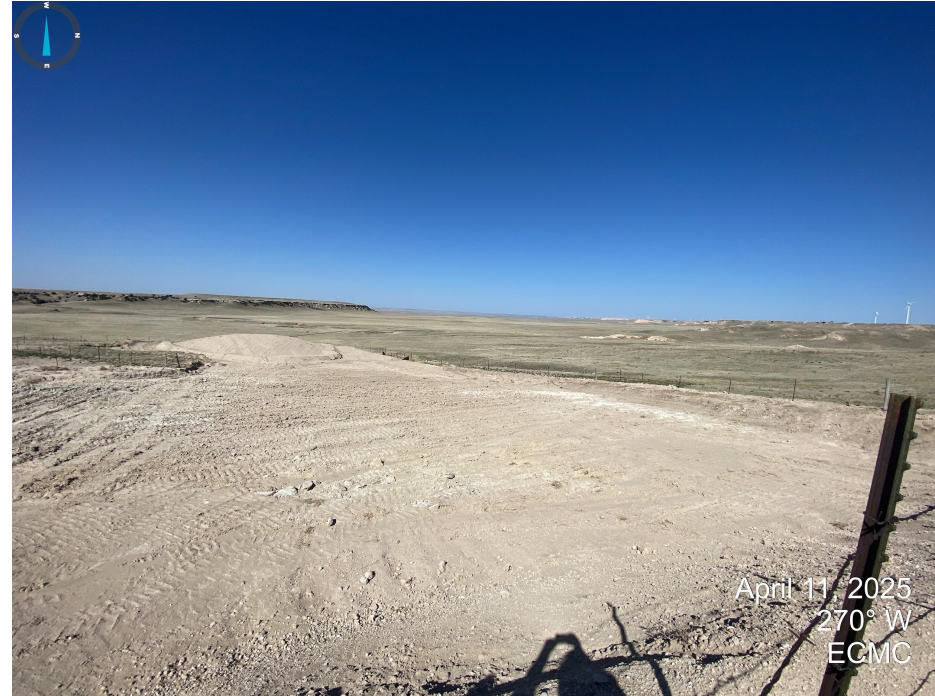
Photos 16 & 17. Overview of pit/salt kill excavation.
