Interim Reclamation and Stormwater Inspection

Date: 04/11/2025

Operator: WESTERN OPERATING COMPANY - 95620

Location ID: 312291

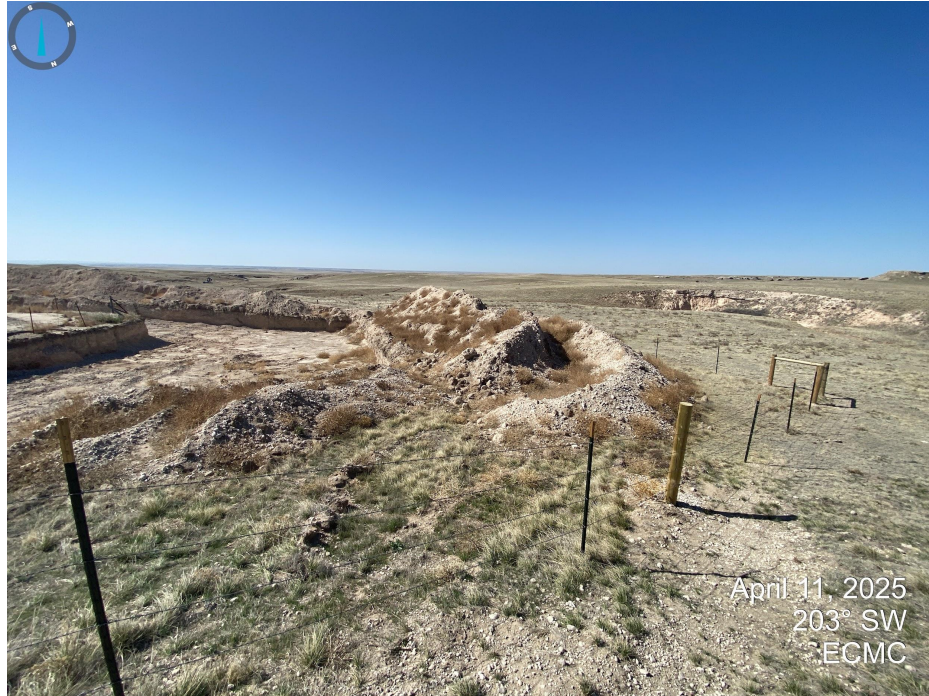
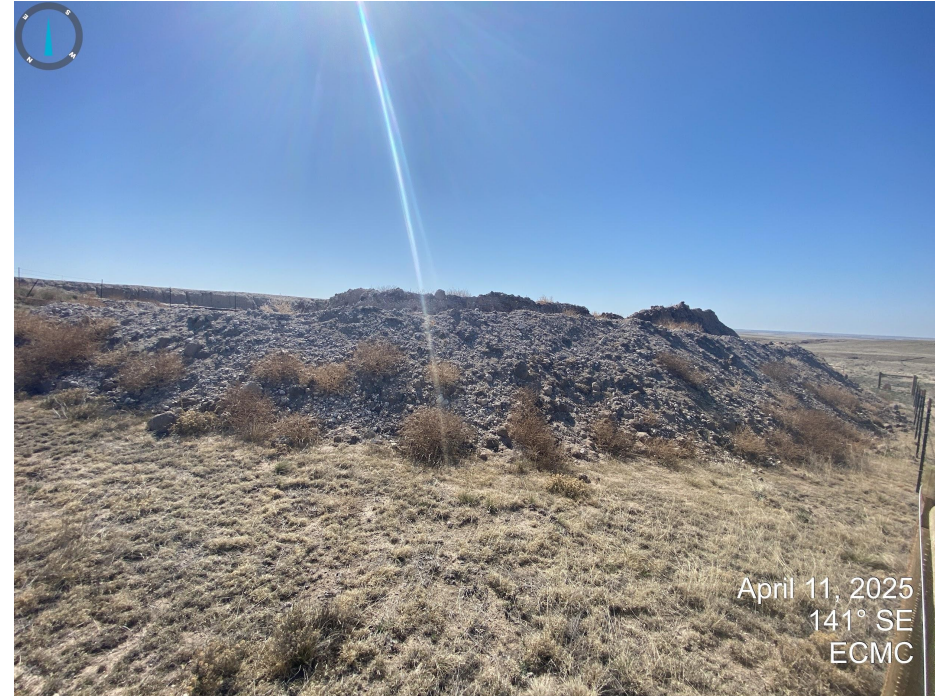
Photos 1 & 2. Taken from the north side of the stockpiled soils. No perimeter stormwater control measures/ BMPs, or impermeable liners underneath the stockpile were observed. Impacted soils appear to have been placed directly on top of undisturbed lands. Additionally, it does not appear that topsoil has been salvaged Per Rule 1002.b prior to stockpiling the soil on undisturbed portions of land. Undesirable vegetation observed throughout stockpiled areas.

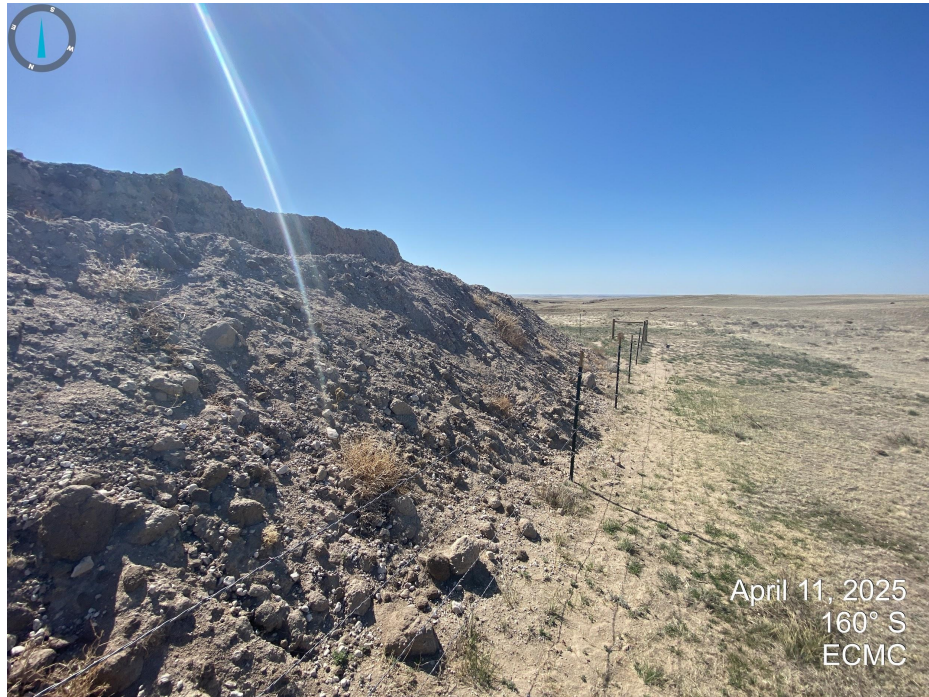
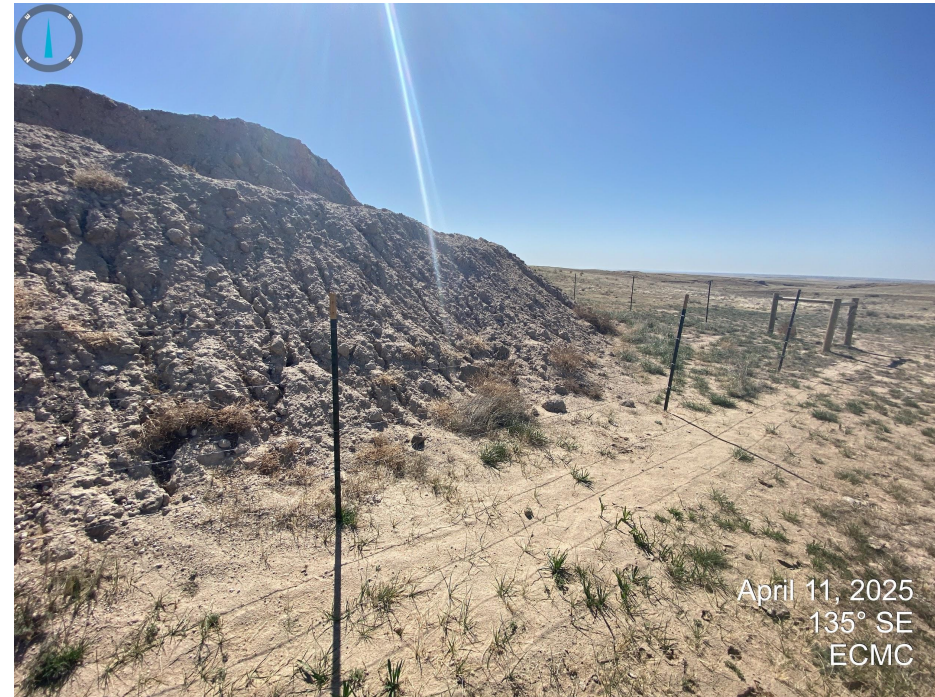
Photos 3 & 4. Taken from the western portion of the excavation area. Evidence of unstabilized soils (rill erosion) and sediment migration outside of the fenced portions. Undesirable vegetation (russian thistle) also observed.

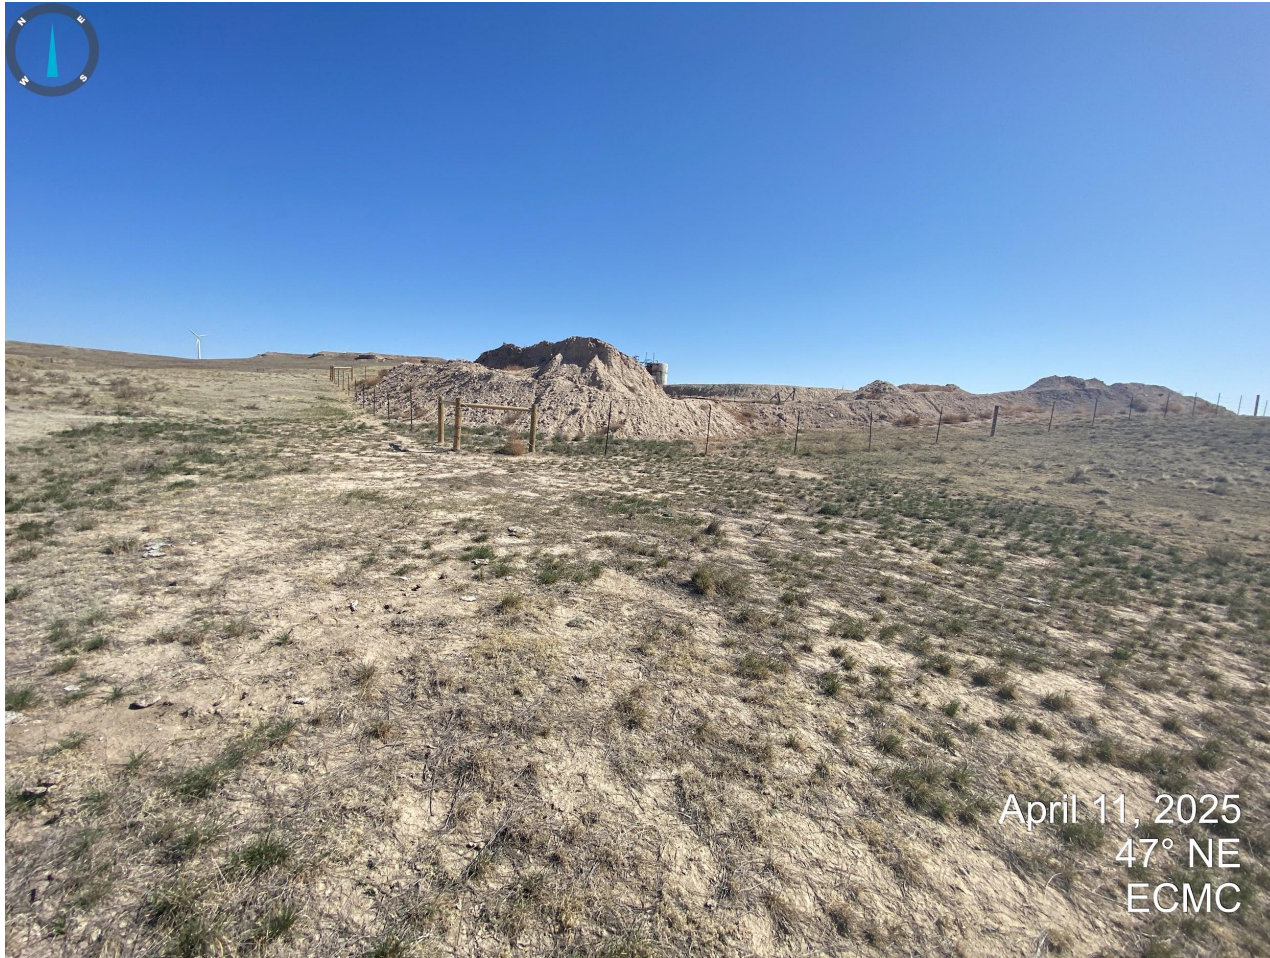
Photo 5. Sediment deposition resulting from unstabilized stockpiles, southwest corner of the pit.

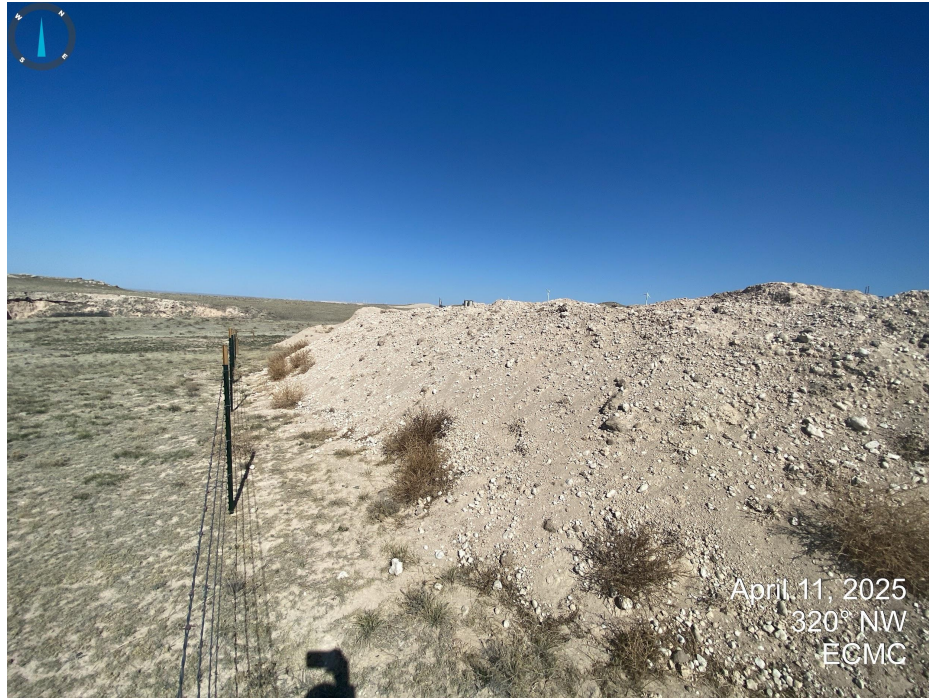
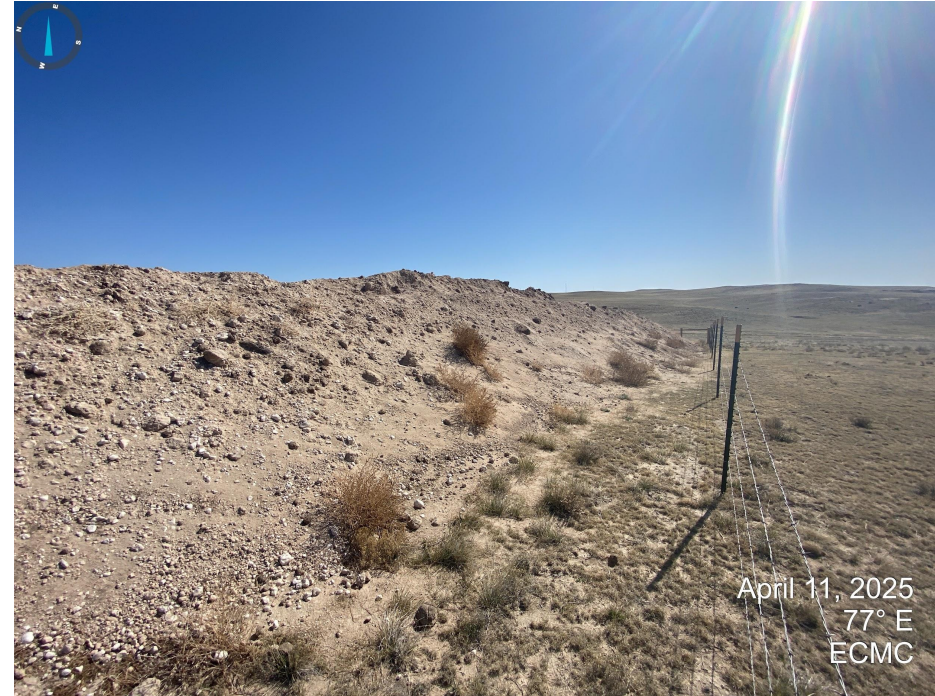
Photos 6 & 7. Taken from the southern portion of the stockpile soils. Photo illustrates evidence of unstabilized soil (unconsolidated) and tumbleweed debris.

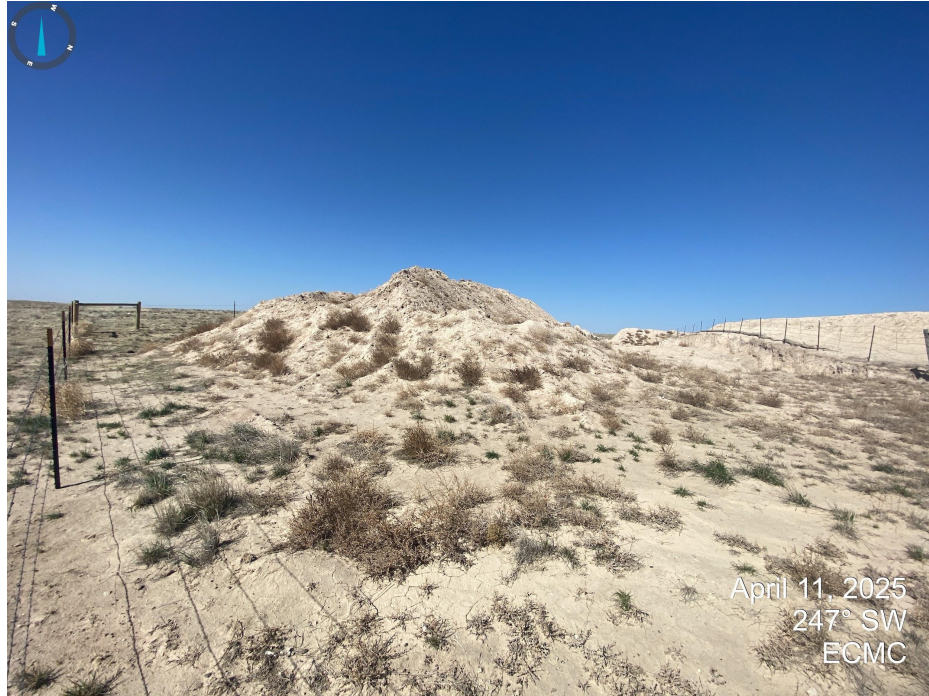
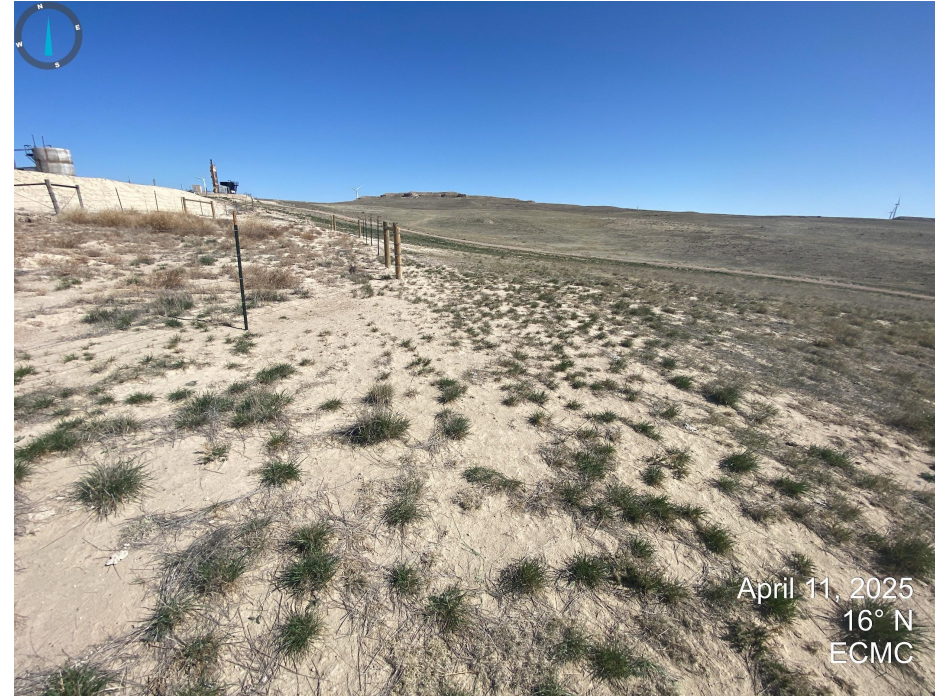
Photos 8 & 9. Taken from the southeastern corner of the location. No apparent perimeter stormwater control measures and sediment deposition observed. Tumbleweed debris also pictured.

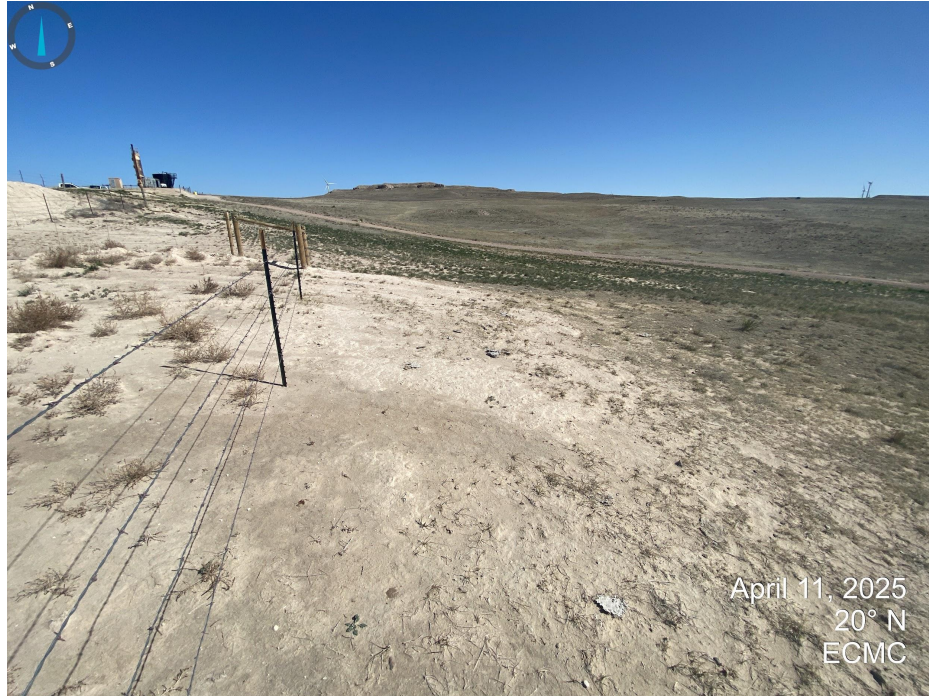
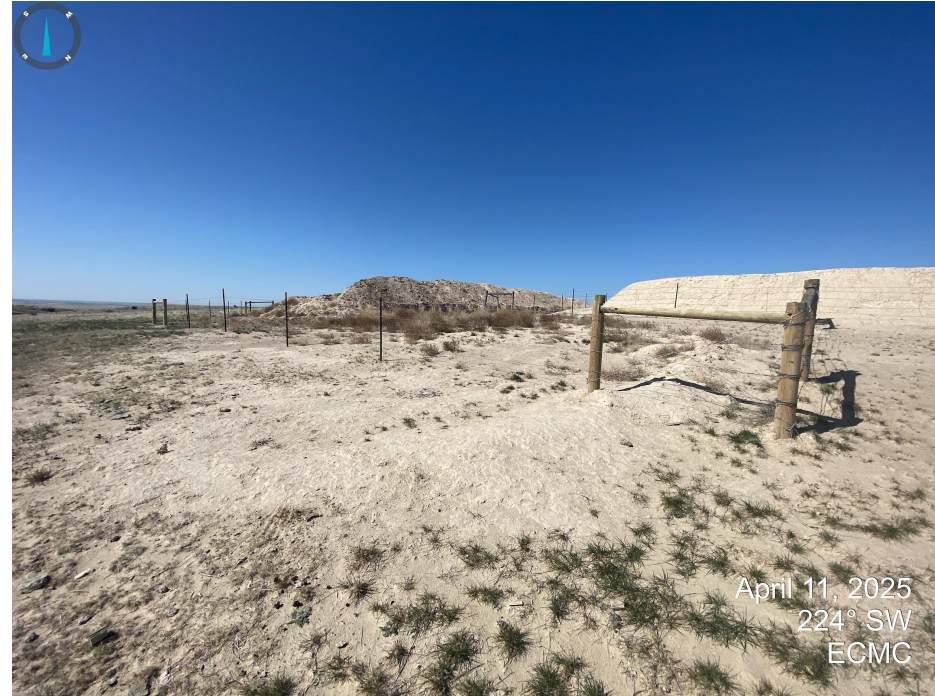
Photos 10 & 11. Sediment deposition resulting from unstabilized soils, southeast corner of the pit. No apparent stormwater controls measures/BMPs observed.

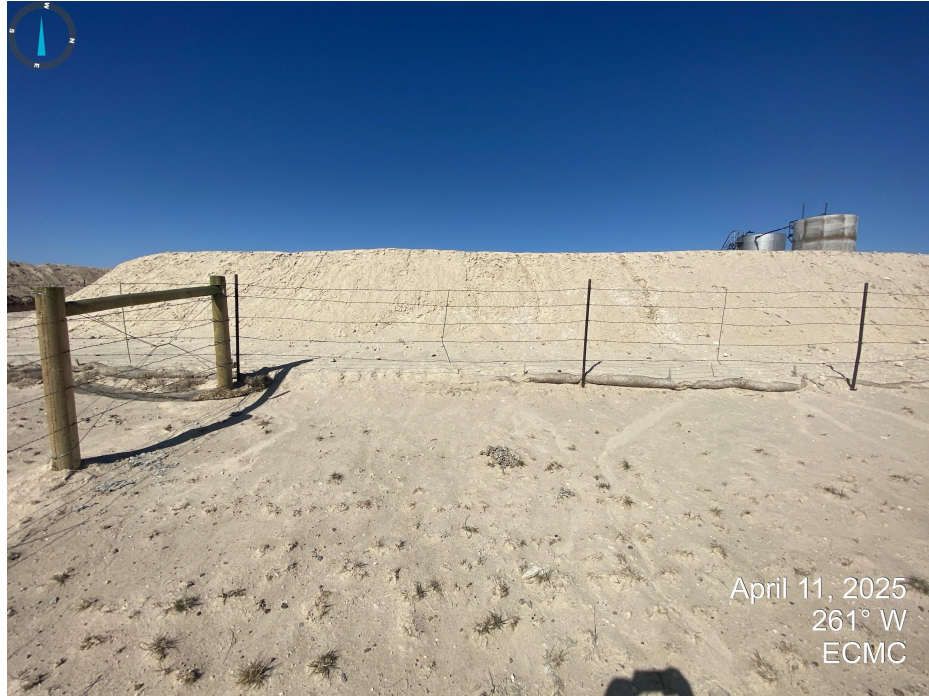
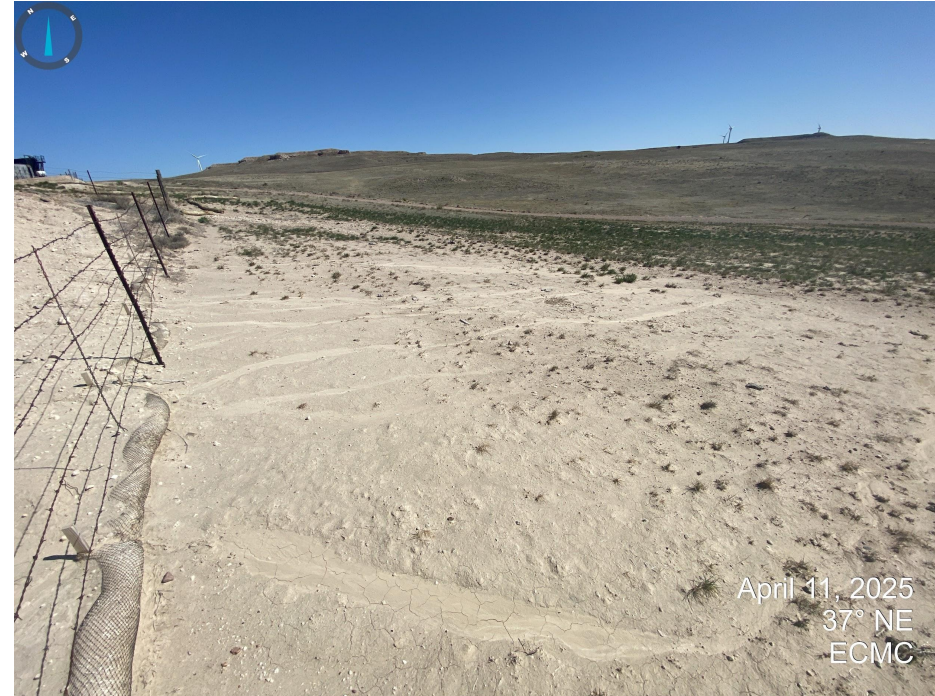
Photos 12 & 13. Taken from the eastern portion of the pit. Erosion degradation resulting from unstabilized soils and improperly functioning and/or lack of stormwater controls.

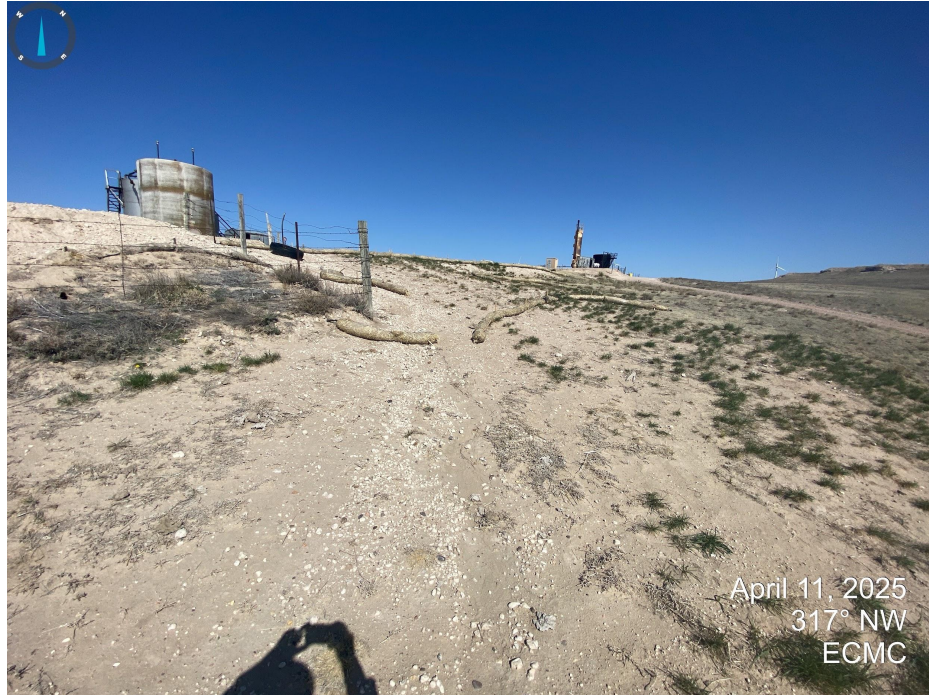
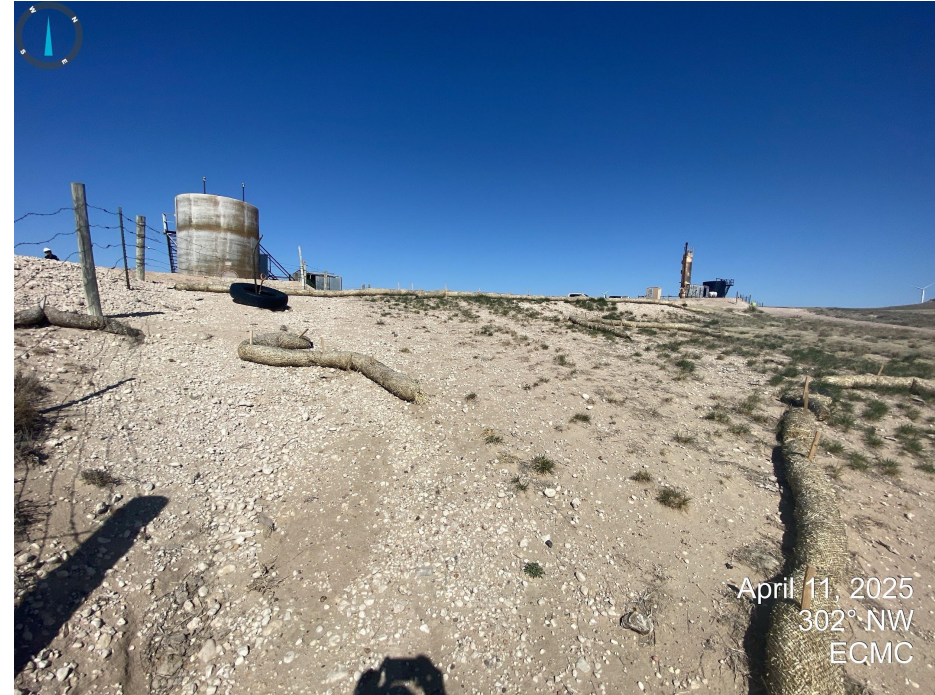
Photos 14 & 15. Erosion degradation occurring on the northern/eastern portion of the production areas, near the pit. Stormwater control measures appear to be degraded/damaged and not properly functioning with erosion degradation evidence.

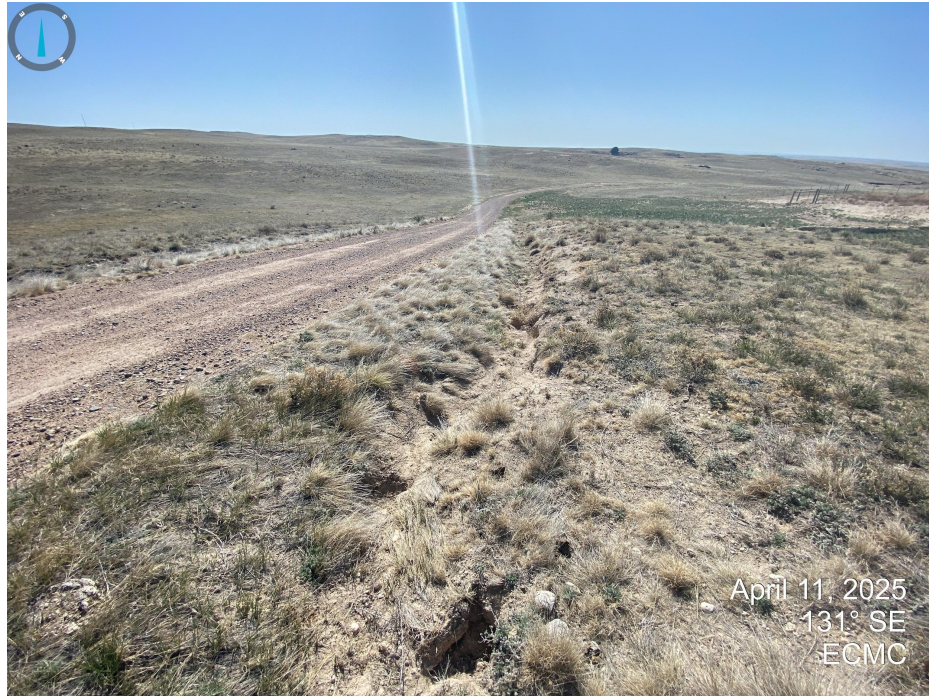
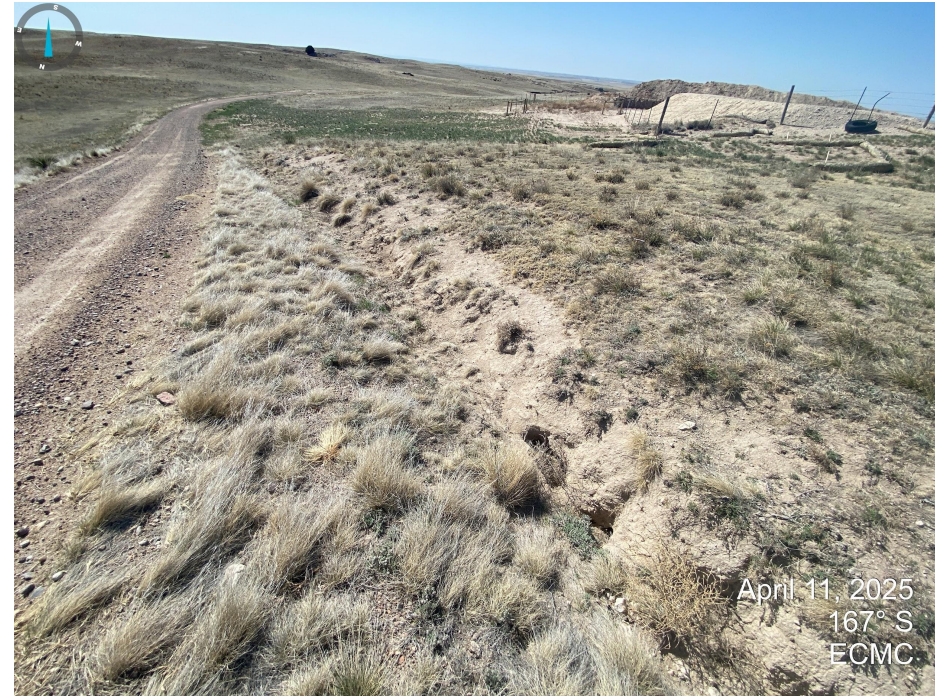
Photos 16 & 17. Taken north of pit along the access road. Evidence of erosion degradation, previously documented, does not appear to have been repaired/stabilized with no evidence of control measures/BMPs observed that would prevent further erosion of the production areas and access roads.
