Interim Reclamation and Stormwater Inspection

Date: 04/11/2025

Operator: WESTERN OPERATING COMPANY - 95620

Inspection Photos
Location Name: Propst C-1X
Location ID: 312228

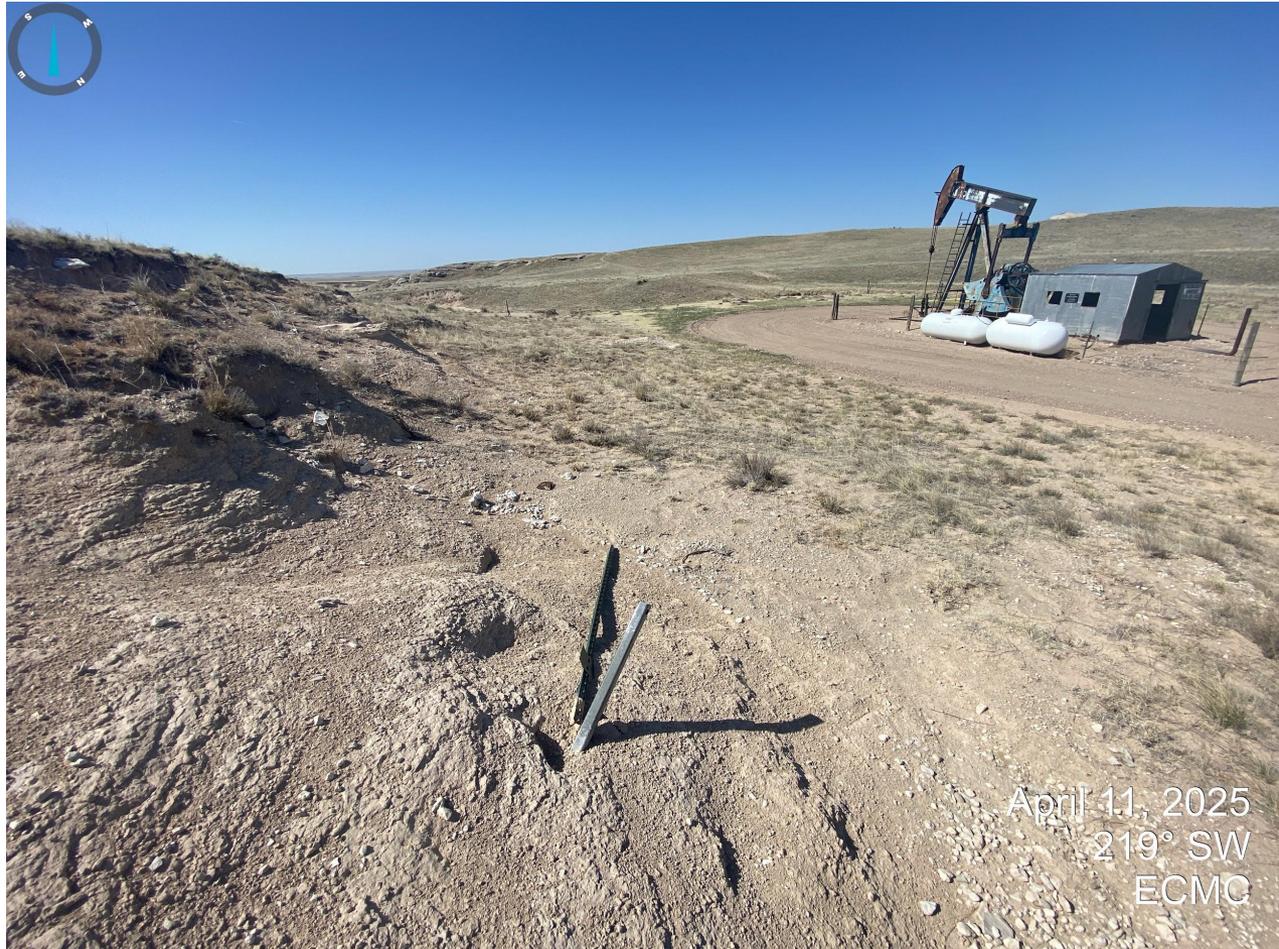
Photo 1. Northeastern guyline anchor maker needs to be reinstalled.

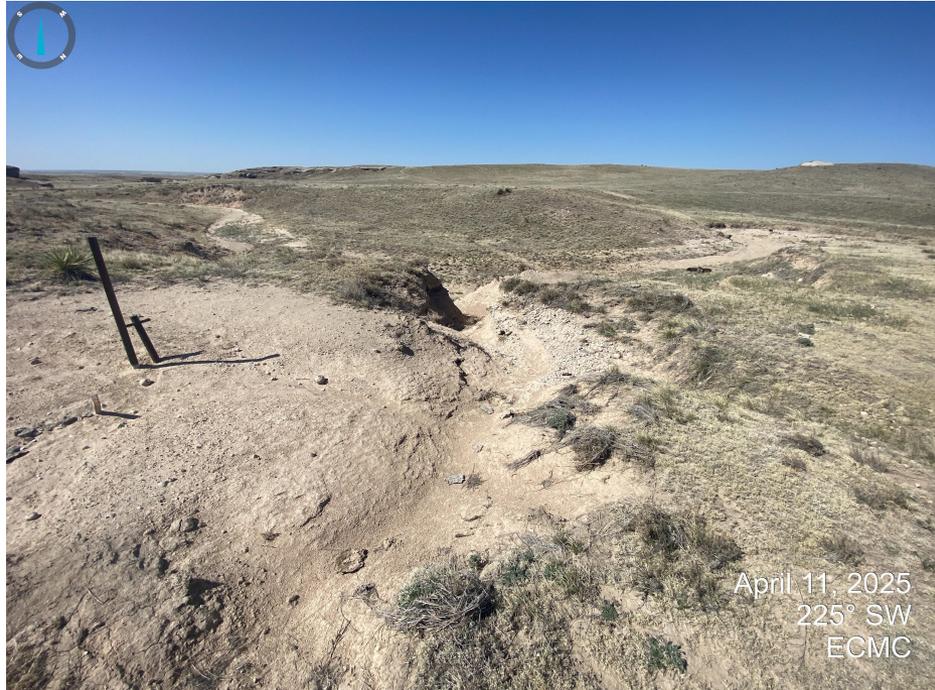
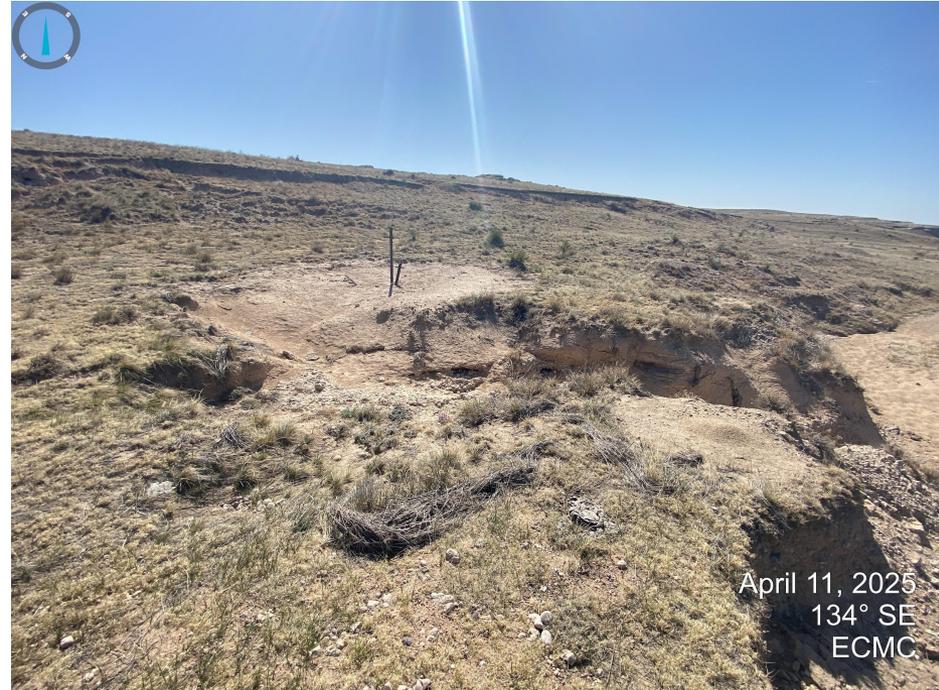
Photos 2 & 3. Erosion degradation evident on the southeastern portion of the production areas. No apparent stormwater control measures/BMPs observed at the time of this inspection.

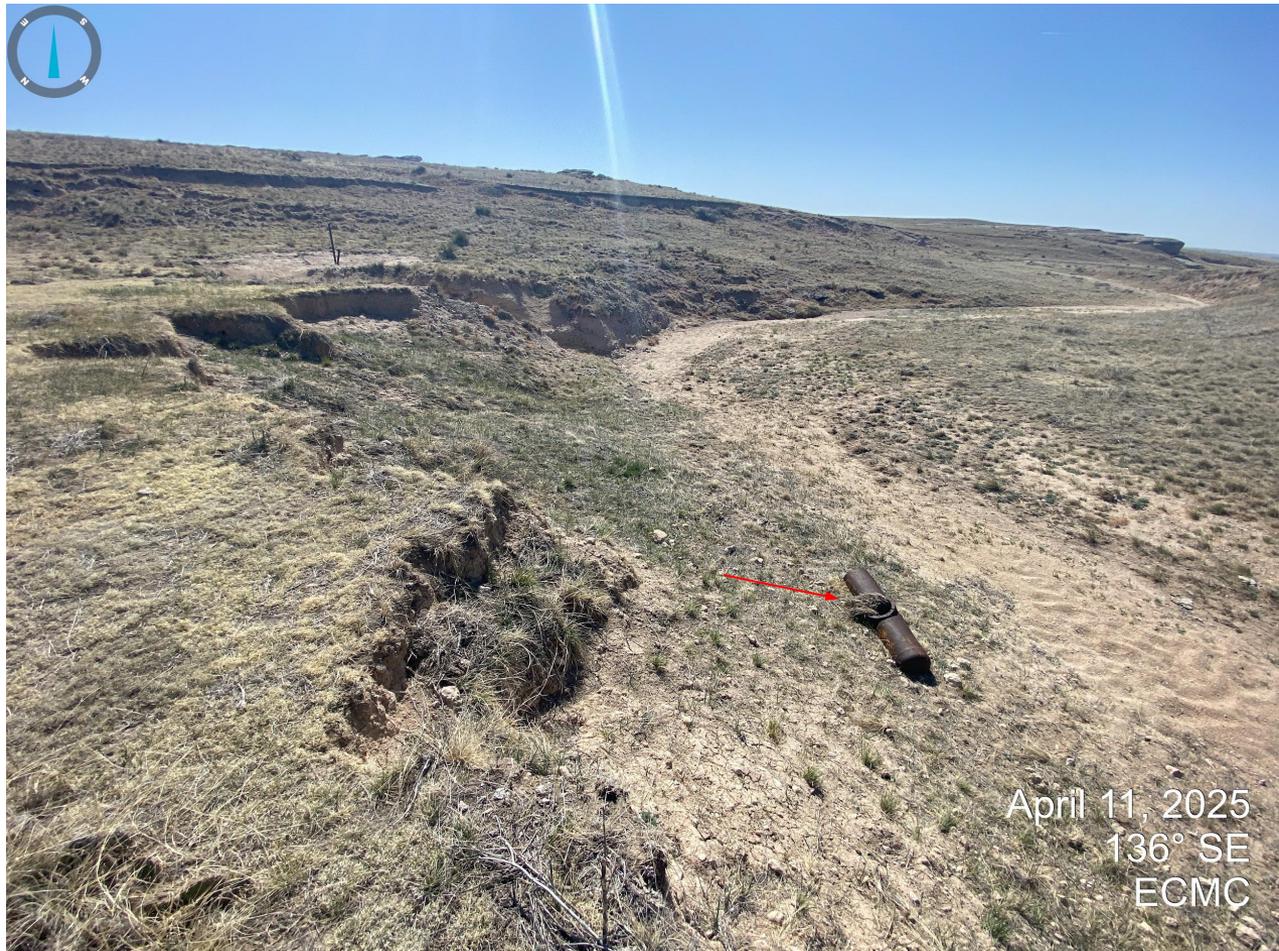
Photo 4. Pipe (debris) remains from the previous inspection; south of the well location in nearby drainage.

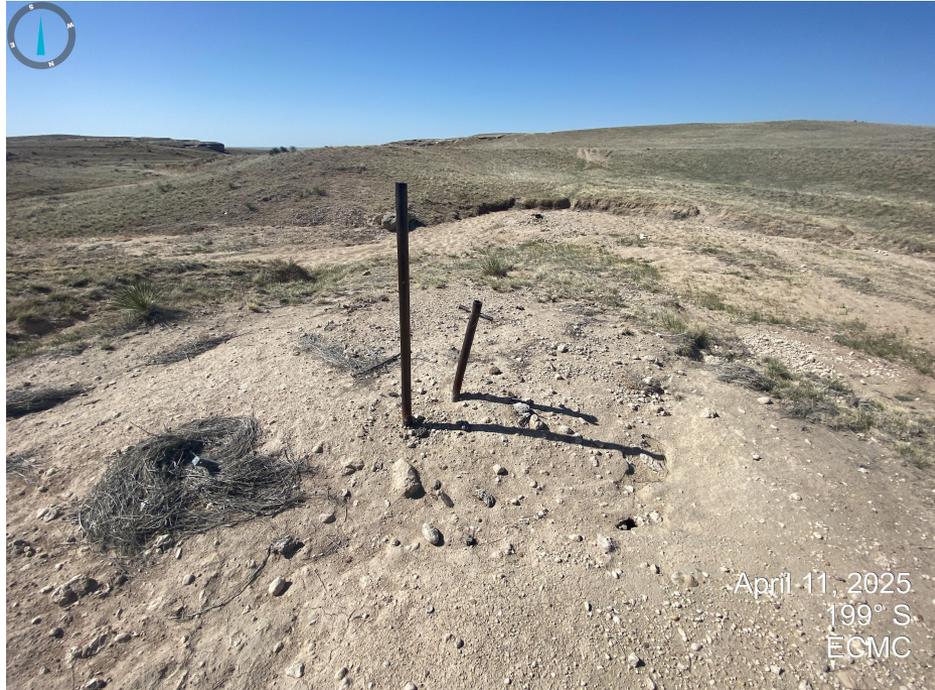
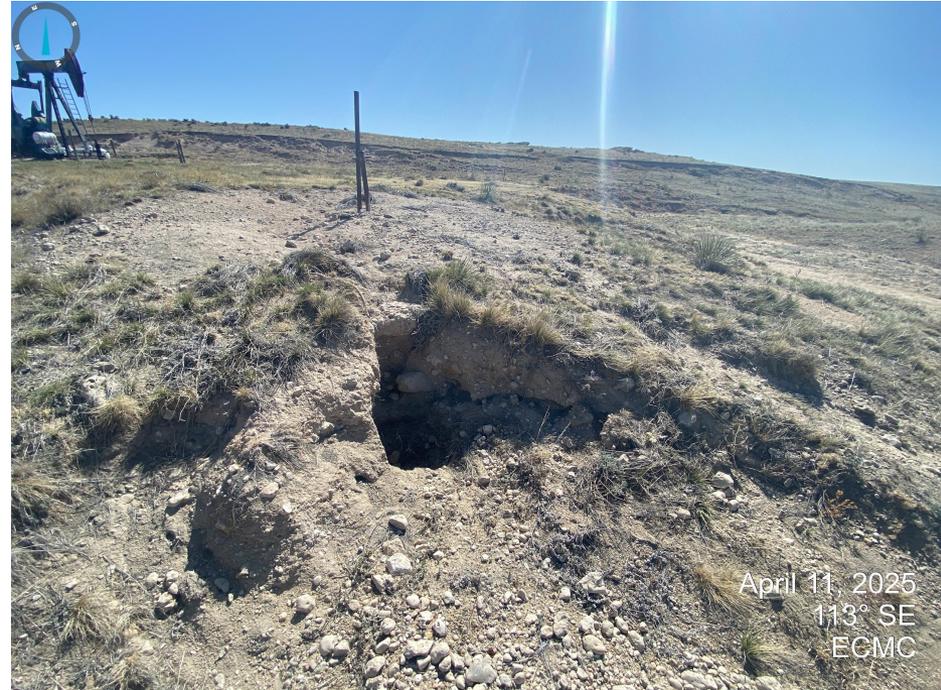
Photos 5 & 6. Erosion degradation evident on the southwestern portion of the production areas. No apparent stormwater control measures/BMPs observed at the time of this inspection.
