# Inspection Photos

API: 017-07453

Operator: **RESOURCE DEVELOPMENT TECHNOLOGY LLC**

Inspection Date: 4/9/2025

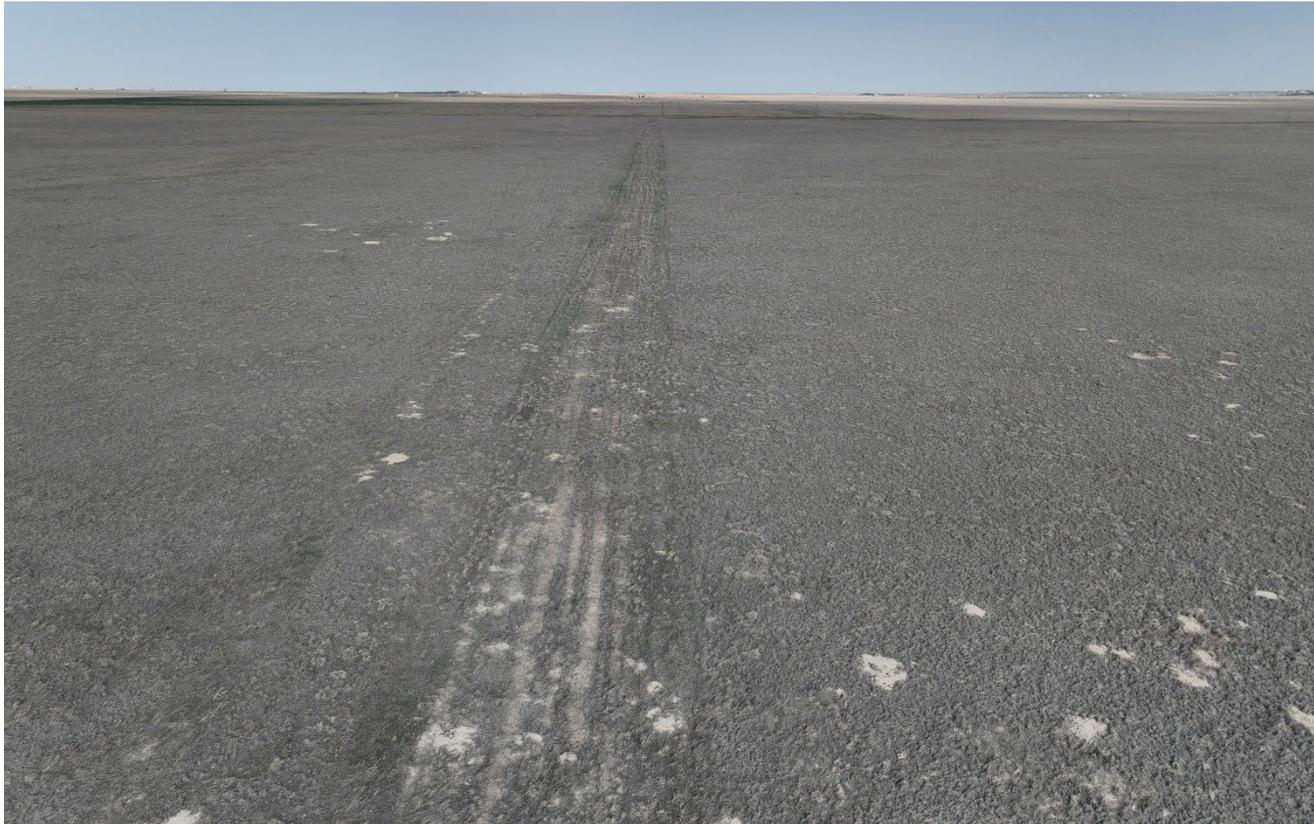
**Photo 1.** Drone aerial photo facing east toward the access road. Photo taken from above the wellsite location.

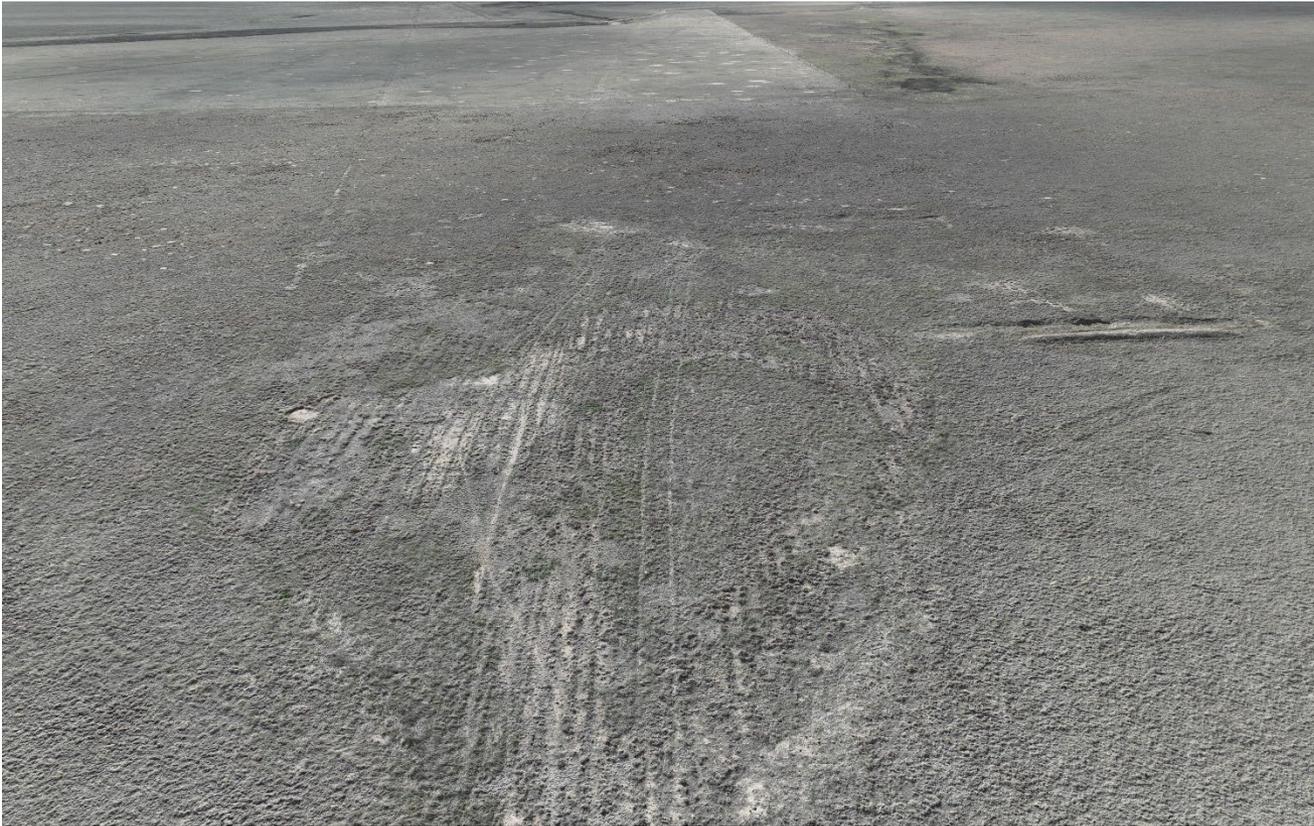
**Photo 2.** Drone aerial photo facing west overlooking the former wellsite location.

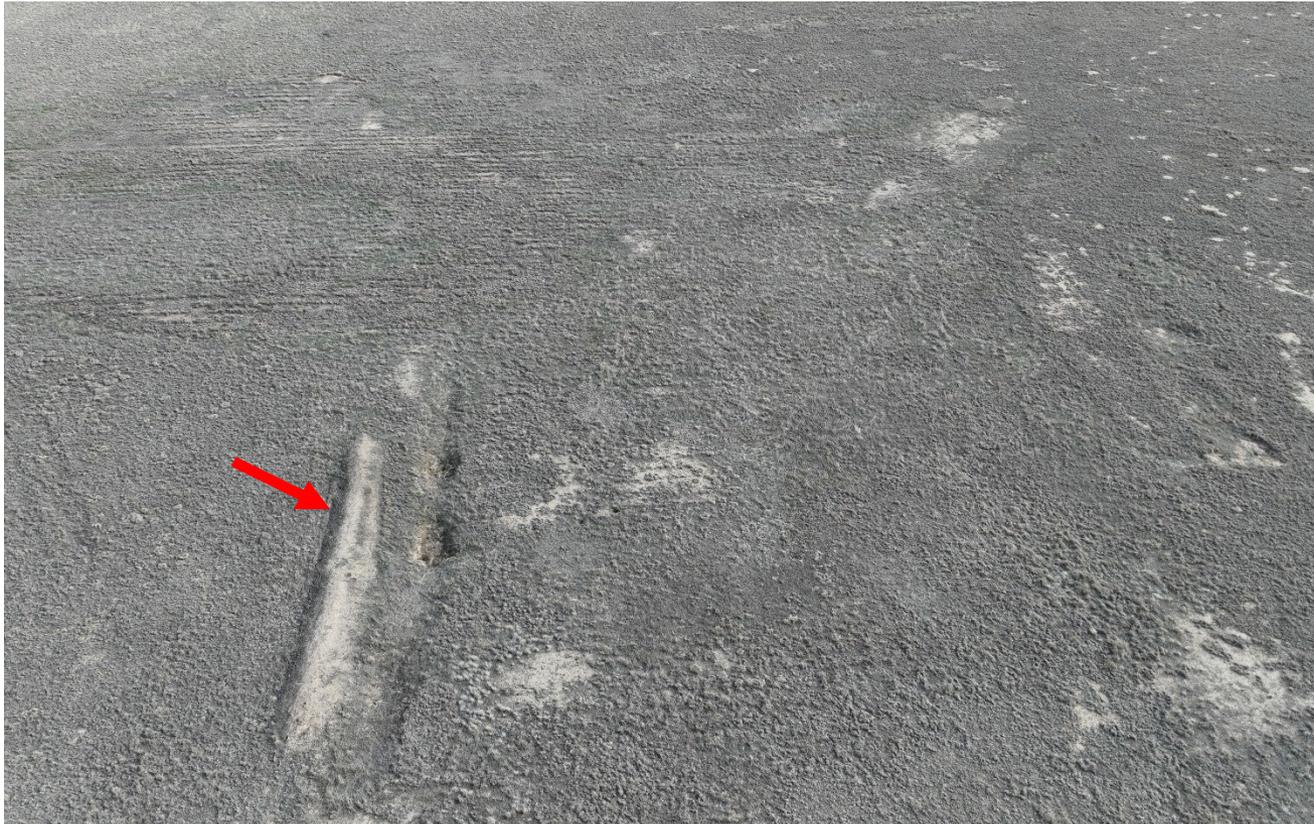
**Photo 3.** Drone aerial photo facing south toward the location. There is a berm and a depression of the former pit shown at red arrow.

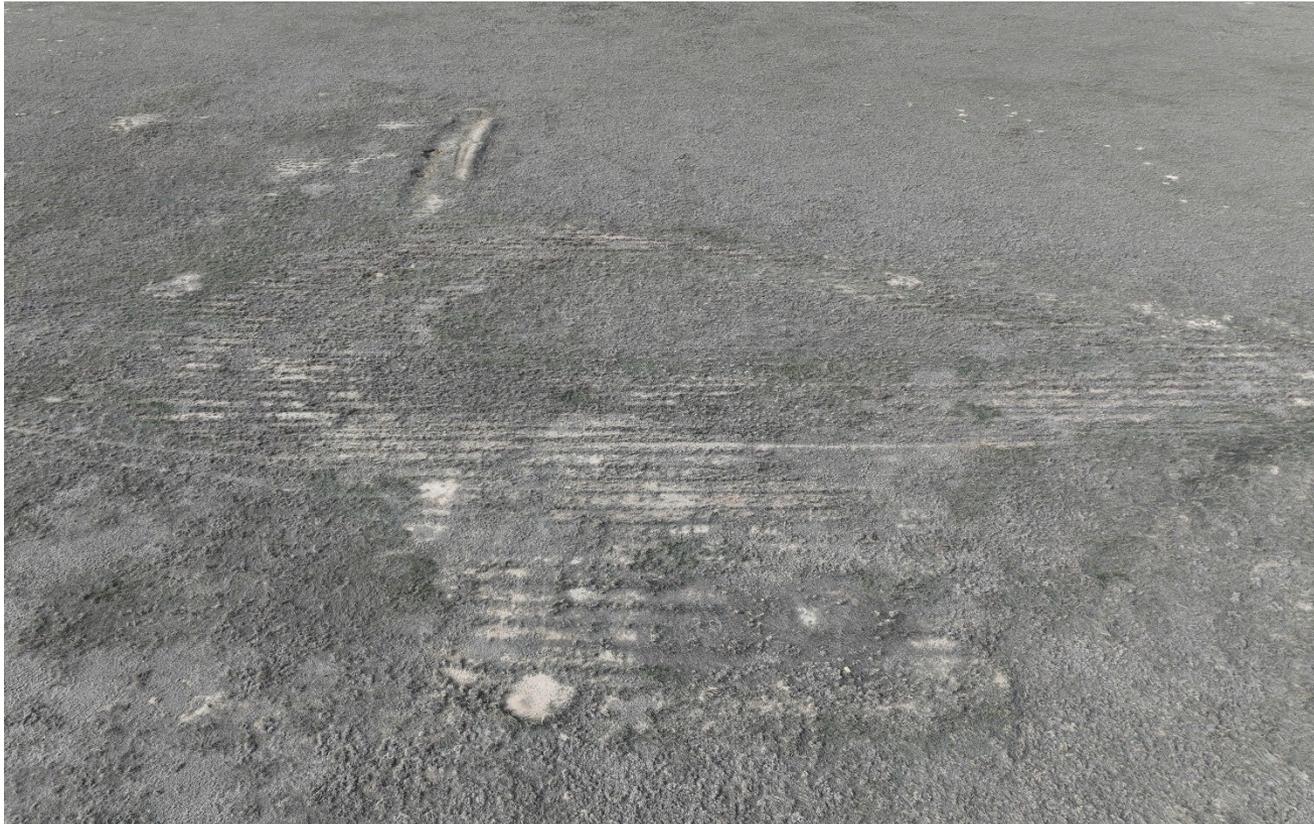
**Photo 4.** Drone aerial photo facing north toward the location. There appears to be rows of vegetation and bare soil due to decompaction ripping in one direction..

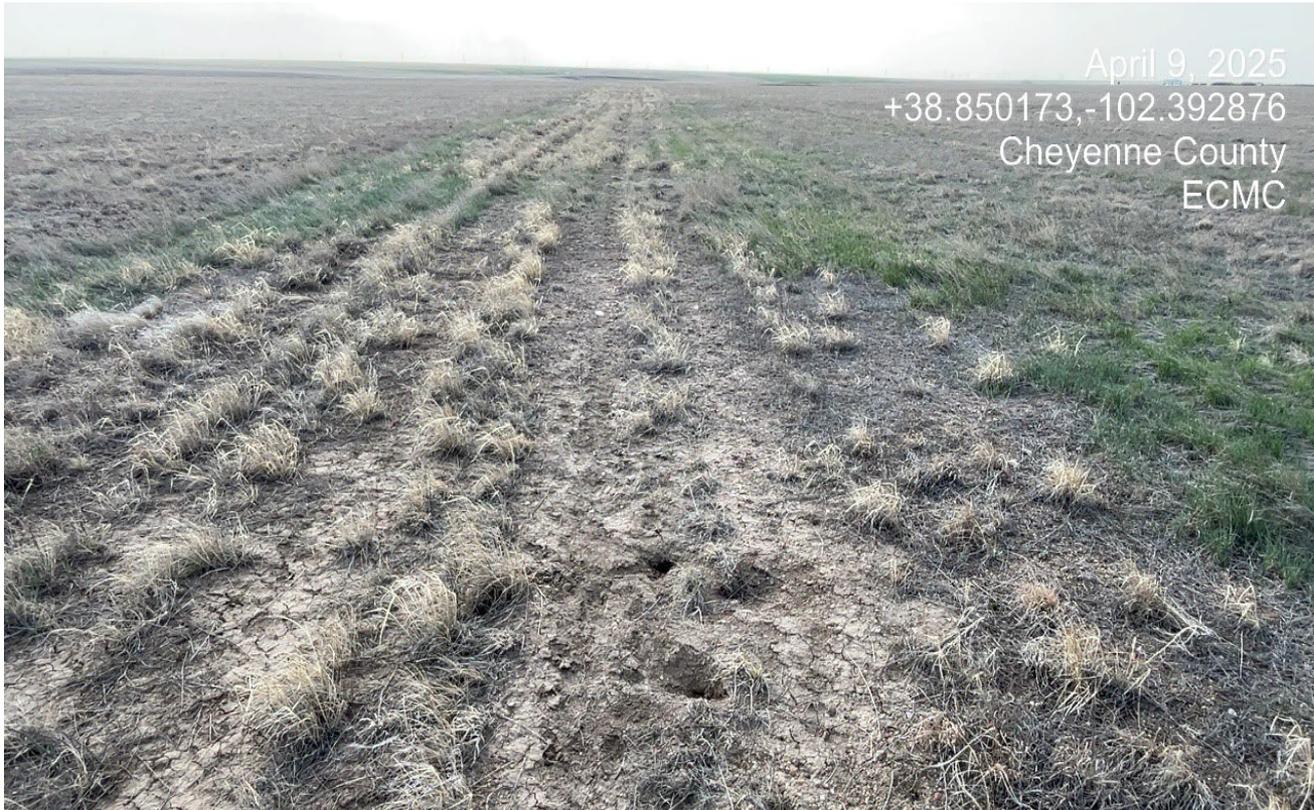
**Photo 5.** Facing west along the access road.

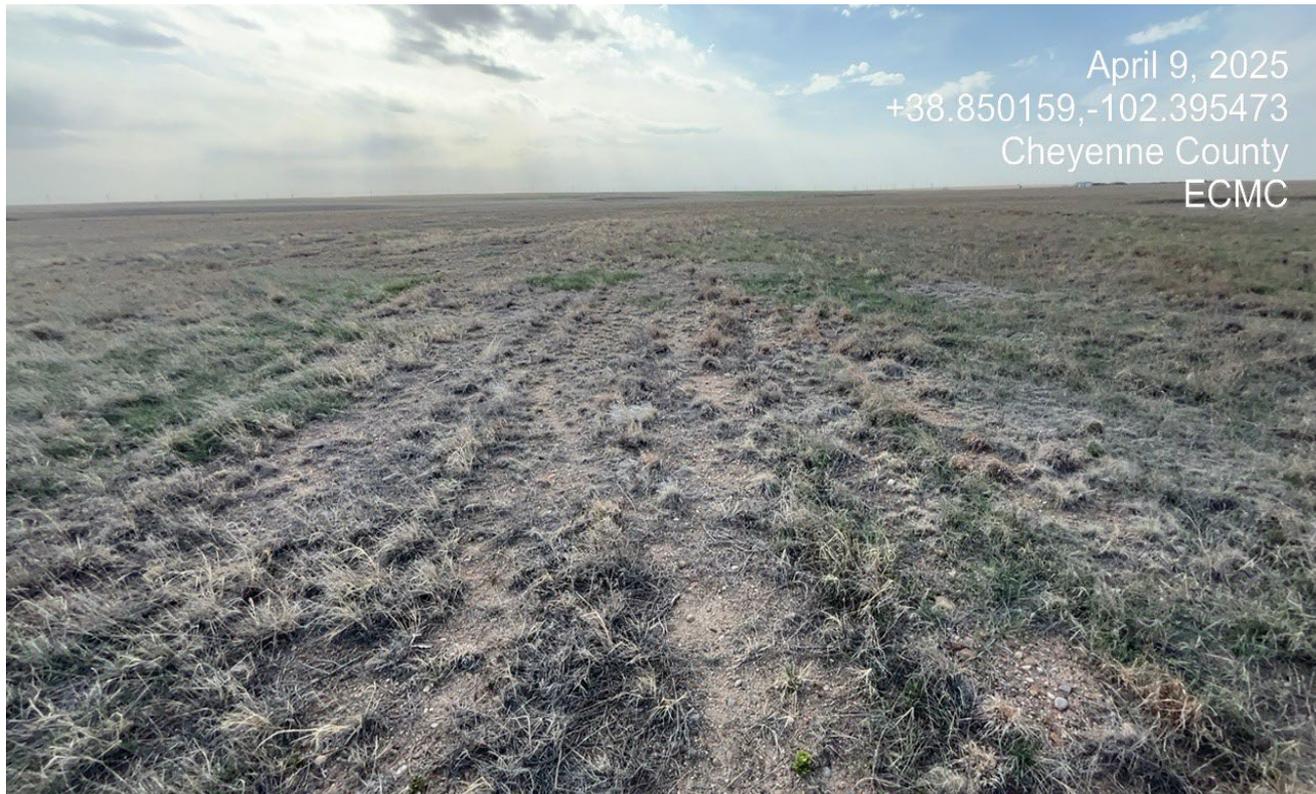
**Photo 6.** Facing west toward the location. It appears perennial is progressing at the location.

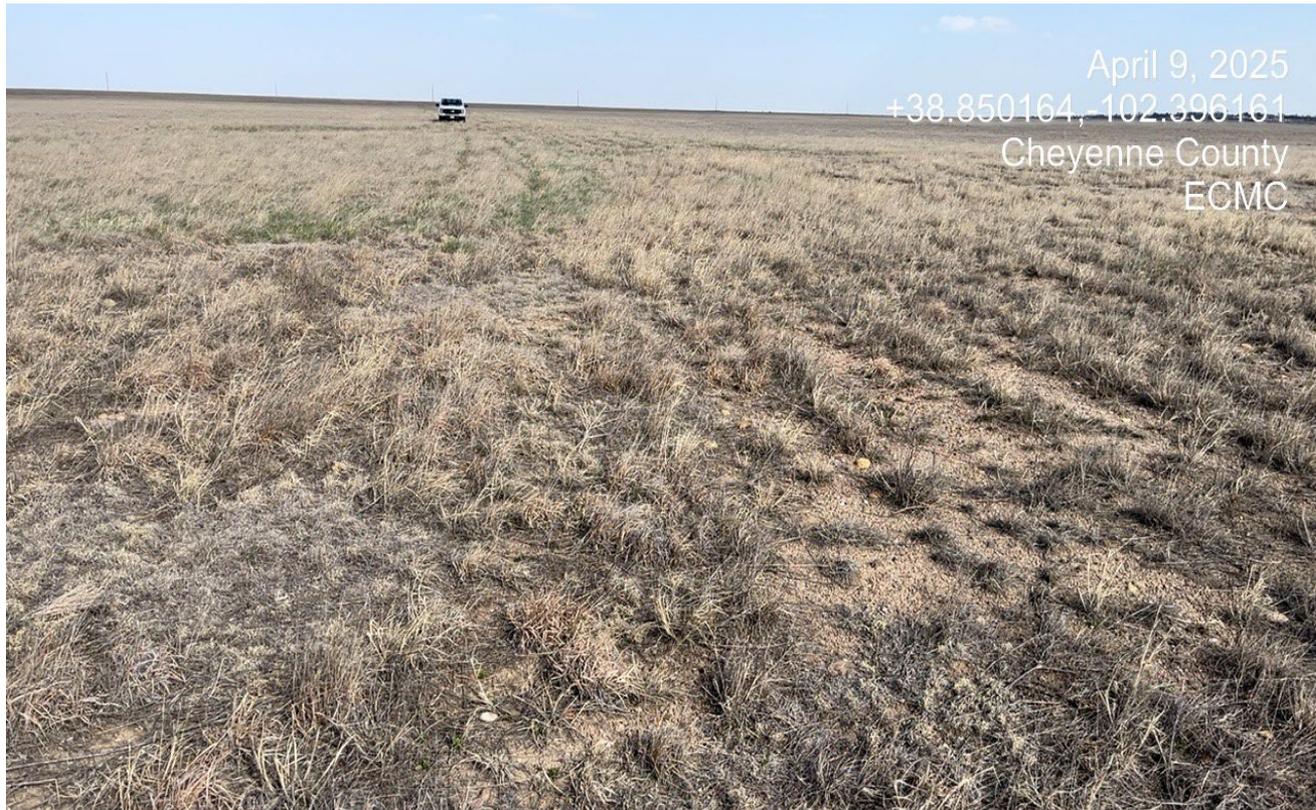
**Photo 7.** Facing east toward the location. It appears perennial is progressing at the location.

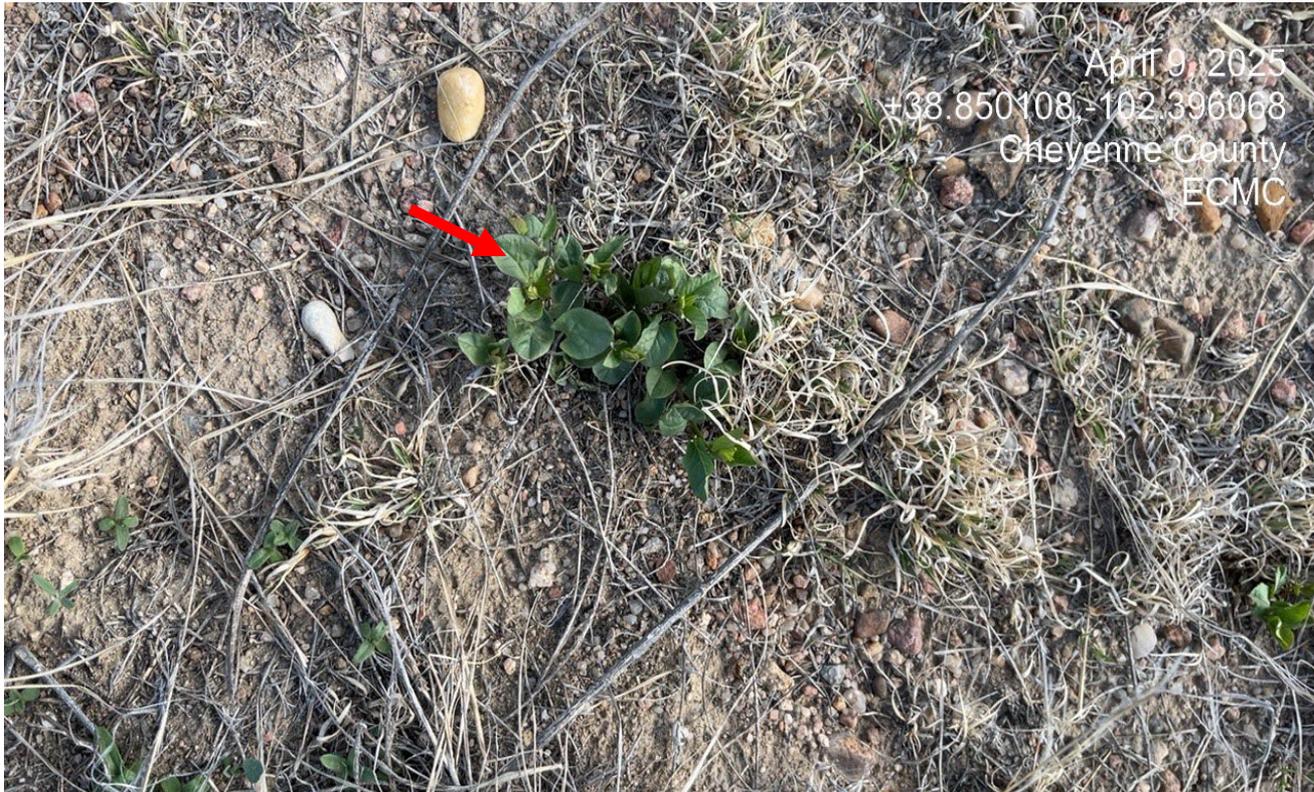
**Photo 8.** View of groundcover shows some noxious weed beginning to emerge. Red arrow points to Field bindweed.

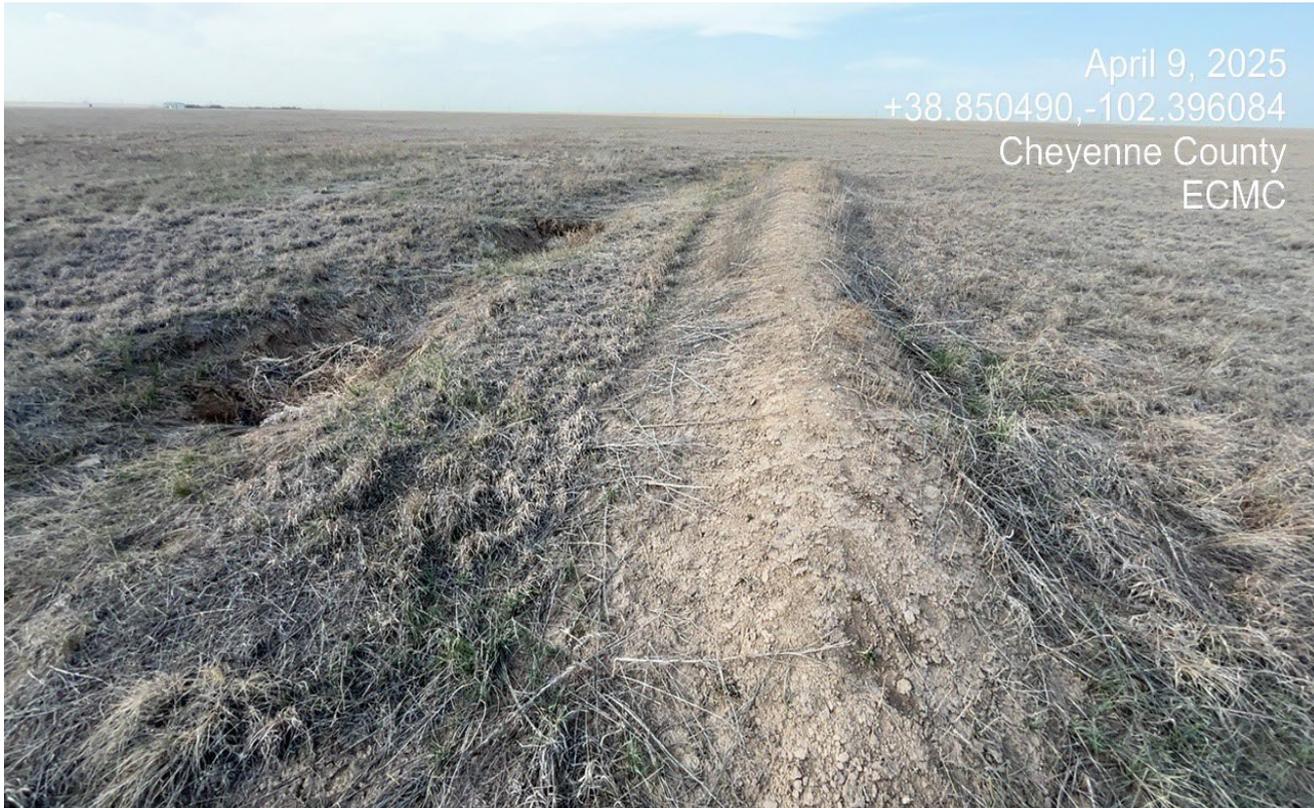
**Photo 9** North side of the location. There is a berm and shallow depression of a former pit.

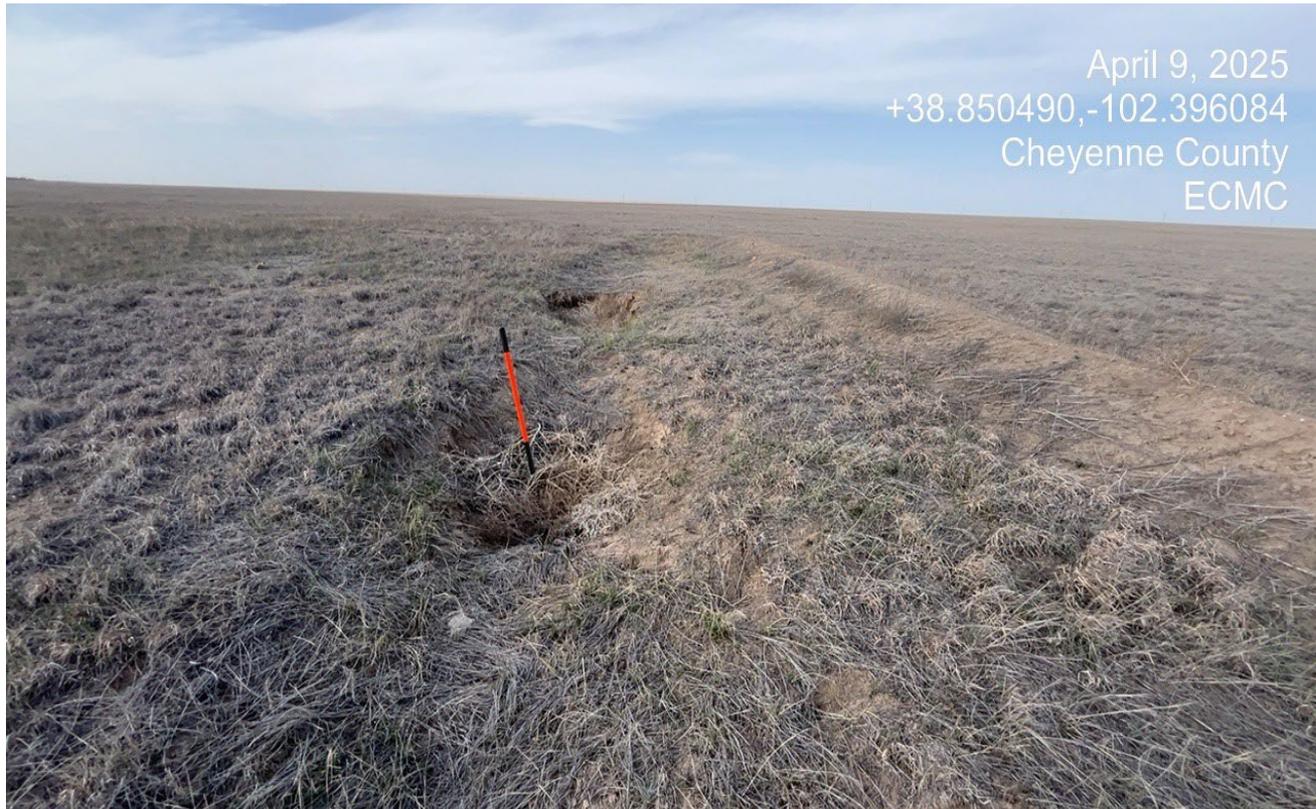
**Photo 10.** Facing north at the former pit area. There are two areas of subsidence at this former pit. Red arrow points to 4.5' shovel for scale.

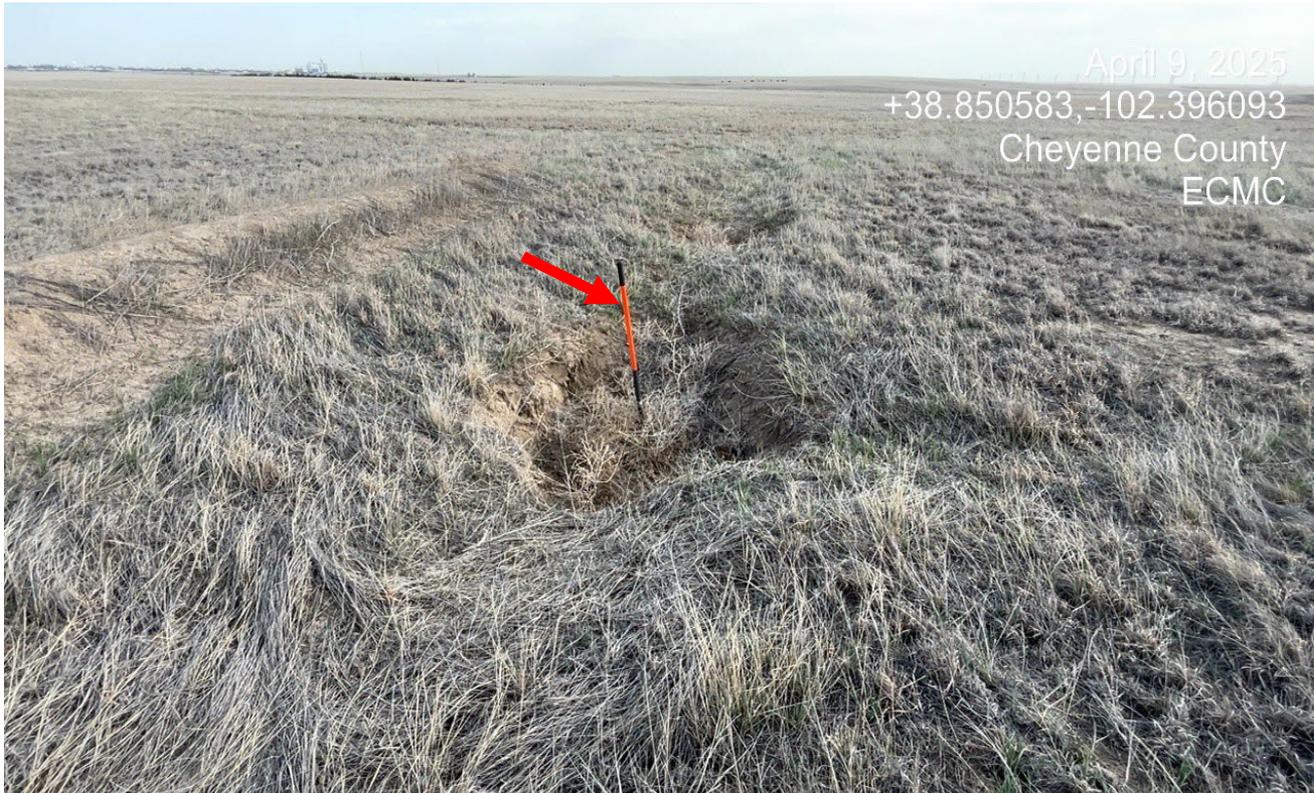
**Photo 11.** Facing south at the former pit area. There are two areas of subsidence at this former pit. Red arrow points to 4.5' shovel for scale.

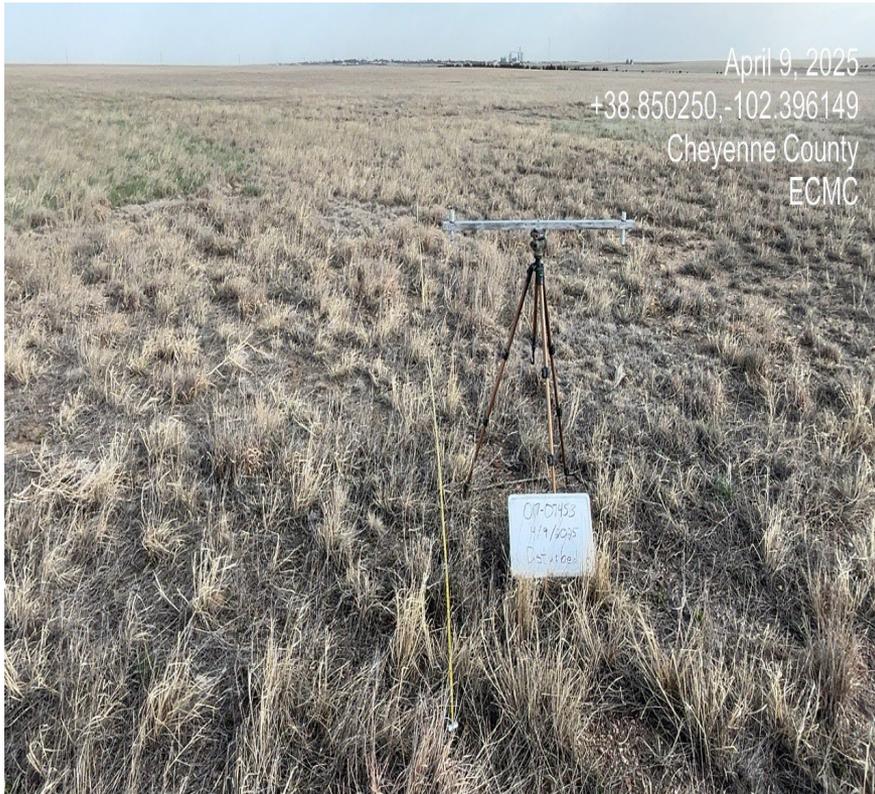
**Photo 12.** Facing southeast at the beginning of the transect at the location.

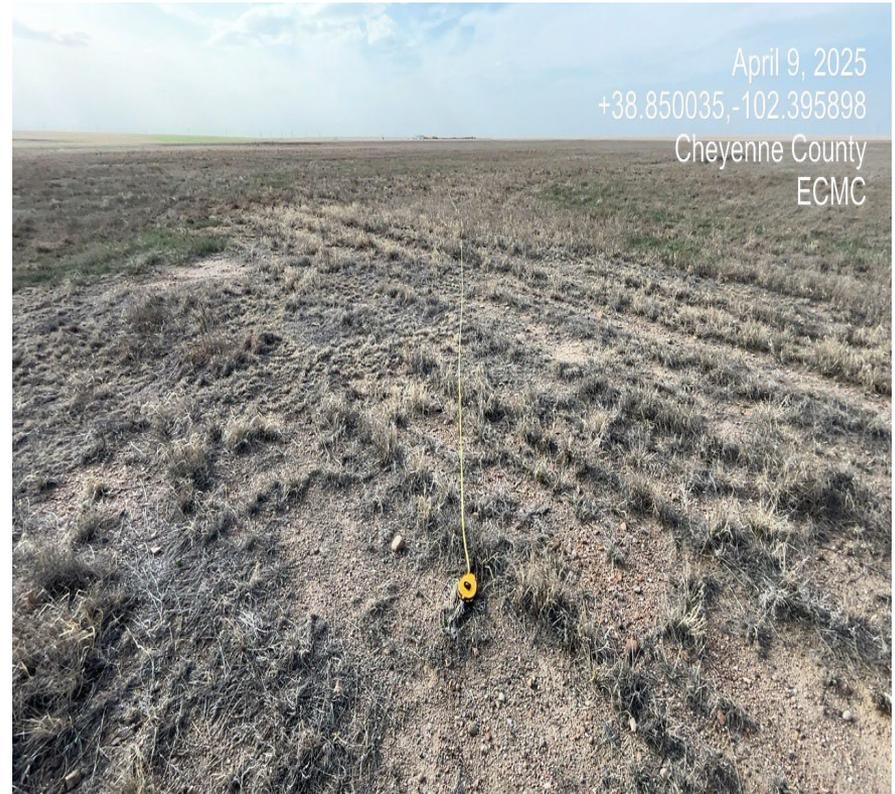
**Photo 13.** Facing northwest at the end of the transect at the location.

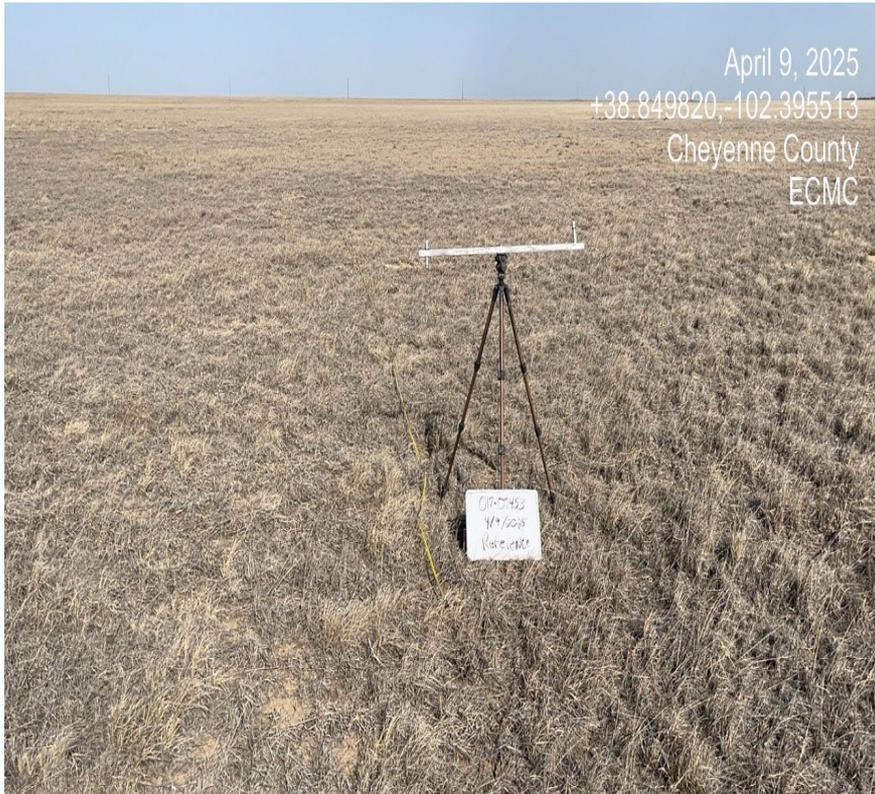
**Photo 14.** Facing southeast at the beginning of the transect at the reference area.

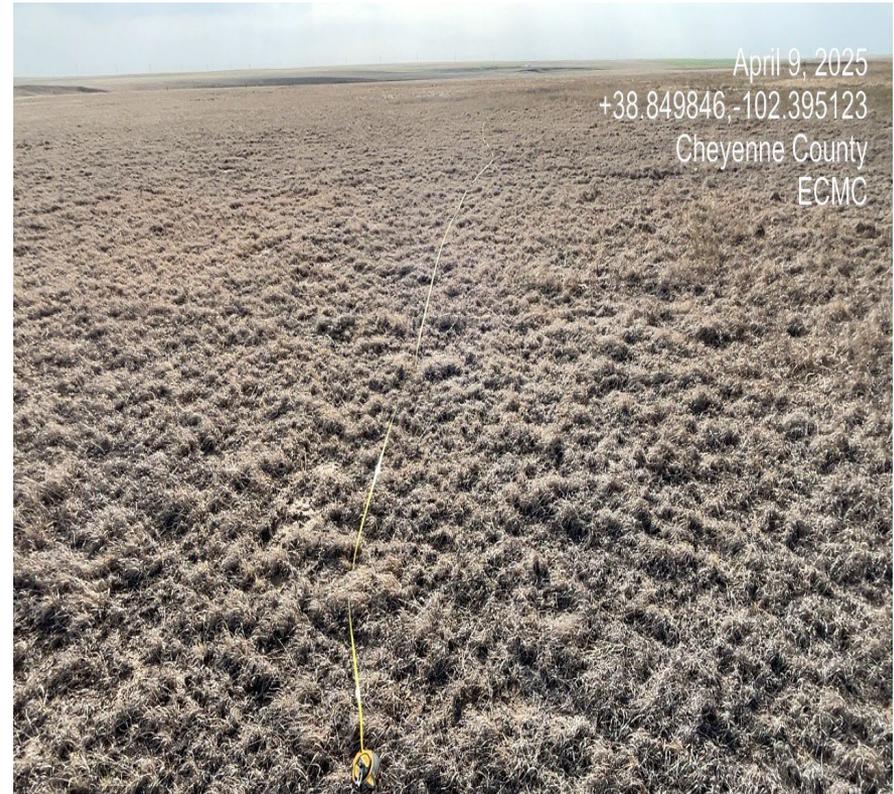
**Photo 15.** Facing northwest at the end of the transect at the reference area.
