Inspection Photos
Location Name: Lincoln 2 (OWP)
API: 05-061-06008

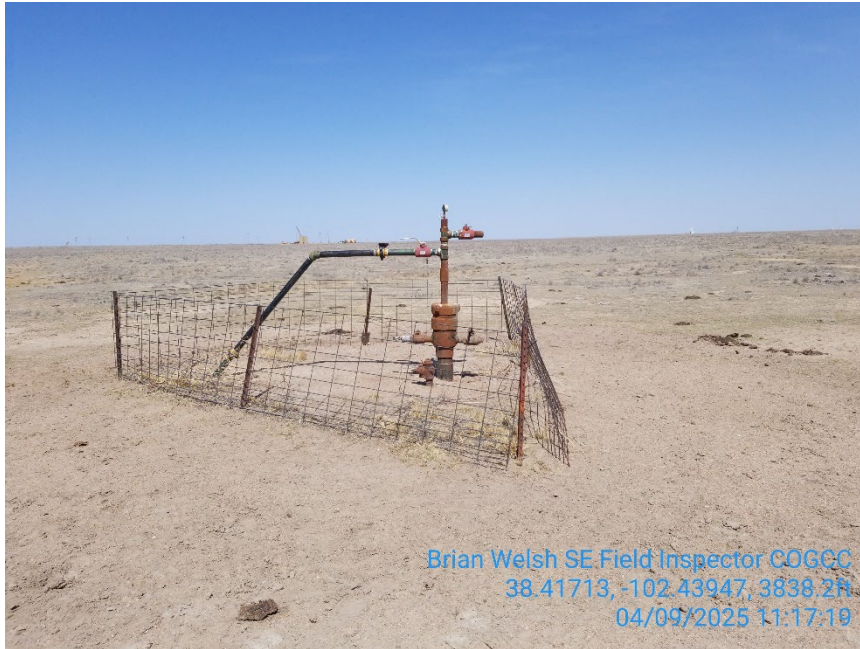
Wellhead is fenced with wire panels

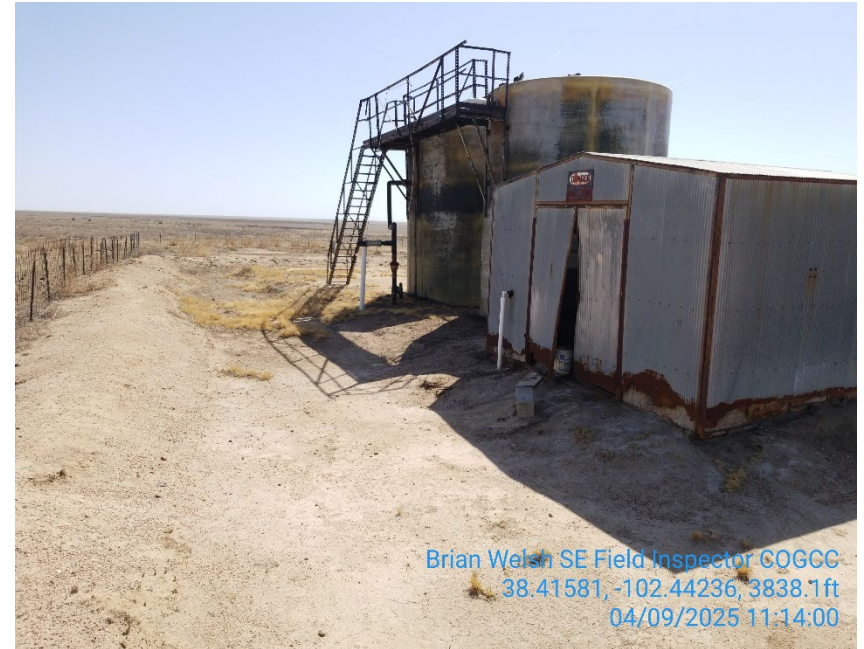
Northwest corner of the tank battery looking southeast

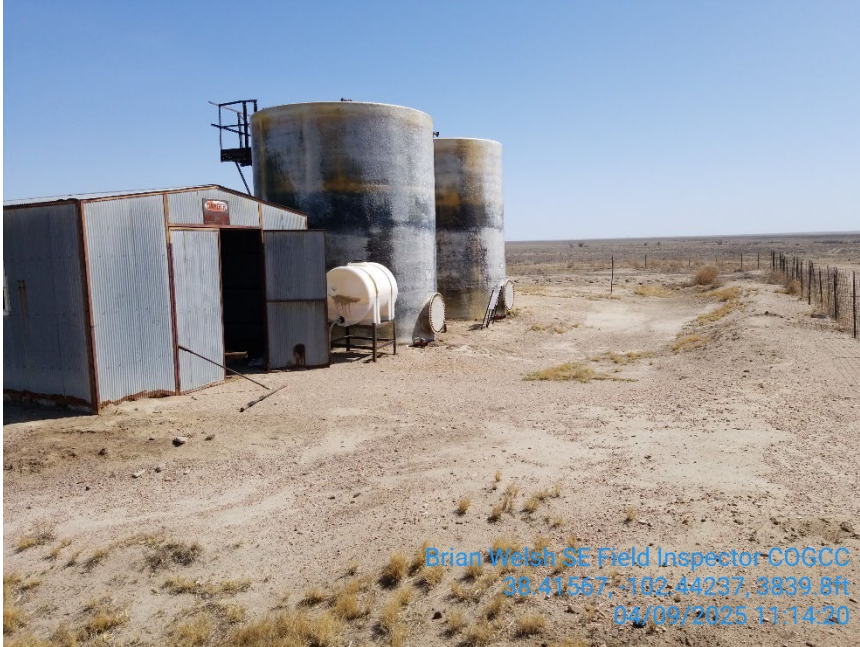
Southwest corner of the tank battery looking northeast

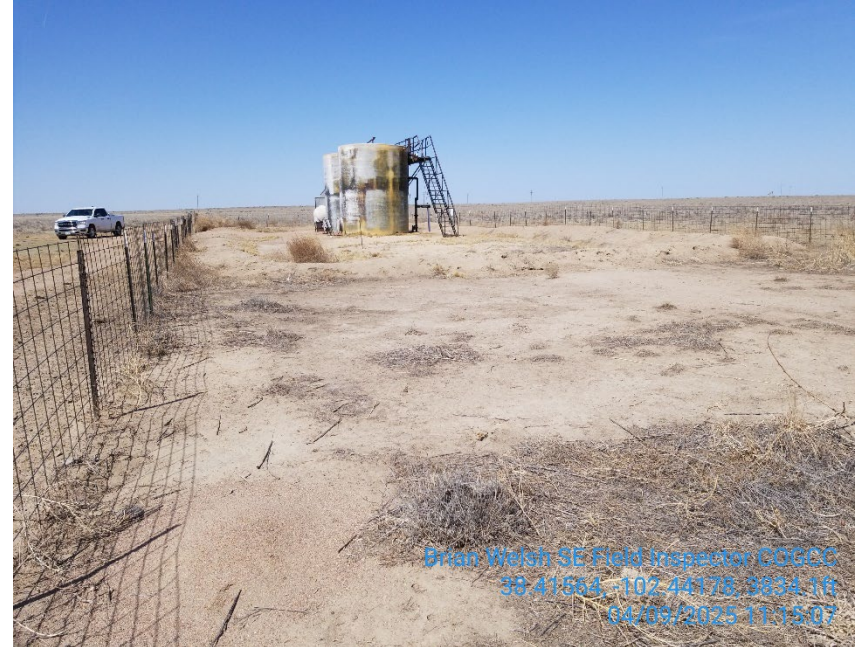
Southeast corner of the tank battery looking northwest

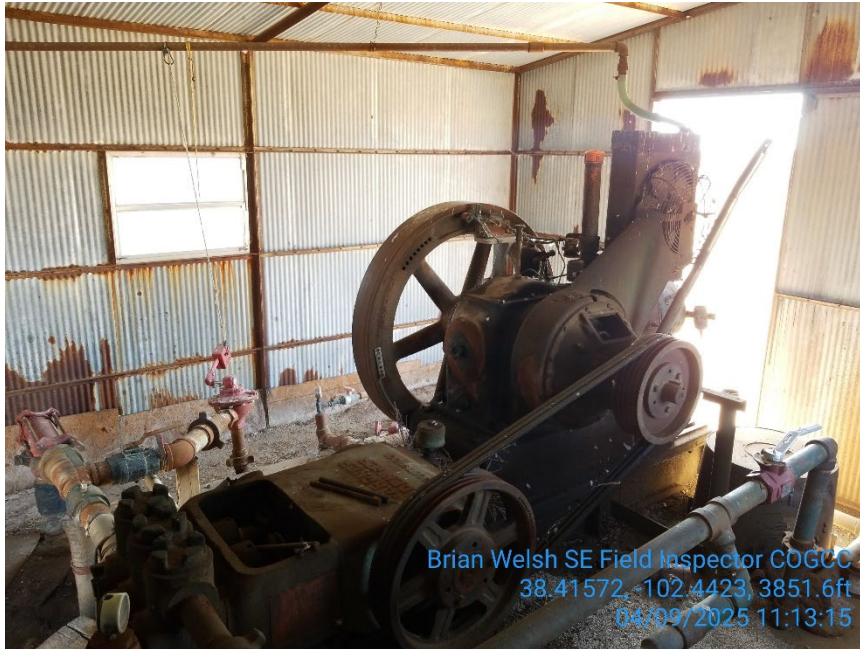
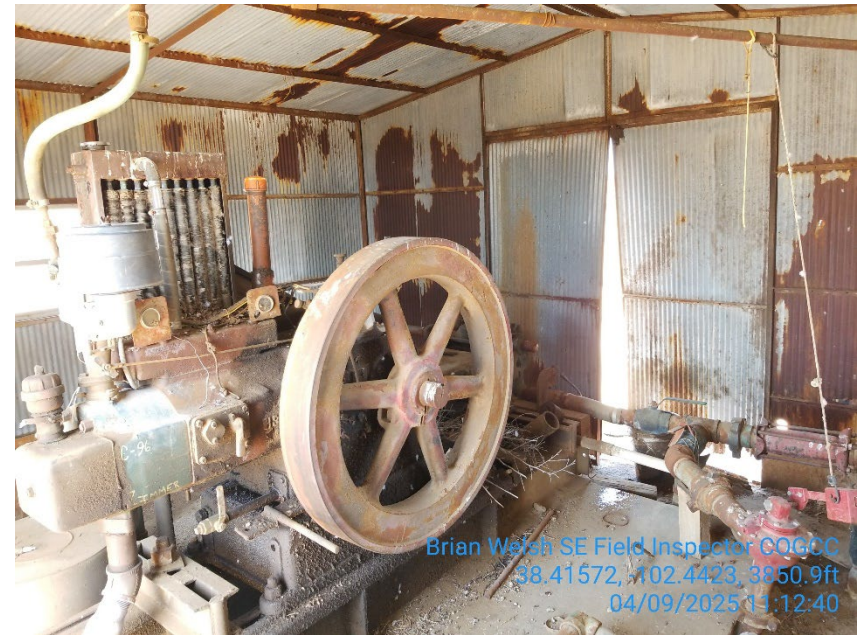
These are all pictures of inside the metal shed associated with the injection well. There is an Arrow gas engine along with a triplex pump and dump valves.

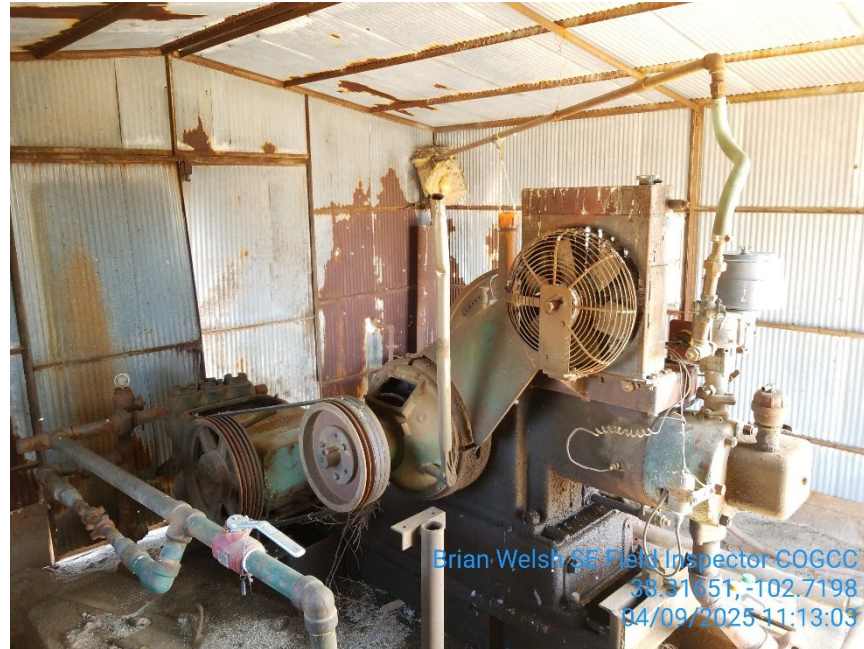
Inside the metal shed
