# Inspection/Audit Photos

Location Name: TEP ROCKY MOUNTAIN LLC Jolley KP 41-28 Pad

Location ID: 423258

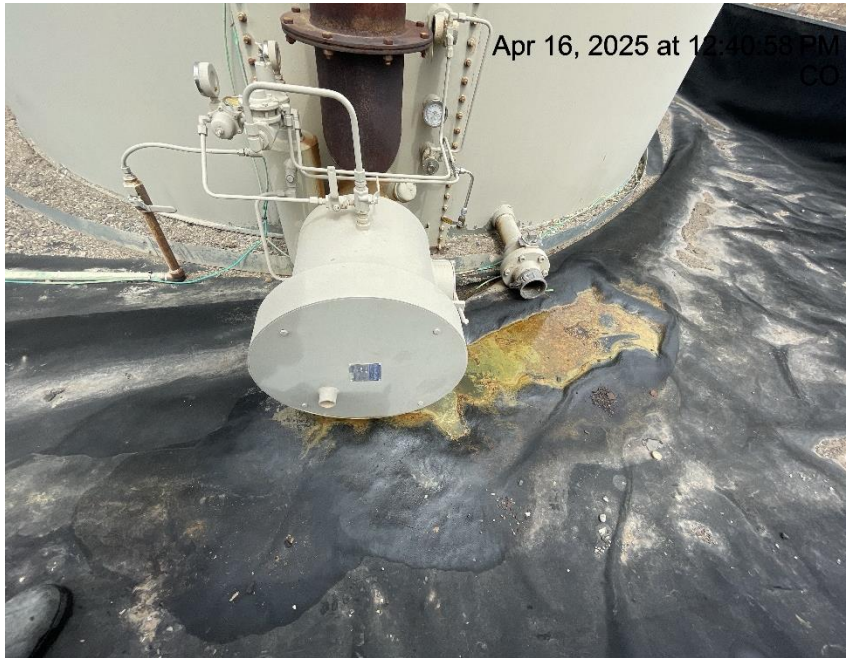
Photo # 1793 E & P waste in secondary containment

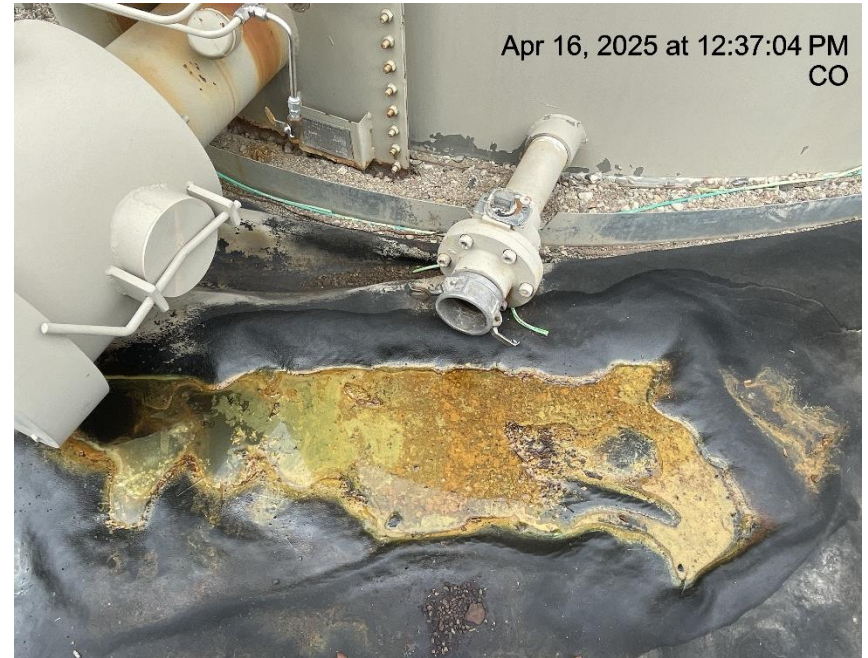
Photo # 1794 E & P waste in secondary containment

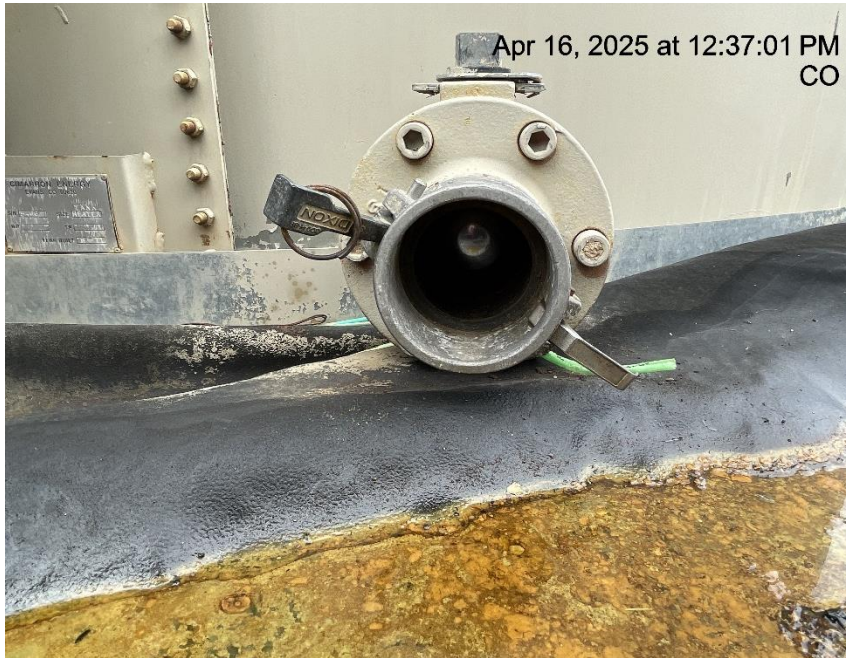
Photo # 1795 Open ended load line

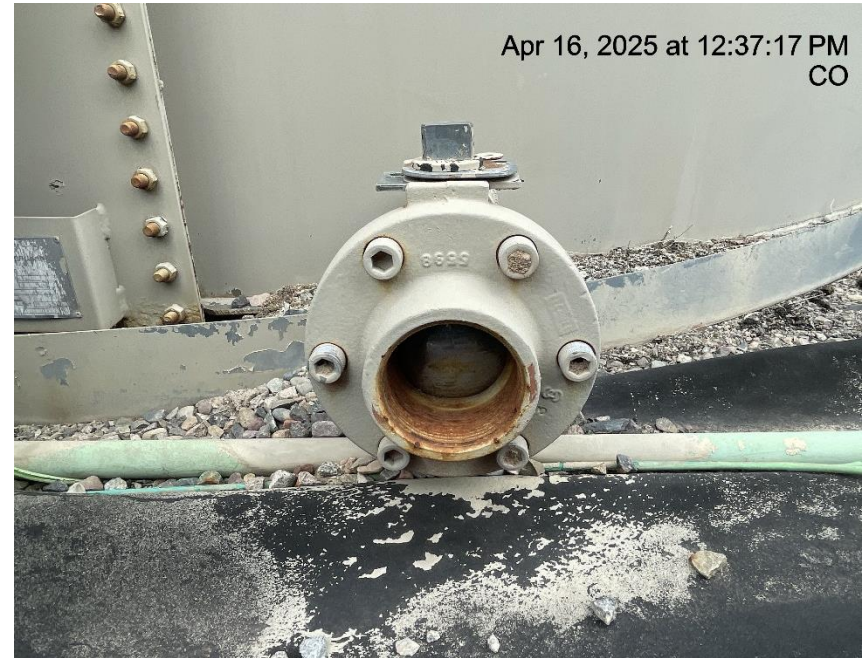
Photo # 1796 Open ended load line

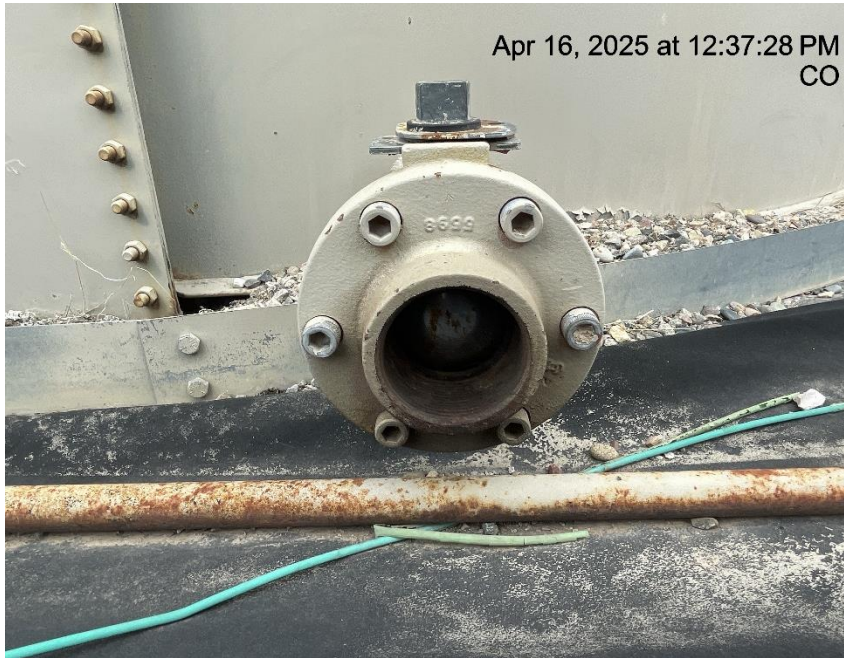
Photo # 1797 Open ended load line

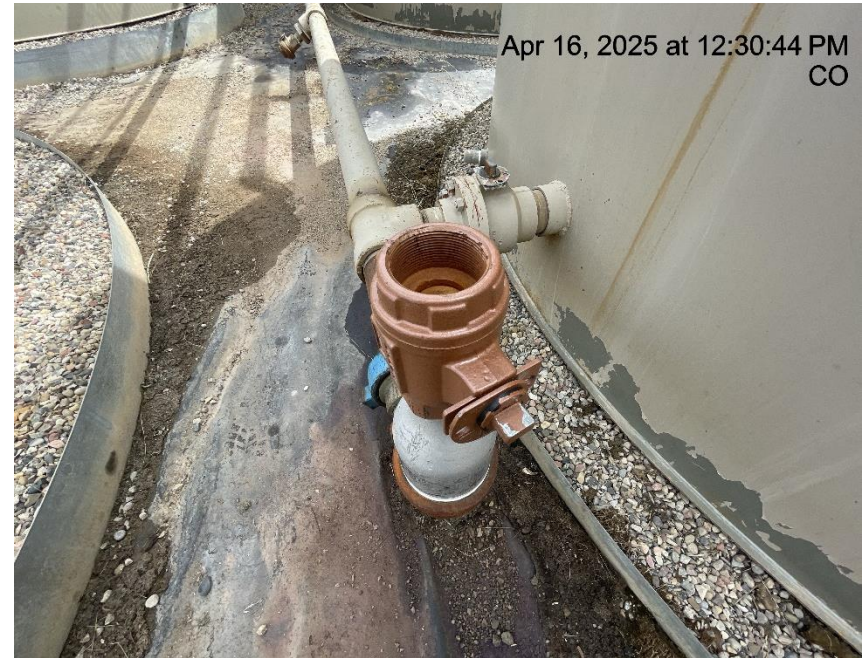
Photo # 1798 Open ended load line

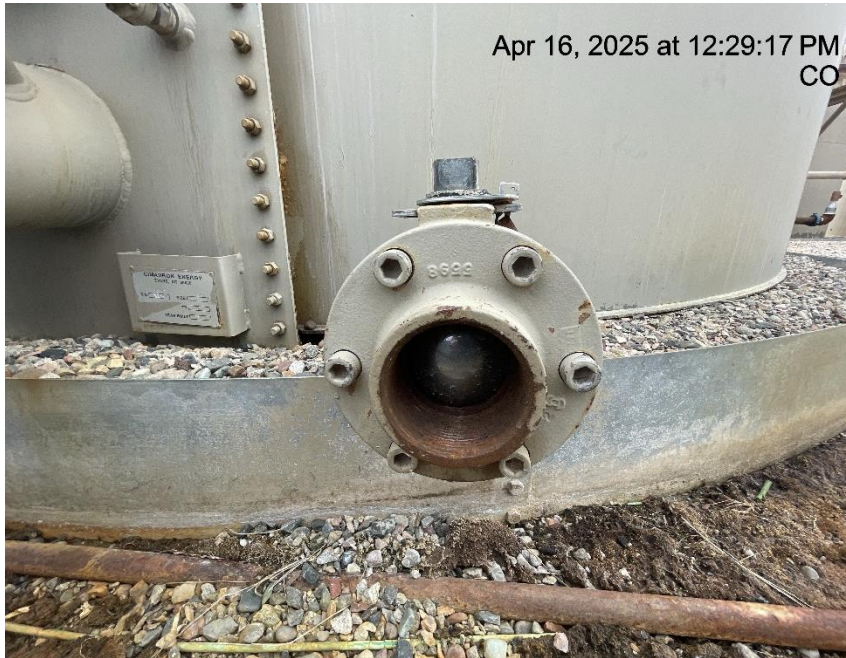
Photo # 1799 Open ended load line

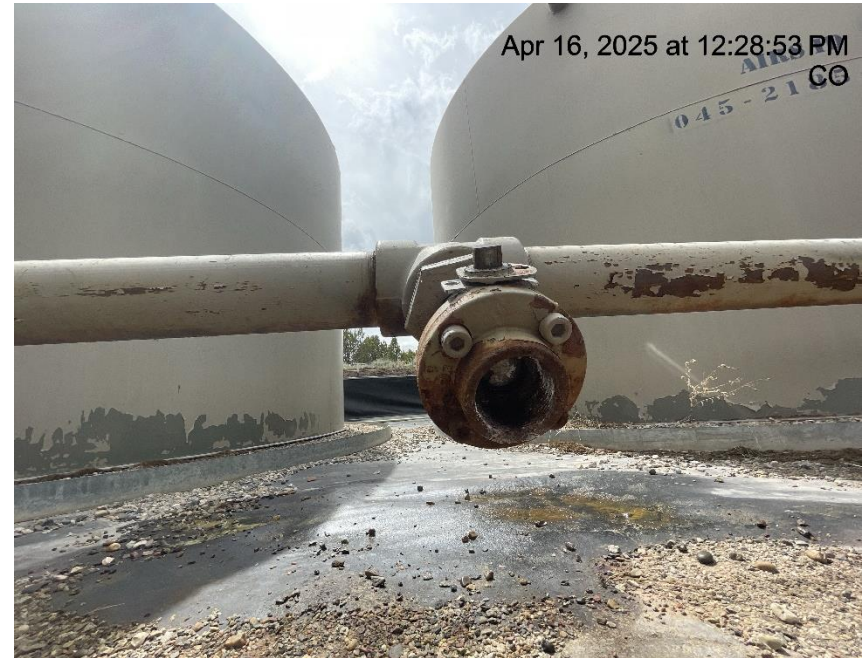
Photo # 1800 Open ended load line

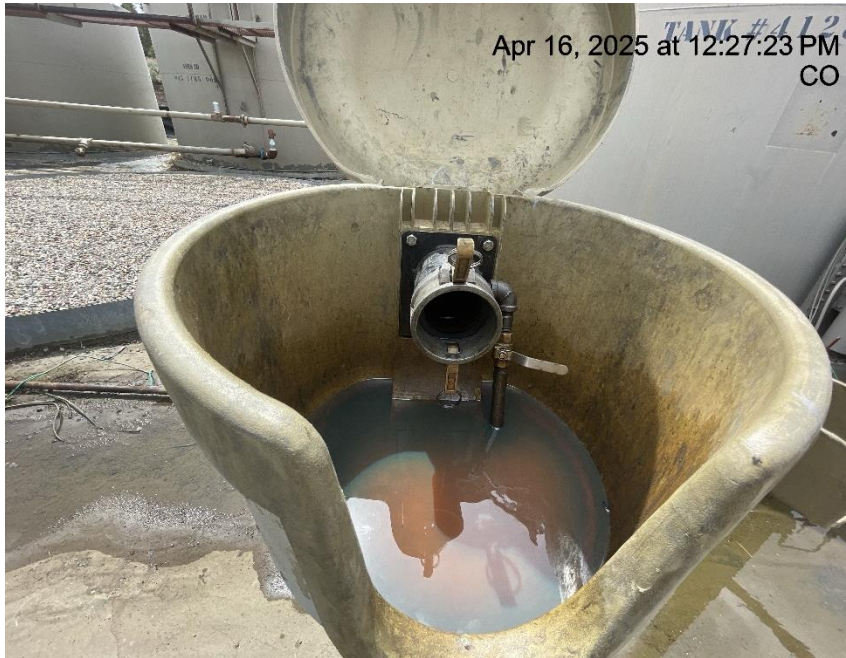
Photo # 1801 Open ended load line

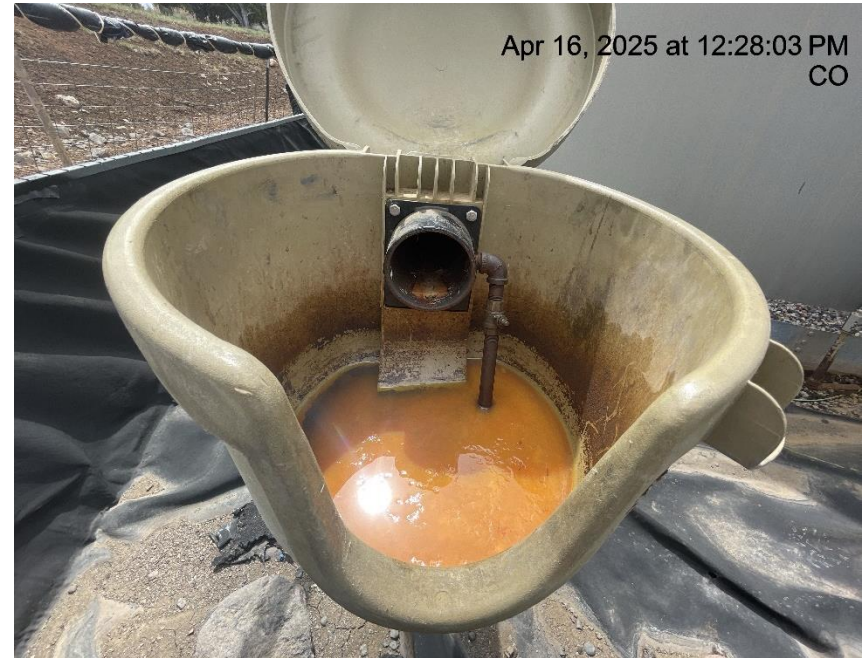
Photo # 1802 Open ended load line

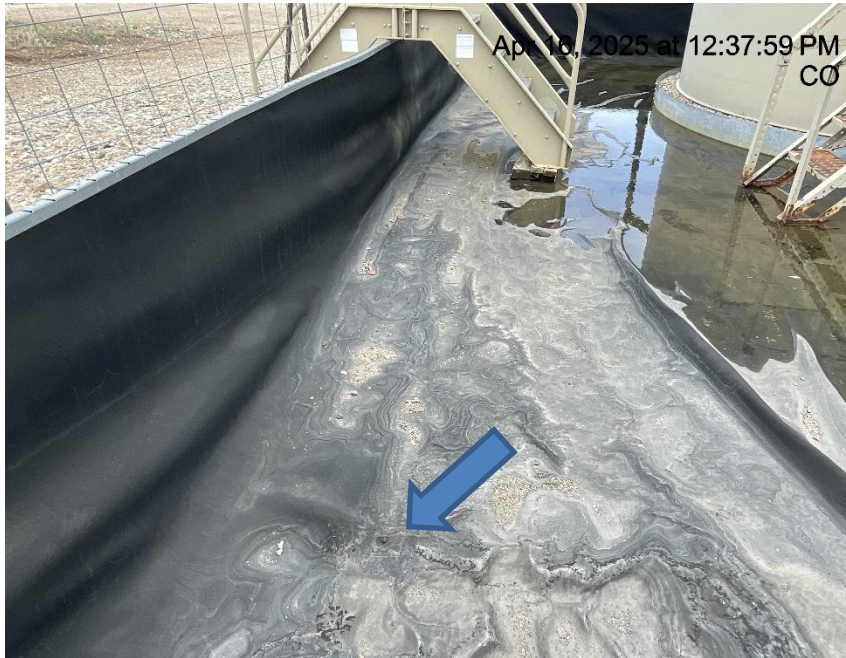
**Photo # 1803 Hole in secondary containment liner/liner needs maintenance**

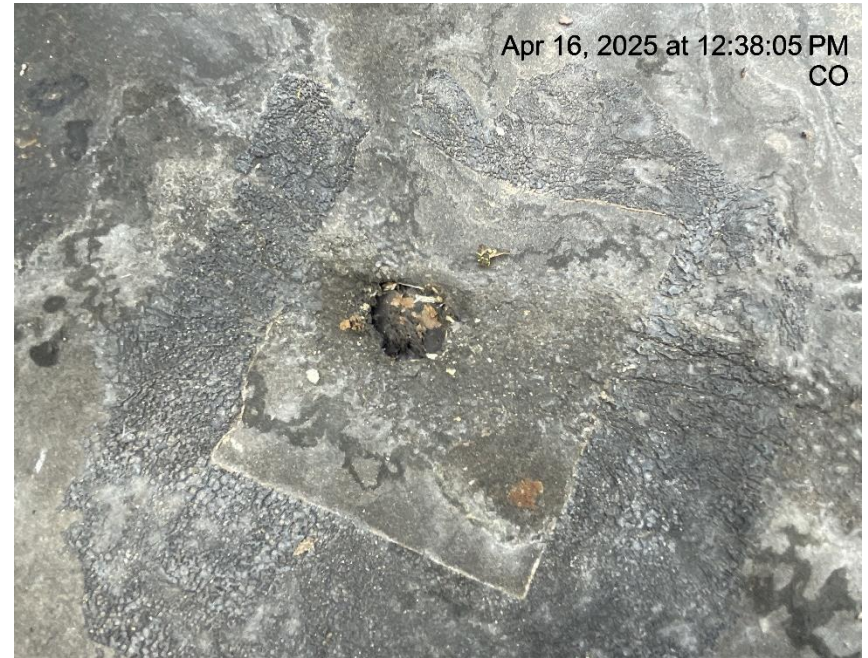
**Photo # 1804 Hole in secondary containment liner/liner needs maintenance**

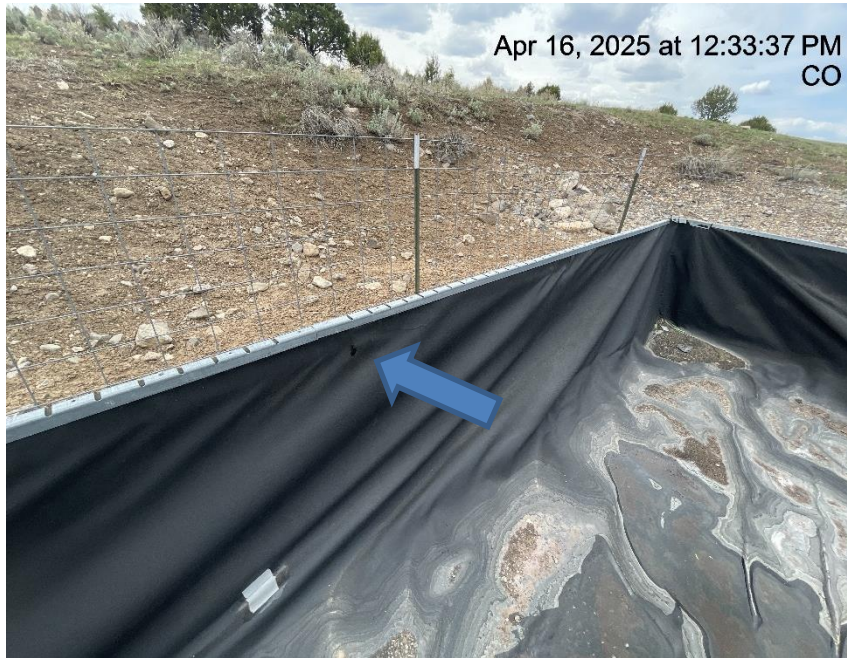
**Photo # 1805 Hole in secondary containment liner/liner needs maintenance**

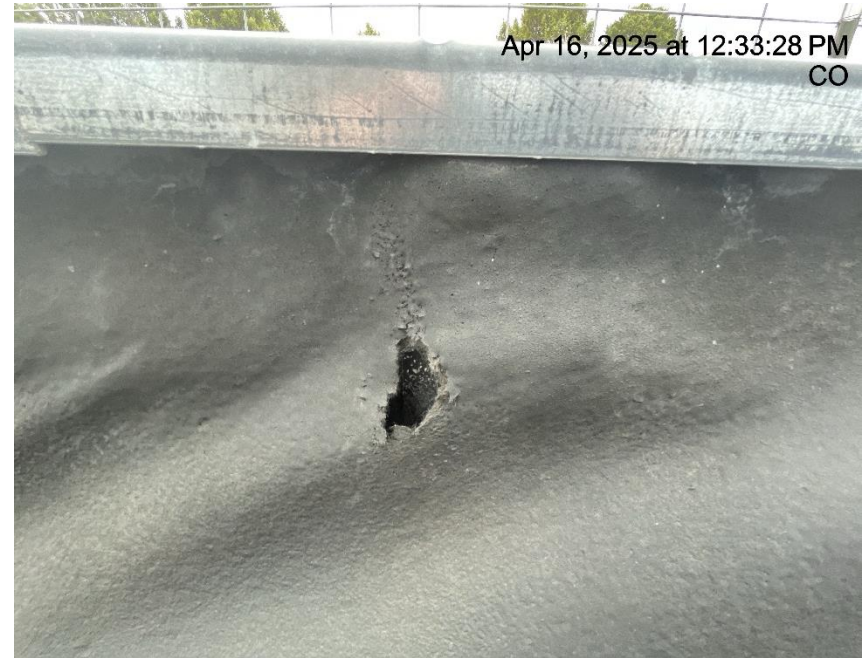
**Photo # 1806 Hole in secondary containment liner/liner needs maintenance**

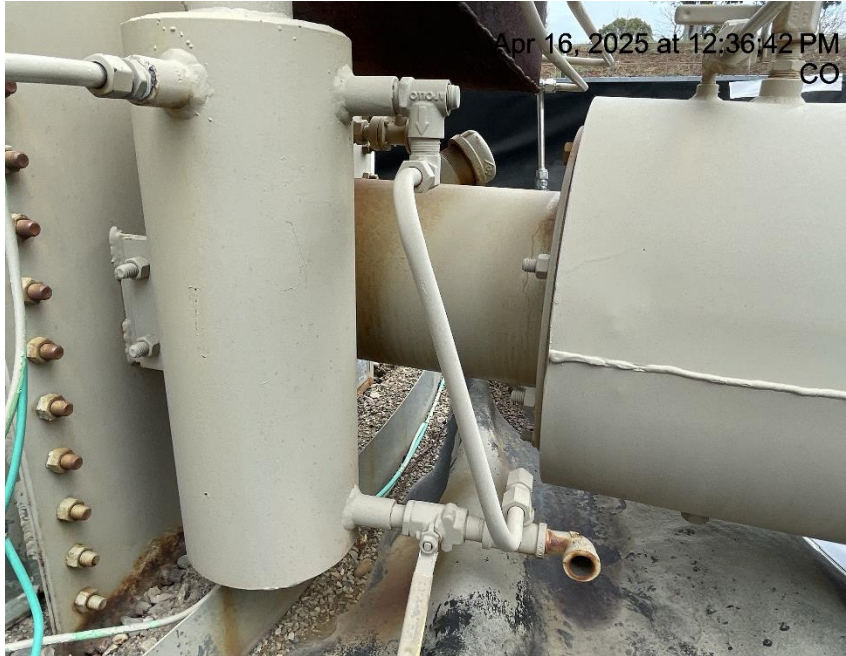
**Photo # 1807 PRV vent line on tank heater does not comply with CECMC pressure safety device rules or general safety rules**
