Inspection/Audit Photos

Location Name: TEP Rocky Mountain LLC Jolley KP 22-21 Pad

Location ID: 335209

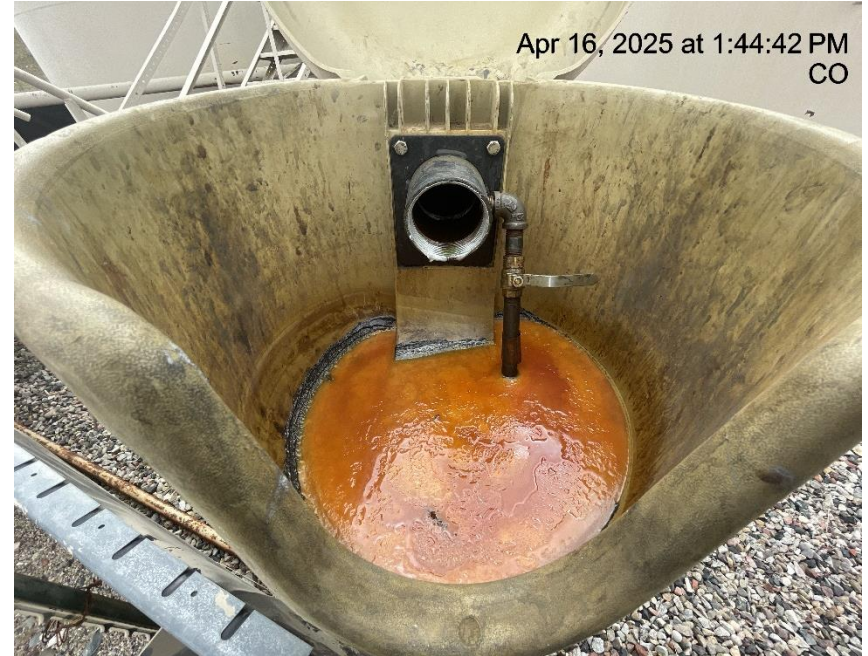
Photo # 2063 Open ended load line

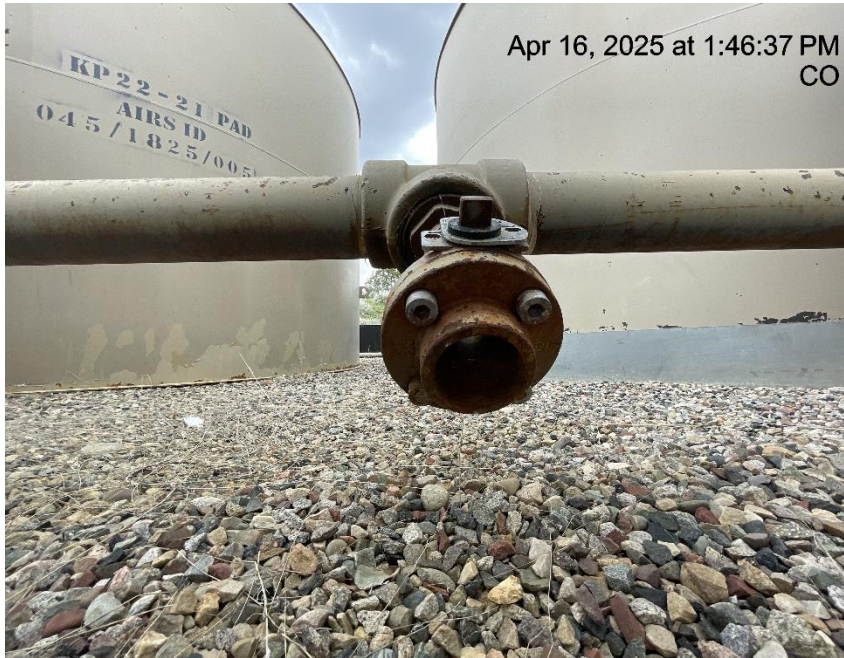
Photo # 2064 Open ended load line

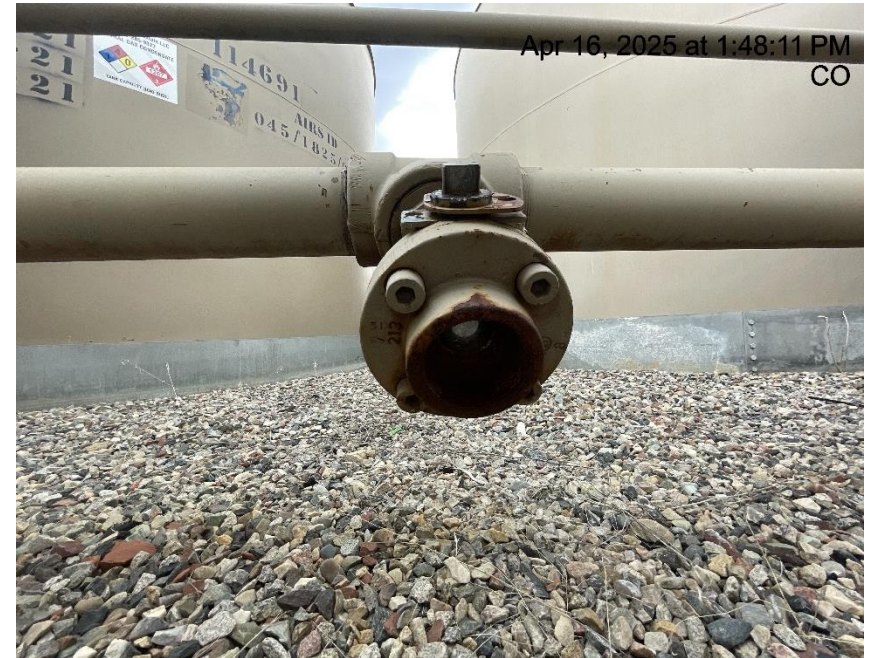
Photo # 2065 Open ended load line

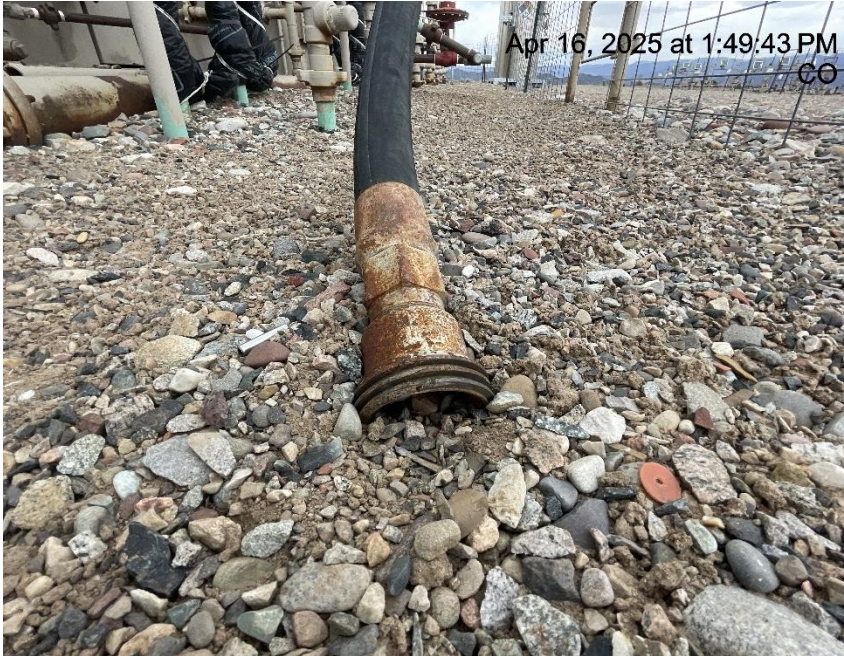
**Photo # 2066 Open ended kelly hose/wildlife hazard
/available for entry by wildlife**

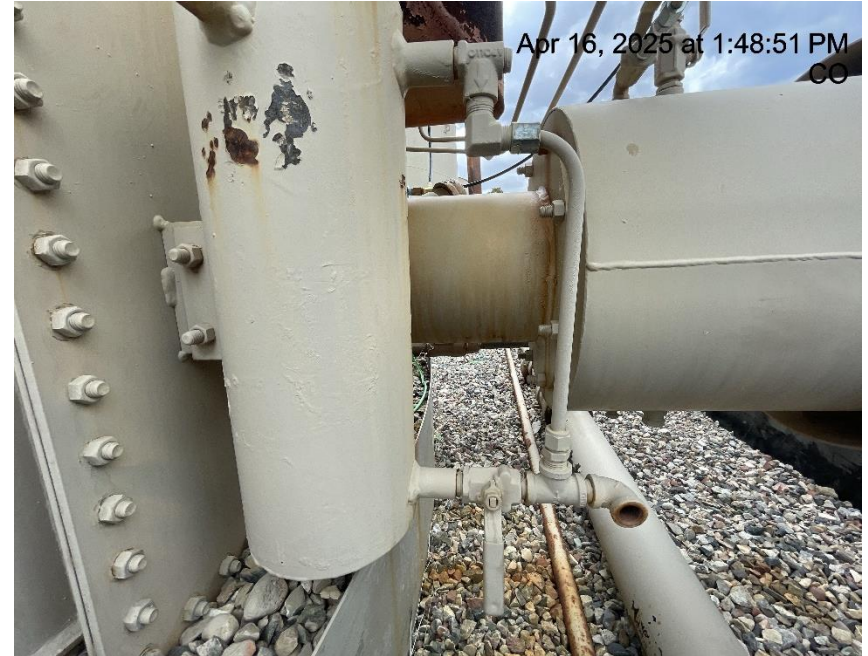
**Photo # 2067 PRV vent line does not comply with CECMC
pressure safety device rules or general safety rules**

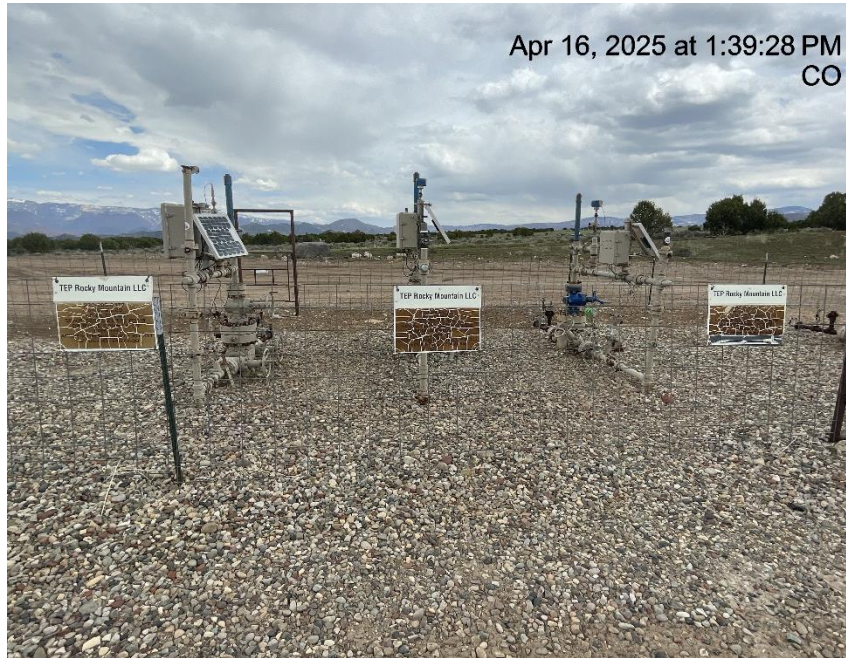
Photo # 2068 Multiple wellhead signs weathered & illegible /not in compliance with CECMC rules

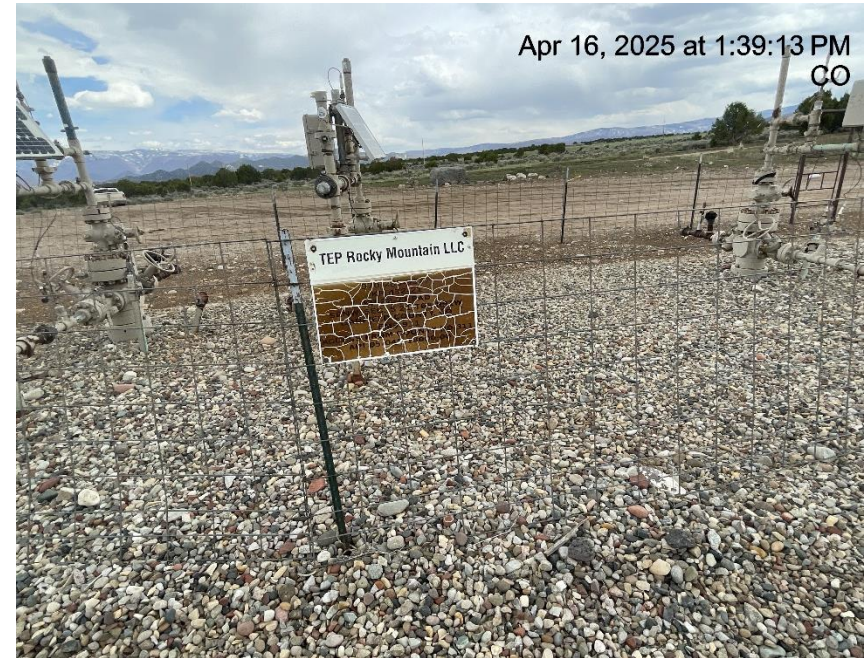
Photo # 2069 Wellhead sign weathered & illegible/not in compliance with CECMC rules

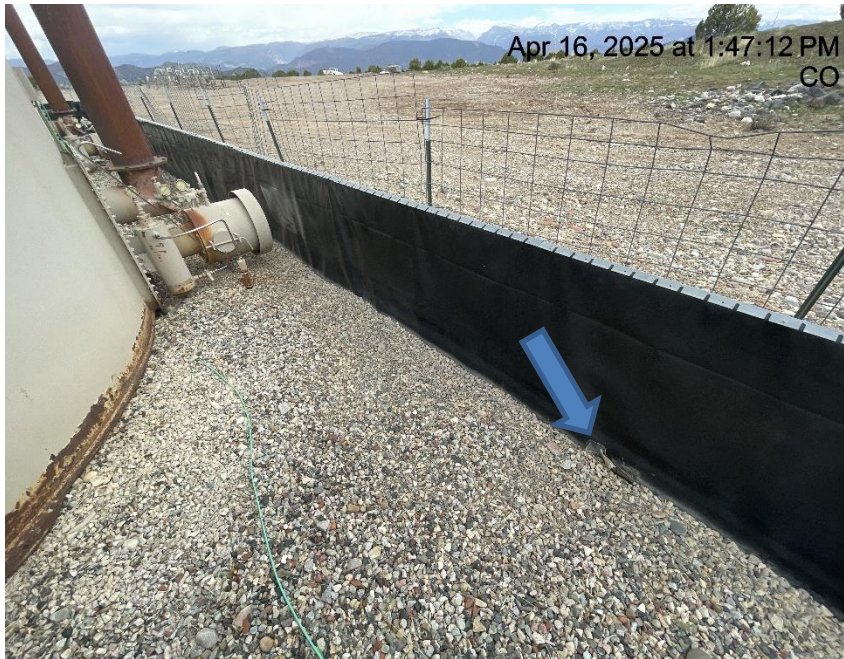
Photo # 2070 Hole in secondary containment liner/liner needs maintenance

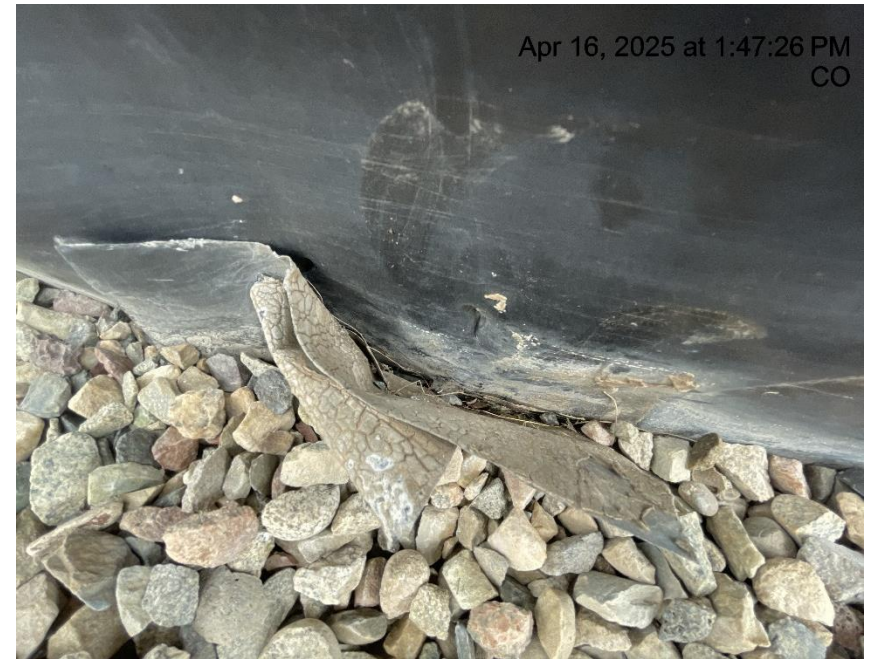
Photo # 2071 Hole in secondary containment liner/liner needs maintenance

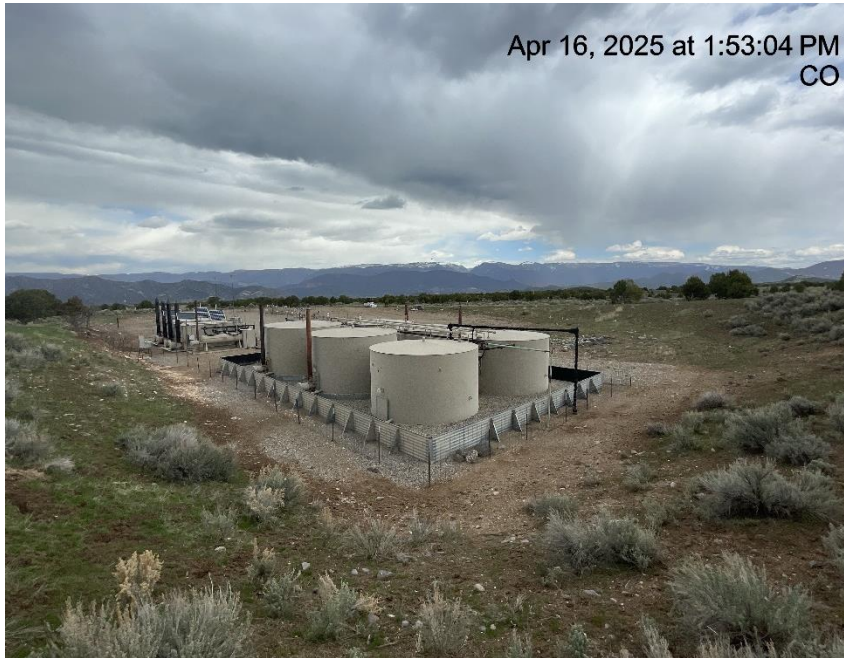
Photo # 2072 Total of 6 production tanks on location however operators FORM 2A only lists 5/not in compliance with CECMC rules

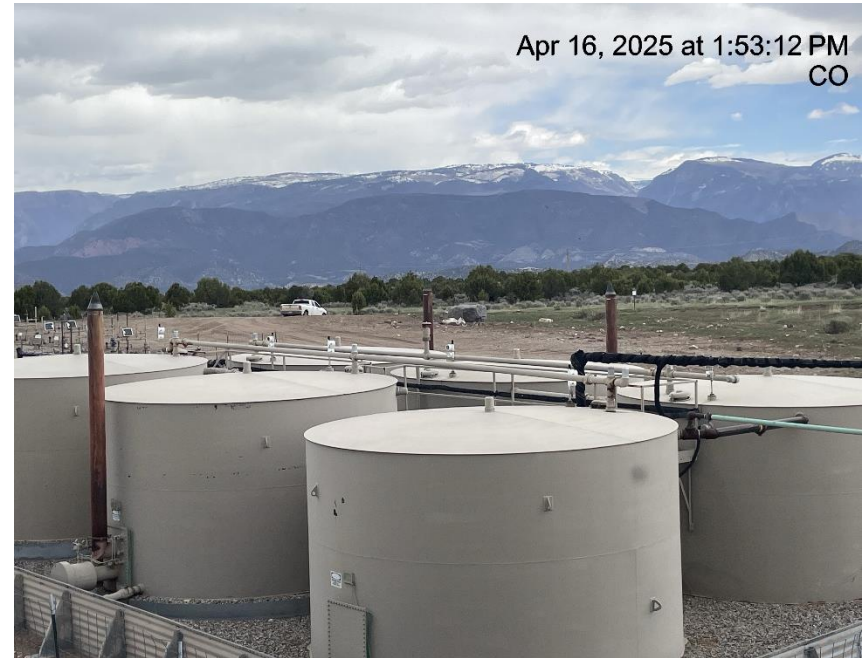
Photo # 2073 Total of 6 production tanks on location however operators FORM 2A only lists 5/not in compliance with CECMC rules

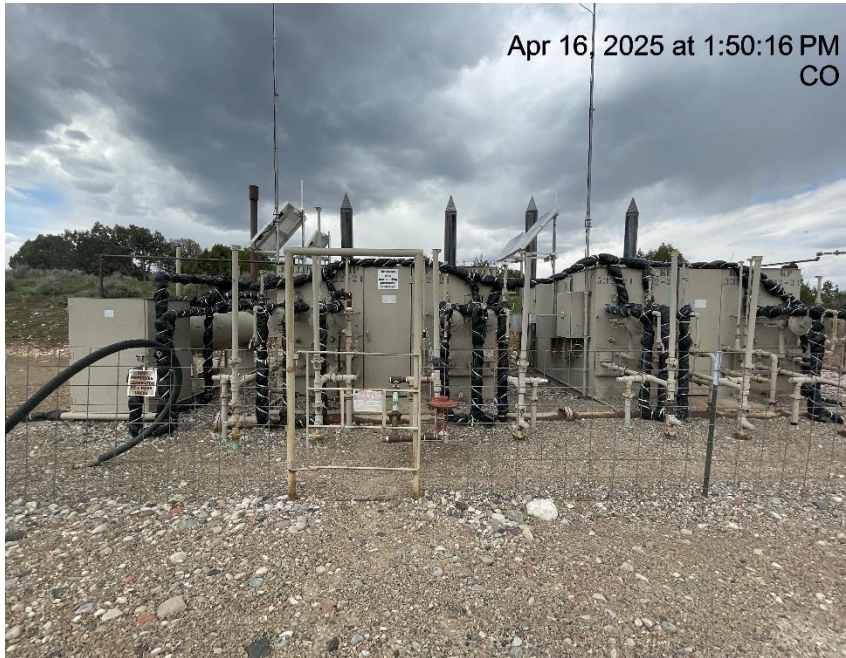
Photo # 2074 Total of 9 separators on location however operators FORM 2A only lists 8/not in compliance with CECMC rules
