Arch Oil & Gas LLC
J P Weise 2
Location ID: 312744

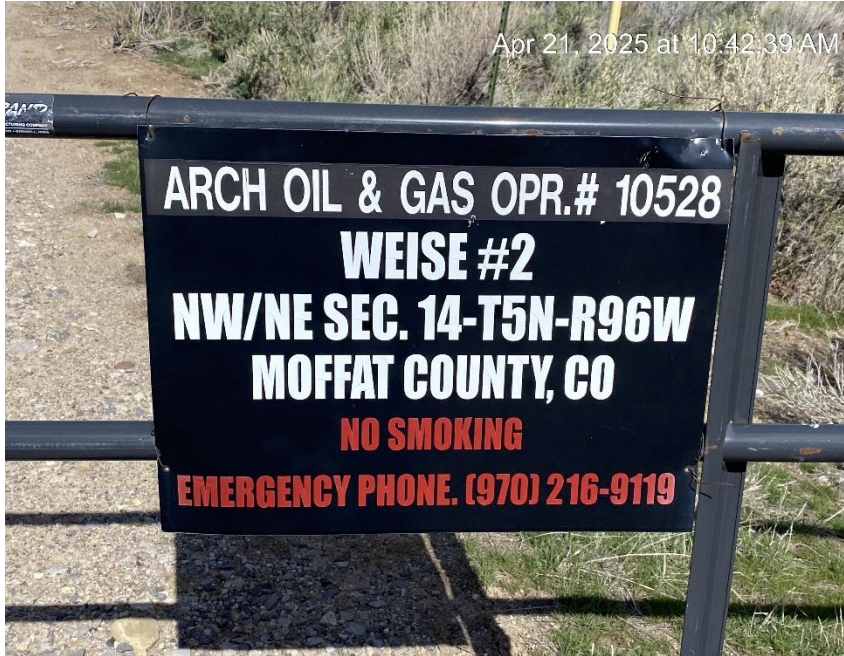
Missing information

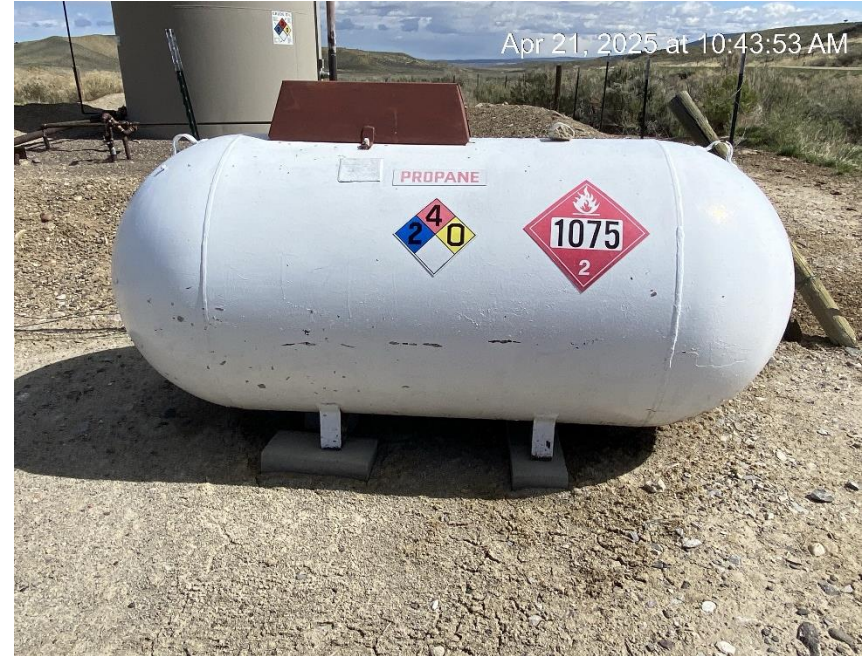
Unused equipment

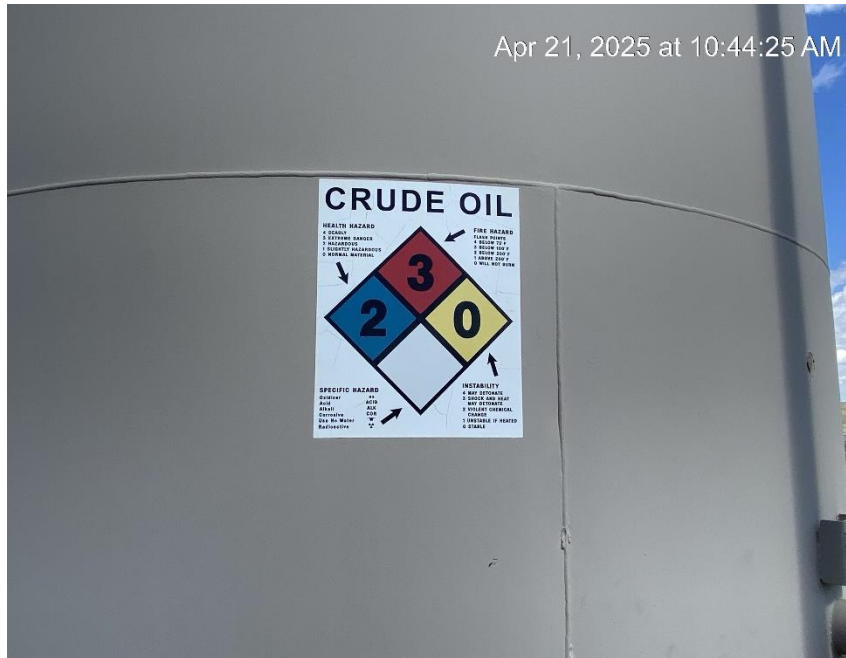
Label on opposite side of tank

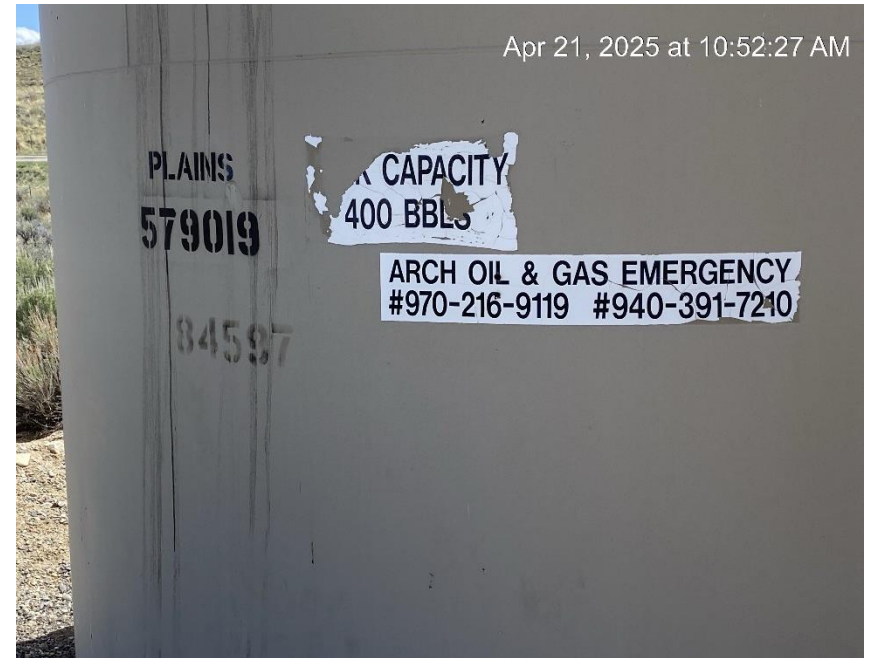
Damaged label

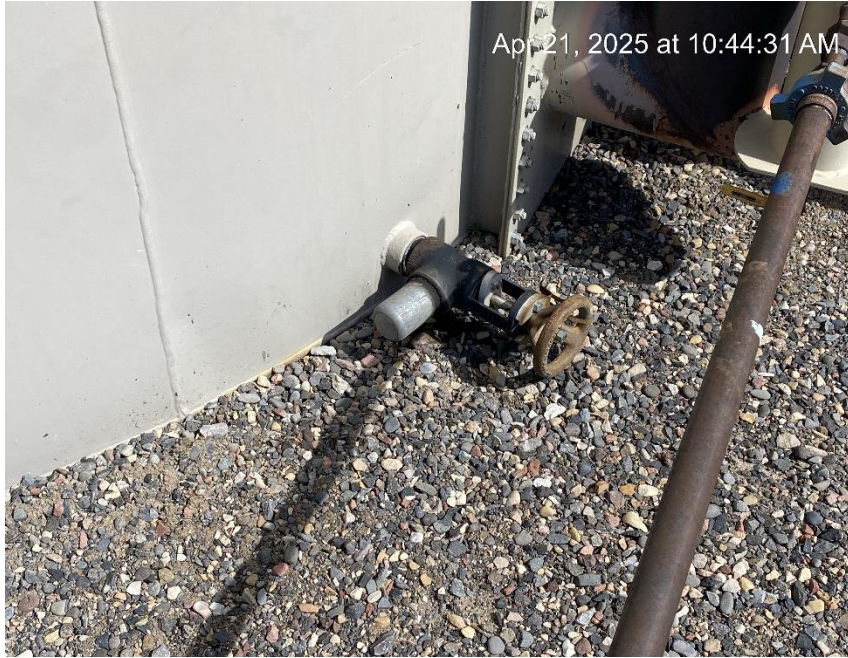
Stained soil below valve

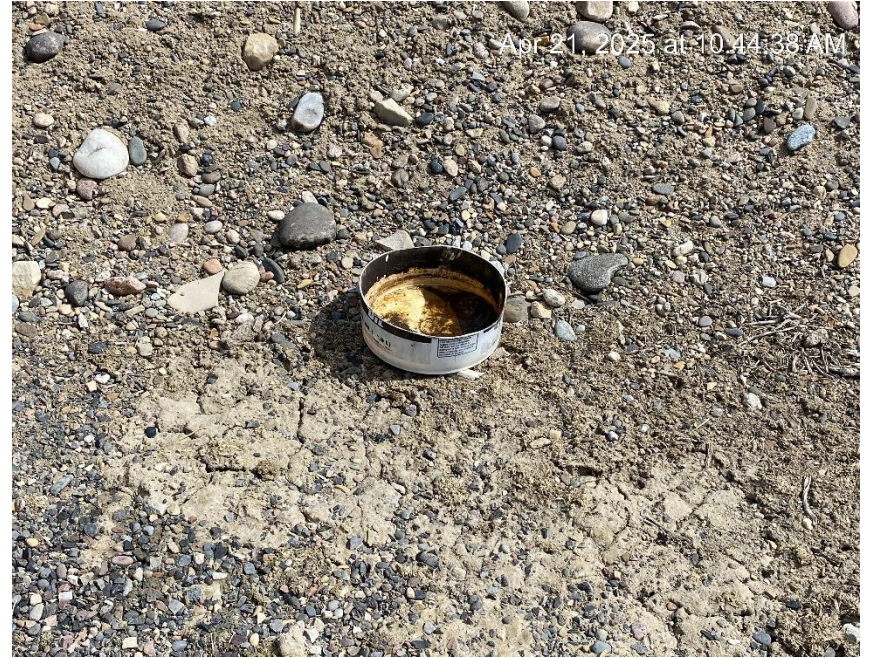
Debris

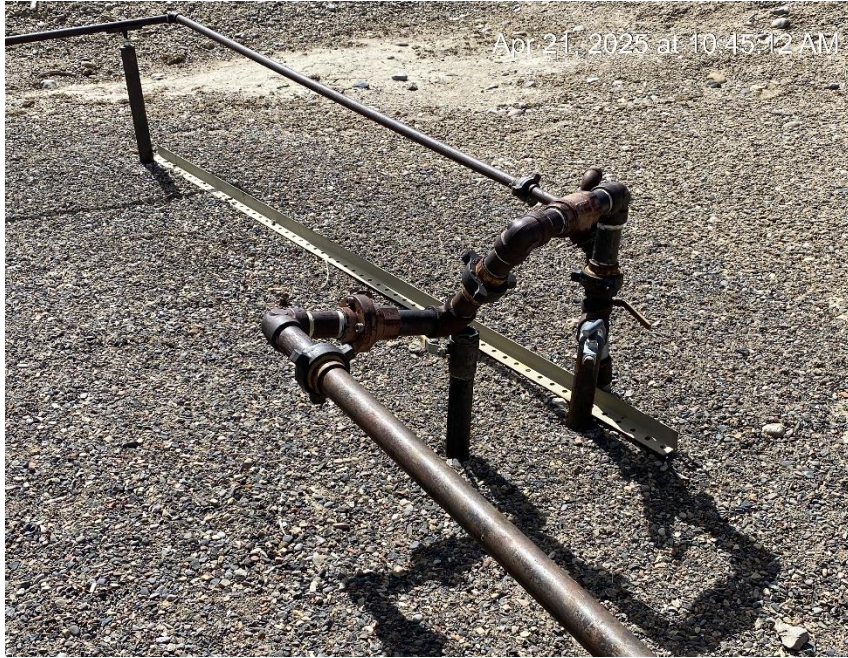
Debris

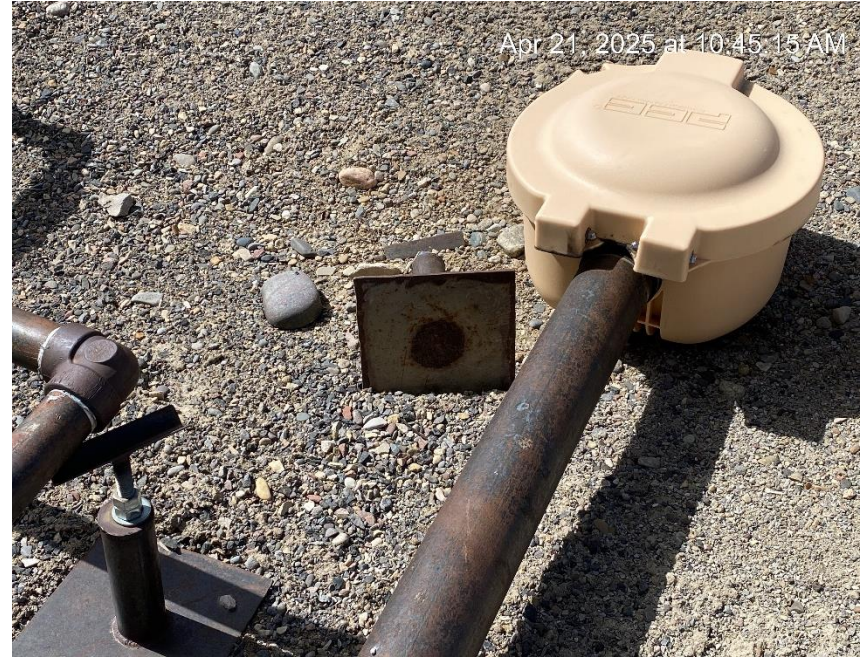
Debris

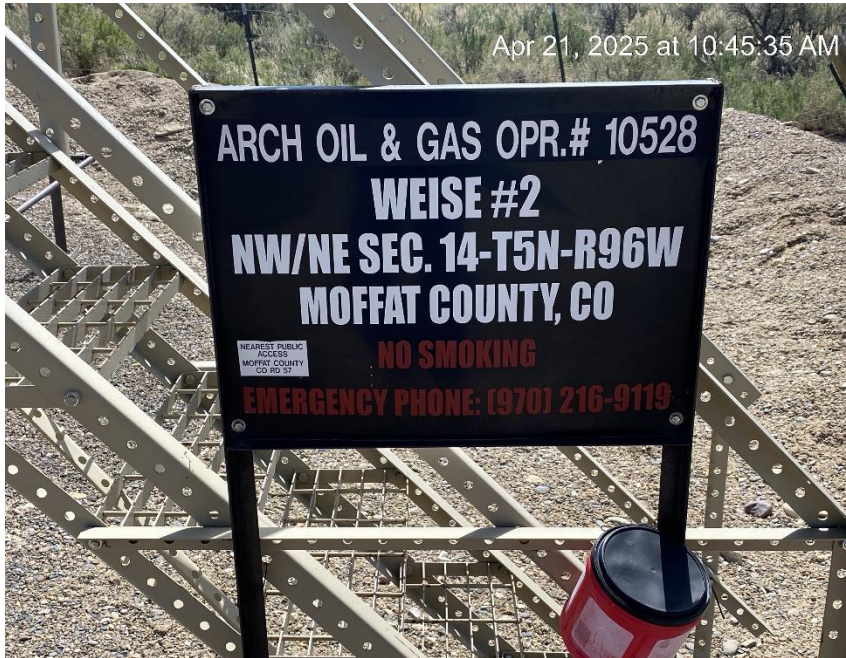
Missing required information

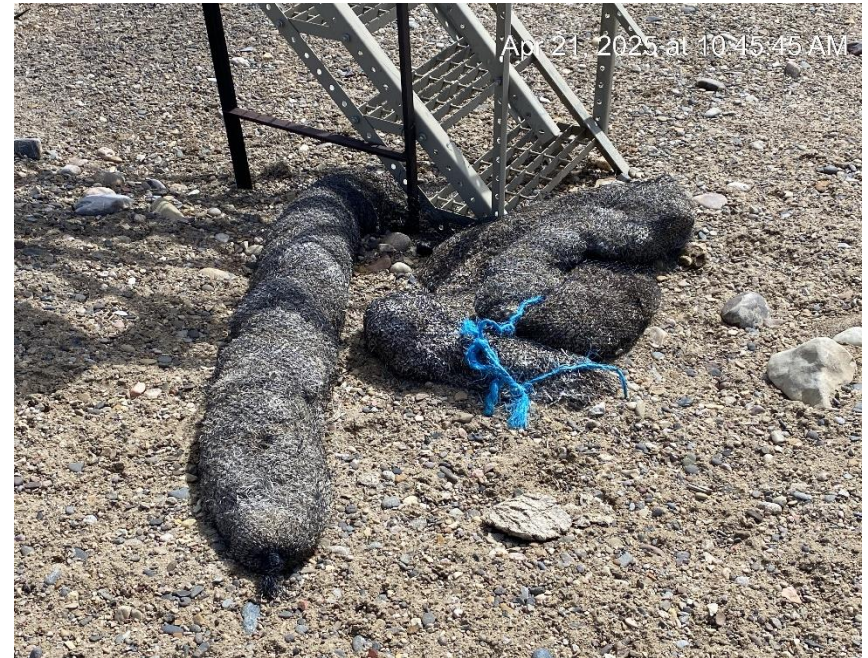
Debris

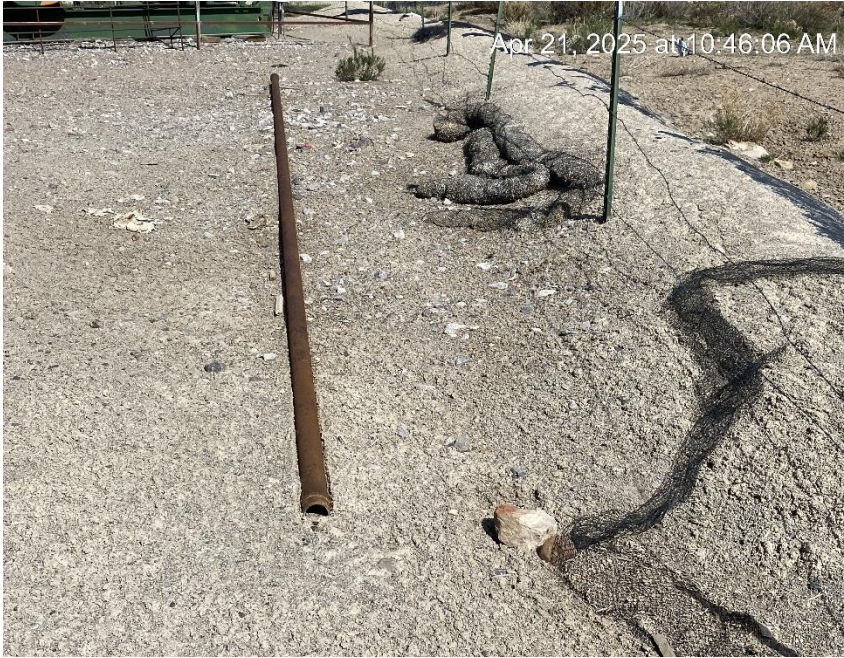
Debris

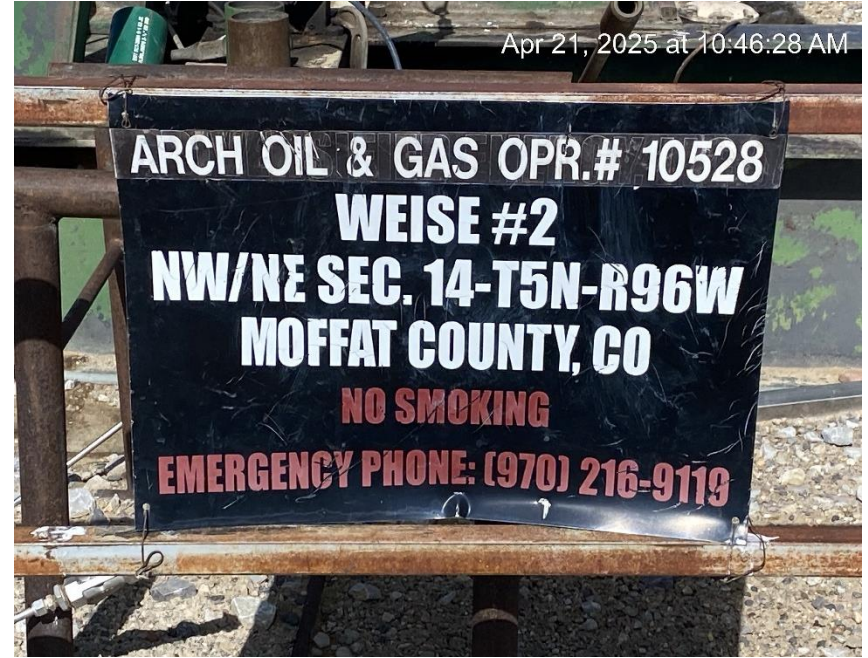
Missing required information

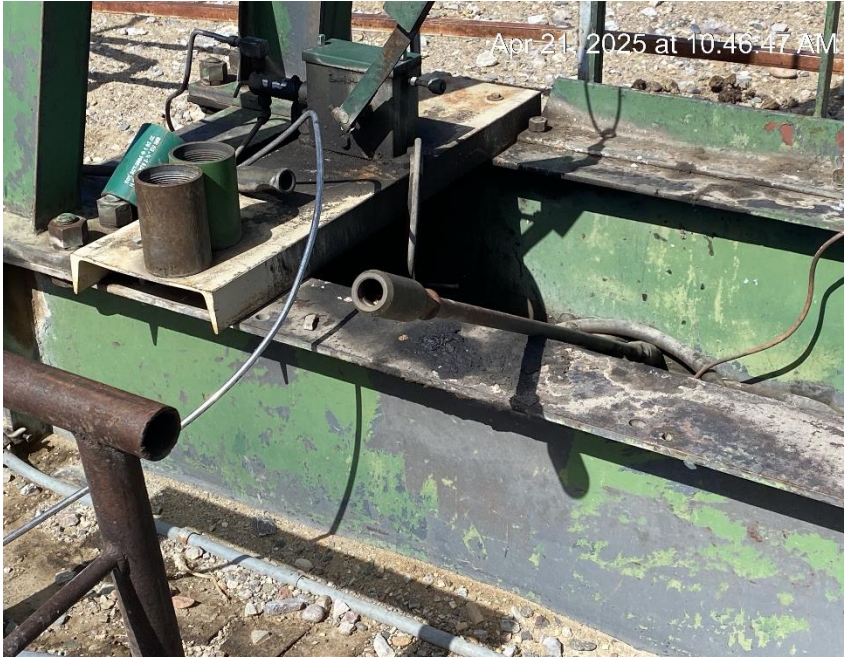
Debris

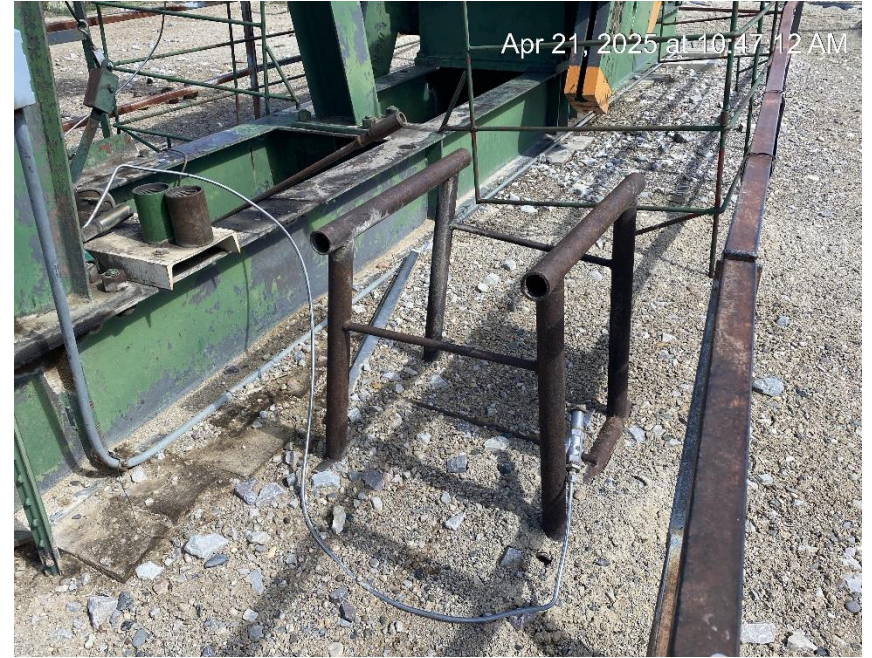
Debris

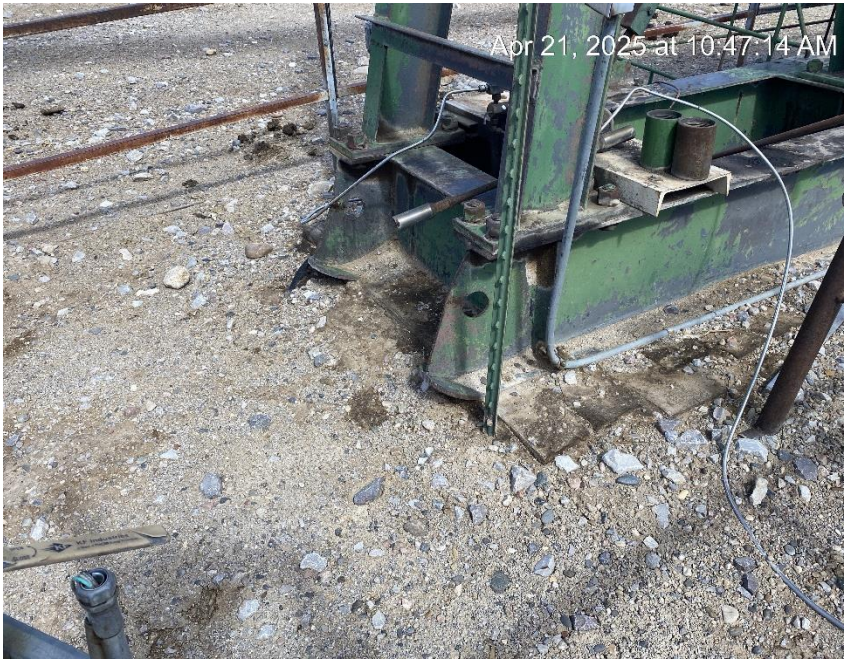
Debris. Stained soil.

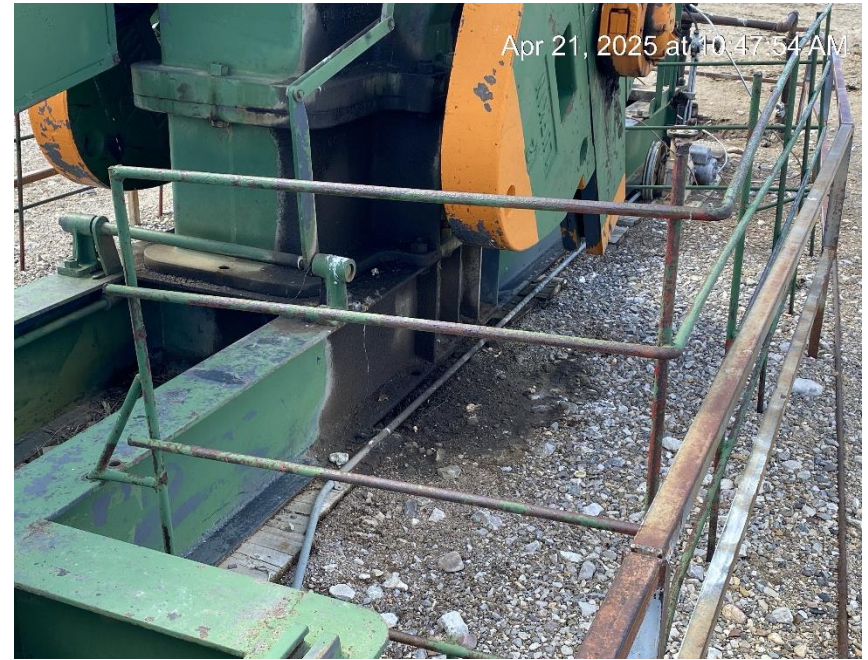
Leaking equipment with stained soil

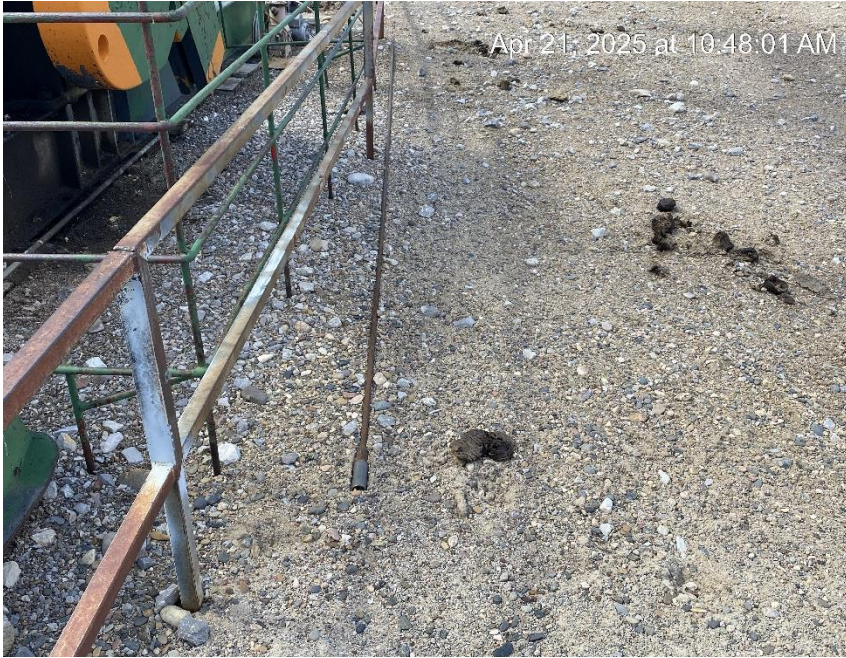
Debris

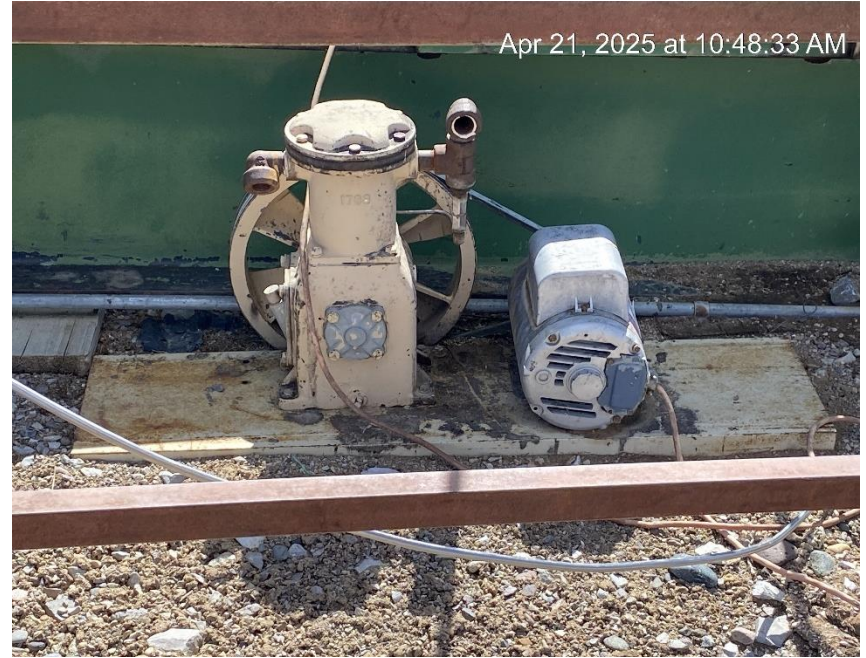
Debris

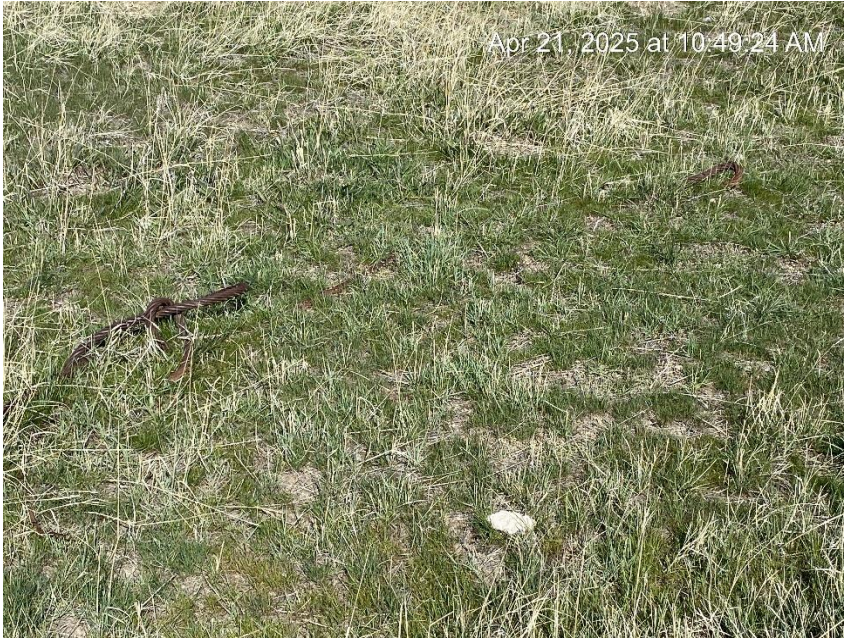
Debris

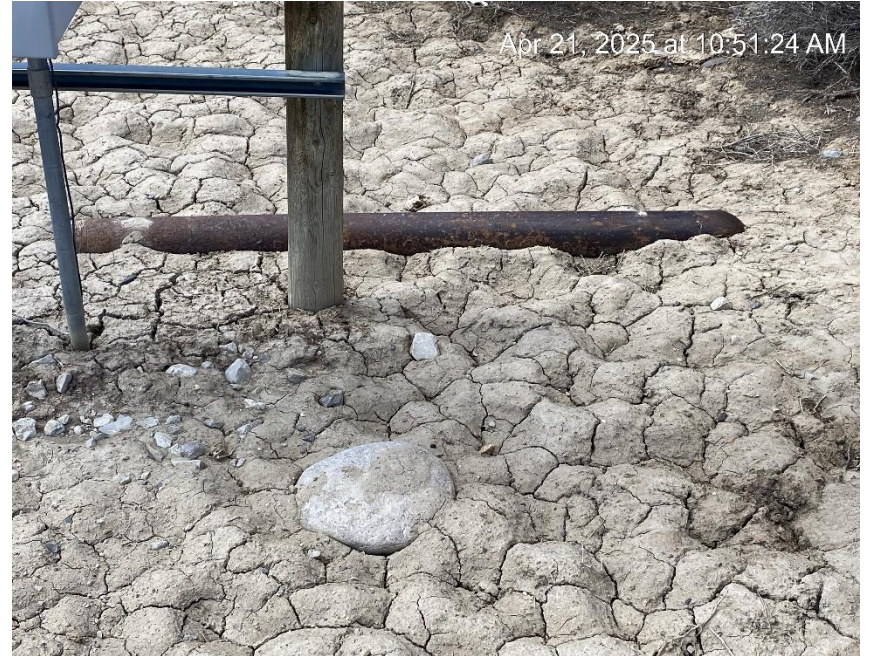
Debris

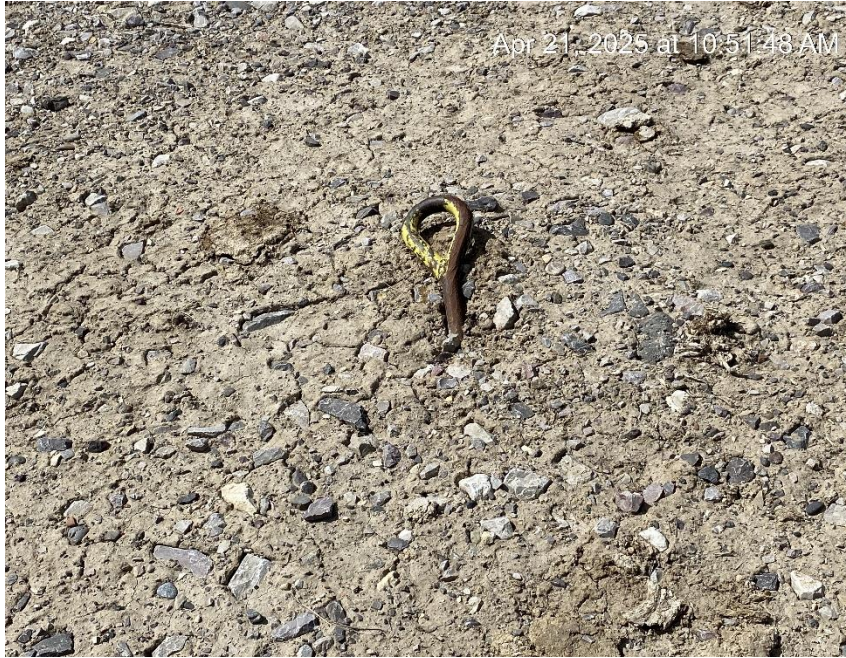
Unmarked anchor
