**Inspection/Audit Photos**  
**Location Name: QB Energy SCHWARTZ (O2E) Pad**  
**Location #: 334740**

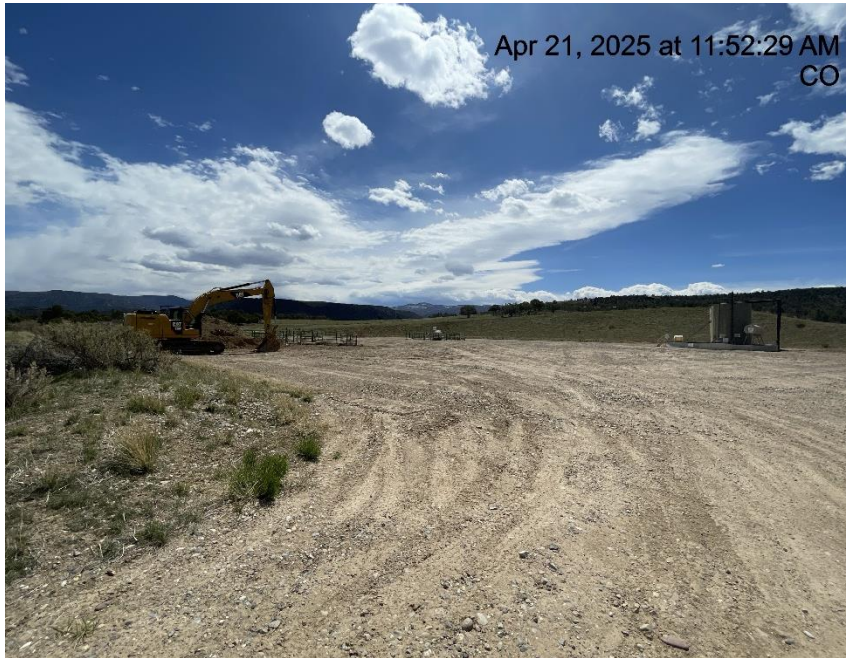
**Photo # 3546 From entrance to location**

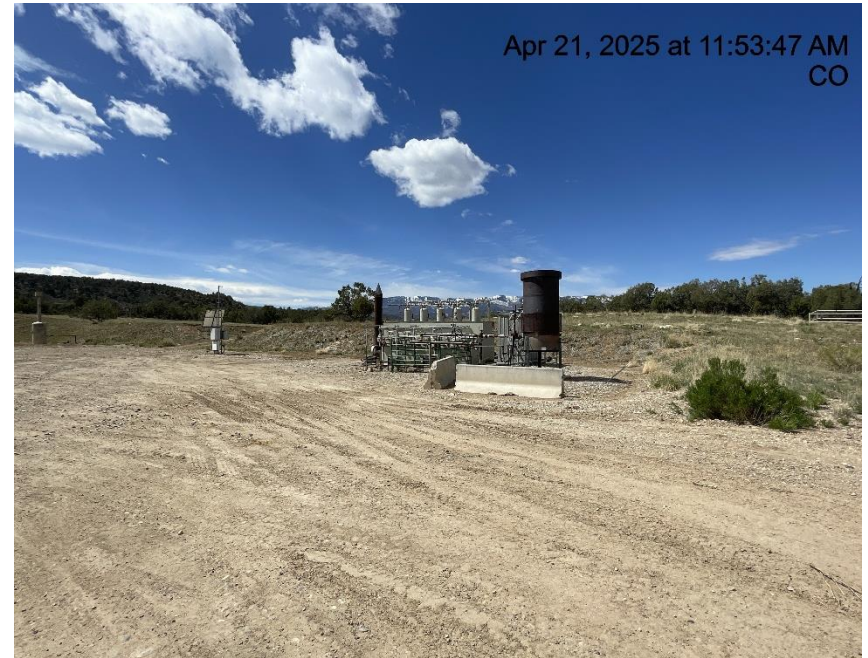
**Photo # 3547 From entrance to location**

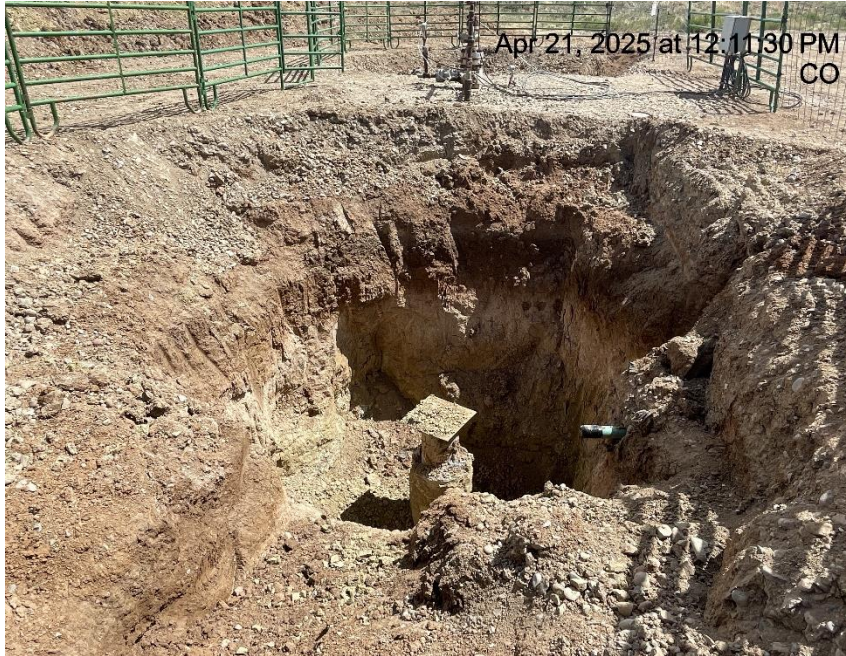
**Photo # 3558 Excavated area around SCHWARTZ 2-14A (O2E)**

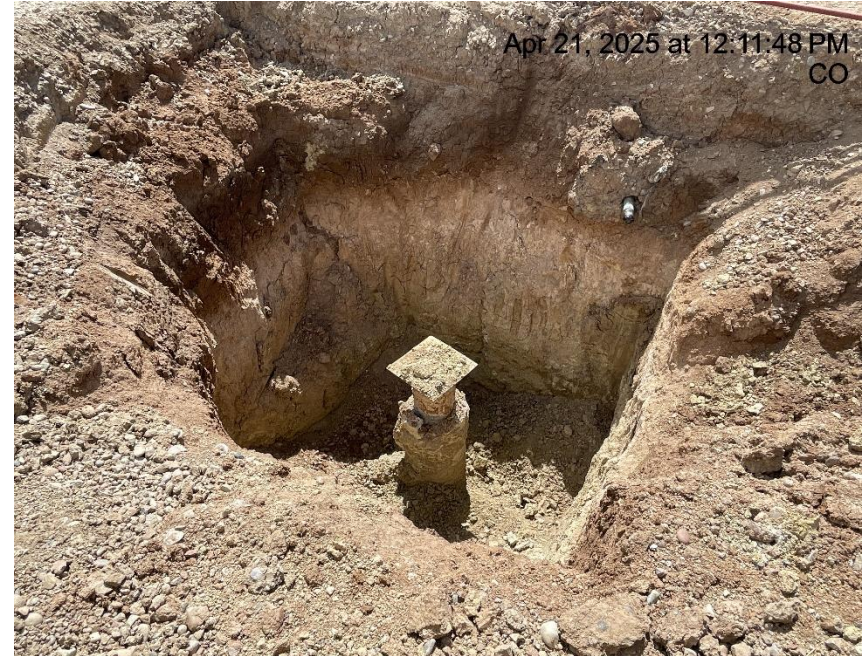
**Photo # 3559 Excavated area around SCHWARTZ 2-14A (O2E)**

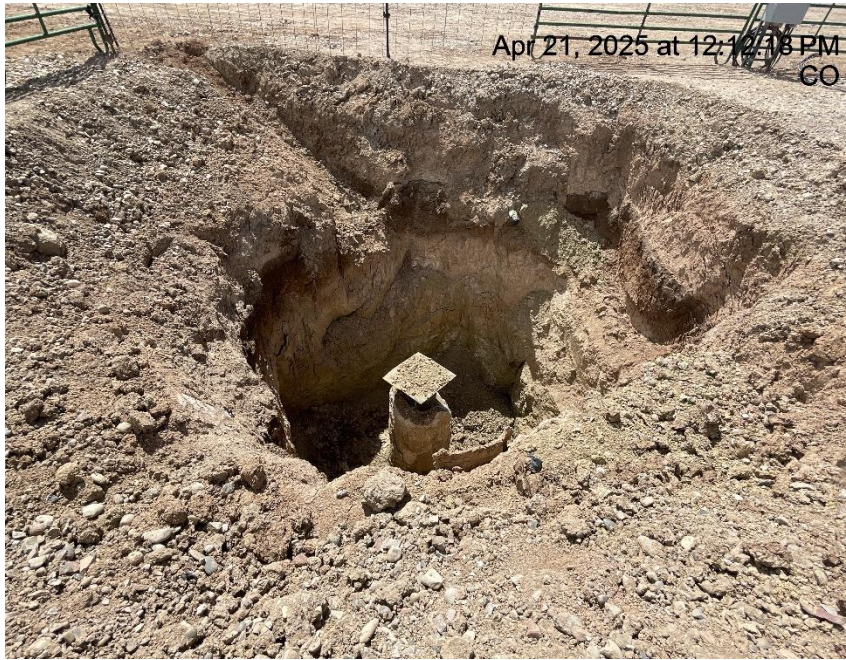
**Photo # 3560 Excavated area around SCHWARTZ 11-2A (O2E)**

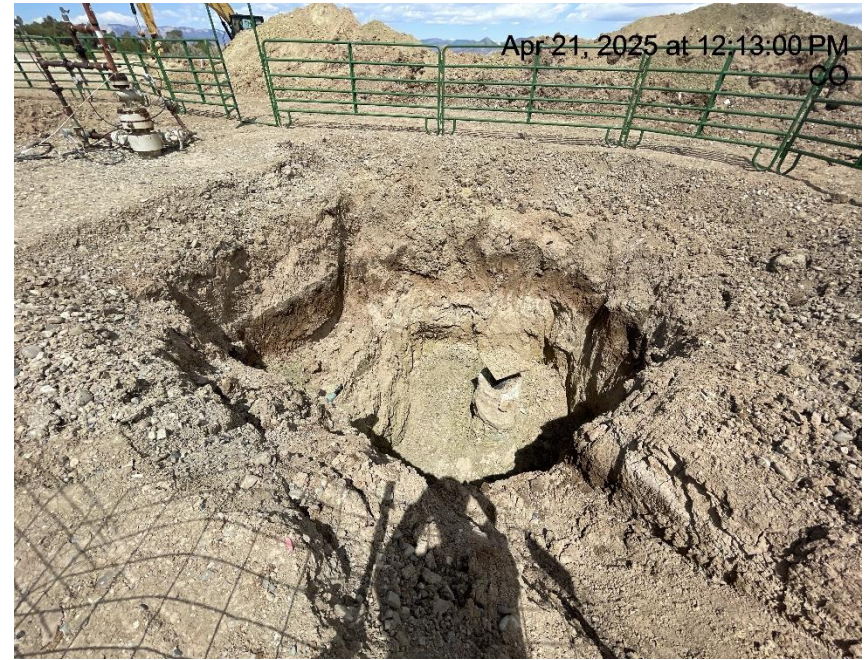
**Photo # 3561 Excavated area around SCHWARTZ 11-2A (O2E)**

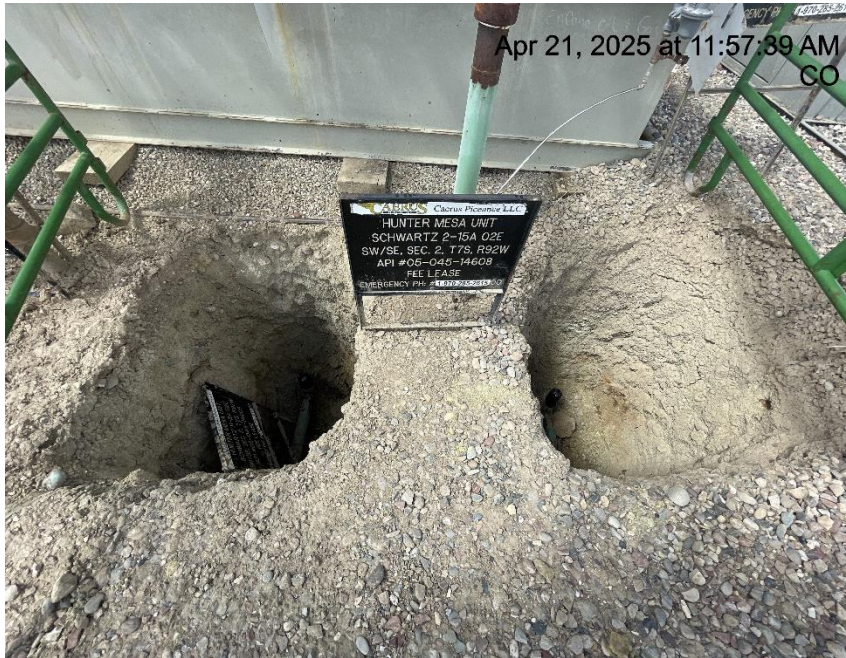
Photo # 3562 Excavated areas in front of separators lack wildlife egress/wildlife hazard

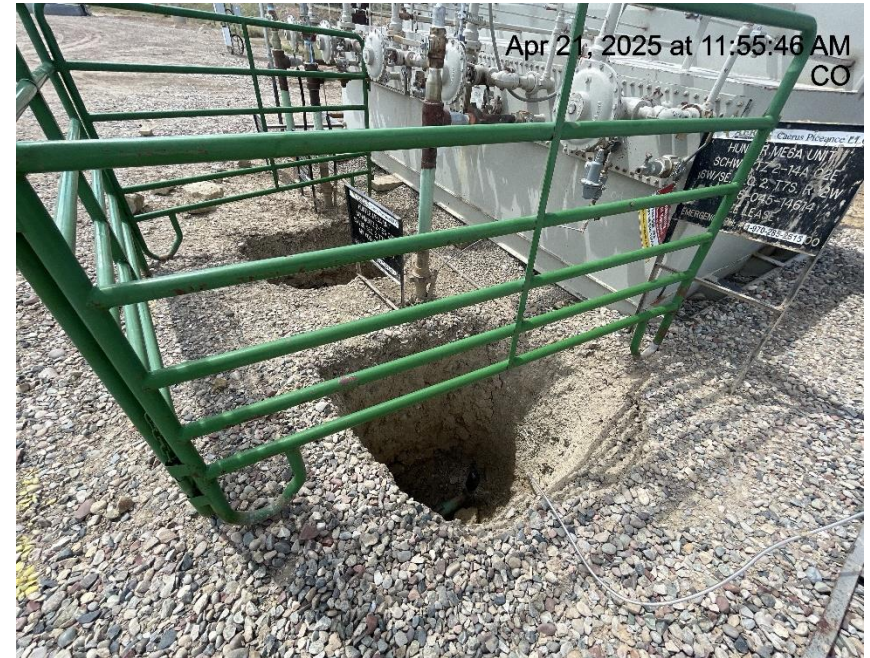
Photo # 3563 Excavated area in front of separators not fully enclosed by cattle panels/wildlife hazard & personnel hazard

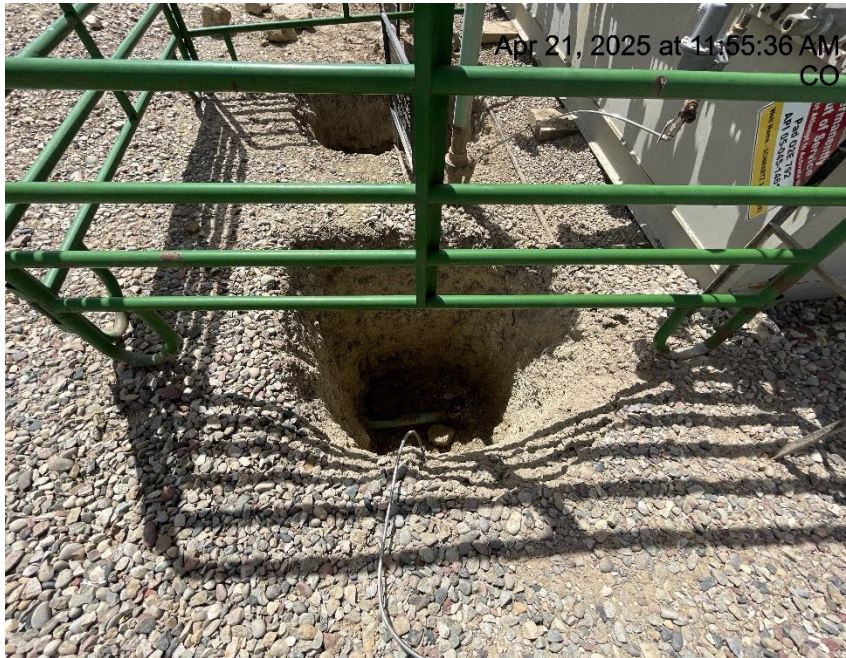
**Photo # 3564 Excavated area in front of separators not fully enclosed by cattle panels/wildlife hazard & personnel hazard**

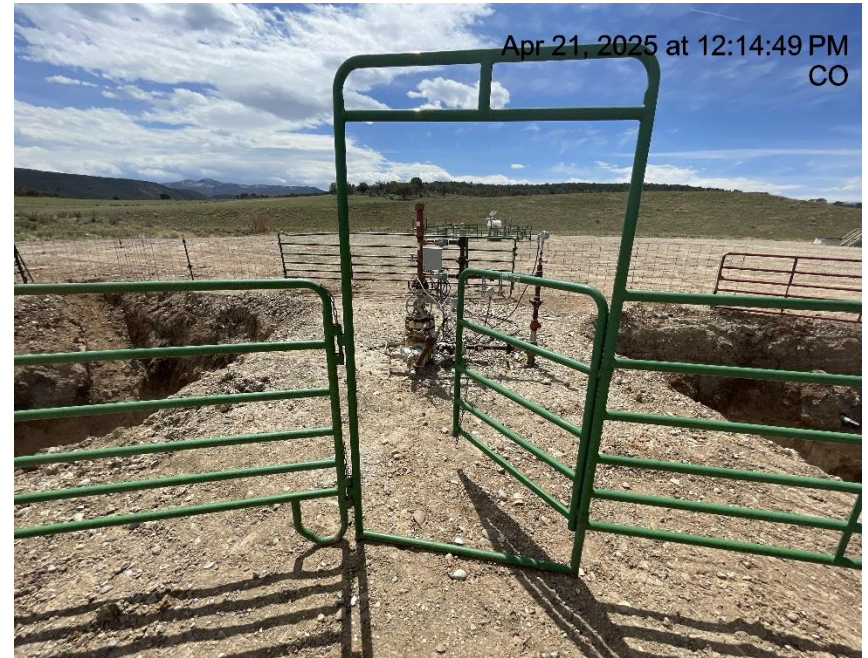
**Photo # 3565 Gate for panels around wellhead excavation areas open/wildlife hazard/available for entry by wildlife**

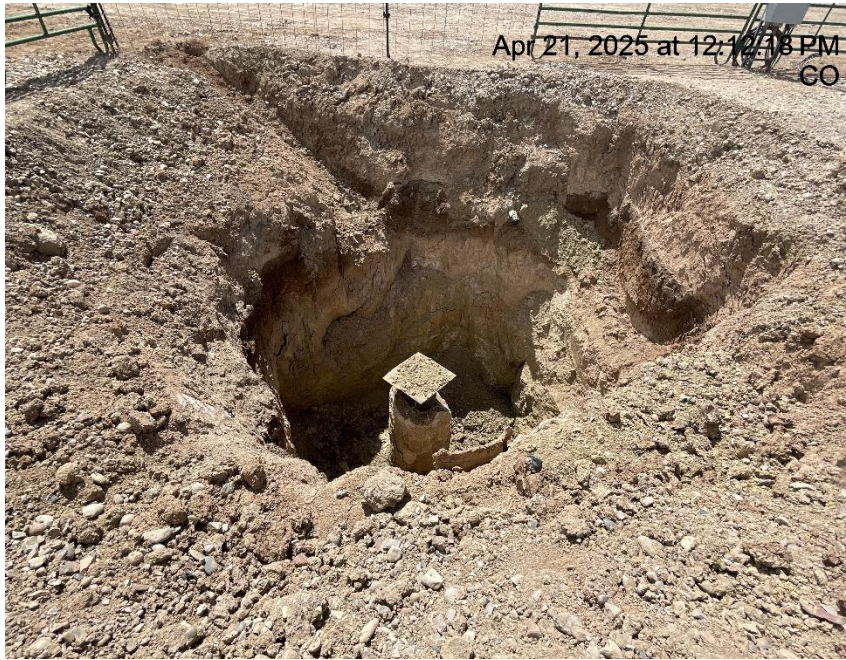
**Photo # 3566 Excavated area around wellhead lacks wildlife egress/wildlife hazard**

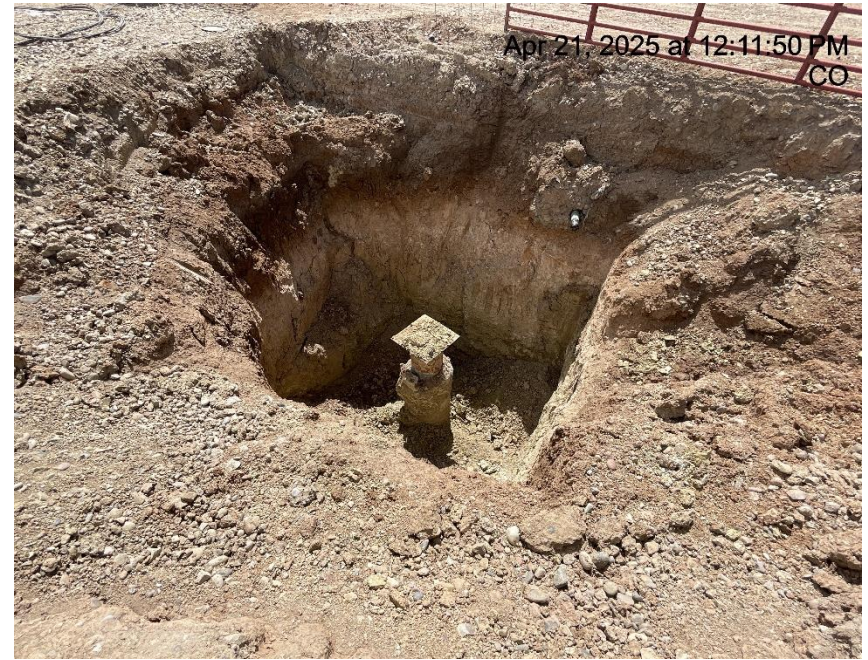
**Photo # 3567 Excavated area around wellhead lacks wildlife egress/wildlife hazard**

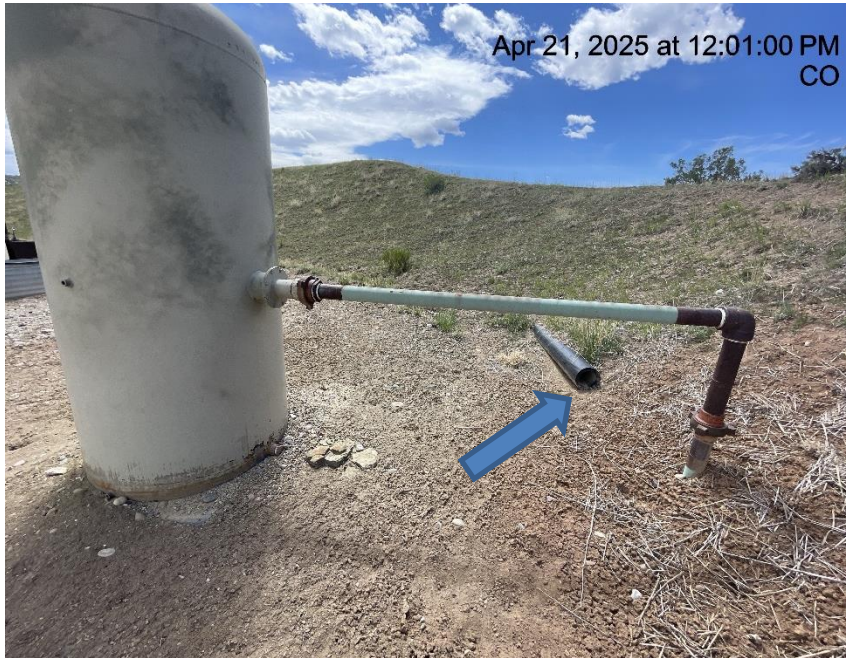
**Photo # 3568 Poly pipe open ended/wildlife hazard  
/available for entry by wildlife**

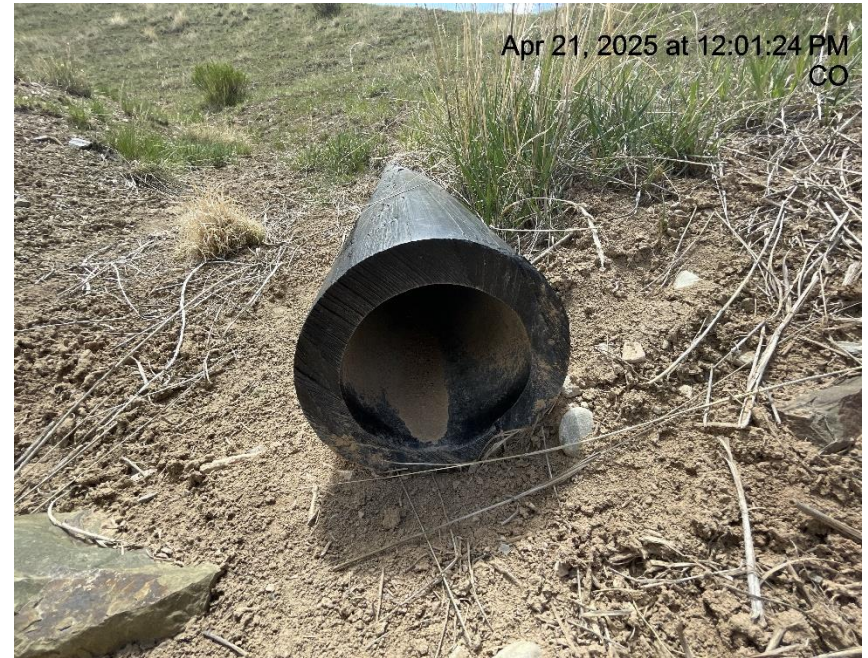
**Photo # 3569 Poly pipe open ended/wildlife hazard  
/available for entry by wildlife**

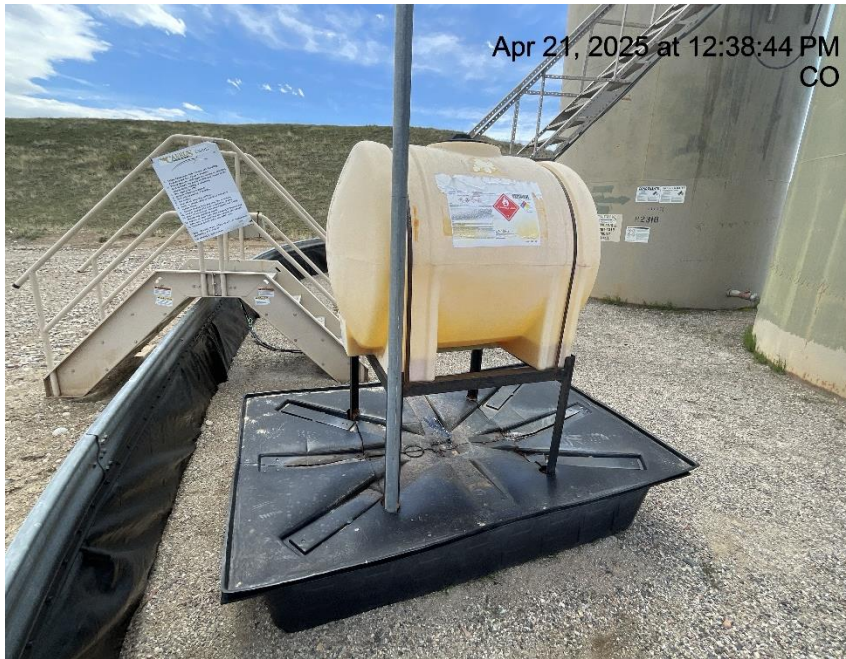
**Photo # 3570 Unused equipment**

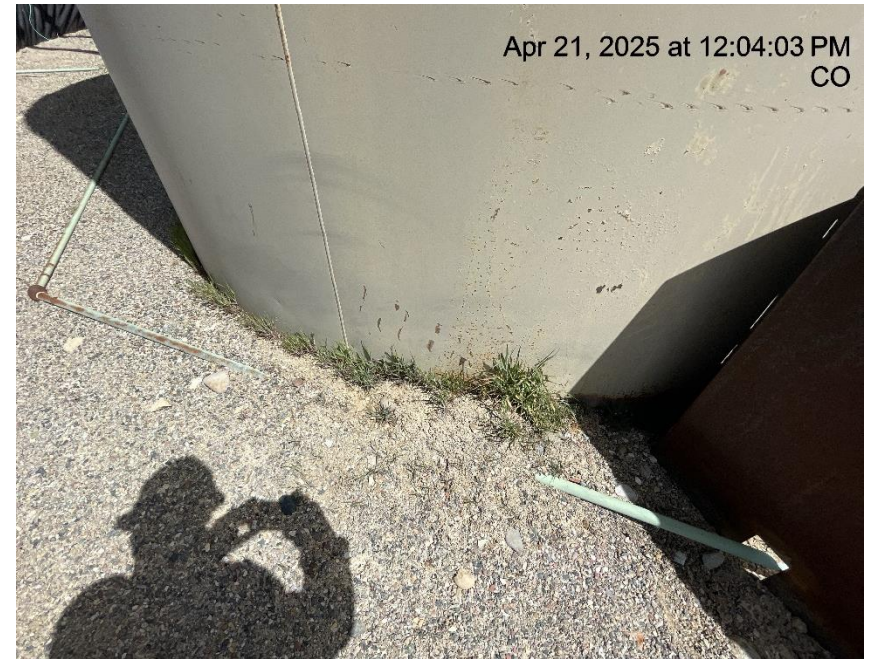
**Photo # 3571 Small amount of weeds in secondary containment**

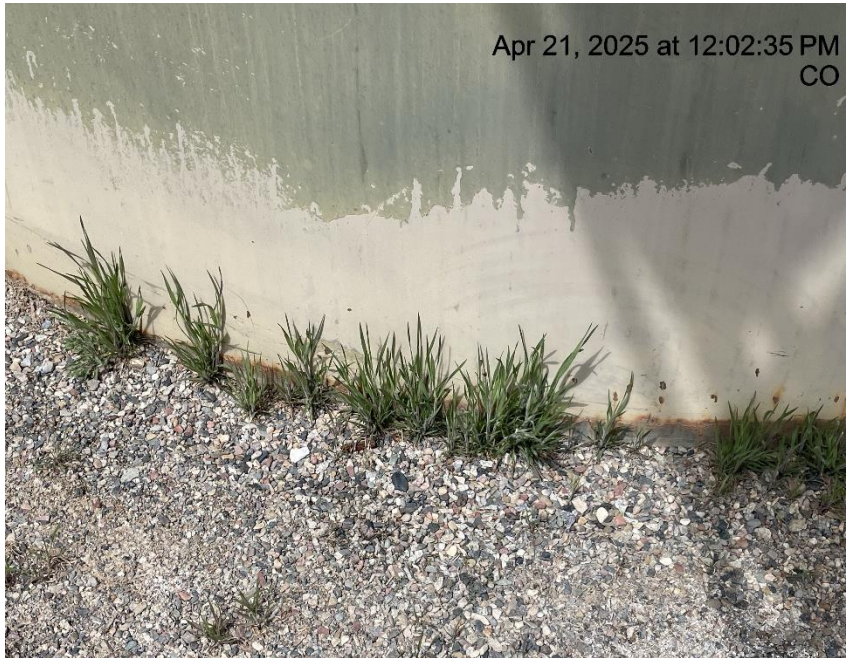
**Photo # 3572 Small amount of weeds in secondary containment**

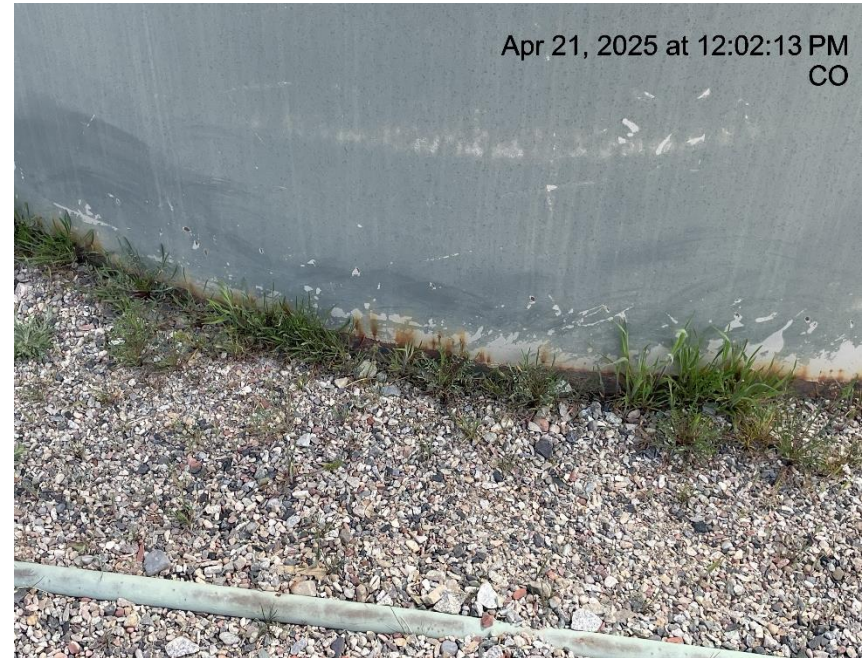
**Photo # 3573 Small amount of weeds in secondary containment**

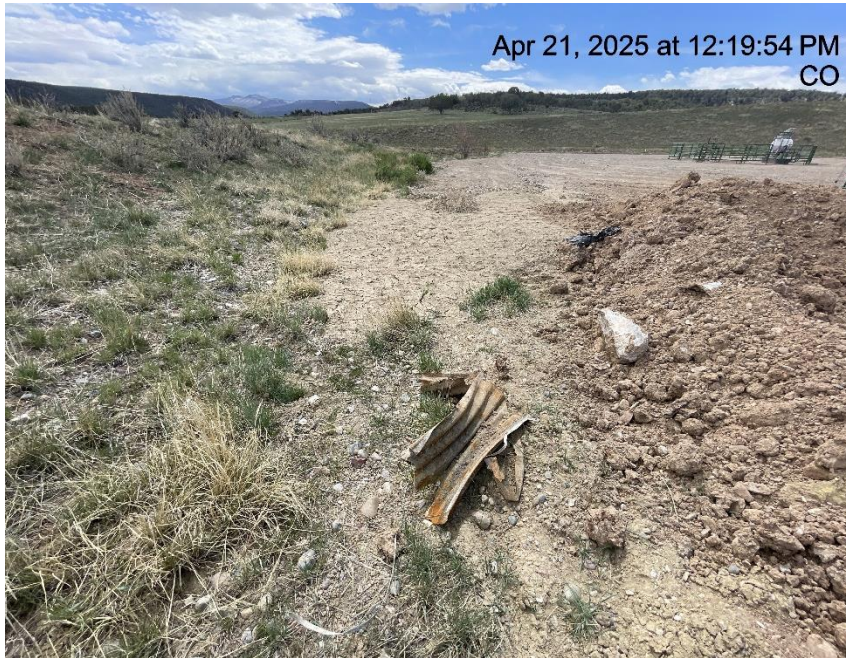
**Photo # 3574 Debris**

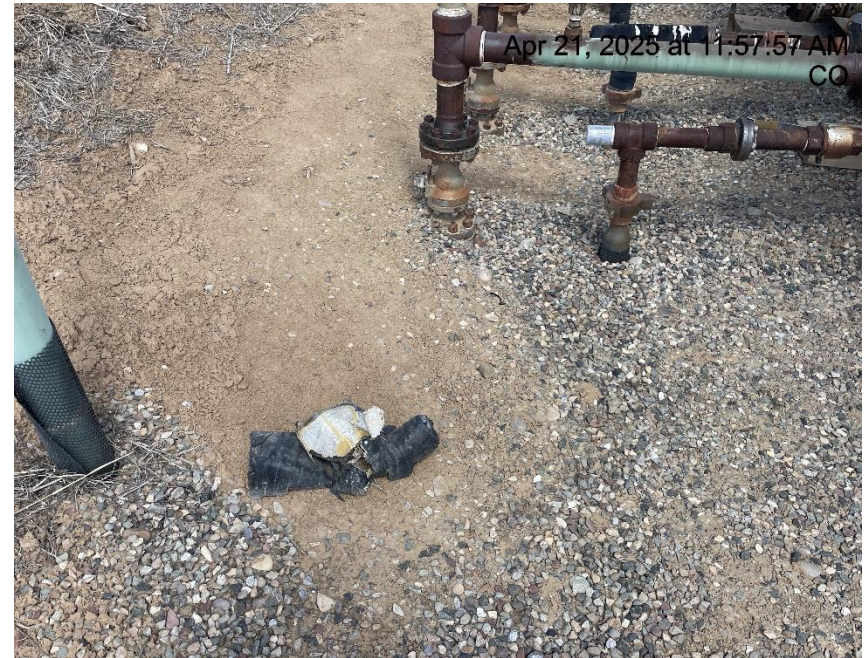
**Photo # 3575 Debris**
