Caerus
17F
Location ID: 335023

COLORADO
Energy & Carbon Management
Commission
Department of Natural Resources

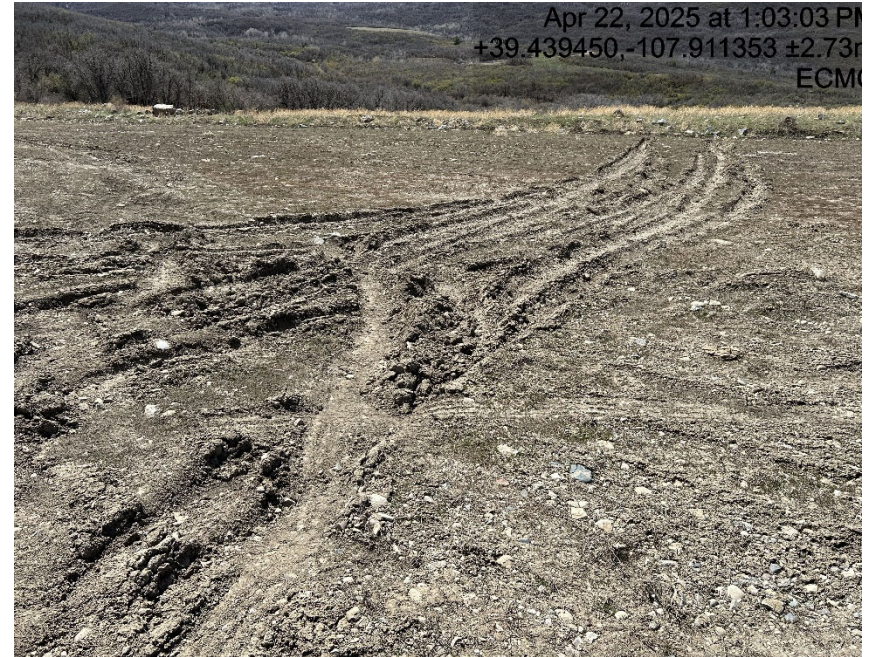
Lack of stabilization/compaction

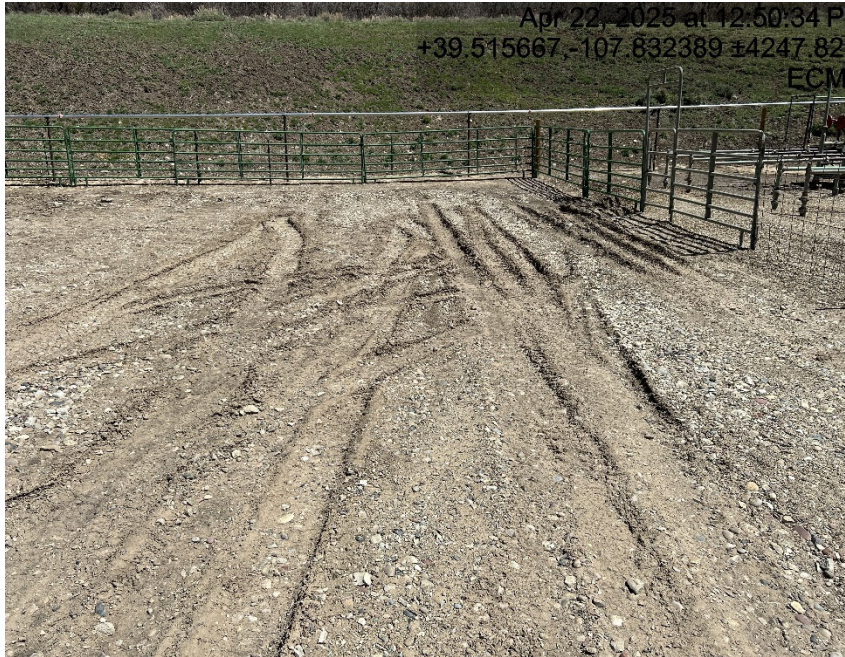
Lack of stabilization/compaction

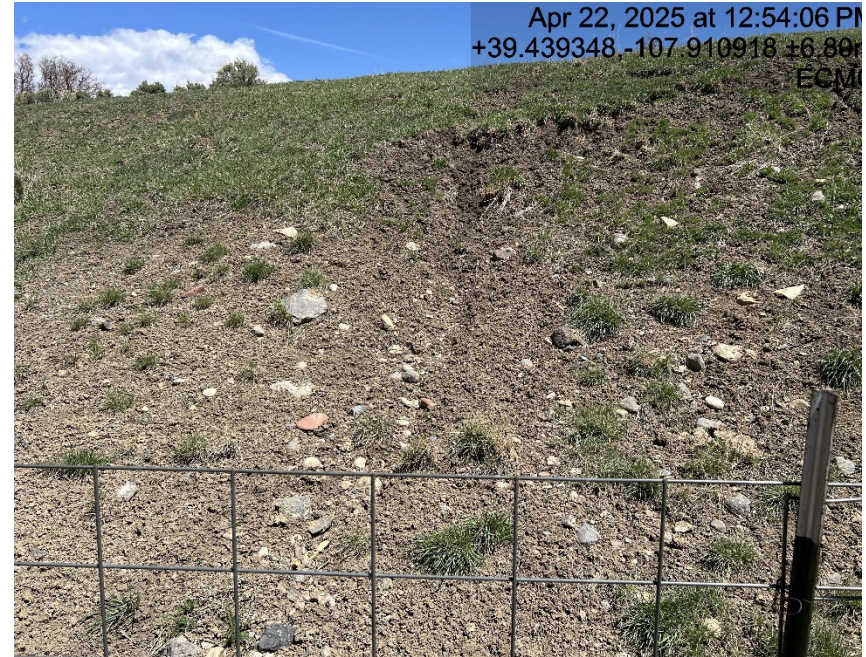
Erosion on cut slope by tank battery

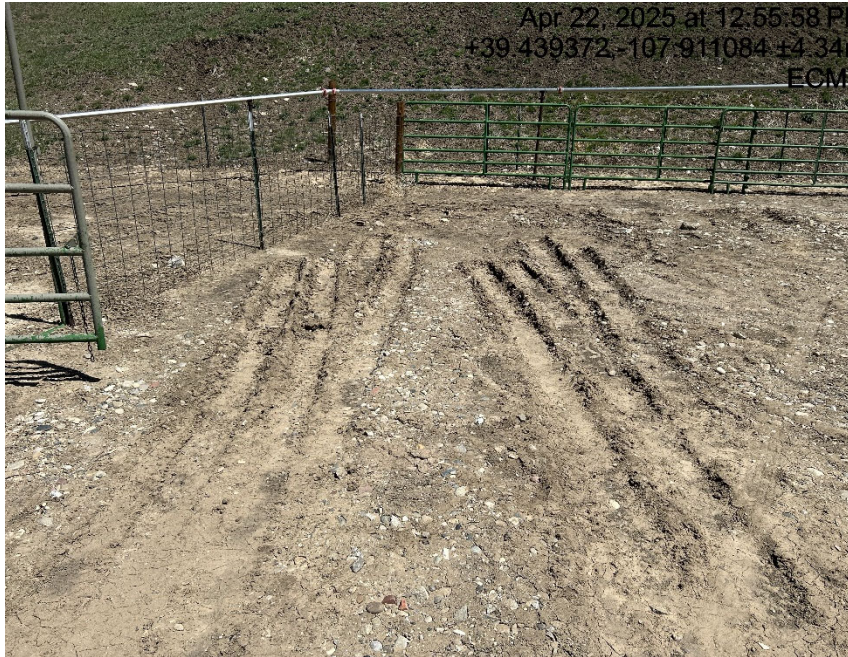
Lack of stabilization/compaction

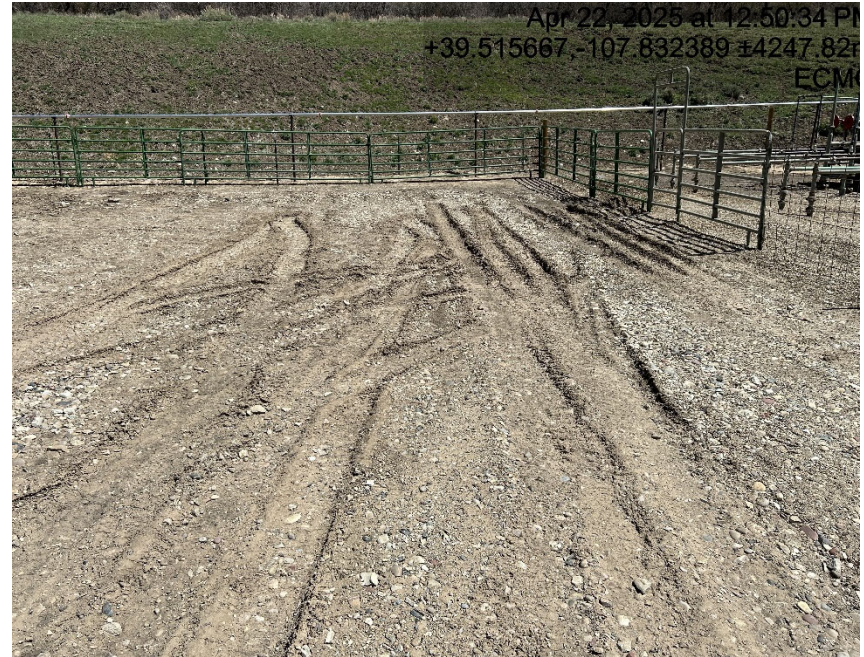
Lack of stabilization/compaction

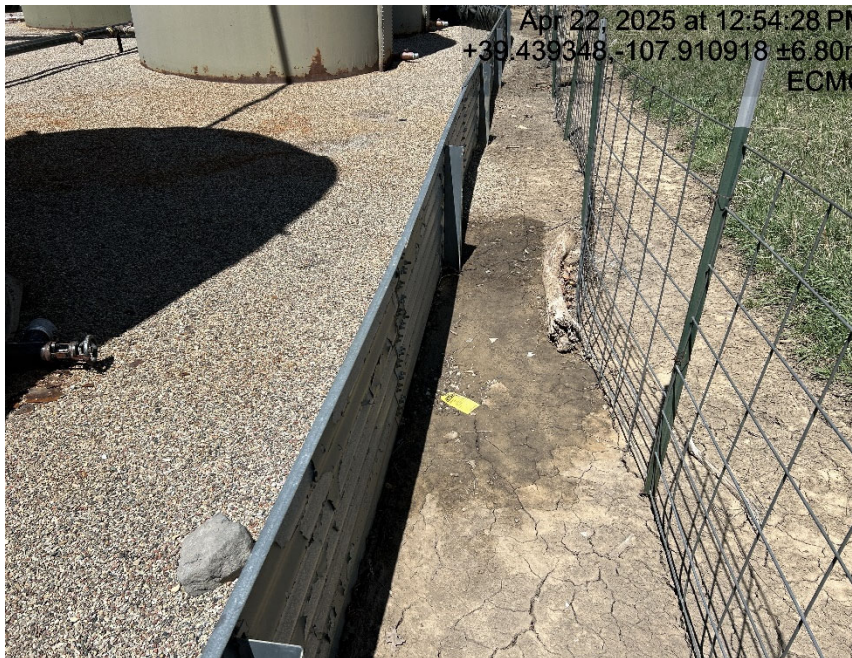
Staining?
