Inspection/Audit Photos

Location Name: TEP ROCKY MOUNTAIN LLC GIBSON GULCH UNIT 8-30 Pad

Location #: 335280

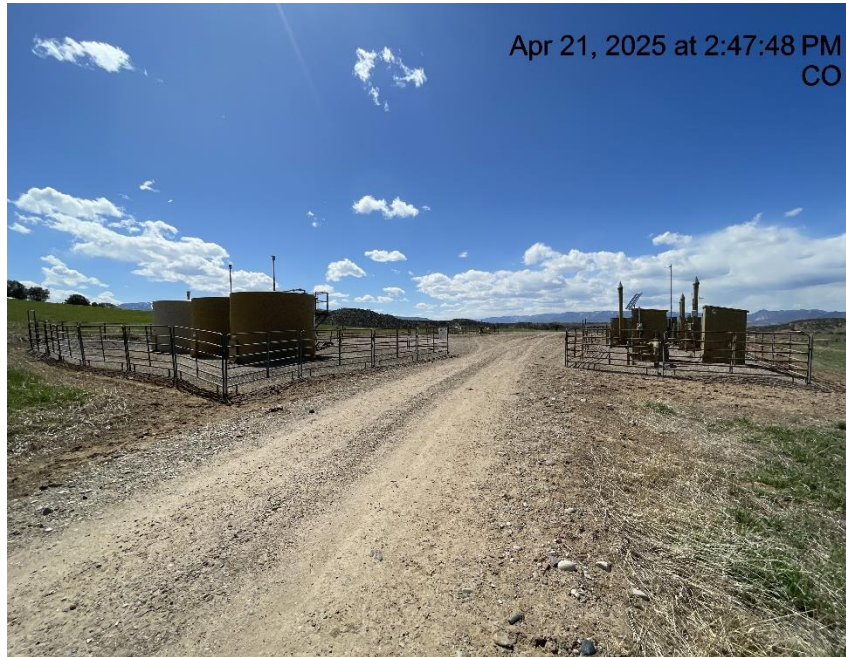
Photo # 4607 From entrance to location

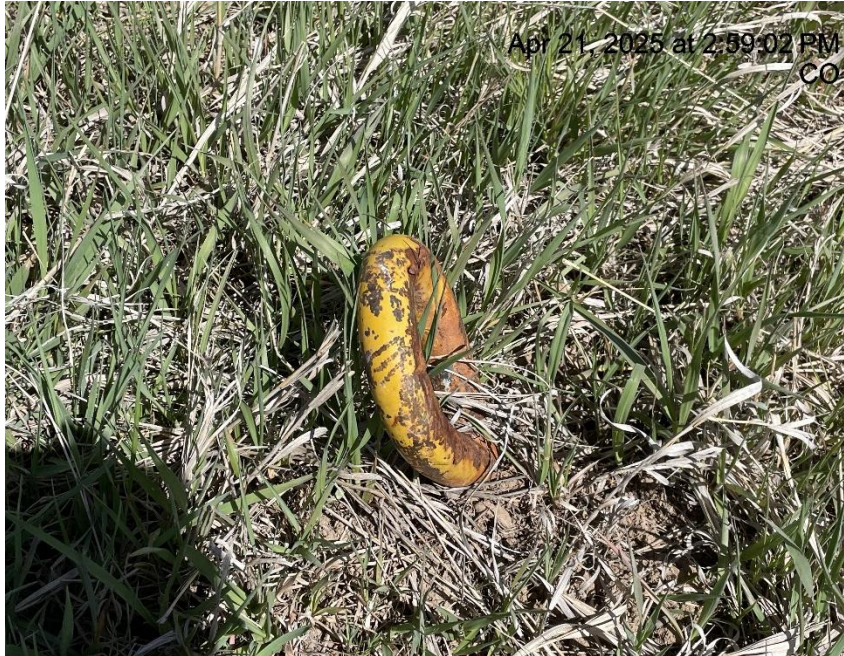
Photo # 4613 Unmarked deadman

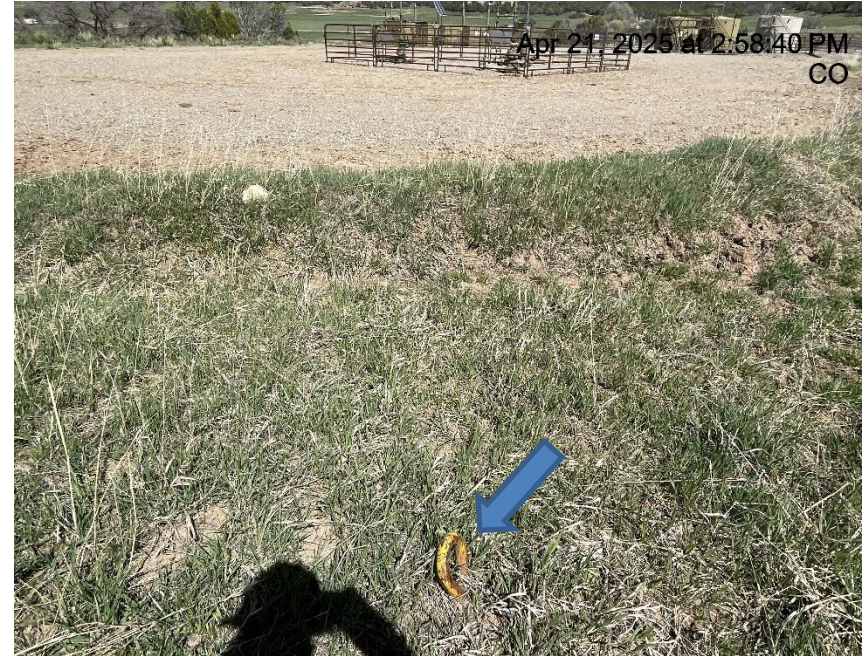
Photo # 4614 Same unmarked deadman

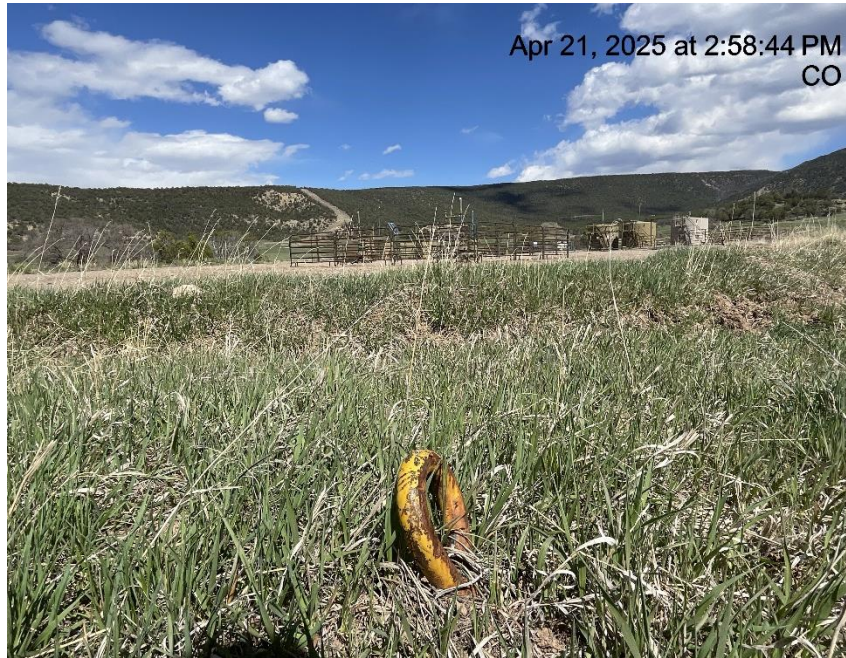
Photo # 4615 Same unmarked deadman from another angle

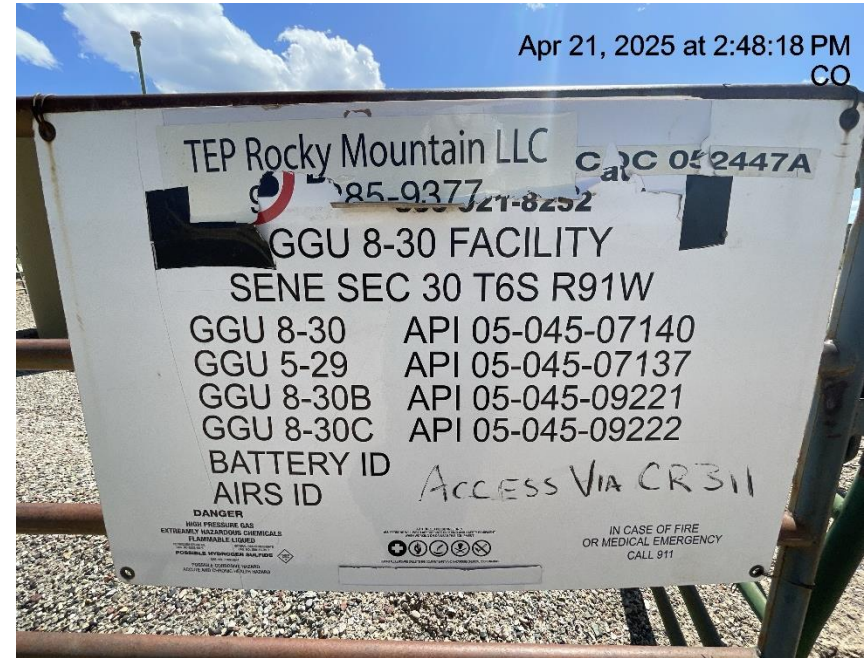
Photo # 4616 Battery sign damaged & some required information is illegible/not in compliance with CECMC rules

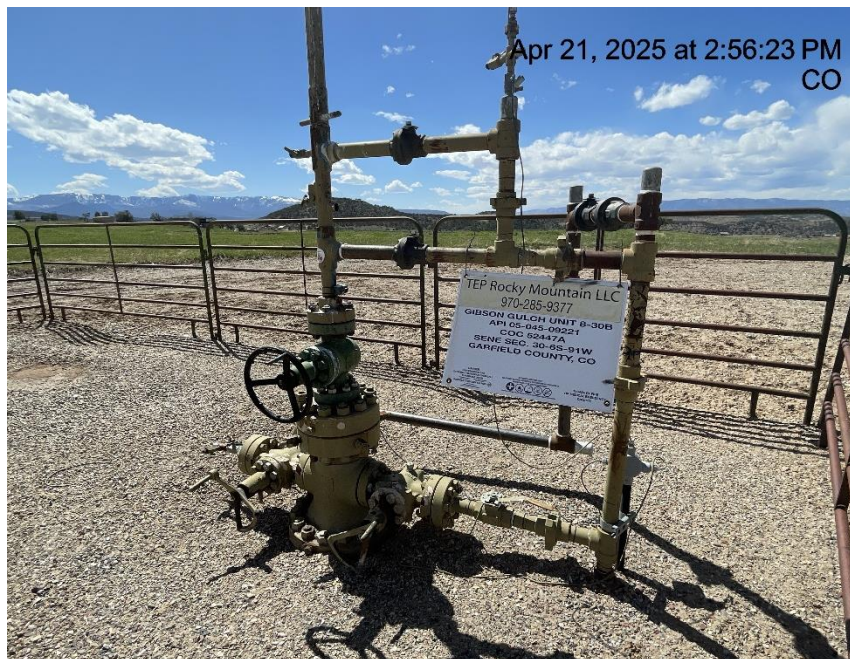
Photo # 4617 GIBSON GULCH 8-30B BH line connected to flowline

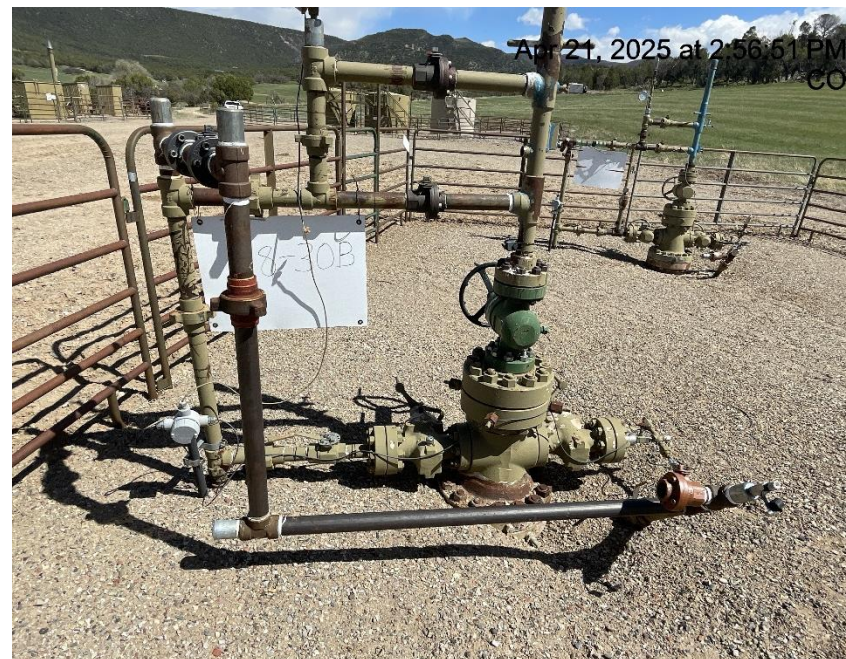
Photo # 4618 GIBSON GULCH 8-30B BH line connected to flowline

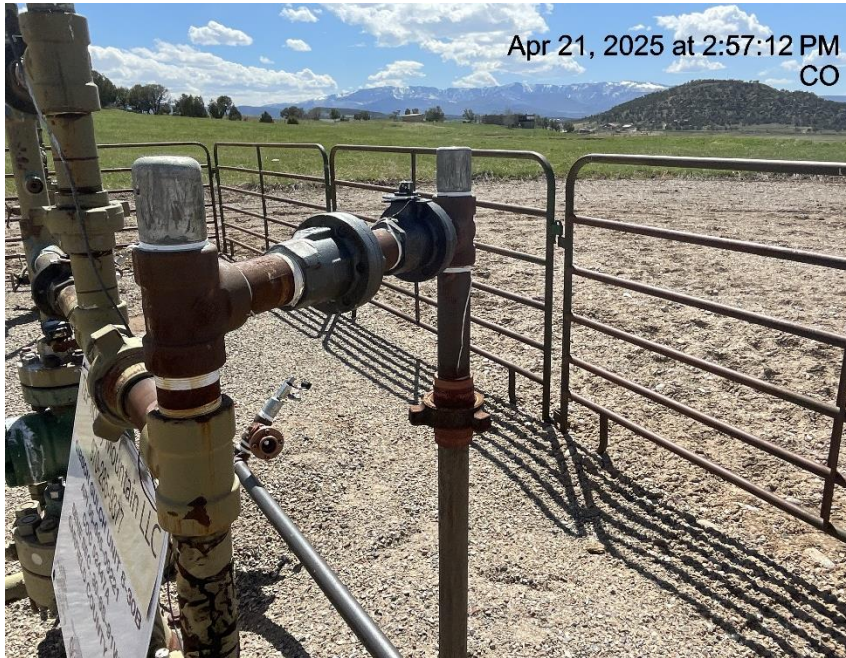
Photo # 4619 GIBSON GULCH 8-30B well - Ball valve on line connecting BH line to flowline appears to be shut

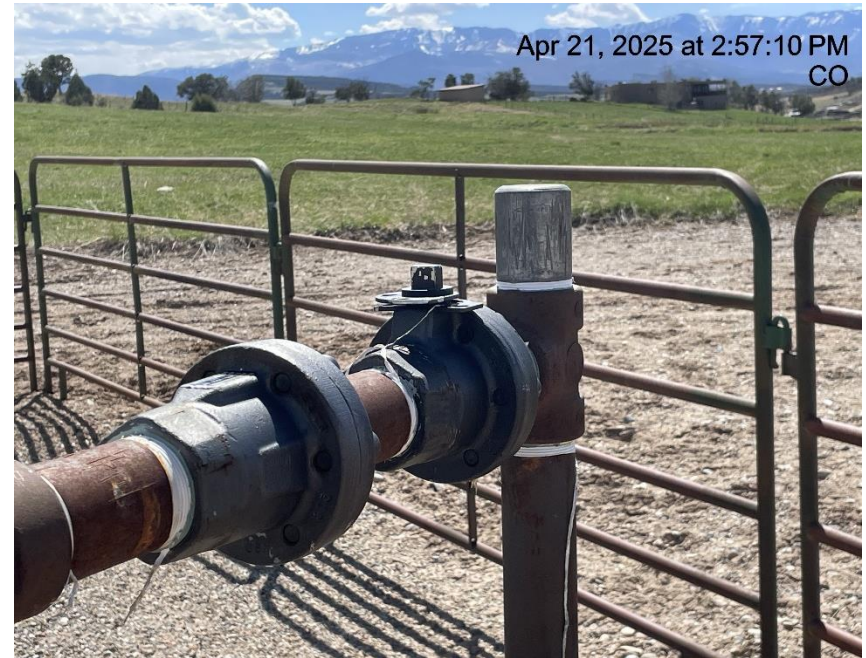
Photo # 4620 GIBSON GULCH 8-30B well - Ball valve on line connecting BH line to flowline appears to be shut

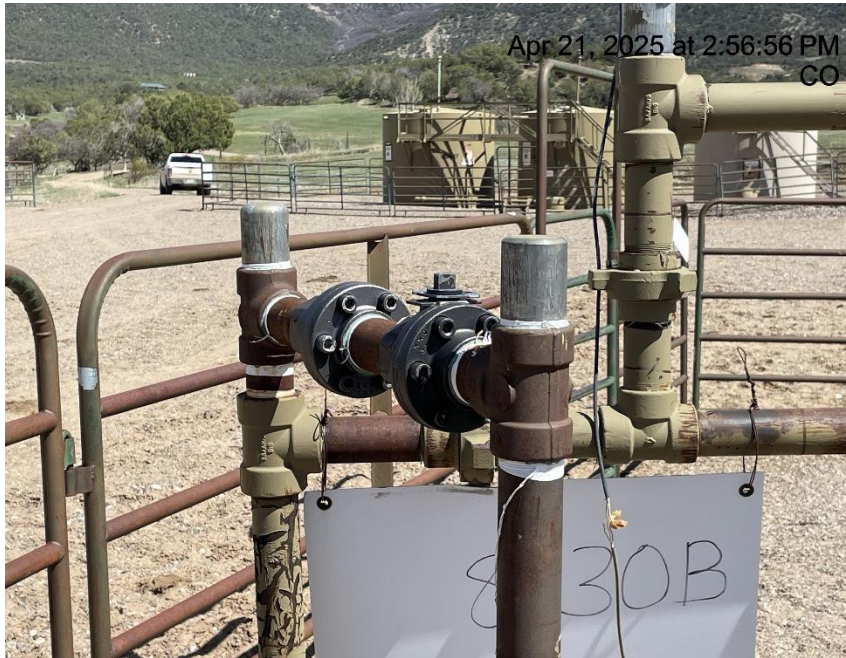
Photo # 4621 GIBSON GULCH 8-30B well - Ball valve on line connecting BH line to flowline appears to be shut

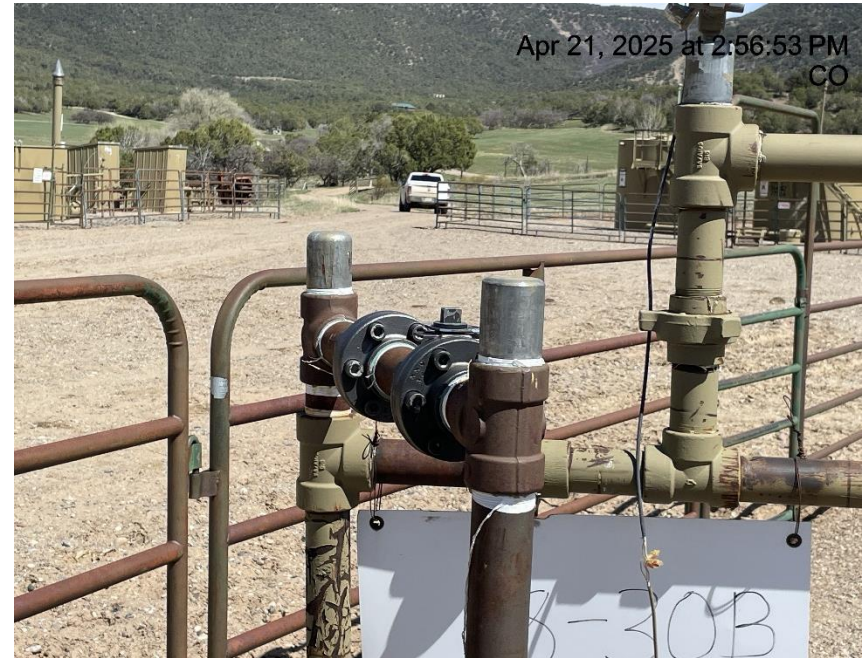
Photo # 4622 GIBSON GULCH 8-30B well - Ball valve on line connecting BH line to flowline appears to be shut
