## Inspection/Audit Photos

Location Name: TEP ROCKY MOUNTAIN LLC GIBSON GULCH UNIT 13-20A

Location #: 335339

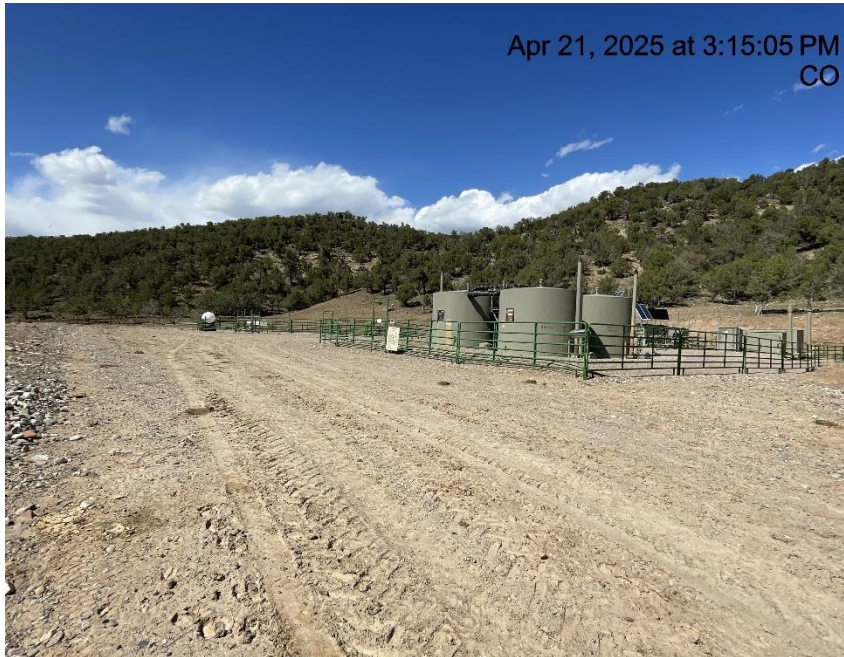
Photo # 4738 From entrance to location

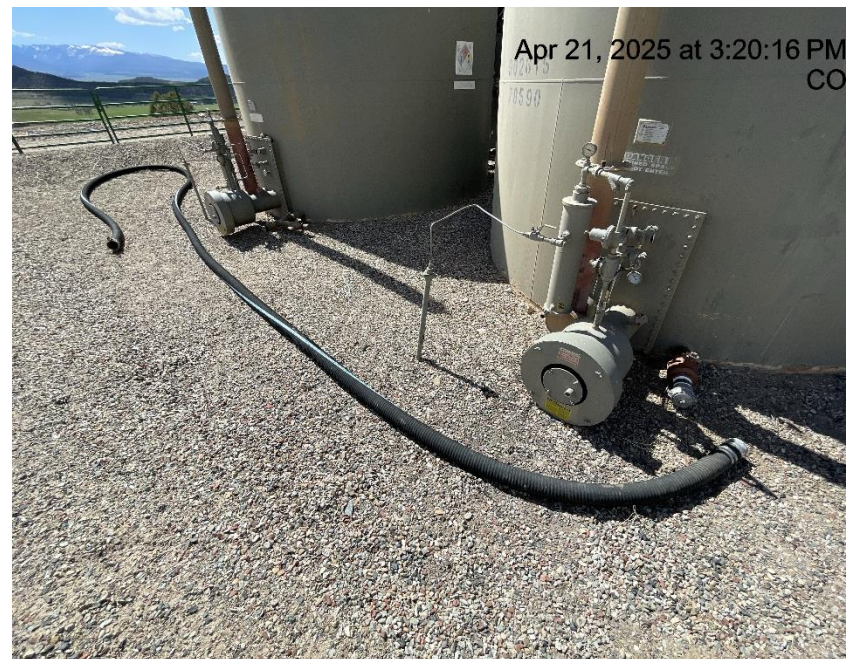
Photo # 4745 Unused hose in secondary containment

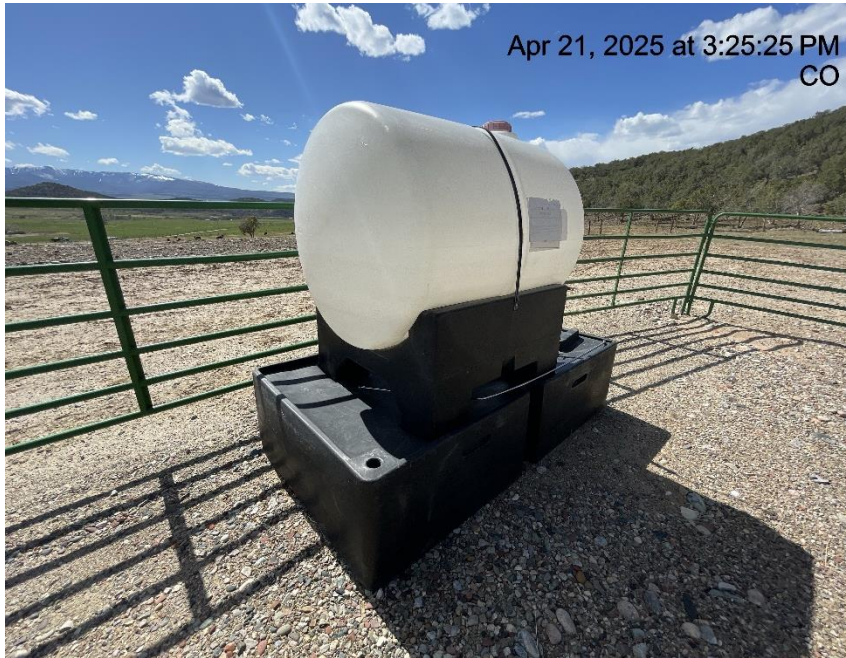
**Photo # 4746 Chemical tank disconnected & not in use/  
unused equipment**

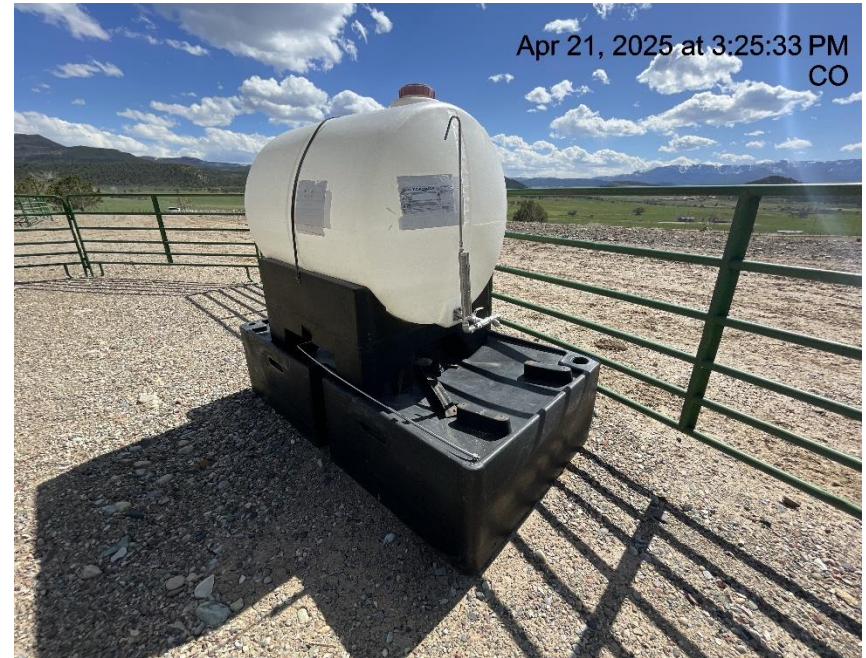
**Photo # 4747 Chemical tank disconnected & not in use/  
unused equipment**

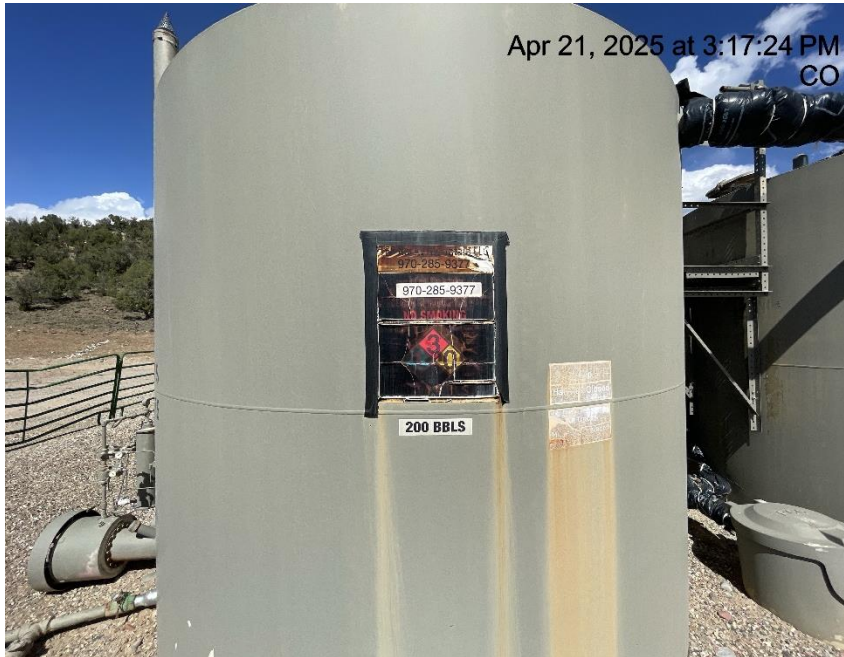
**Photo # 4748 Tank label weathered & some required information is illegible/not in compliance with CECMC rules**

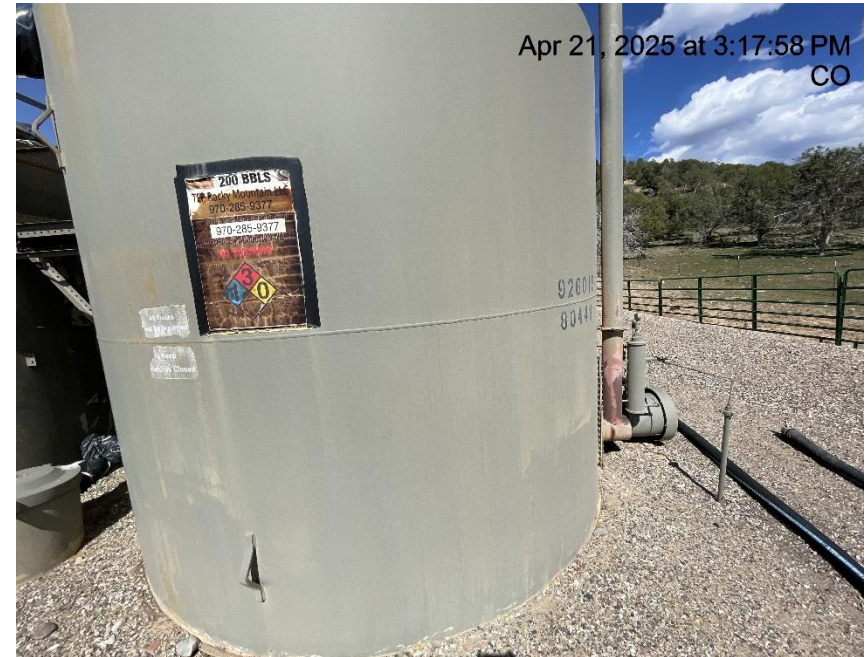
**Photo # 4749 Tank label weathered & some required information is illegible/not in compliance with CECMC rules**
